HS2 WPO29 – Historic Environment Works – Washwood Heath Depot – Enabling Works North Contract

Final Report for Historic Building Recording Survey

Document no.: 1EW04-LMJ-EV-REP-NS03_NLo8-029001

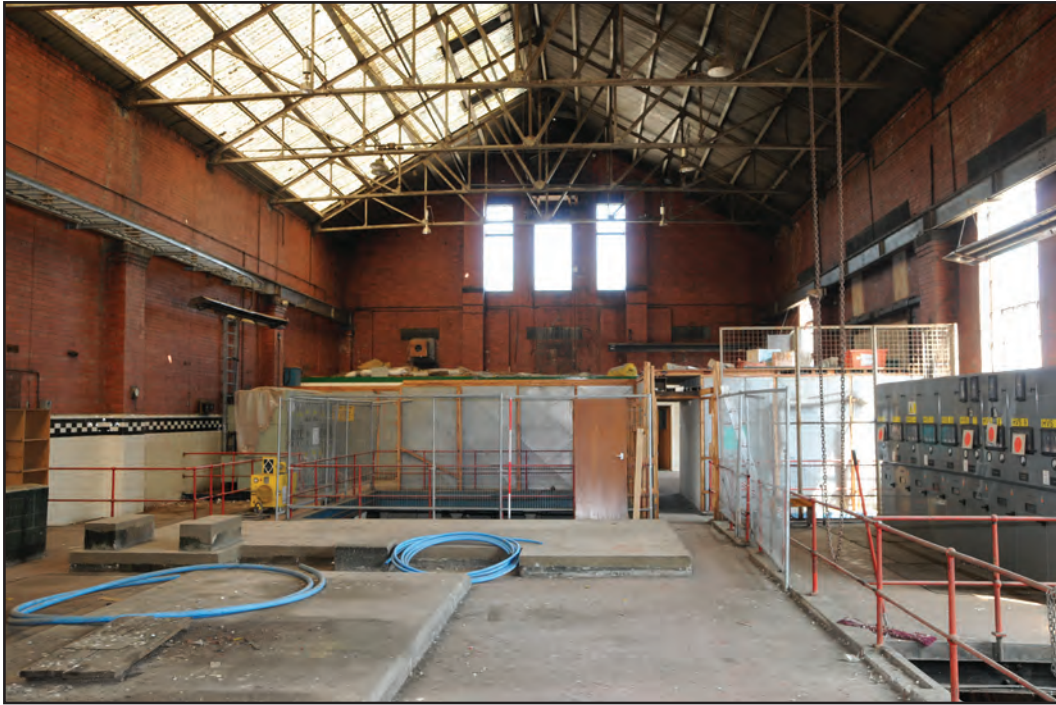
Photograph No. Washwood054

Description: Engine house cast-concrete and parquet brick floor

Site Location: C6c

- 6.2.25 Protruding through the steel plate floor there are the tops of machine beds (Washwood054: Appendix C), which are best appreciated for their size and construction from the basement level (Washwood061: Appendix C). At this level, there are the remains of reinforced cast concrete engine beds, brick piers and steel stanchions reinforcing the walkways above, and in the south-east corner of the room there is a large cylinder head cast by the Brightside Foundry in Sheffield with a reducing drive mechanism (Washwood63: Appendix C). The engine beds are likely to be from the earliest phase of construction of the site. The cast-iron stairs tiling are also likely to be part of the original fittings of the engine house.

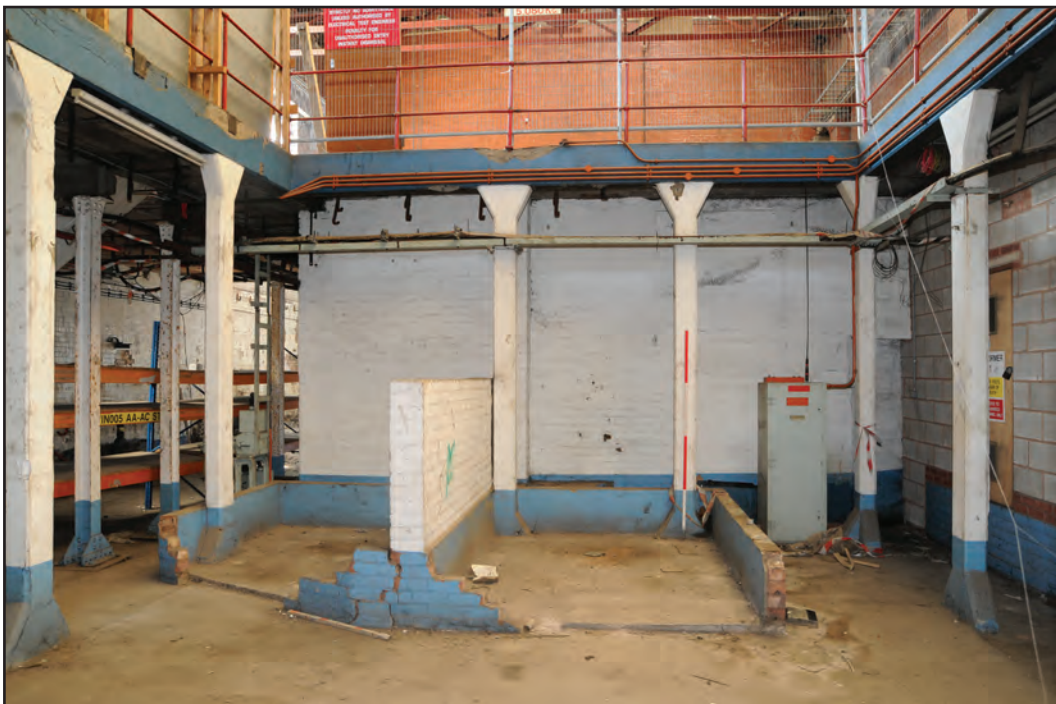
Photograph No. Washwood061
Description: Steam engine footings
Site Location: C6d
Direction From: SE

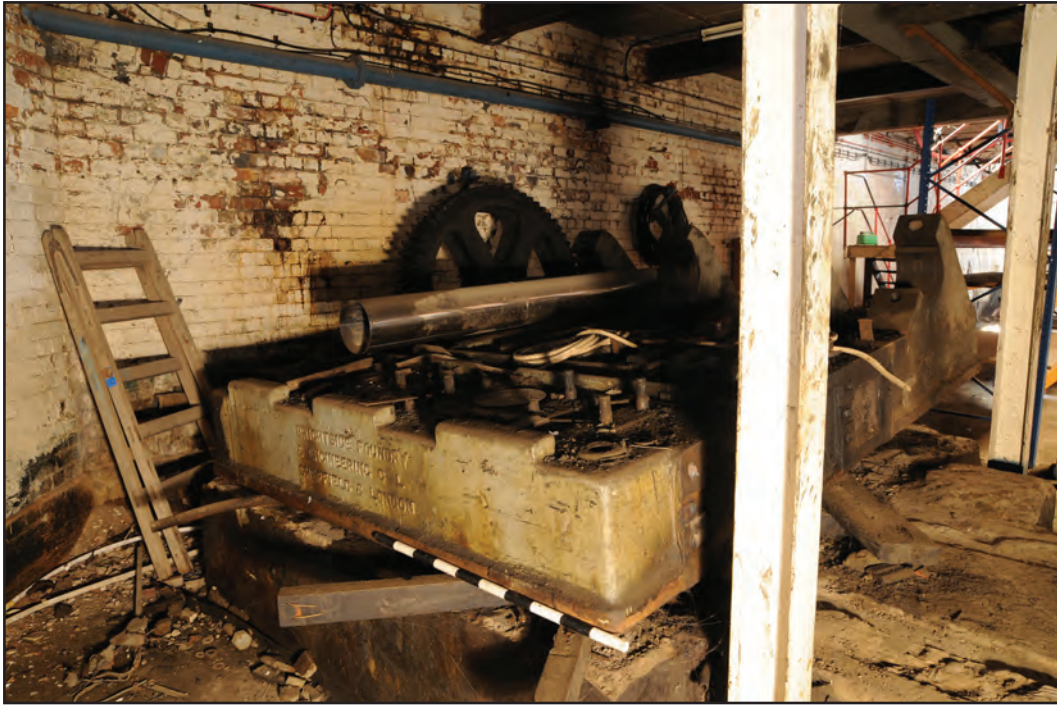
- 7.1.7 A casting in the basement of the engine house bore the name of the Brightside Foundry and Engineering Co. Ltd, Sheffield and London. This was identified as a cylinder head with transverse gearing and it is highly likely that this was part of the original engine mechanism which powered the site. Grace's Industrial Guide identifies that the Brightside Foundry and Engineering Co was founded in 1899; however, no date is given to when the company stopped using that name.

Photograph No. Washwood063
Description: Cylinder head, possibly from a steam engine
Site Location: C6d
Direction From: NE

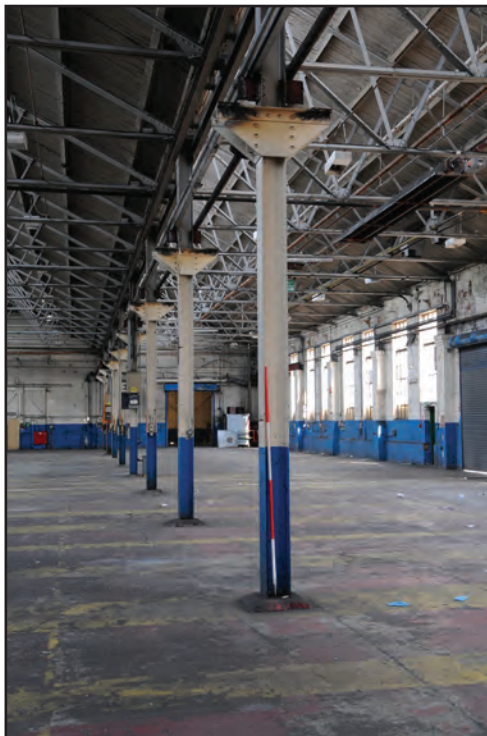
Photograph No. Washwood073
Description: View across sheds interior, taken from within D9
Site Location: D5-D9
Direction From: SW

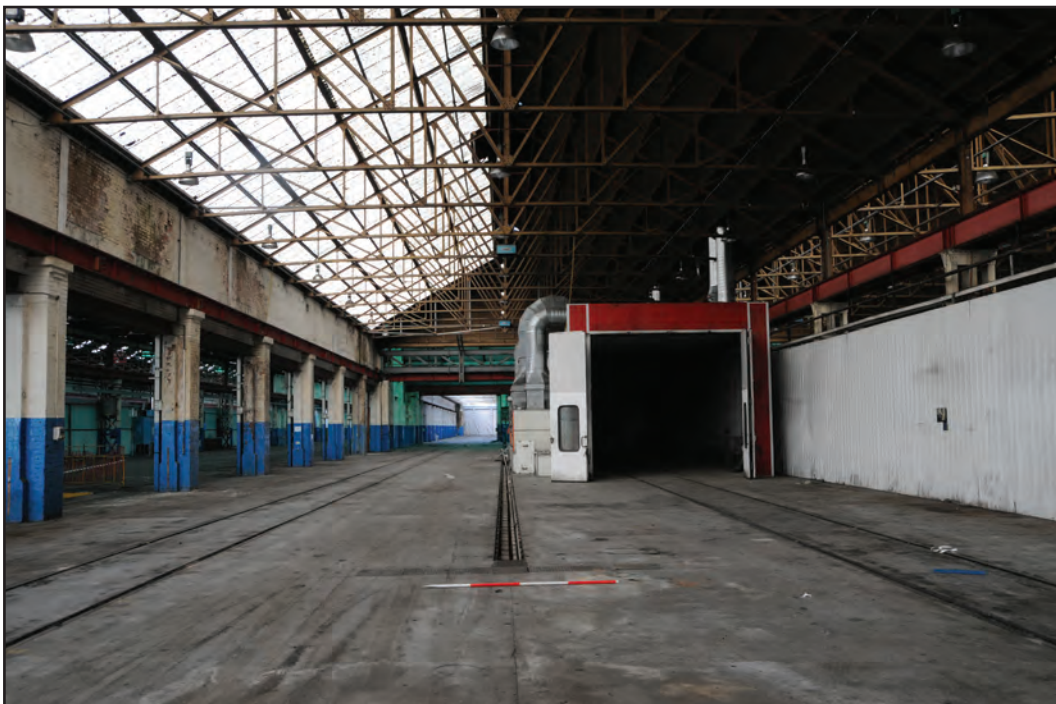
Photograph No. Washwood081

Description: west end of shed interior showing west gable end and inspection trenches

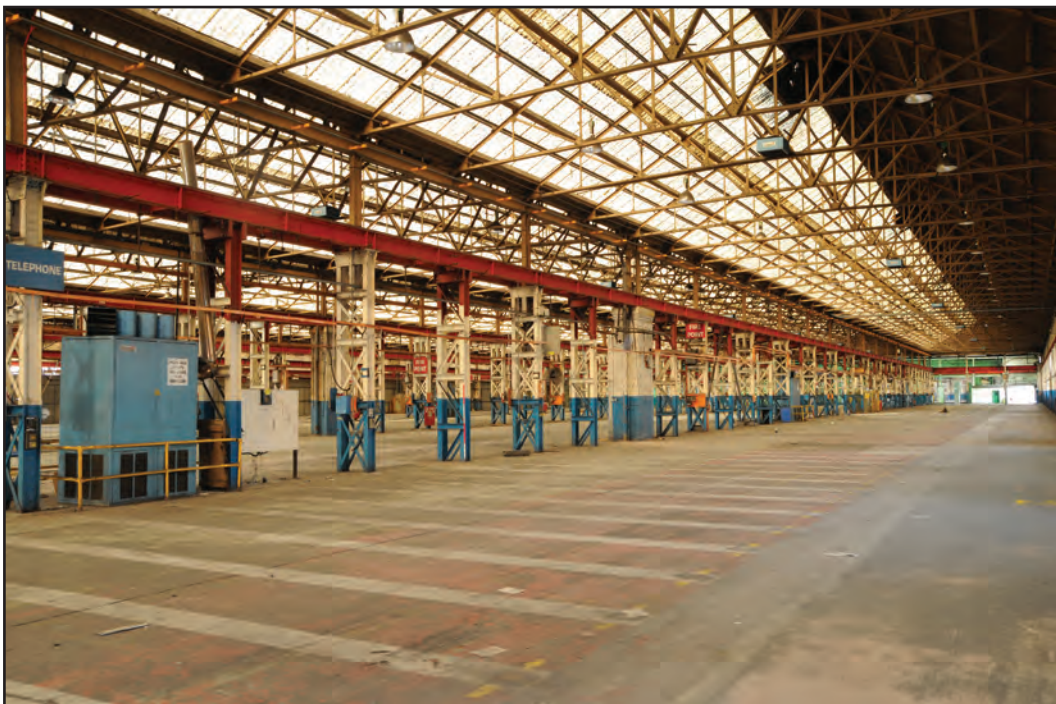
Photograph No. Washwood085

Description: Sheds interior showing how sheds end at different points at west end,
taken from within F5
Site Location: F3-F5
Direction From: ESE

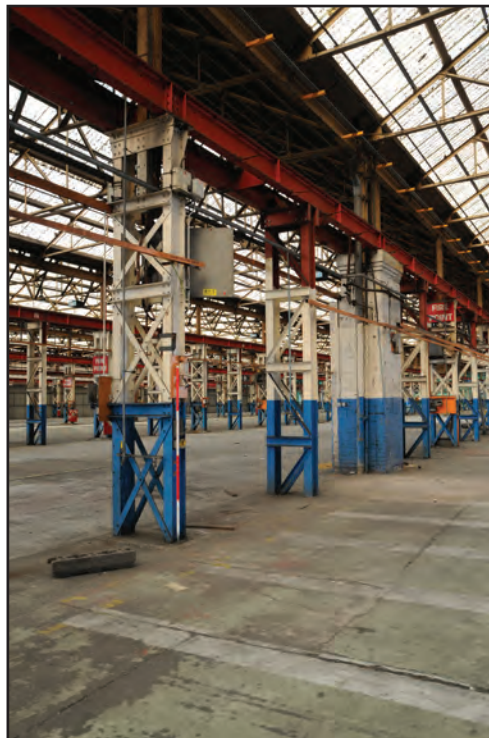
Photograph No. Washwood087

Description: Brick pilasters, stanchions and blocked openings on interior south elevation

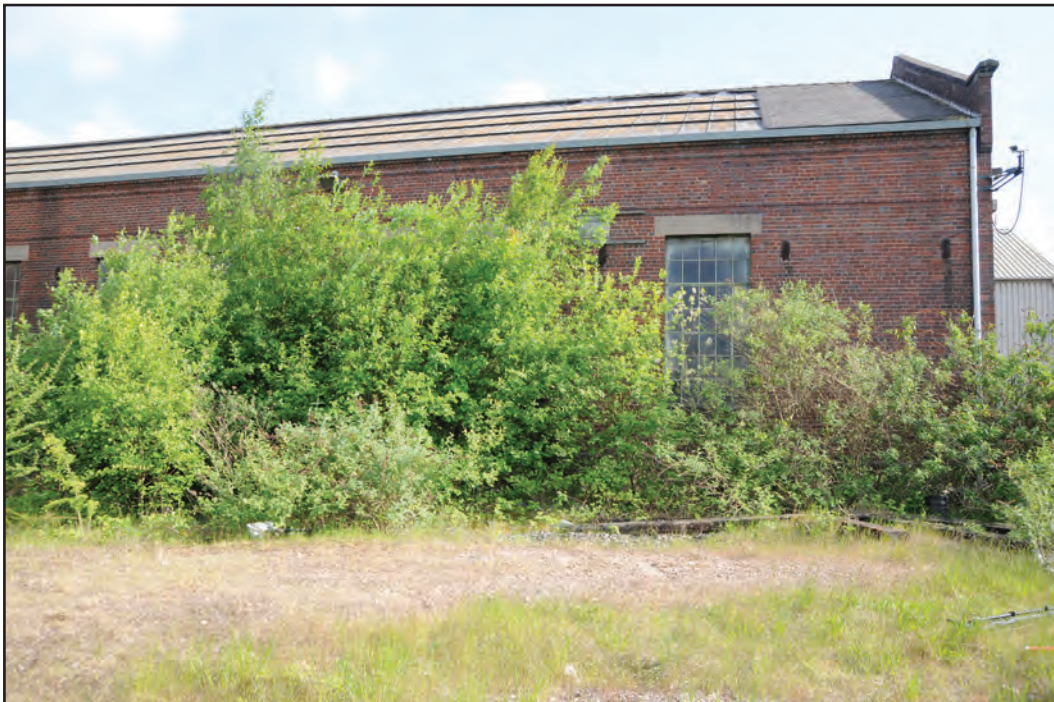
Photograph No. Washwood091

Description: Exterior west gable ends with rail tracks leading into their roller doors

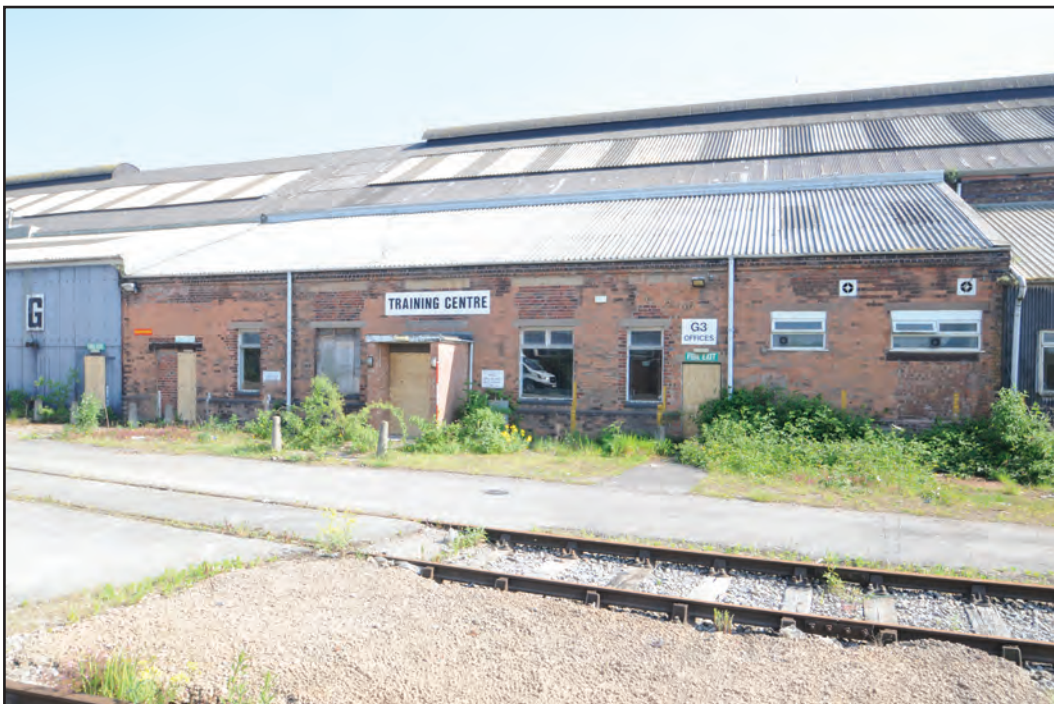
Photograph No. Washwood101

Description: north and west elevations of later offices abutting north elevation of G3

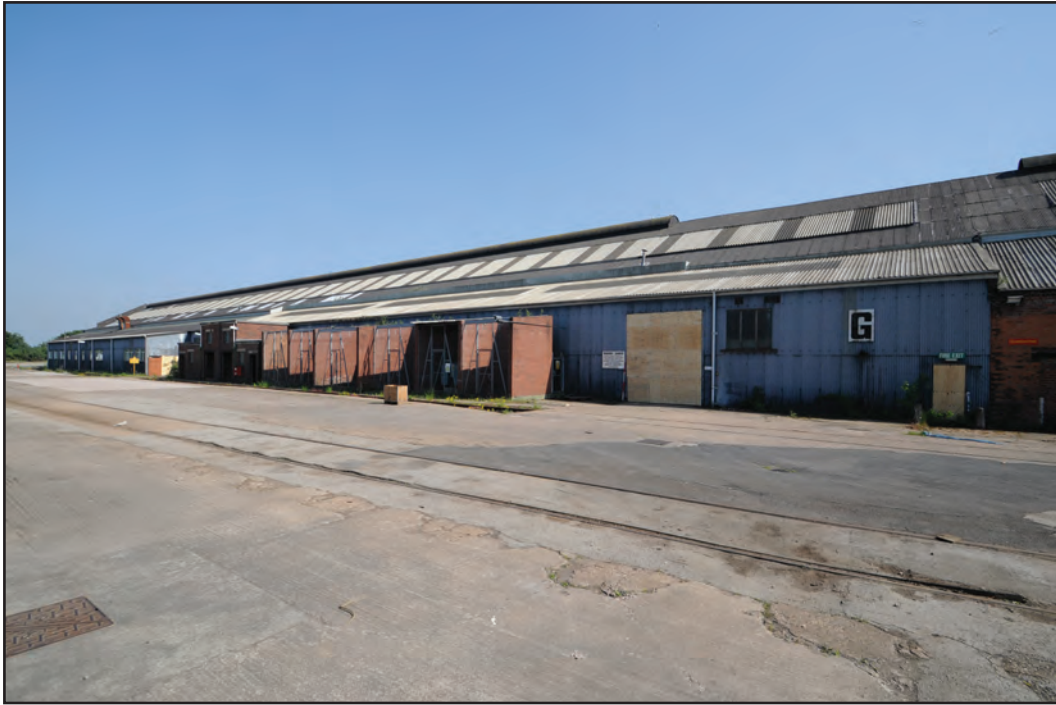
Photograph No. Washwood102

Description: Area of brick offices at the centre of G5

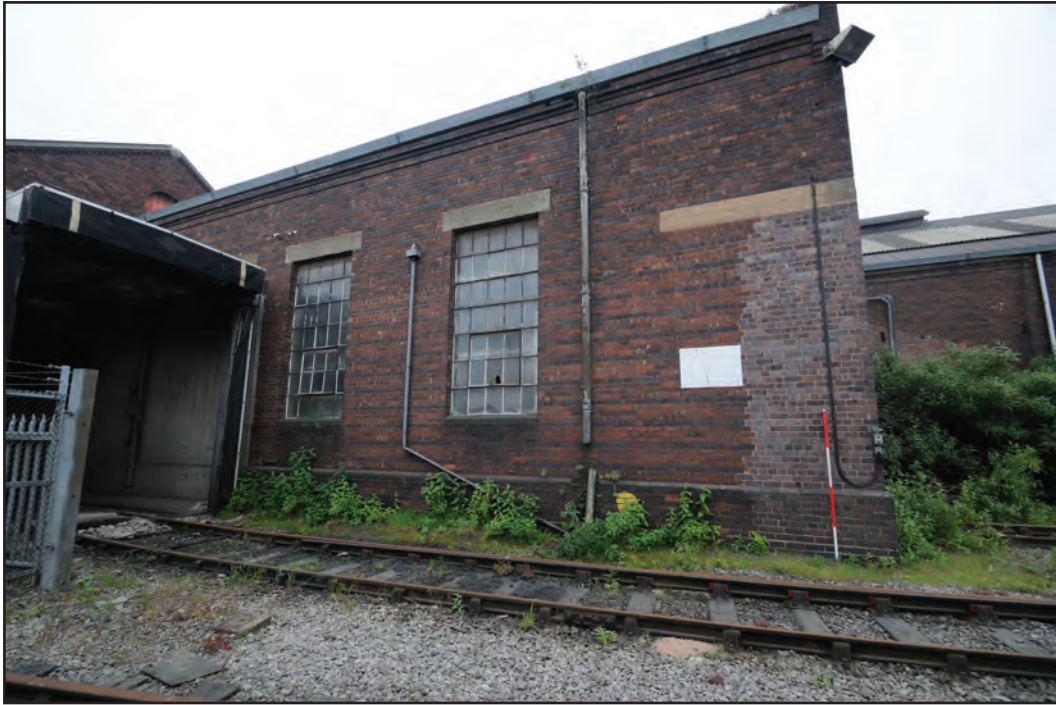
Photograph No. Washwood117

Description: Exterior north elevation with modified brickwork on northwest corner

Site Location: G6c

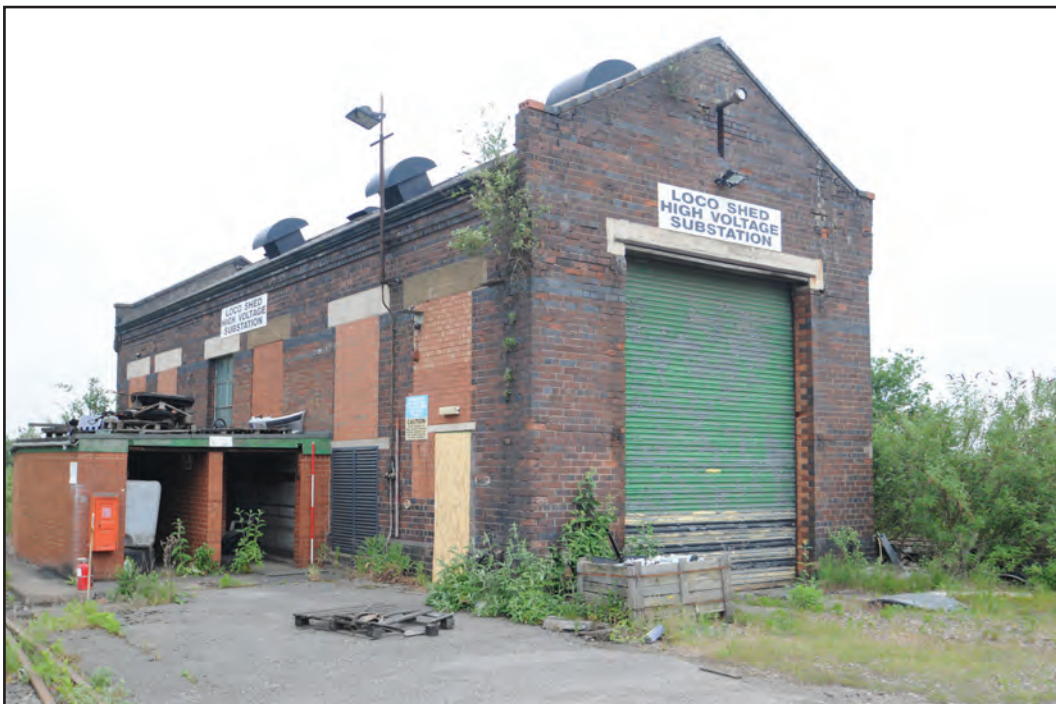
Photograph No. Washwood118

Description: Exterior south and east elevations

Site Location: Loco shed

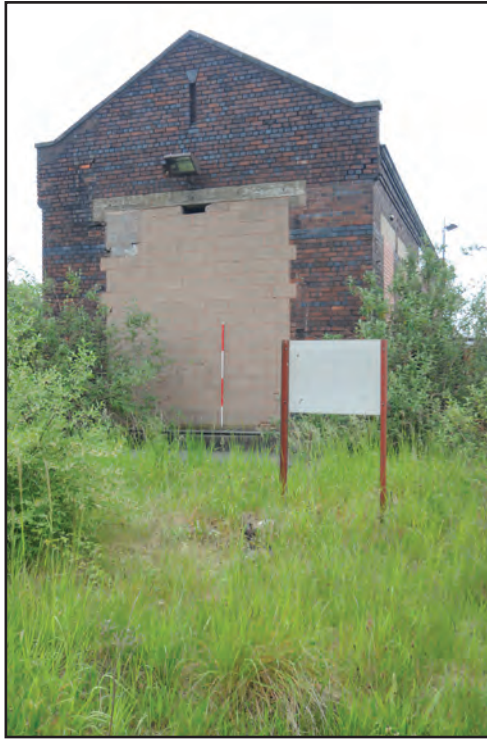
Photograph No. Washwood119
Description: Exterior west elevation with blocked roller door
Site Location: Loco shed
Direction From: WSW

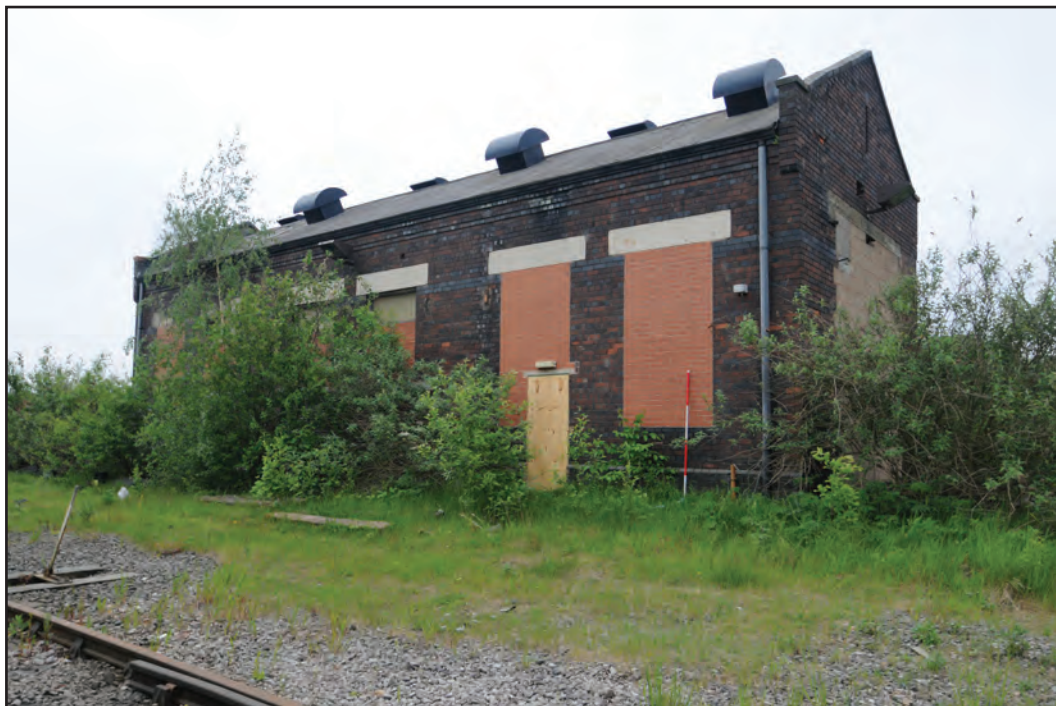
Photograph No. Washwood120
Description: Exterior north and west elevations with blocked openings and ventilation equipment on the roof
Site Location: Loco shed
Direction From: NW

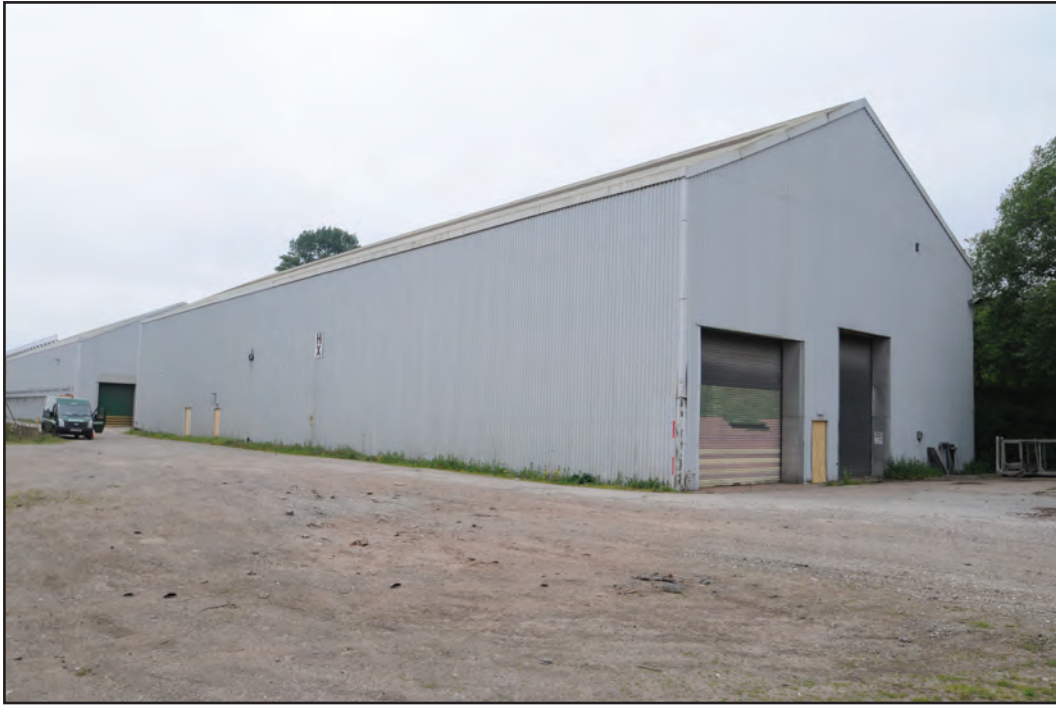
Photograph No. Washwood121
Description: Exterior north and west elevations
Site Location: HX
Direction From: NW

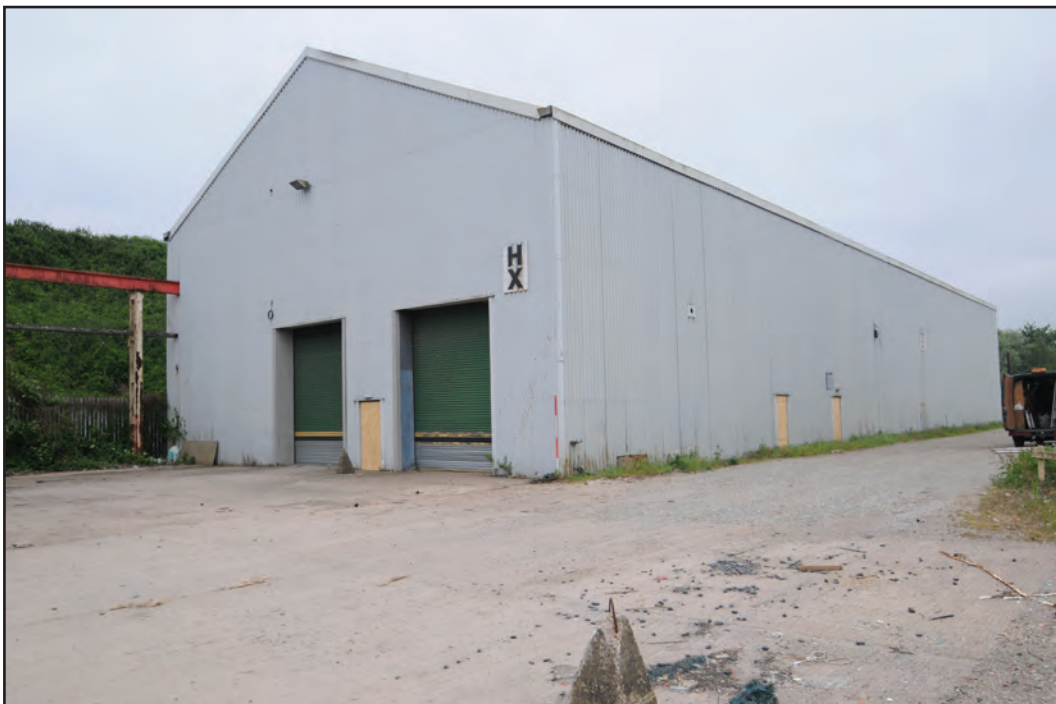
Photograph No. Washwood122
Description: Exterior north and east elevations
Site Location: HX
Direction From: NE

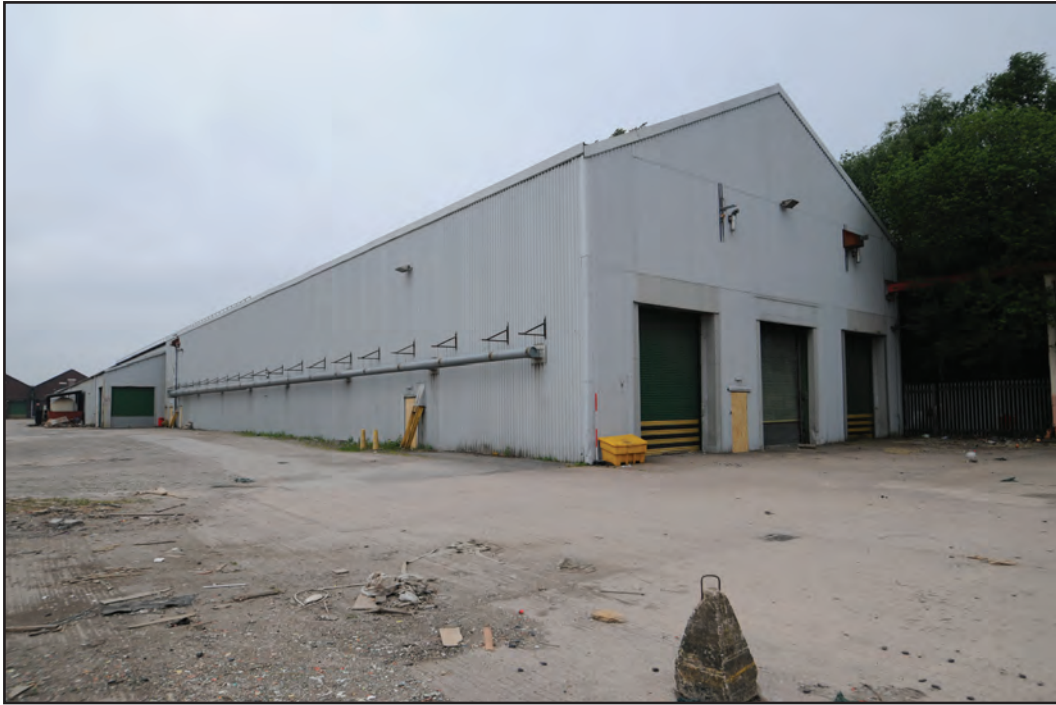
Photograph No. Washwood123

Description: Exterior west elevations of H1 and H2, and exterior north elevation of H2

Site Location: H1/H2

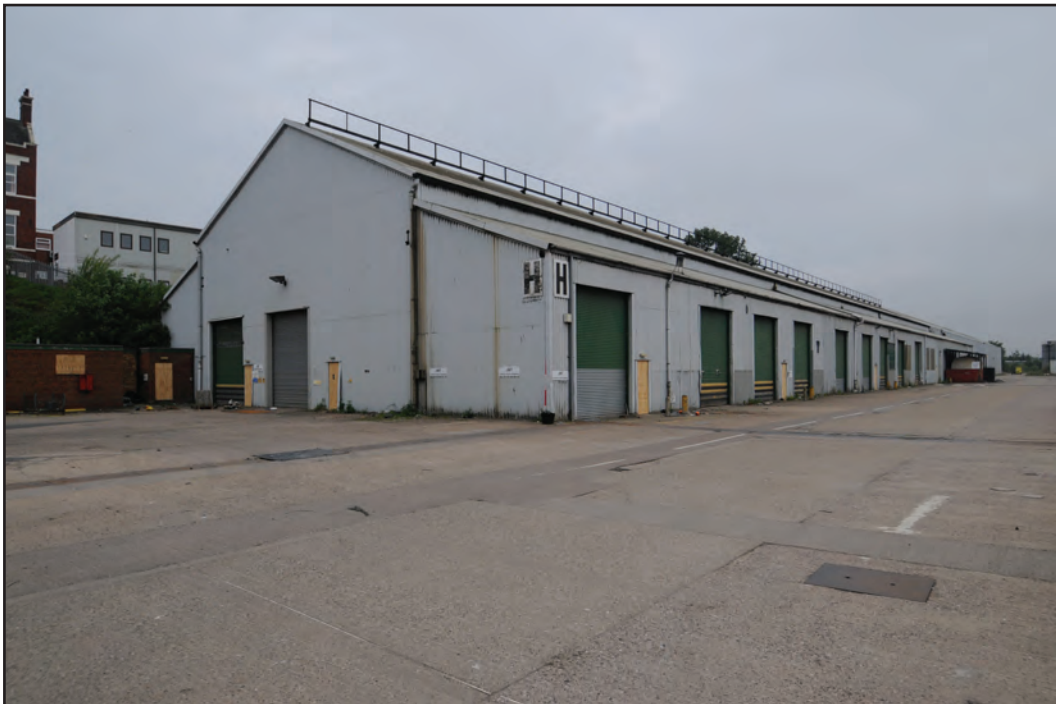
Photograph No. Washwood124

Description: Exterior north and east elevations

Site Location: H1

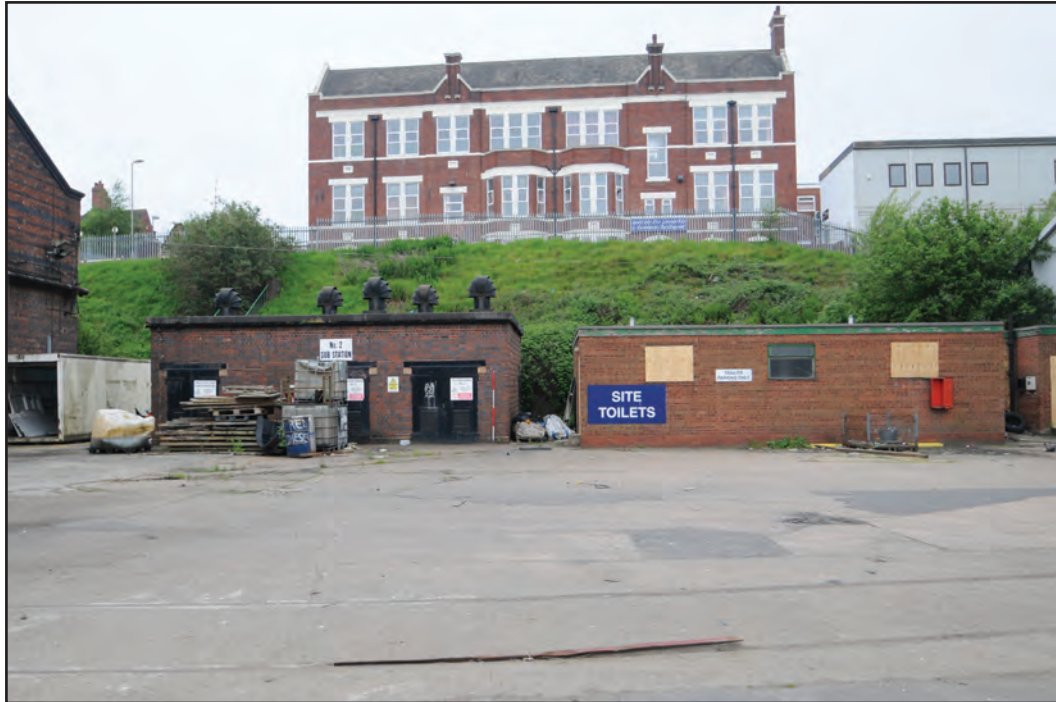
Photograph No. Washwood125
Description: Exterior north elevation and modified brick building to the west
Site Location: No. 2 sub-station
Direction From: N

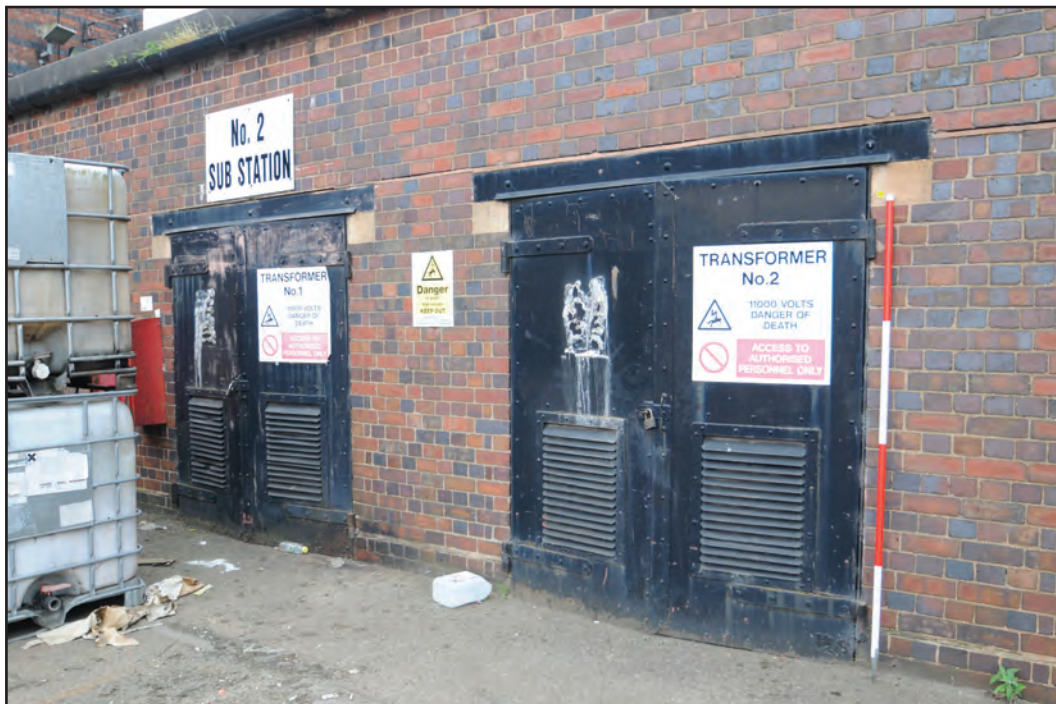
Photograph No. Washwood126
Description: Detail of metal doors
Site Location: No. 2 sub-station
Direction From: NW

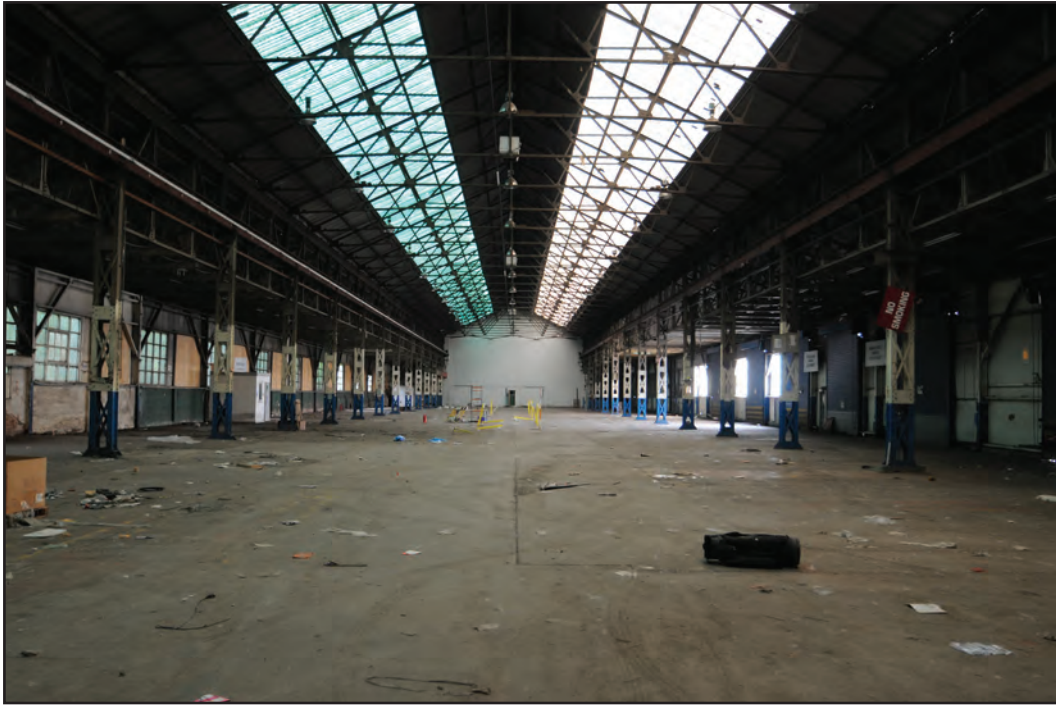
Photograph No. Washwood127
Description: Shed interior
Site Location: H1
Direction From: E

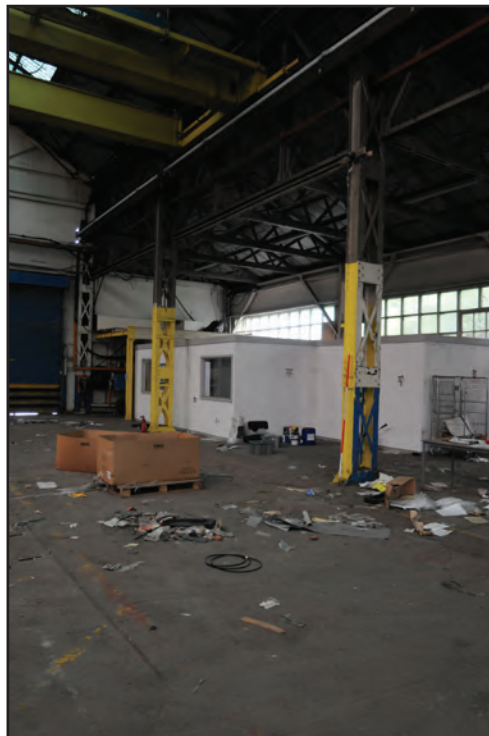
Photograph No. Washwood128
Description: southeast interior corner of shed with stanchions and modern offices
Site Location: H1
Direction From: NW

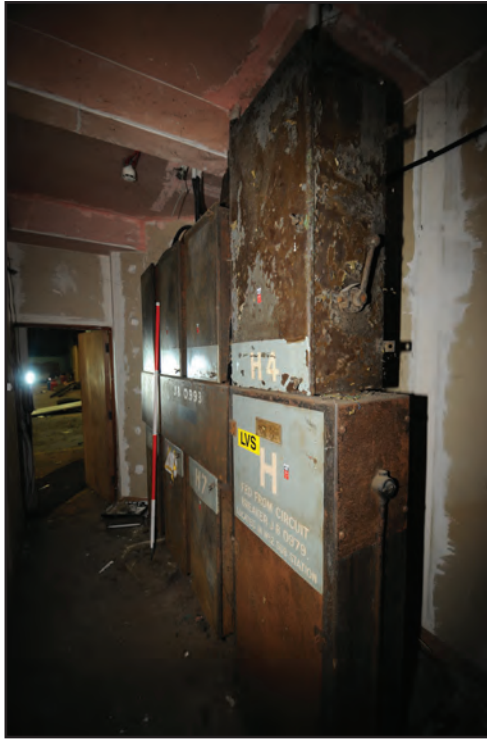
Photograph No. Washwood129
Description: Switch board/circuit breaker
Site Location: H1
Direction From: SW

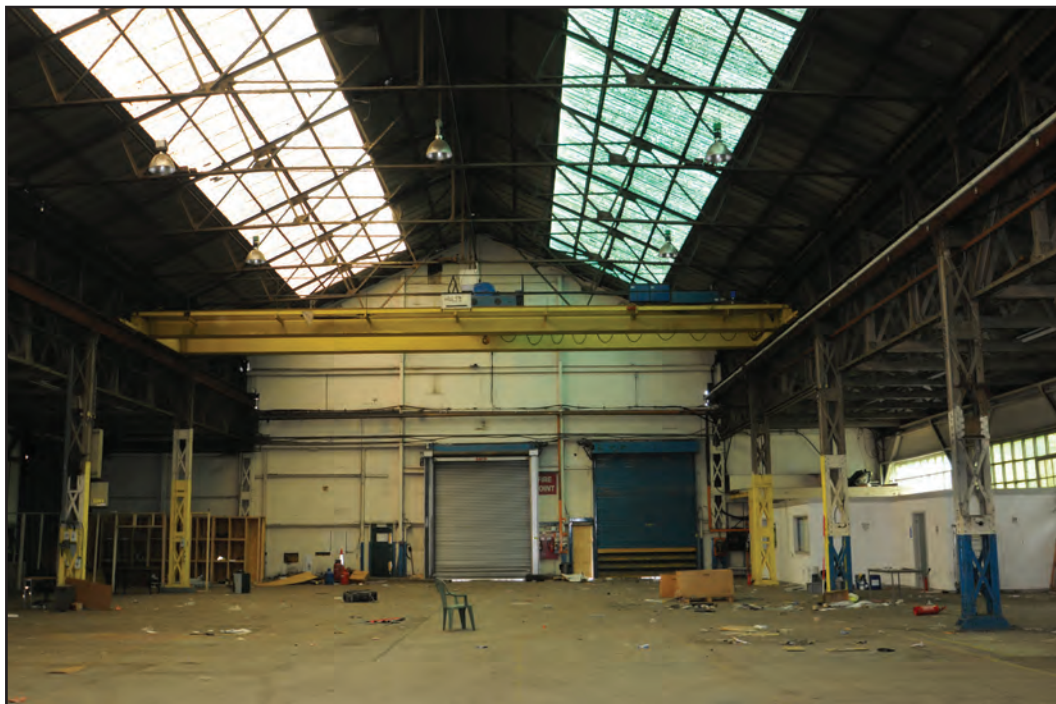
Photograph No. Washwood130
Description: Interior east gable end with travelling crane in front
Site Location: H1
Direction From: W

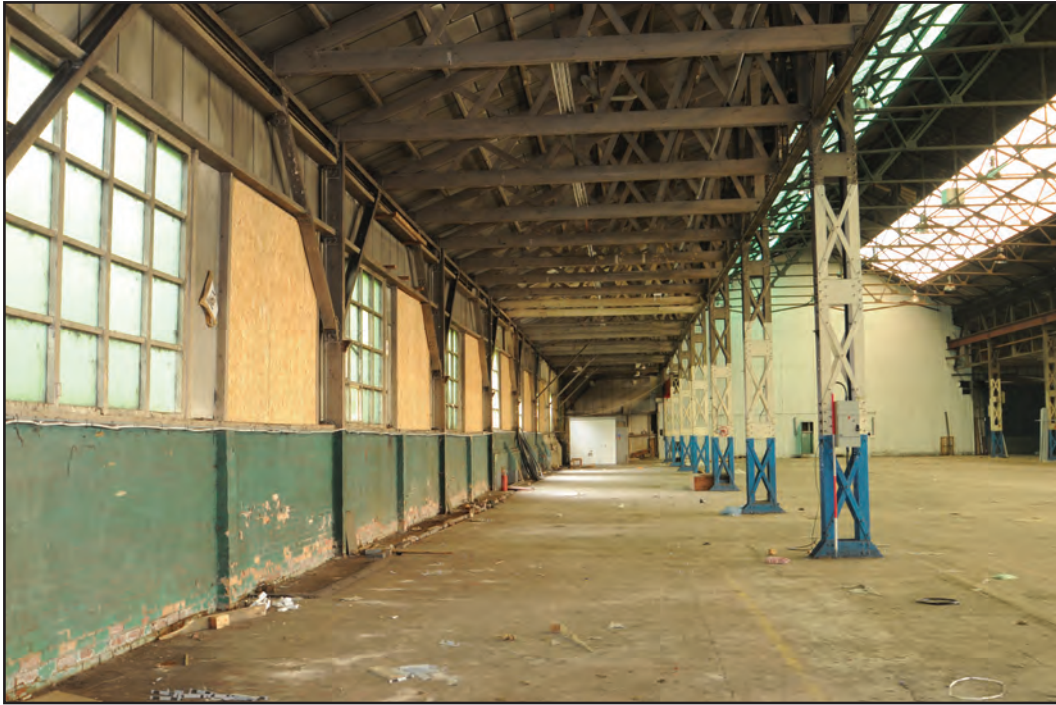
Photograph No. Washwood131
Description: View across south aisle
Site Location: H1
Direction From: E

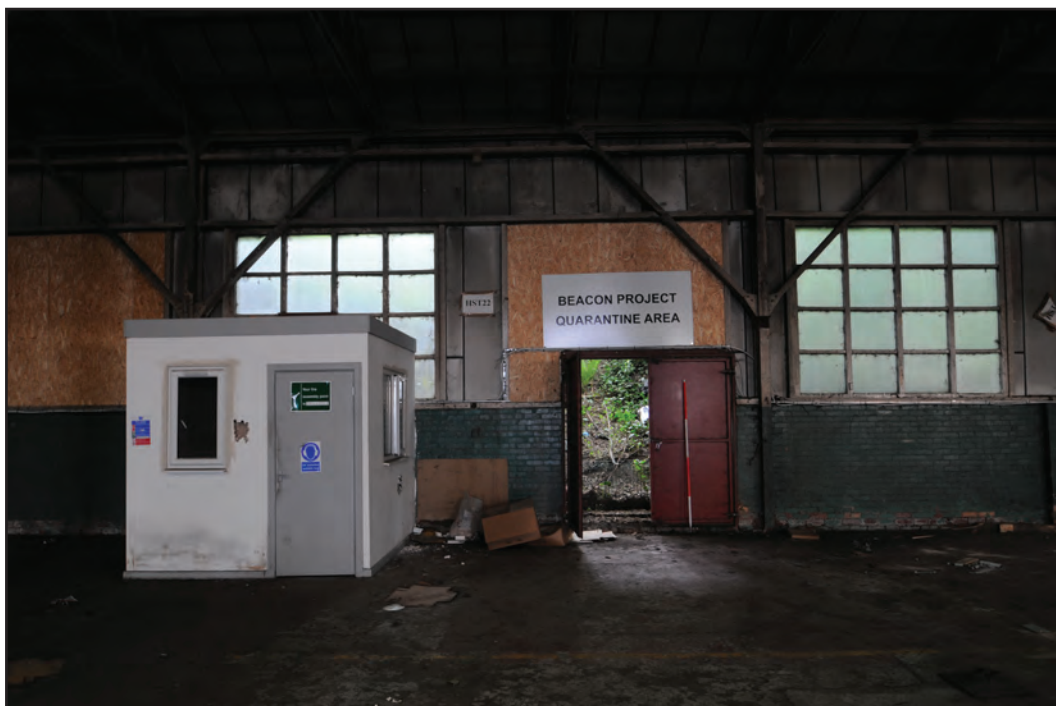
Photograph No. Washwood132
Description: Detail of door and cabin office at centre of south wall
Site Location: H1
Direction From: N

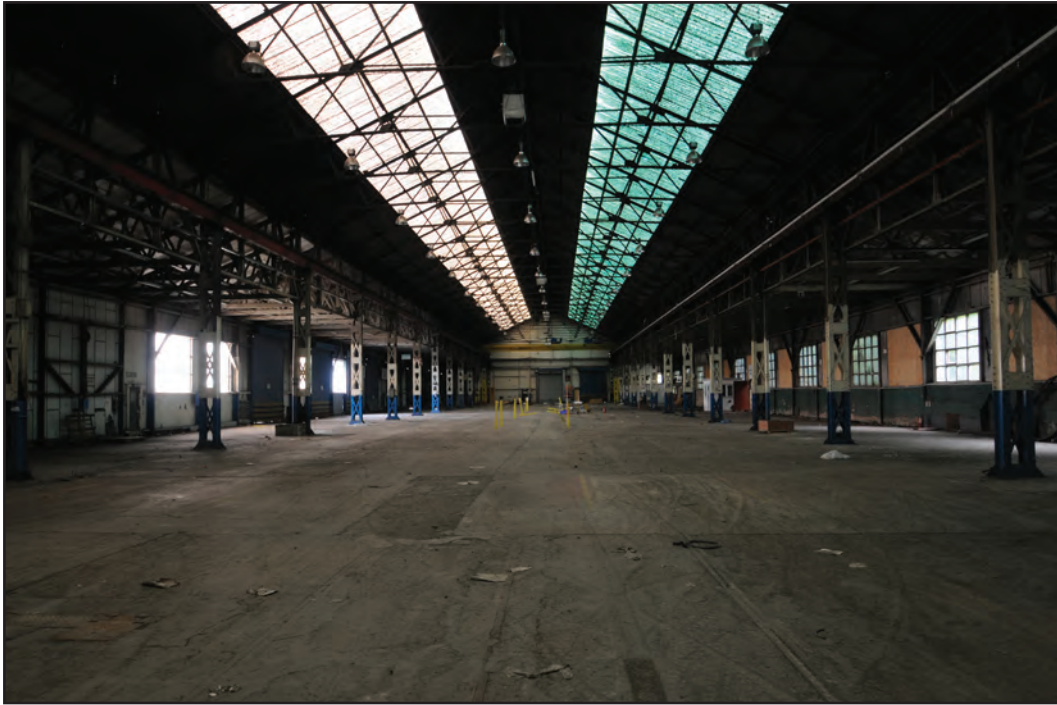
Photograph No. Washwood133
Description: Shed interior
Site Location: H1
Direction From: W

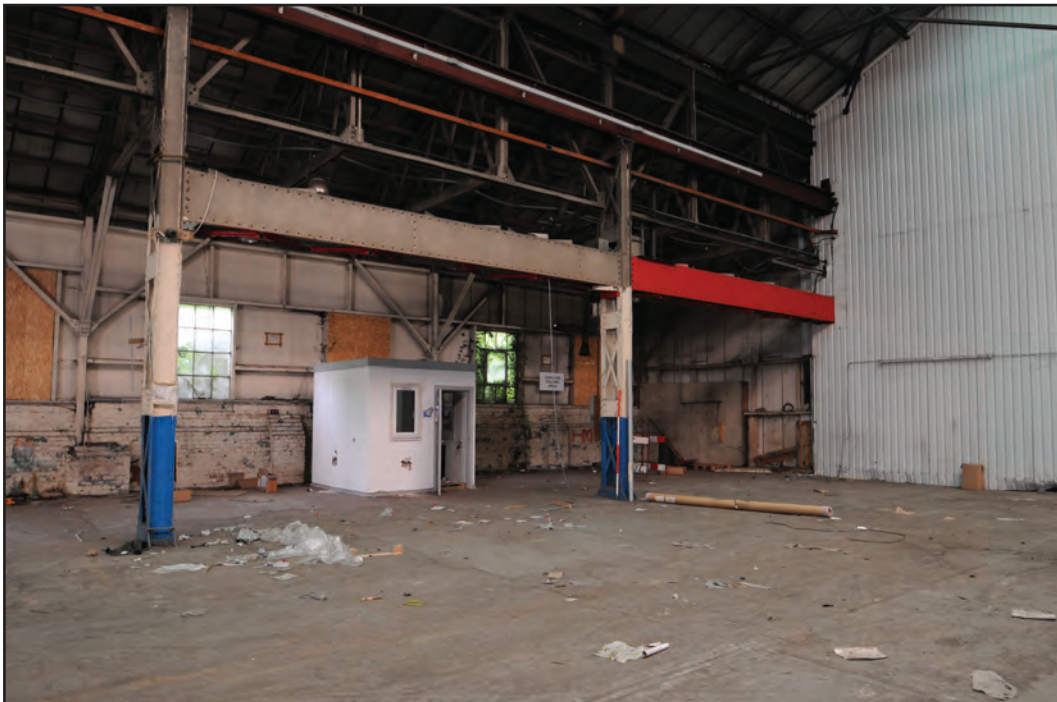
Photograph No. Washwood134
Description: Reinforcing beam at southwest corner of shed interior
Site Location: H1
Direction From: NE

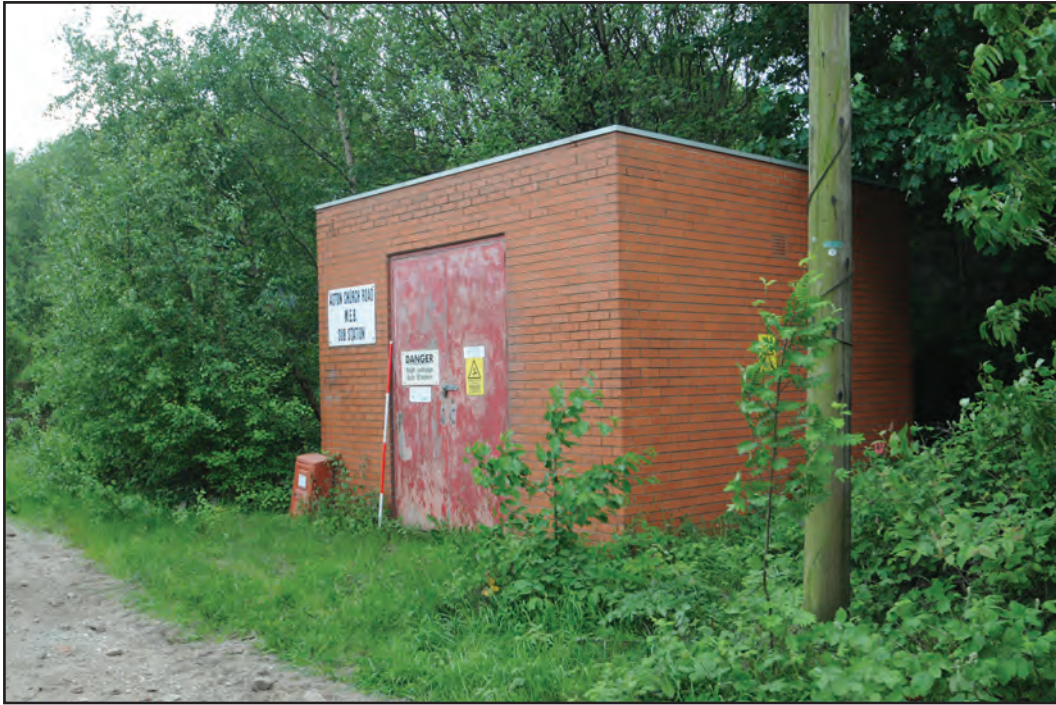
Photograph No. Washwood135
Description: Exterior north and west elevations of small sub-station at southwest corner of site
Site Location: Sub-station
Direction From: NW

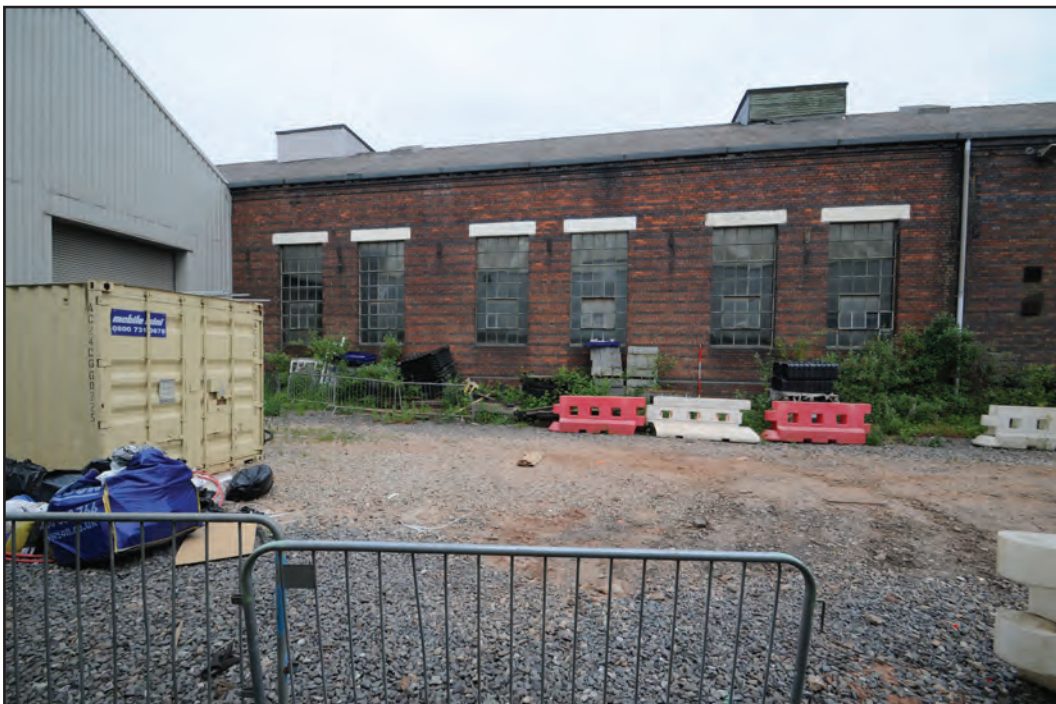
Photograph No. Washwood136
Description: west end of exterior south elevation
Site Location: F5
Direction From: SE

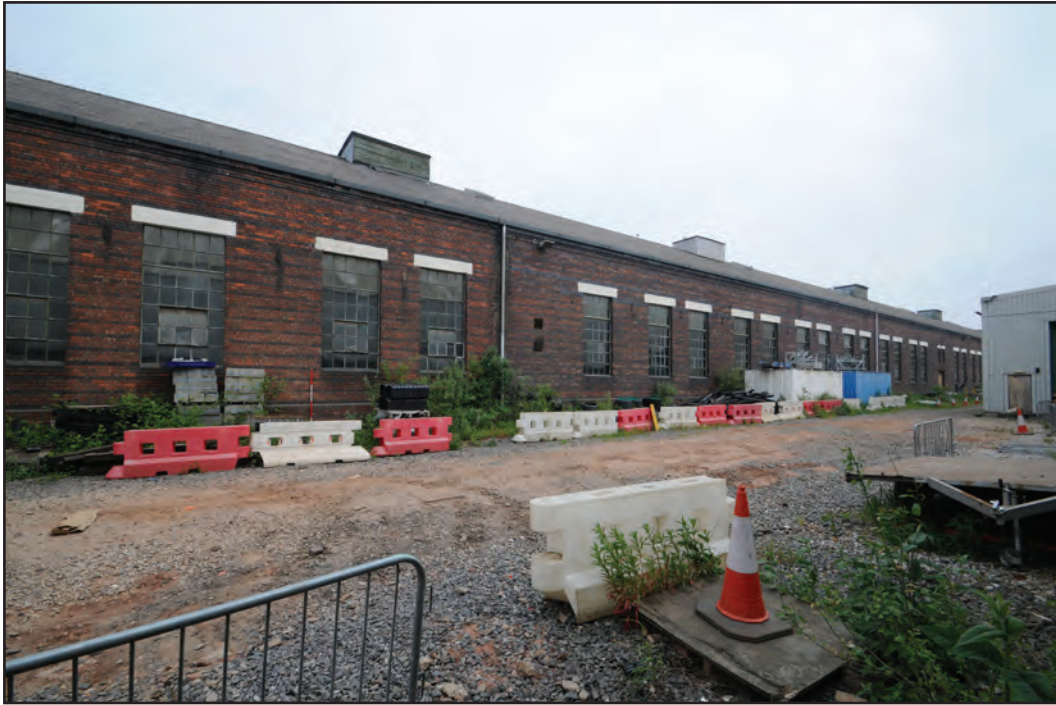
Photograph No. Washwood137
Description: Central area of exterior south elevation
Site Location: F5
Direction From: SW
