HS2 WPO29 – Historic Environment Works – Washwood Heath Depot – Enabling Works North Contract

Final Report for Historic Building Recording Survey

Document no.: 1EW04-LMJ-EV-REP-NS03_NLo8-029001

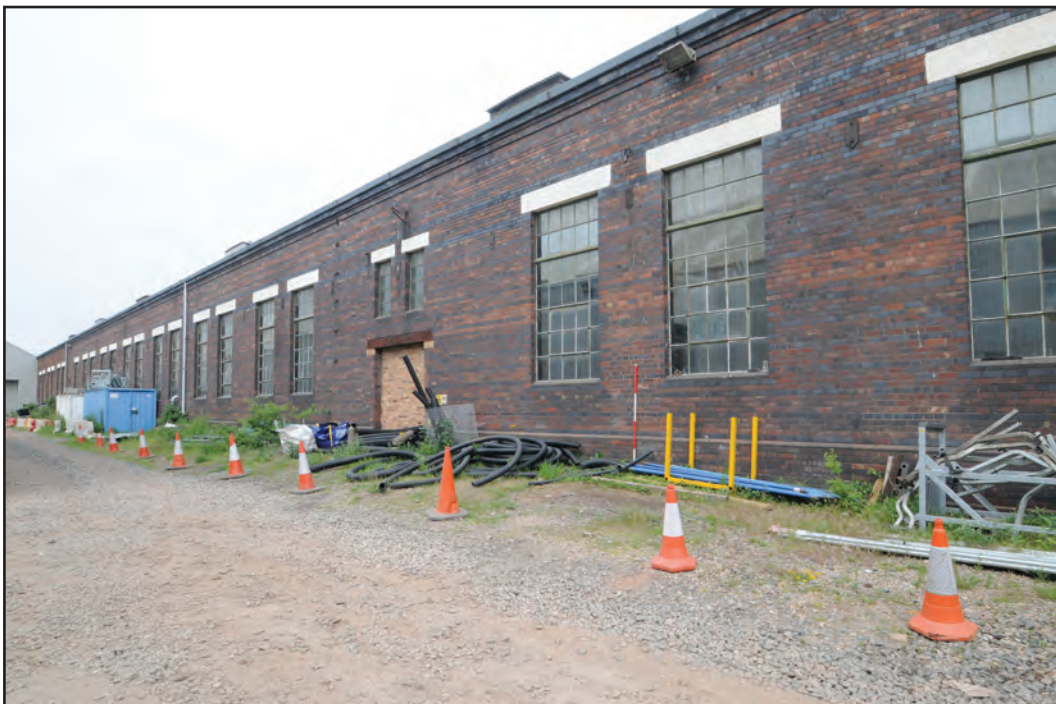
Photograph No. Washwood138
Description: Blocked doorway in central section of exterior south elevation
Site Location: F5
Direction From: SE

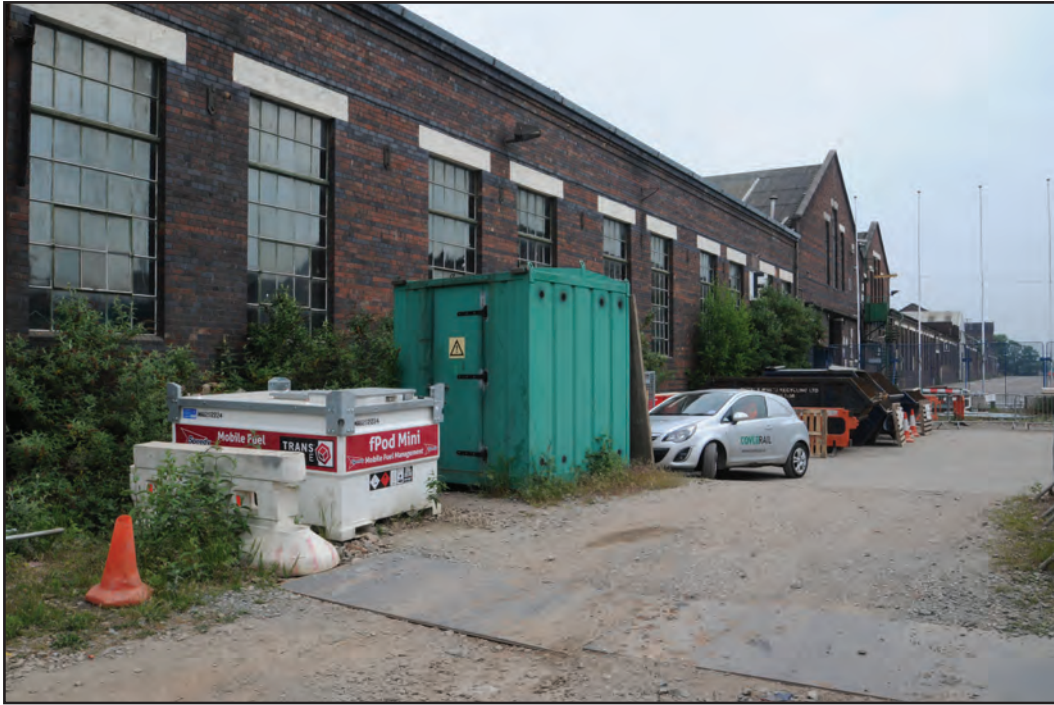
Photograph No. Washwood139
Description: east end of exterior south elevation
Site Location: F5
Direction From: SW

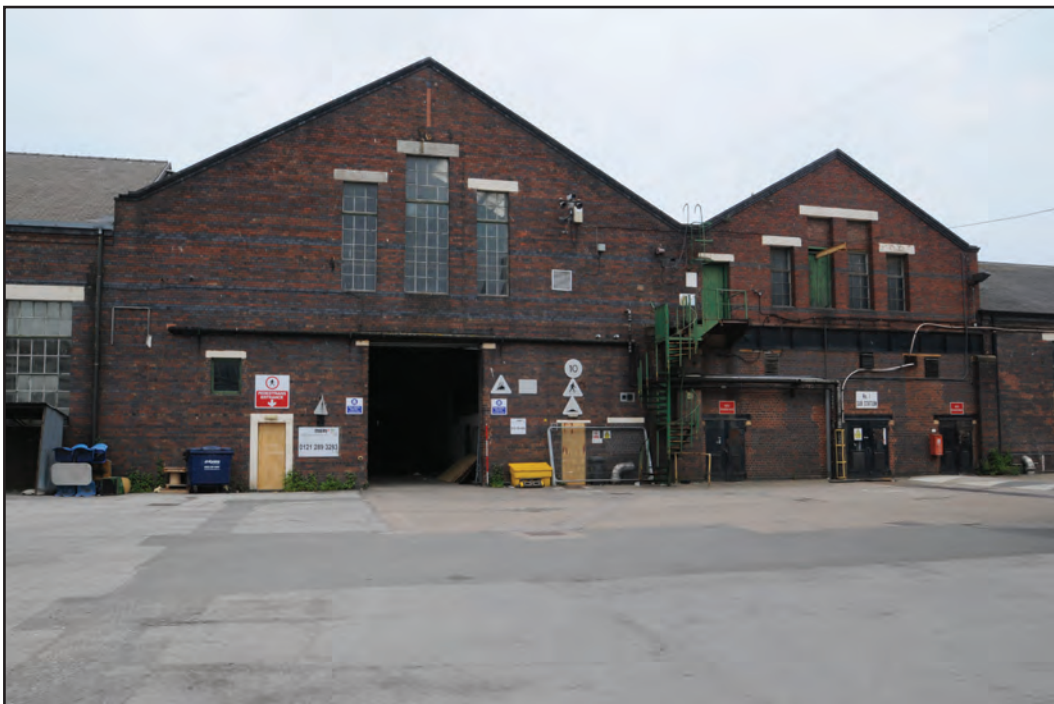
Photograph No. Washwood140
Description: Exterior south gable ends
Site Location: E1/E2
Direction From: S

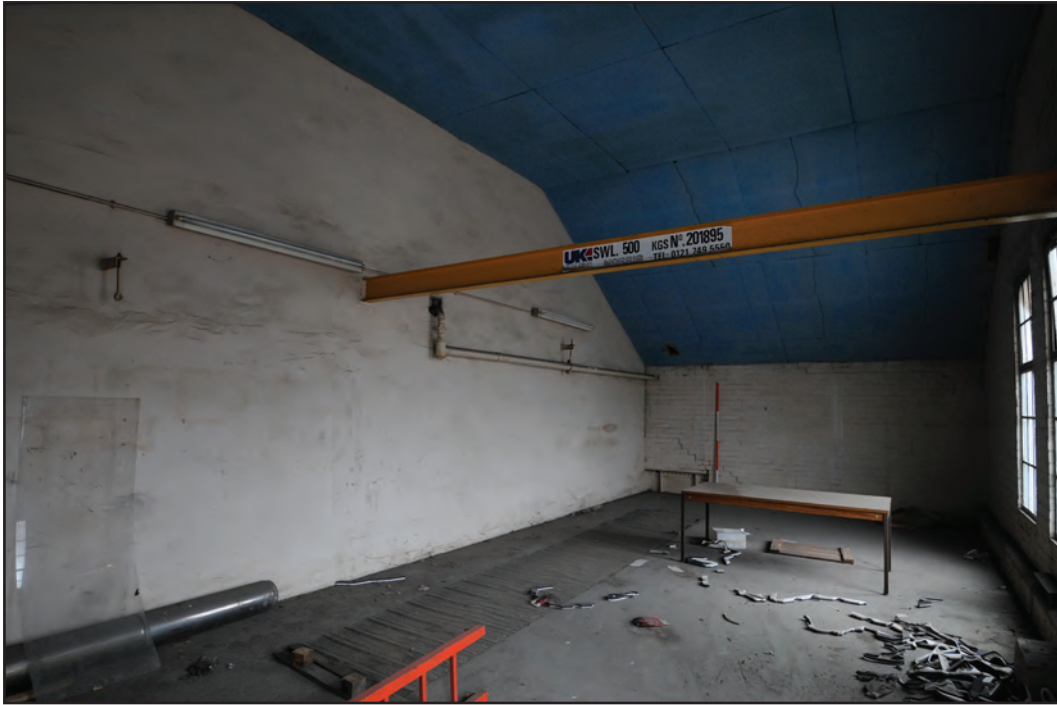
Photograph No. Washwood141
Description: Interior of first floor winch room
Site Location: E3
Direction From: SW

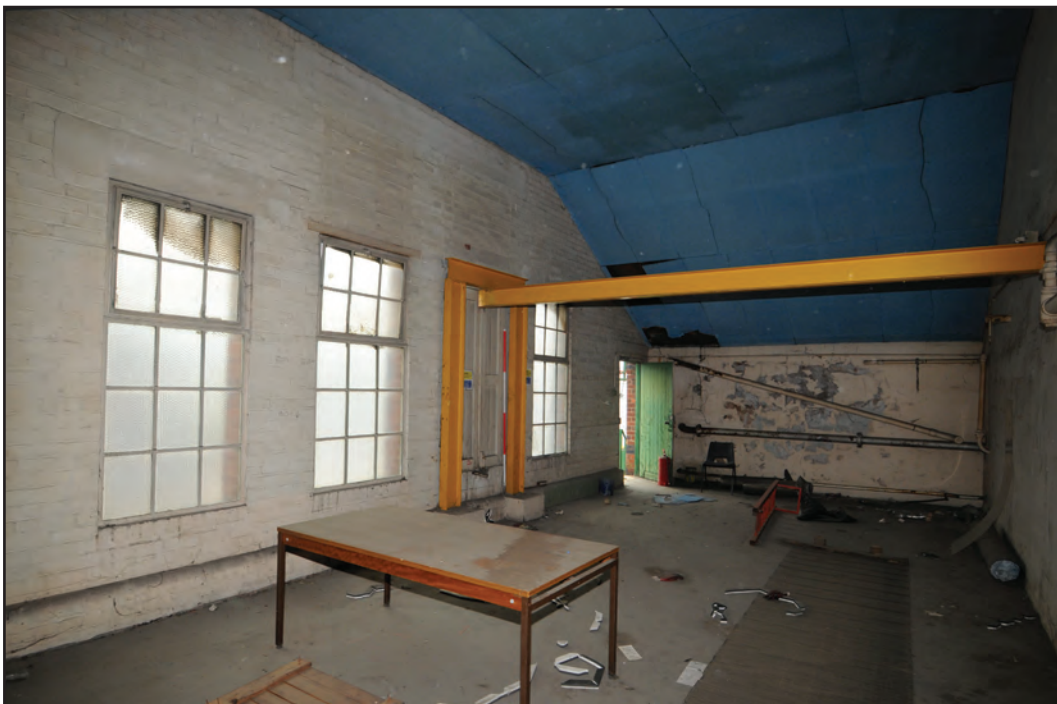
Photograph No. Washwood142
Description: Interior of first floor winch room
Site Location: E3
Direction From: NE

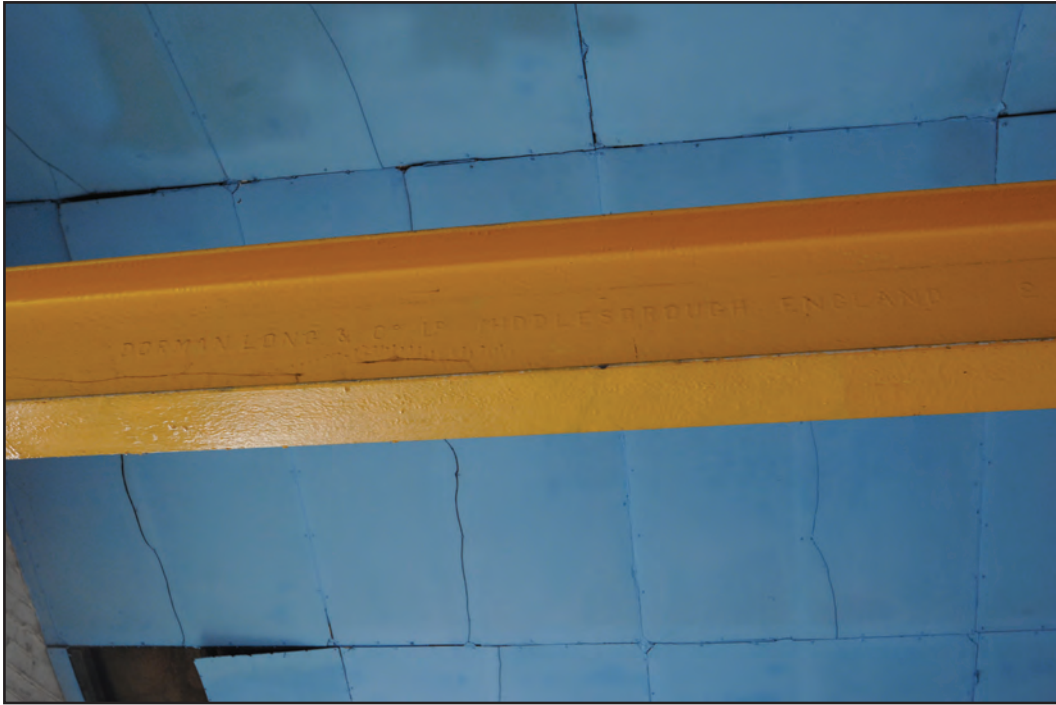
Photograph No. Washwood143
Description: DORMAN LONG & CO LD MIDDLESBROUGH ENGLAND 2 foundry
mark on winch rail
Site Location: E3
Direction From: below E

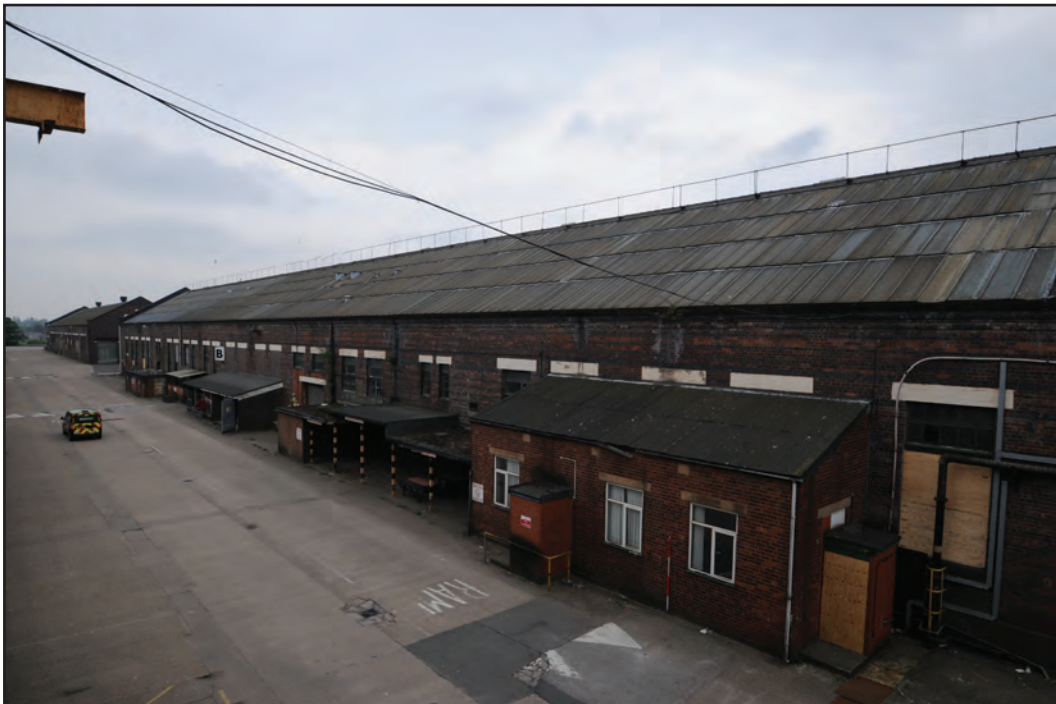
Photograph No. Washwood144
Description: Exterior north elevation
Site Location: B1
Direction From: above NW

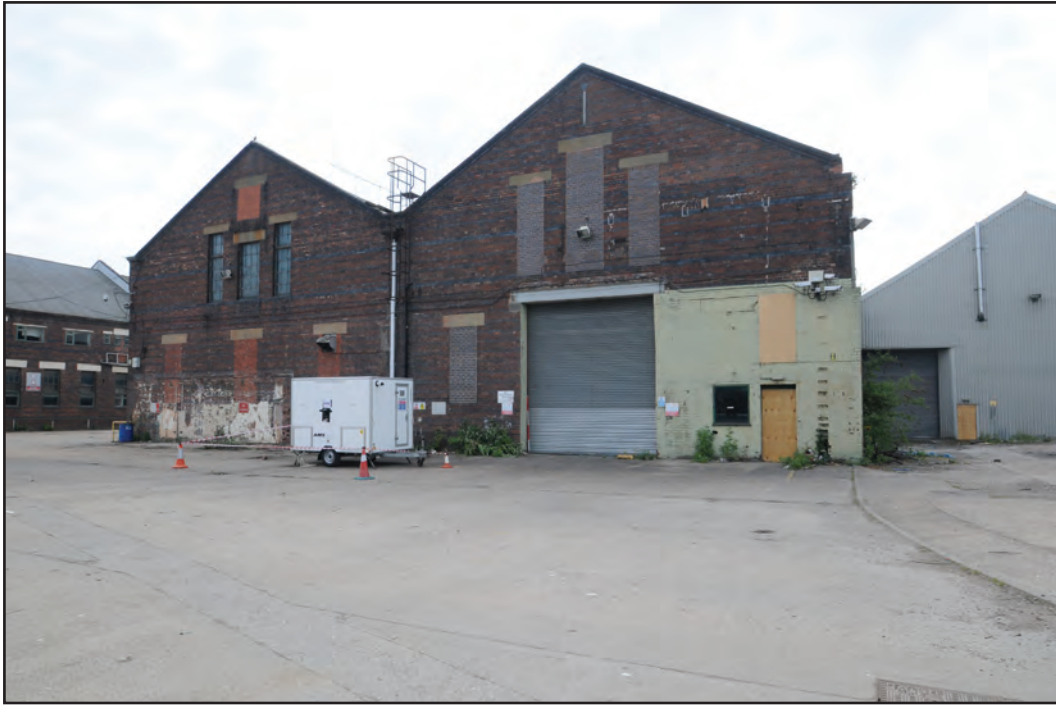
Photograph No. Washwood145
Description: Exterior east gable ends
Site Location: C6a/C6c
Direction From: NE

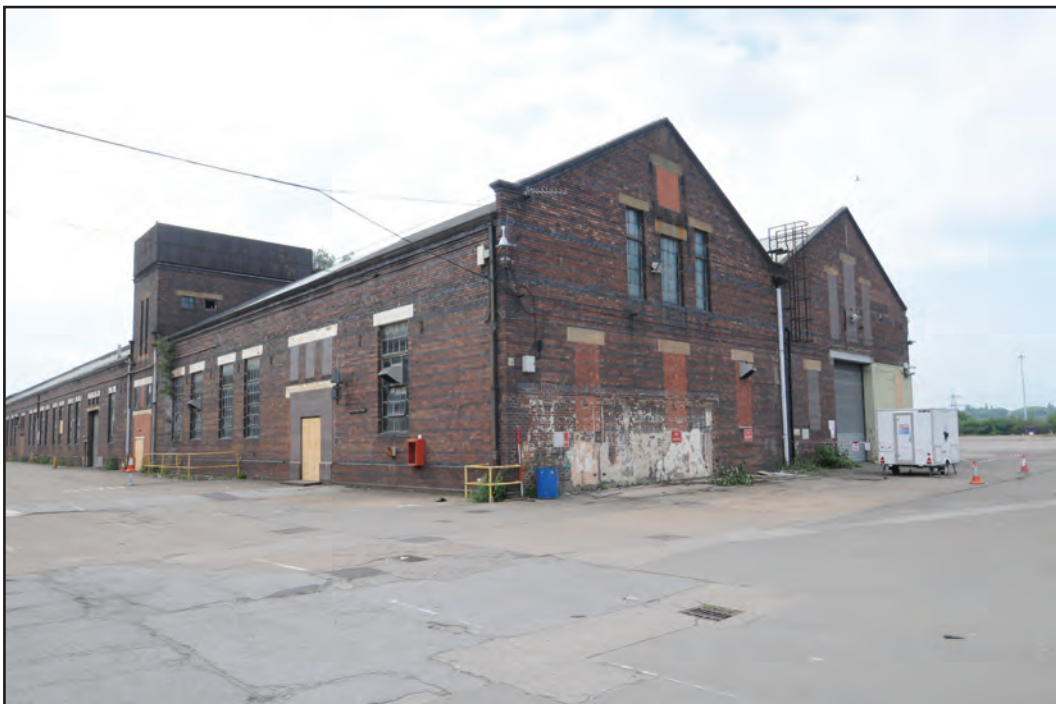
Photograph No. Washwood146
Description: Exterior east gable ends of C6a and C6c, exterior south elevation of C6b
and C6c
Site Location: C6a-C6c
Direction From: SE

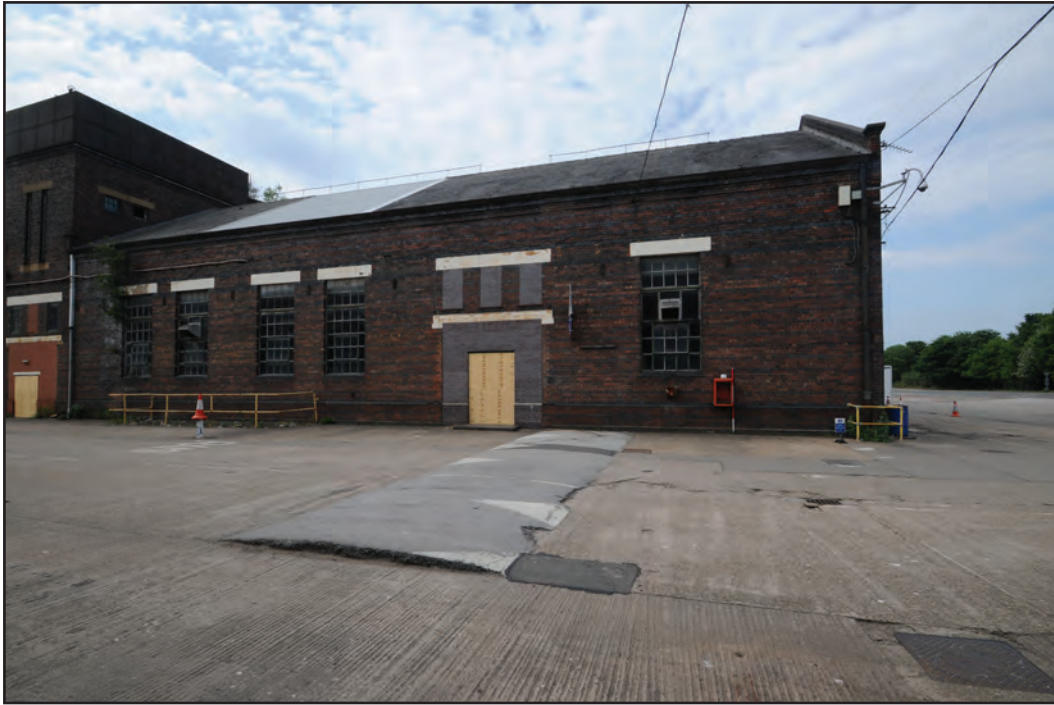
Photograph No. Washwood147
Description: Exterior south elevation
Site Location: C6c
Direction From: SSE

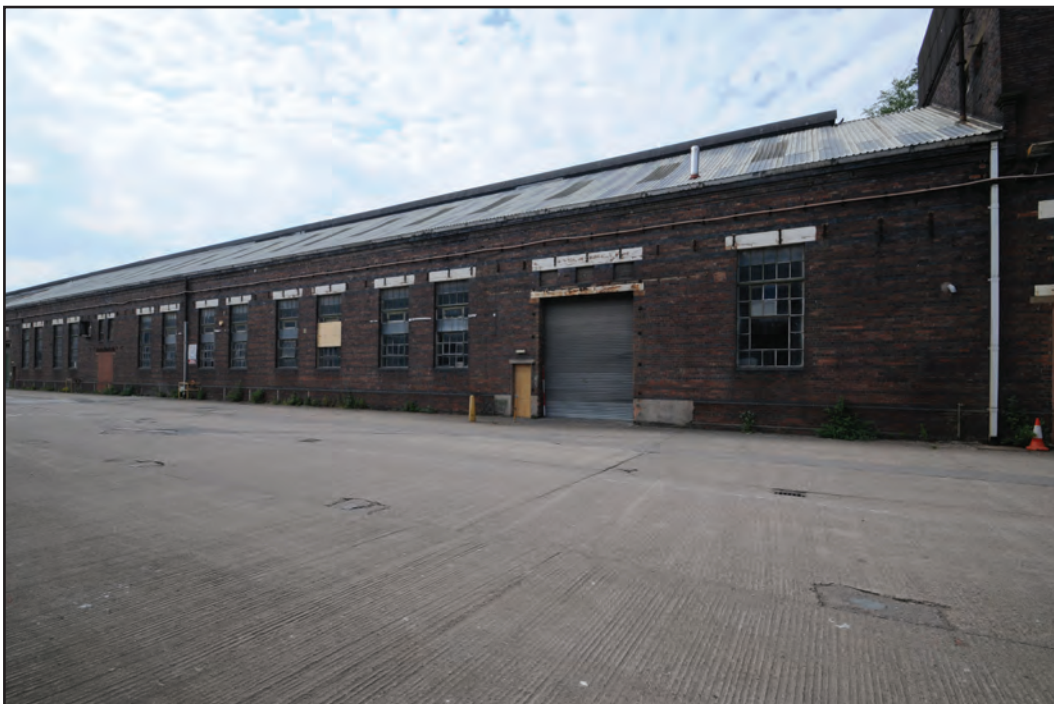
Photograph No. Washwood148
Description: Exterior south elevation, east end
Site Location: C5
Direction From: SSE

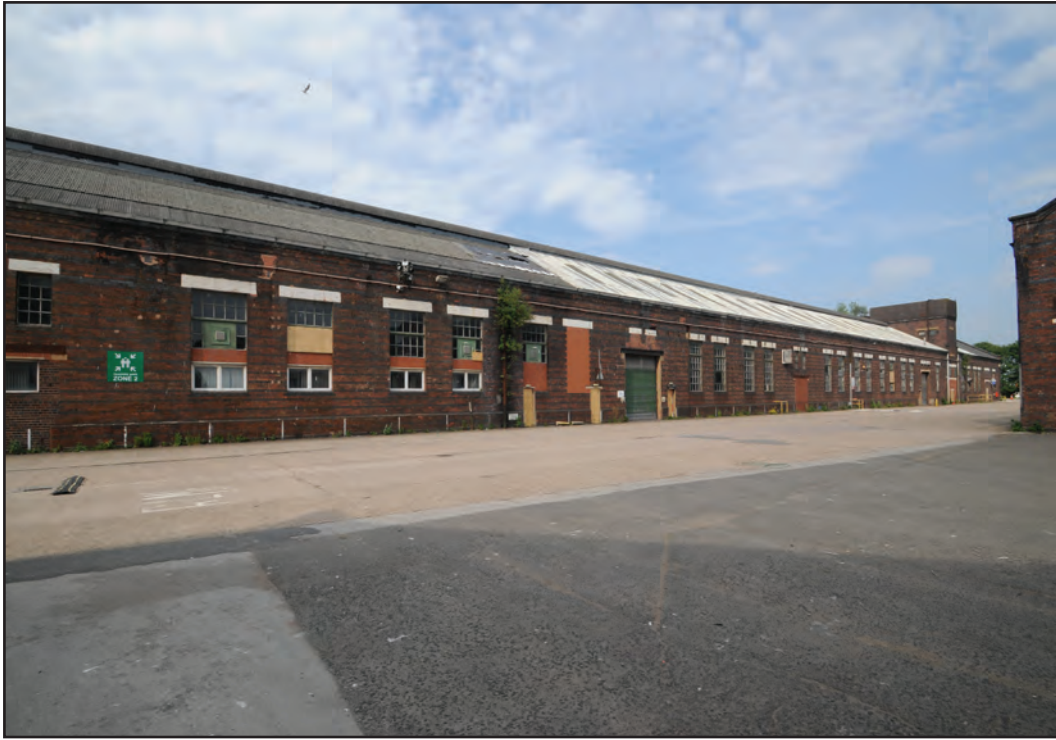
Photograph No. Washwood149
Description: Exterior south elevation, central area
Site Location: C5
Direction From: SW

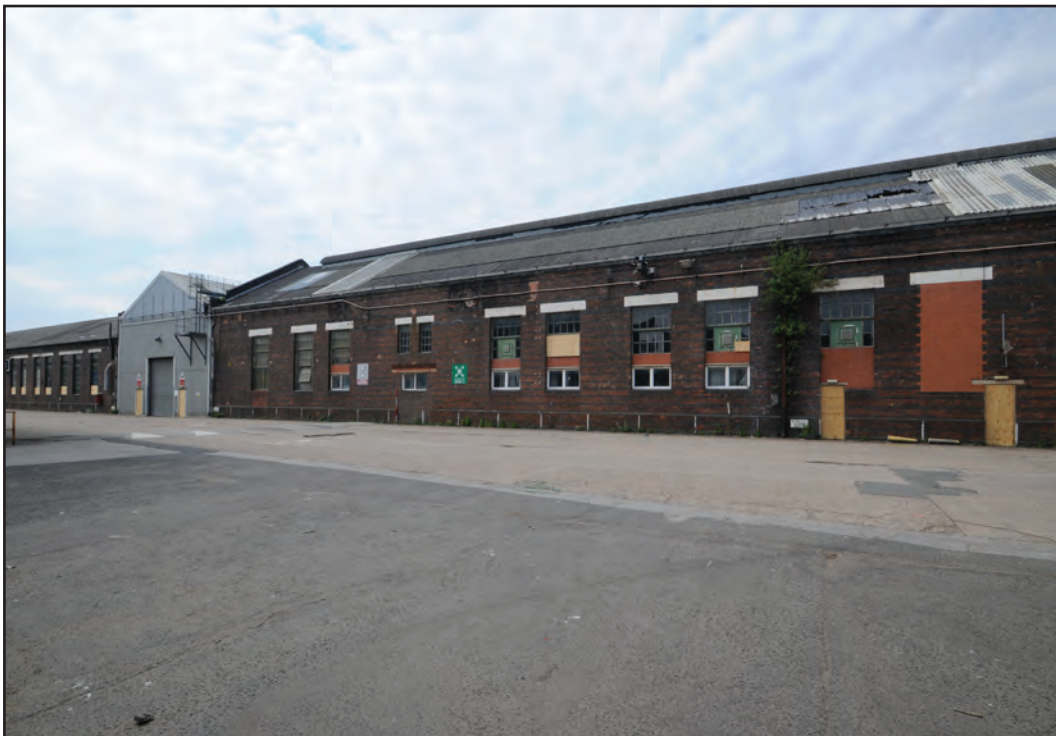
Photograph No. Washwood150
Description: Exterior south elevations including D10 gable end
Site Location: C5/D9/D10
Direction From: SE

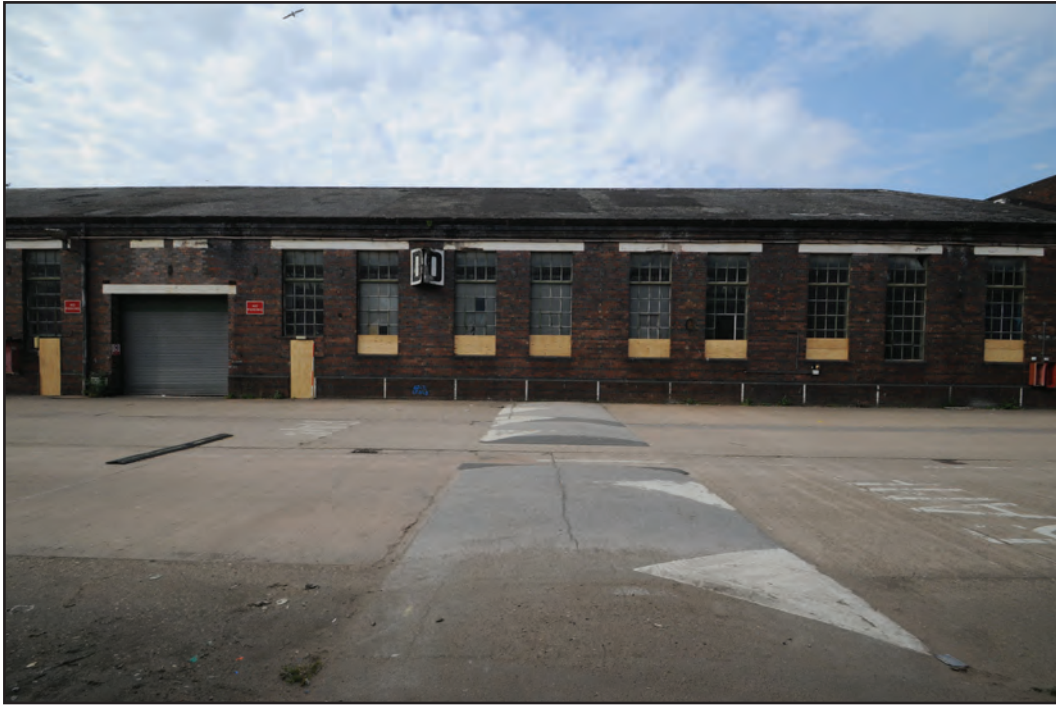
Photograph No. Washwood151
Description: Exterior south elevation
Site Location: D9
Direction From: S

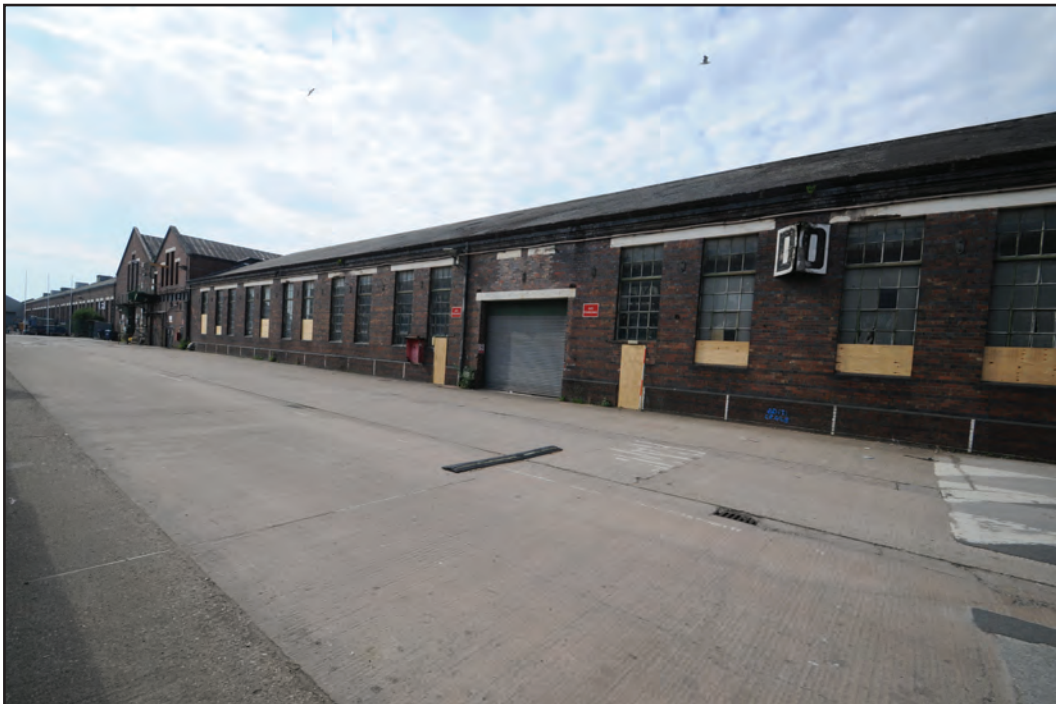
Photograph No. Washwood152
Description: Exterior south elevations including E1 and E2 gable ends
Site Location: D9/E1/E2/F5
Direction From: SE

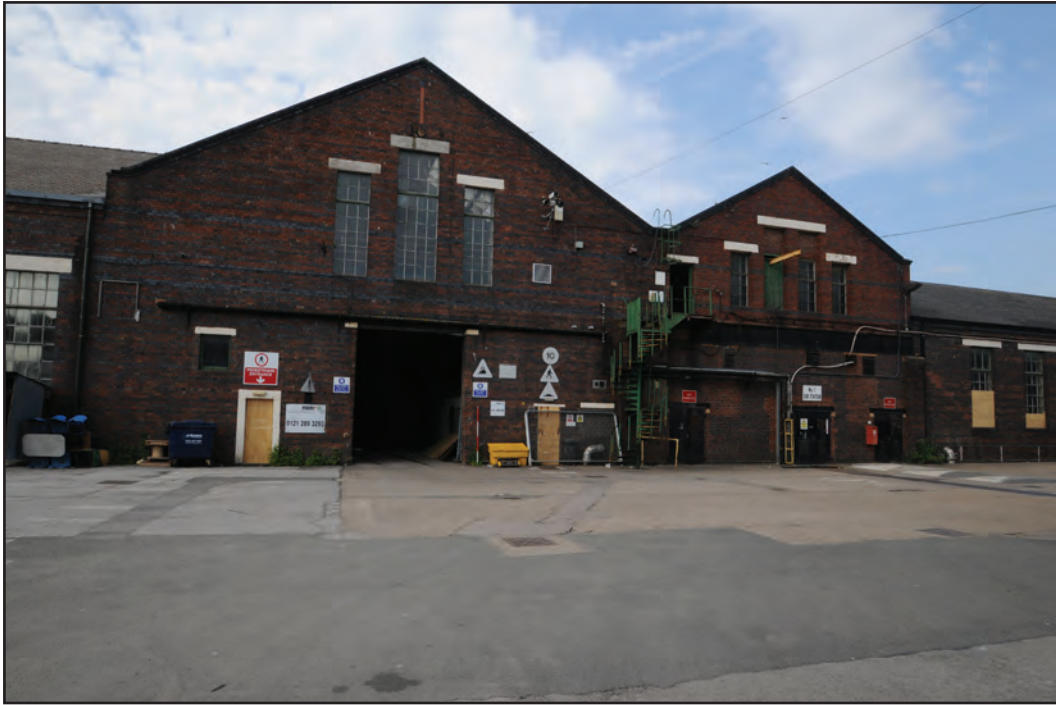
Photograph No. Washwood153
Description: Exterior south gable ends
Site Location: E1/E2
Direction From: SSW

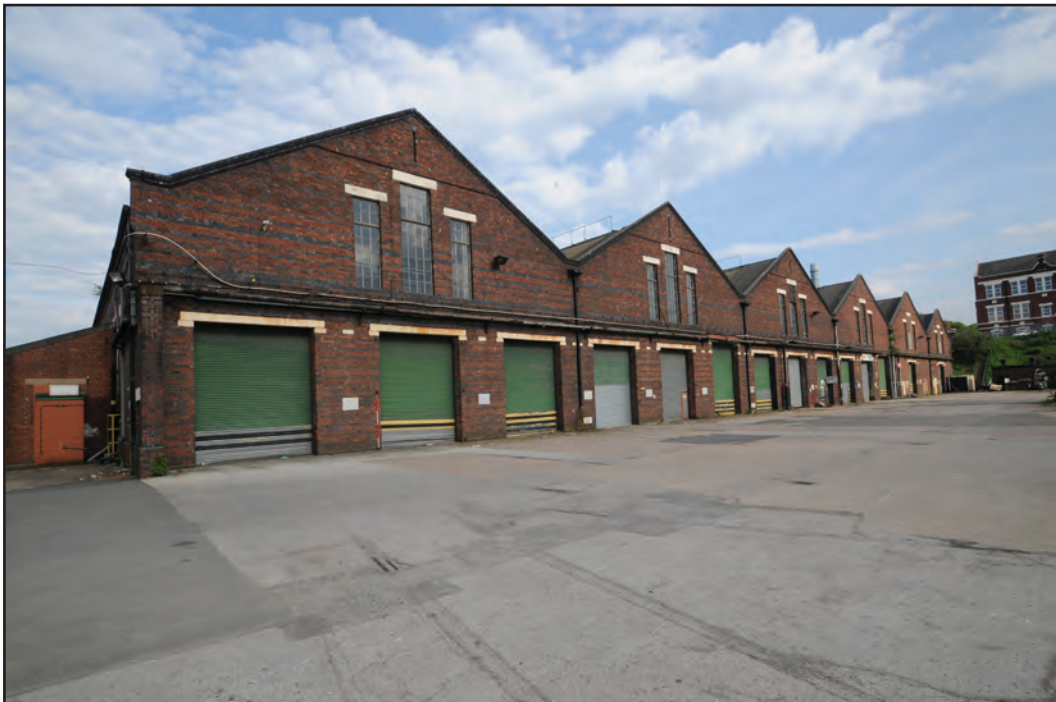
Photograph No. Washwood154
Description: Exterior west gable ends
Site Location: B1-B6
Direction From: NW

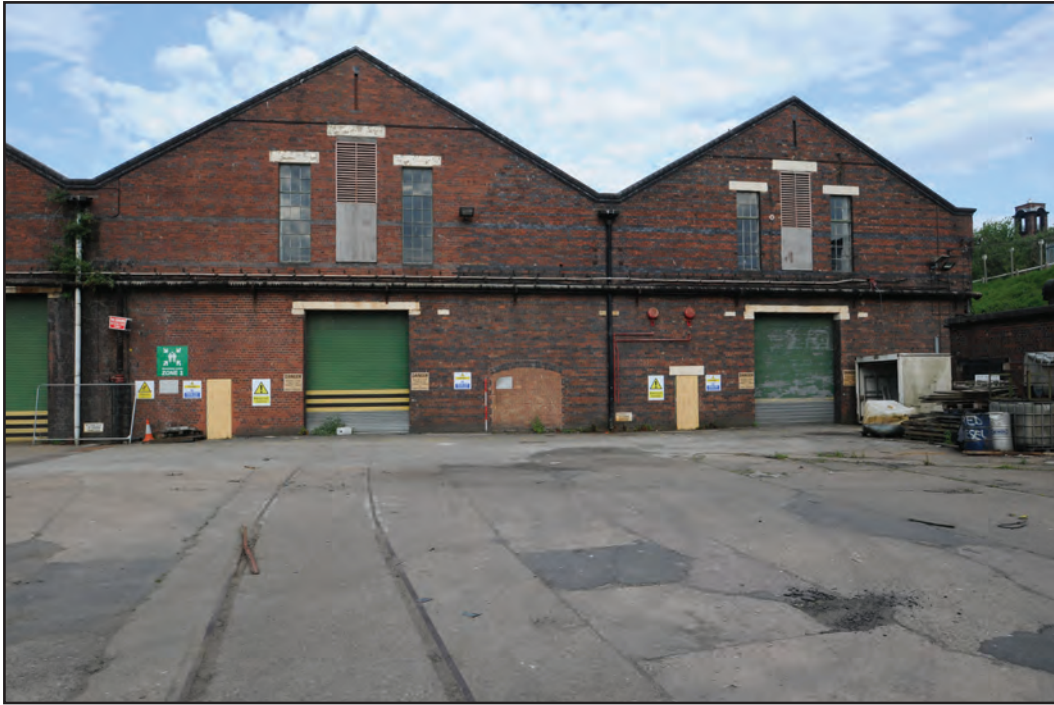
Photograph No. Washwood155
Description: Exterior west gable ends
Site Location: B5/B6
Direction From: W

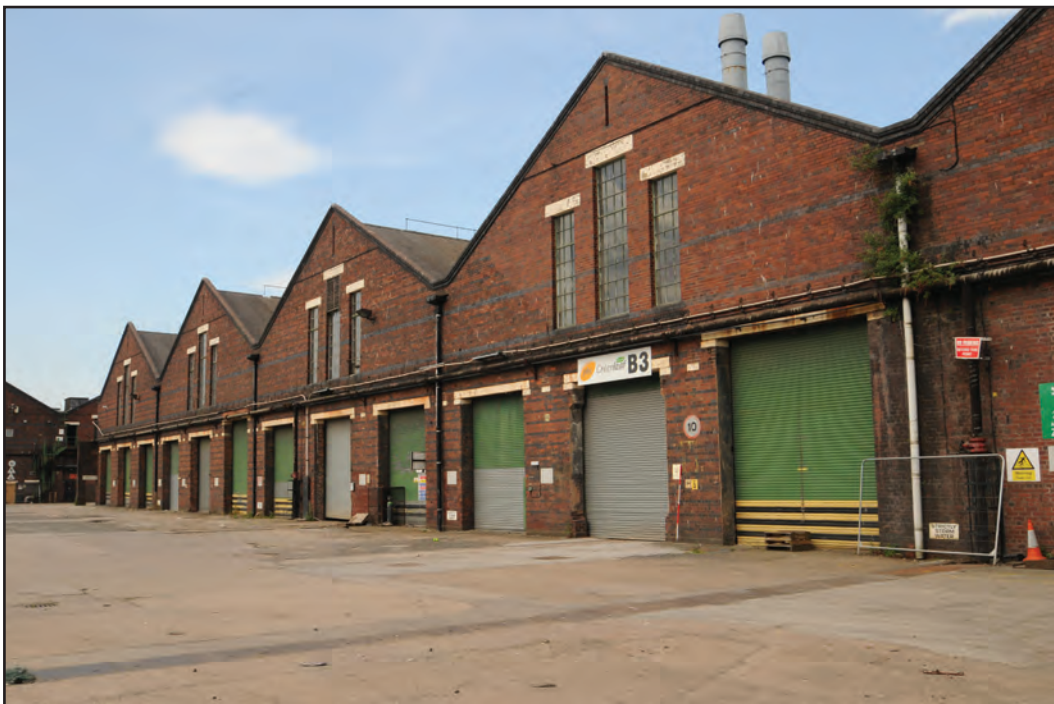
Photograph No. Washwood156
Description: Exterior west gable ends
Site Location: B1-B4
Direction From: SW

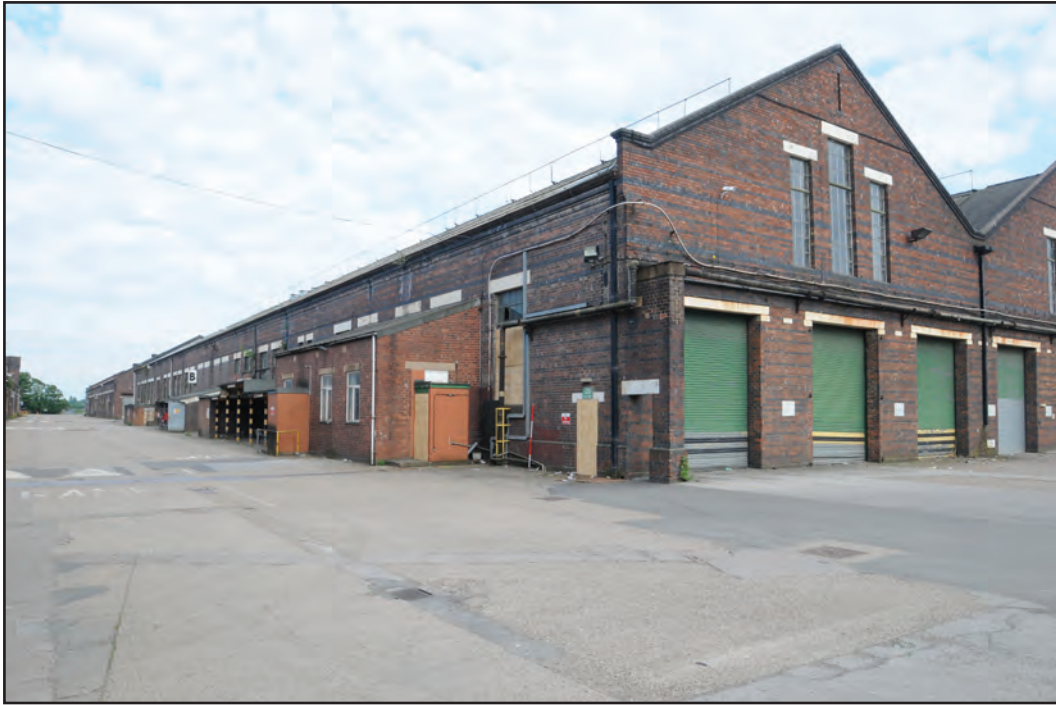
Photograph No. Washwood157
Description: Exterior northwest corner with archway
Site Location: B1
Direction From: NW

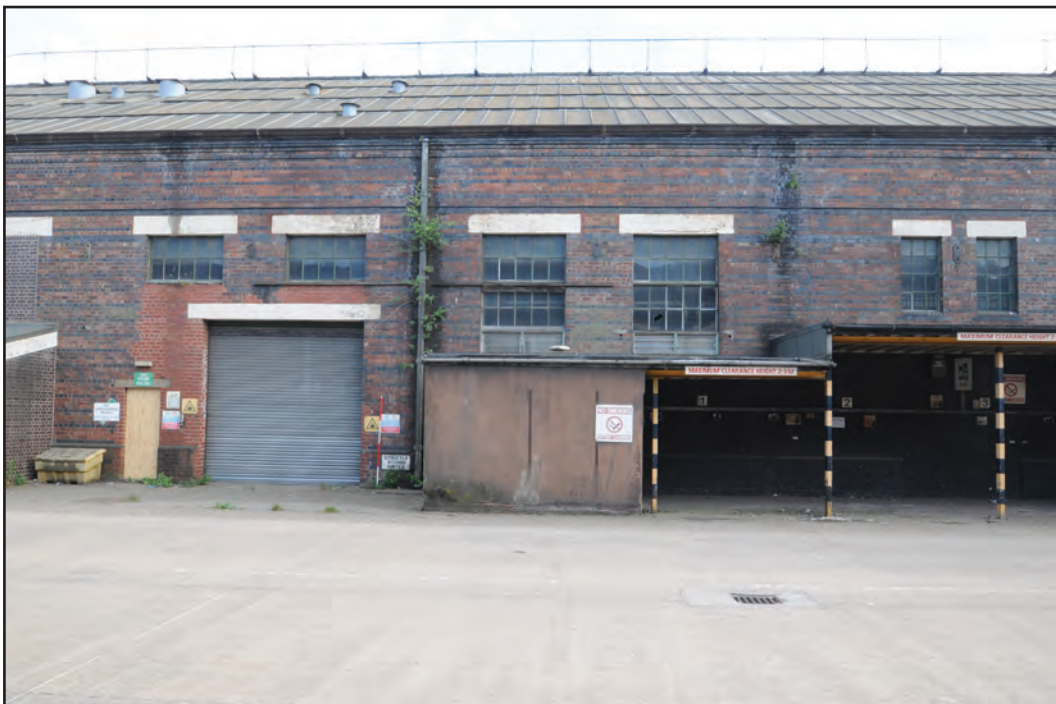
Photograph No. Washwood158
Description: Exterior north elevation with varying windows and inserted openings
Site Location: B1
Direction From: N

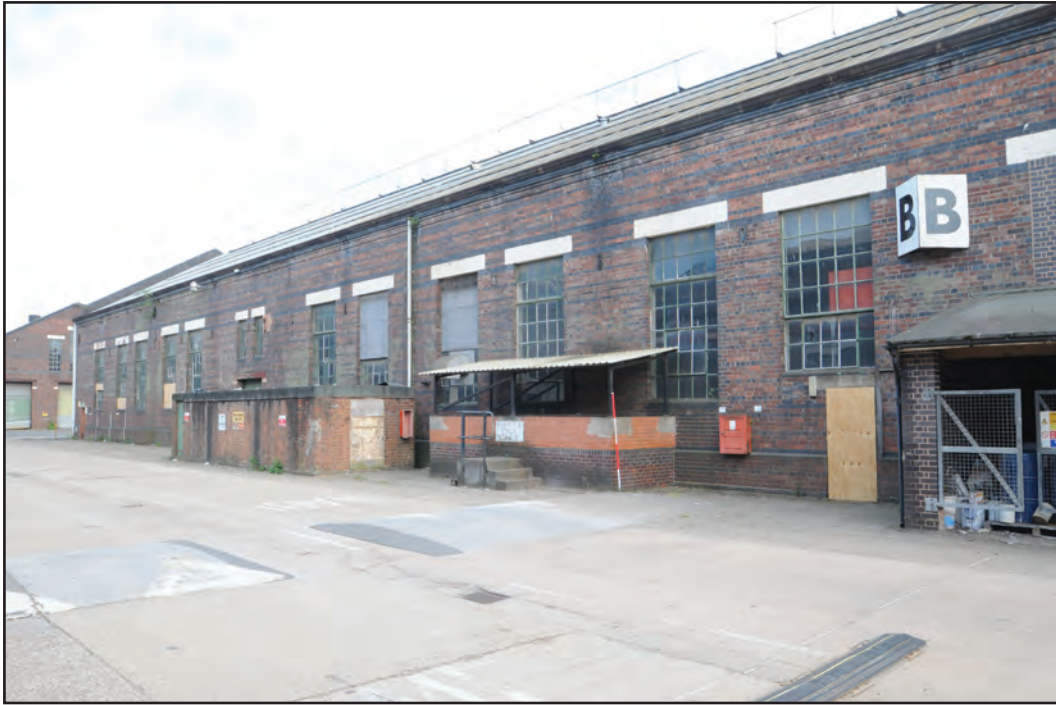
Photograph No. Washwood159

Description: Central area of exterior north elevation with liquid store and brick lean-tos

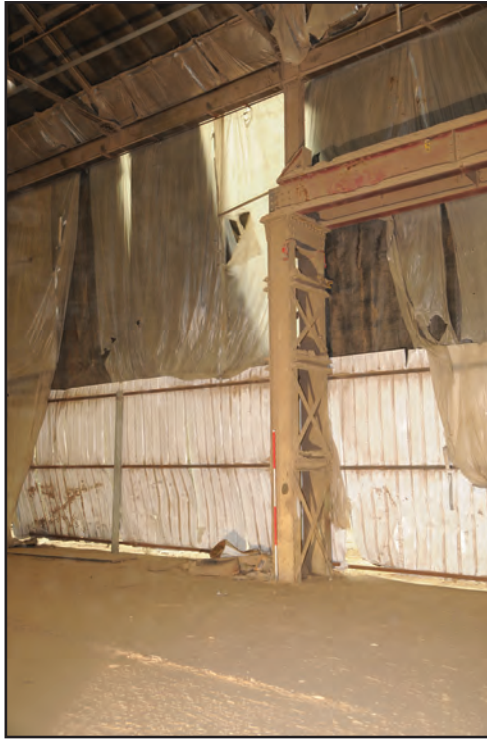
Photograph No. Washwood171
Description: Detail of cut off metal rail at west end of south wall
Site Location: A3
Direction From: NW

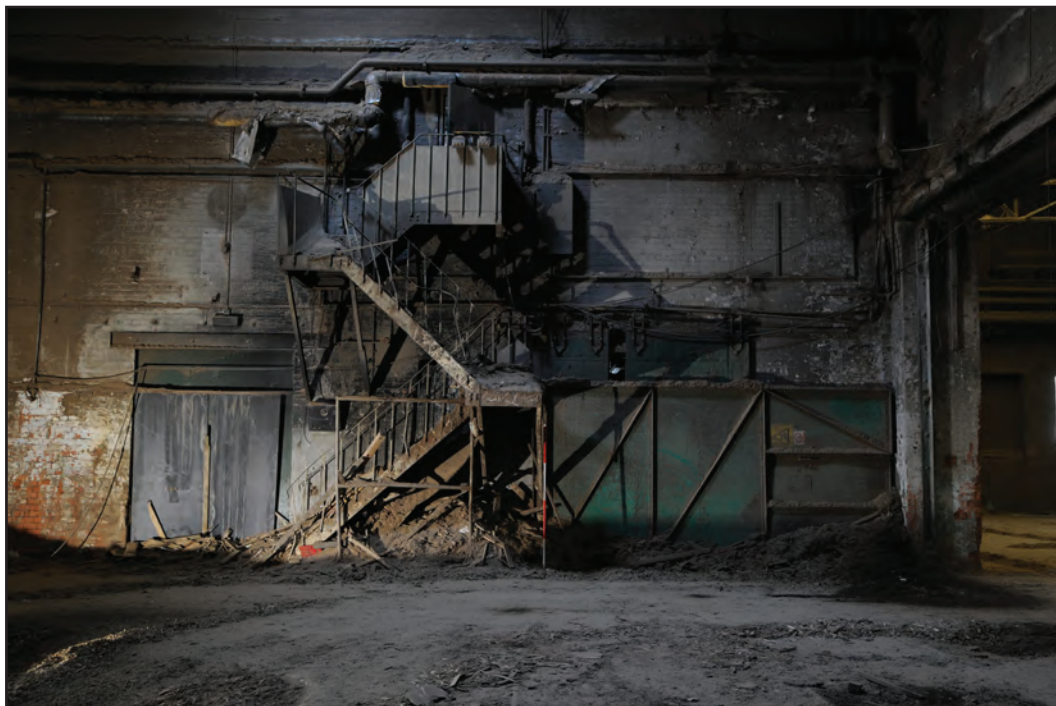
Photograph No. Washwood174

Description: east interior elevation with stairs, metal doors and metal paneled wall

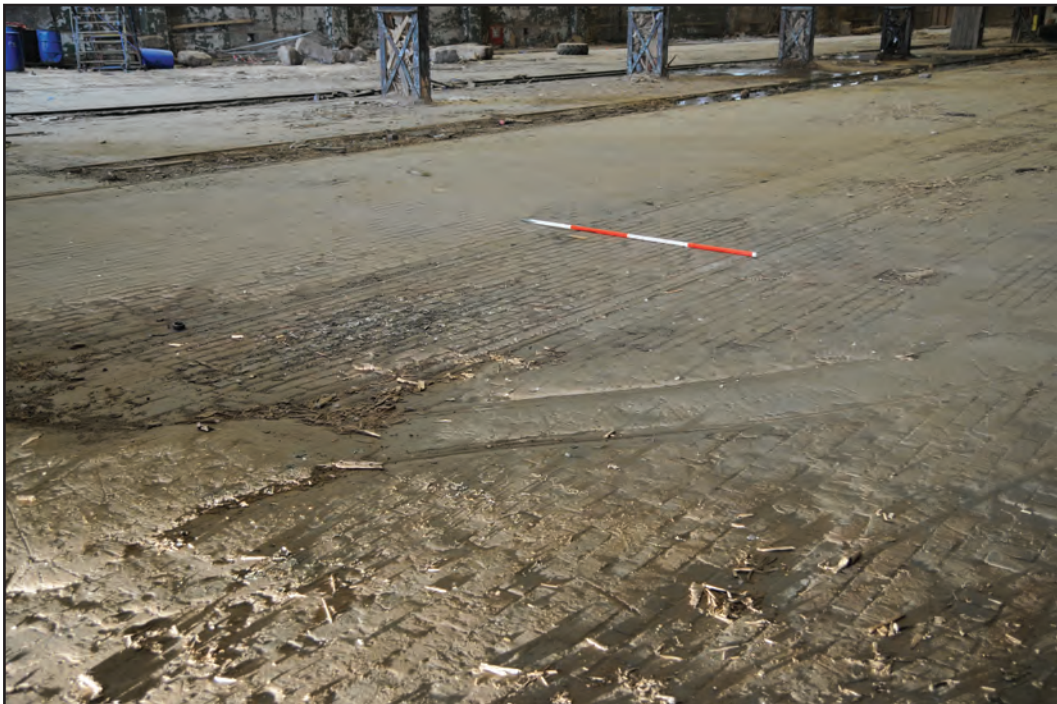
Photograph No. Washwood176
Description: Brick floor with train and cart rails at west end of shed interior
Site Location: A2
Direction From: SW

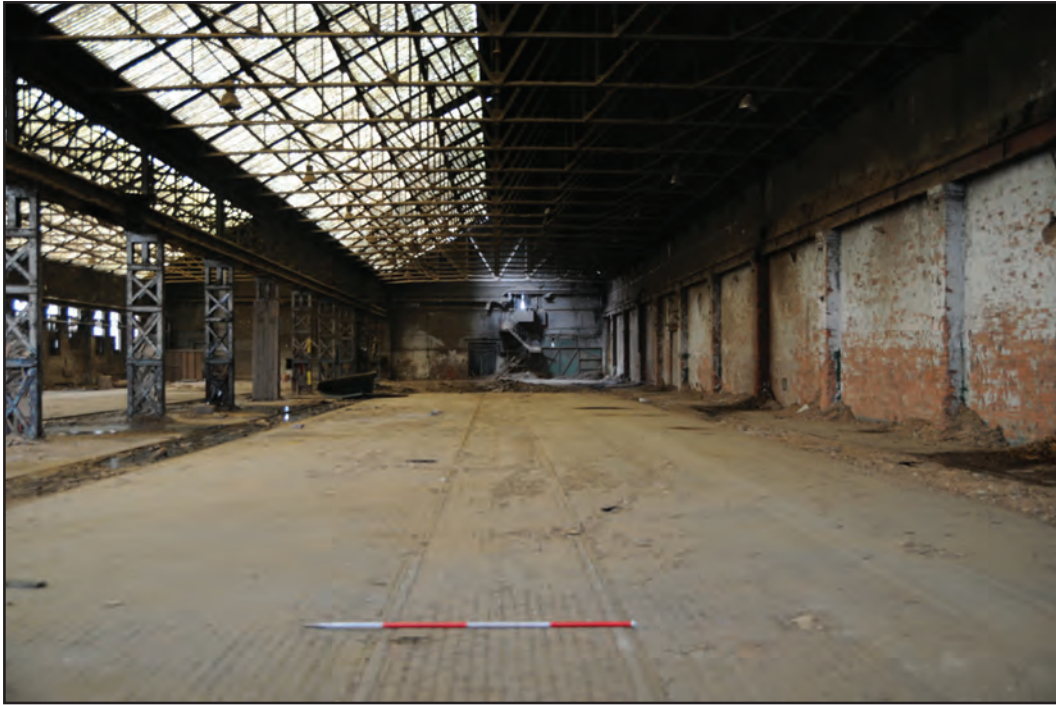
Photograph No. Washwood177

Description: Shed interior with stanchions and open wall into A1 to north (left) and brick wall with pilasters to south

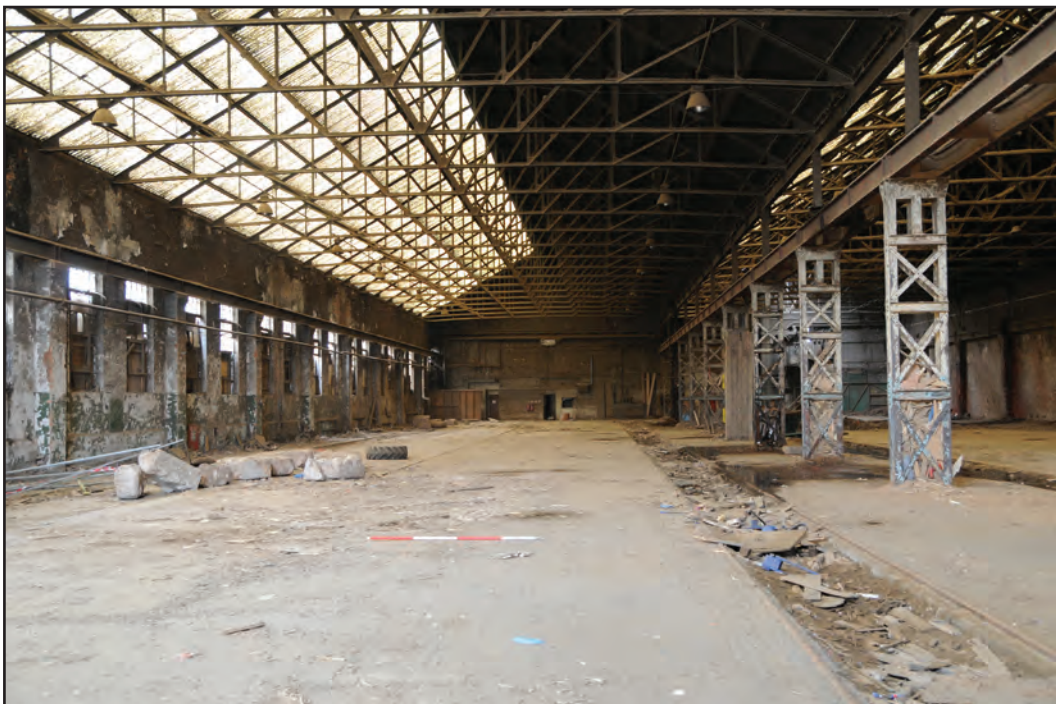
Photograph No. Washwood178

Description: Shed interior with brick wall and pilasters on north acting as Building A exterior north wall

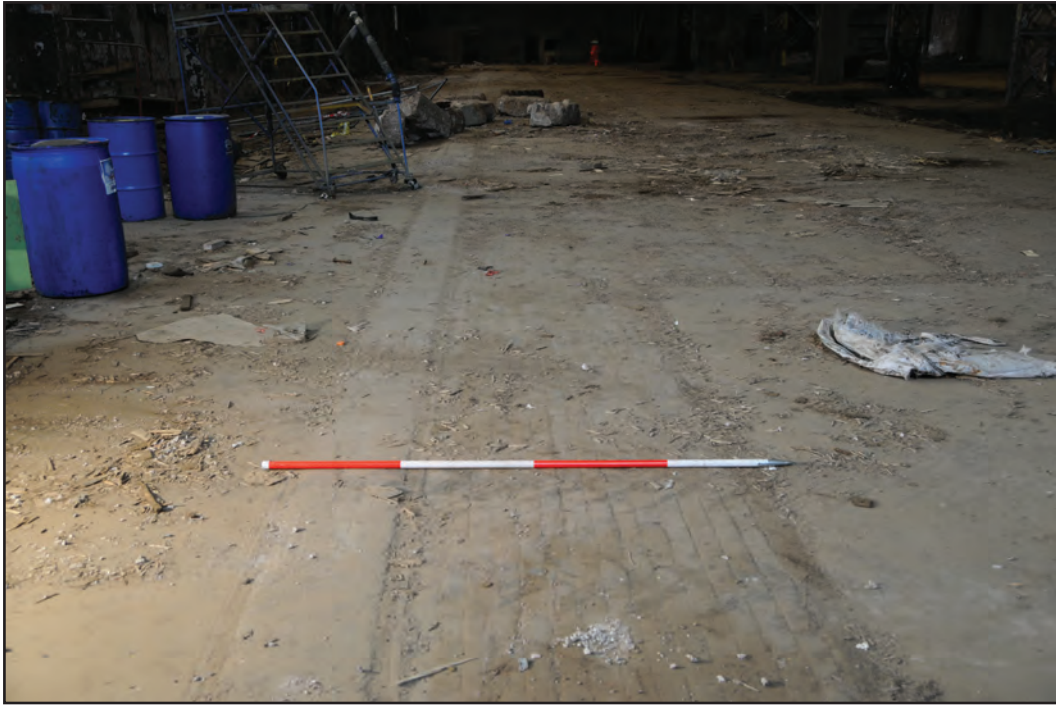
Photograph No. Washwood179
Description: Concrete cast floor with brick infill at west end of shed interior
Site Location: A1
Direction From: W

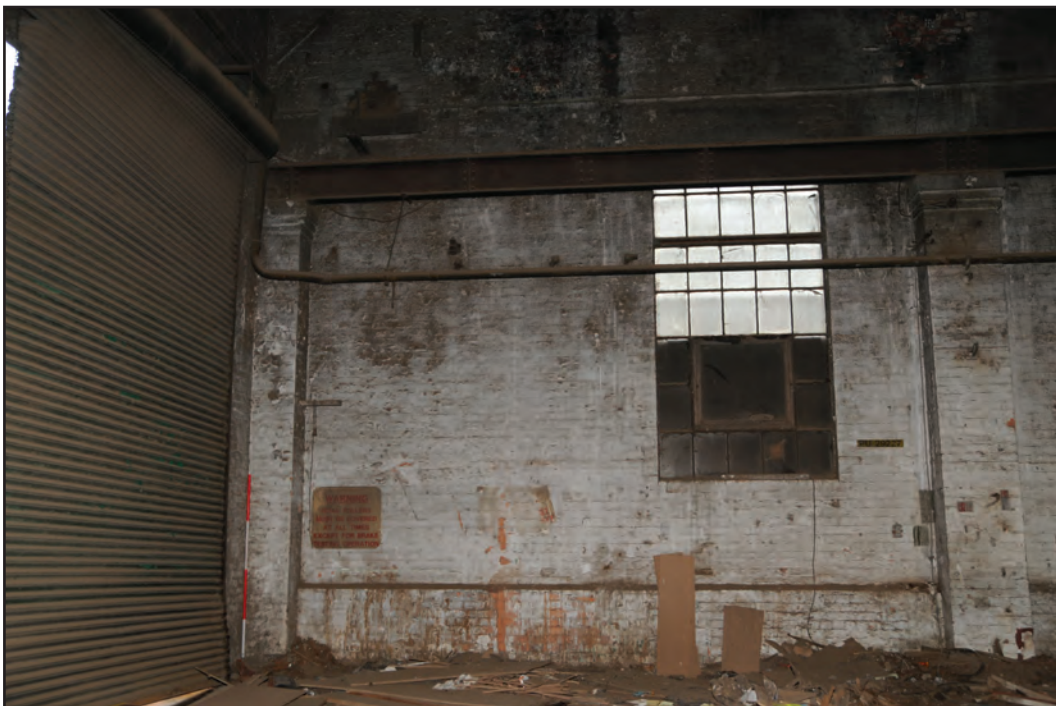
Photograph No. Washwood180
Description: west end of north wall interior elevation with low and high bricked openings
Site Location: A1
Direction From: S

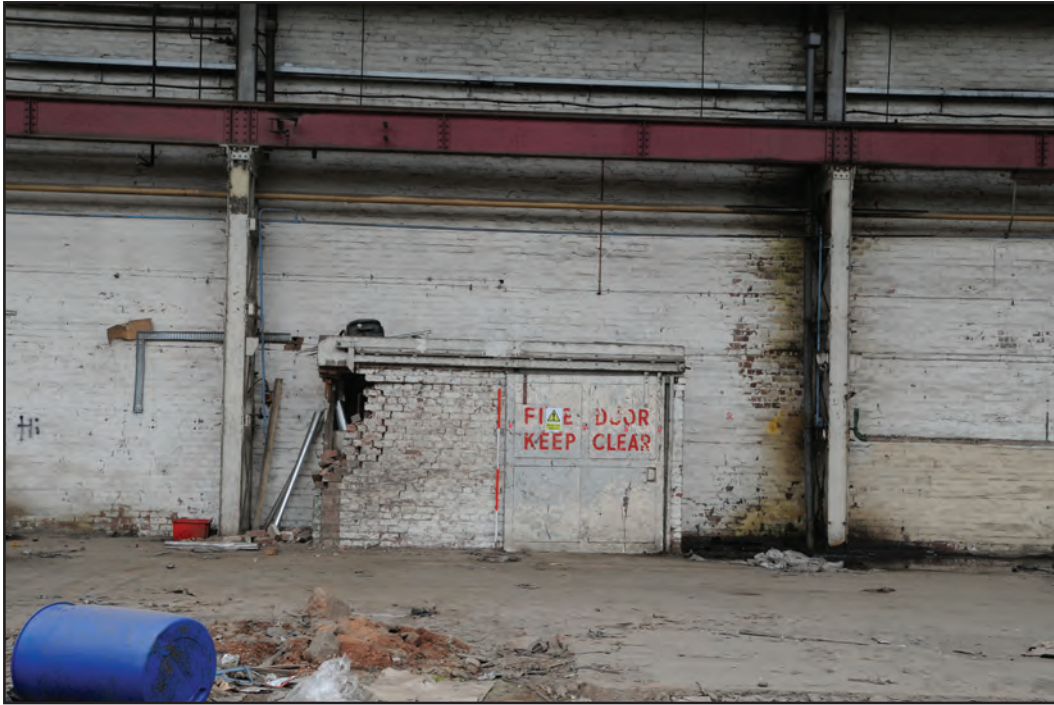
Photograph No. Washwood185
Description: Brick block with door at east end of south elevation for entry into A6
Site Location: A5
Direction From: N
