HS2 WPO29 – Historic Environment Works – Washwood Heath Depot – Enabling Works North Contract

Final Report for Historic Building Recording Survey

Document no.: 1EW04-LMJ-EV-REP-NS03_NLo8-029001

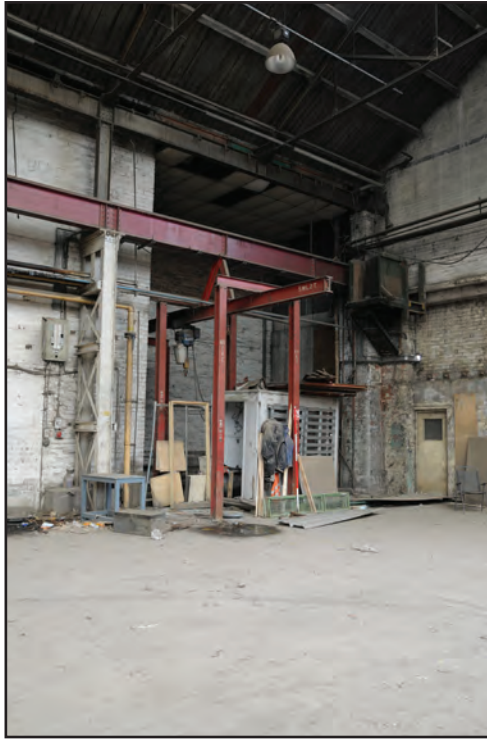
Photograph No. Washwood187
Description: Detail of southwest corner of shed interior with hoist equipment
Site Location: A4
Direction From: NE

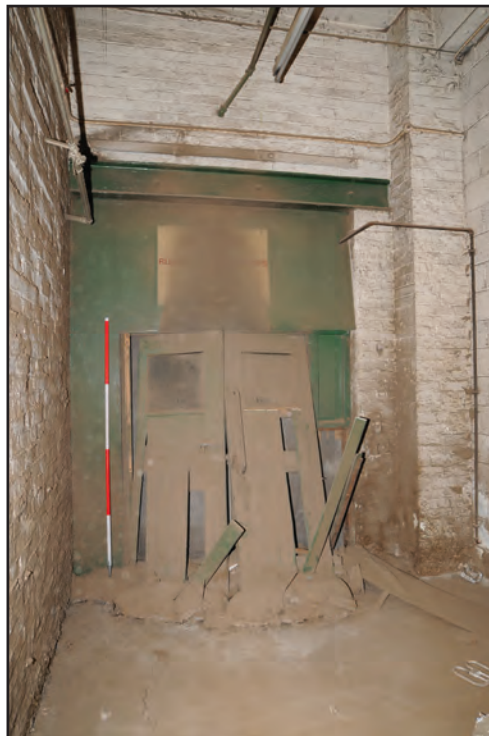
Photograph No. Washwood192
Description: Blocked access from offices into A2 ground floor
Site Location: A7
Direction From: E

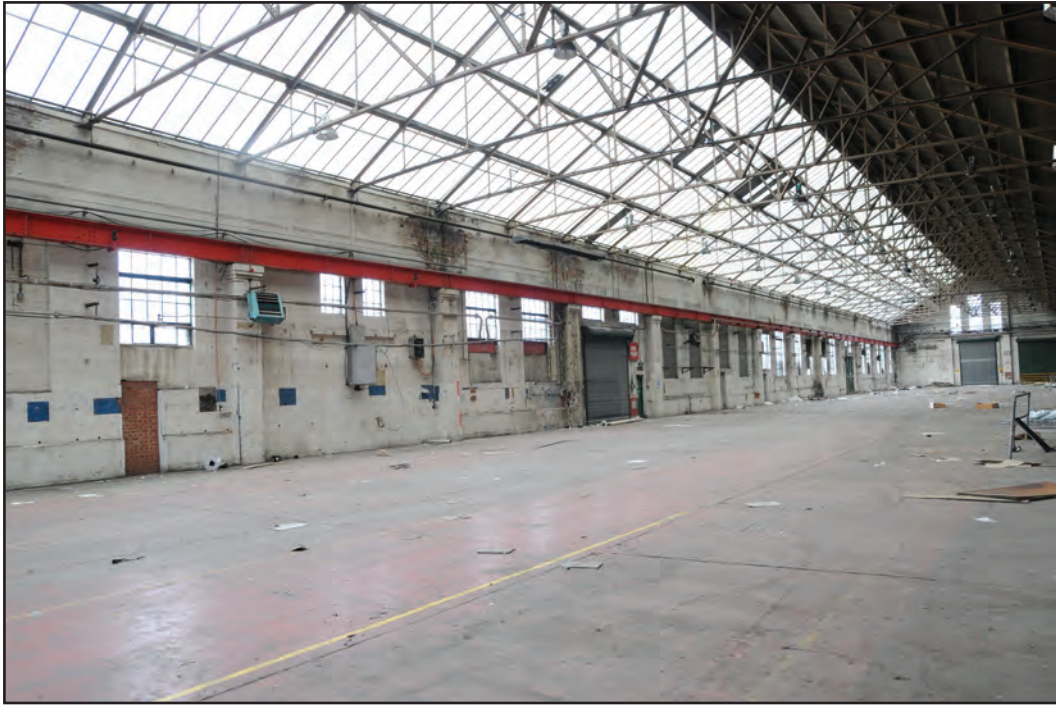
Photograph No. Washwood195

Description: Interior north elevation with various windows and doors acting as exterior north wall of Building B

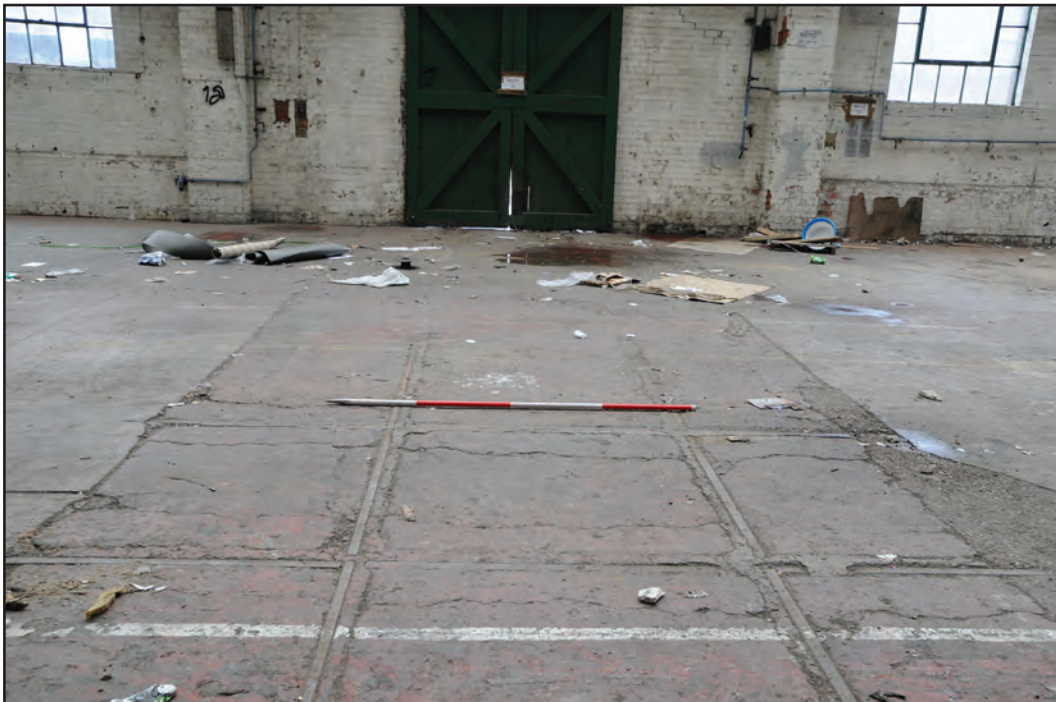
Photograph No. Washwood196

Description: Detail of two direction train rails crossing at E end of shed interior

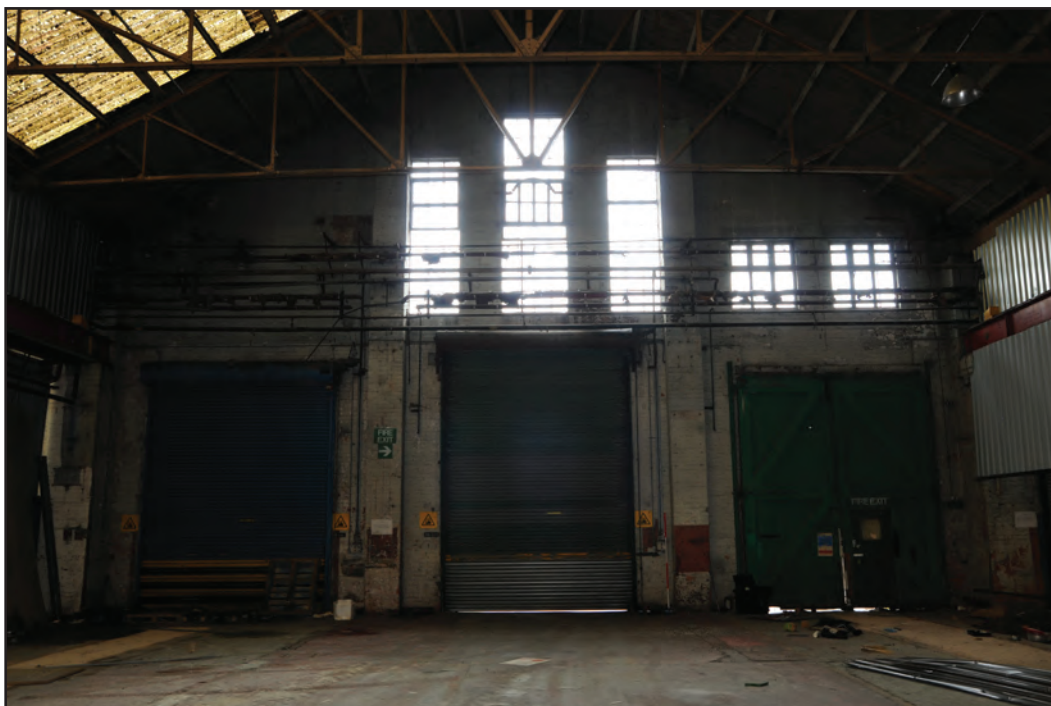
Photograph No. Washwood198
Description: General view of shed interior
Site Location: B2
Direction From: E

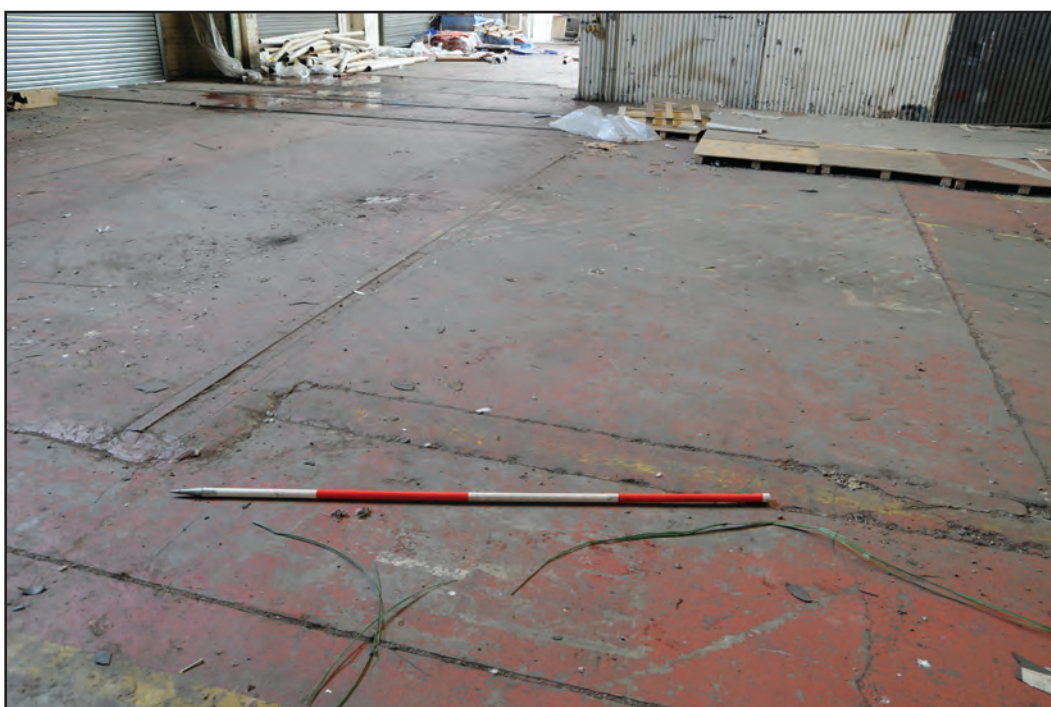
Photograph No. Washwood199
Description: Interior east gable end
Site Location: B2
Direction From: W

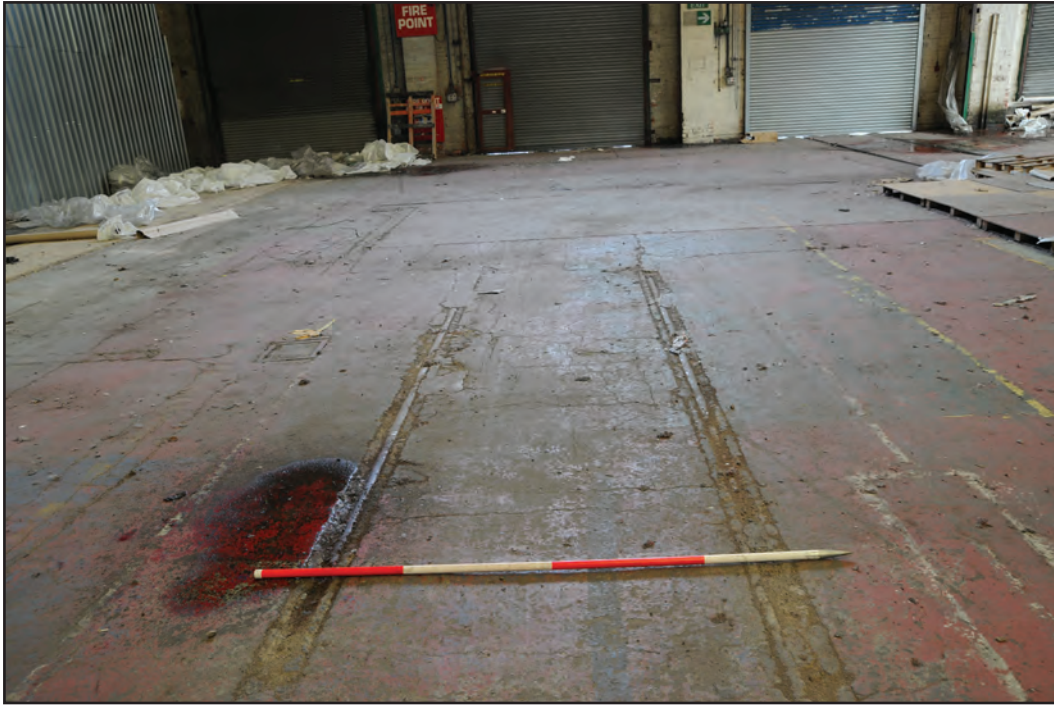
Photograph No. Washwood200
Description: Cast concrete floor with rails and drains at west end of interior
Site Location: B2
Direction From: SE

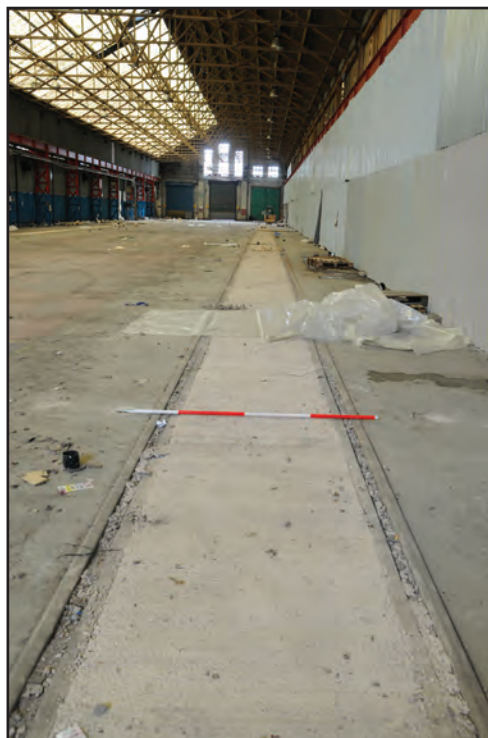
Photograph No. Washwood201
Description: Train rails at west end of shed interior
Site Location: B2
Direction From: E

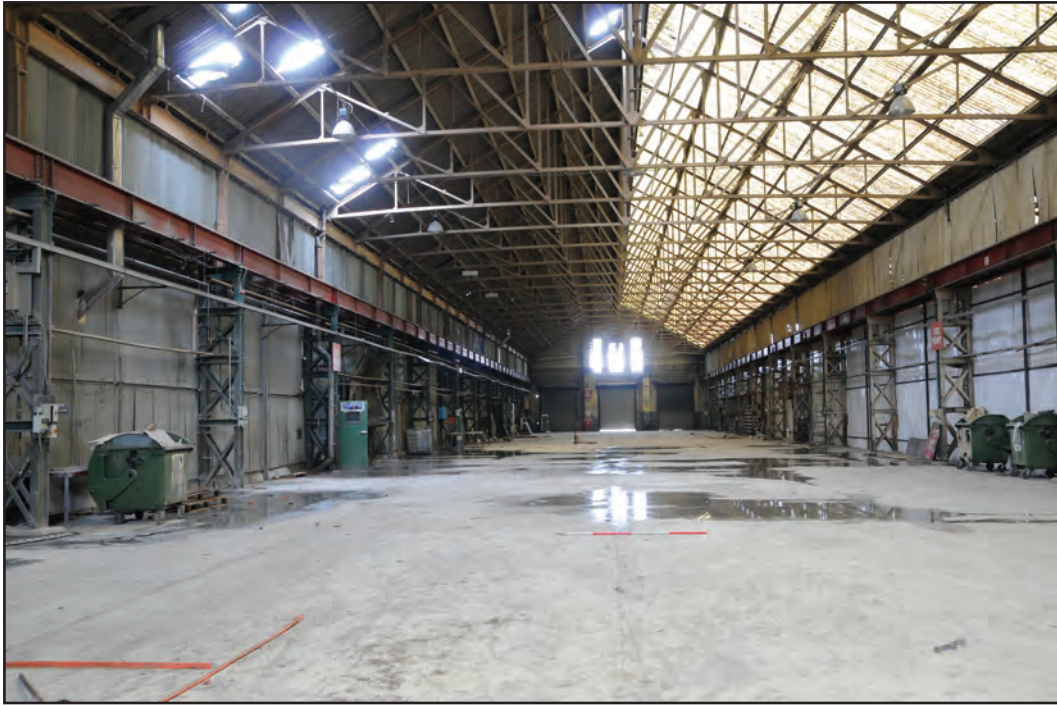
Photograph No. Washwood202
Description: Train rails oriented east-west at south side of shed interior with modern concrete infill of inspection trench
Site Location: B2
Direction From: W

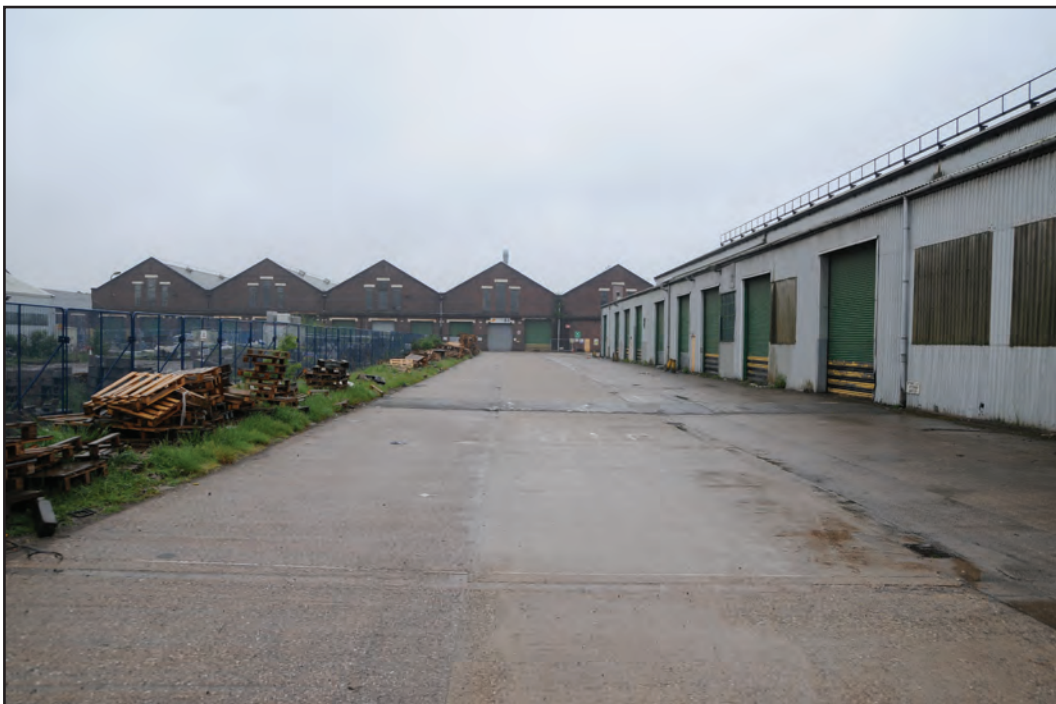
Photograph No. Washwood219
Description: Train rails leading into the west end gables of Building F
Site Location: F
Direction From: W

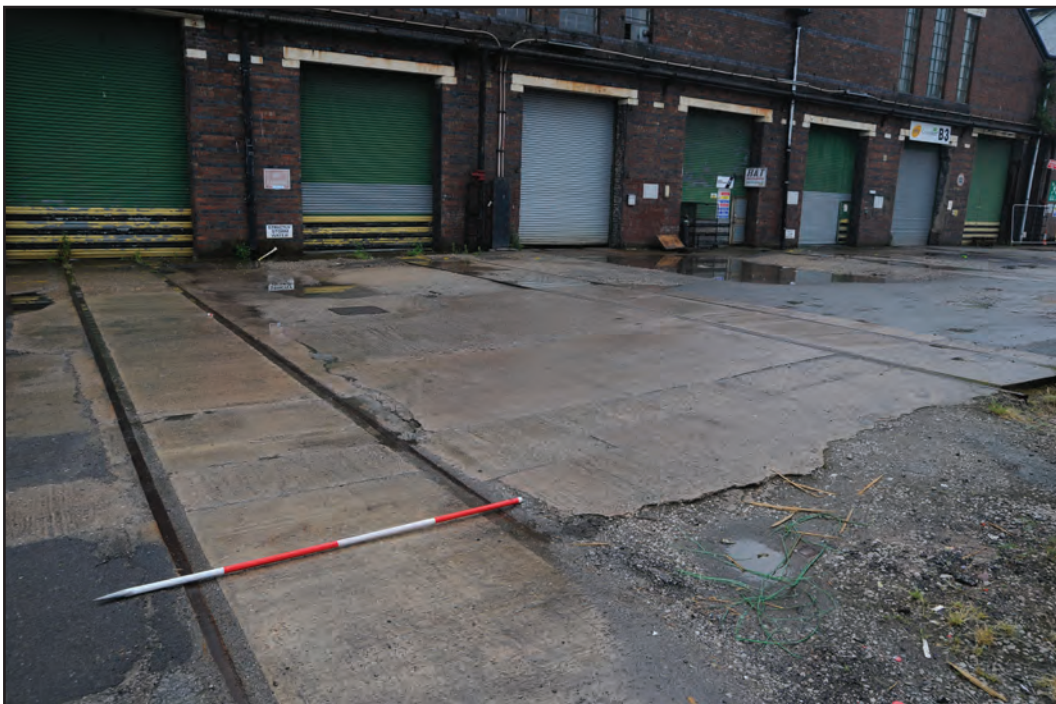
Photograph No. Washwood223
Description: Possible air raid shelter with entry steps
Site Location: Air raid shelter
Direction From: SW

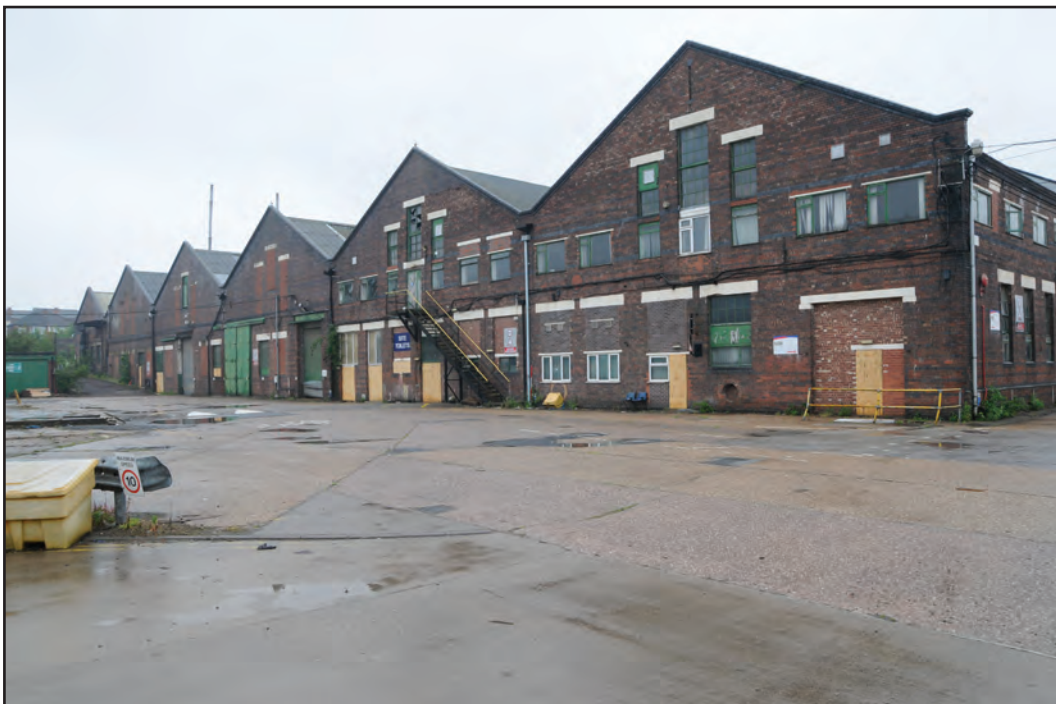
Photograph No. Washwood227
Description: Exterior east gable ends (offices)
Site Location: A1/A2
Direction From: E

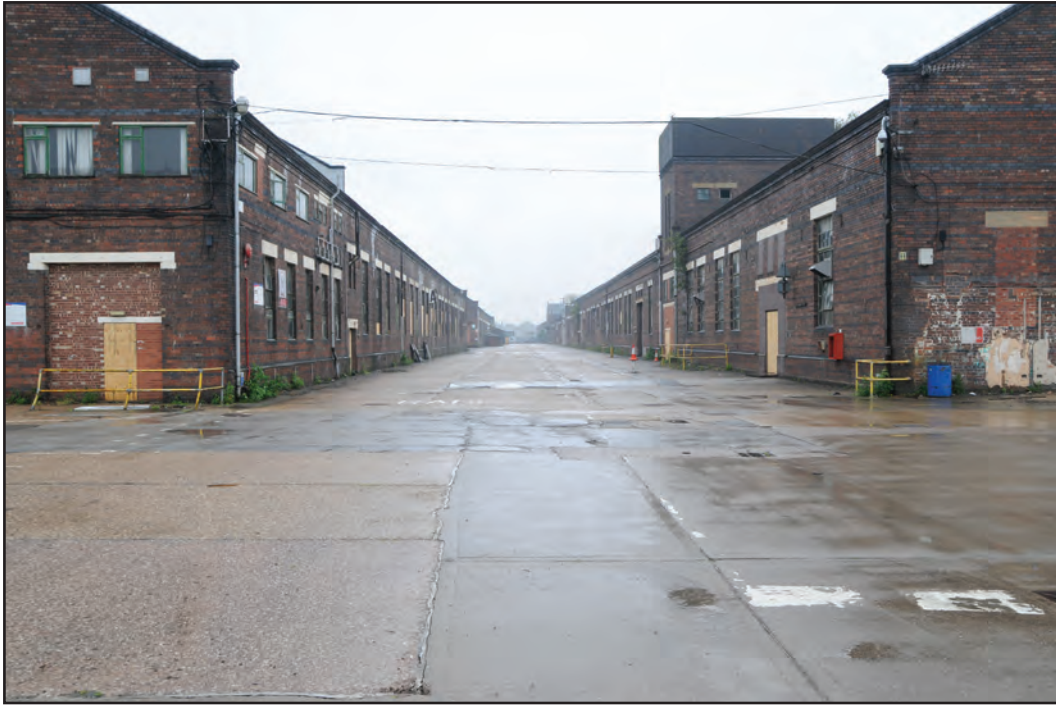
Photograph No. Washwood228
Description: Exterior east gable ends
Site Location: A1-A6
Direction From: NE

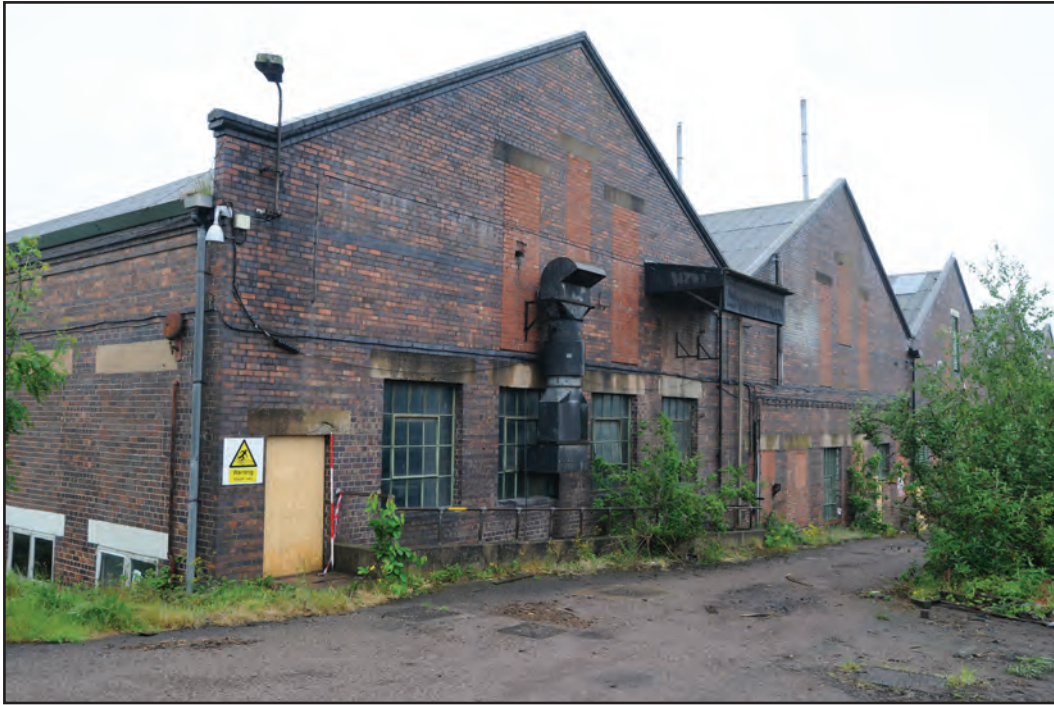
Photograph No. Washwood230
Description: Exterior east gable ends
Site Location: A3/A4
Direction From: ESE

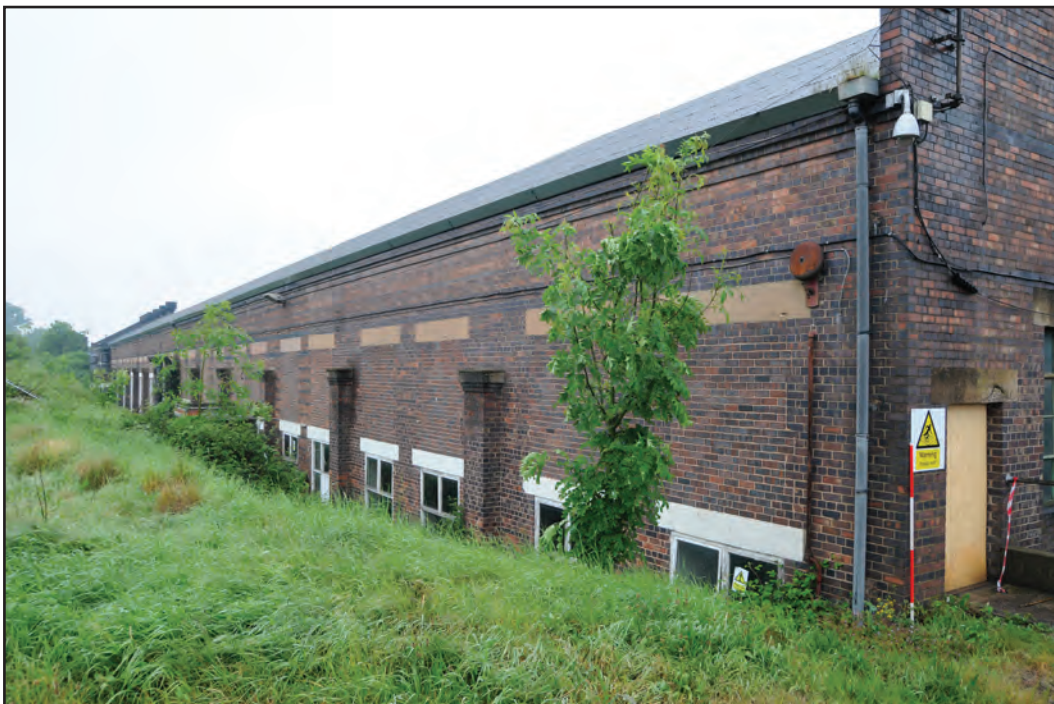
Photograph No. Washwood231
Description: Exterior east gable ends
Site Location: A5/A6
Direction From: SE

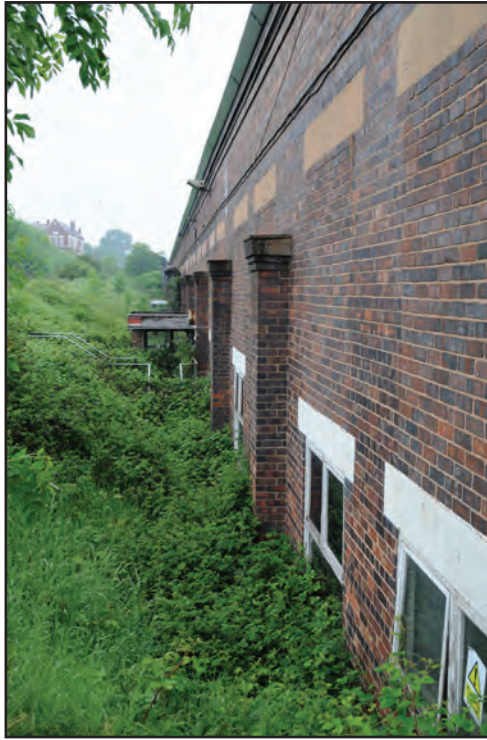
Photograph No. Washwood232
Description: Exterior south elevation at east end
Site Location: A6
Direction From: ESE

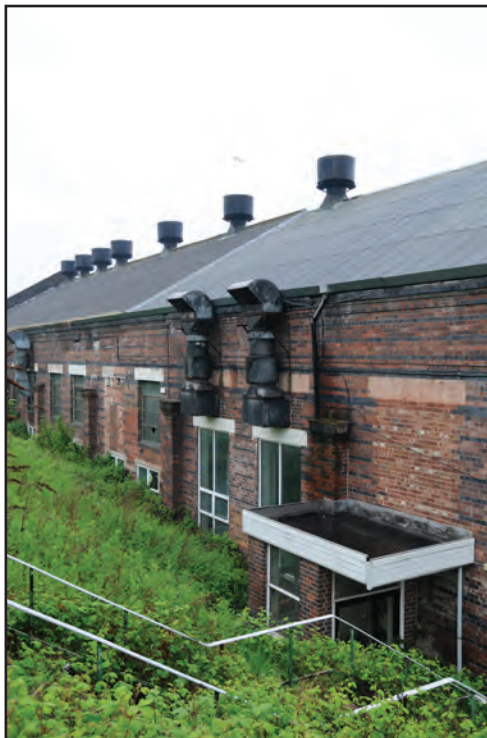
Photograph No. Washwood233
Description: Pilasters on exterior south elevation
Site Location: A6
Direction From: E

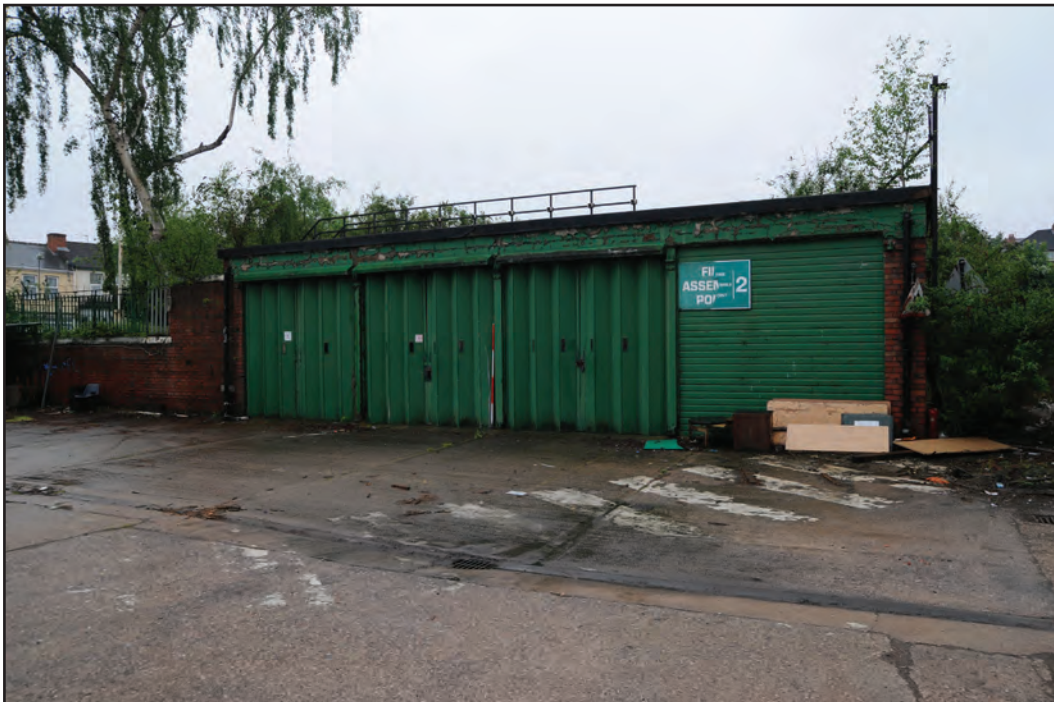
Photograph No. Washwood235
Description: Exterior south elevation with curved southwest corner
Site Location: Gatehouse
Direction From: SW

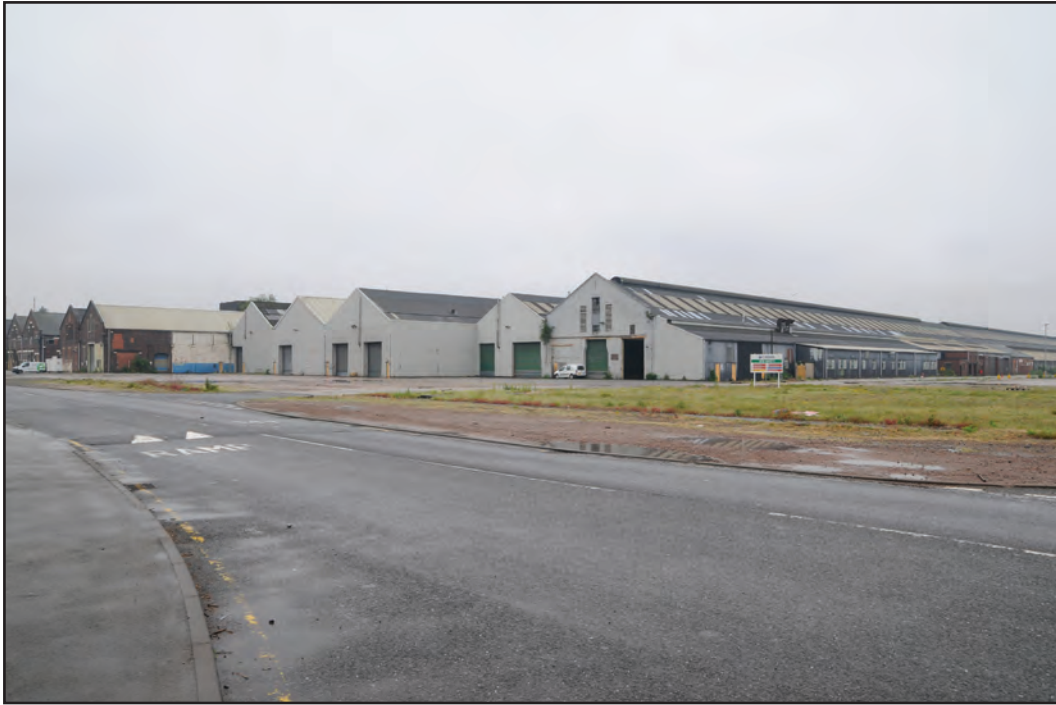
Photograph No. Washwood236
Description: Exterior north elevation
Site Location: Firehouse?
Direction From: NW

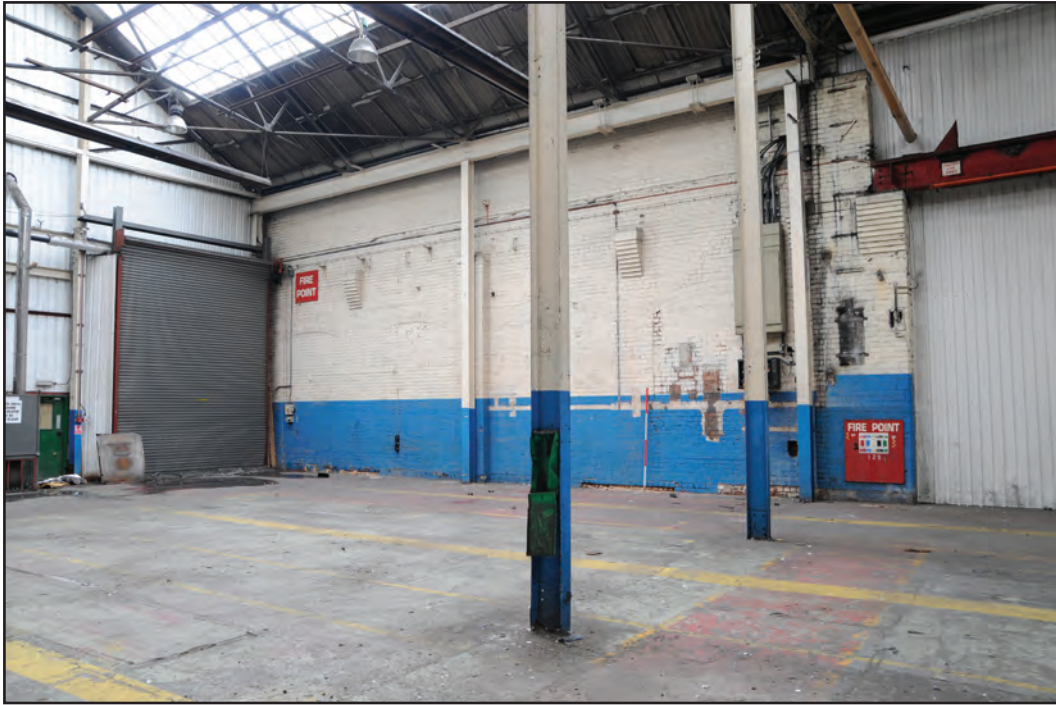
Photograph No. Washwood239

Description: Extension at east end of C3 with additional small stanchions, corbel detail from earlier exterior elevation, and detail of steel rail end resting on pilaster at original building end

Site Location: C3

Direction From: NW

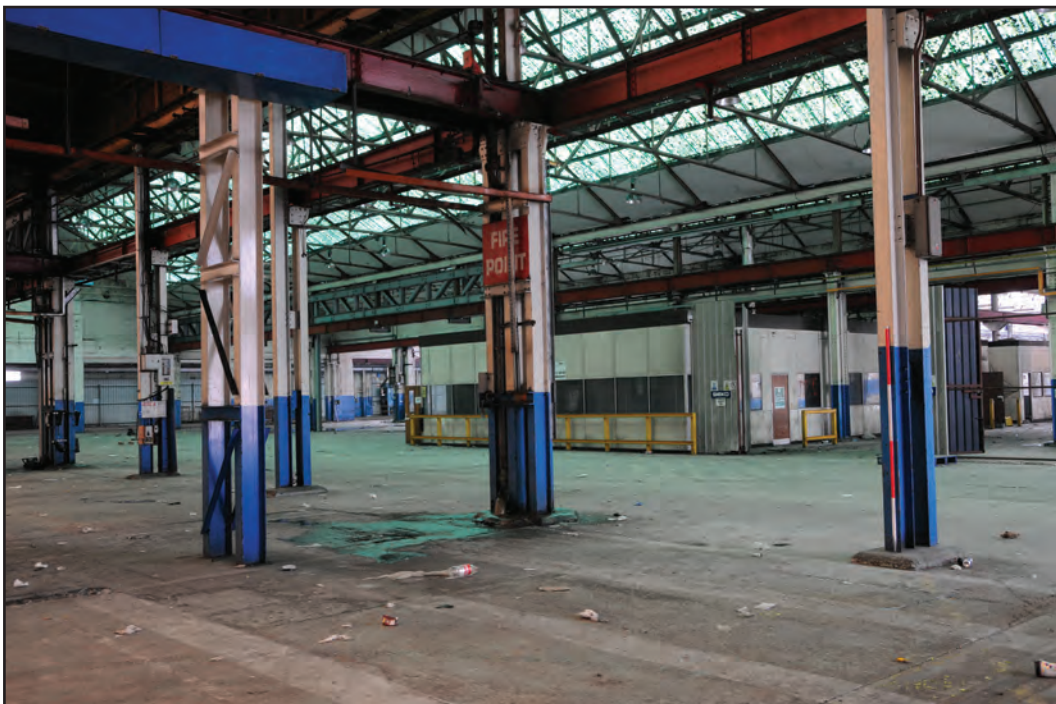
Photograph No. Washwood240

Description: Three different stanchions at east end of shed interior

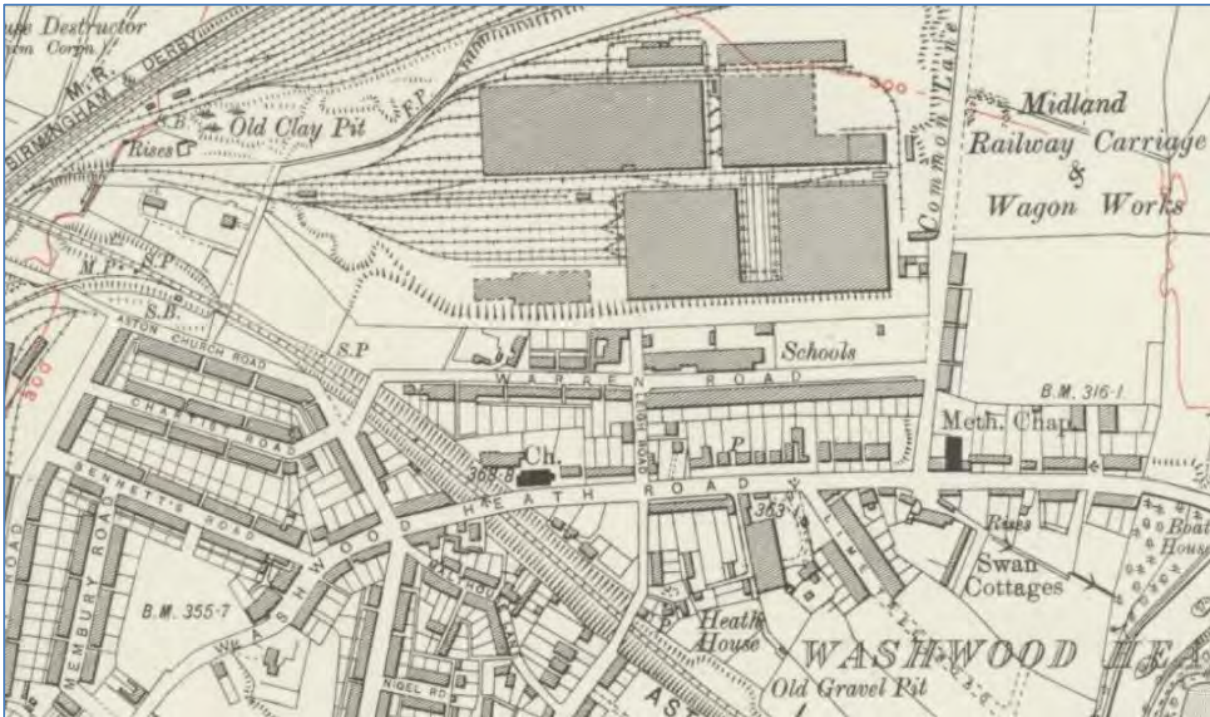
Plate 3: Ordnance Survey mapping of 1920, revised in 1913

- 2.2.2 Mapping published in 1920, shortly after the war, was also based on the 1913 survey (Figure 3 in Appendix B). This fills in the missing blanks and provides a detailed layout of the works, largely in its current form, comprising six separate structures on an east-west alignment and accessed by railway tracks from Washwood Heath Sidings off the Birmingham & Derby Line. Like the nearby Saltley Works, the Midland Works manufactured, maintained and designed rolling stock, which required much less heavy engineering work than building engines and locomotives. However, it was still an extensive process requiring a variety of buildings to accommodate different processes. These are likely to have included timber drying sheds, a trimming shop, smithy, wheel-shops, fitting and machine shops, and a paint shop where the final coachwork was added.
