Submitter OASouth

Line 1: [OA South] County[Northamptonshire] Parish:[Harpole, Kislingbury & Upper Heyford]

Site[M1 D Way] Site code[M1D 17]

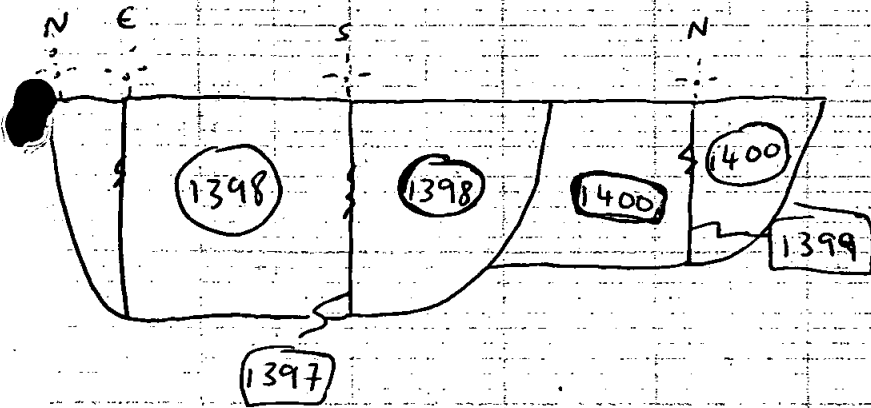
1397 + 1399

SECTION SKETCH SHOWING DITCHES

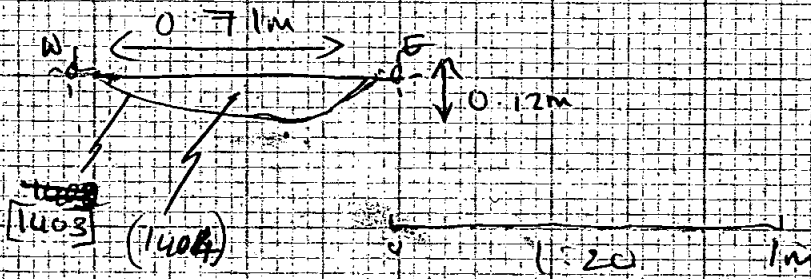
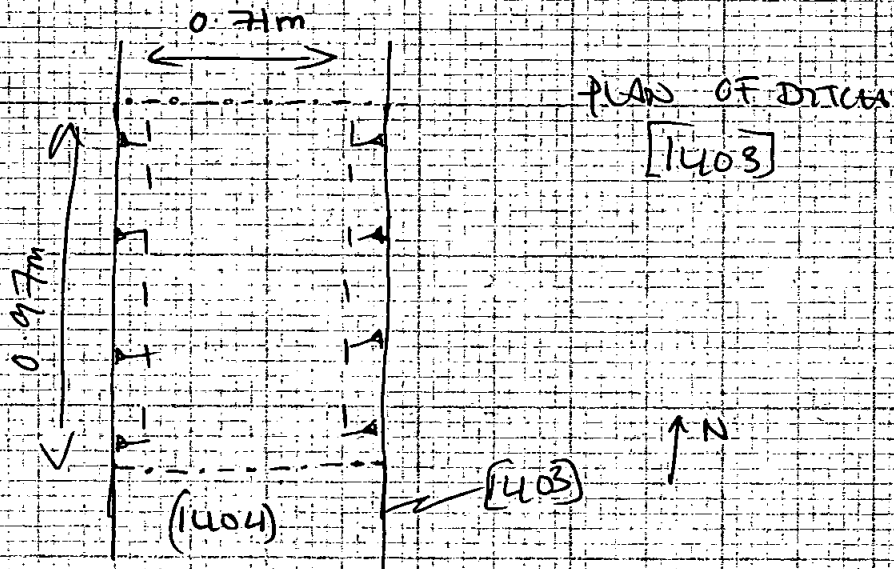
SECTION DRAWING DITCH [1403]

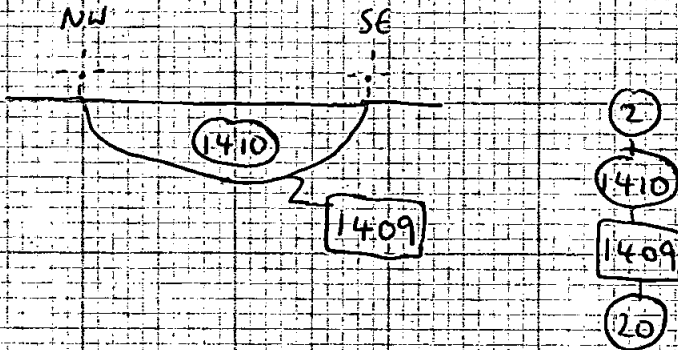
1409

SOUTH WEST SECTION SKETCH SHOWING PIT

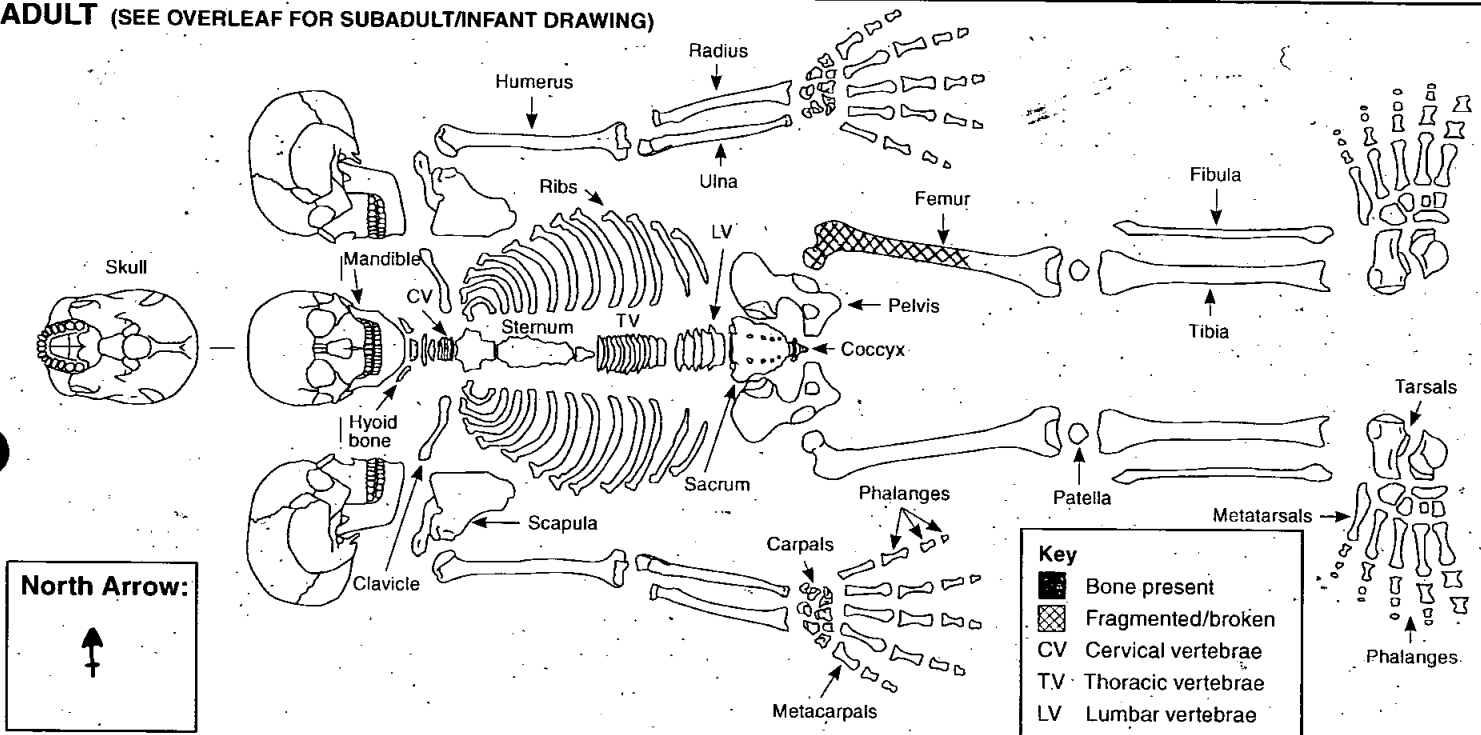
ADULT (SEE OVERLEAF FOR SUBADULT/INFANT DRAWING)

ONLY LEFT FEMUR REMAINING - ALIGNED E-W.
FRAGMENT OF BONE FOUND IN GRAVE FILL (1427) S OF FEMUR.

8- FRAGMENTED
 9- FRAGMENTED
 10- MOST OF GRAVE LOST DUE TO HEAVY MACHINING.
 11- TROWEL + PLASTIC TOOLS, OVERCAST, WATERLOGGED.
 12- VERY POOR CONDITIONS - FLOODED + FROZEN MULTIPLE TIMES.

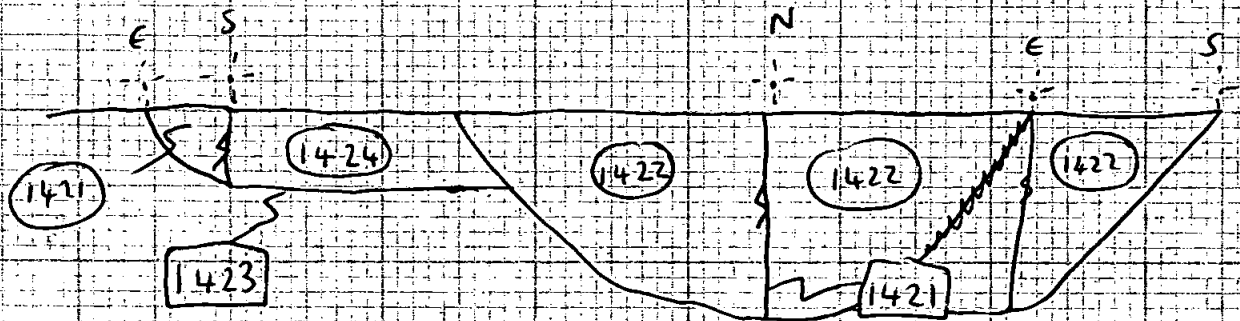
1
1421 + 1423

SKETCH OF
EAST FACING SECTION SHOWING DITCHES **1421 + 1423**

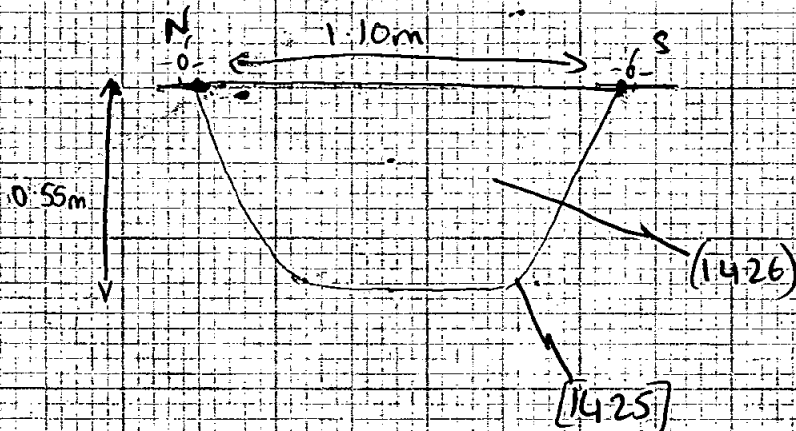
1425

SECTION OF
DITCH [1425]

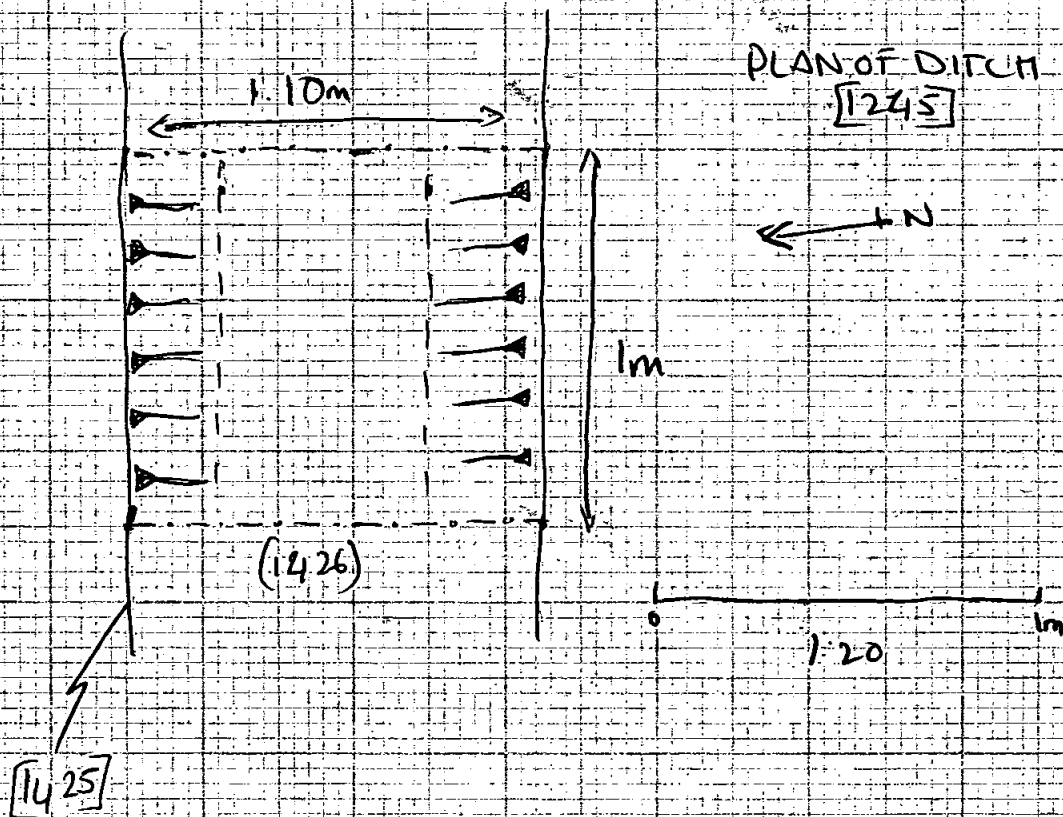
PLAN OF DITCH
[1425]

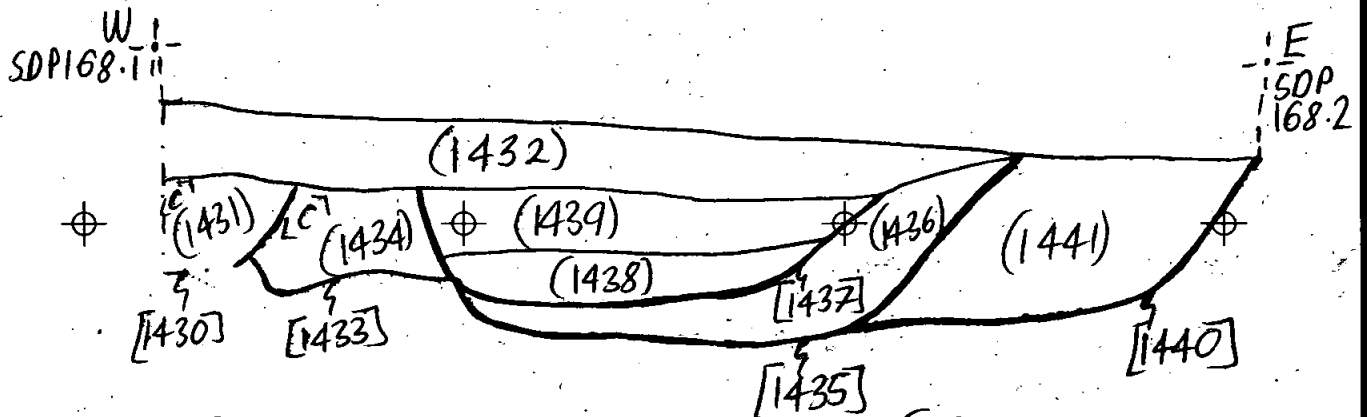
South facing section

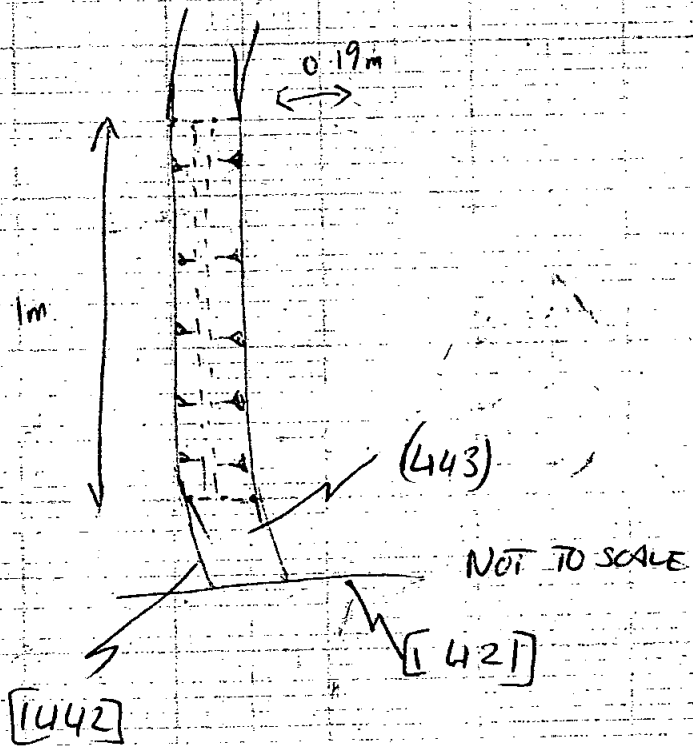
PLAN OF
DITCH
[1442]

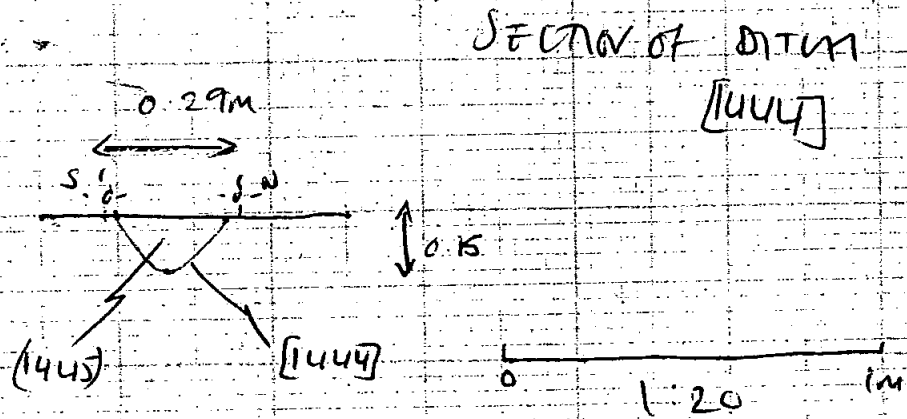
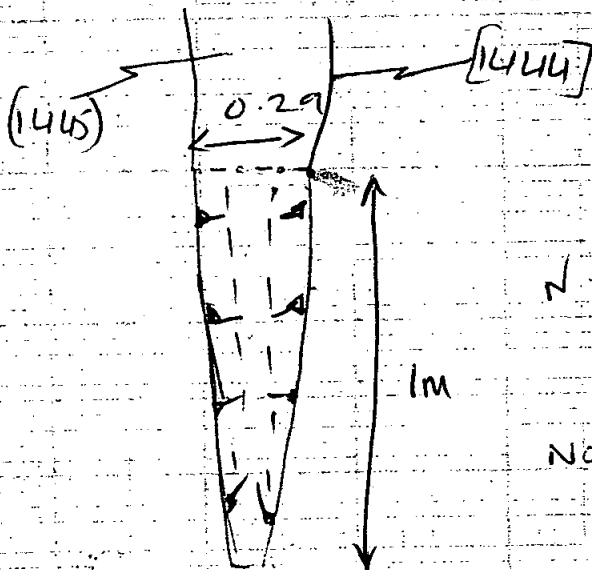
SHEET N° 2 OF 2
CONTEXTS 1444

PLAN OF
DITCH [1444]

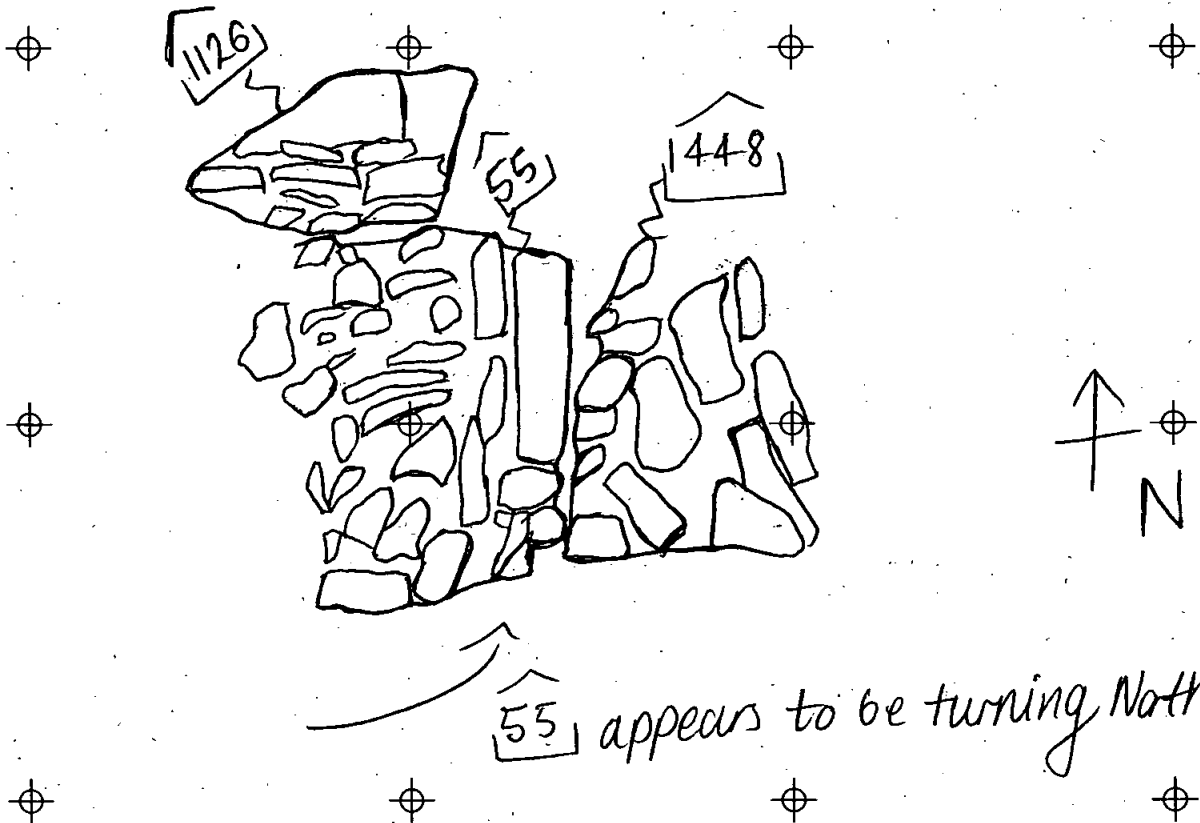
Sketch shows 55, turning + view in plan of relationship to 1448.
Also shows 1126 abutting 55

Interpretation/Discussion: <u>Structure of E-W running wall as part of Roman "temple" building for 1320. Is possibly it is butting wall 55, as the is later extension to the East of the temple structure. However, as 55 appears to be turning as it meets 1448, it could be that 1448 is instead abuted by 55.</u>				
Finds (tick): None [] Pot [] Bone [] Flint [] Stone [] Burnt stone [] Glass [] Metal [] CBM [] Wood [] Leather []				
<input type="checkbox"/> Small Finds			Recorder <u>TS</u>	
<input type="checkbox"/> Samples			Date <u>27/2/18</u>	
<input type="checkbox"/> Building Materials			Initials

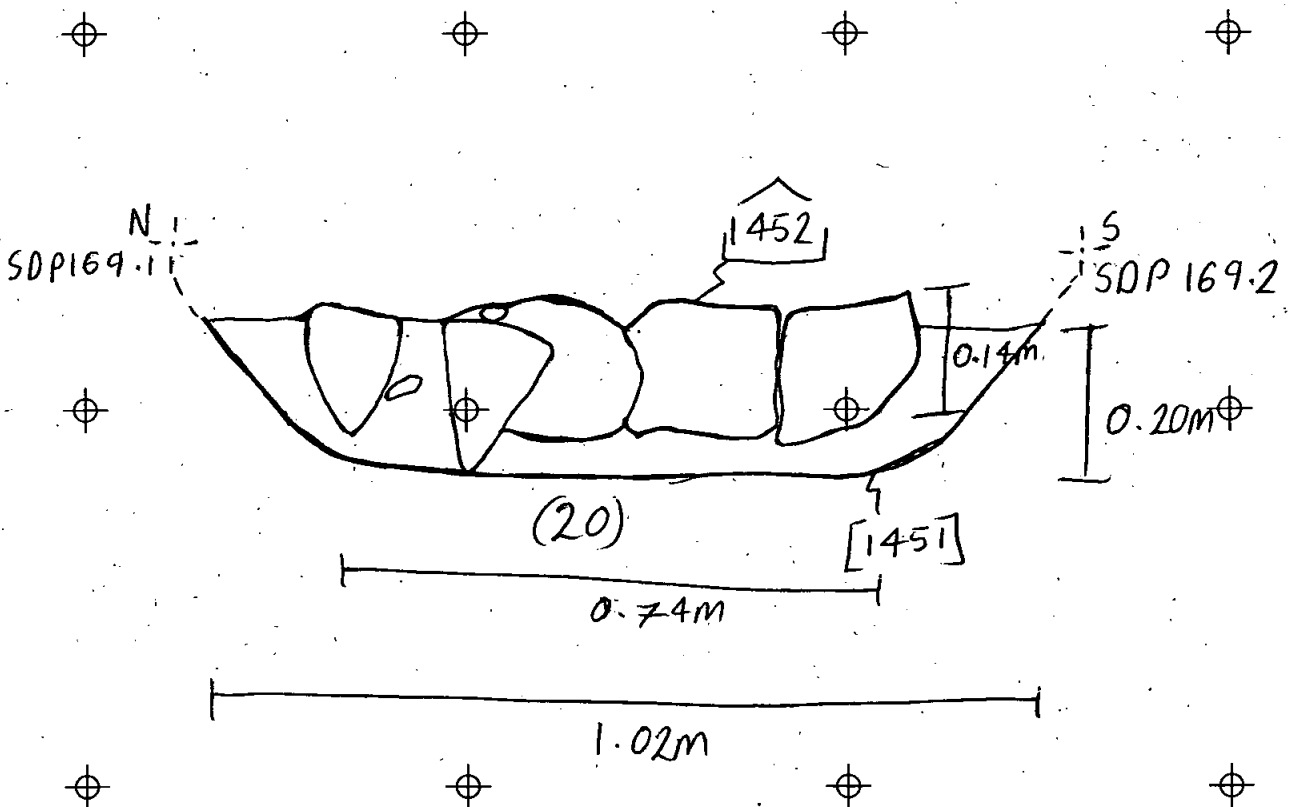
[1452] same as [55]

Interpretation/Discussion: Wall structure as part of Roman "temple" building to the Eastern end of area 1. Run E-W, is probably the same as [55], which appears to be abutted by [1126] and potentially [1448]

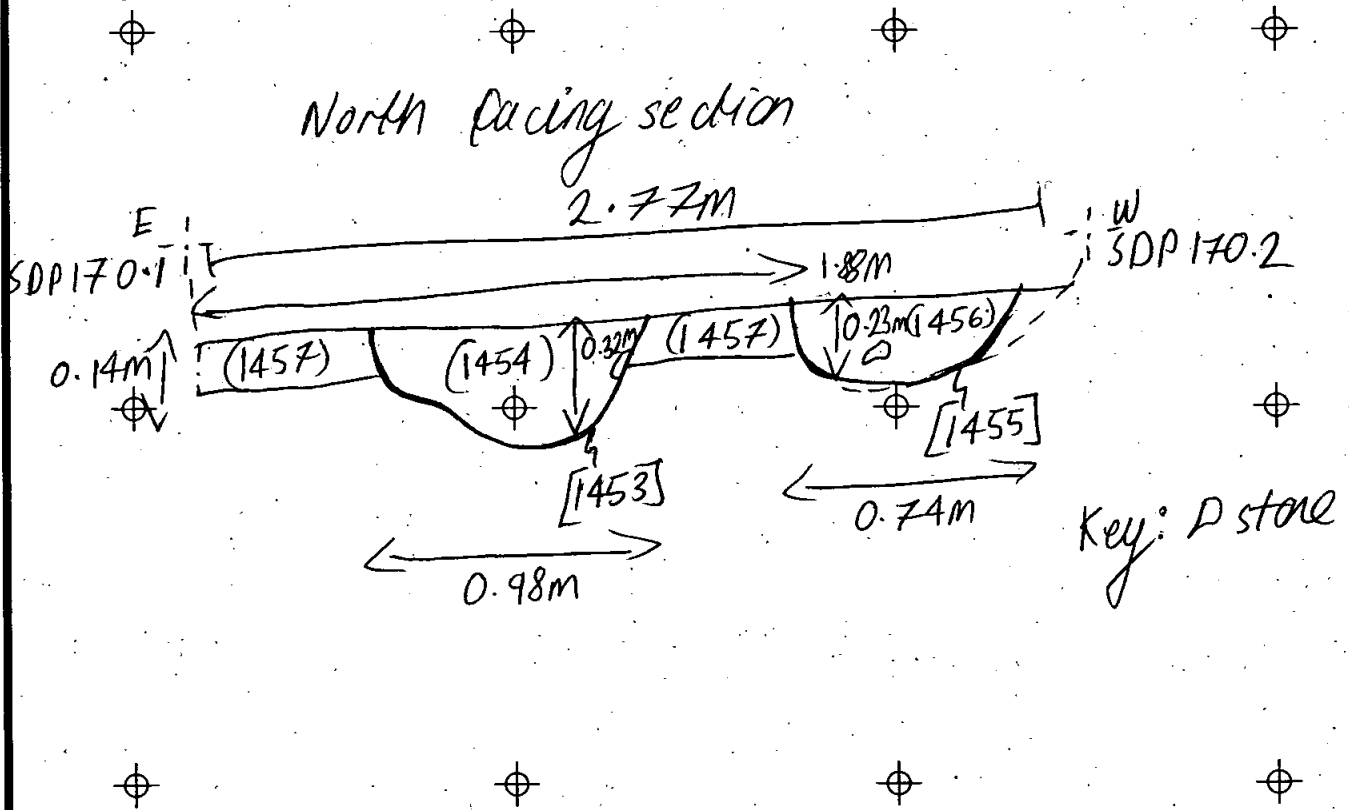
North facing section

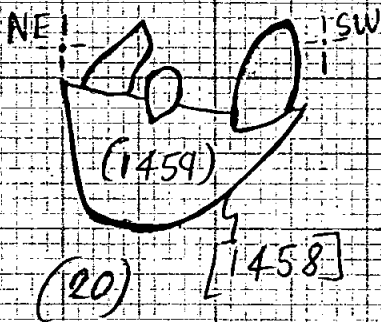
North West facing
section of
posthole [1458]
