# Corn Exchange, North Square, Dorchester

## Building Recording of Cellars beneath Car Park

Report No. 53552/5/1

July 2021

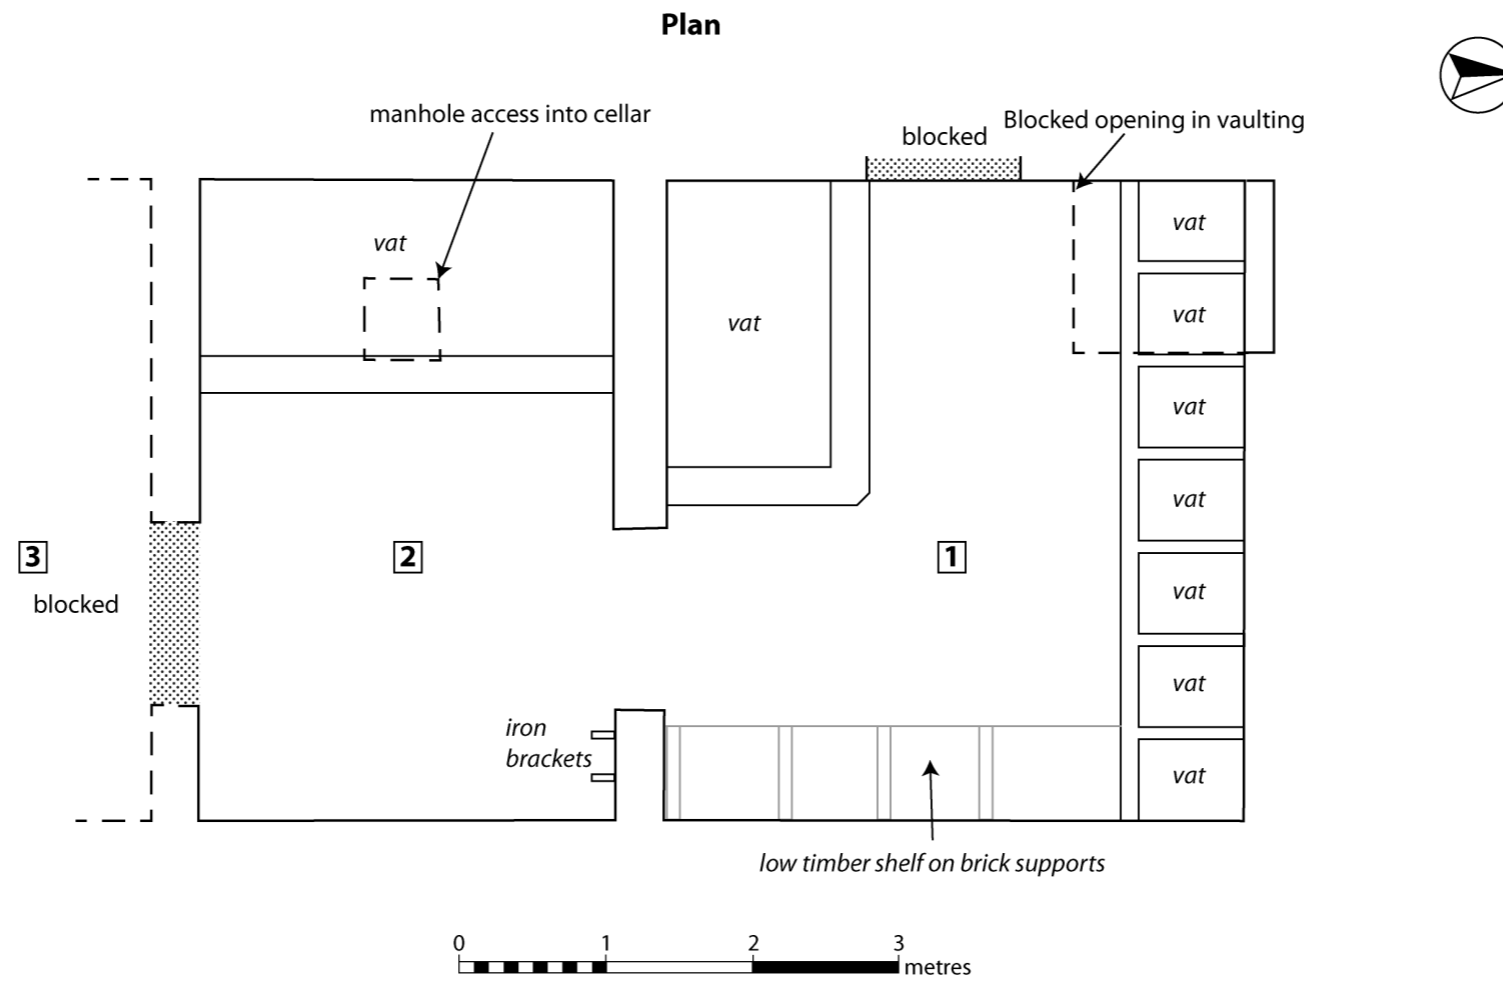
Figure 3: Plan and elevation of cellars.

**West Internal Elevation**

The structure survives as a series of underground vaulted cells along the North Square frontage, beneath the north west part of the car park behind the Corn Exchange and is accessed by a small rectangular manhole into the top of Cell 2 (Figure 2; Plates 12 & 15). No trace of the building(s) above the cellars is now visible. The cellar structure consists of a row of two rectangular barrel-vaulted cells aligned along the North Square frontage, with a third blocked cell to the south (Figure 3). These have been numbered 1-3 from the north.

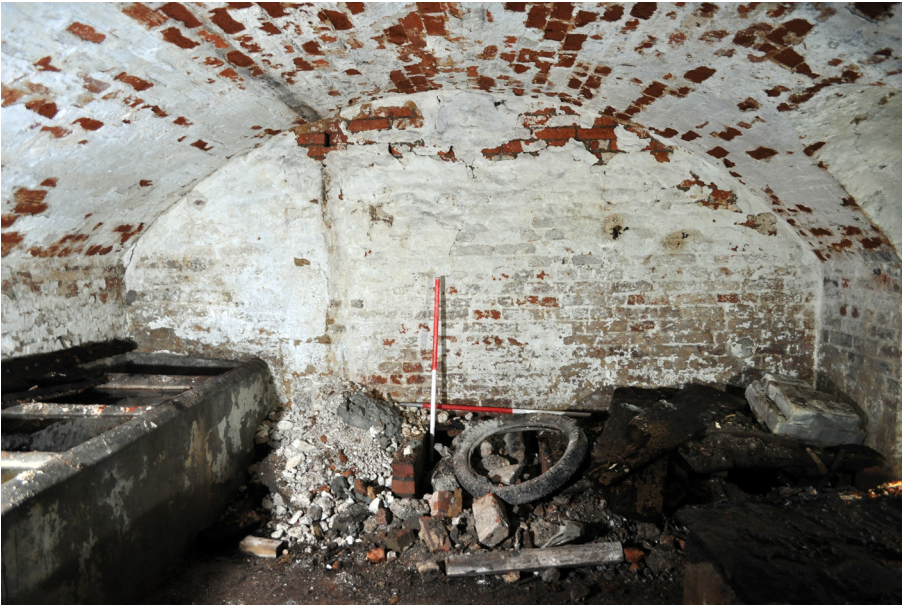
The interior of the cellars is obscured by piles of debris. In Cell 1 was a pile of stone rubble, soil and timber in the west part (Plate 2) and another smaller dump of concrete rubble, brick and cement (together with a motorcycle tyre) at the east end (Plate 1). In Cell 2 but is a large amount of rubble and a large quantity of concrete that has flowed in from the blocking of Cell 3 (Plates 3 & 11). There is also a large mound of concrete and tarmac at the west end beneath the existing access opening (Plate 12).

*Plate 1: Cell 1 looking east. 1m scale.*

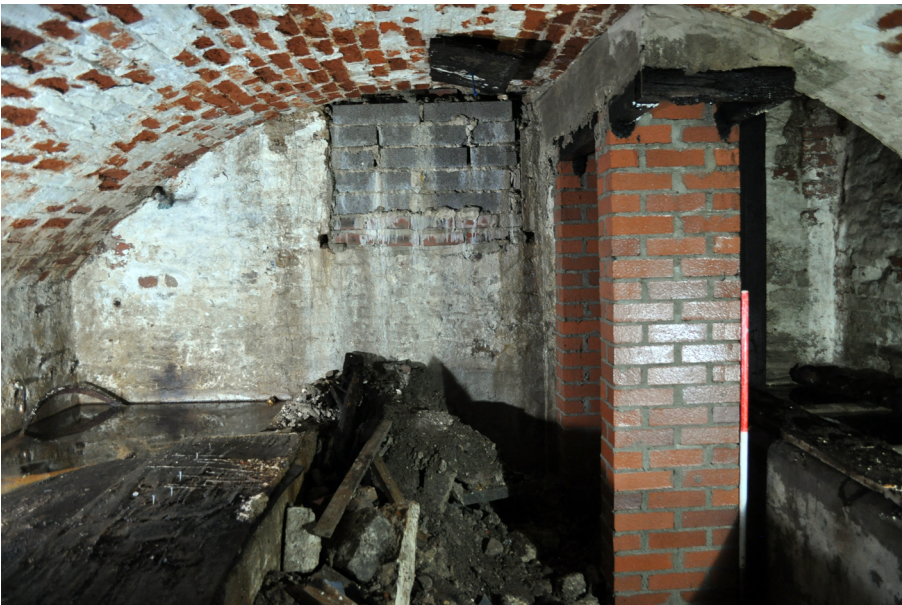
*Plate 2: Cell 1 looking west. 1m scale.*

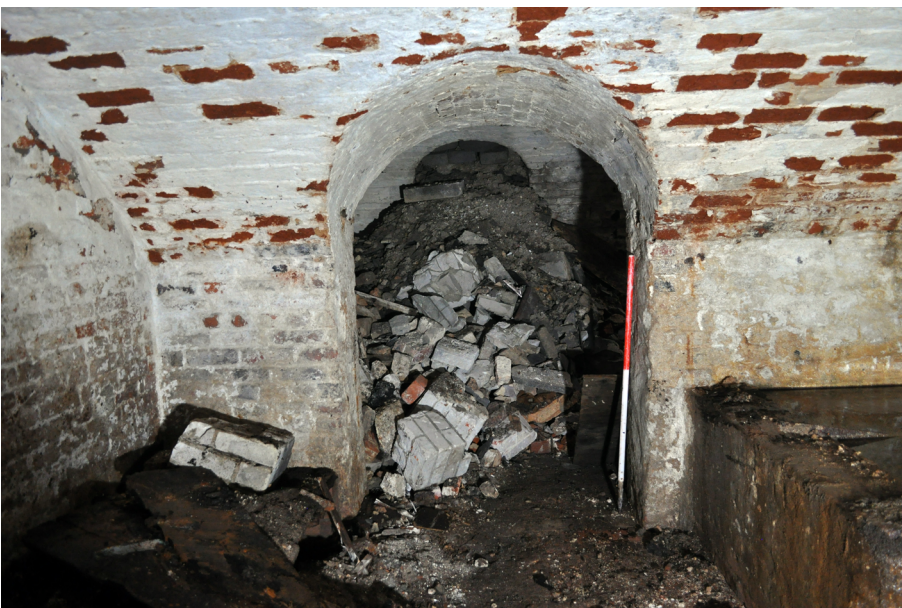
Cell 2 is to the south of Cell 1 and is connected to it by a 1.25 m wide doorway with a semi-circular vaulted head (Plate 3). Cell 2 is rectangular, measuring 4.38 m by 2.81 m across and with a maximum height of 2.15 m. The north and south walls of the cell are of limewashed brick and are of one build with the barrel-vaulted ceiling. The east wall is of limewashed limestone rubble with occasional brick. The west wall is also of limewashed stone rubble, but most of the visible part of this wall has been rebuilt in concrete block with some brick (Plate 12). The ragged edge of the original stonework is visible around the edge of the barrel vault. The floor is of brick (Plate 13). Across the west part of Cell 2 was a large vat, measuring 2.81 m by 1.19 m internally and 0.62 m deep, built of brick with a cement lining (Plate 14). Two iron brackets are fixed to the north wall at the east end.

Cell 3 lay to the south of Cell 2 and is connected to it by an opening similar to that between Cells 1 and 2. The whole of Cell 3 was blocked with concrete, which had flowed out into Cell 2, with the upper part blocked with concrete blocks (Plates 3 & 11). The size and layout of Cell 3 is not known, nor whether there are further cells beyond to the south.

*Plate 3: Looking South from Cell 1 into Cell 2 and blocking of Cell 3 in background. 1m scale.*

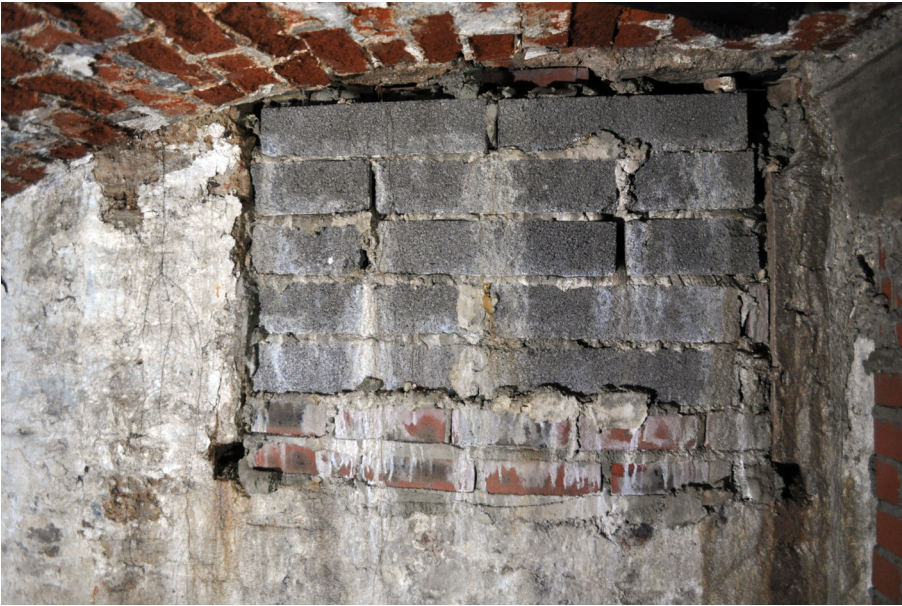
Cell 1 at the north end is rectangular, measuring 4.38 m by 3.93 m across and with a maximum height of 2.12 m. It is connected to Cell 2 by an opening in the east end of the south wall. The north and south walls of the cell are of limewashed brick and the segmental brick vault springs from these walls. The east wall is of limewashed brick in an irregular English Bond (Plate 1). The west wall is primarily of limewashed limestone rubble with occasional brick (Plate 2). There is a central former window opening, measuring 0.95 m by 0.90 m, set in the upper part of the wall. It is blocked by two rows of bricks and concrete blockwork above (Plate 4). The reveals are partly of brick and at the bottom is a cut-out on each side, perhaps for a sill. The floor is of brick.

The blocked opening in the west wall of Cell 1, with the evidence of a removed sill, was most likely a window, providing light to this northern cell. It is possible that there was a similar window opening in Cell 2, but all evidence for this has been removed by the modern rebuild of the upper part of the west wall.

*Plate 4: Blocked window in west wall of Cell 1.*

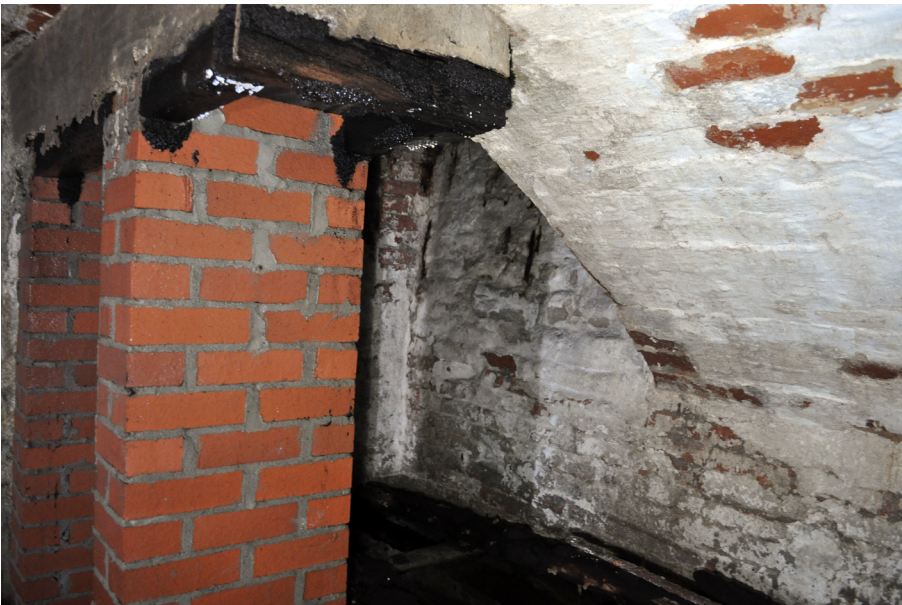
In the north west corner of the room, is a rectangular opening in the vault, 1.47 m by 1.25 m across, which was originally open at the top (Plates 5-6). The north wall here is of rubble stone and slopes outwards towards the top. There is an area of brick in the west wall. This opening has been sealed by a concrete slab, supported by a concrete beam behind wooden shuttering and a single vertical square post (Plate 6). This opening is partly obscured by a modern concrete support on brick piers.

*Plate 5: View of north west corner of Cell 1.*

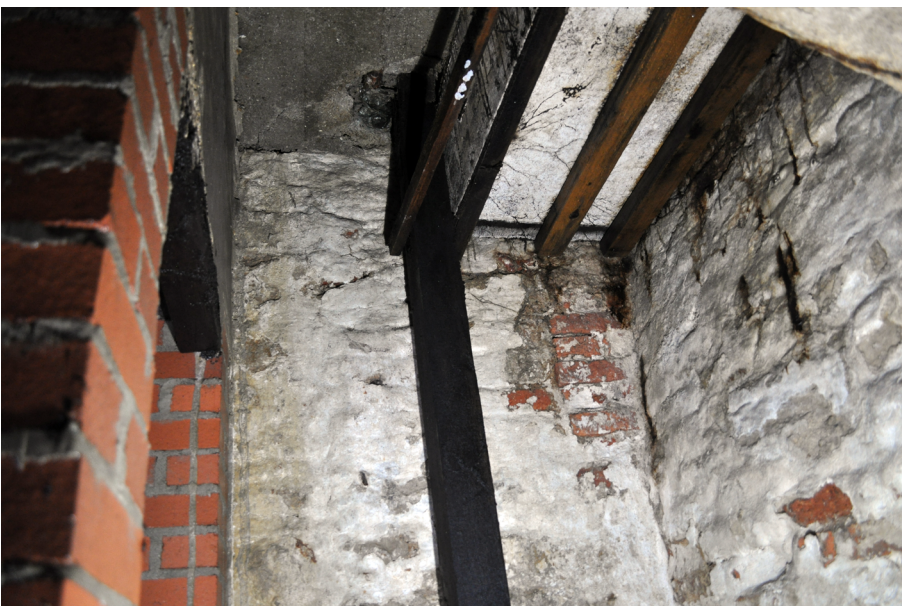
*Plate 6: Detail of north west corner of Cell 1 showing detail of blocking of opening.*

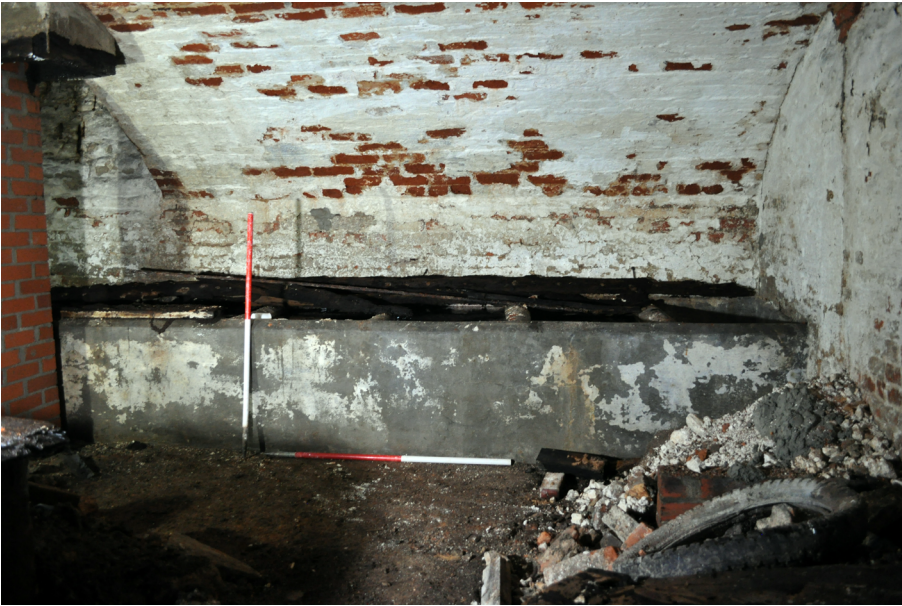
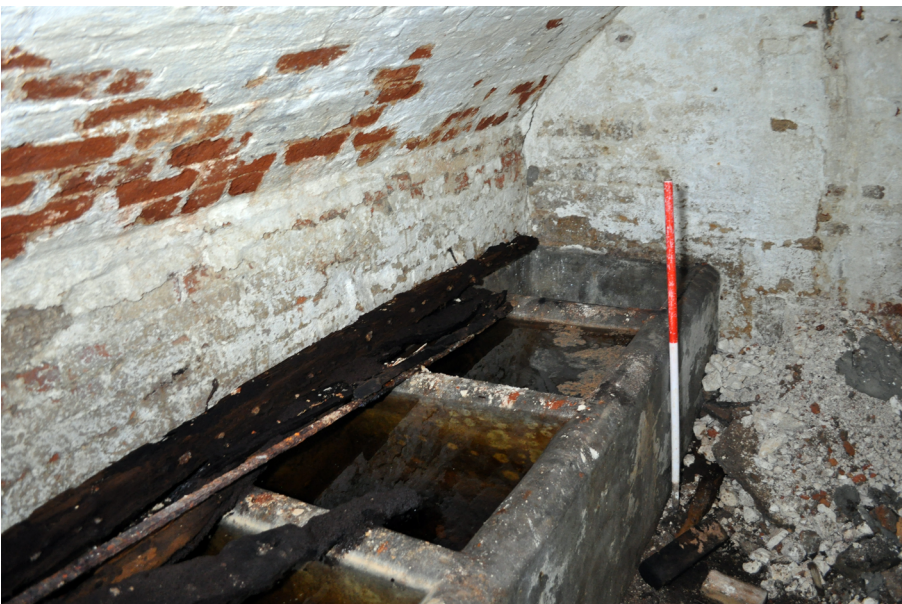
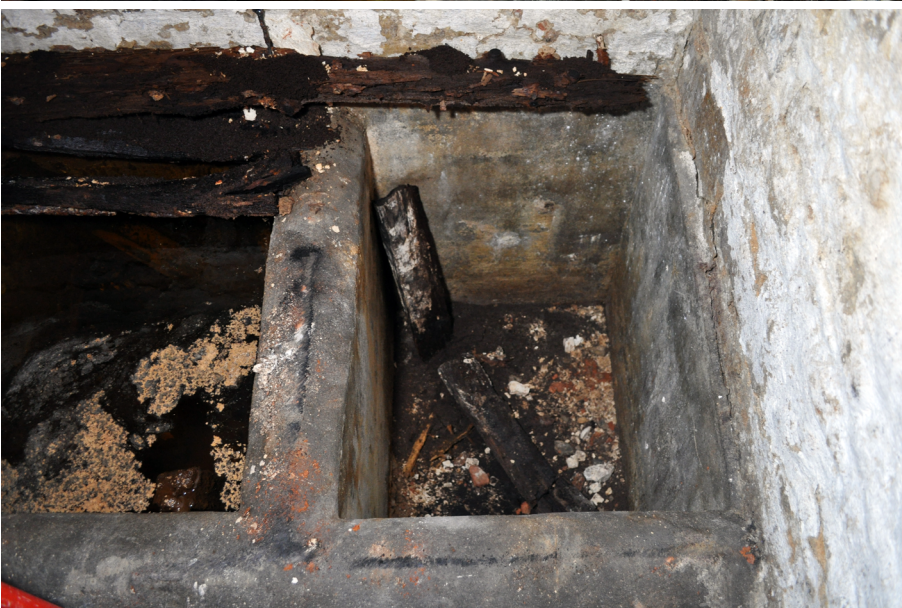
Along the north wall was a range of seven rectangular vats built of brick with a cement render, each measuring 0.72 m by 0.55 m across and 0.79 m deep (Plates 7-9). Another large vat, built of brick with a cement render lining and measuring 1.95 m by 1.11 m internally and 0.62 m deep, lay on the south side of the room (Plate 10). Along the east wall was a low wooden shelf 0.64 m wide and 0.30 m high supported on brick piers.

The vats in both Cells 1 and 2 are built over the top of the brick floor and are butted against the walls. It is likely they are a later insertion as the brickwork is bonded with a grey sandy cement mortar, unlike the lime mortar bonding of the cellar walls and vaulting. The low wooden shelf in Cell 1 is also a secondary addition with modern brickwork and mortar.

The vats in both Cells 1 and 2 are not closely datable, but the character of the bricks and the cement render used in their construction suggests a later nineteenth century or later date. The function of the vats is not certain, but may have been associated with the butchery trade. North Square was historically the location of the shambles and continued to have a concentration of butcher's shops into the twentieth century. For example, the 1893 Ling's Dorchester Almanack contains a map of North Square that shows that the house just north of the site was occupied by J. H. Groves, butcher, and there were two more butcher's shops in North Square, with other butchers trading in the Market House. One possible use of the vats may be for brine to cure hams and bacon. If the vats are of later nineteenth century date, then this suggests the cellars were still accessible and in use after the construction of the Market House in 1848. Perhaps they were used by one or more of the butchers trading in the Market House.

*Plate 7: Cell 1 looking north showing row of vats along north wall. 1m scales.*

*Plate 8: Vats along north wall of Cell 1. 1m scale.*

*Plate 9: Detail of vat.*

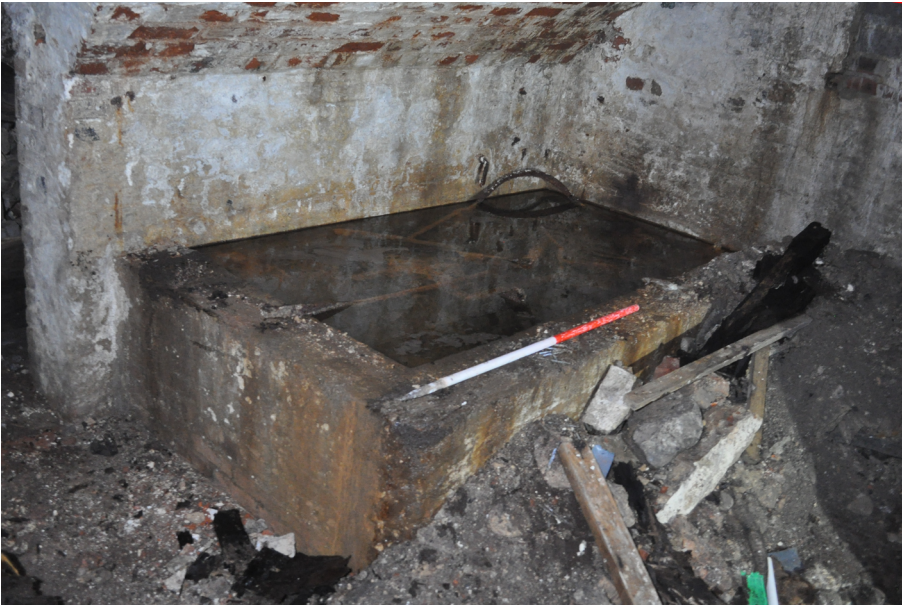
*Plate 10: Vat against south wall of Cell 1. 1m scale.*

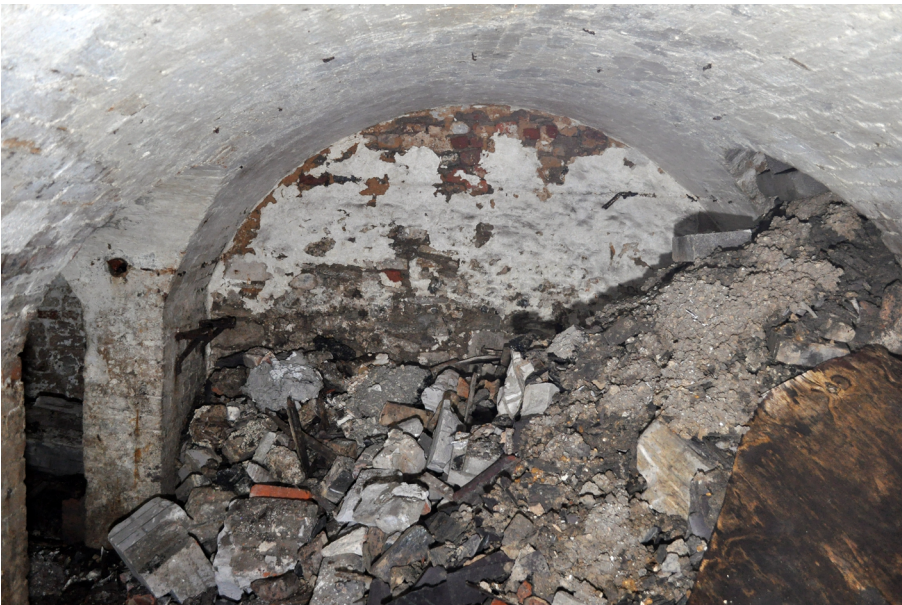
*Plate 11: Cell 2 looking east with concrete from blocking of Cell 3 to right.*

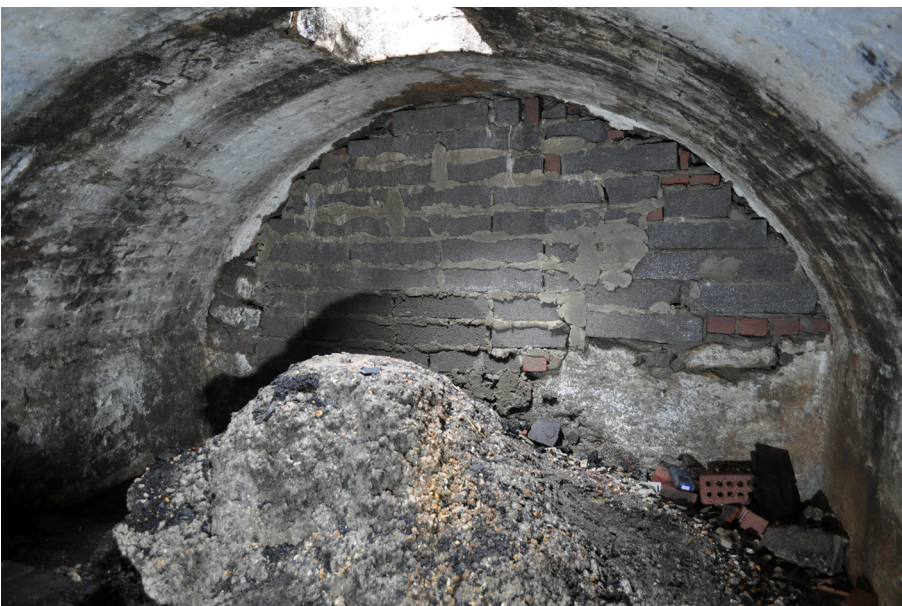
*Plate 12: Cell 2 looking west showing rebuilt west wall and access through opening in vault.*

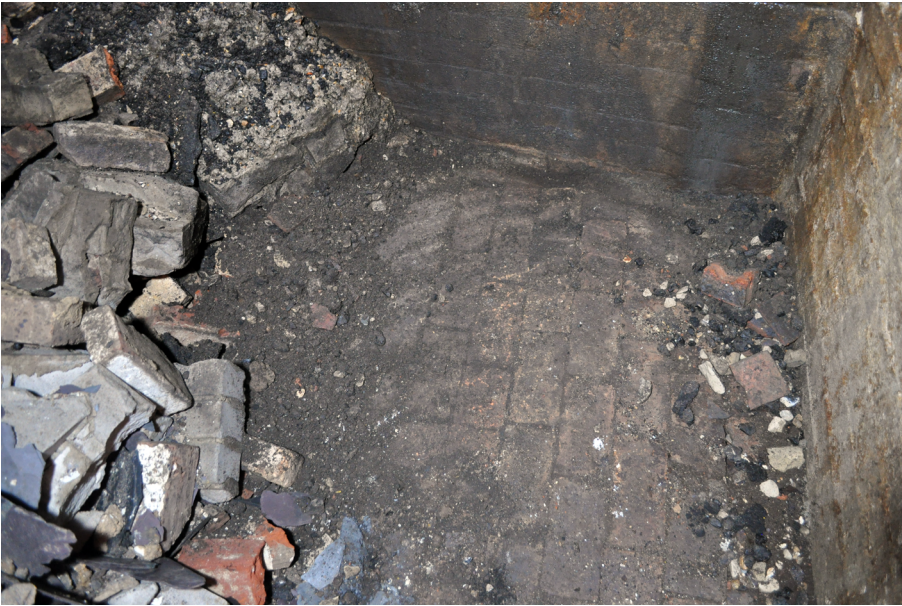
*Plate 13: Detail of brick floor in Cell 2.*

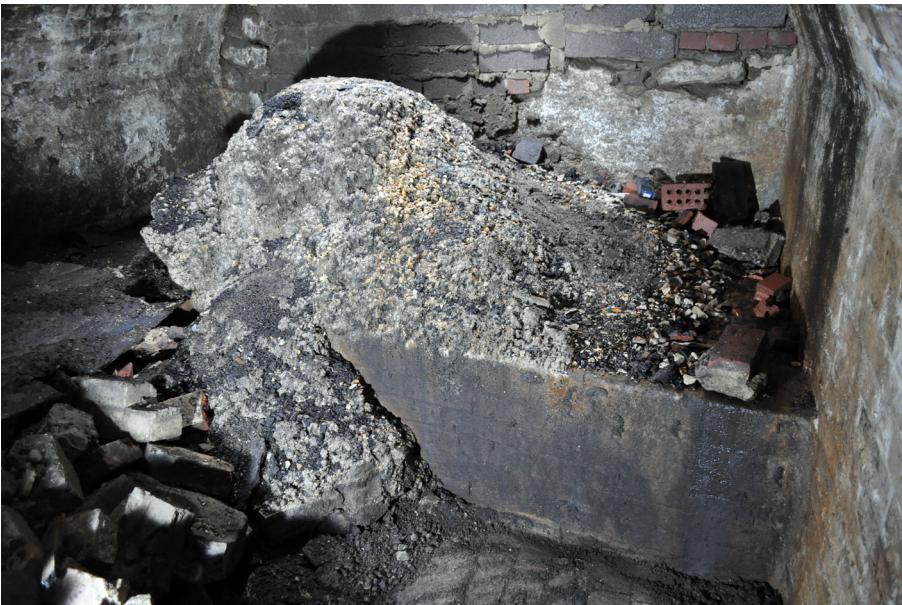
*Plate 14: Vat in west end of Cell 2.*

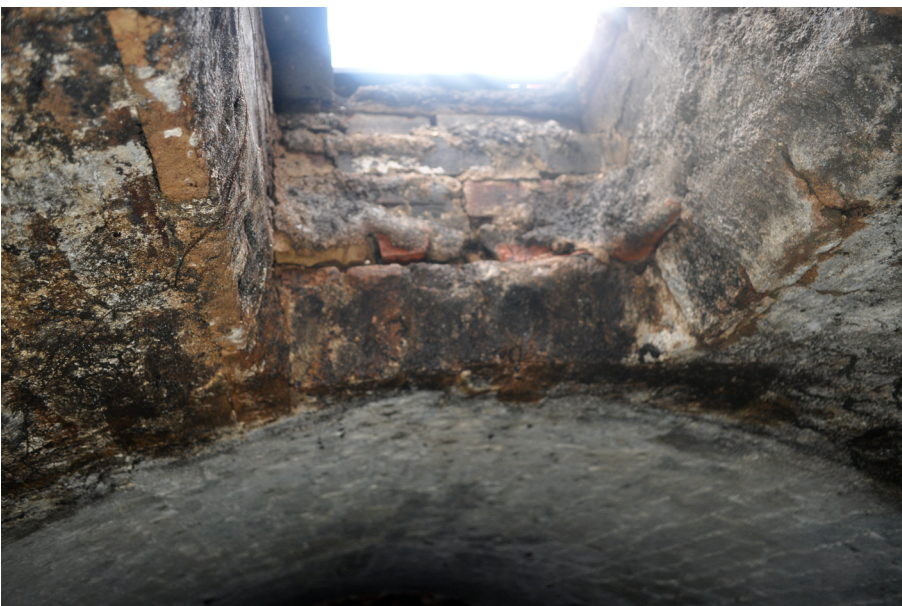
There is a small roughly rectangular opening pierced through the vault towards the west side, which forms the current access point to the cellars. It is clearly a secondary feature cut through the vault and is covered by a modern metal manhole cover. This opening reveals the vaulting is a single brick thick and over is rough brickwork (Plate 15).

*Plate 15: Detail of brickwork in access hatch in vault of Cell 2.*
