# Corn Exchange Extension, North Square, Dorchester, Dorset

## Archaeological Assessment

Report No. 53552/1/1

January 2021

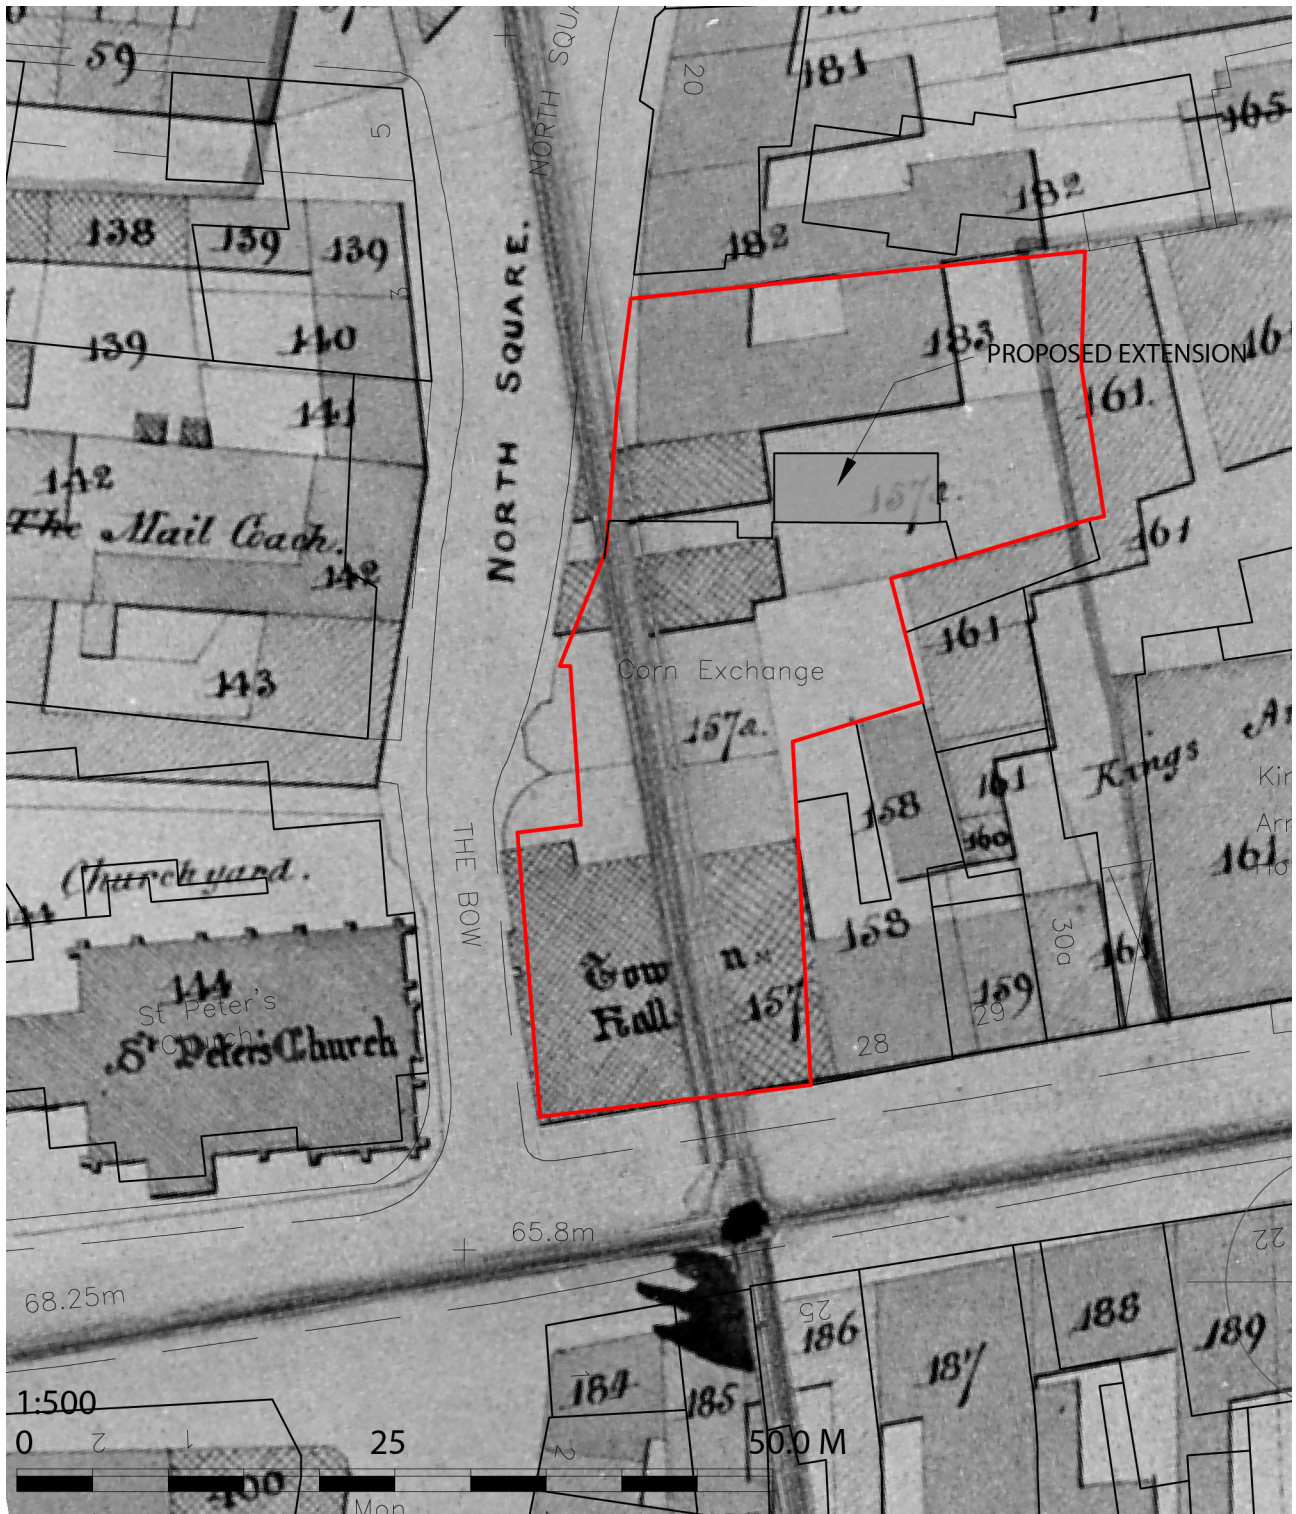
Figure 3: Extract of 1848 Plan of Dorchester (DHC D/COO:E/7) overlain by modern map and Site Boundary.

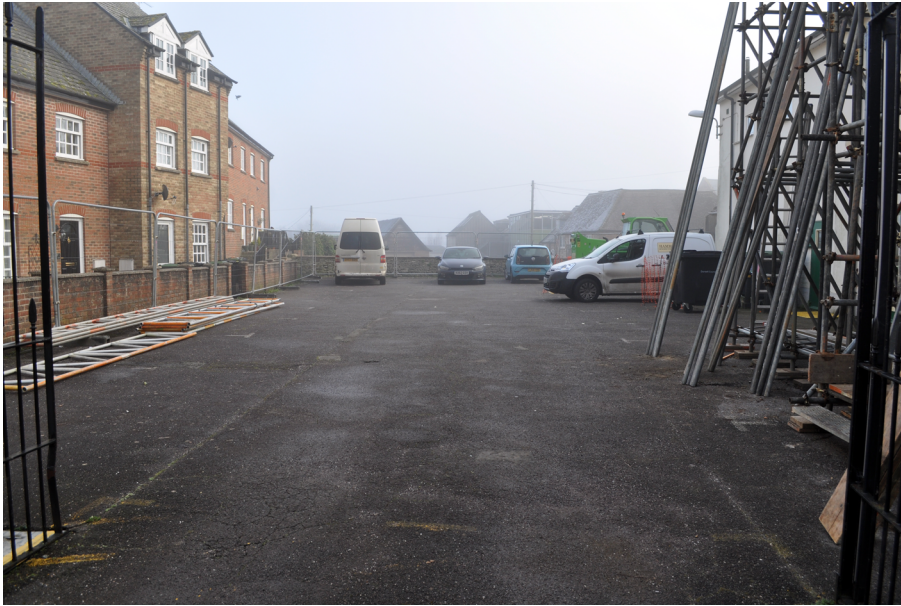
*Plate 1: View of Car Park north of Corn Exchange, looking east.*

A site visit was undertaken on 7 January 2021 to record current ground conditions. Plates 1–2 show the current condition of the car park and the area of the proposed new extension. The retaining wall between the east end of the car park and the King's Arms site is shown on Plates 3–4.

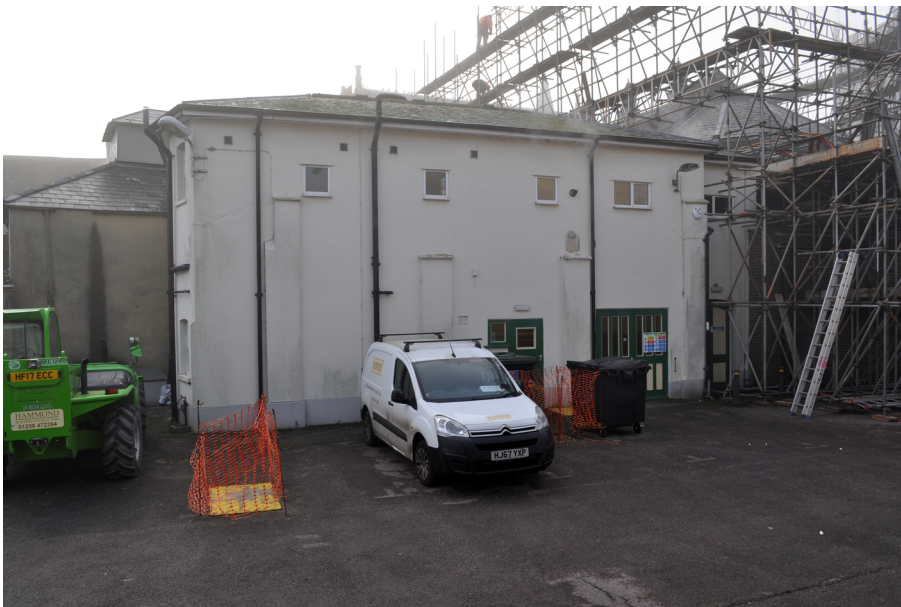
*Plate 2: View of area of proposed new extension with locations of boreholes BH02 and BH03 surrounded by orange netlon fencing, looking south.*

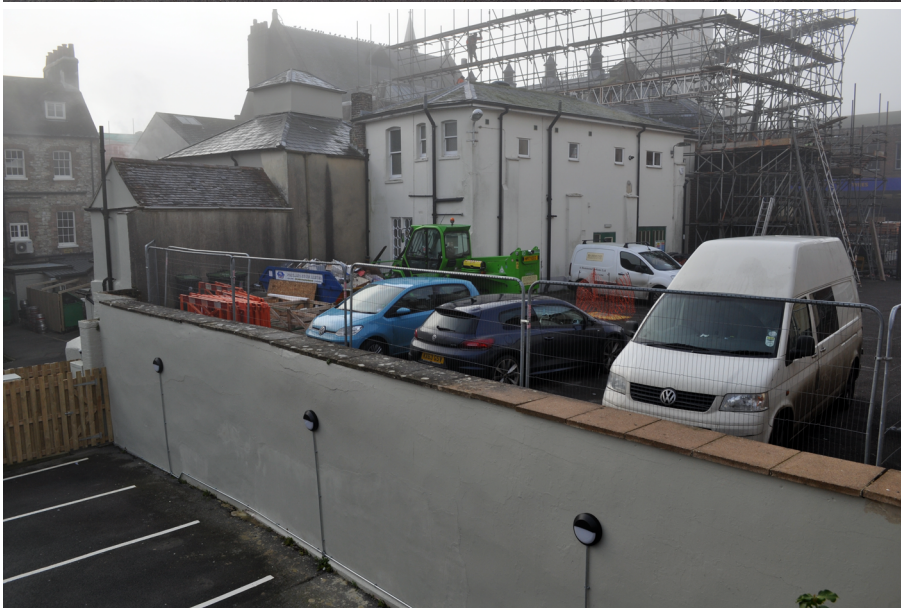
*Plate 3: View of retaining wall of terrace constructed for nineteenth century Market House, looking south.*

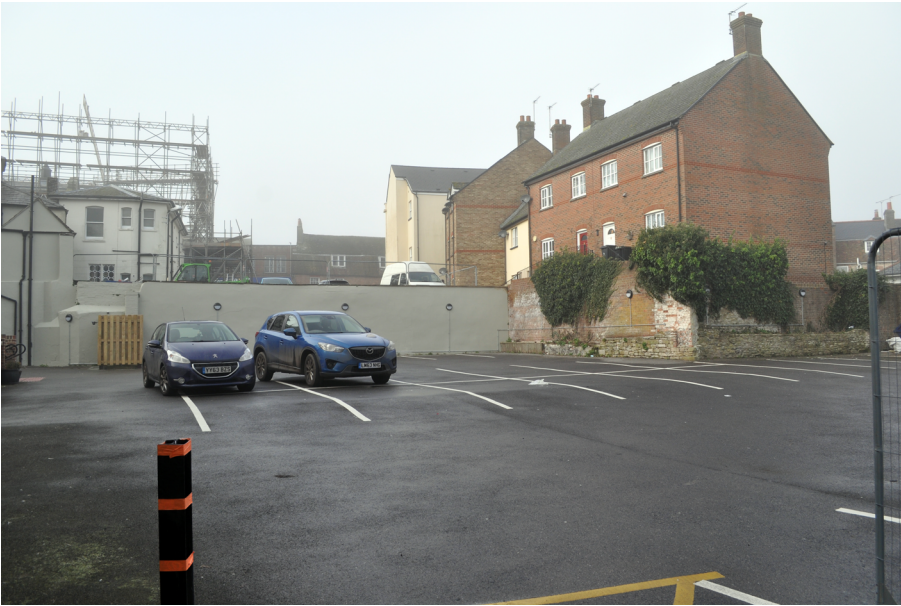
*Plate 4: View west showing difference in levels between the site (to rear) and the Kings Arms car park (in foreground).*

Examination of the Kings Arms car park gives some evidence for the likely earlier ground levels. The north wall of the car park has some blocked openings in the brick wall, which appear to relate to the buildings in this area present in the later nineteenth century. These openings suggest that the present ground levels are similar to those of the later nineteenth century. The western part of the Kings Arms car park appears to have been levelled and may have been terraced into the slope. The evidence from the Kings Arms car park indicates that the present town hall car park has been artificially built up to form the present level surface.

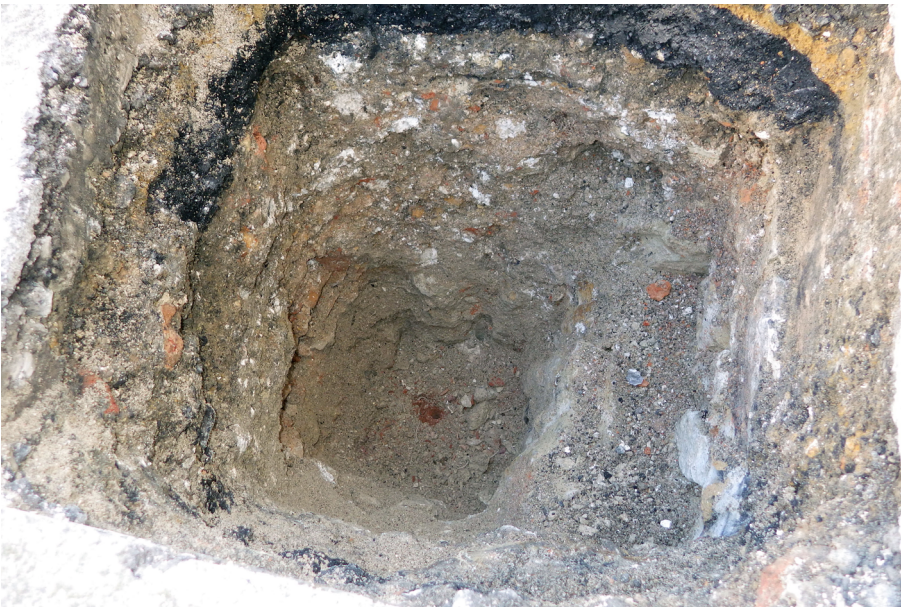
*Plate 5: Trial Hole TP1. (Photo supplied by Mike Dencher).*

TP1 revealed some detail of the lower parts of the existing building. Below the above ground rendered part of the building the brick wall continued down to about 0.25 m below ground level. Below this was stone masonry down to a depth of 0.5 m, at which point the wall stepped out 0.20m and comprised large stone blocks. In both trial holes TP2 and TP3, traces of the tiled floor of the former Market House were found immediately below the car park surface. Further traces of this floor had been previously exposed when the north boundary wall to the car park was built in 2004 (Terrain Archaeology 2004a), suggesting the remains of this floor are extensive beneath the car park surface. All three trial holes exposed the upper part of the levelling deposits forming the level terrace for the construction of the Market House.

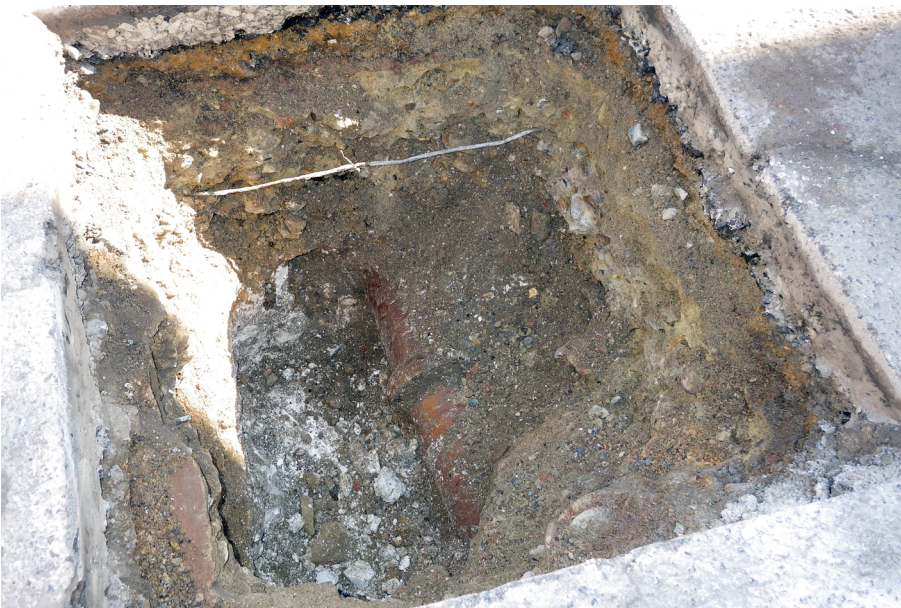
*Plate 6: Trial Hole TP2. (Photo supplied by Mike Dencher).*

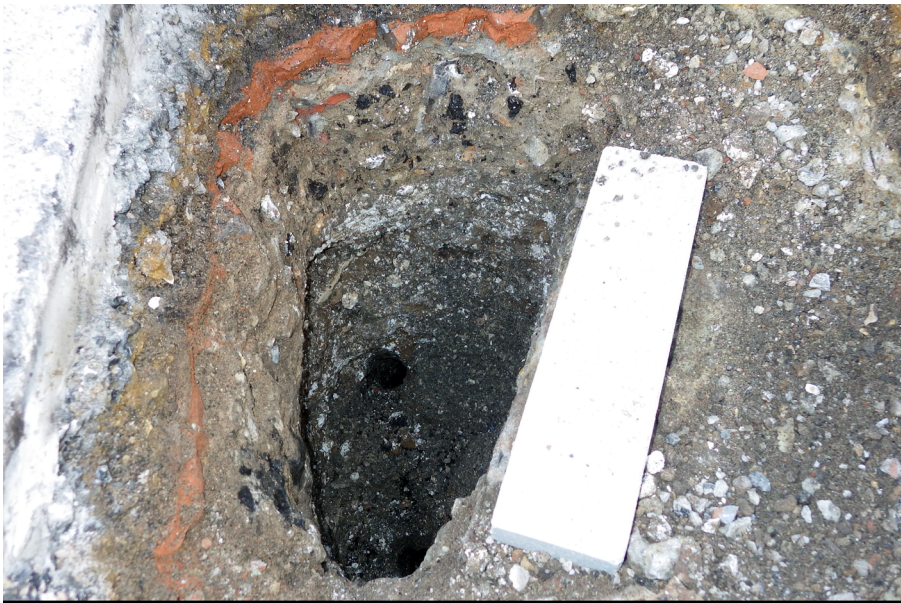
Plate 7: Trial Hole TP3. (Photo supplied by Mike Dencher).

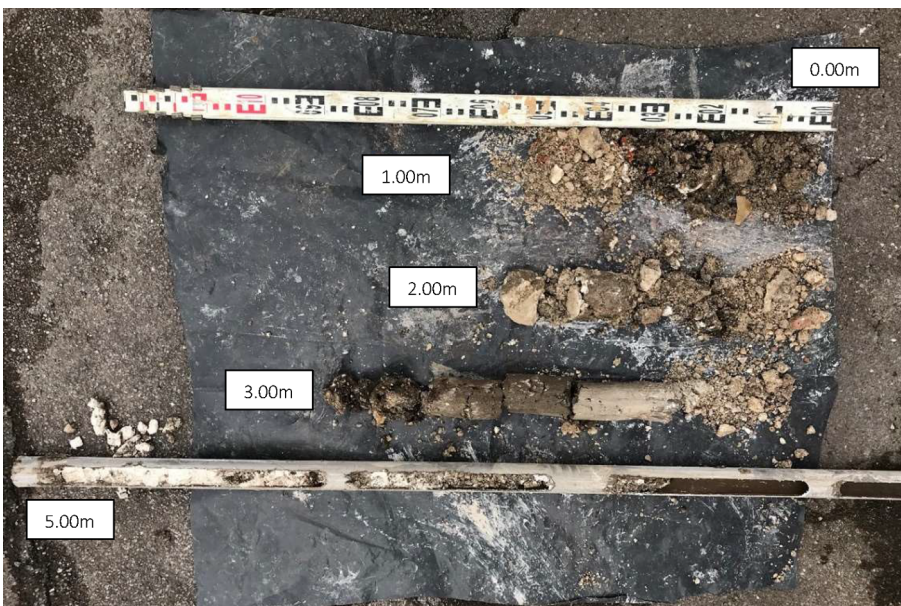
Plate 8: Borehole BH02 sample. (Photo from Advanced Investigations System Ltd 2020).

Two boreholes (BH02 and BH03) were drilled to a depth of five metres in October and November 2020 by Advanced Investigation Systems Ltd to investigate further the ground conditions on site. Borehole BH02 was drilled through the backfilled trial hole TP2 and borehole BH03 through TP3. The deposits recorded are presented in Table 2.

Both boreholes revealed thick deposits of Made Ground consisting of mixed deposits of clay, limestone, flint and chalk rubble, which have been interpreted as the deposits forming the level terrace for the construction of the nineteenth century Market House. Immediately below these Made Ground deposits, natural chalk was encountered at a depth of 3.9 m below ground level in BH02 and 3.3 m below ground level in BH03. Examination of the photographs of the recovered core samples (Plates 8–9) suggests that the nineteenth century deposits overlay the natural chalk in BH02, but in BH03, there was a 0.25 m thick layer of dark brown soil overlying the chalk. This may be the remains of the former soil cover prior to the construction of the Market House. The character of the soil suggests it is more likely to be a post-medieval garden soil, rather than a remnant of the Roman ground surface, which is normally lighter in colour and more clayey than the soil seen in BH03. In BH02, the upper part of the natural chalk appears disturbed (hence the greater depth of the top of the chalk?). This borehole appears to be within the former footprint of a post-medieval building shown on the 1810 map (Figure 2), which may be the cause of the disturbance.

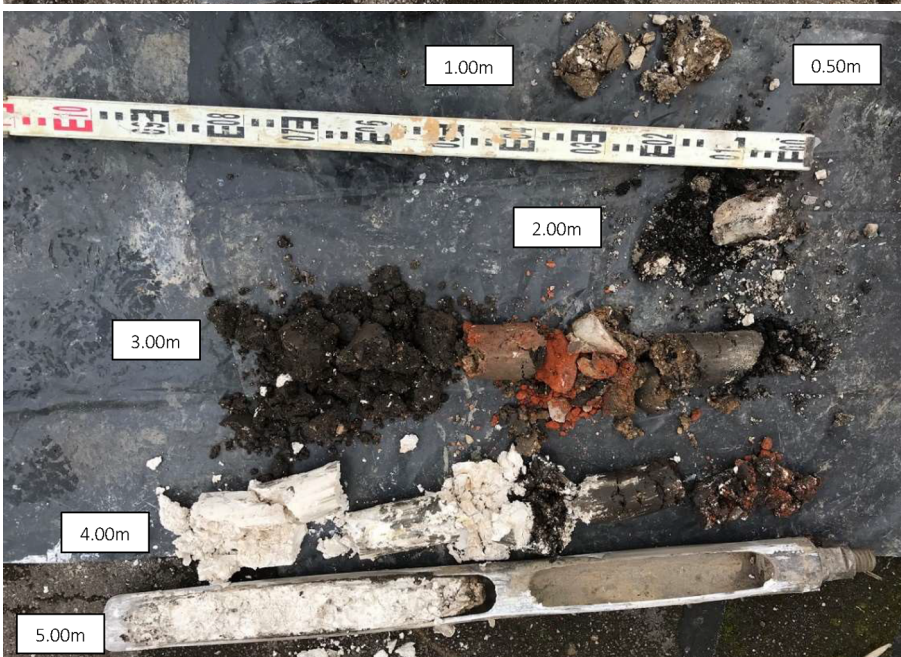
Plate 9: Borehole BH03 sample. (Photo from Advanced Investigations System Ltd 2020).
