**Church of St Lawrence, Appleby in-Westmorland,  
Cumbria**

***Statement of Significance: Corporation & Castle Pews***

**Prepared for the PCC of St Lawrence, Appleby-in-Westmorland**

**Marion Barter Associates Ltd**

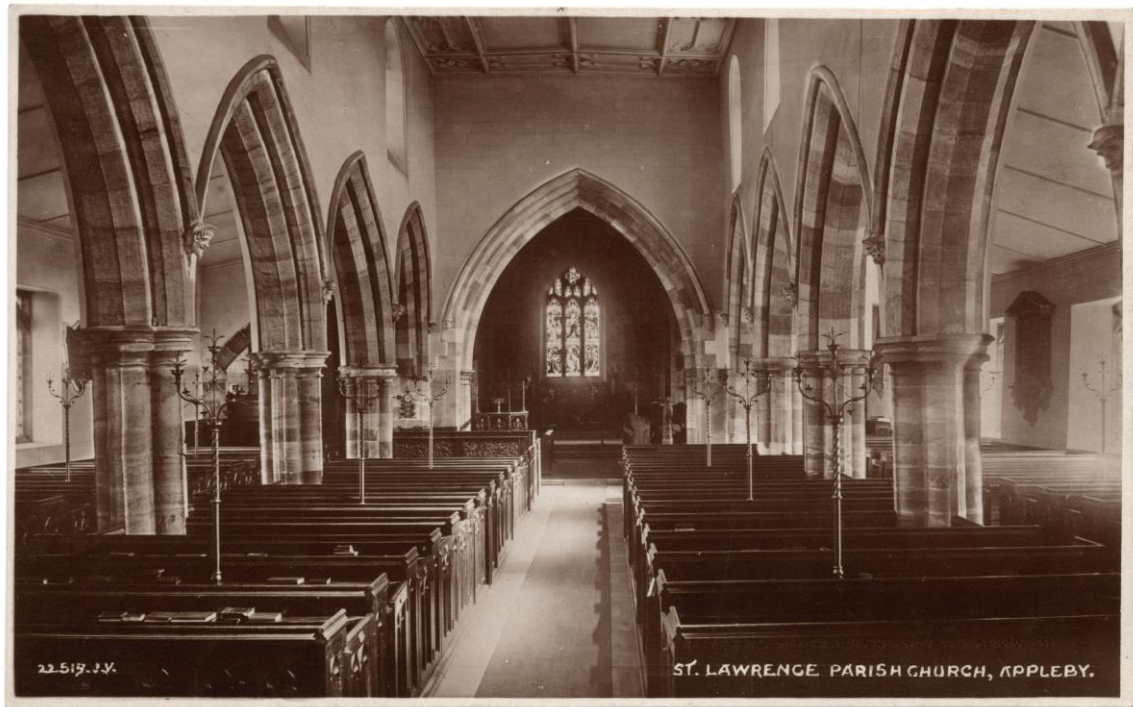
*Fig.3: undated postcard of the nave from the west (courtesy John Tillotson)*

The postcard (Fig.3) shows the nave at a later date, in about 1895, after the current metalwork pulpit had been installed to the north side of the chancel steps. The corporation and castle pews can be seen towards the front of the nave, on the left.

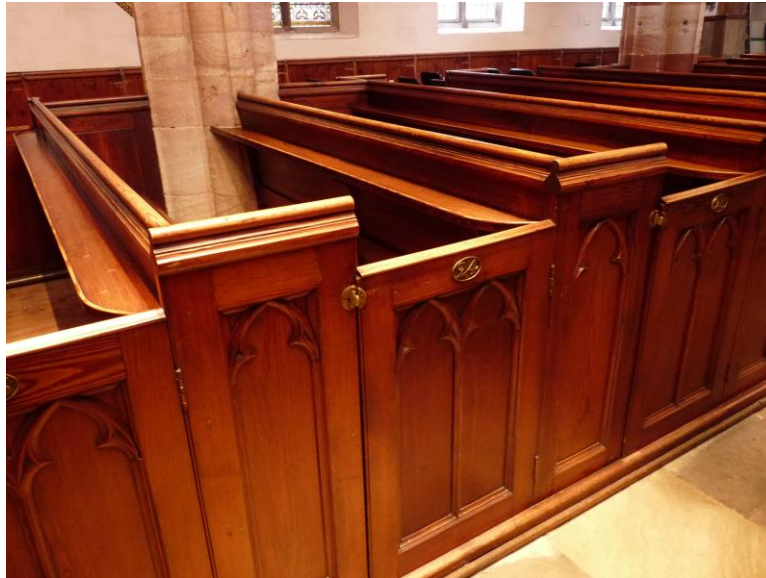
*Fig.5: pews on north side of the nave, installed 1862-3*

The nave and south aisle are filled with pitch pine pews, installed as part of the Ewan Christian restoration in 1862-3. The pews and platform in the north aisle were removed under a recent Faculty, and the floor re-laid with stone paving, in 2018. A block of pews was also removed from the east end of the nave (south side), to create space for the re-located font, in c2007.

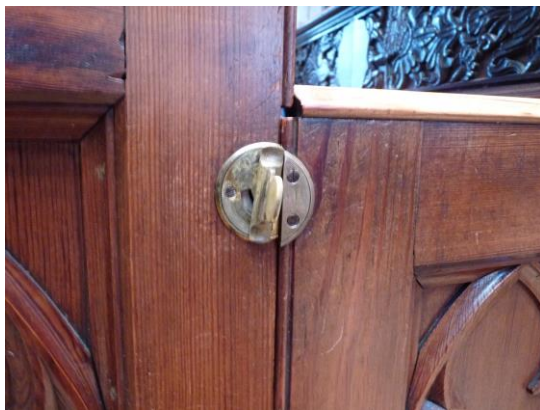
*Fig.6: brass door fitting*

It is not known whether Ewan Christian designed the nave seating or if it was ‘off the peg’, provided by an ecclesiastical furnishing supplier, selected from a catalogue. The pews have doors with brass swivel latches and higher bench ends, both with blind gothic tracery. The use of pews with doors was old-fashioned by the 1860s. The bench ends and pew backs have a roll moulding. The pews are in blocks on pine pew platforms. Brass pew numbers are fixed to the doors (re-set). A pine book shelf is fitted to the back of each pew.

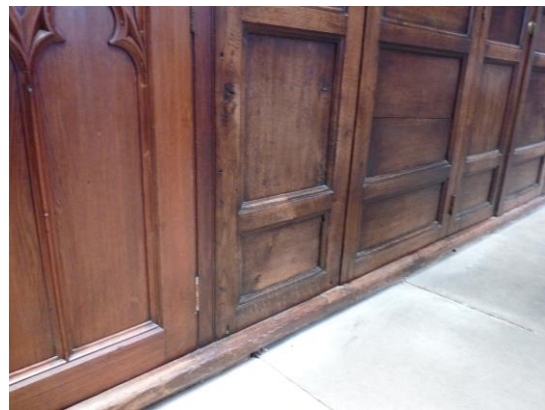
*Fig.7: castle pew (right) and nave pews (left) on same pine platform*

The three pews stand on a pine platform, continuous with the platform for the rest of the 1863 nave seating. It is clear that the pews were re-arranged as part of the 1863 restoration and have not been moved since, but there is no record of their earlier configuration or precise location in the church.

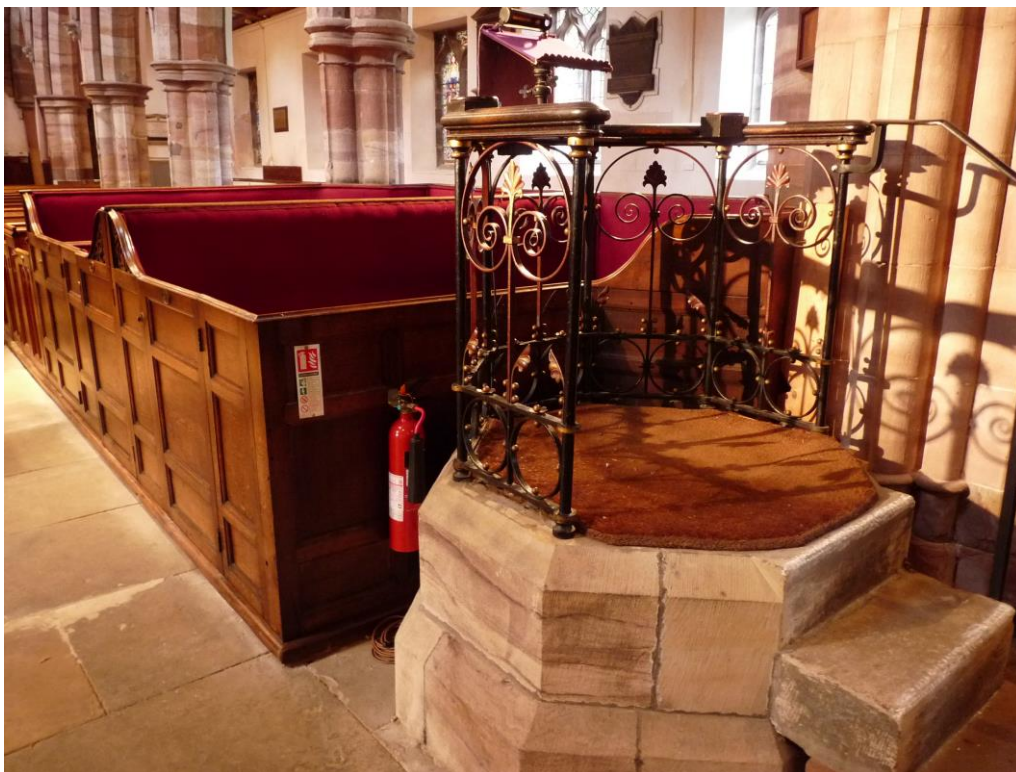
*Fig.8: pulpit and pews, from the south-east*

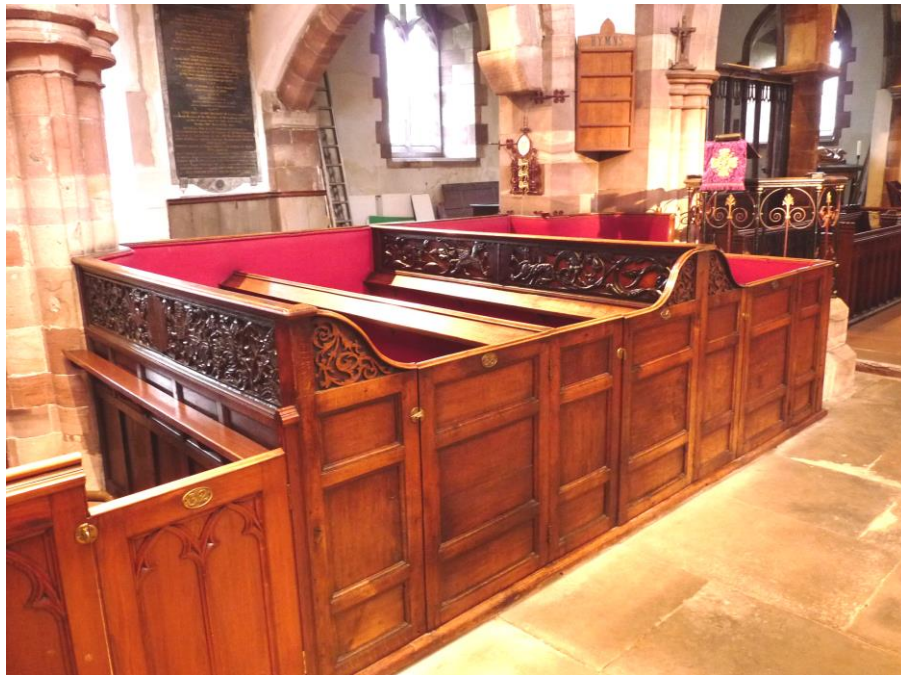
*Fig.9: corporation and castle pews from the south-west*

The south side of the pews consists of oak panelling with three doors; the character of the panelling suggests this is early late 17<sup>th</sup> or early 18<sup>th</sup> century, altered and re-set in the 1863 restoration. The pew platform, brass swivel latches and pew numbers (re-set) date from 1863. The north and west sides of the pews are enclosed with similar panelling, although the west panelling is later and may be of 1860s. On the inner face of the northern section of panelling in the middle pew, the bottom rail has painted lettering: 'J.xxxx Seats' (visible below the north seat); this seems to represent the name of a former pew-holder and the number of seats they held, although the surname and number are erased. It is plausible that this name was formerly on a top rail, suggesting this panelling has been re-assembled using

joinery from a different pew (a common practice in Victorian restorations). The east front of the corporation pew is of similar panelling to the other sides, shaped around the pulpit and the pier north of the chancel steps.

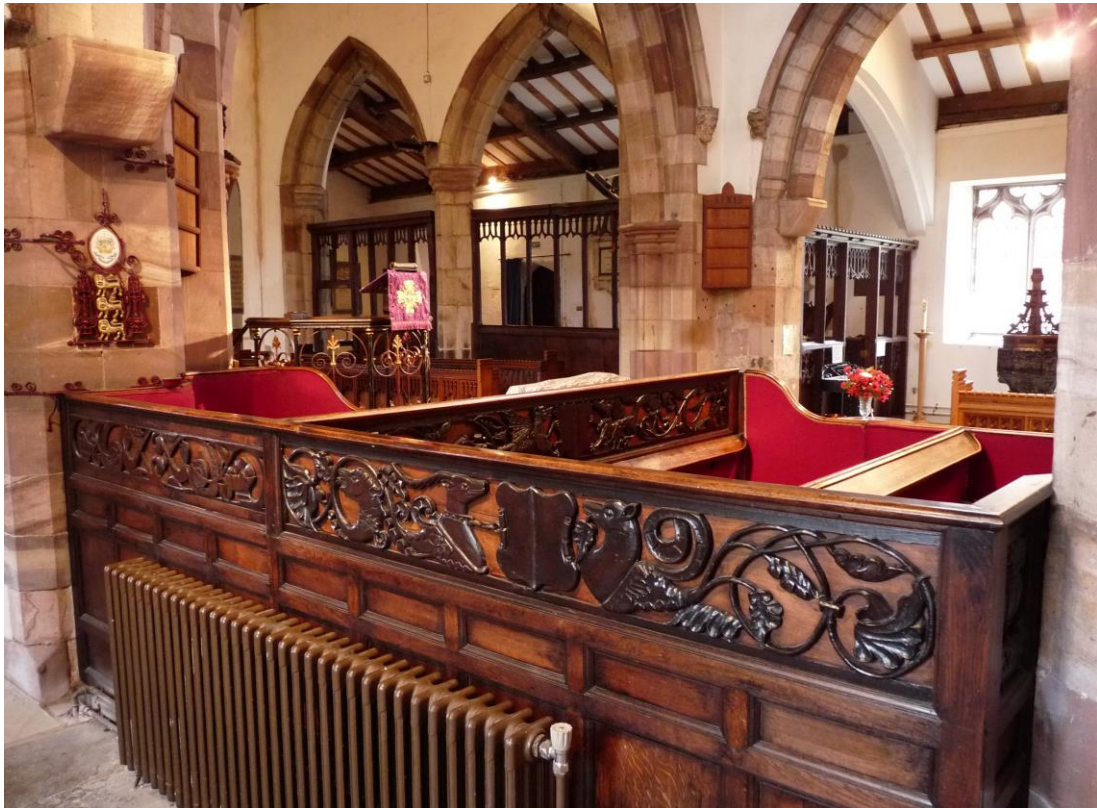
*Fig.10: north side of the pews from the north-west*

The north and west sections of panelling and the section between the pair of Castle Pews and the Corporation Pew are topped with four re-set sections of carved frieze or decorative panels, raising the overall height of the enclosure above the height of the doors and the rest of the nave seating.

The four friezes are on the outer north (two sections of frieze) and west sections of panelling, and also on the back of the corporation pew facing west into the middle (castle) pew. None of the carved friezes are visible from within the corporation pew. They are best viewed from the north-west. The re-set sections of carved oak frieze, stained dark, are not of matching design; three contrasting styles can be identified, strongly suggesting they were made by different craftsmen and originated on separate structures.

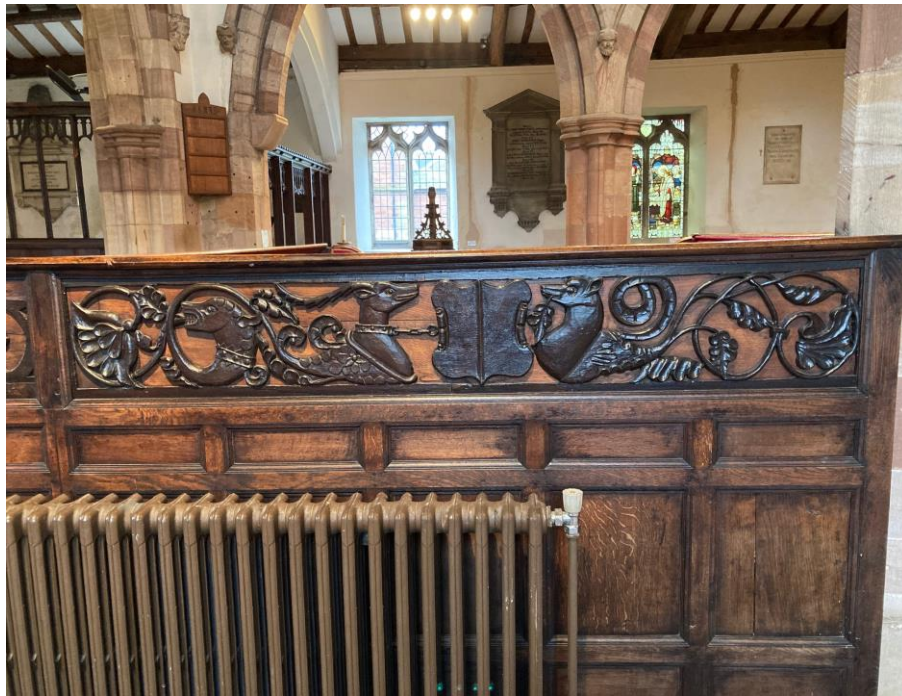
*Fig.11: frieze on western end of north panelling (from the north)*

The two most similar in style and composition are the western frieze on the north-facing section (Fig.11) and the west-facing frieze (Fig.12) dividing the Castle Pew from the Corporation Pew, although the latter appears to have been altered and may be a composite of more than one carved panel.

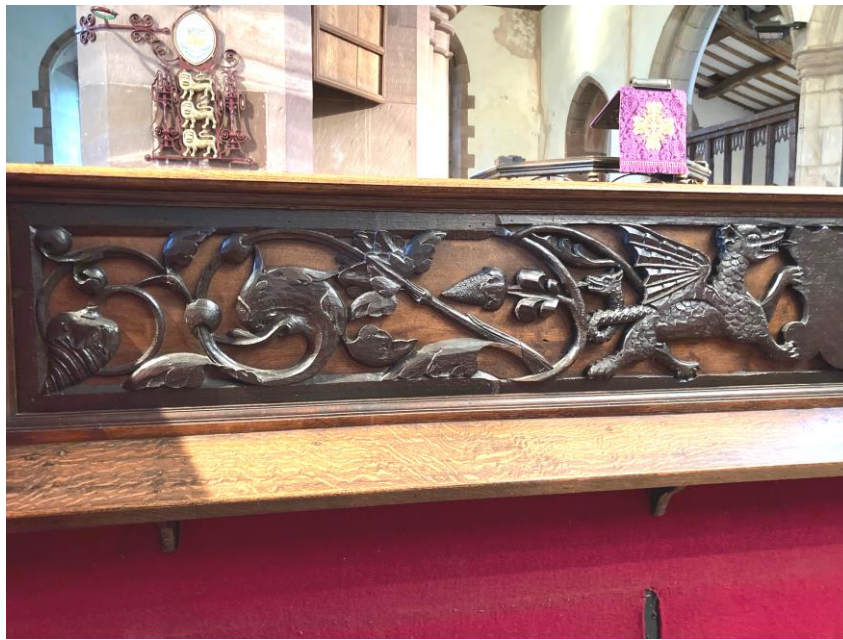
*Fig.12: the left part of west-facing frieze between the castle and corporation pews*

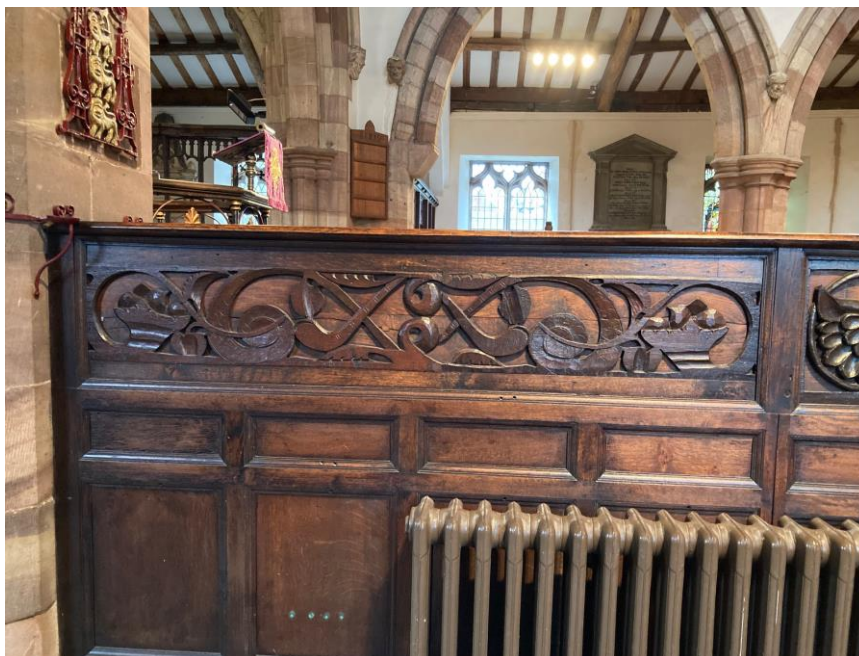
*Fig.13: eastern frieze on north pew panelling (from north)*

The eastern frieze on the north panel has curvilinear decoration with flattish, uncarved surfaces, giving the panel an unfinished appearance in contrast to the finely carved detail on the other three panels.

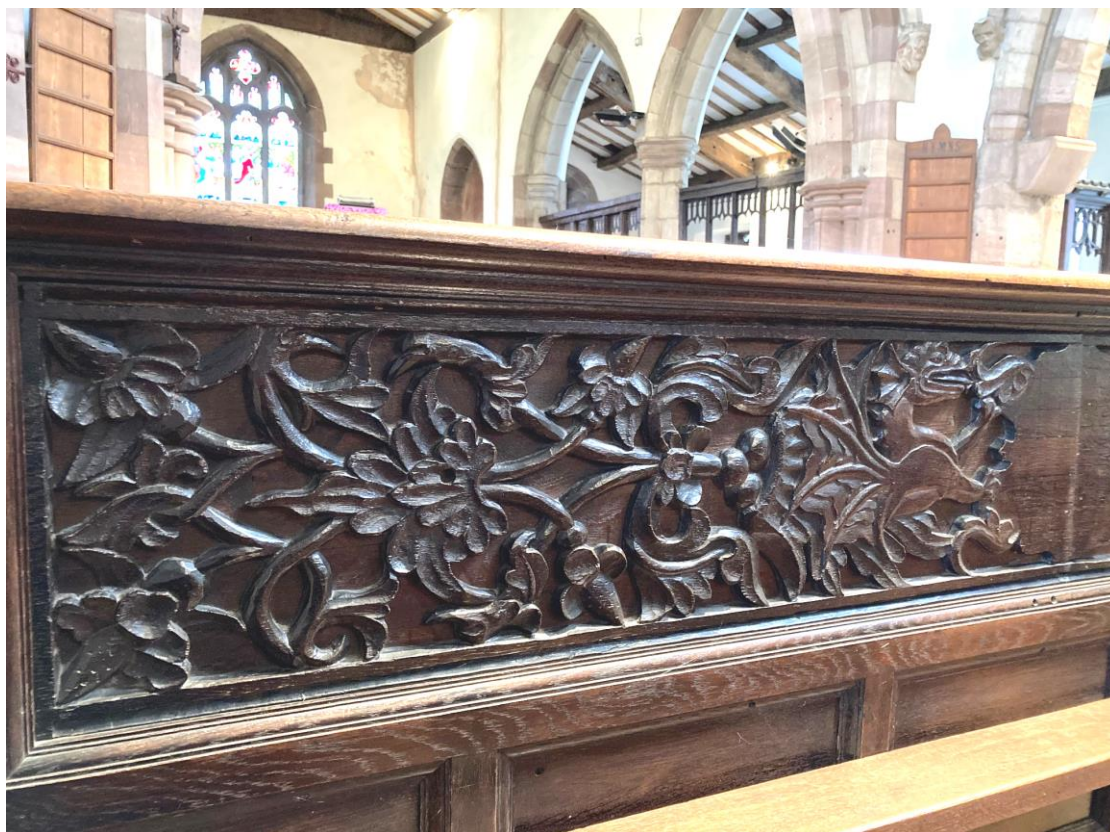
*Fig.14: re-set carved frieze with Clifford/Brandon arms on shield on the west-facing side of the castle pew*

The north-facing frieze is of very different character to the other friezes, with denser and bolder foliage carving, contained within a less altered frame and possibly on its original backing. The RCHME noted that this includes ‘a shield with traces of the painted arms of Clifford impaling Brandon’; this refers to Henry Clifford, 2<sup>nd</sup> Earl of Cumberland and his wife Eleanor, daughter of Charles Brandon, 1<sup>st</sup> Duke of Suffolk and Princess Mary Tudor who married in 1537.<sup>20</sup> The shield is supported by a lion and a dragon; the detail may have been added later and is not easily legible; the same arms are among those on the memorial to Lady Anne Clifford, in the north chapel.

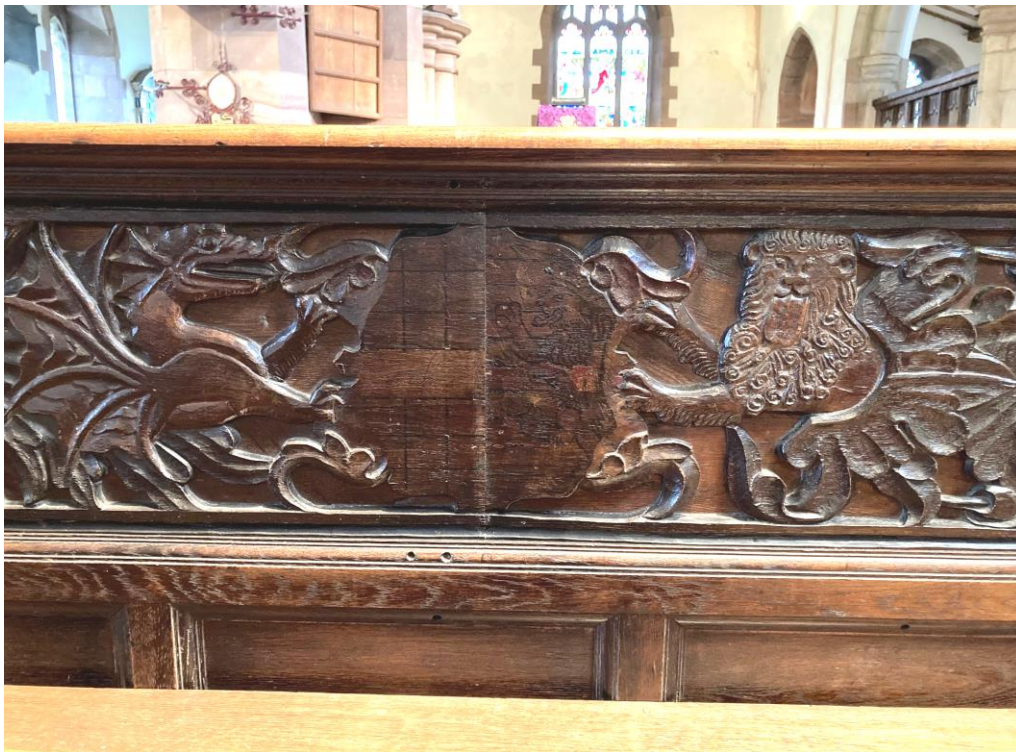
*Fig.15: shield with Clifford impaling Brandon on the west-facing frieze*

Both the current guidebook and the Historic England List Entry refer to a Foliate Man, although on close inspection, this appears to be a stylised lion with a curly mane and talons on his outstretched paws; the lion is the right hand of the supporters to the Clifford/Brandon shield on the outer west-facing frieze, opposite a dragon.

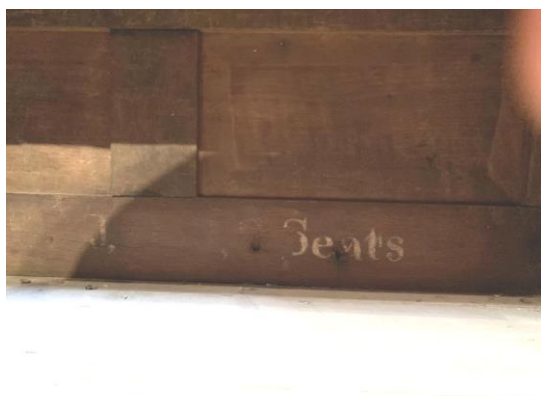
*Fig.18: former pew-holder's name on bottom rail of north panelling*

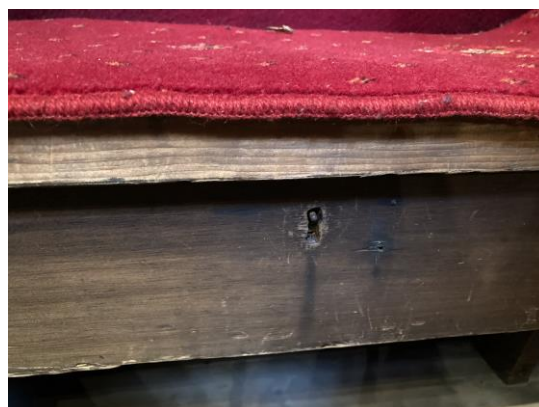
*Fig.19: locked pine drawer for books in the castle pew, below a seat*

The inner faces of the panelling, the seat backs and part of the arcade pier are lined with red baize. There were upholstered seat cushions, until they were damaged during flooding in December 2015. The pine seats are supported from below with pine brackets (part of the 1860s phase). In one of the castle pews, there is a locked drawer below the seat, for hymn and prayer books. The book rests are pine, with an oak-grained finish.

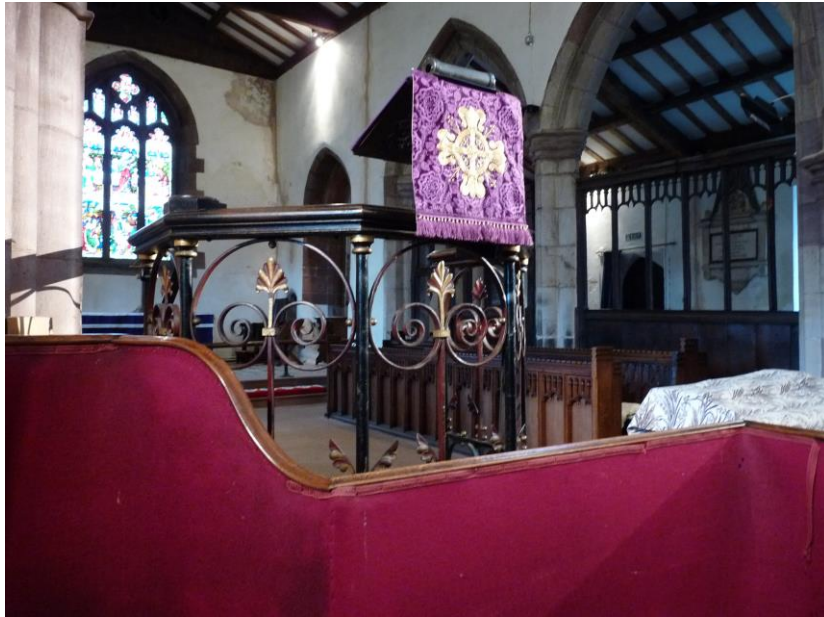
*Fig.20: red baize lining to corporation pew, and pulpit, from west*
