# HS2 Phase 1 Central Section, Archaeological Works, Windmill Hill LS093/94 (1C17WMHTT), Warwickshire Trial Trench Report

Document no.: 1EW03-FUS-EV-REP-CS07\_CL24-007292

Map Number: 1C17WMHTT\_3  
 Map Name: Windmill Hill LS093/94, Ladbroke, Warwickshire – Evaluation Trench  
 Community Forum Area 16  
 Ladbroke and Southam

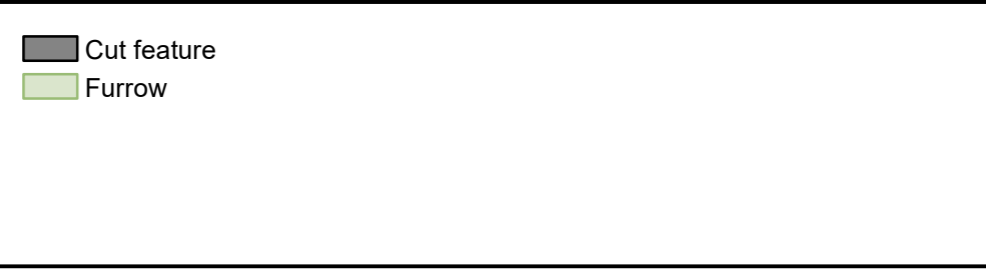
- Site Boundary
- Evaluation
- Watching Brief
- Section line
- Excavated intervention
- Cut feature
- Furrow
