1EW03 - Enabling Works Central

AWHi – Post-Excavation Assessment Report for Archaeological Recording at Doddershall DMV (C25089), Doddershall Embankment Buckinghamshire, AC250/24 Site Code: 1C19DDHAR

Document no.: 1EW03-FUS-EV-REP-CS05-007852

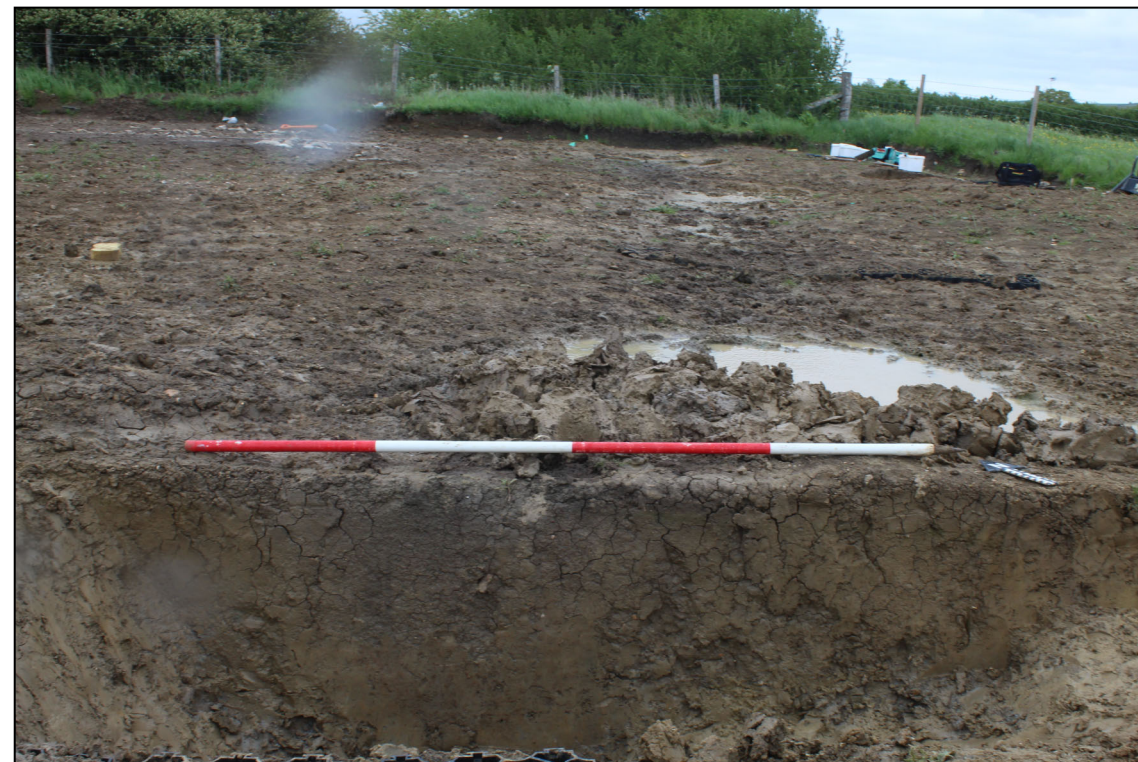
Boundary ditch, looking north-east (2m scales)

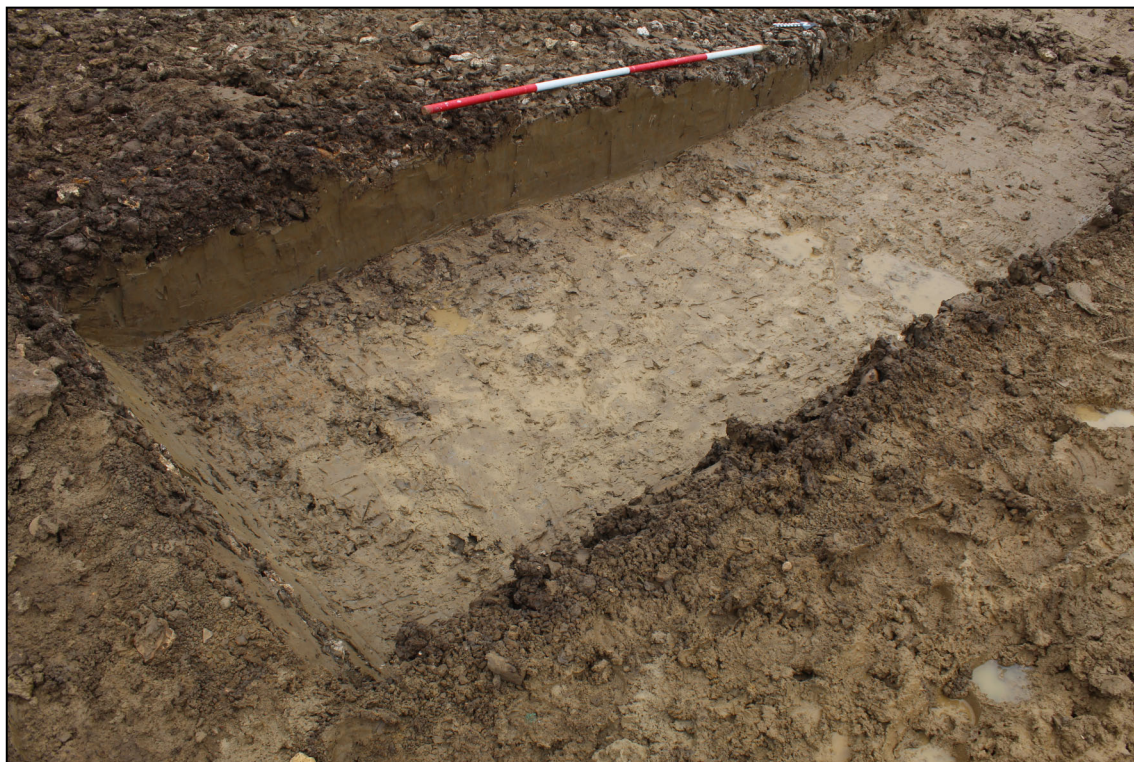
Ditch 10235 and gravel deposit 10237, looking south-west (1m and 2m scale)

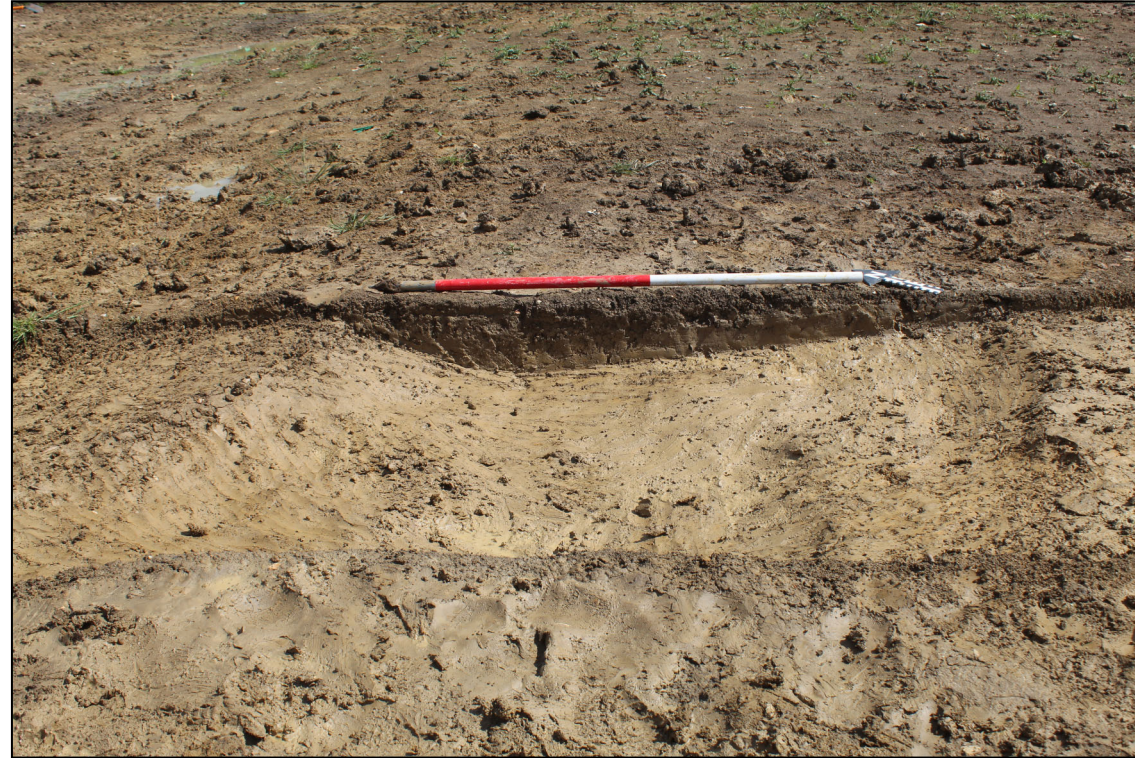
Ditch 10212, looking north-east (1m scale)

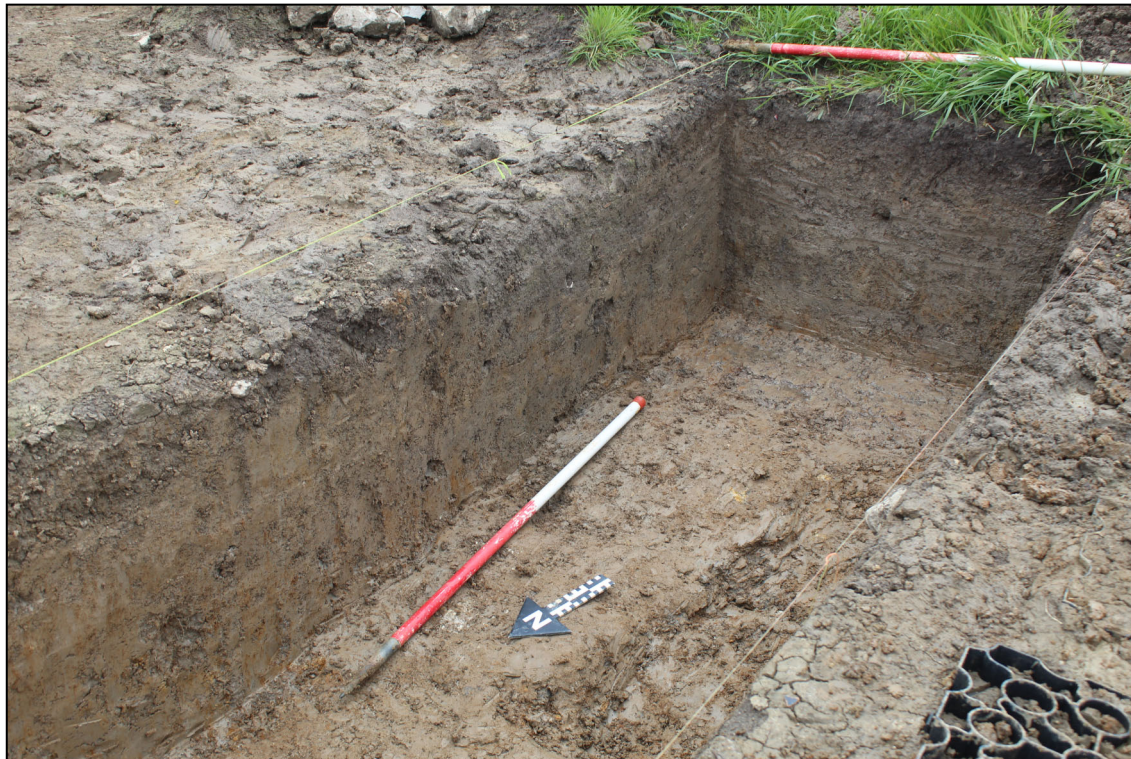
Pond 10231, looking south-east (1m scale)

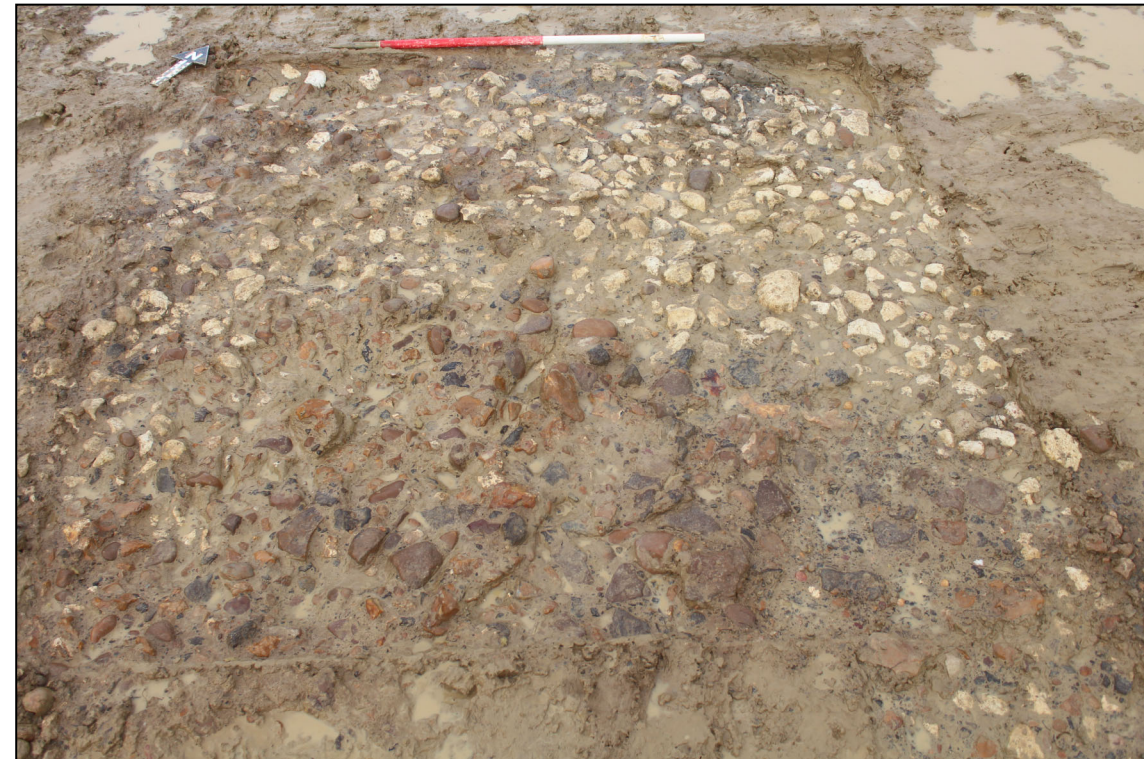
Metalled surface 10045, looking north-west (1m scale)

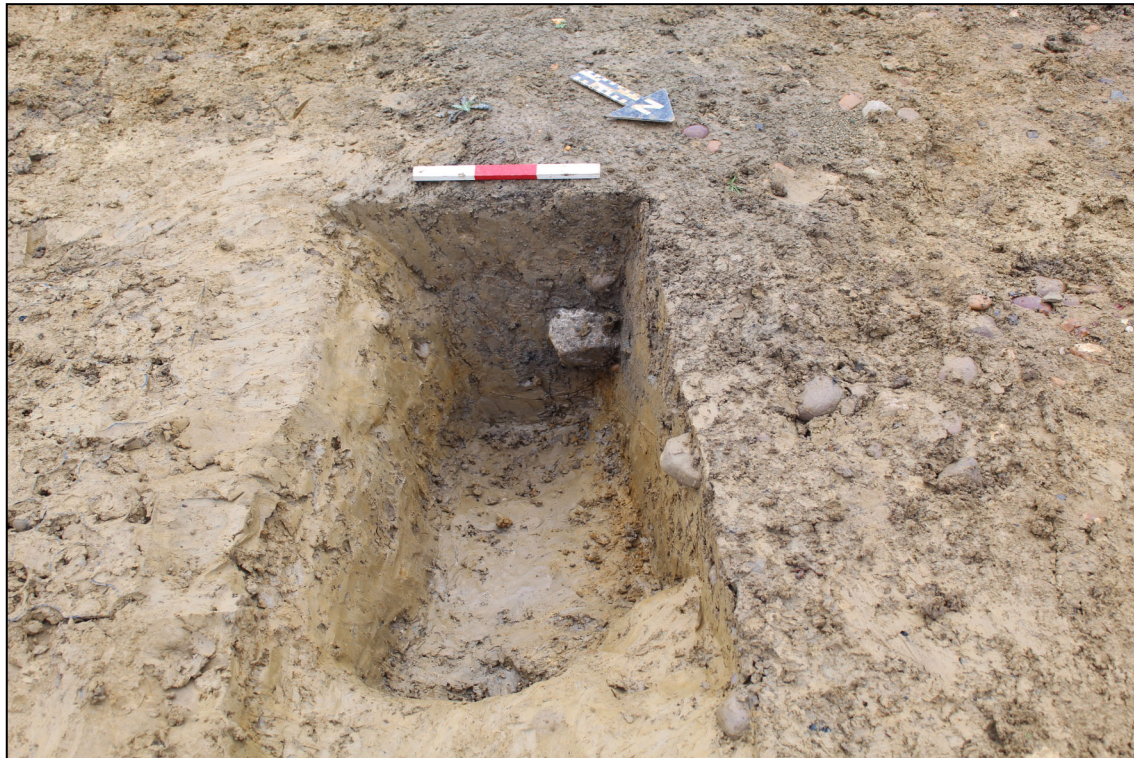
Ditch 20175, looking south-east (0.3m scale)

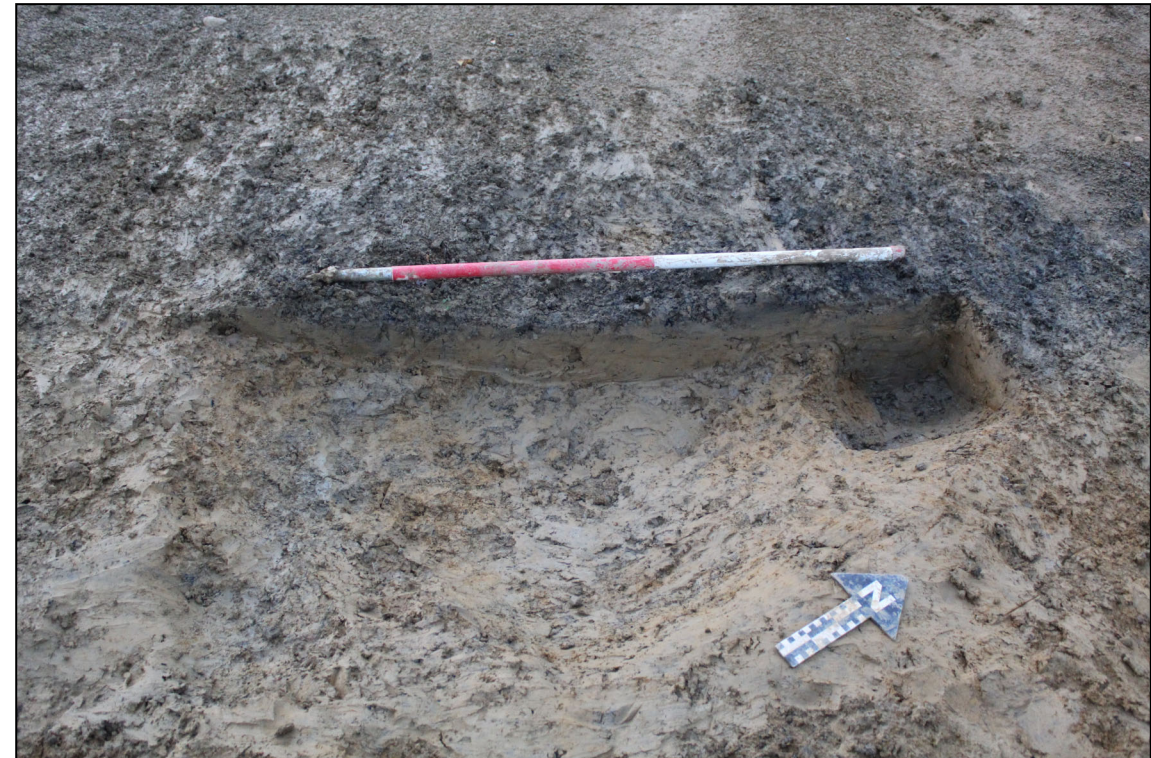
Ditch 20154, looking north-east (1m scale)

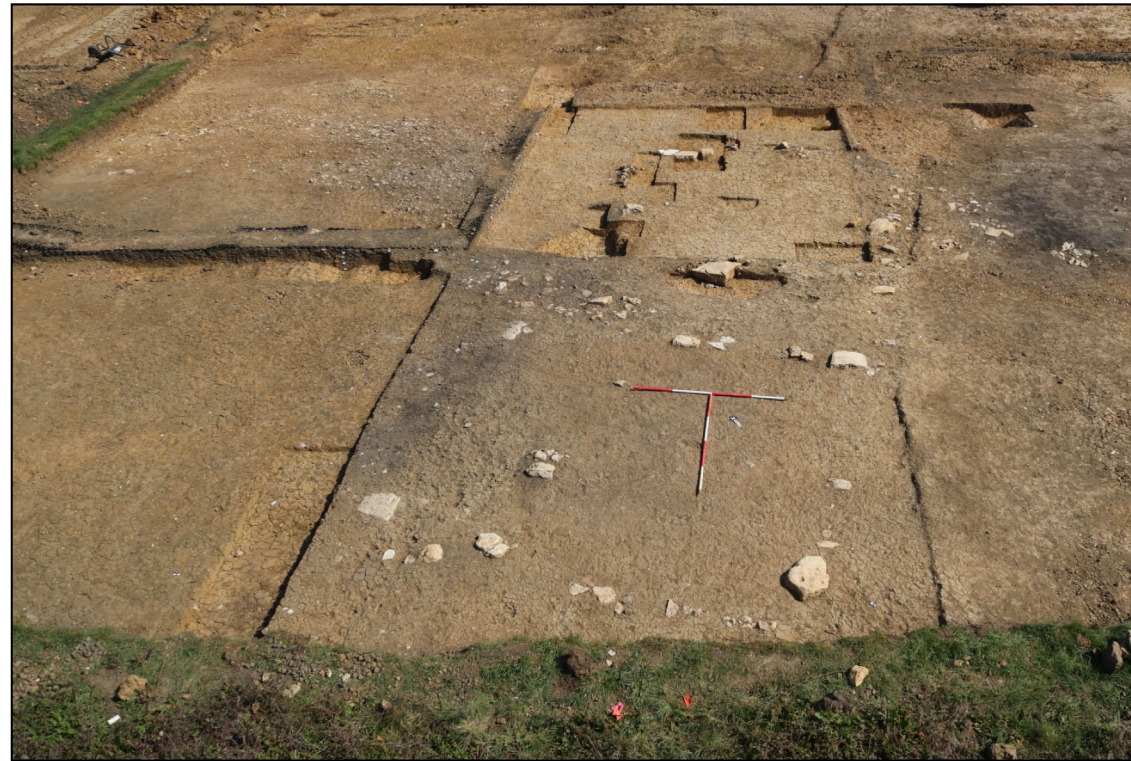
House Platform 6, looking north-east (2m scales)

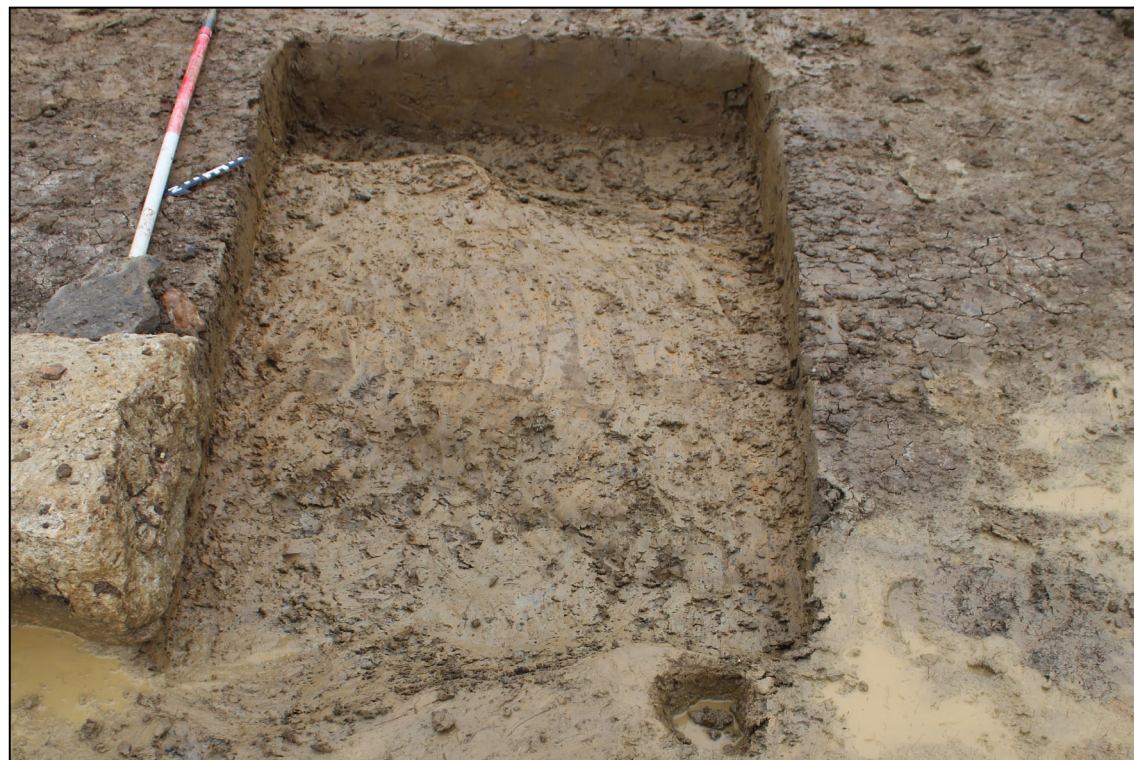
House Platform 6 gully, looking north-east (1m scale)

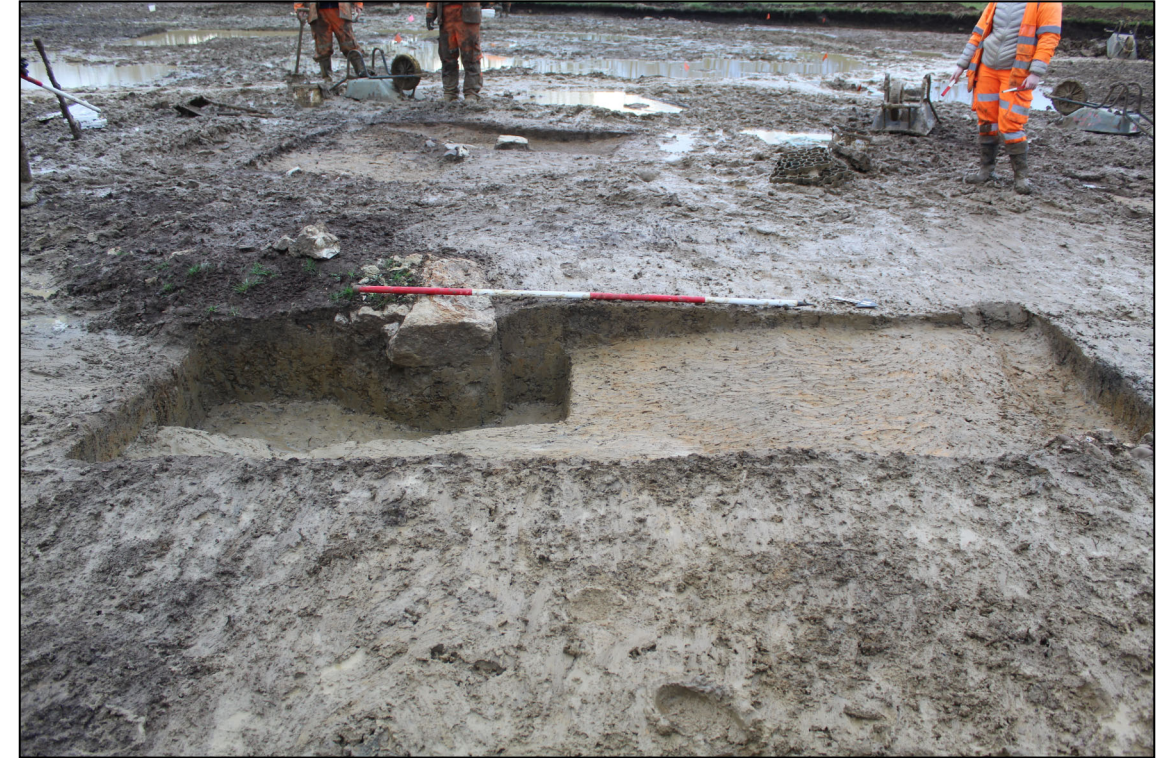
House Platform 7, 20589 and 20590, looking south-west (2m scales)

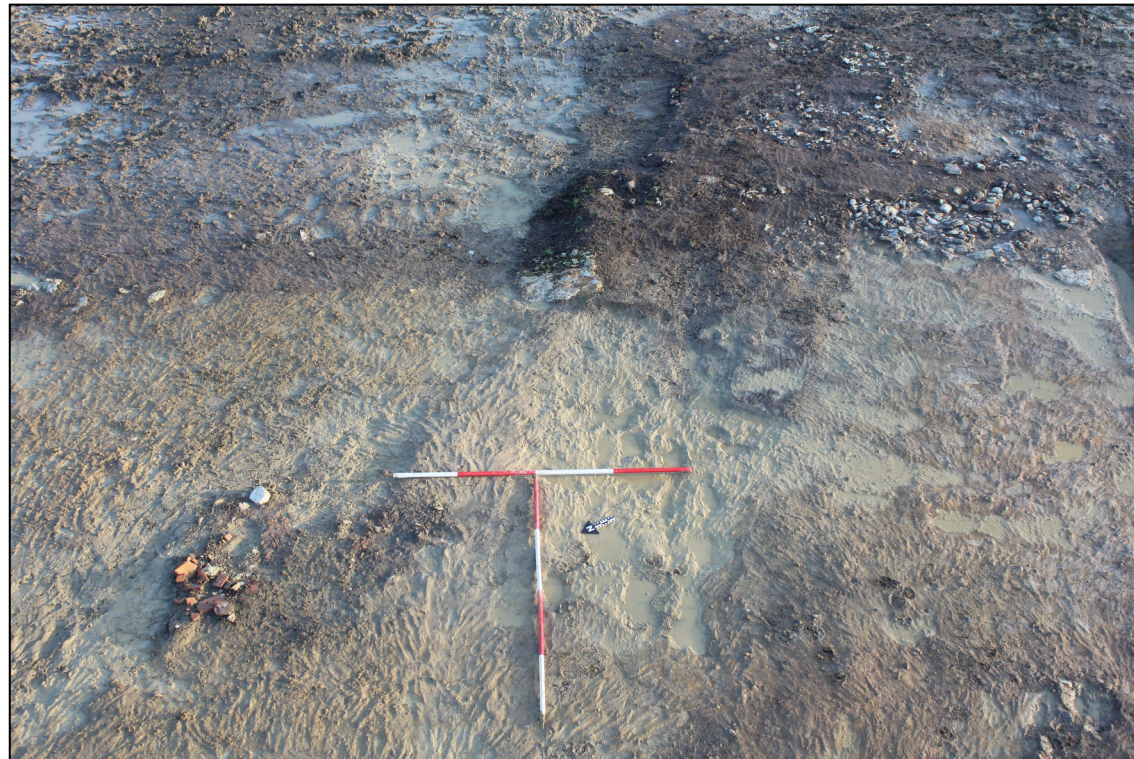
House Platform 7, looking south-east (2m scales)

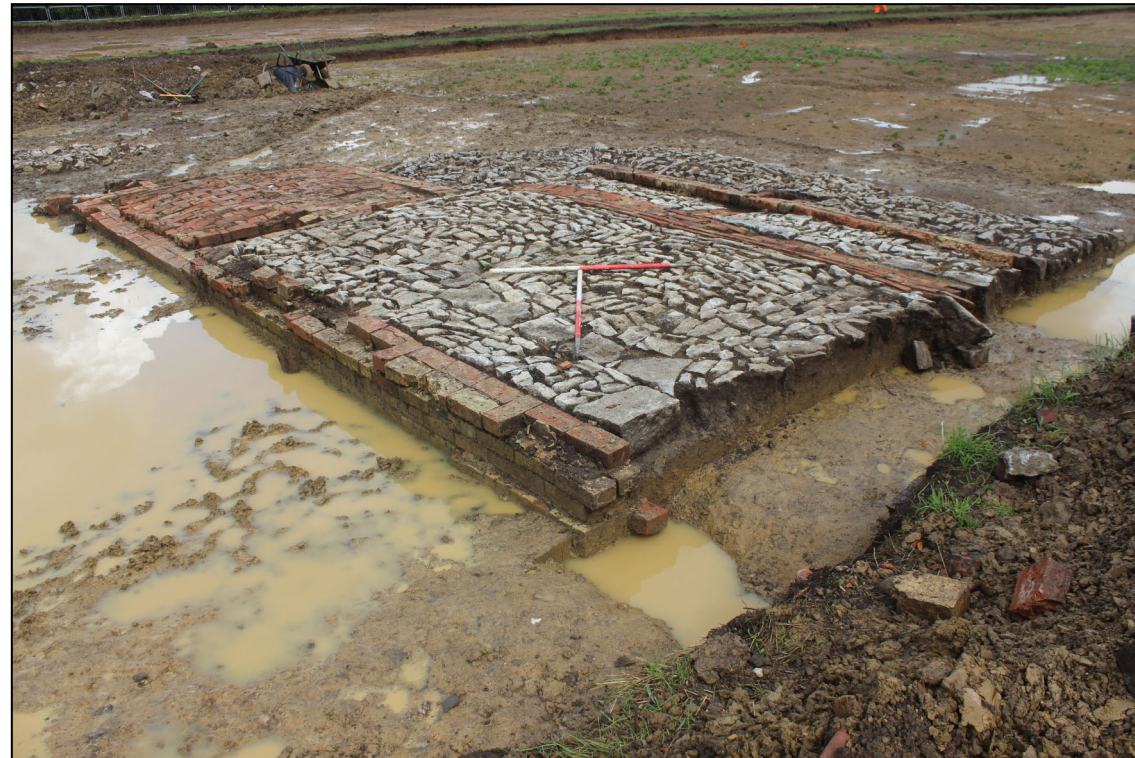
Building 20003, looking east (1m scales)

- 2.5.5 Also located in the southern part of the site there was a south-west/north-east oriented brick-built structure 20003, 9.1m long and c. 5m wide. This was immediately adjacent to and in line with a standing timber barn situated to the south. Structure had 19th-20th century pottery in one of the foundation cuts. The walls were of brick, with a limestone floor and doorstep, with brick lined and covered drains. It appears on the 1st Edition Ordnance survey map and can be interpreted as a post-medieval barn. To the north of Structure 20003, closely adjacent on the south side of Ditch CH was a large oval pit, aligned north-west to south-east, 6.63m long and 3.56m wide, and 0.30m deep. This pit may have earlier origins, but there was a small amount of 20th century pottery in the upper fill. The pit

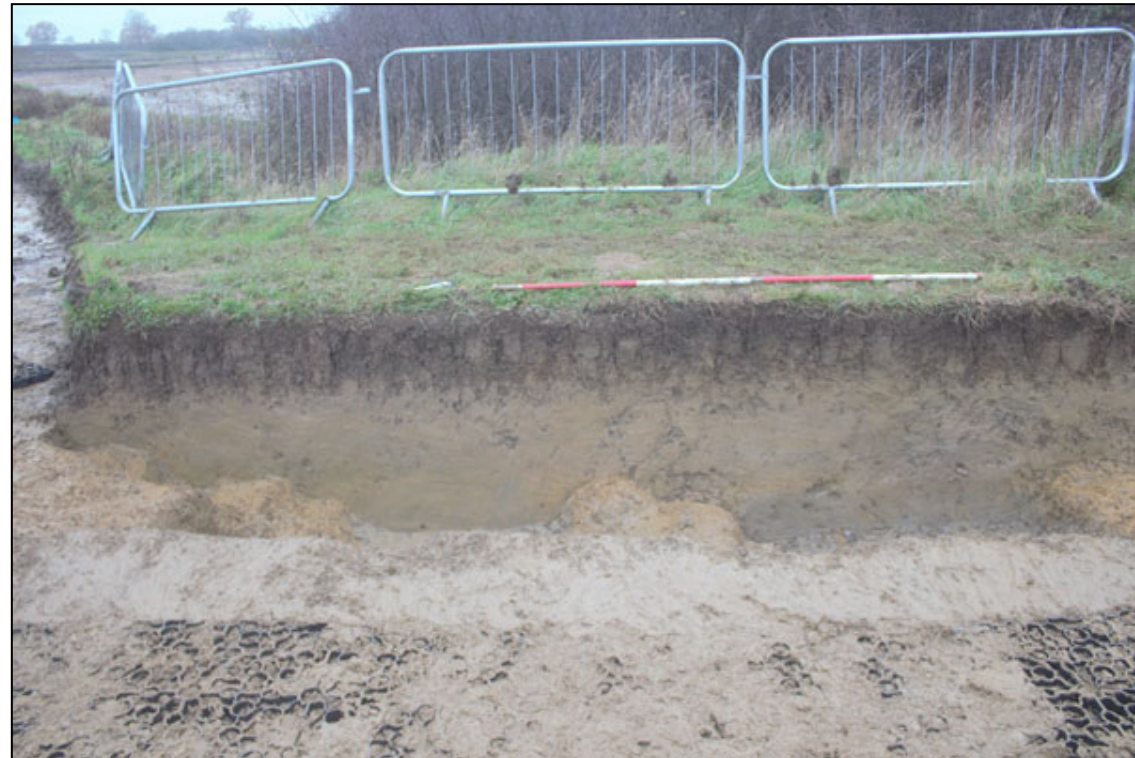
Section showing relationship between ditch 20142 and its re-cut 20128 (2m scale)

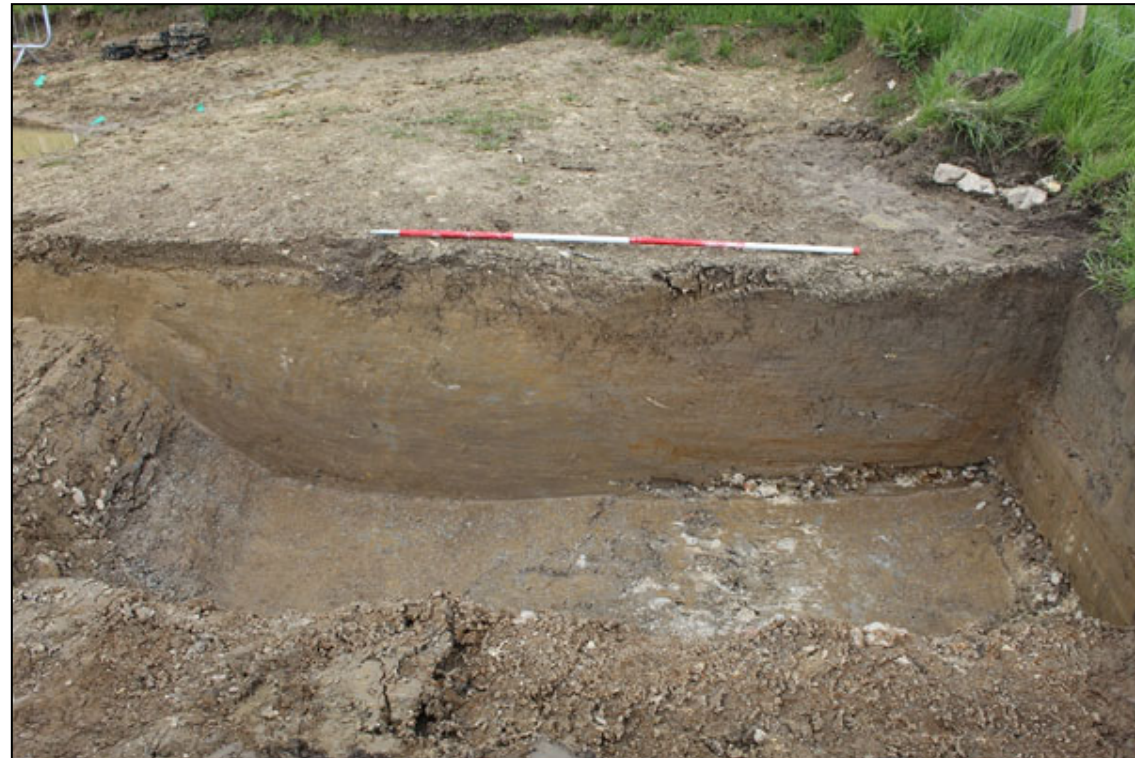
Section of a possible pond 10231 (scale 2m)

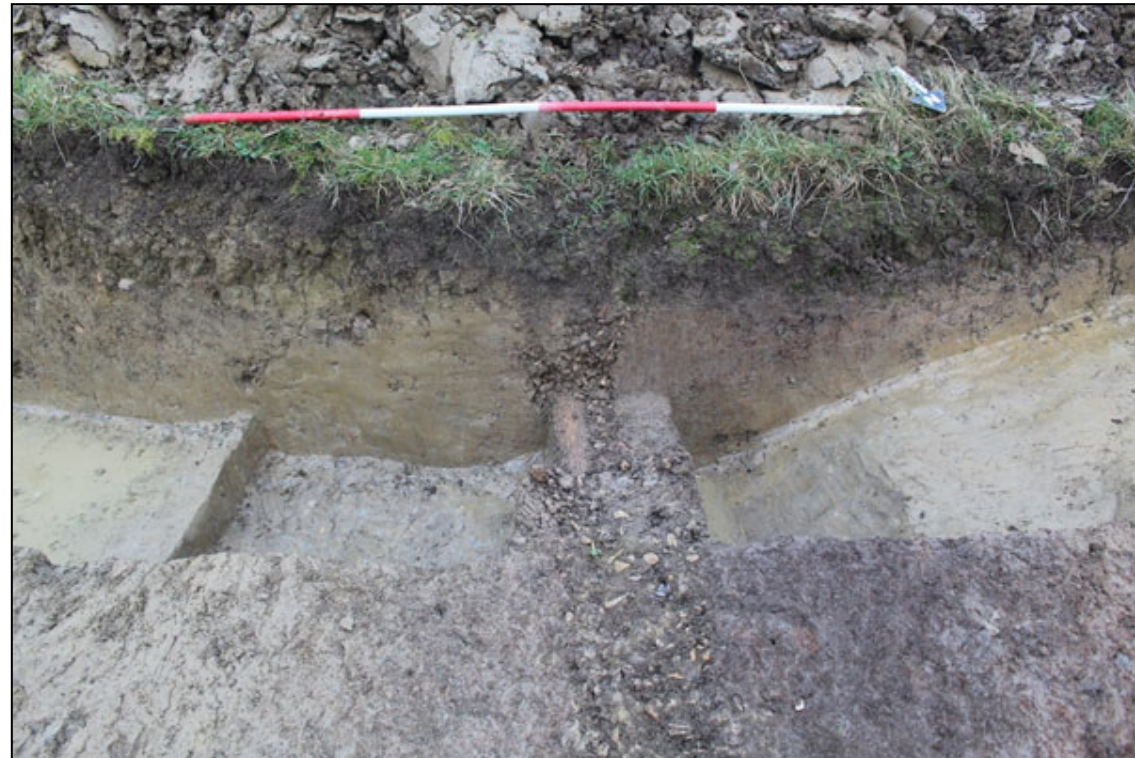
Section showing ditch 20256, looking south-west (scale 2m)
