MAGNA ARCHAEOLOGICAL EVALUATION

February 2022

OASIS ID: thevindo1-504942

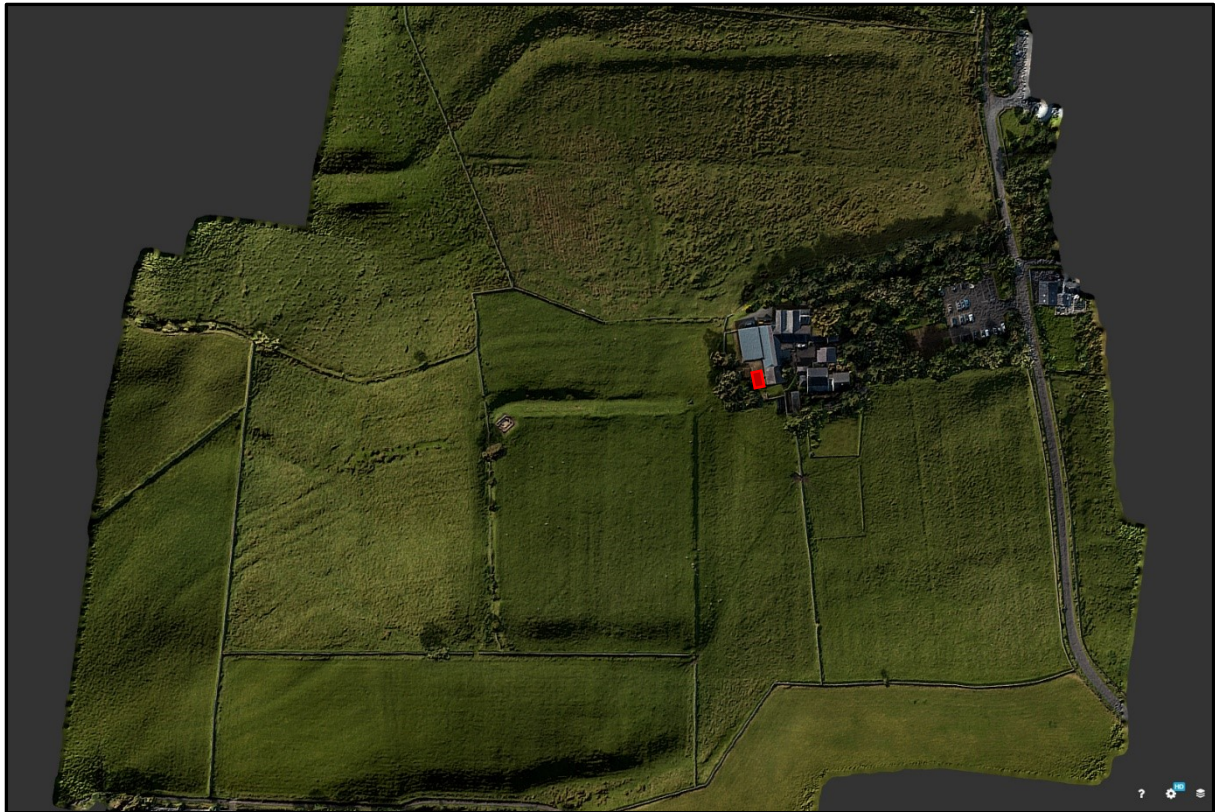
Figure 2. The location of Magna fort with the evaluation trench (marked in red)

The Vindolanda Trust excavated an evaluation trench, running north/south between gallery two at the Roman Army Museum and the existing agricultural Nissen shed, within the proposed development site area (figures 2, 3). The trench was excavated by the Trusts experienced archaeological team, with the work undertaken under the direct supervision of the Vindolanda Trusts Director of Excavations and CEO, Dr Andrew Birley in February 2022.

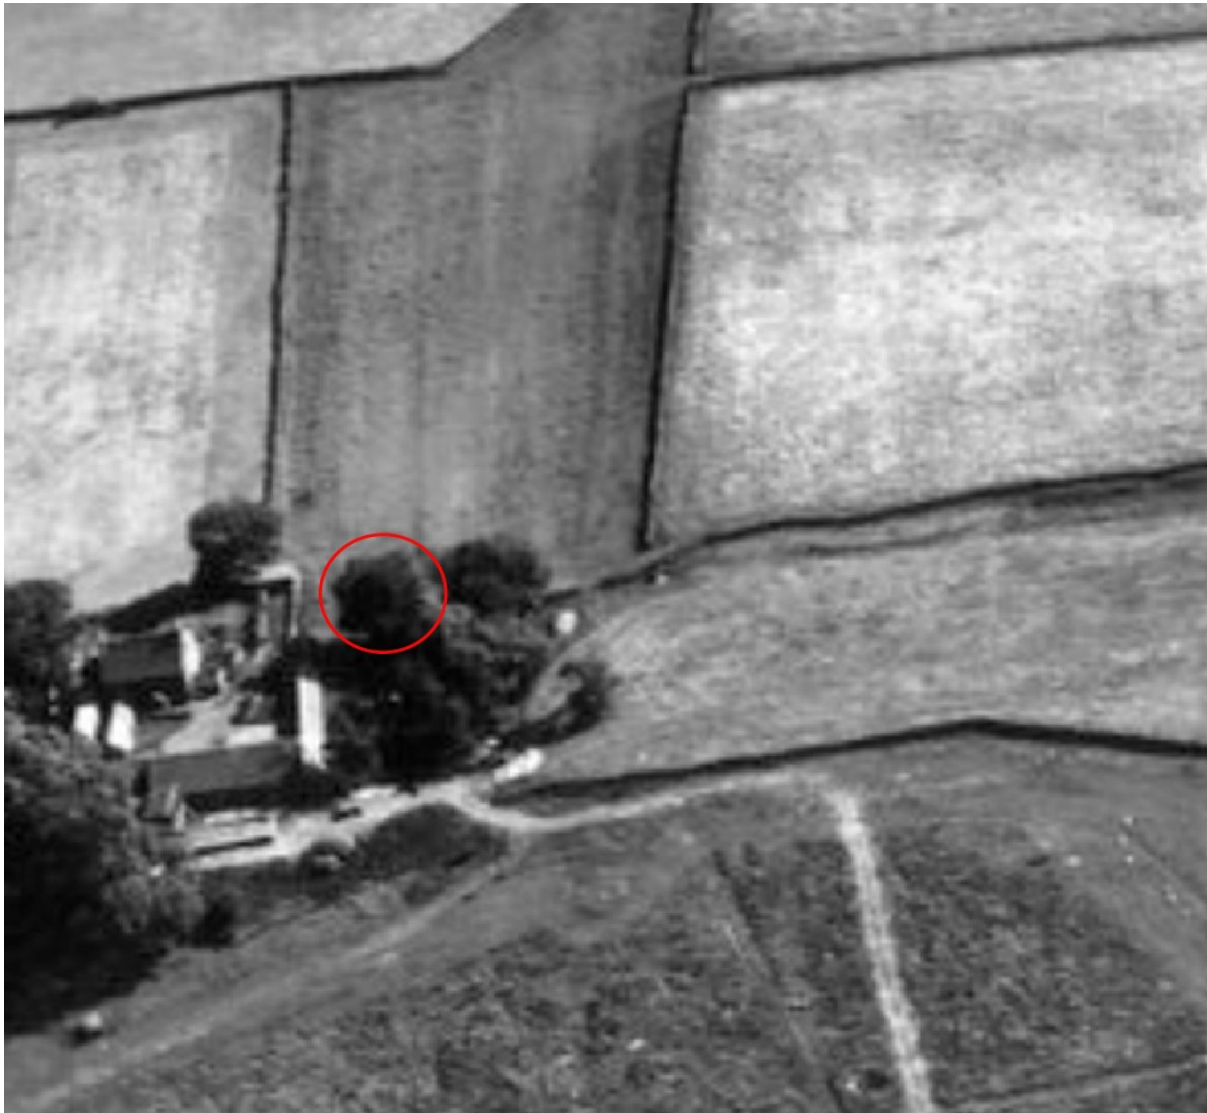
Figure 5. Showing the position of the tree seen located in the Magna evaluation trench. Last recorded standing in this photograph taken in June 1964 (Birley et al 2022: 1).

from M2022-3. The tree, last seen in an aerial image taken of Carvoran (Figure 5) in June 1964, must have either fallen or been cut down shortly after that photograph was recorded.

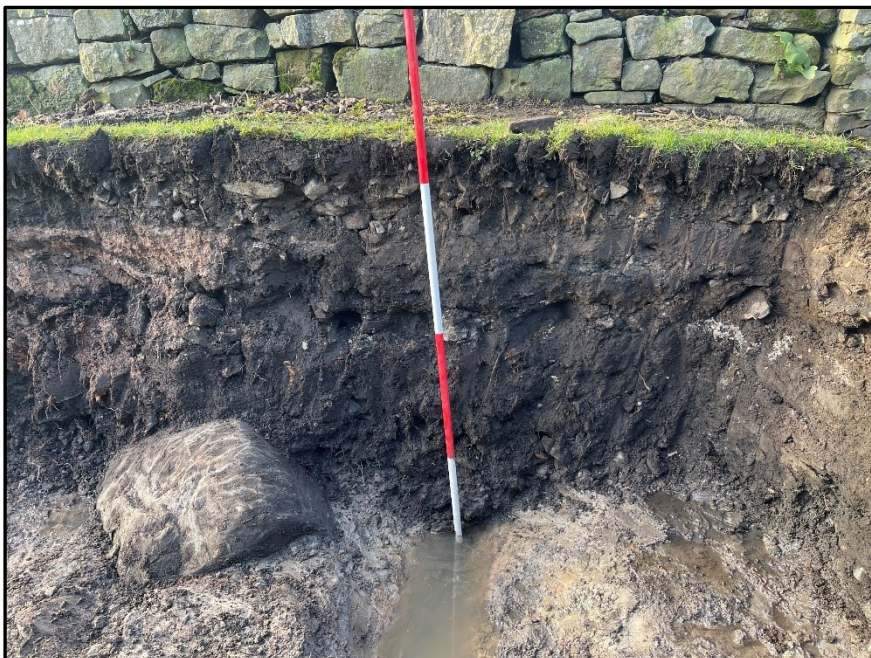
Figure 6. The V-shaped cut through the natural subsoil at the base of the north-western edge of the evaluation with the whinstone boulder in situ on the southern side of the V-cut. The depth of nightsoil above the cut is almost 1m from the base to the thin layer or lime.

M2022-5 ran the entire length of the trench, and the depth of the farming nightsoil fill was consistent throughout, extending into every section of the trench edge. At the northern 1.5m of the trench a V-shaped cut, running east/west had sliced through the natural subsoil and clay deposits. It is possible that this feature (M2022-6) was either used as a drainage channel for the new farm buildings or represented the pre-existing base of a Roman or pre-Roman feature in the landscape which was later cleaned out by farming activities. Its fill was identical to the nightsoil deposits above it.

The V-shaped cut had a maximum width of 40cm and was steeper on its southern side with an almost 45degree angle (figure 7). It was placed to carefully avoid an in-situ whinstone boulder on its southern edge and had a maximum depth of 27cm above the relatively flat clay surface above. The colour of the clay matrix in the sides of the trench was a mottled red/grey/white which is consistent of the subsoil found elsewhere at the site (Birley, Andrew R 2003: 280-295).

The feature's fill (figure 6) was similar in nature to M2022-5 although slightly more waterlogged in nature as water gathered in this cut. No Roman or pre-19th century material was recovered from within M2022-6. Its true nature, Roman or otherwise may only be determined if it is explored beyond the limited boundaries of the current evaluation trench (figure 4).

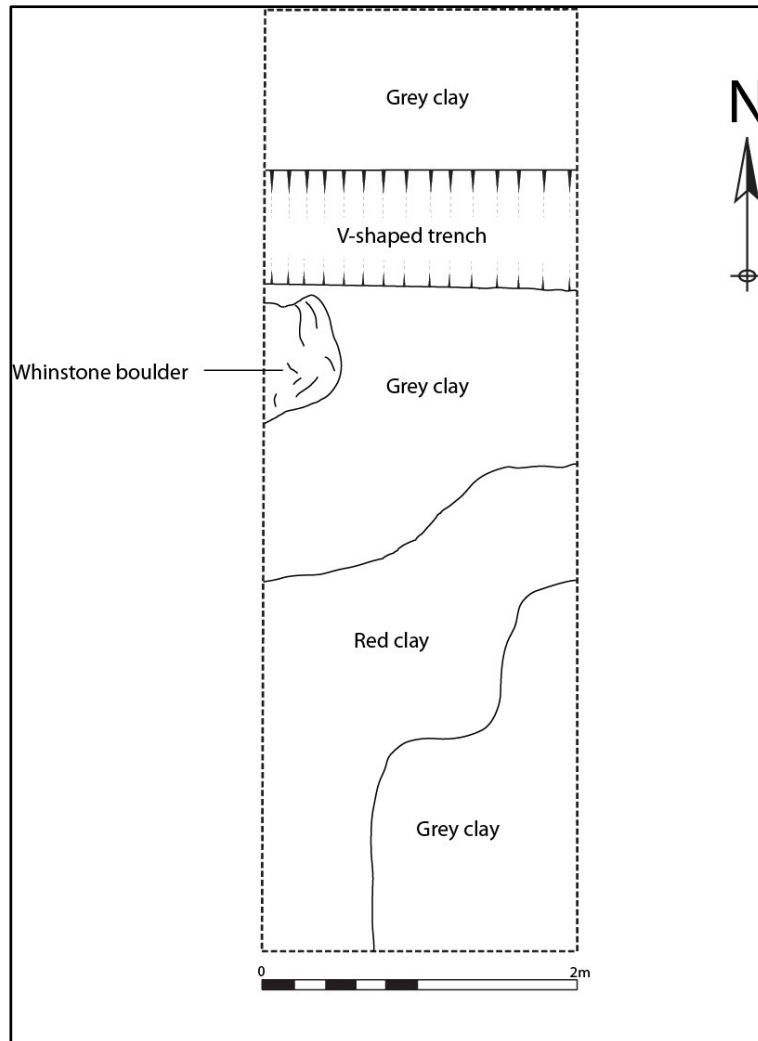
Figure 7. A plan of the trench showing the location of the V-cut trench, boulder, and main layering of coloured natural boulder clay.
