# Kirkby Thore Play Area, Kirkby Thore, Cumbria

Archaeological Watching Brief  
Report EH032/02

## Archaeological Watching Brief Report For Kirkby Thore Parish Council

**DATE ISSUED:** December 2020  
**JOB NUMBER:** EH032  
**REPORT NUMBER:** 02 Version (1.0)  
**SCHEDULED MONUMENT:** SM 13450  
**GRID REFERENCE:** NY 63493 25679

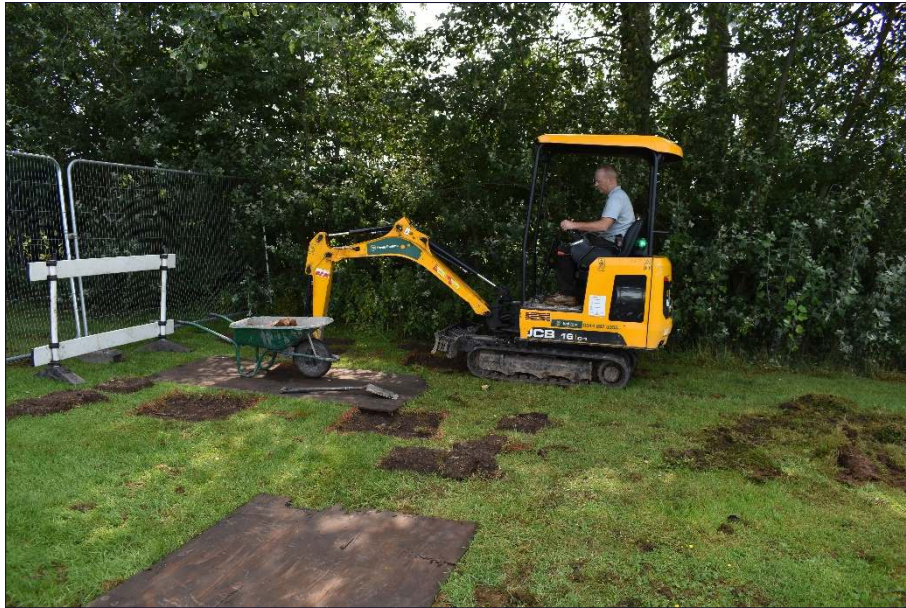
**Plate 1:** Excavation underway in Area A on the northwest side of the site, looking east

- 4.1.1 The archaeological watching brief was undertaken over two days on 10<sup>th</sup> and 11<sup>th</sup> August 2020. This work comprised the monitoring of the excavation of 25 small-scale individual excavations in total, which were required to house the concrete bases for the new play equipment (Plate 1 & Plate 2).

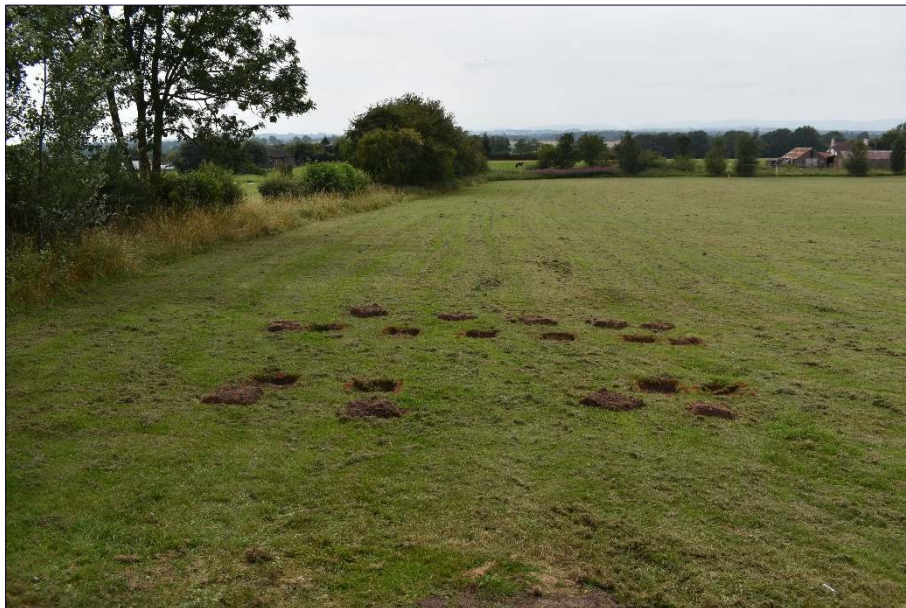
**Plate 2:** Excavated pits in Area B on the southeast side of the site, looking southeast

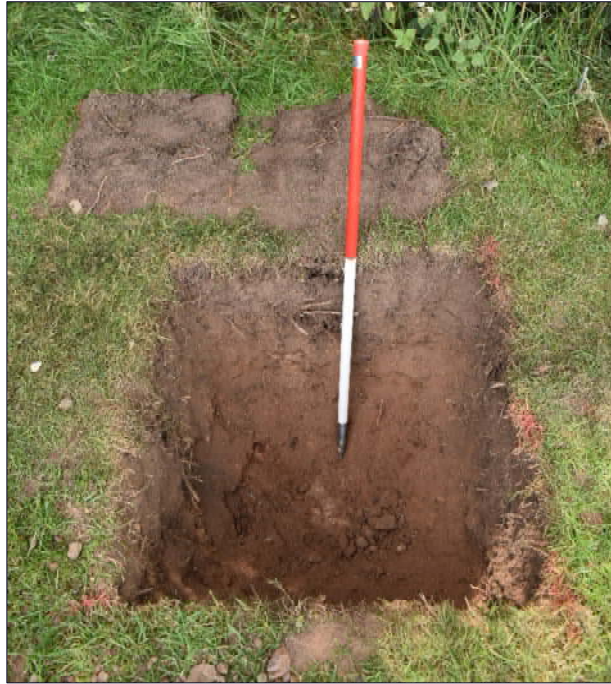
**Plate 3:** Excavation in Area A on the northwest side of the site, looking east (1m scale)

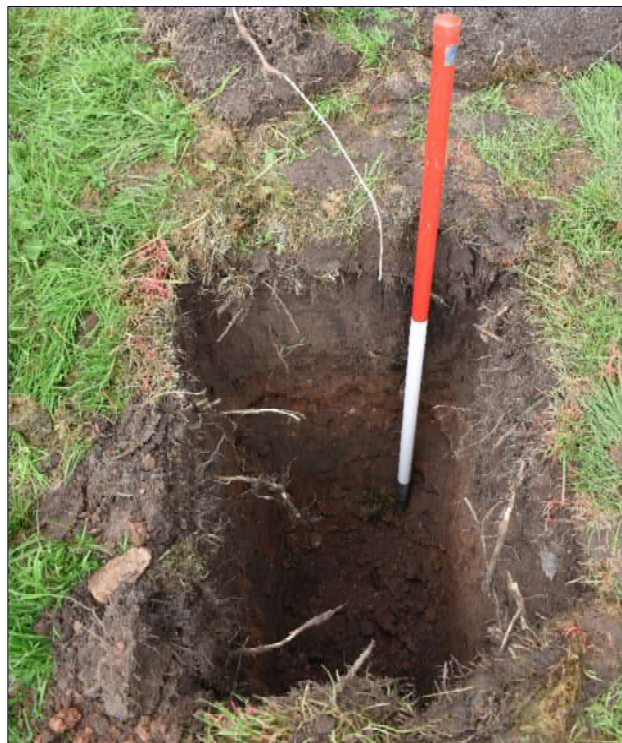
- 4.2.3 The deepest excavations (at 1.0m) were located on the northeast side of the area for a new pedestal slide (Plate 4). Two excavations in Area C reached this depth revealing compacted boulder clay beneath the natural sand **(102)**.

**Plate 4:** Deepest excavation area in Area C on the north side of the site, looking southwest (1m scale)

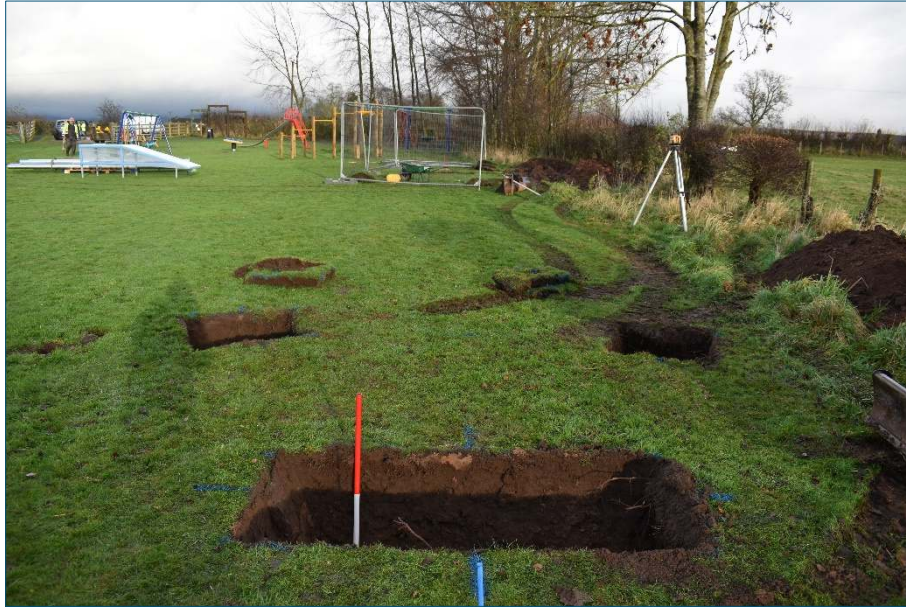
- 4.2.4 The longest two trenches were located either end of the zip wire on the south side of the site measuring 1.8m by 0.8m (Plate 5 and Plate 6). These also penetrated the natural sand **(102)**.

**Plate 5:** Excavations for the zip wire on the south side of the site, looking northeast (1m scale)

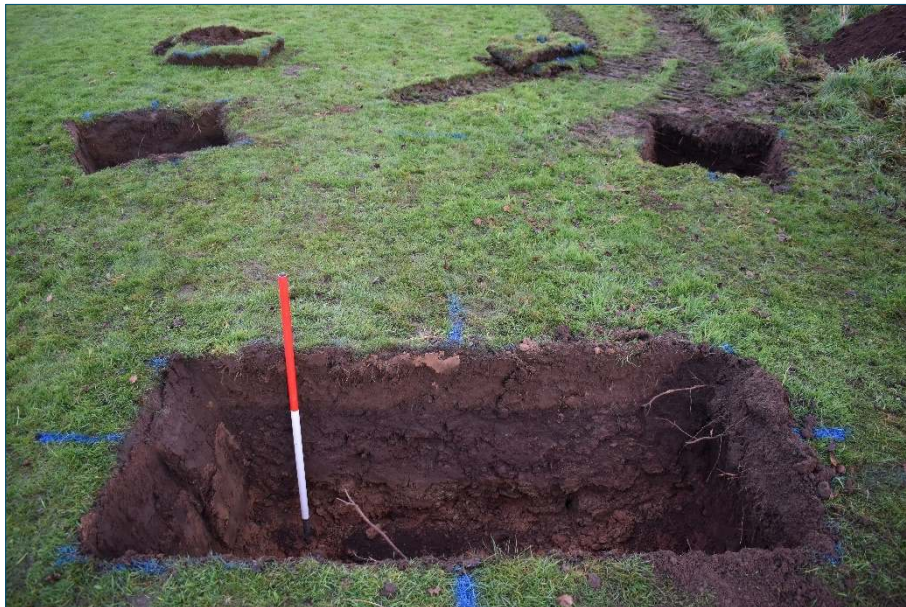
- 4.2.2 To the south in the area of the zip wire, a 0.1m-deep layer of topsoil and turf **(100)** overlay 0.3m of sandy loam subsoil **(101)**, below which was the natural drift geology **(102)** with some large boulders.

**Plate 5:** Southwest-facing section through the zip wire trench, looking northeast (1m scale)
