Archaeological Watching Brief
Report EH083/02

The King's School, Fence Avenue Macclesfield, Cheshire

Archaeological Watching Brief Report For Barratt & David Wilson Homes

DATE ISSUED: November 2021
JOB NUMBER: EH083
REPORT NUMBER: 02 Version (1.0)
PLANNING REFERENCE: 20/0246M
GRID REFERENCE: SJ 9259 7388
OASIS REFERENCE: edenheri1-434050

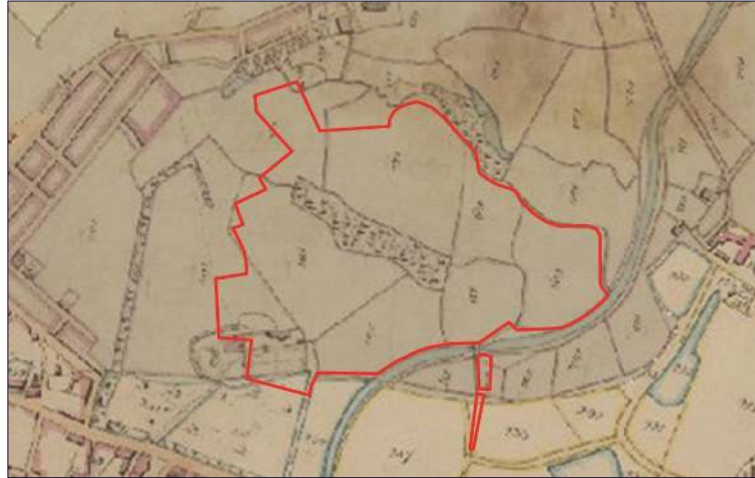
Plate 1: Extract from the 1849 Tithe map (University of Salford 2015)

- 3.2.1 There was no known evidence for medieval (or earlier) activity within the proposed development area. The Cheshire Tithe map of 1849 (Plate 1) shows the proposed development area as predominantly rural but with buildings to the north, south and west. A property is depicted on the southwest side of the proposed development area, the land to the north and east being listed as pasture, meadow and woodland (University of Salford 2015, 8). The township boundary is depicted crossing the south side of the proposed development area on this map.

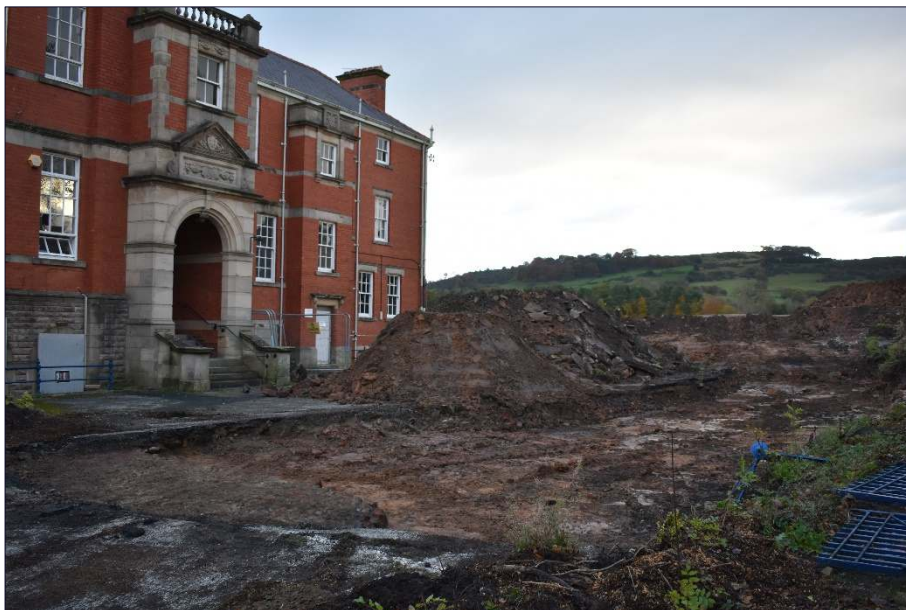
Plate 2: Area excavated for the access road to the south of the main building, looking northeast

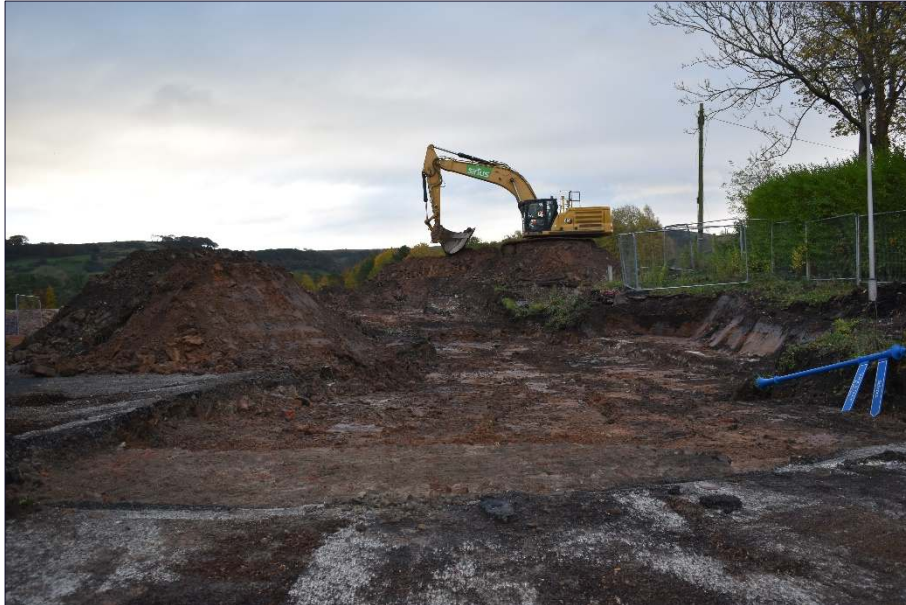
Plate 3: Excavated area south of the main building, looking east

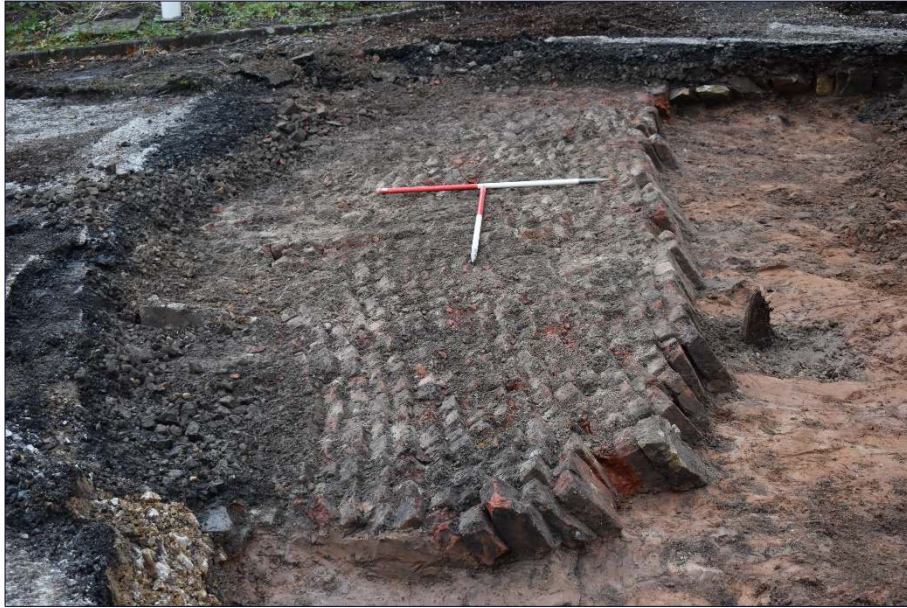
- 4.2.1 The excavation within the former carpark revealed layer of red bricks **(101)** measuring 5.8m by 2.5m in the west end of the excavated area. The bricks were all hand-made, each measuring 230mm by 100mm by 25mm, and were bedded in yellow sand. The bricks had been stacked on their ends to form a 0.2m-deep layer overlying the natural clay **(100)** but were leaning slightly to the west creating a jagged upper surface, which was presumably due to the rising ground level (Plate 4). The bricks were evidently re-used from elsewhere as several had traces of mortar on their surfaces. Immediately to the east the brick was replaced by a similar layer of yellow sandstone pieces **(102)**, which had also been laid on their sides to form a foundation for the tarmac carpark surface **(103)**. The stone was inspected and was unshaped but could have come from an earlier building (Plate 5).

Plate 4: Brick layer (101) at the west side of the carpark, looking north

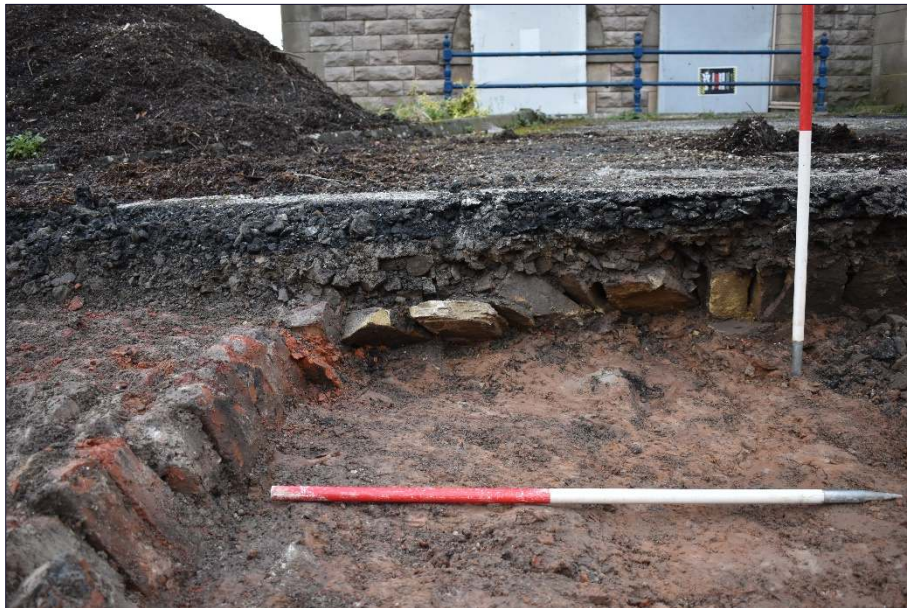
Plate 5: Brick and sandstone layers (101) and (102) at the west side of the carpark, looking north

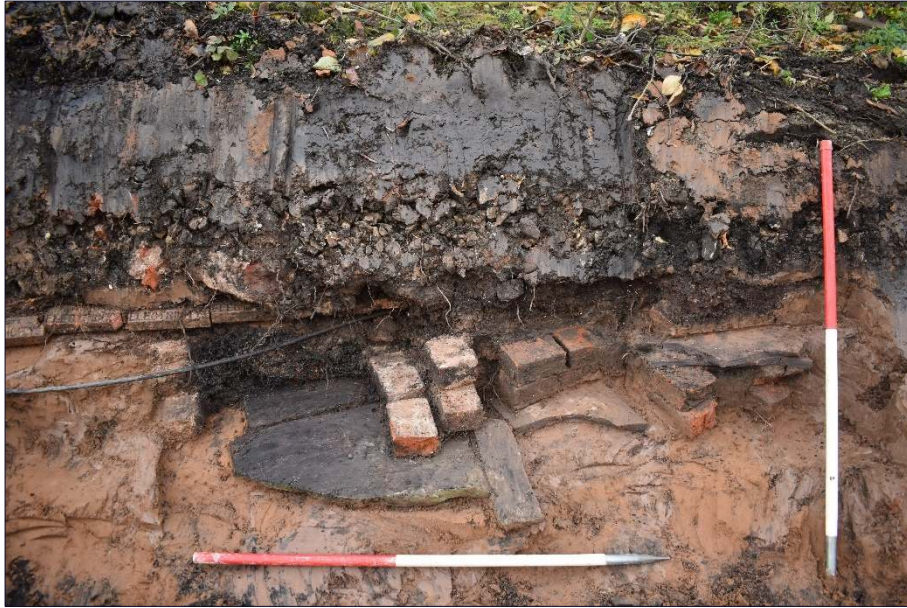
- 4.2.2 Two modern 0.6m-square postholes were seen to cut through the brick and stone surfaces **(101)** and the natural clay **(100)**. Each contained the base of a 0.1m-square timber post, and filled with modern hardcore, possibly for a fence or signs. A modern drain was also revealed in the southern baulk of the excavation, along with a brick 0.5m-wide 0.2m-deep brick manhole or inspection chamber **(104)**, associated with an electricity cable marked by a row of bricks stamped with 'electricity' (Plate 6).

Plate 6: Brick inspection chamber **(104)** in the southern bank of the excavated area, looking south

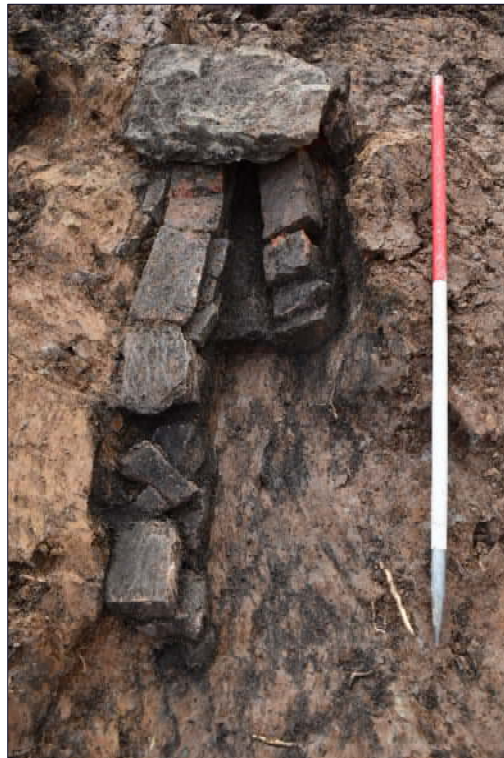
Plate 7: Brick and stone drain **[106]/(107)** in the eastern excavated area, looking southeast

- 4.2.4 A stone drain was revealed cutting the natural clay **(100)** at the centre of the eastern excavated area, aligned northwest to southeast (Figure 5). The cut of the drain **[106]** was 2.5m long, 0.45m wide and 0.2m deep with vertical sides and base. The base had been lined with small stones, and the sides were lined with squared stones and two rows of red bricks to form the drain **(107)**. This was capped with yellow sandstone slabs measuring up to 0.45m by 0.3m by 0.08m (Plate 7). The drain was filled with a deposit of black clay silt **(108)** which contained a sherd of modern ceramic and an iron nail.

- 4.2.5 The drain appeared to have been truncated at either end by later activity, so its full extent was uncertain. This was covered in a 0.3m-deep layer of topsoil **(105)** which also covered the eastern side of the excavation. Numerous tree roots were also present in this area from a recently removed tree.

- 4.3.1 The drain **[106]/(107)** could have potentially been associated with a small post-medieval building, which is depicted in this location, to the west of Fence Cottage, on historic Ordnance Survey maps of 1898 and 1909 (Figure 3b and Figure 3c). This building, along with the buildings associated with Fence Cottage, were evidently demolished following the construction of King's School in 1908.

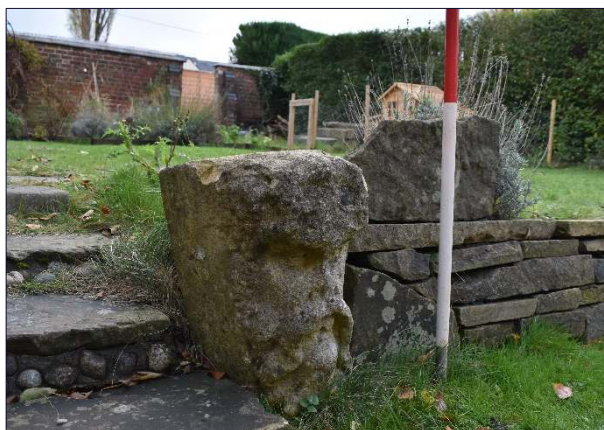
- 4.3.3 During the watching brief the resident of No.24 Fence Avenue exhibited a carved keystone which is believed to have come from one of the buildings associated with Fence House (Plate 8). This was the only convincing evidence identified during the project for the former presence of these buildings.

Plate 8: Carved stone from Fence House in the garden of No.24 Fence Avenue, looking southeast
