**Archaeological Watching Brief
Report EH354/02**

Land at The Bungalow, Lathom Park Lathom, Ormskirk, Lancashire

Archaeological Watching Brief Report for Mr Danny Johnson

DATE ISSUED: January 2025
JOB NUMBER: EH354
REPORT NUMBER: 02 Version (1.0)
PLANNING REFERENCE: 2024/0509/FUL
GRID REFERENCE: SD 4598 0905
OASIS REFERENCE: edenheri1-531265

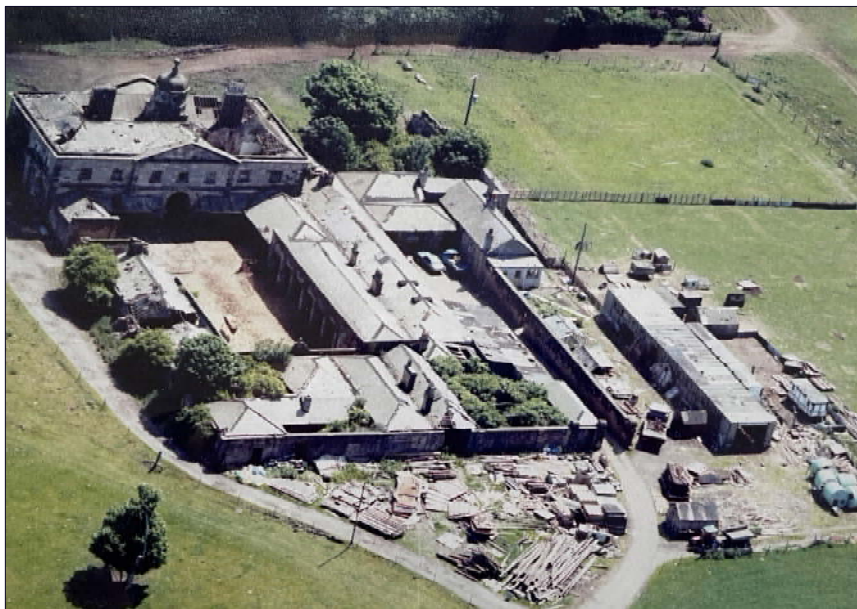
Plate 2: Lathom House showing the proposed development area on the right, looking east
(Source: Mr Danny Johnson)

3.2.11 Later 20th century Ordnance Survey maps suggest the area to the south of the house was cleared although the Ha-Ha survived as an earthwork to the south of the site of the new garage (Figure 7). A 1990s aerial photograph provided by Mr Danny Johnson shows the area prior the redevelopment of the West Wing and prior to the construction of The Bungalow, this being built in 1997 (Plate 2).

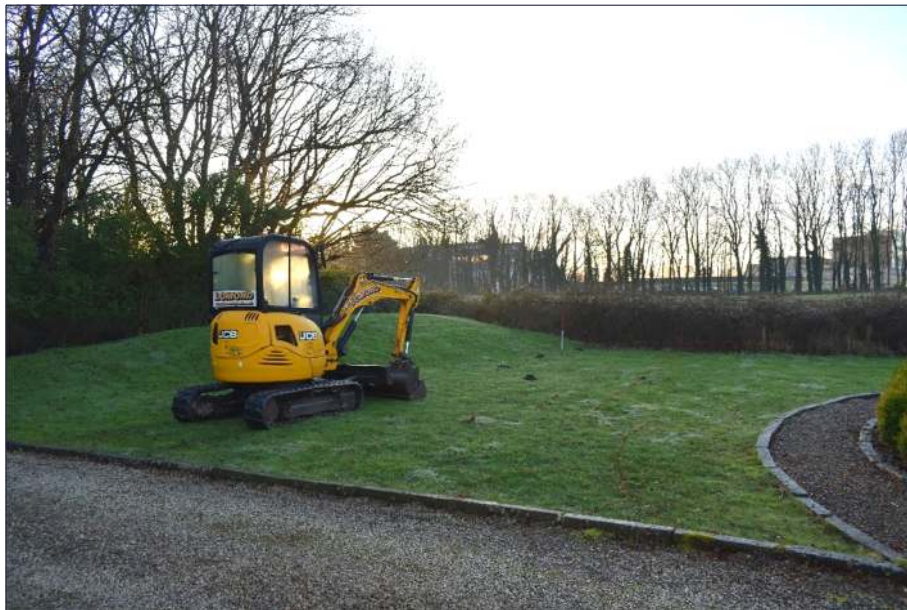
- 4.1.2 The area of the proposed new garage comprised an area of lawn to the east of The Bungalow to the south of the existing drive (Plate 3). Woodland bounded the east side of the site, with a garden area and pond to the west side. The area of the garage contained a mound (not present in the 1990s) which was believed to be spoil associated with the construction of The Bungalow or the adjacent drive. The mound measured approximately 11m by 5m, being 0.7m high, and was first removed by machine to the level of the lawn (Plate 4). The material comprised mostly dark grey/brown loam **(100)** containing modern plastic sheeting, metal, brick, concrete, gravel, cable and stone fragments.

Plate 3: Area of the proposed new garage showing the modern topsoil mound, looking south-west

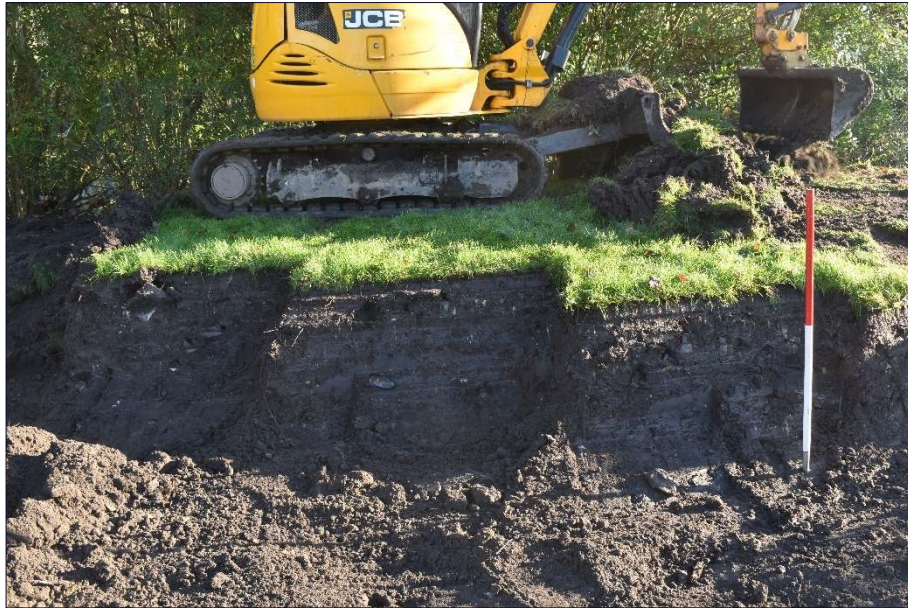
- 4.1.3 A deposit of stone pieces and red brick **(101)** was revealed beneath the mound, between 0.1m and 0.2m deep; the materials were similar to those used in the construction of The Bungalow. Modern plastic and metal objects were also recovered from this deposit, confirming the mound was modern.
- 4.1.4 Turf and topsoil **(100)** were subsequently removed from the remainder of the area to a depth of 0.3m below ground level (bgl) to expose brick and timber foundations of a modern greenhouse and shed, which had previously occupied this part of the garden. These were also removed from the site.

Plate 4: Section through the modern topsoil mound, looking west (1m scale)

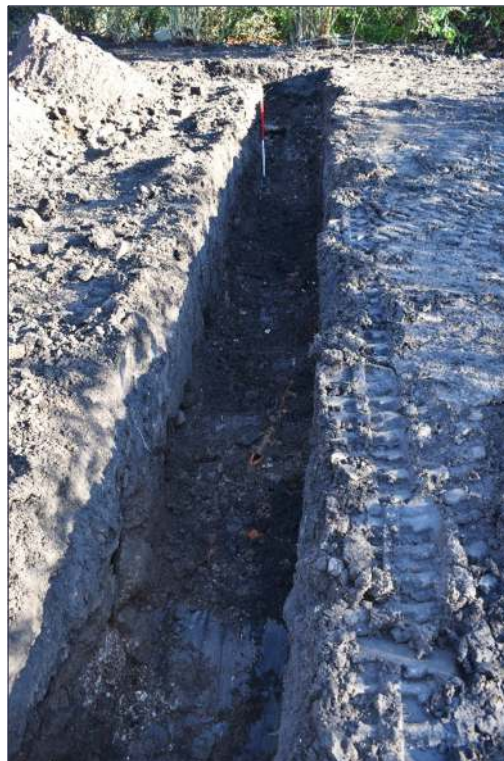
Plate 5: Southern foundation trench showing made ground (**102**), looking west (1m scale)

4.1.5 Following topsoil stripping, three 0.75m-wide trenches were excavated on the east, south and west sides of the area to a depth of between 1.2m and 1.4m for the garage foundations. These excavations revealed 0.9m of made ground, which was present throughout the trenches to the full depth of the

excavations. The made ground comprised a loose deposit of grey silty sand (**102**) containing frequent stone pieces and mortar fragments, which was interpreted as probable demolition rubble (Plate 5).

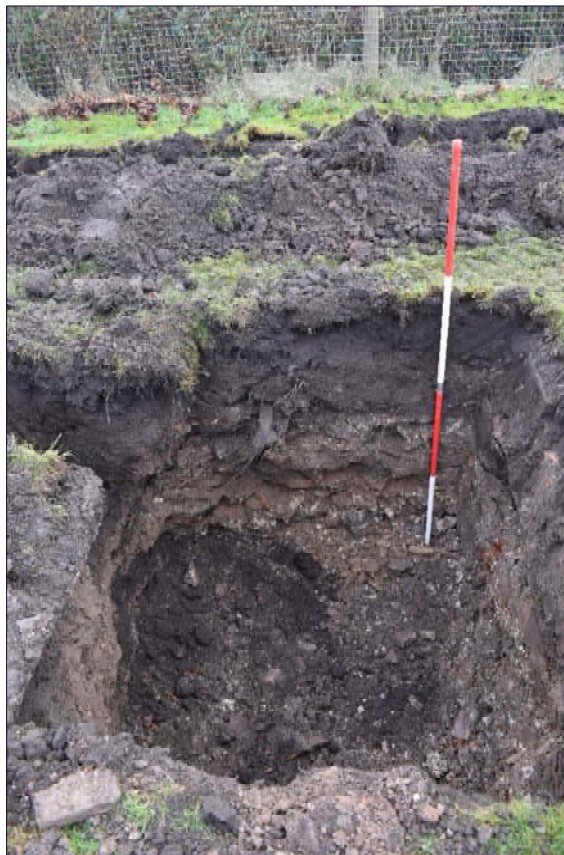
- 4.1.6 Two ceramic drains had been laid within the demolition deposit (**102**), aligned east-west and north-south. The deposit also produced several sherds of post-medieval pottery and clay pipe fragments.
- 4.1.7 Another 1.5m by 1.5m trench for a soak-away was excavated to the west of this area to a depth of c.1.5m with a 0.35m-wide 0.9-m deep drainage trench running westwards to the garage (Figure 8; Plate 6). This revealed the continuation of the made ground (**102**) throughout the excavations.
- 4.1.8 A further 0.35m-wide 0.4m-deep trench was excavated to the south for an electricity supply between The Bungalow and the new garage (Figure 8). This also revealed topsoil (**100**) and made ground (**102**).

Plate 6: Soak-away trench showing c.1.5m of made ground (**102**), looking south (2m scale)

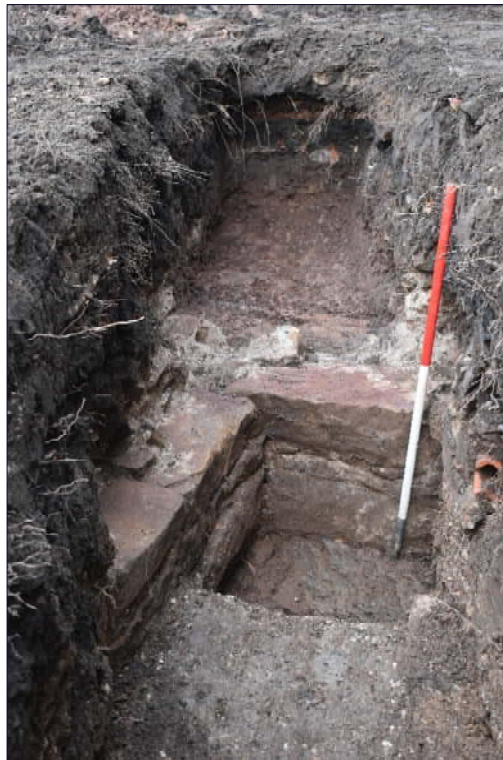
- 4.2.1 The natural fragmented bedrock (**103**) was revealed in the north end of the foundation trench at a depth of 0.5m blg. The bedrock had been removed in this area for the construction of the stone structure (**104**) creating a step (Figure 9 and Figure 10). A vertical cut [**104**] had been made for a red sandstone wall (**104**) which crossed the trench with a north-east to south-west alignment, forming a revetment. This wall was 0.75m deep, with further bedrock (**103**) revealed to the south side.

- 4.2.2 The structure (**104**) as revealed in the trench, consisted of an L-shaped stone wall measuring 0.5m wide and 0.8m long from east to west and 1.5m long from north to south (Plate 7 and Plate 8). The wall consisted of two courses of roughly shaped red sandstone blocks up to 0.5m long and 0.25m deep bonded with lime mortar and infilled with smaller sandstone slabs. The top of the wall had evidently been demolished and may have formed part of the demolition deposit (**102**) to the south.

Plate7: Revetment wall (**105**) cutting the bedrock (**103**), looking north (1m scale)

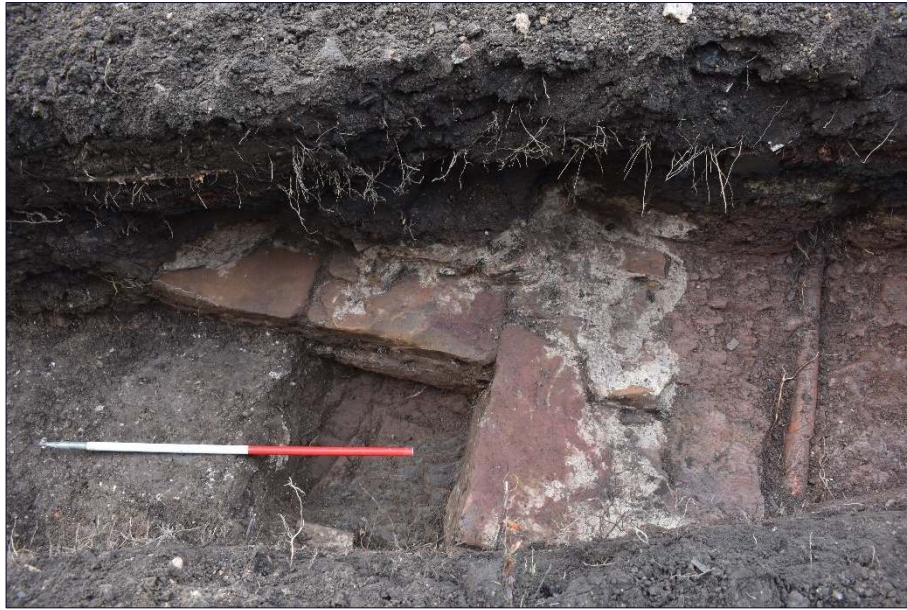
Plate 8: Revetment wall (105) cutting the bedrock (103), looking east (1m scale)

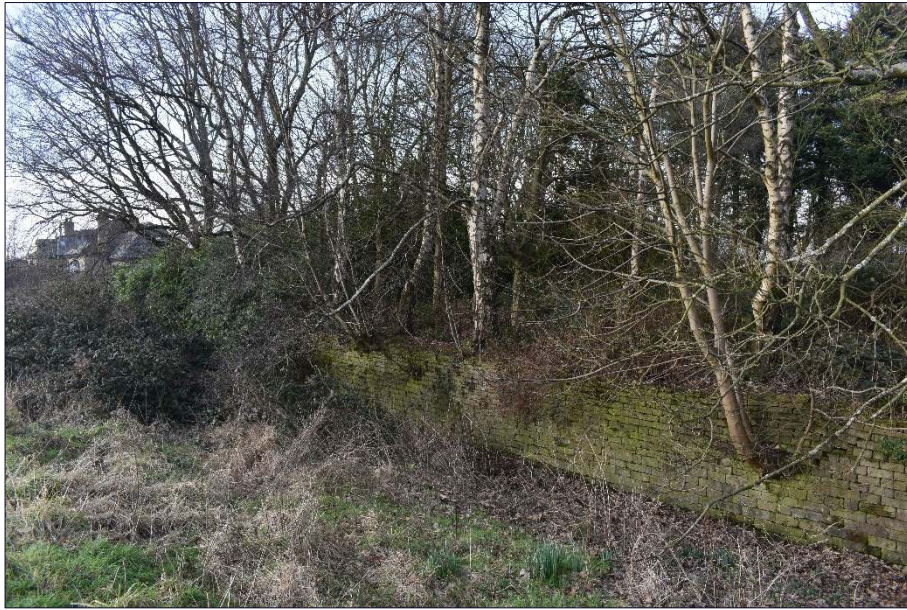
Plate 9: The surviving Ha Ha to the south of the excavation area showing the change in ground level, looking north-west (The Bungalow is on the left of the photograph)
