DOCUMENTARY EVIDENCE FOR MEDIEVAL CERAMIC ROOFING MATERIALS

AND ITS ARCHAEOLOGICAL IMPLICATIONS: SOME THOUGHTS

Stephen Moorhouse

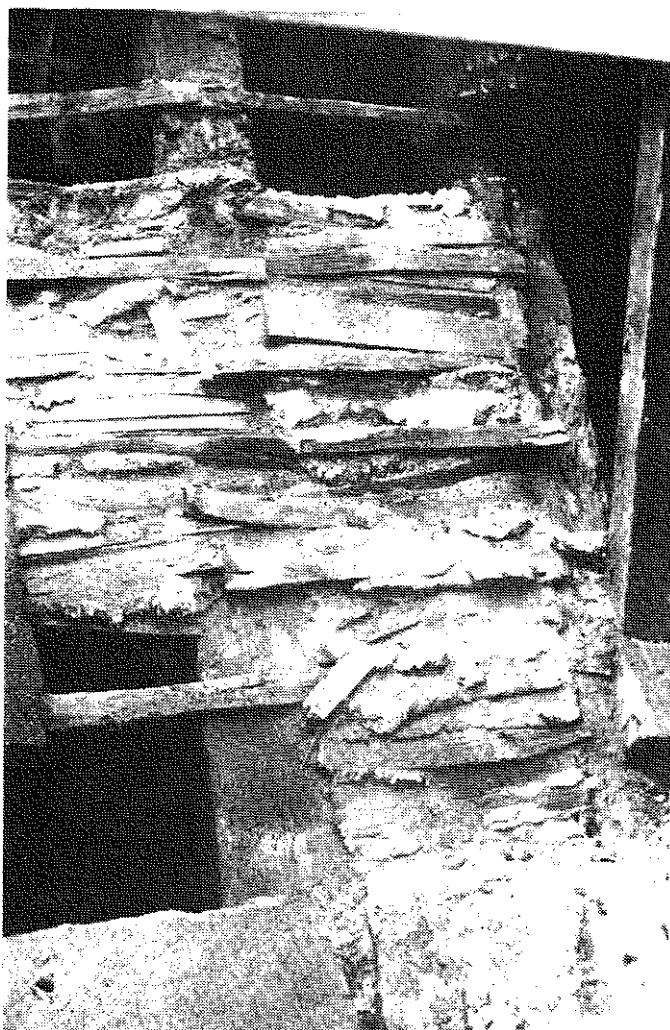
Fig. 1. Original laths, plaster roof and stone slates (removed) revealed during repairs to the roof of the late medieval Charlston Hall (West Yorkshire) in 1987. The absence of another set of lath nail holes shows that the surviving laths are the original ones. The exposed lower backs of the stone tiles were covered with plaster from the plastering between the rafters, forming a kind of ceiling. Similar evidence has been noted on ceramic tiles (photo: S. Moorhouse)

Accounts show that pointing on roofs was both widespread and a common practice. Roofers and slaters are frequently paid, along with the costs of buying lime for the work. It has been assumed that the mortar was used for back-pointing the tiles inside the building, a technique frowned upon in recent centuries, for it prevents the roof and building from breathing by allowing air in through the gaps in the tiles. In some cases where quantities of lime purchased and the length of roof required or laid is given (usually in rods or perches), the amount of mortar is far in excess of that needed for back-pointing the given length of roof. It seems likely that the whole of the inside surface of the laths between the rafters is being coated to produce a form of ceiling. This suggestion could be supported by the occasional purchase in accounts of two lots of lime; traditional plastering of a surface usually has two coats, one as a filler and a much finer solution as a surface finish - a technique still employed by modern plasterers. The antiquity of the plastering on a standing building could be suggested by examining the number of lath replacements on the rafters. At Sharlston Hall (West Yorkshire), a late medieval timber framed building, such a plastered ceiling has been identified under the tiles and between the rafters. Here the plastering could be confirmed as being contemporary with the medieval frame of the building because there were no secondary nail positions for earlier laths on the rafters, suggesting that the existing laths were the original ones to the building, and hence the ceiling also probably original. In addition, the plaster had set against the existing roof cover of stone slates, suggesting that the majority of the surviving slates were also original (Fig. 1).

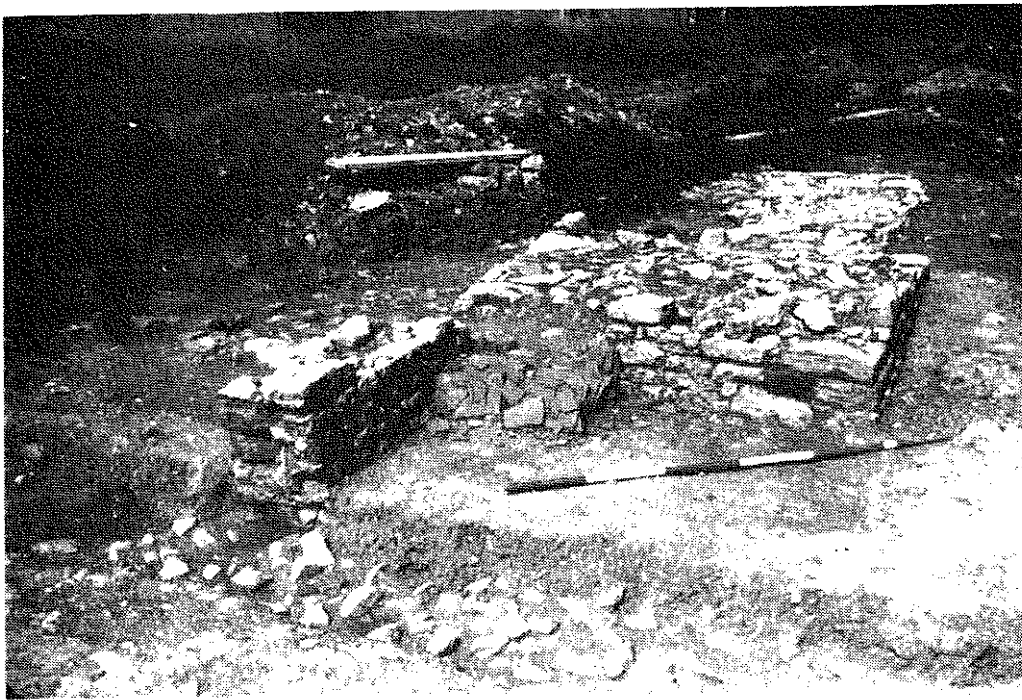
Fig. 2. Stack of ceramic tiles from behind the base of the staircase of the 14th century hall at Whaddon (Bucks). This and similar stacks excavated elsewhere are either tiles kept handy for quick repair work or stock piled during the dismantling of the building, in this case during the later Middle Ages. See Griffiths 1979 (photo: S. Moorhouse)

The constant damage to roof coverings meant that tiles were often stockpiled, anticipating the inevitable. This is clear from the documents in a number of different ways. Most frequently tiles are bought against repair and remain in the store at audit. A typical entry occurs in the Petworth (Sussex) accounts for 1349, when 1100 tiles (*tegulis*) and 55 hip tiles (*hupes*) were bought 'which remain for the store of the manor' (Salzman 1955, 34). An unusual instance occurs in the sale of the moveable property following the death of John Greene, late rector of Castle Combe (Somerset) in 1439. One purchase was an unspecified number of tiles (*tegulis*) for 5s., probably a reserve stock of tiles for future repairs, the price suggesting a considerable number (Scrope 1852, 227). Such piles of tiles are often seen around farms today, or stacked in the corner of churchyards. They have also been attested archaeology in the medieval period. A group of at least 30 flat tiles were stacked beneath the external stair of the hall on the manor complex at Whaddon (Buckinghamshire), a site abandoned during the 14th century (Griffiths 1979, 65; Fig. 2 and 3).

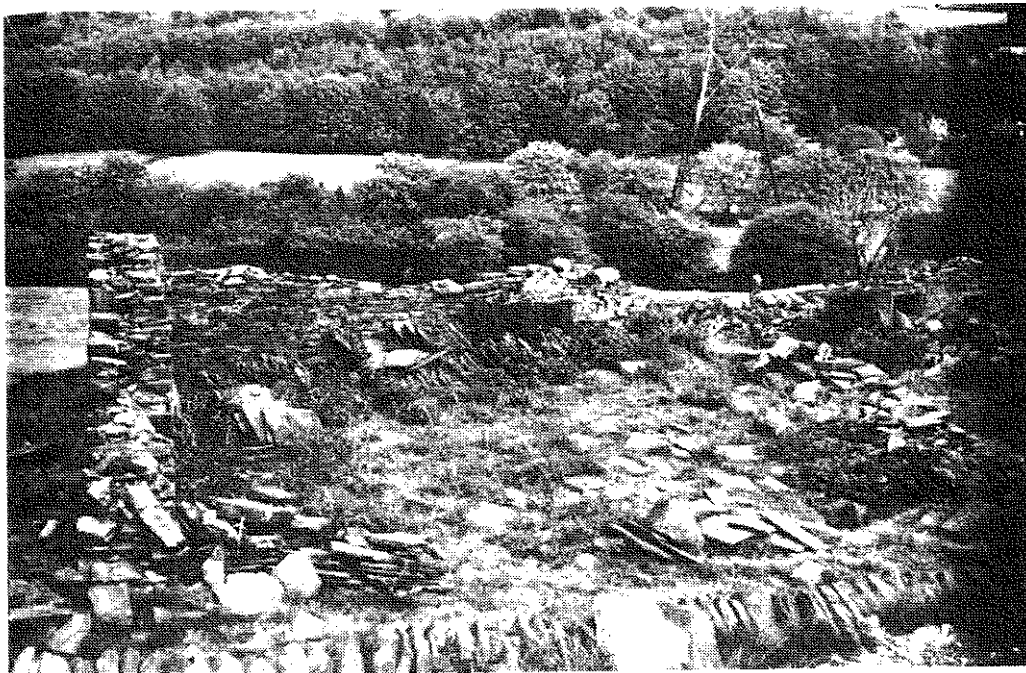
Fig. 3. Stack of stone slates in the corner of a ruined building at Cold Well, Southowram (West Yorkshire), a farm abandoned in the 1950s. Piles of stone or ceramic tiles are the first thing to be removed from abandoned or ruined buildings for re-use elsewhere and are often found today in the corners of buildings. The documents suggest that the re-use of particularly ceramic tiles was common practise during the Middle Ages (photo: S. Moorhouse, 1987)

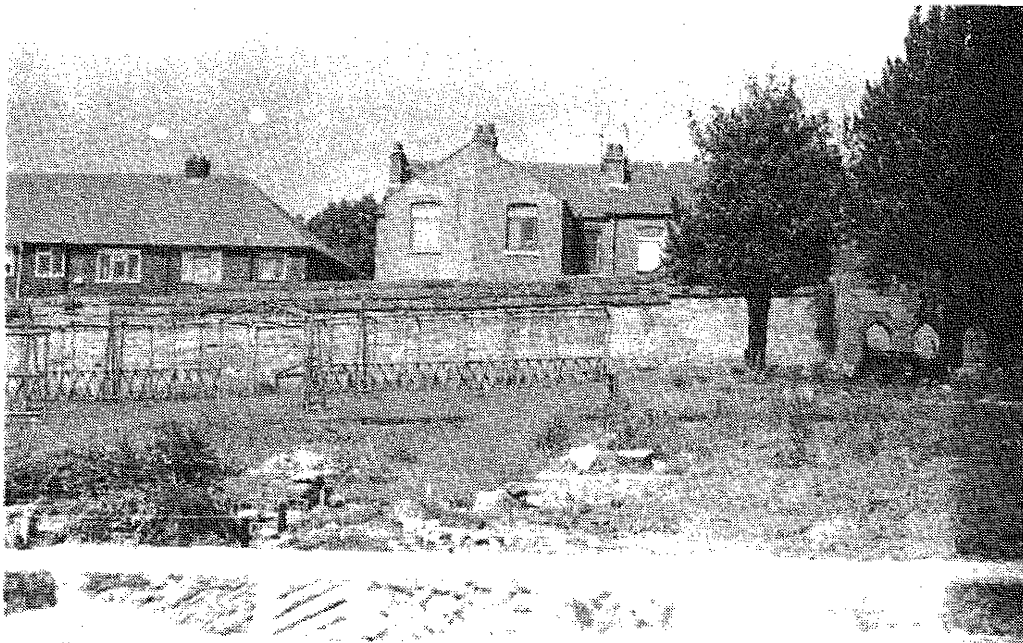
Fig. 5. Late medieval stone precinct wall to St Anne's Charterhouse, Coventry. The stone coping imitates the overlapping appearance of stone or ceramic tiles (photo: S. Moorhouse)

Ceramic tiles are usually associated with houses, farm buildings and churches, but a wide range of other less obvious structures were covered with tiles. Of the many that could be given, those found within the garden are perhaps the most numerous, ranging from summer houses to garden sheds. At Highclare (Hampshire) in 1398, a new shelter and covered way in the large garden there required 23,000 plain tiles and 250 ridge tiles to cover it, which John Harvey has estimated represents an open-sided passage 280ft long (Harvey 1981, 88). One now seemingly unusual use of tiles, but common practice in the Middle Ages, was as a coping along the tops of walls. This protected the wall from the elements, rain, frost and hence disrepair. Stone, thatch, sods and tiles are all documented. Tiles are not uncommon. At Silkstead (Hampshire) in 1276 pegs (for the tiles) were bought for roofing the wall around the herber in the garden there (Harvey 1981, 110). References to the construction or repair of walls at St Swithin's Priory, Winchester, are typical of those areas where ceramic wall copings were common. In 1536-37, amongst other things, £2 2s. was spent on tiles, crests and tilepins for the Sacrist's garden wall; in 1311/12 18s. was spent on roofing 'hospital walls'; and the Hordarian's roll for 1382 gives details of building a wall between the kitchen garden and the Hordarian's little green close (*le Prail*), for which 400 tiles at 3s.2d. and 17 crests at 12³/₄d. were purchased (Kitchen 1892, 111, 139, 281). Churchwarden's accounts show that in some regions churchyards were coped with tiles, as at Tilney (Norfolk) in 1531 when a tiler was paid for repairing with 300 tiles the stile and wall there (Stallard 1922, 140), while, more explicitly, at Walberswick (Suffolk) in 1496, 2s.4d. was spent on an unspecified number of tiles 'for covering (*kurying*) of the [garden]wall' (Lewis 1947, 77) (Fig. 5 and 6).

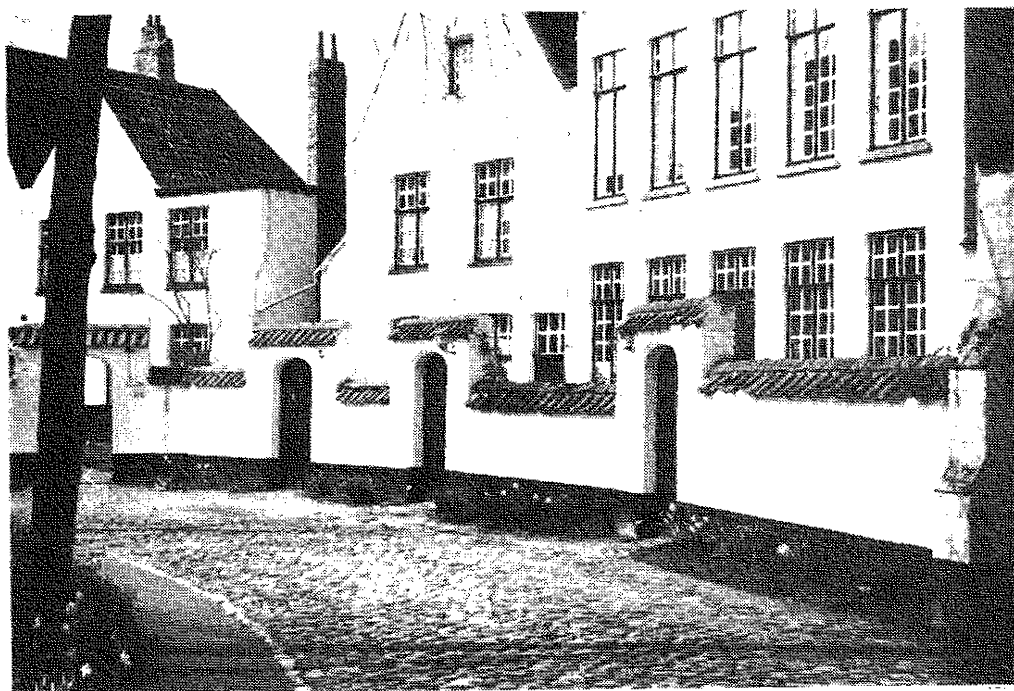
Fig. 6. Ceramic flat tiles and ridge tiles capping walls in modern Brugge. Account rolls suggest that similarly-looking wall tops must have been commonplace in central and southern England during the Middle Ages (photo: S. Moorhouse)

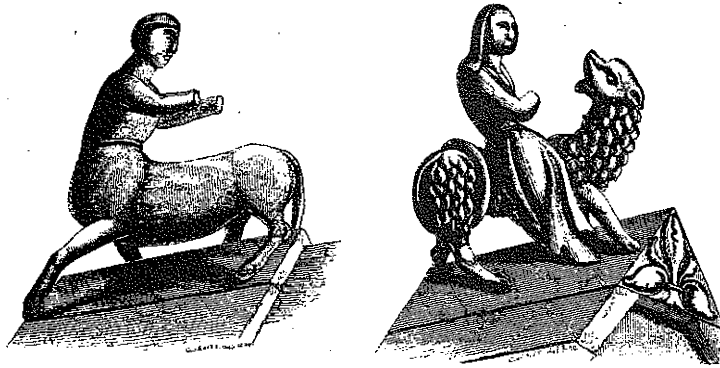
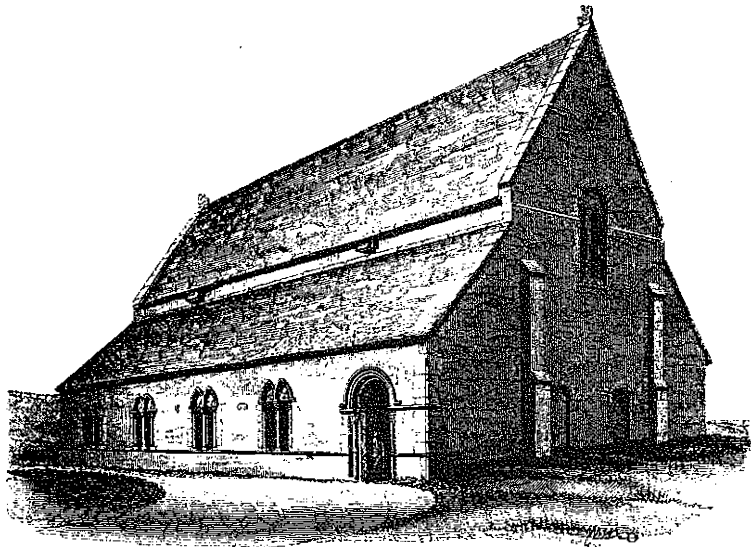
HIP KNOBS, OR GABLE CRESTS

Fig. 7. Twelfth-century stone roof finials from either gable of the relaid roof at Oakham Castle Hall (Rutland). These and later stone finials formed the inspiration for ceramic copies (from Hudson Turner 1851, pls between pp 28-29 and 30-31).

Pottery building materials used on the medieval roof were very much a social divider. The excavation of medieval peasant settlements has shown that where tiles are found suggesting that they were used on the roof, they are so few in number as to suggest that they did not cover the whole roof, and probably had some specialised purpose, such as a guard around the smoke vent to prevent the thatch catching fire (Beresford and Hurst 1971, 100). Tiles of all types are very much associated with the wealthy and land-owning classes, from the seignorial landlord upwards. Ornamental roof furniture is found in both town and country, with pieces coming from buildings of almost every use, whether they be in urban tenement, manorial site, monastic precinct, agricultural buildings or even churches. Their numbers and variety suggest that they were very much part of the building traditions of medieval Britain, and any building of any standing would not be complete without its pottery ornamentation on the ridge. There seems to have been little competition with more solid structures of stone or timber, for the shapes and ornamentation produced by the potter could not be matched in any other material. The elaborate three-tiered stone louver built at Hampton Court in 1535 (Salzman 1967, 219) is likely to adorn the most prestigious of roofs. Such sophisticated methods of ventilation would not only look out of place on most domestic buildings, but would be unnecessary. Pottery equivalents were just as effective, despite having permanently open apertures, yet were relatively cheap to replace, either through breakage or even a change in fashion. Building accounts make it clear that houses were clearly used as a means of expressing position and influence, and therefore their appearance and perhaps individuality was important. Does ornamental pottery roof furniture fall into this expression of individualism? It would certainly help to explain the sophistication and detail on some pieces, like the louver from the seignorial manor site at Great Easton, Essex (Dunning 1966), and the fact that although general types were made, no two pieces are identical (Fig. 7).
