Bridges of Bedfordshire

BEDFORDSHIRE ARCHAEOLOGY
MONOGRAPH No 2

Angela Simco & Peter M^cKeague

Bedfordshire Archaeology Occasional Monograph Series
No 2 1997

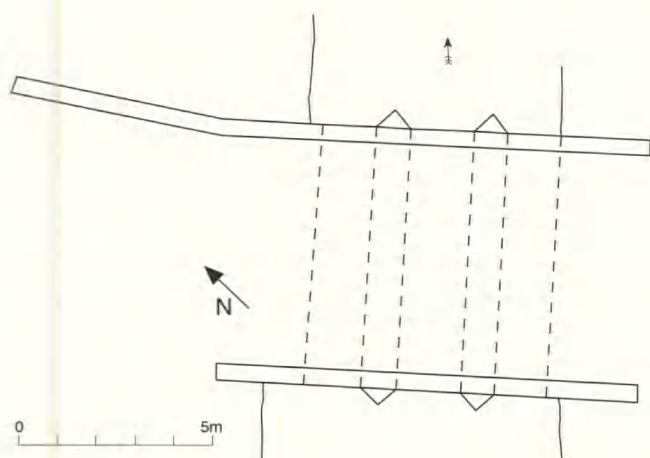
Fig 2 Hinwick bridge: ground plan

Hinwick bridge¹ was built by Richard Orlebar of Hinwick House in 1779,² and carries the Podington-Wollaston road

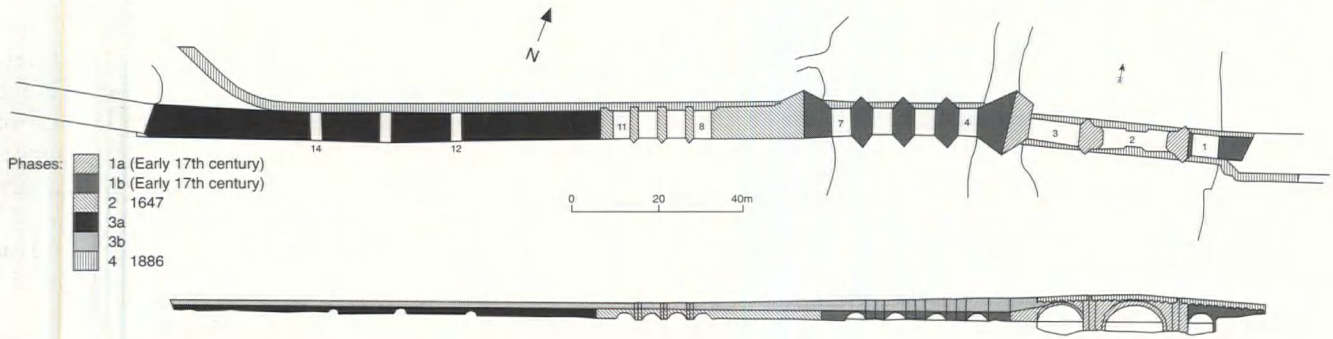
Fig 7 St Neots bridge: phase plan and elevation

Despite variations in design, arches 1 to 7 belong to one broad phase of construction. Assuming that one arch was formed at a time, in keeping with medieval methods, a construction sequence can be proposed. The earliest

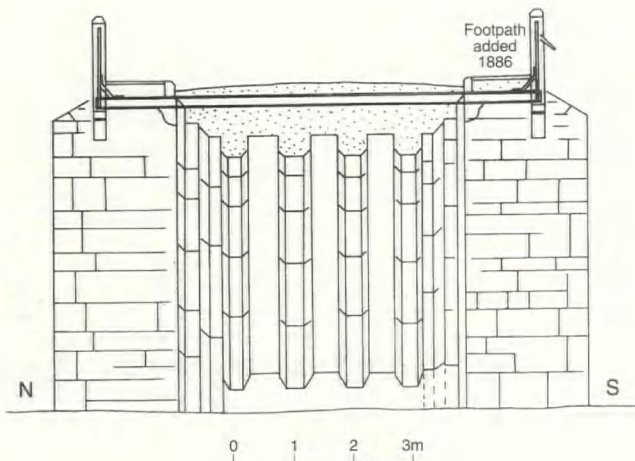
Fig 10 St Neots bridge: section through arch 2, showing ribbing

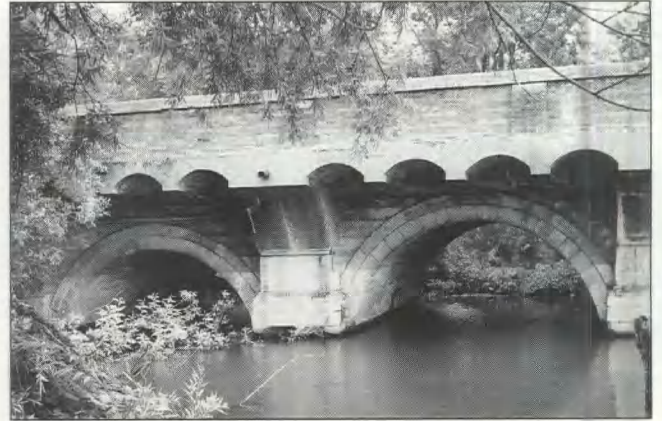
Fig 11 St Neots bridge: causeway arches 8 and 9, north face (Co Engineer)

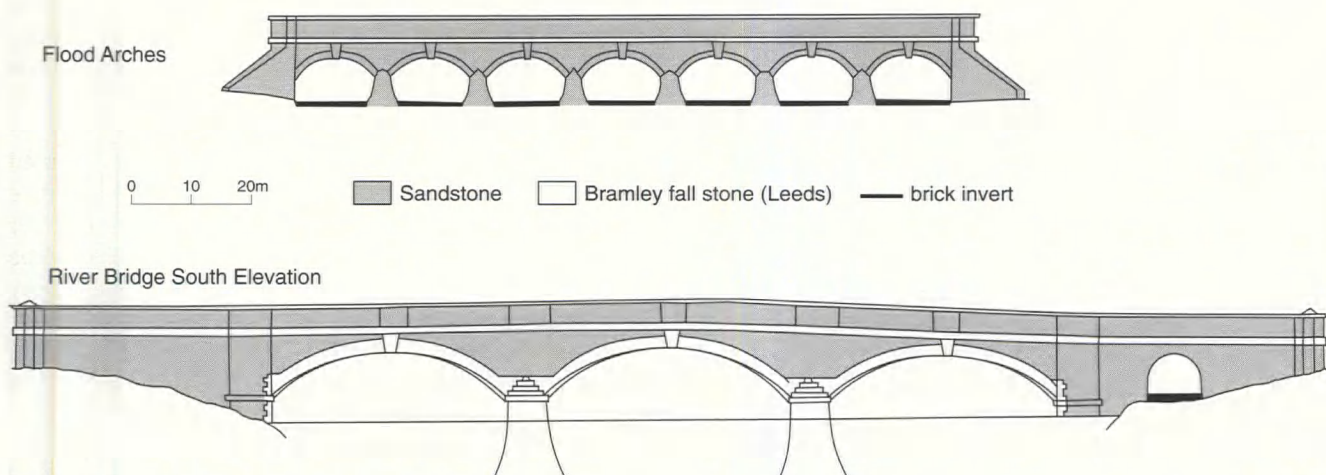
Fig 17 Tempsford bridge and flood arches: construction materials

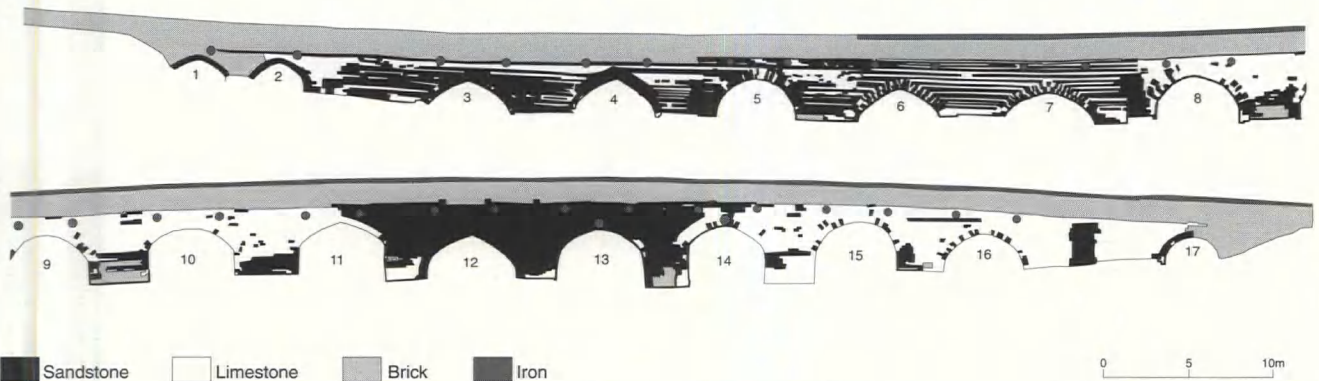
Fig 20 Barford bridge: construction materials, east elevation

times, it seems that the pier bases, abutments, arch soffits and, possibly, cutwaters were in sandstone whilst the remainder was in rubble limestone. There was a moulded limestone string course; where it survives, its chamfered upper surface and moulded lower face suggest that it dates from the 15th century. Only part of the original line of the string course survives (Fig 21), extending over the crown of the arches but dropping at pier 7/8 (the original south abutment), at pier 9/10, over arch 12 (which has been rebuilt), and formerly at the original northern abutment. Perhaps the string course was originally much more

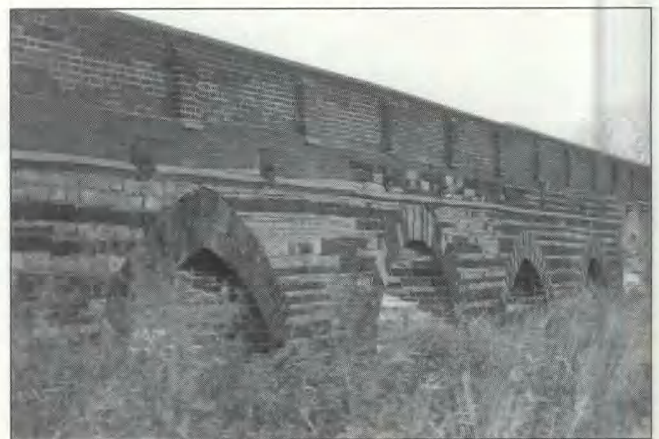
Fig 22 Barford bridge: east face of flood arches (arch 4 in foreground)

The arches consisted of two orders of alternating limestone and sandstone voussoirs forming a chequerboard pattern, though all of them, apart from arches 6 and 7,

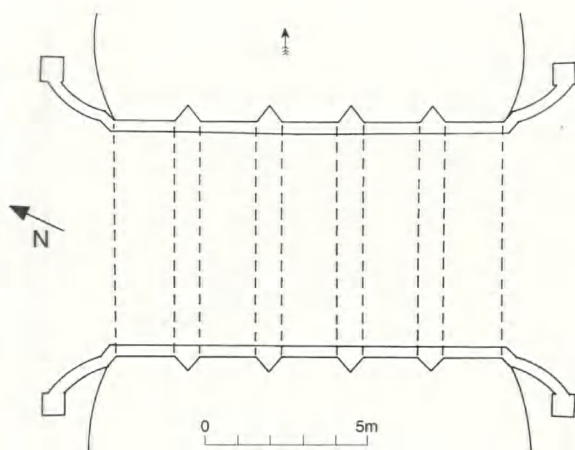
Fig 25 Cardington bridge: ground plan

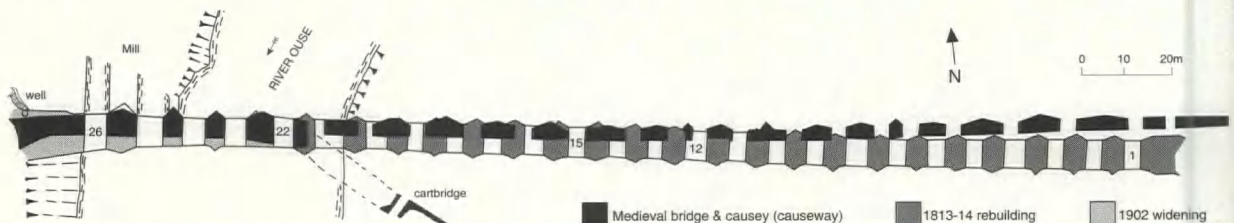
Fig 35 Bromham bridge: phase plan

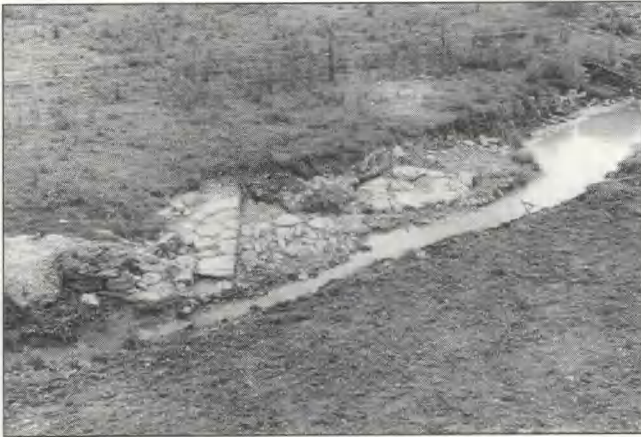
Fig 38 Bromham bridge: remains of cart bridge

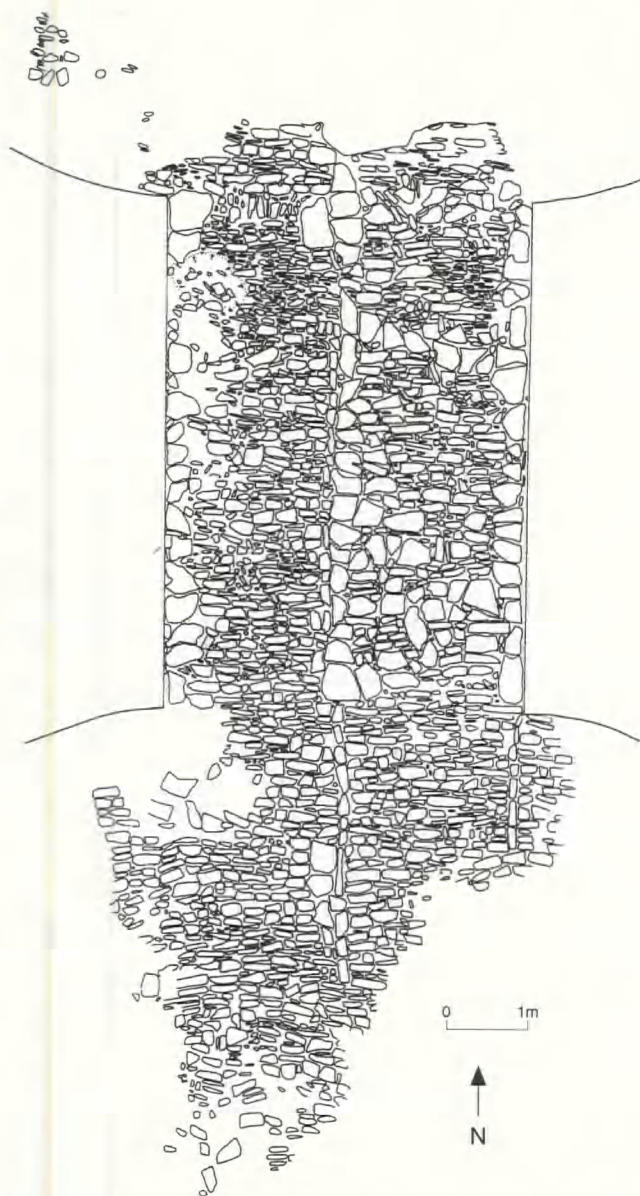
Fig 40 Bromham bridge: plan of invert, arch 20

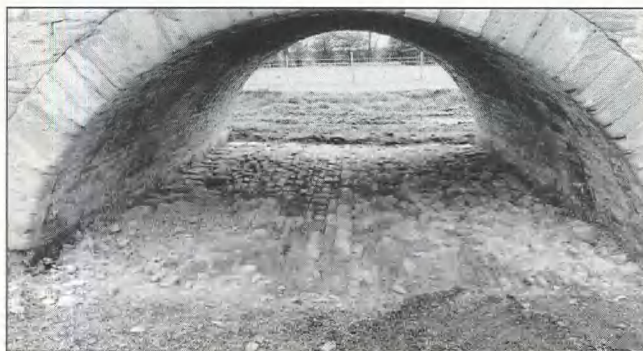
Fig 41 Bromham bridge: limestone invert

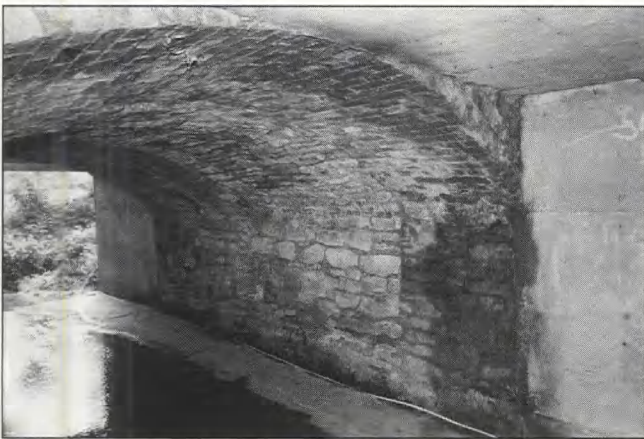
Fig 44 Tysmill bridge: soffit from the north, showing successive widenings

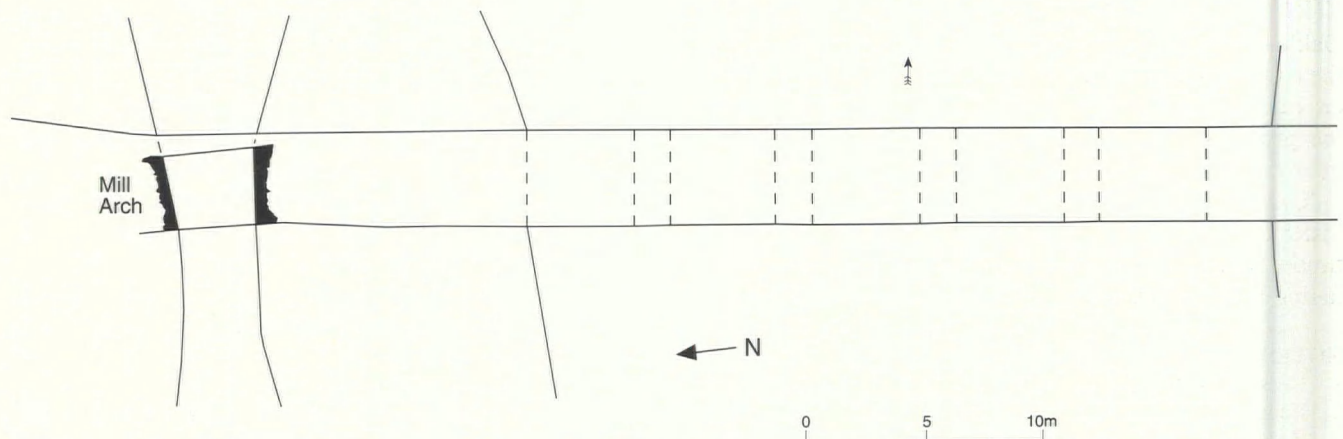
Fig 47 Oakley bridge: ground plan

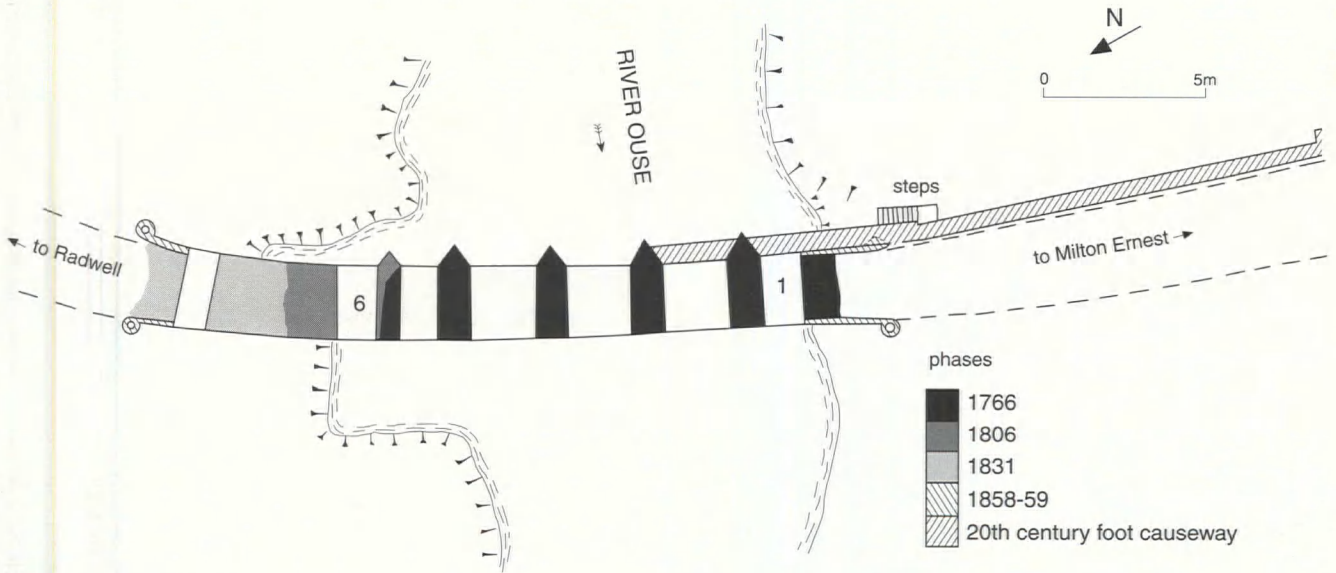
Fig 53 Radwell bridge: phase plan

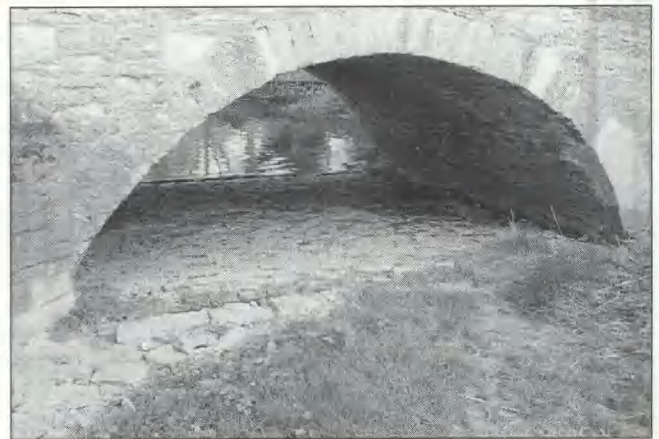
Fig 59 Felmersham bridge: invert, arch 1

The arch floors are protected by a series of extremely well-preserved pitched stone inverts. That nearest Felmersham (arch 1) is usually dry and is easily accessible from the bank (Fig 59). It is composed of tightly set pitched limestone blocks laid parallel to the carriageway, similar to some of the inverts at Bromham. Unlike Bromham, however, the Felmersham inverts are 'framed and set' within horizontal timber sill beams laid against the arch faces. A series of vertical piles helps to hold the beams in position. The inverts, forming a continuous 'pavement', extend downstream of the bridge for 4 ft 3 in (1.30m) and traces of a similar upstream apron survive at pier 1/2. Originally this extended right up to the apex of the cut-

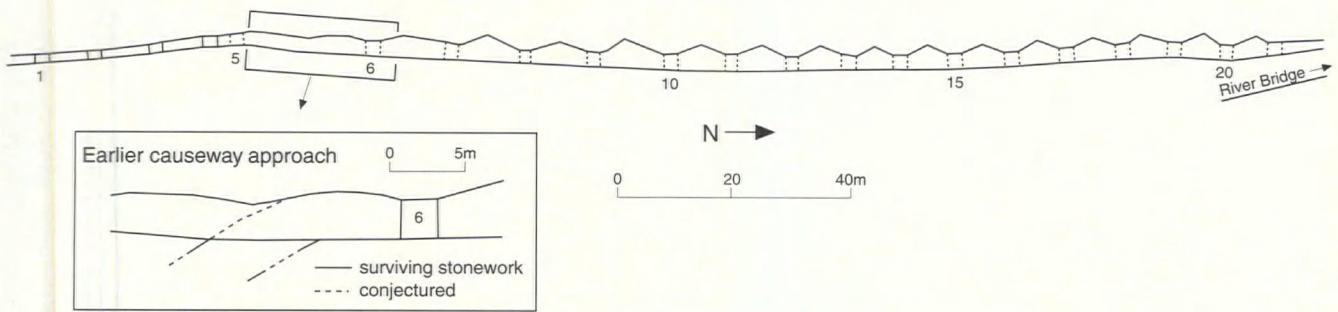
Fig 61 Harrold bridge: plan of causeway

Differences in style throughout the causeway suggest three main periods of development. Most of the work, except the southernmost five arches (at the Carlton end), is typically medieval, built of massive piers with triangular cutwaters on the upstream (west) elevation (Fig 60). The width varies between 7 ft 9 in (2.4m) and 8 ft 10 in (2.7m). However, the arches concealed in the later road bridge have round profiles whereas the remainder are pointed. This change may be significant, reflecting development from the round arches used in early medieval times to the gothic style (with pointed arches) which became popular in the late 12th or early 13th century. The earliest phase of the flood arches may therefore be the oldest surviving part of the bridge.

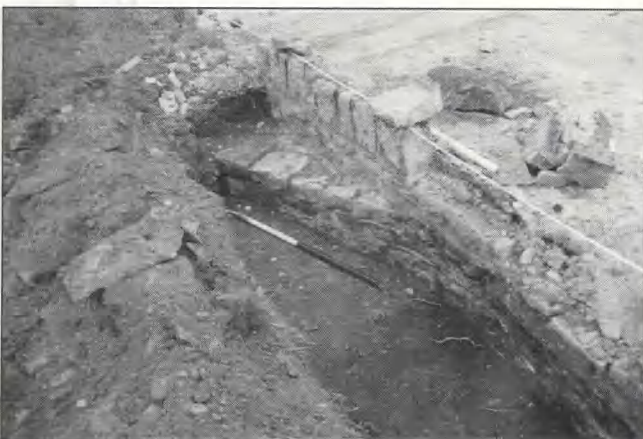
Fig 62 Harrold bridge: footing of early causeway approach ramp, between arches 5 and 6

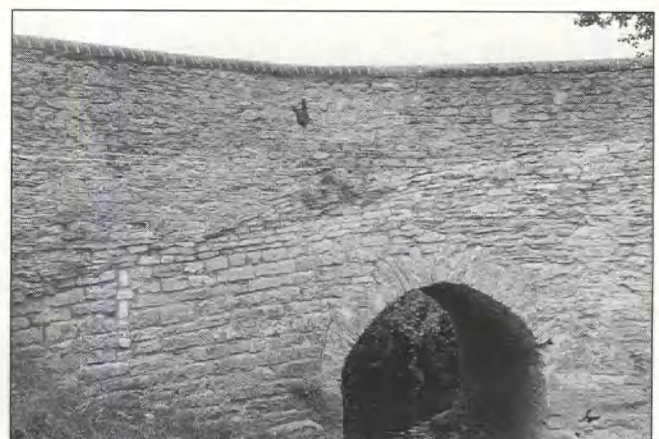
Fig 63 Harrold bridge: east face of river arch 10, showing line of original access ramp on to river bridge (before repair)

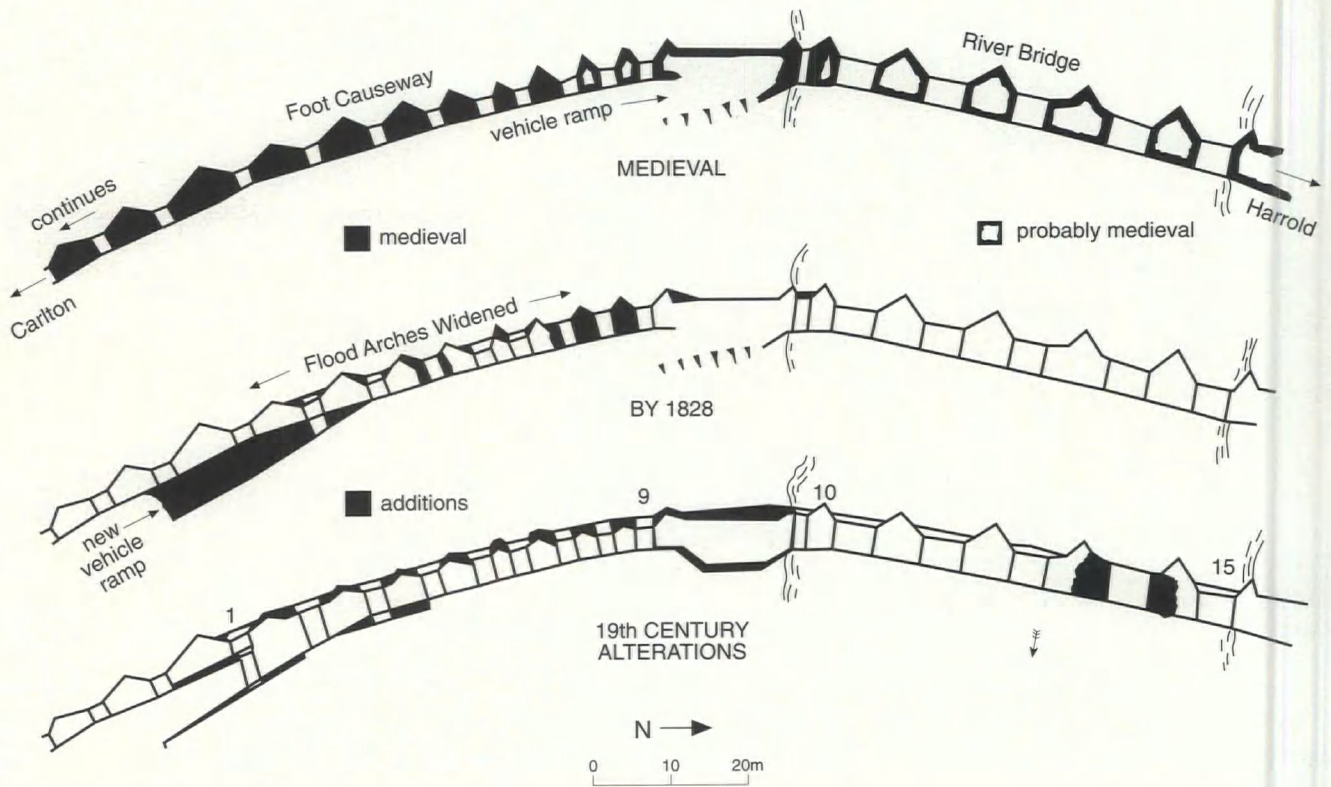
Fig 64 Harrold bridge: phase plan of river bridge and flood arches

At an unknown date, the nine causeway arches nearest the river were widened to take vehicular traffic across the lowest part of the flood plain (Fig 64). In order to accommodate the new vehicle approach ramp the eastern face of the causeway was kicked back from about 50 ft (15m) north of causeway arch 20 (the original face was revealed when the modern road surface was removed during the 1990 repairs). Flood arches 1 and 2 were widened on the east side, and all the flood arches except arch 1 were widened to the west by inserting an additional limestone arch ring which sprang from the cutwaters (Fig 65). (Evidence of this widening does not occur in arches 4, 7, 8 and 9 as they have since been rebuilt.)

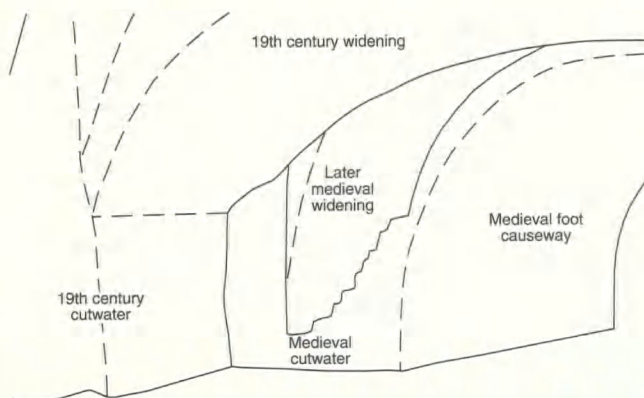
Fig 65 Harrold bridge: flood arch 6 from west, showing successive widenings

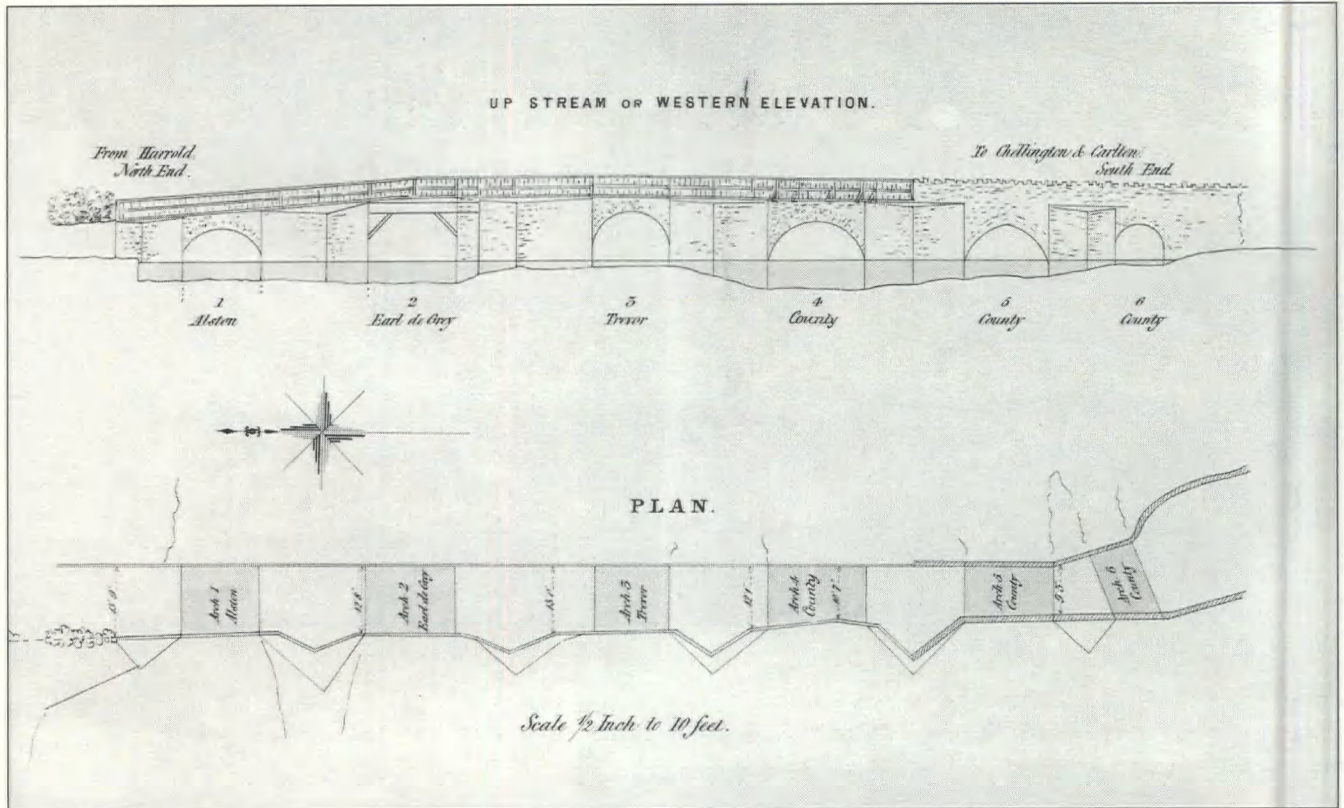
Fig 67 Harrold bridge: plan and elevation of the river bridge in 1855, showing wooden railings and the timber span at arch 14 (Beds Record Office: QSX 19)

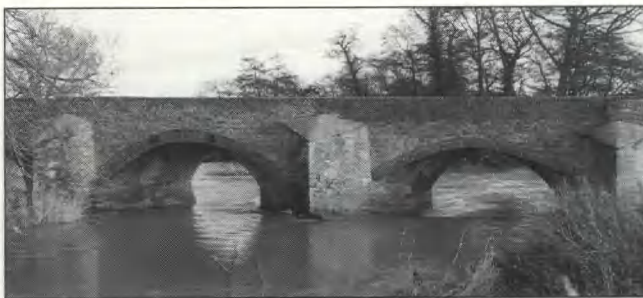
Fig 68 Harrold bridge: west face of arches 11 and 12, showing 1857 widening

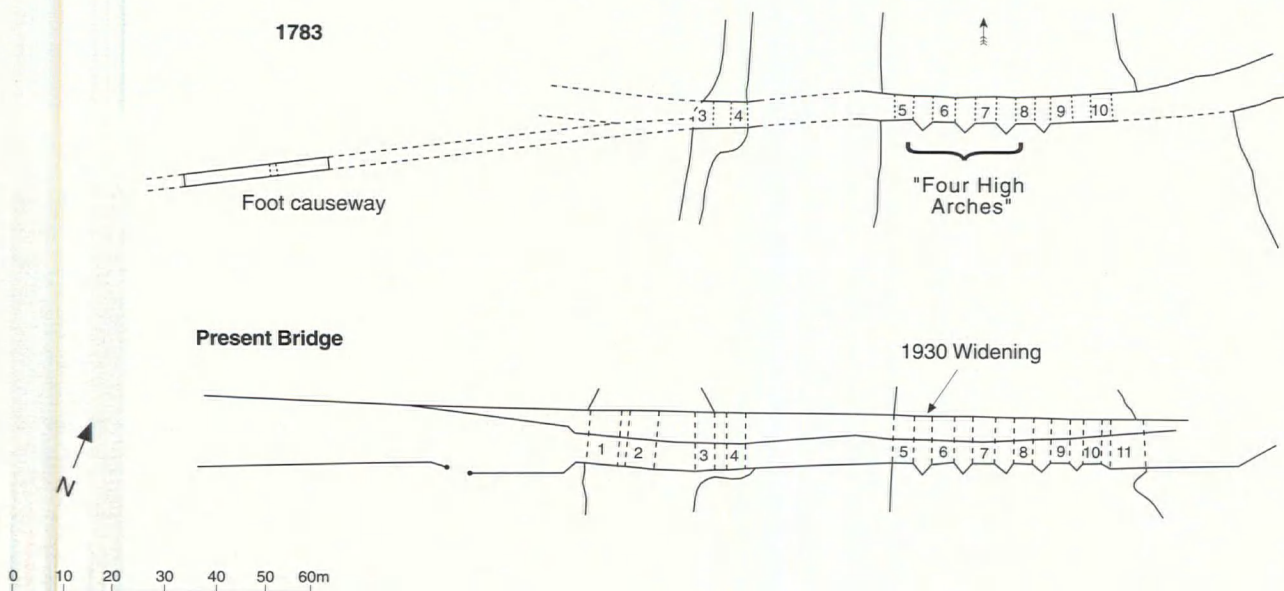
Fig 73 Turvey bridge: phase plan (original drawing by Martin Cook)

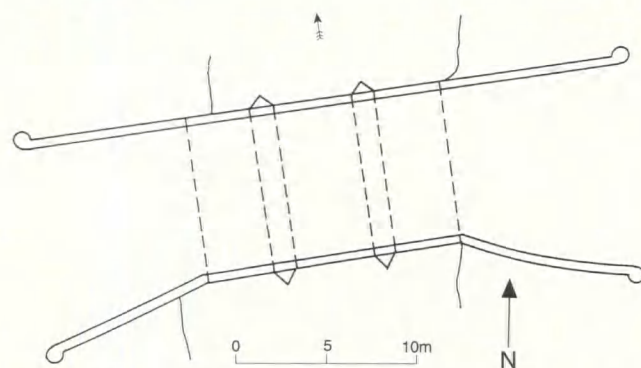
Fig 90 Biggleswade bridge: ground plan

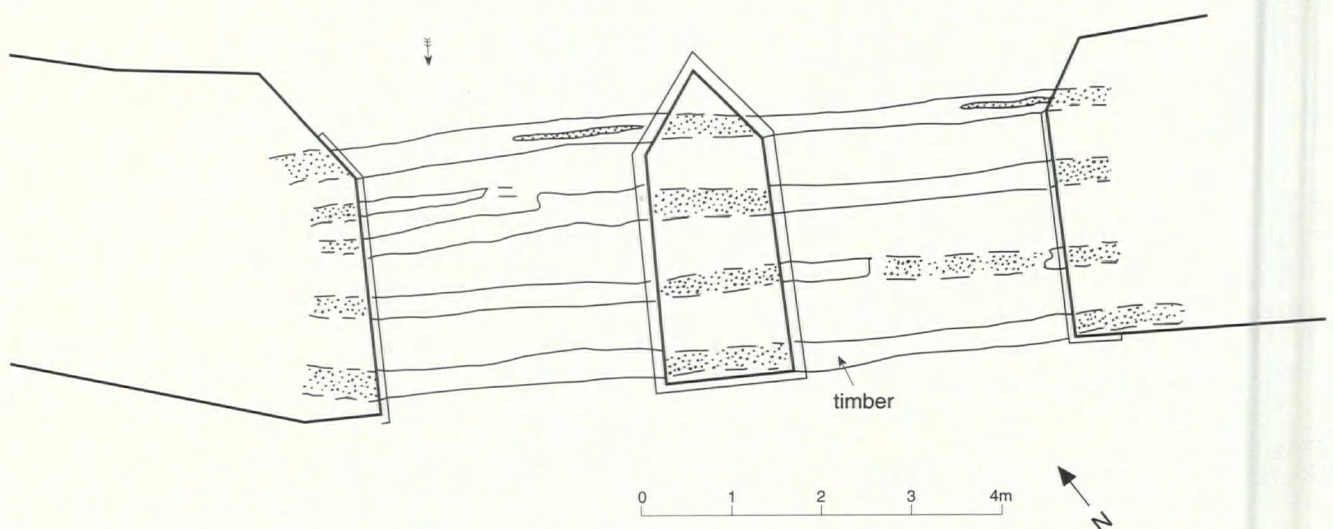
Fig 91 Sutton bridge: ground plan, showing timber foundation raft

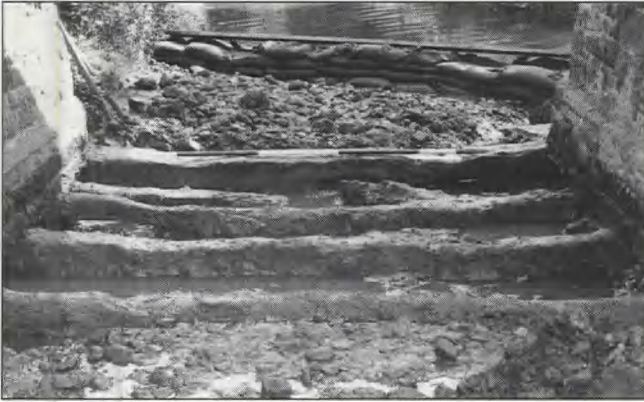
Fig 92 Sutton bridge: timber foundation under west arch, during excavation

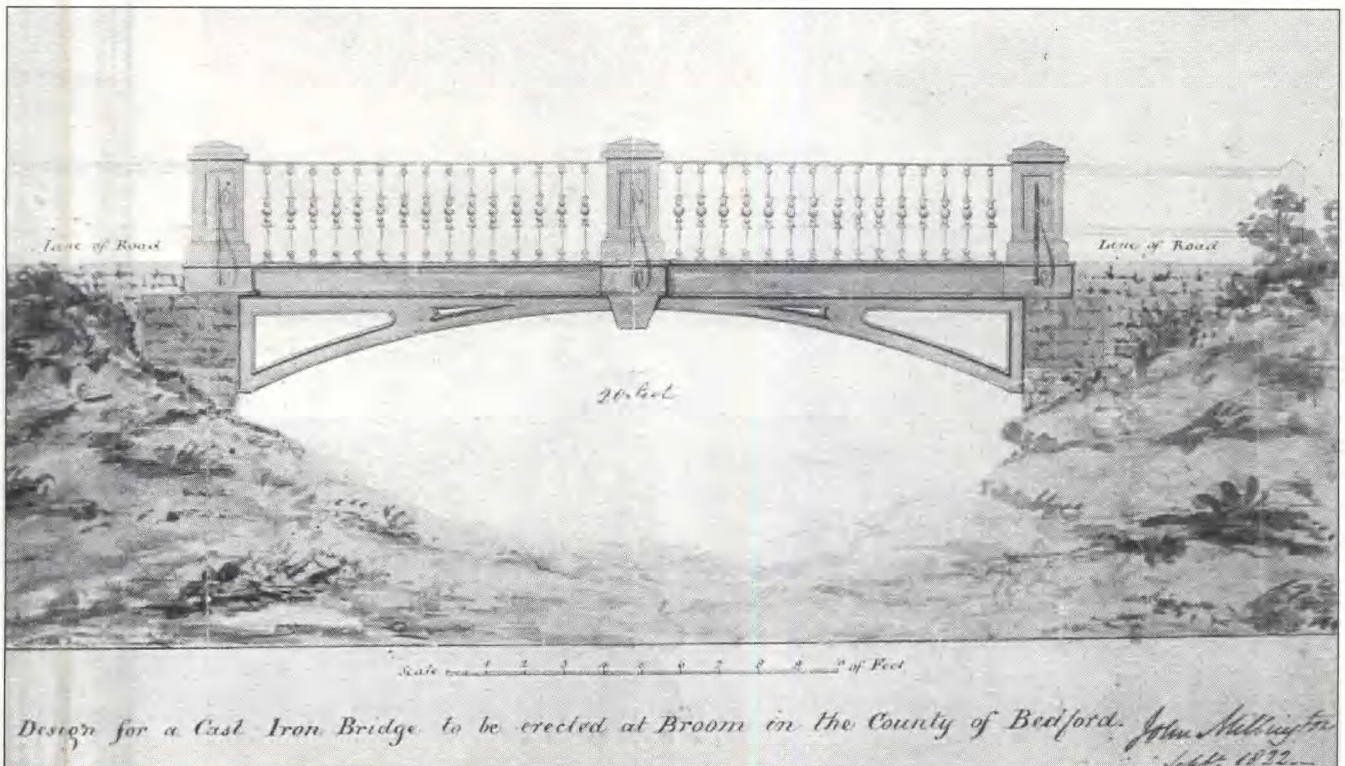
Fig 97 Broom bridge, Southill: design drawing by John Millington, 1823 (Beds Record Office: PB 3/1)

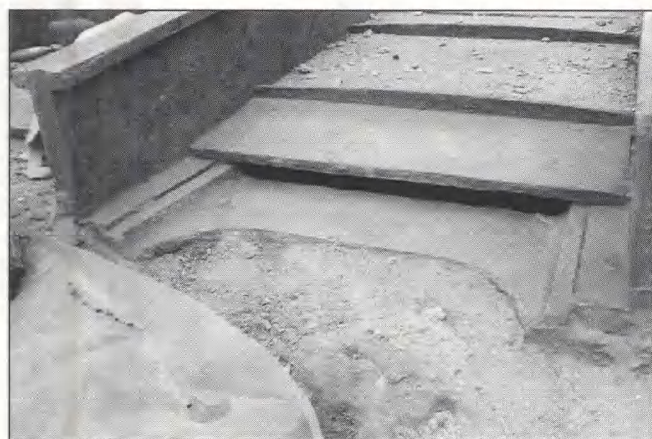
Fig 120 Lock bridge, Broom: close-up of ironwork over east abutment

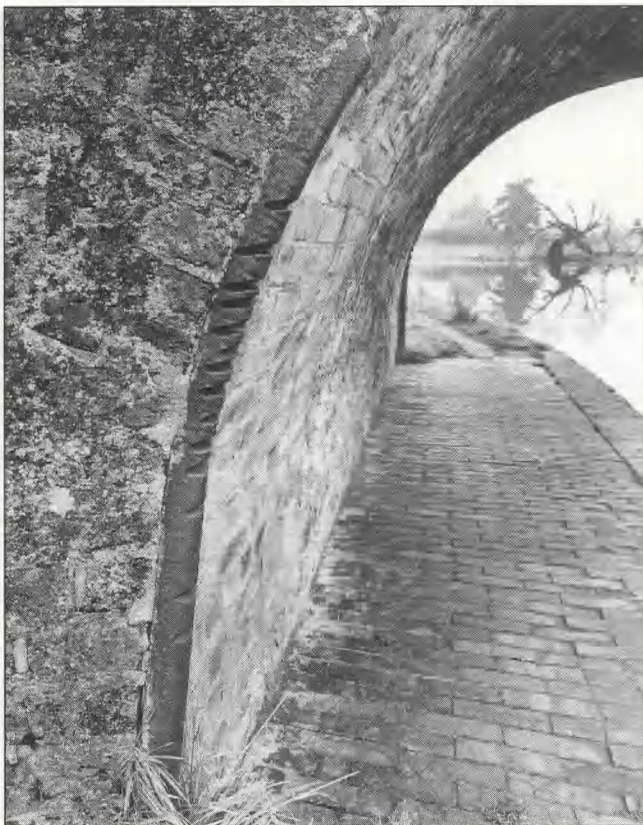
Fig 125 Sandhole canal bridge: iron guard at north-east quoin, grooves worn by tow ropes (Beds Photographic Services)

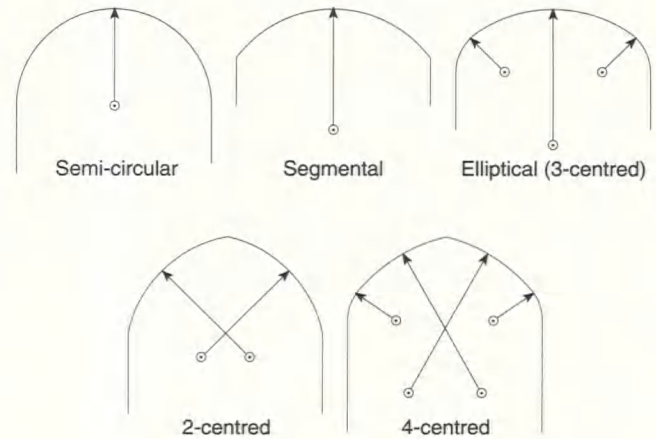
Fig 133 The geometry of the main arch shapes

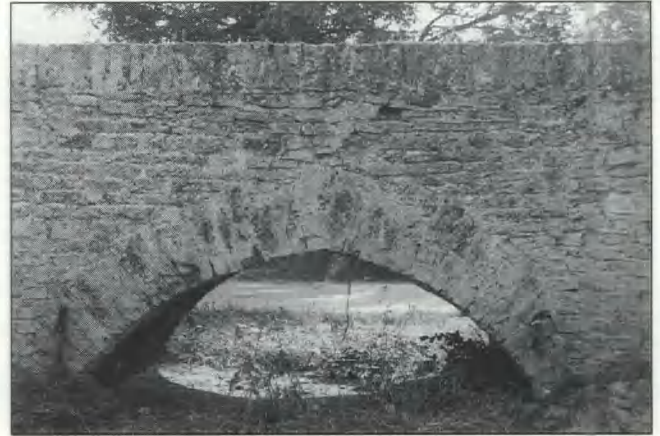
Fig 134 Harrold causeway: rubble limestone arch and walling

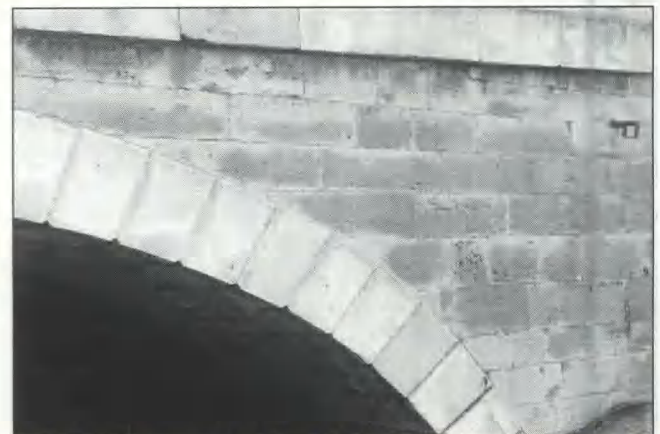
Fig 135 Bedford bridge: voussoirs and ashlar walling

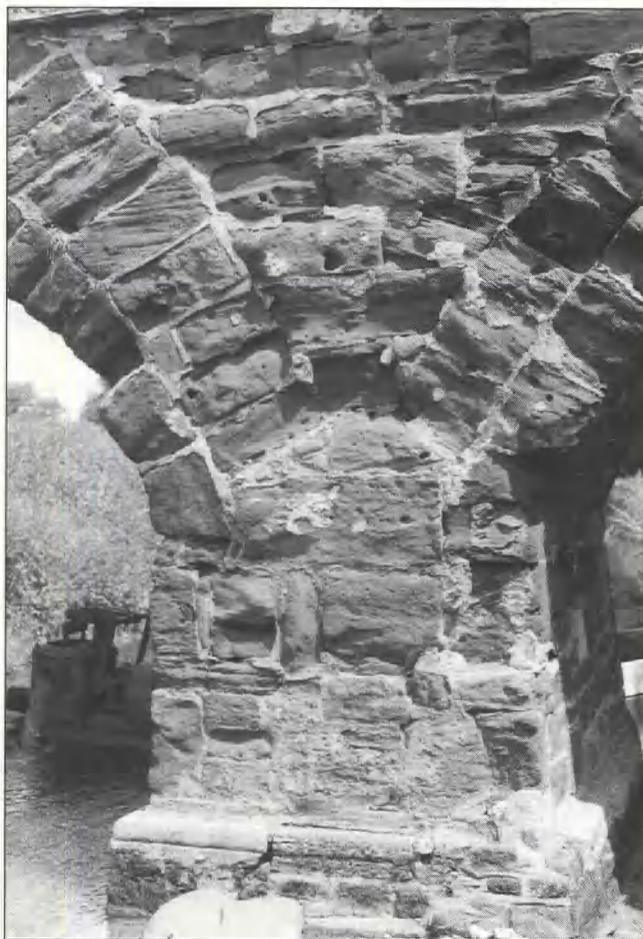
Fig 137 Sutton bridge: fine joints in stonework, with later pointing (before repair in 1986)

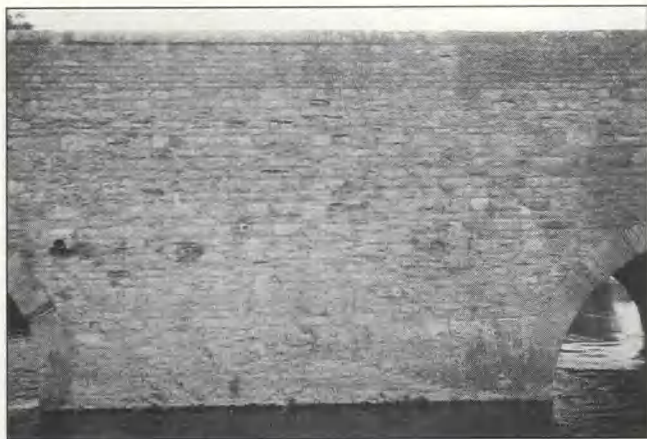
Fig 138 Bromham bridge: squared coursed limestone walling, 1902
