Bedfordshire Archaeology, 1973-1975

Compiled by DAVID H. KENNETT

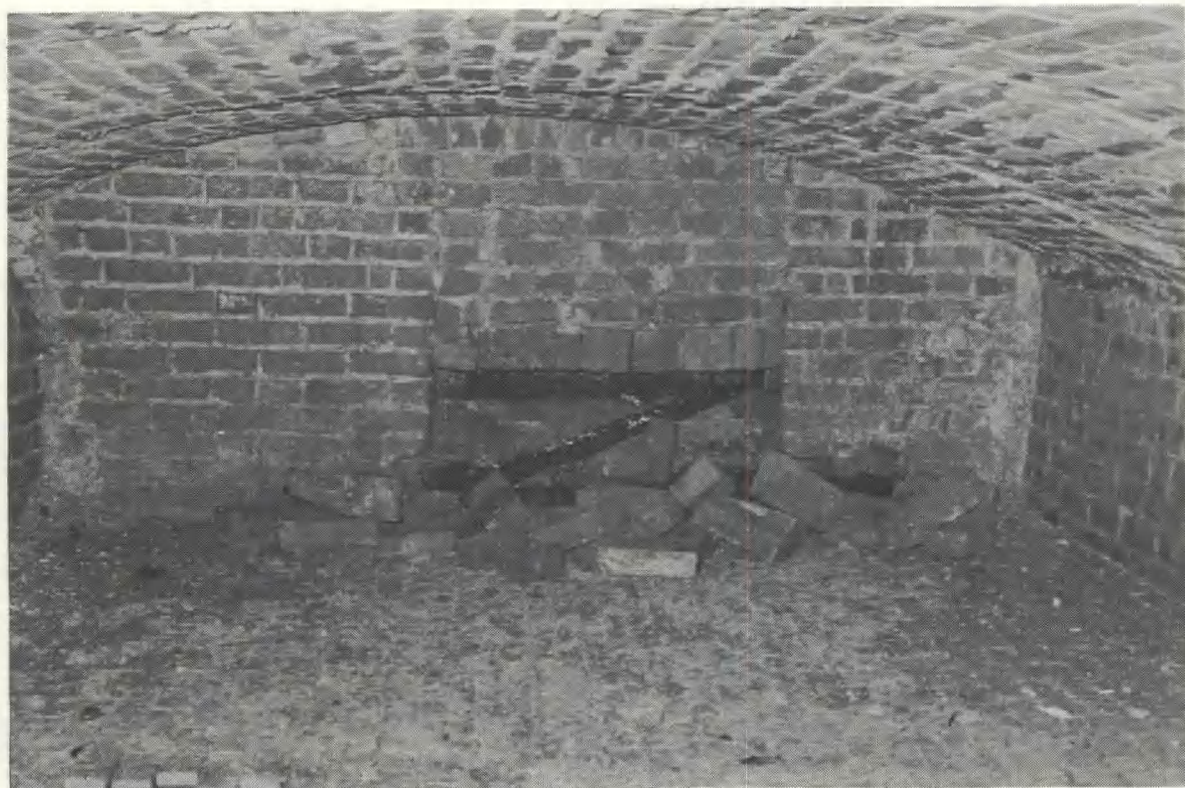
Plate 1 Brick Cistern at Stopsley

Construction of a car-park for the Stopsley Sports' Centre beside the Butterfield's Green Road during 1973, revealed a subterranean vault measuring some 3m square. Entirely constructed and floored with local hand-made bricks, it was roofed by an elliptical arch vault, 70cm above the floor at the sides and 120cm high at the centre (pl 1). There was a man-hole like opening in the roof about 60cm square, at the eastern end, whilst an opening 90cm wide on the west of the chamber had been bricked-up with more recent, though still hand-made, bricks. At the base of this opening were three timbers, all badly charred, that had supported the more recent blocking work. Half-way along the south side of the room some of the floor bricks had been removed to reveal what seemed to be a water-filled drain or soak away. The room seems to have been a water cistern, and

probably dates from the early nineteenth century. The man-hole like opening would have accommodated pumping machinery, whilst the blocked-up opening either allowed for the entry or overflow of water. It is known that the Manor of Hayes once stood on the site, and was probably replaced by a farmhouse, which was the forerunner to the present Manor Farm which stands a hundred metres to the north.

Since the discovery the vault has been filled with rubble to preserve it, and the hole has now been covered by the tarmac of the car-park.
