Cruck-Frame Buildings in Bedfordshire

N.W. ALCOCK and P.J. WOODWARD

MOAT FARM, MARSTON MORETAINE

275 BEDFORD ROAD, HUSBORNE CRAWLEY
(SP 953363; Beds. C.C./S.M.R. 3737; Plates 5-8; Figure 9)

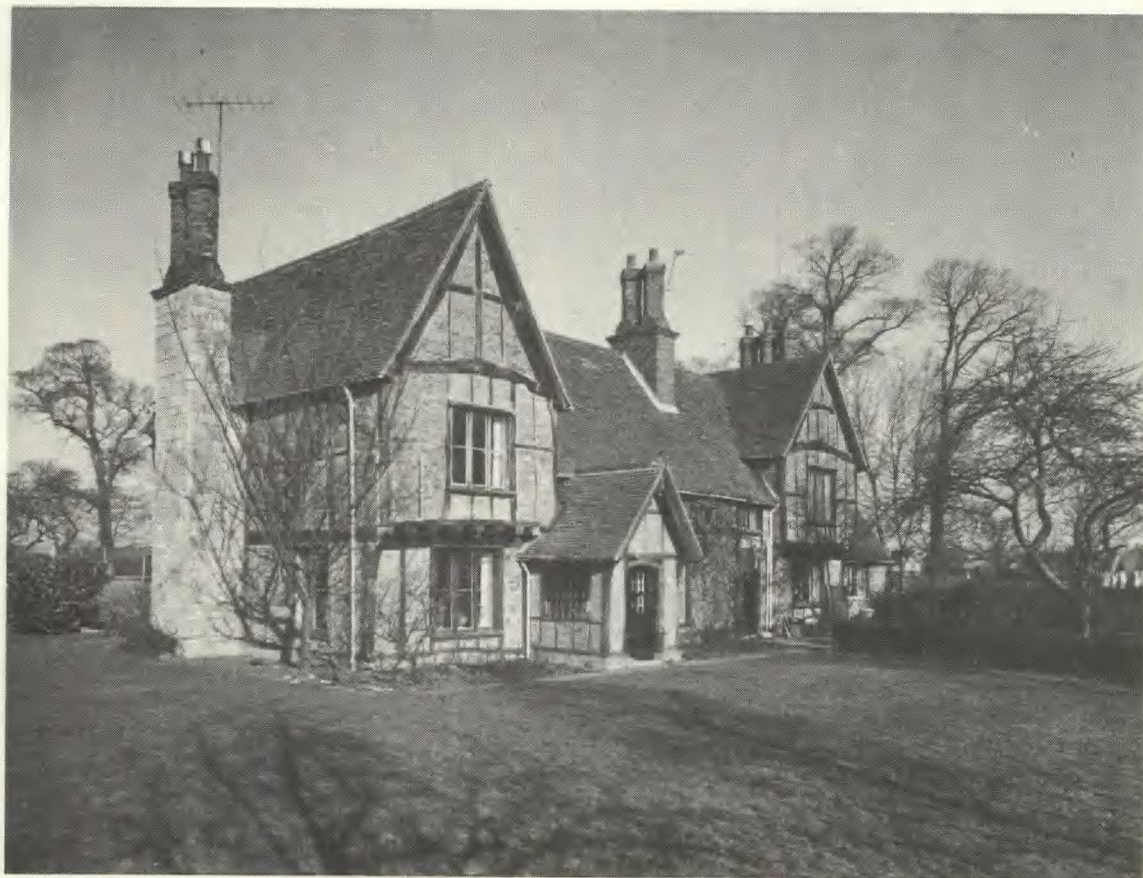
Pl 1 Exterior from south of Moat Farm, Marston Moretaine.

The two cross-wings are extremely similar. On the south side both are flush with the hall range on the ground floor and jettied above, while on north side they run back 2m and are un-jettied. The wings are much narrower than the hall range, and it is noticeable that their first floors are significantly taller than their ground floors.

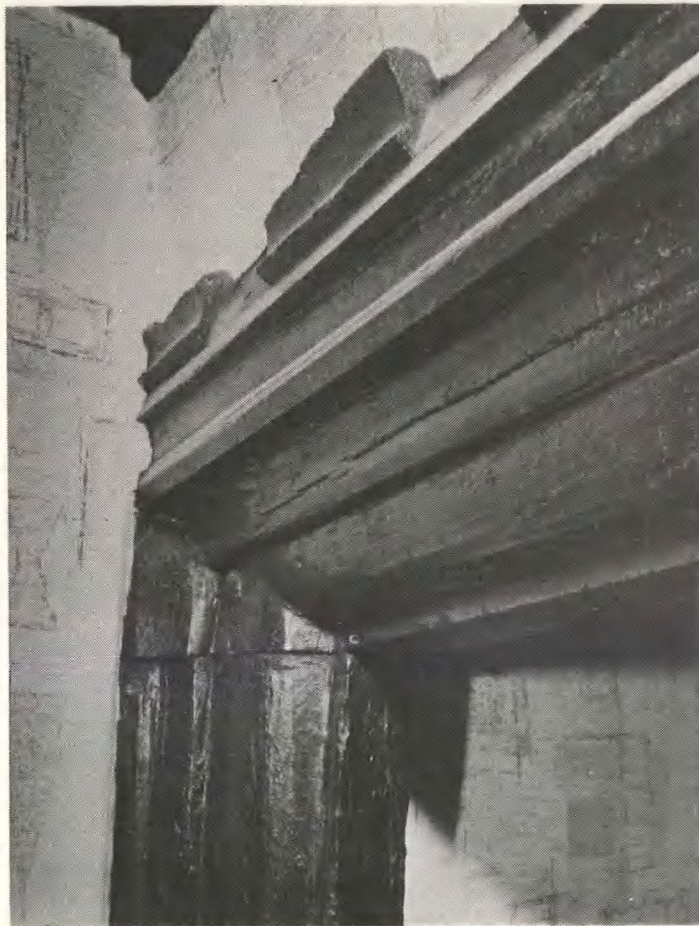
Pl 2 Detail of cross-beam of hall crucks, Moat Farm, Marston Moretaine.

The hall is unusually wide (6.2 metres internally) and its most important features are the central open cruck truss and the spere truss (fig 3). The roof is heavily smoke-blackened, and the plank-like common rafters, (5 by 20cm) are supported on a square-set ridge-piece and two purlins. The latter are chamfered with step stops and have simple splayed scarfs. The central truss has a saddle apex, a cranked collar, arch braces and wide wind-braces. There is also a cross beam only 2m above the present floor, which is clearly original because the blade moulding is returned on the beam (pl 2); the beam has birds-mouth joints around the blades.

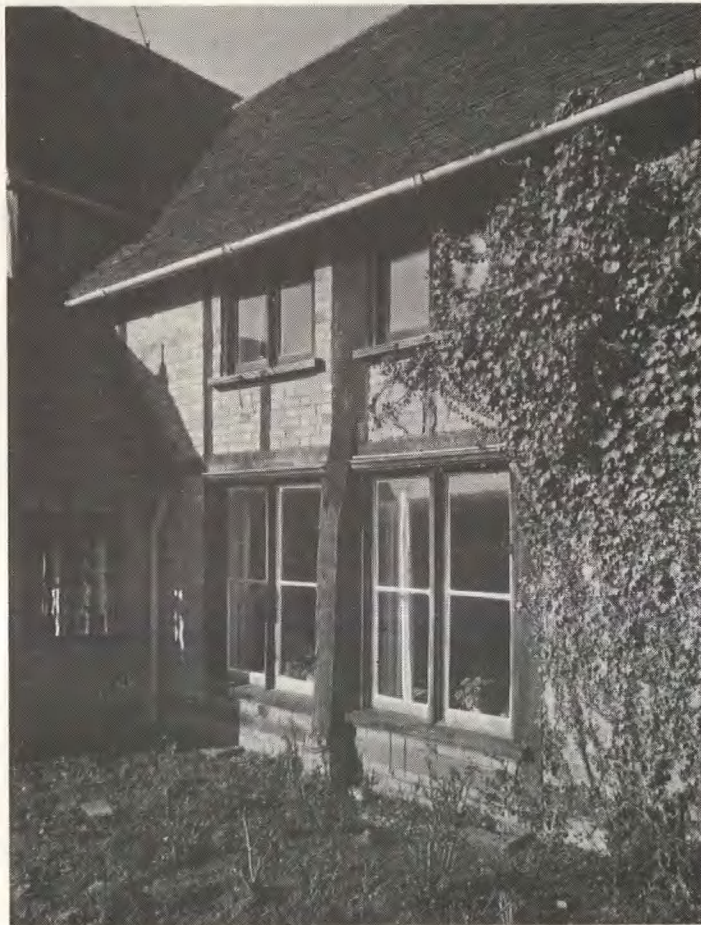
Pl 3 Detail of external buttress, Moat Farm, Marston Moretaine.

Externally, the truss shows a very curious feature (pl 3; fig 6). Each of its 32cm wide studs carries the wall plate, and below this has the outlines of two tenons from spurs (otherwise concealed). Slightly lower down, the stud is thickened to form a heavy projecting buttress (20cm square). Superficially, the buttress appears to be part of the cruck blade, but this is definitely not so, because it is one piece of wood with the upper part of the

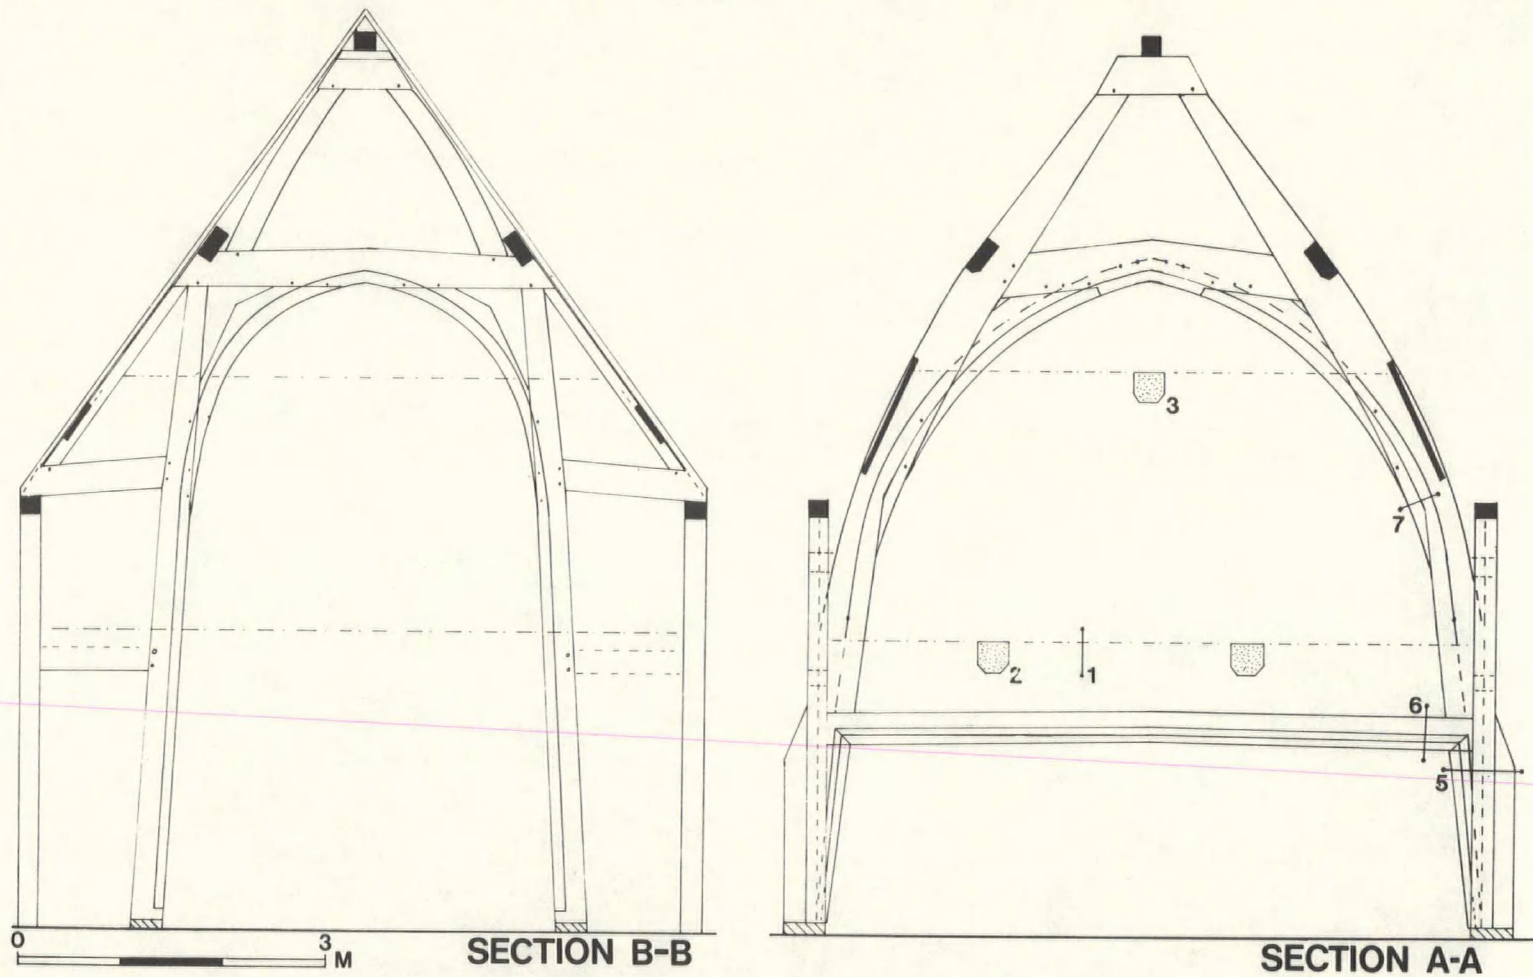
Fig 3 Moat Farm, Marston Mortaine. Section A-A, cruck truss; and B-B spere truss. Numerals refer to moulding details.

The spare truss is unusual, because its main posts are canted inwards; there are spurs at wall-plate level and at about head height. The arch-braces have quarter-round mouldings which are carried right down the posts. The principal rafters are slightly cranked.

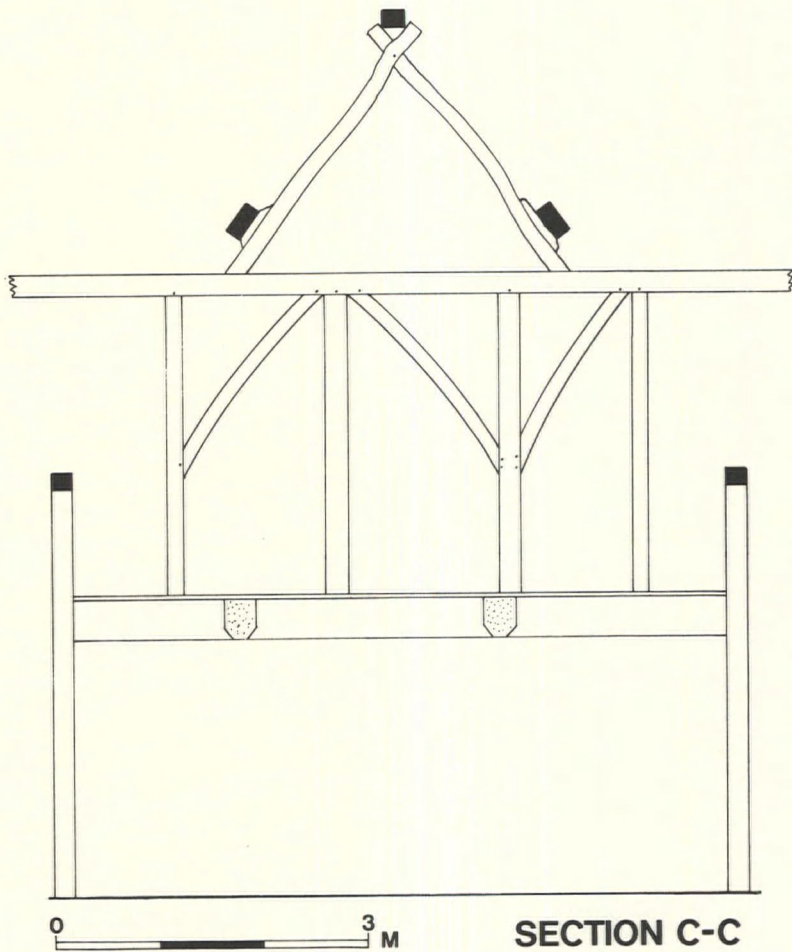
Fig 4 Moat Farm, Marston Mortaine. Section C-C, end of hall.

Superficially from this evidence, the hall and wing are contemporary, but (apart from the contrast with the east end) close examination shows that the wing is later. The principal evidence comes from the ridge-piece. This continues past the truss and, although the rear of the truss is entirely clean, the ridge is heavily smoked. Also, the first truss east of the end wall has common rafters above the purlins, but below this the rafters are heavy (20cm square) and carry a pair of wind-braces. These rafters have the appearance of an intermediate truss, but this is unlikely because it would imply a hall of enormous

length. It is more probable that they are the relics of the end truss of the hall, and that this was of tie-beam construction, as the rafters are not consistent with either a cruck or an aisled truss.

The framing has been largely replaced but seems to have had studs at about 60cm spacing, and there is now a rail half way up each storey. However, in the part exposed at the west end of the hall, the studs are at 1.5m intervals with long upward braces (fig 4), and this is an alternative possibility for the original wall framing.

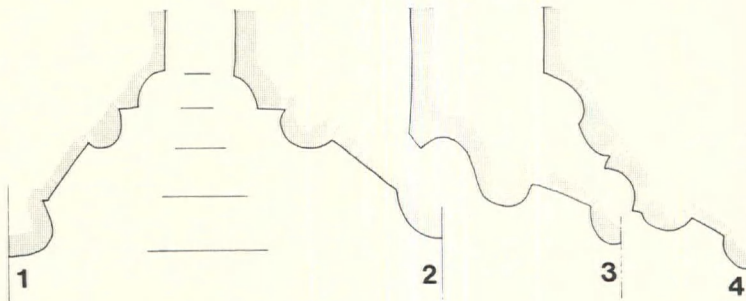
Fig 5 Moat Farm, Marston Mortaine. Beam Mouldings 1-4. Nos 1-3 are as marked in Fig 3. No. 4 is the upper floor ceiling beam in the East wing. Scale: $\frac{1}{4}$ full size.

There is one major stage of improvement evident in the house, dateable to the later sixteenth century. The hall was ceiled over with intersecting moulded beams (fig 5) and with a cornice around the walls; there are bosses carved with roses at their intersections. A large chimney was inserted against the spere truss, probably intended to serve both floors (although this is uncertain as

the fireplaces are completely blocked). The room or rooms over the hall were also ceiled, with a spine beam using almost the same moulding as the floor beams (fig 5).

Moulded axial ceiling and cornice beams are also present above the first floor rooms of the east wing, and similar ones are probably concealed in the west wing. These may also be of the later sixteenth century, but the moulding is much more complex, (fig 5, moulding 4) and they may well be an original part of the wing.

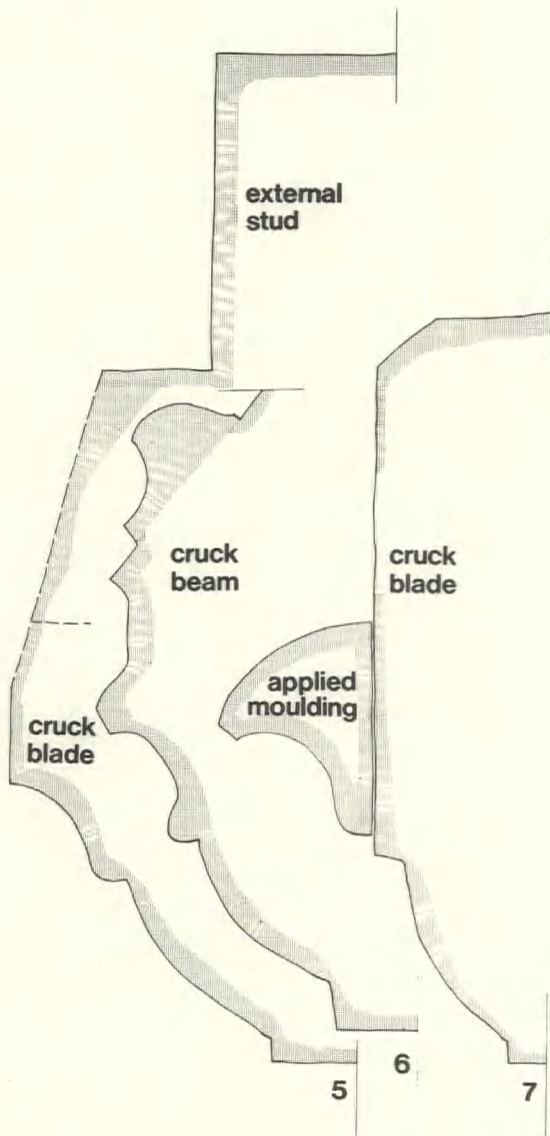
Fig 6 Moat Farm, Marston Moretaine. Cruck truss mouldings 5-7. Scale $\frac{1}{4}$ full size

The truss is highly decorated (fig 6). There are heavy quarter-round mouldings separated by a fillet on the lower parts of the blades, the cross-beam and the arch-braces. They are thinned out (though not properly stopped) on the blades below the braces, some 1.5m above the beam. This curious gap could have been occupied by a capital or similar feature, but any evidence on the face of the blades is obscured by a partition wall. A heavy hollow-moulded strip (8cm in projection and thickness) is applied to the side of the truss in an arch outside the quarter-round moulding, held on with infrequent pegs. It now only exists on the west side at first floor level, and partly buried in the wall on the ground floor, but its shadow and its peg-holes show that it did reach the centre of the collar, and was present on both sides of the truss. It almost certainly formed a complete arch, interrupted only by the cross-beam. The latter carries this same hollow-moulding (but carved in the solid above the quarter-round), and above this, the beam is battlemented.

The date for the hall can be suggested from the truss moulding (fig 6). The heavy quarter-round is characteristically fourteenth century,⁶ although the use of battlementing is normally later. Taken together, a date of *circa* 1400 may be correct; the cross-passage doorway is also consistent with this.⁷

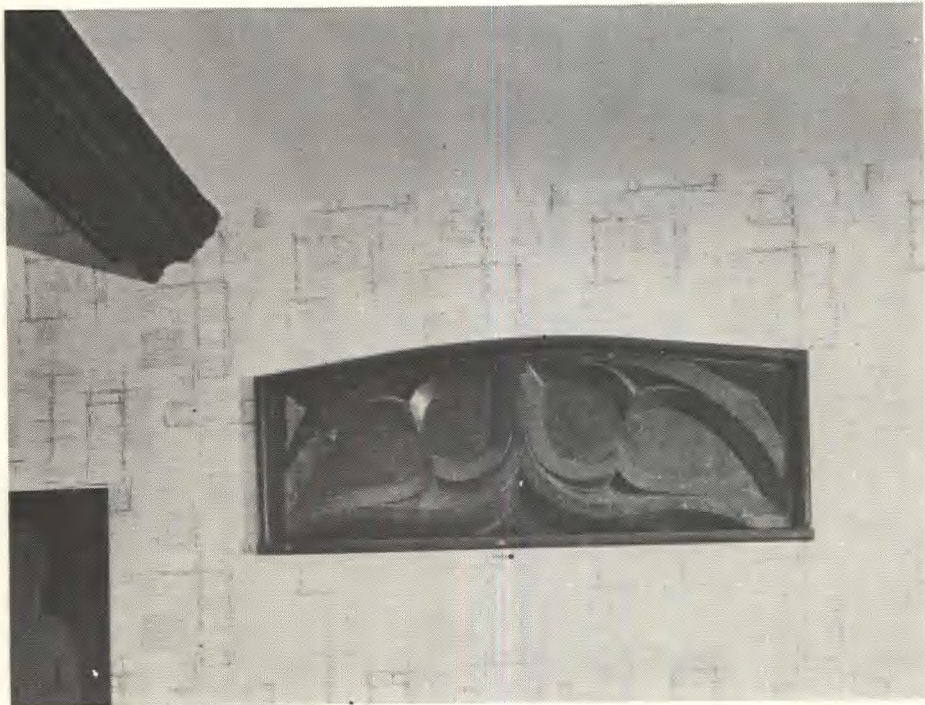
Pl 4 Blind tracery, detail, opposite G on figure 2.

One other early feature should be noted: a set of three wooden panels of blind cusped tracery (pl 4; fig 8). Two are identical (pl 4), and the third is very similar. Their original function is not certain, but the general shape and ogee lower moulding suggests that they were probably door-heads. Two are clearly not *in situ*, being incorporated in modern partitioning of the hall; the third (fig 8,G) is over the ground-floor door from the hall to the west wing, but also appears to have been built in recently. A wooden lintel with battlementing is also reset, over the present outer door on the north side of the hall.

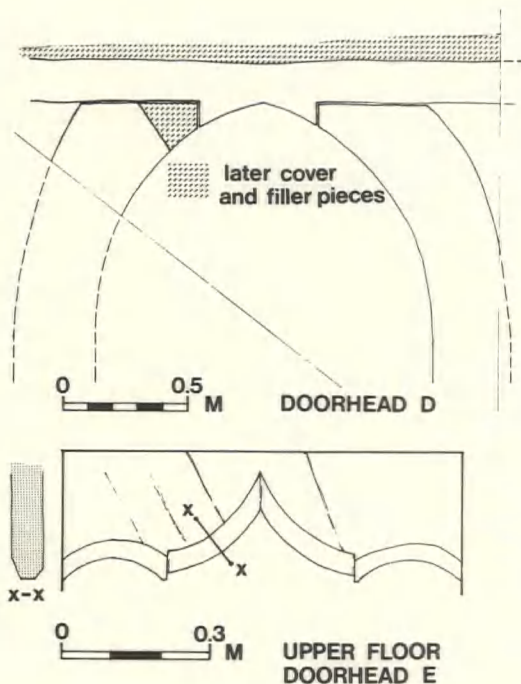
Fig 7 Moat Farm, Marston Moretaine. Door head details D and E.

the cruck blades and spurs, and the original North doorway of the cross-passage. This is two-centred, composed of two heavy curved jambs and a lintel (fig 7). Both ends of the hall are now formed by the side walls of the cross-wings, but this is not the original arrangement. At the east end the wall is concealed; the hall purlins and ridge piece are only connected to the wing roof with rough props, and the ridge extends several feet beyond the side-wall. At the west end (fig 4), a pair of irregular rafters stands on the wall-plate of the wing, crossed at the apex for the ridge and supporting the purlins on blocks. This truss is filled with wattle-and-daub, and all of the hall side is smoke-blackened.

A doorhead of depressed ogee form (fig 7) poses the same problems of date as these beams. It is located in the west wing, at first floor level, leading into the stair in the north-west corner between wing and hall. The lean-to projection housing this stair is entirely modern but the door-head may be *in situ*. If this is correct, then there was presumably an earlier stair in the same place as the present one:

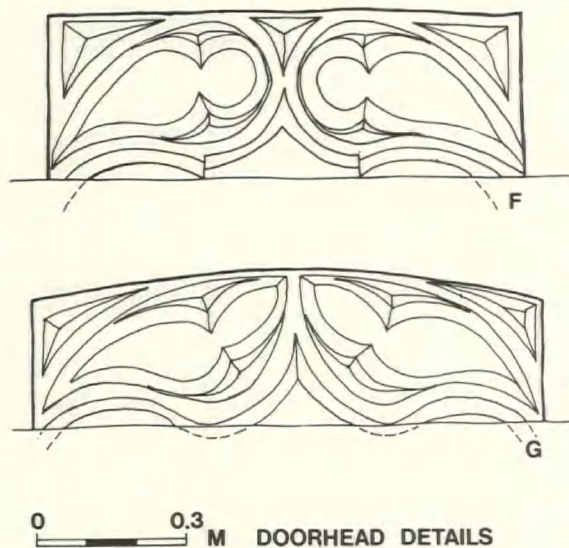
Fig 8 Moat Farm, Marston Moretaine. Blind Cusped Tracery, door head details F and G.

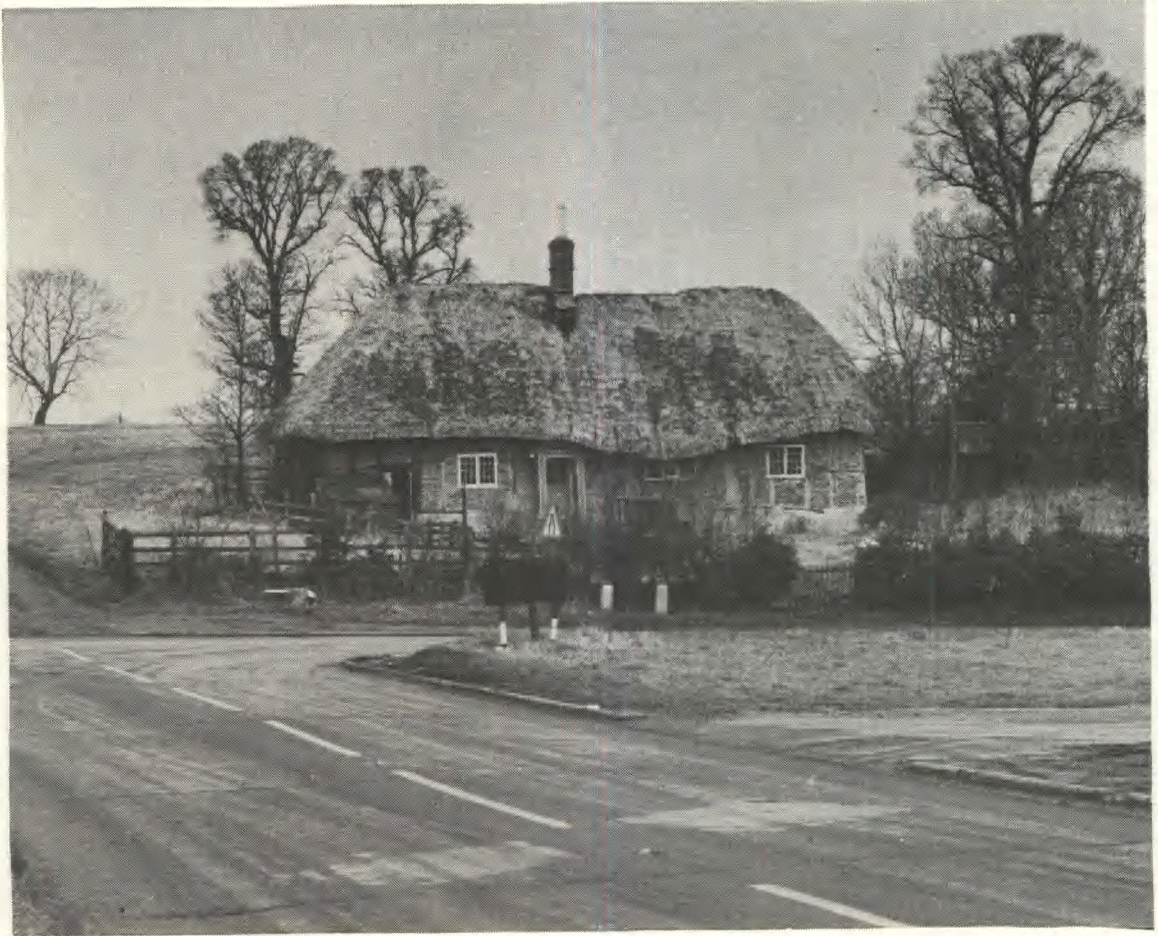
Pl 5 Exterior from south-east of Husbourne Crawley before conversion.
 [Photograph: Bedfordshire County Council]

have been slightly trimmed. The dissimilarity between these two pairs suggests that the original roof was of a half hipped form, but it is difficult to understand exactly how the ridge piece originally continued from the two centre trusses. At the north end, truss 4 is completed with a brick gable, but was certainly of half-hip form until the recent conversion (pl 5).

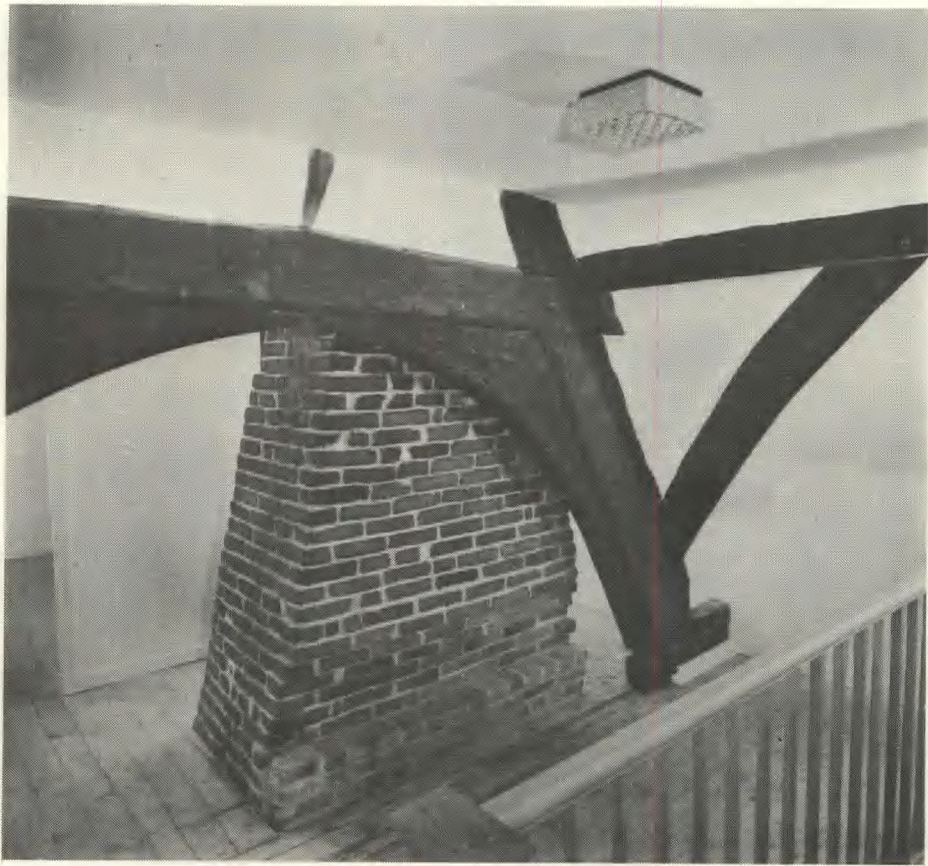
Pl 6 Detail of hall cruck, Husbourne Crawley.
[Photograph: Bedfordshire County Council.]

The main hall cruck truss 2 (fig 9; pl 6) has a saddle apex, a slightly cranked collar, arch braces and a low tie-beam. This tie-beam has in the main been removed, but was undoubtedly continuous because it has a straight lap joint and no stop unlike the notched lap of, for example, the spur in truss 3.¹⁰ All these timbers are chamfered on their interior edges. Daub on boards and wattle fills the upper triangle of this truss but is not smoke-blackened like the surrounding structure, and is therefore a later infilling. The evidence of the chamfers, the arch braces and smoke blackening of all upper timbers in the two bays on either side of 2, shows undoubtedly that truss 2 was the open central cruck truss for a two-bay hall.

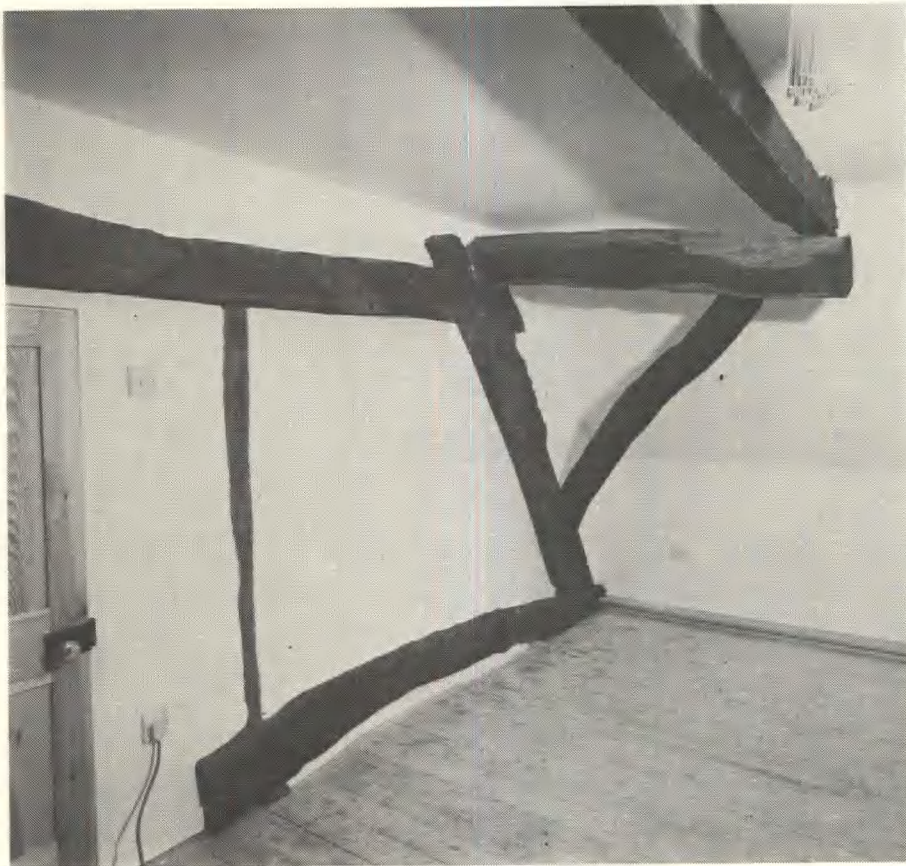
Pl 7 Detail of 'flying purlins', Husbourne Crawley.
[Photograph: Bedfordshire County Council.]

The structure at the southern end is very remarkable. The purlins, extending 1.4m beyond truss 1, are supported by wind-braces but are otherwise 'flying' (pl 7). They carry a cross-beam (omitted from fig 9) at their ends, and the beam, the wind-braces and the purlins (including their free ends) are heavily smoke-blackened.⁹ The cross-beam is puzzlingly different in character from the rest of the structure, as it is very straight with a regular square section; it is not jointed to the purlins, but must be pegged in place. This end of the house was presumably fully hipped from an early date (as it still remains).

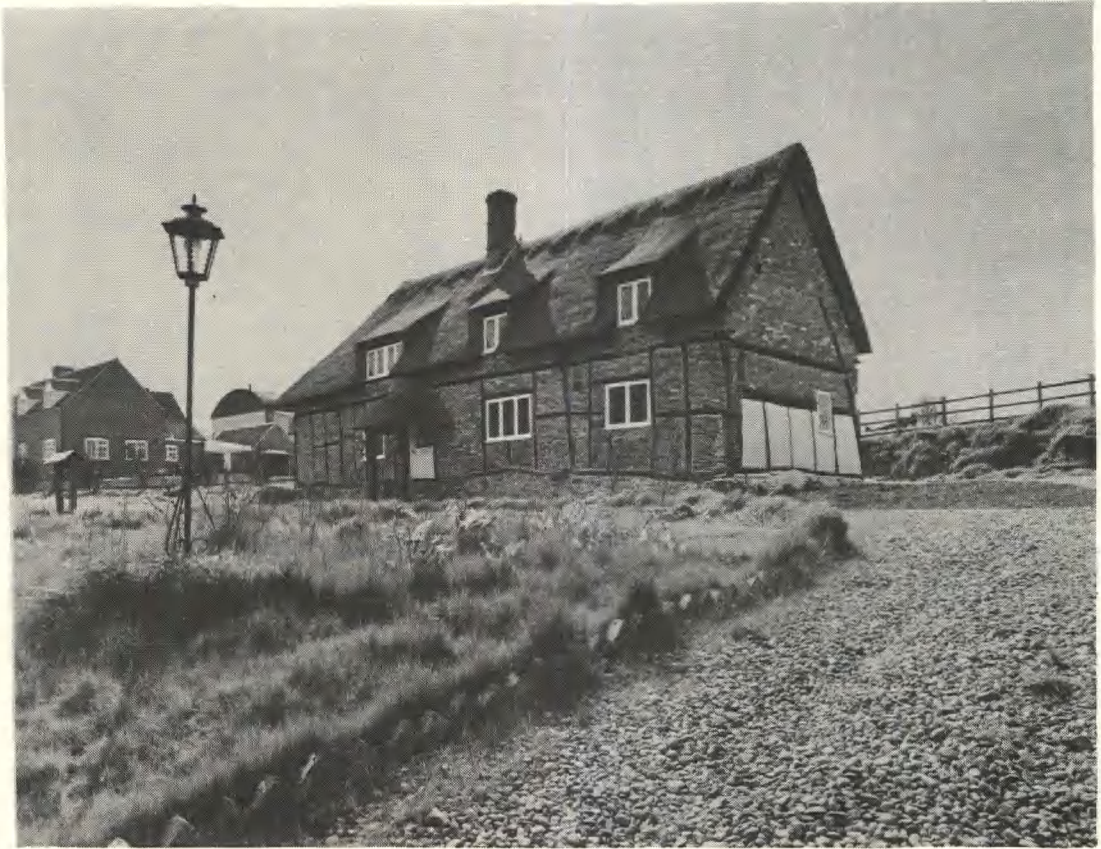
Pl 8 Exterior from north-east after conversion, Husbourne Crawley.
[Photograph: Bedfordshire County Council]

the cruck blade tell us that this was always the end truss of the building. The surviving studs, from an examination of the peg holes, are probably contemporary (pl 8).

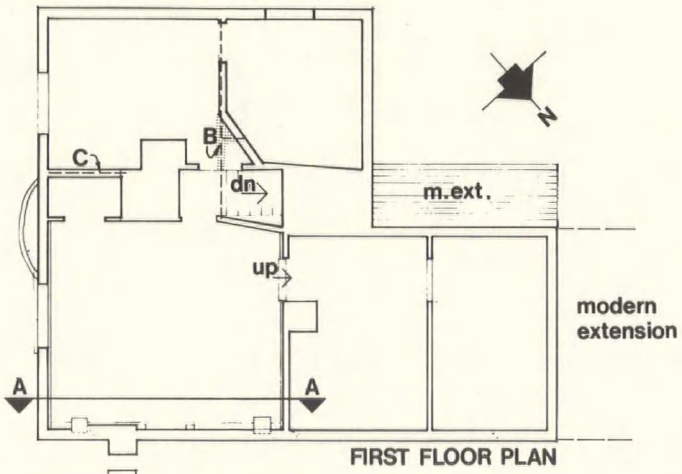
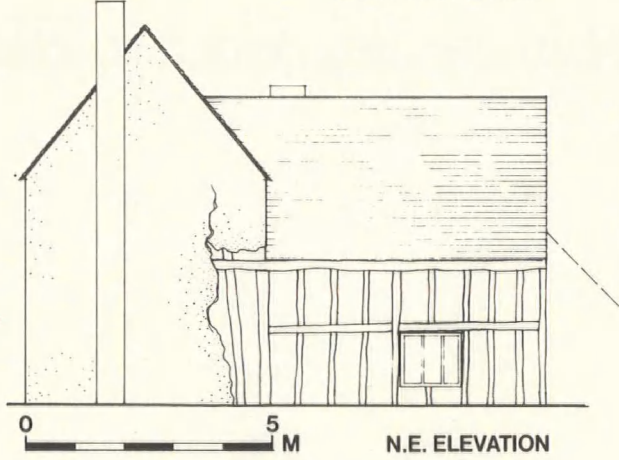
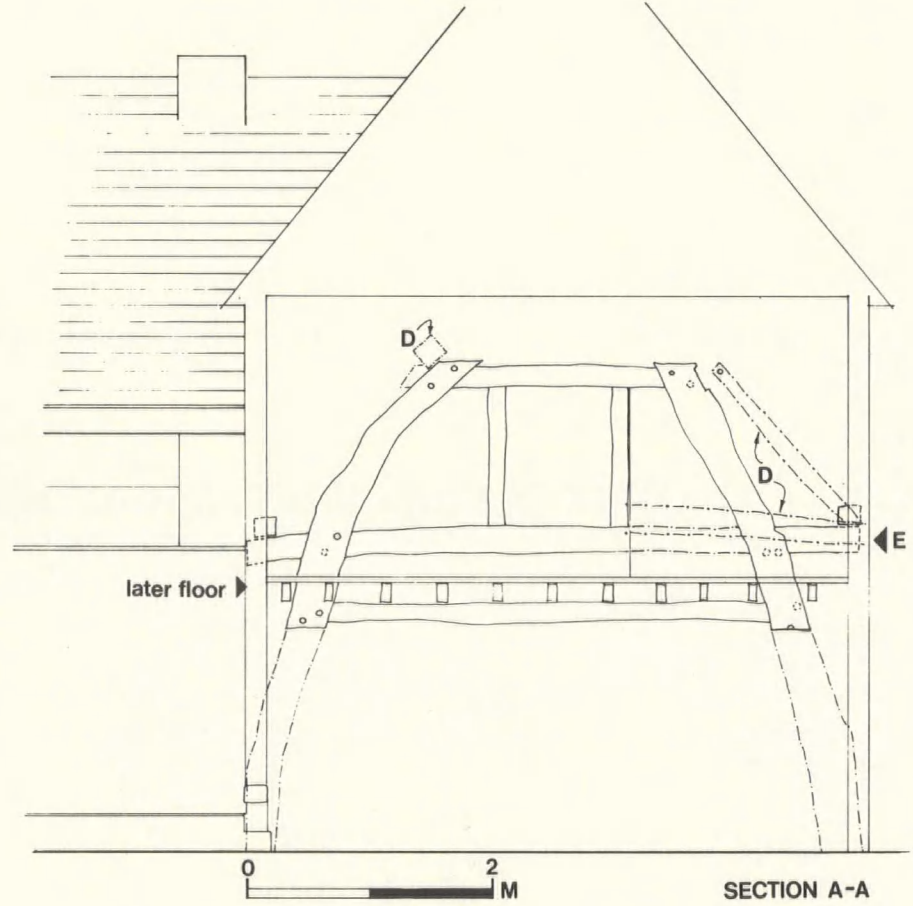
10-12 WEST HILL ASPLEY GUISE

- B - smoke-blackened purlin and rafter
- C - probable cross-beam of second cruck at level E and reused rafter, s-b
- D - line of purlin from B, rafter and cross-beam from C

Fig 10 Aspley Guise cruck frame building.

The cruck at 10-12 West Hill, Aspley Guise (SP 942359; Beds C.C./S.M.R. 3681 Figure 10) is very fragmentary, but shows similarities with Husbourne Crawley. One truss survives in part (fig 10), and has the doubled tie-beam as truss 4 of Husbourne Crawley, suggesting that it is the end truss of a two-storeyed bay. The next truss has been removed apart from its tie-beam, but the purlins remain and show smoke-blackening over what would be the hall; beyond this nothing remains.
