Numbers 7 and 9 West Street, Dunstable

J. M. BAILEY

NUMBERS 7 AND 9 WEST STREET

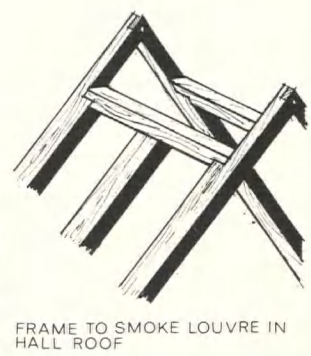
Fig 3 Nos 7 and 9 West Street, Dunstable: perspective reconstruction and framing details.

there was apparently only one tension brace. This was on the inner face of the studs between the north west upper corner post and bressummer. Neither the north east corner post nor the eastern half of the bressummer had mortices for a tension brace. The reason for only one tension brace may be because of the construction form of the western side of the front bay of the building, discussed later. None of the studs survived at the ground floor level of this front elevation. Fortunately the mid-plate survived intact and along the underside were the slots for door and window spandrels and the mortices for door and window posts. There were also hollow mouldings running across the positions of the door and window heads. All of these details are shown in figure 2 together with a reconstruction of the door and window detail. The gable was infilled with close studding, all of which survived. A conjectural reconstruction of the front elevation is shown in figure 3.

A conjectural isometric reconstruction of the original building is shown in figure 3. Some time in the late sixteenth century a fireplace and chimney were added at the extreme north end of the hall and abutting to its west wall. The chimney was built from Totternhoe stone robbed from one of the two Priors, several of the stones were moulded. When the chimney was added the hall was floored over. To support the new floor joists a new primary joist was inserted across the apparent end of the hall (Section EE fig 2). This primary joist extended through the line of the west wall presumably relating to a structure to the south of No 9.

The floor joists over the shop were jointed to binding joist by means of central tenon and morticed with pegs. There were two scarf joints used in the building. The purlins were jointed with a butted scarf with secret bridle and secured with one peg. The other joint used in the top plate and here a squint-butted scarf with secret bridle secured with two pegs was used. (fig 3).

The method of framing the end jetty is shown in figure 3.
