Job Name: Burnhope Reservoir

Doc Ref: BH005

Subject: **Built Heritage Technical Note**

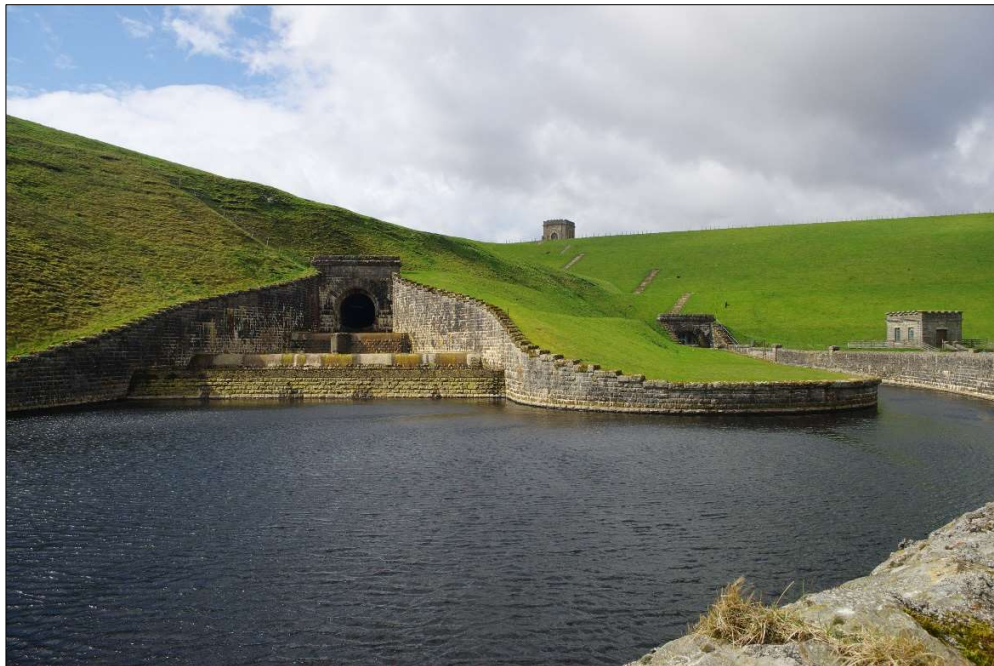
Plate 3: general arrangement showing the overflow tunnel (left) and outlet tunnel (right) with draw-off tower above

The outlet tunnel, which is concrete and c.3m wide, connects to a draw-off tower located on the reservoir embankment, which controls the flow of water to the outlet portal. South of the draw-off tower is an overflow weir and sump, which connect to a further tunnel (the overflow tunnel) which runs broadly parallel with the outlet tunnel and exits further to the east (Plate 3). The distance from the draw-off tower to the outlet portal is approximately 200m.

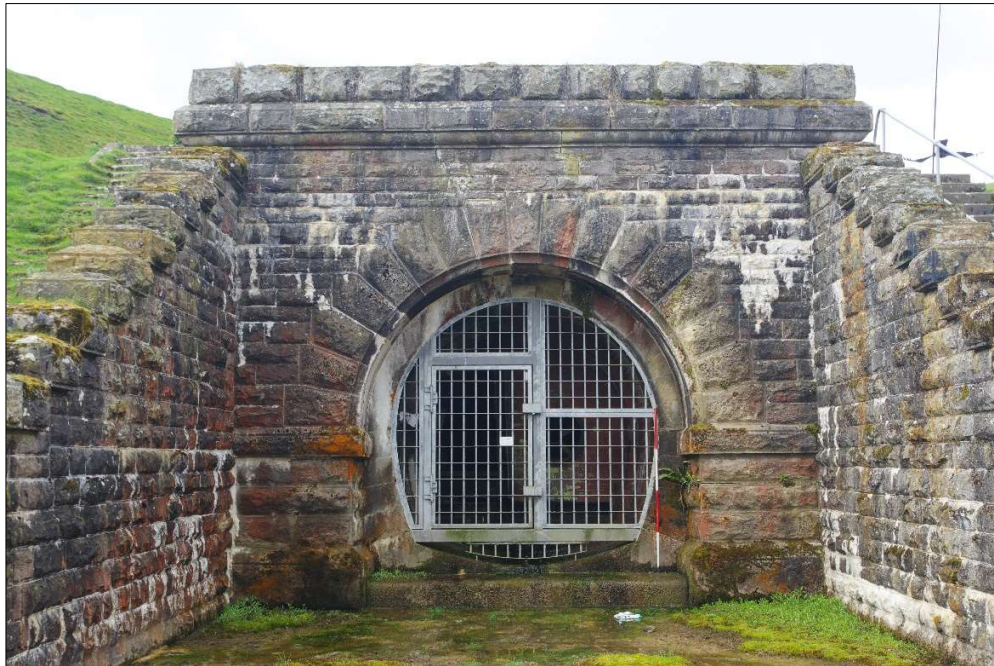
Plate 4: the portal facing west

The main walls of the outlet tunnel portal are constructed of regular blocks of evenly coursed dressed sandstone with rusticated facing, extending to approximately 6.3m in height from the base of the tailbay

culvert (Plate 4). The walls are approximately 600mm thick. The portal walls project above ground surface to the west to 1.2m, with the upper courses marked by a projecting rounded string course on the eastern side, with large rusticated rectangular blocks (c 750mm by 500mm) forming the coping stones for the walls.

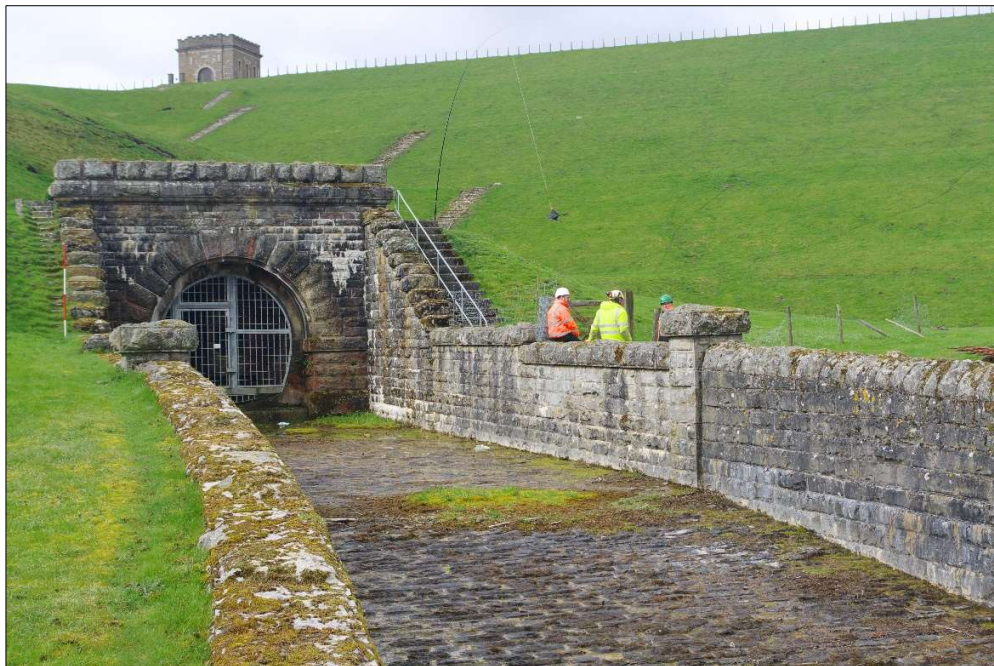
Plate 5: the portal, side walls and channel

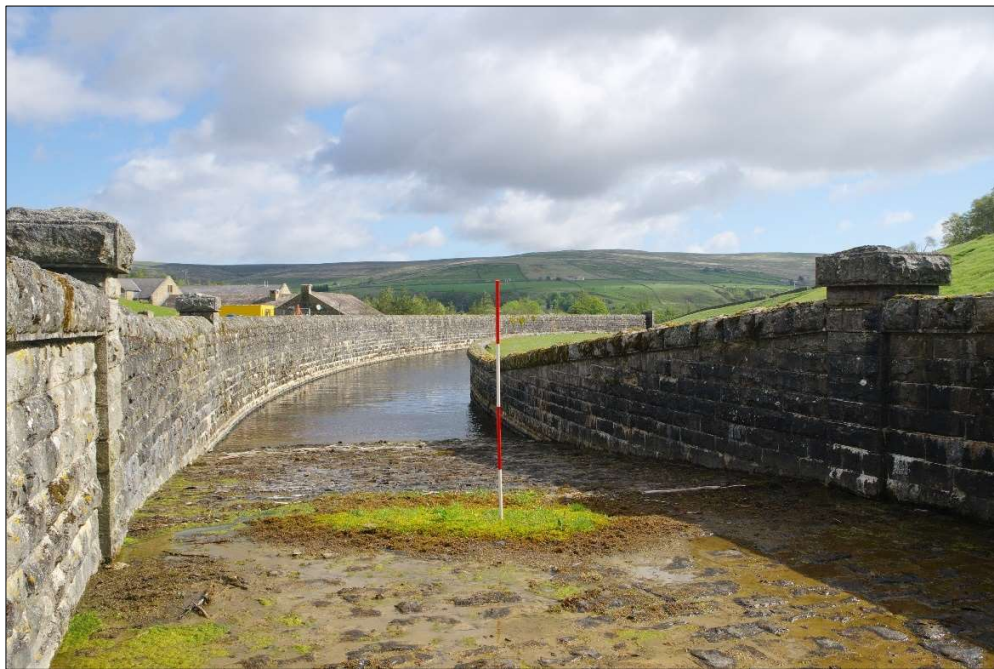
Plate 6: tailbay channel facing north-east

The tailbay channel is 5.9m in width, and curves 68m north-eastwards to a large basin, which in turn empties into Burnhope Burn via a series of weirs (Plate 6). The portal is abutted on the north and south sides by retaining walls which extend eastwards for 20m and step down from the full height of the wall, and then one course further at their midpoint; these walls mirror the stonework of the portal being also constructed of regular blocks of evenly coursed dressed sandstone with rusticated facing and topped by large rusticated rectangular blocks forming the coping stones for the wall. At the eastern end of the walls are large pillars, 2.25m in height, which mark the upper edge of a slope in the tailbay channel. These pillars are built of the same rusticated stone but have much larger square coping stones forming the pillar caps. A further pillar on the north side of the tailbay channel marks the lower edge of the slope in the channel, but without an equivalent pillar on the south side. The walls for the rest of the channel are lower and plainer, with rounded coping stones, and may be a later construction. The base of the tailbay channel comprises granite setts.

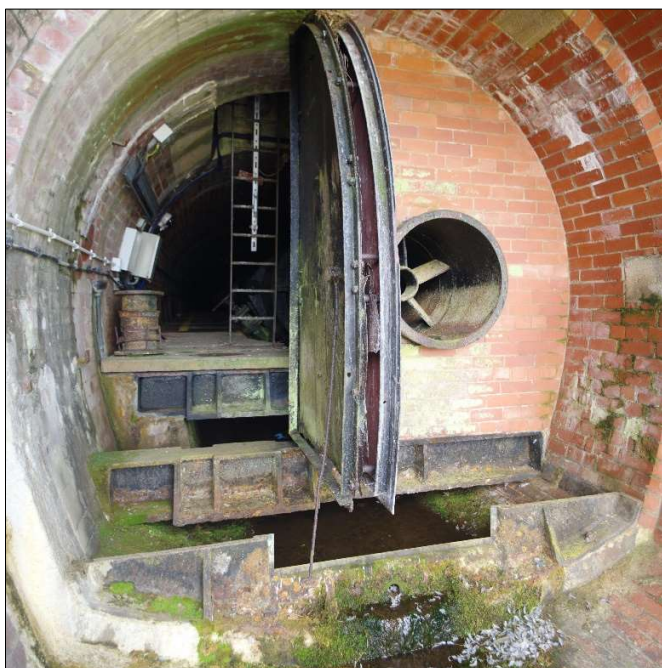
Plate 7: tunnel interior facing west

The portal rests on large foundation blocks of chamfered sandstone, c.1.3m in width, which project out from the line of the portal entrance; the springers for the outer arch comprise projecting rectangular blocks to the same width as the foundations. The outer portal arch is round with rusticated voussoirs with a chamfered interior edge. A further inner horse-shoe arch within the portal is built of dressed ashlar blocks. This sits on the concrete base of the tunnel, which projects forwards to the lip of the outer arch, forming a threshold into the tunnel. The tunnel is secured by a modern metal gate; internally the concrete tunnel is lined with modern brick forming the supporting structure for the outlet valve (Plate 7).
