**Silverband Mine Brake House, Dufton Fell,
Milburn, Cumbria**
Built Heritage Assessment Report

Project Ref: 330201954 | Rev: A | Date: July 2022

Report Title: Built Heritage Assessment Report

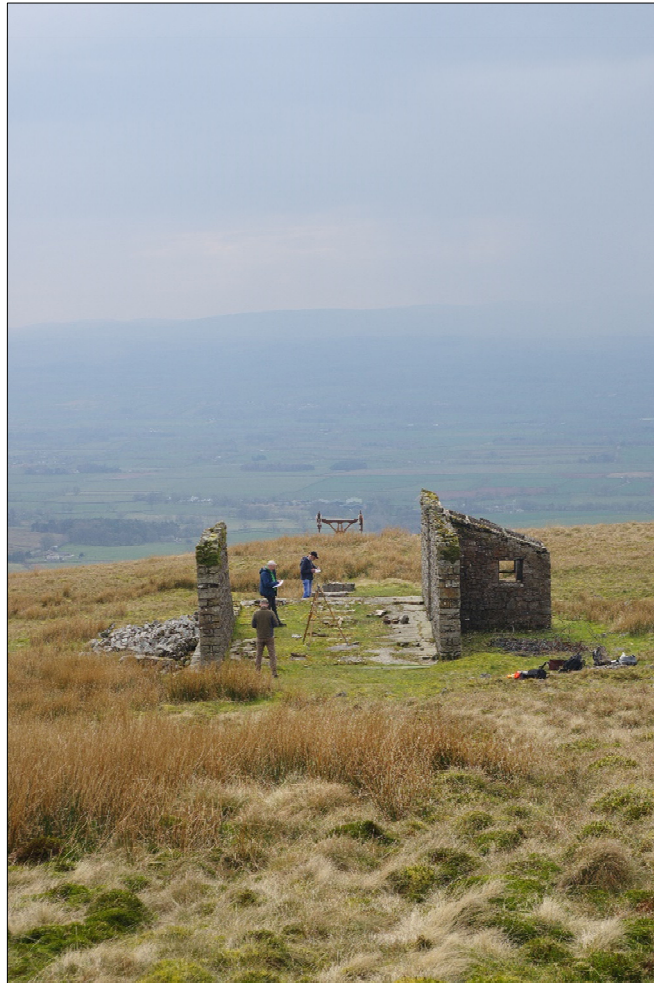
Plate 1: the Brake House during the survey, April 2022, facing south-west; the white building in the distance marks the position of the former terminus for the ropeway in Milburn

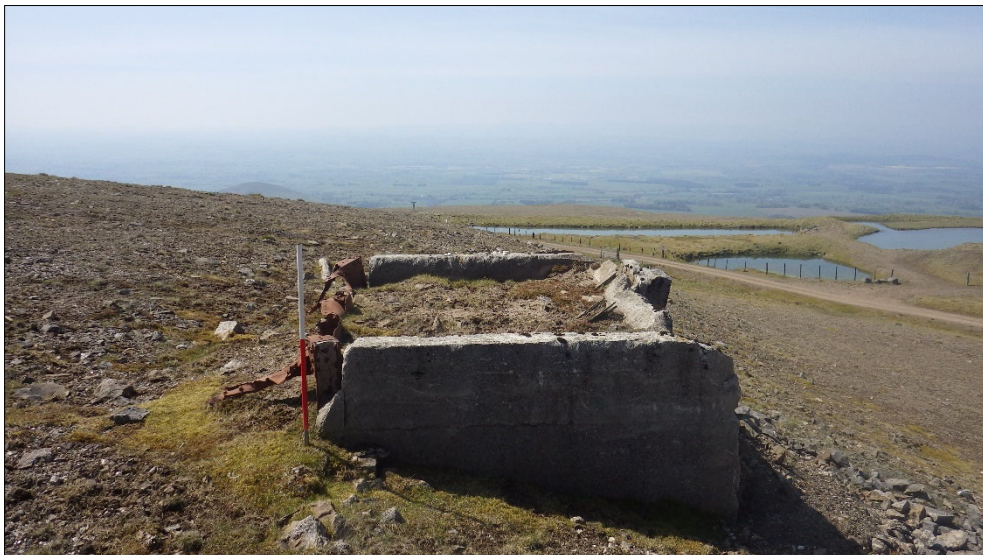
Plate 8: the pylon base at the mine (Pylon -1), recorded in 2019 (NAA 2019, 18); Pylon 1 is visible in the middle distance

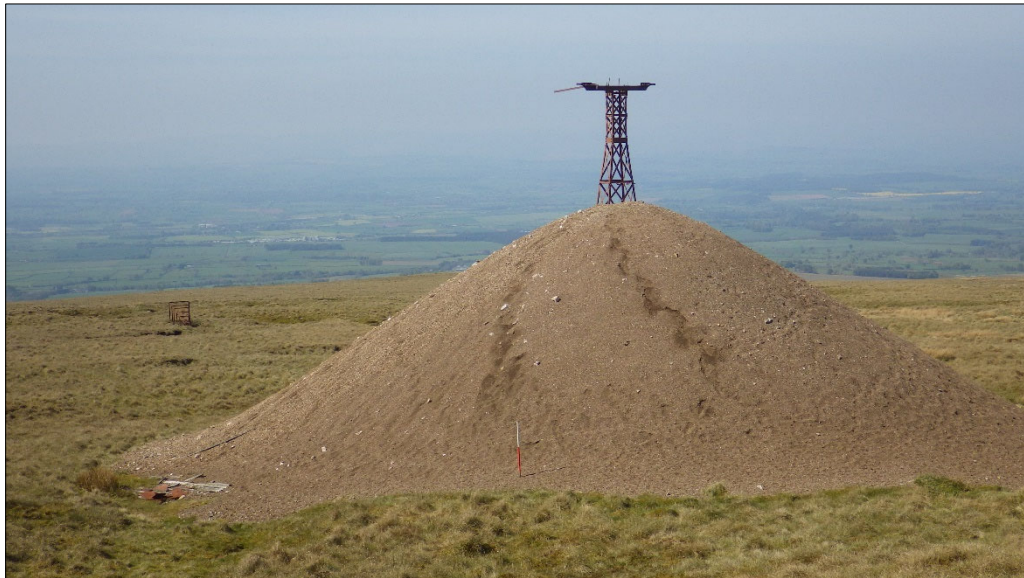
Plate 10: Pylon 1, facing south, photographed in 2019; Pylon 2 is visible on its side, left of the photograph

- 3.1.3 Historic England record a pylon at NY 7014 3155 (the first south of the access road) as follows: *"only the base of the pylon remains in situ. It has been twisted as though attempts have been made to rip it out of the ground. Remains of an external ladder are still attached."* This pylon (referred to as Pylon 0) was not seen during the 2022 survey, the first identified being Pylon 1 which sits on top of a large mound of spoil – Historic England describe this as an 'earlier' spoil heap, but it appears that the heap was deliberately dumped to allow the pylon to sit higher up in the landscape, and to operate as an intermediate pylon, so minimising the drop down from the loading station to the ground level, which is a 40m drop in 250m (Plate 10).

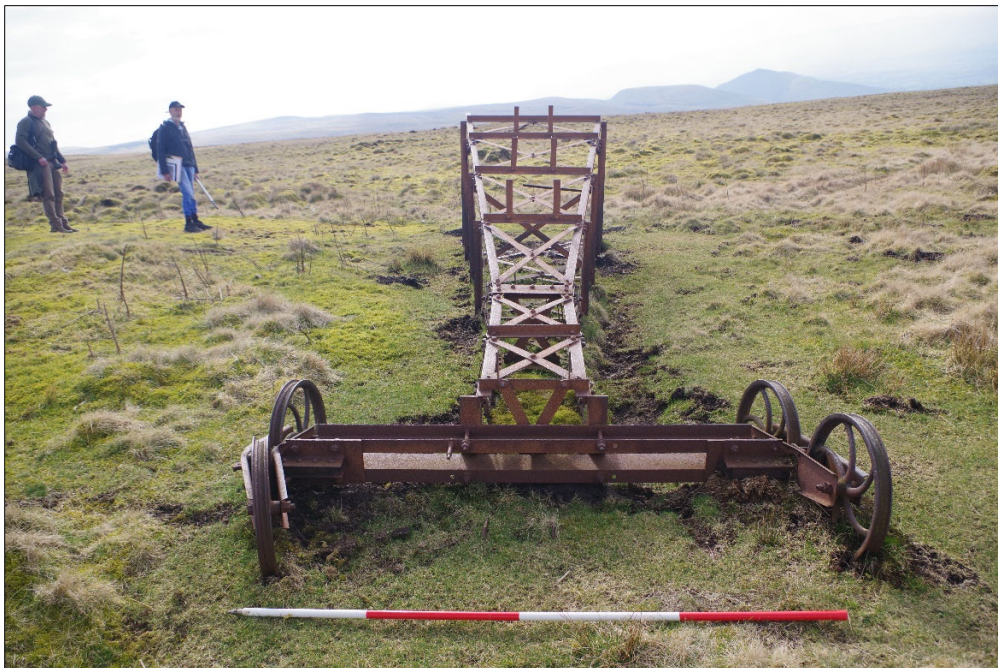
Plate 11: Pylon 3, facing east

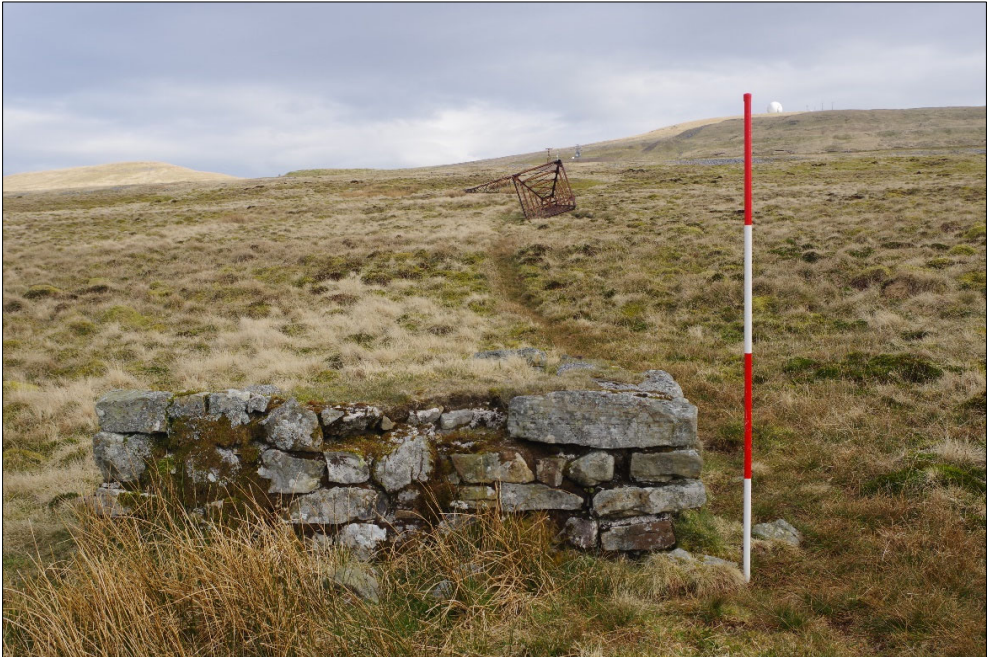
Plate 12: Pylon 4, base facing north with displaced pylon to the north

- 3.1.2 The pylon bases, where these survive, appear to be entirely built of random coursed roughly dressed stone and are c.2.5m square and up to 1m in height (Plates 12 and 13); some (e.g., Pylon 12) have been capped with cement. It is unclear whether all the pylon bases were originally bonded with cement, though it seems likely; most are now heavily turfed over, making confirmation of this difficult. Where only the lowest part of a pylon frame was identified as a pylon location, it was also unclear whether the pylons originally were affixed into a base, since buried in peat, or whether directly fixed into the ground without a base (though this seems implausible as it would be liable to become unstable through vibrations from the buckets moving along the ropeway).

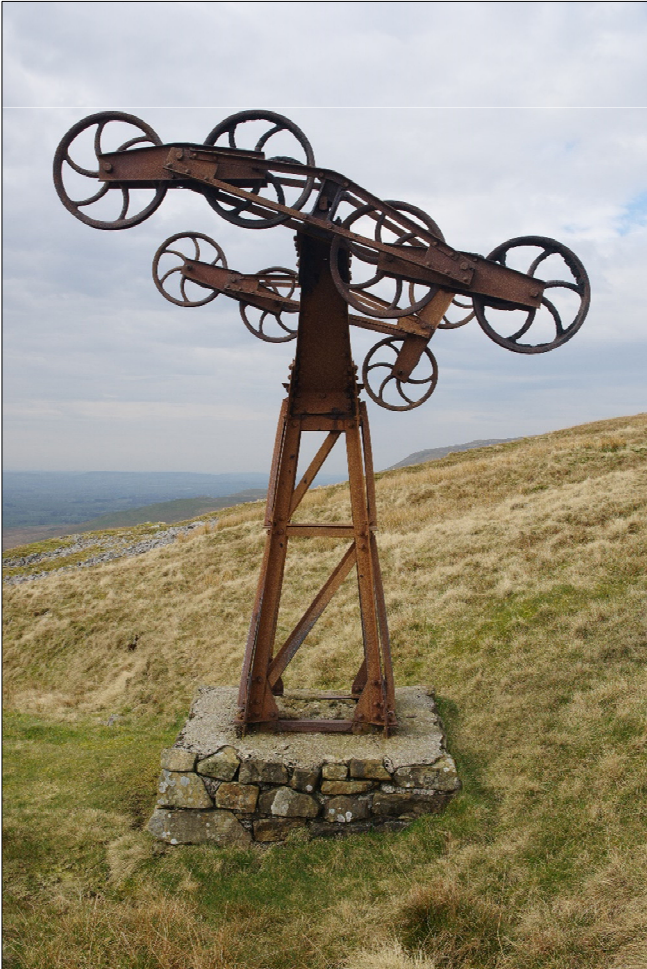
Plate 13: Pylon 12, facing west

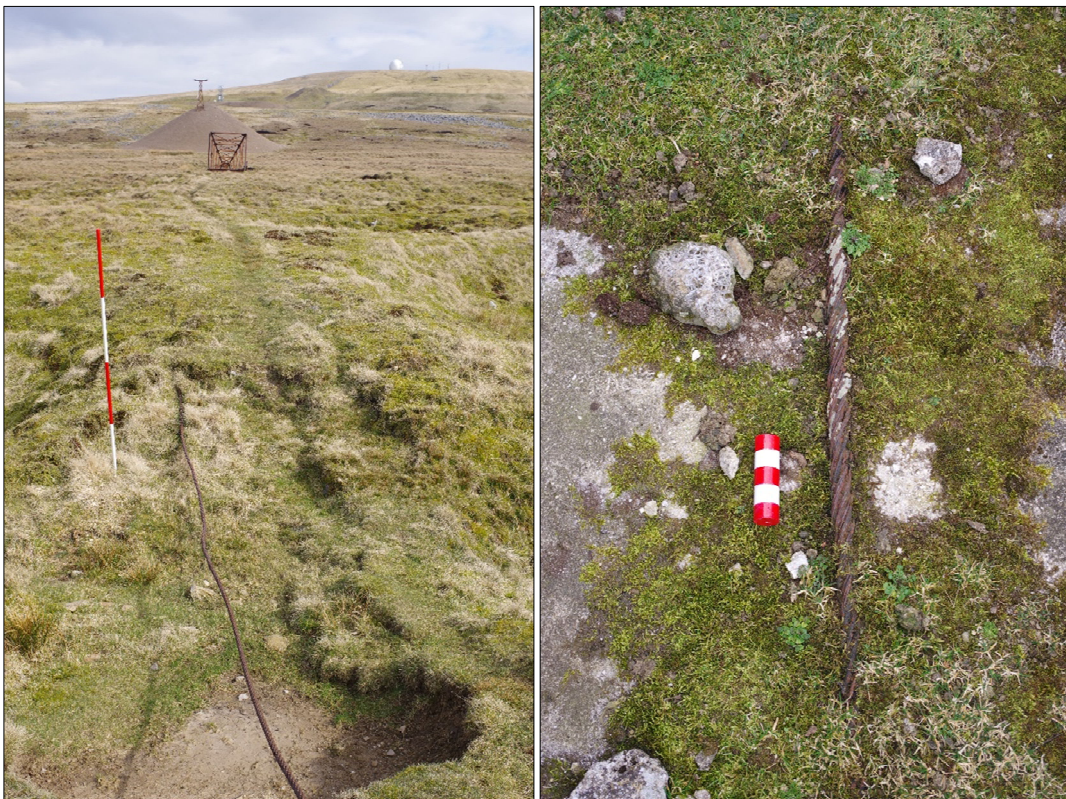
Plate 14: ropeway cable on the route of the pylons (left, facing north) and in the Brake House (right, plan view)

- 3.1.4 Lengths of ropeway cable were identified partially buried across the survey area, but traceable in isolated areas of erosion along the alignment of the ropeway, or closely associated with the felled pylons. A section of rope was also visible partially buried and *in situ* in the Brake House (Plate 14). Large quantities of wire rope were also rolled up and stored on the north-west side of the Brake House, probably stock-piled for later removal but then never used.

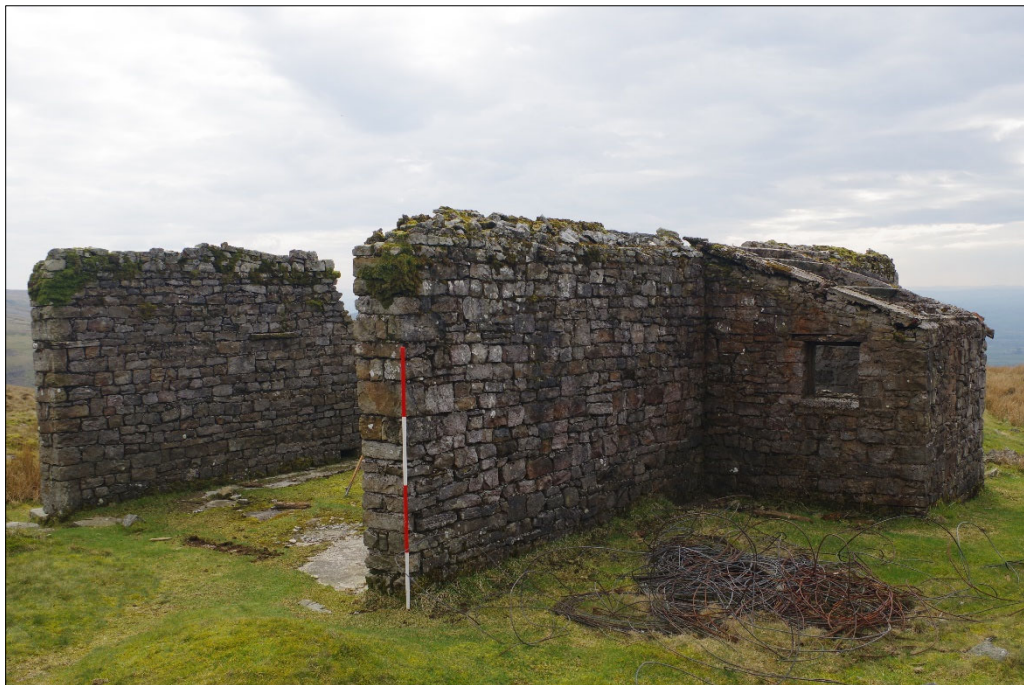
Plate 15: the Brake House, facing east; note coiled wire rope bottom left

- 3.2.1 The Brake House is a broadly rectangular structure, measuring 12.40m in length by 5.85m in width, and orientated north-east to south-west, aligned with the course of the ropeway (Figure 3). On the north-western side of the building is a small outshut, contemporary with the main building and measuring 2.75m by 2.45m (Plate 15). This is referred to as the brakesman's hut.

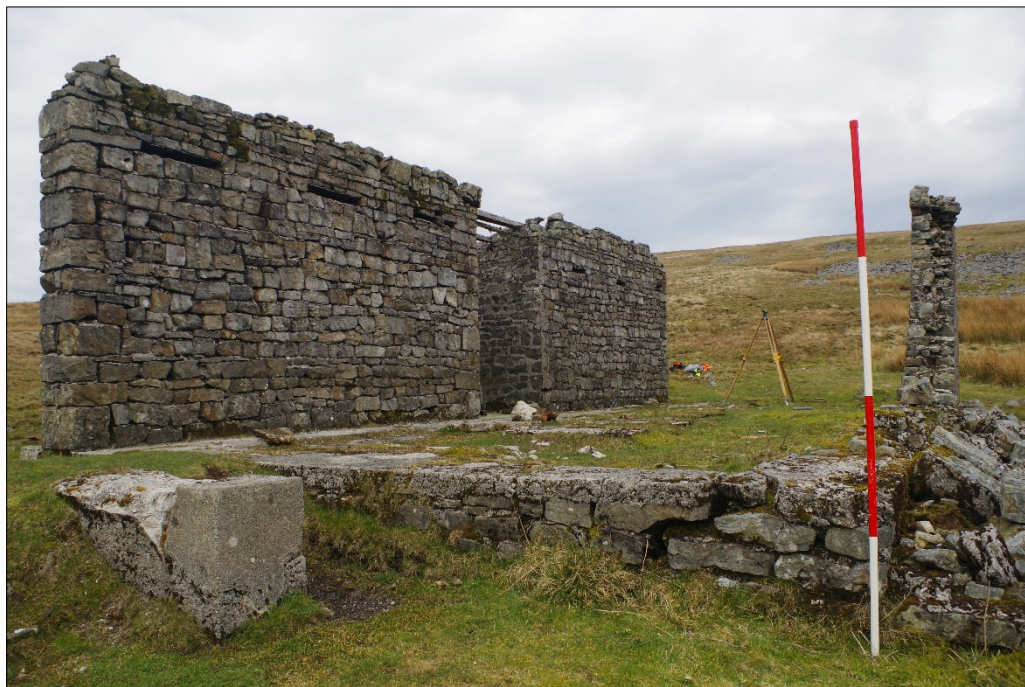
Plate 16: the Brake House, facing north; the collapsed wall is on the right of the picture, and the wall appears to abut the floor slab at this point. One of the external mounting blocks is visible to the left.

been many). The remains of eight roof trusses, comprising sawn-off ends of the timbers, were visible affixed into the walls, or their positions were evident through rectangular sockets for the joists in the same positions (labelled 'R' on the drawings – Figure 5). The south-east wall had half-collapsed, down to the floor slab, seemingly in a single event, as the wall is visible splayed out on the ground to the east of the building. Only a 7.5m length of this wall now survives (Figures 4 and 5, Plate 16).

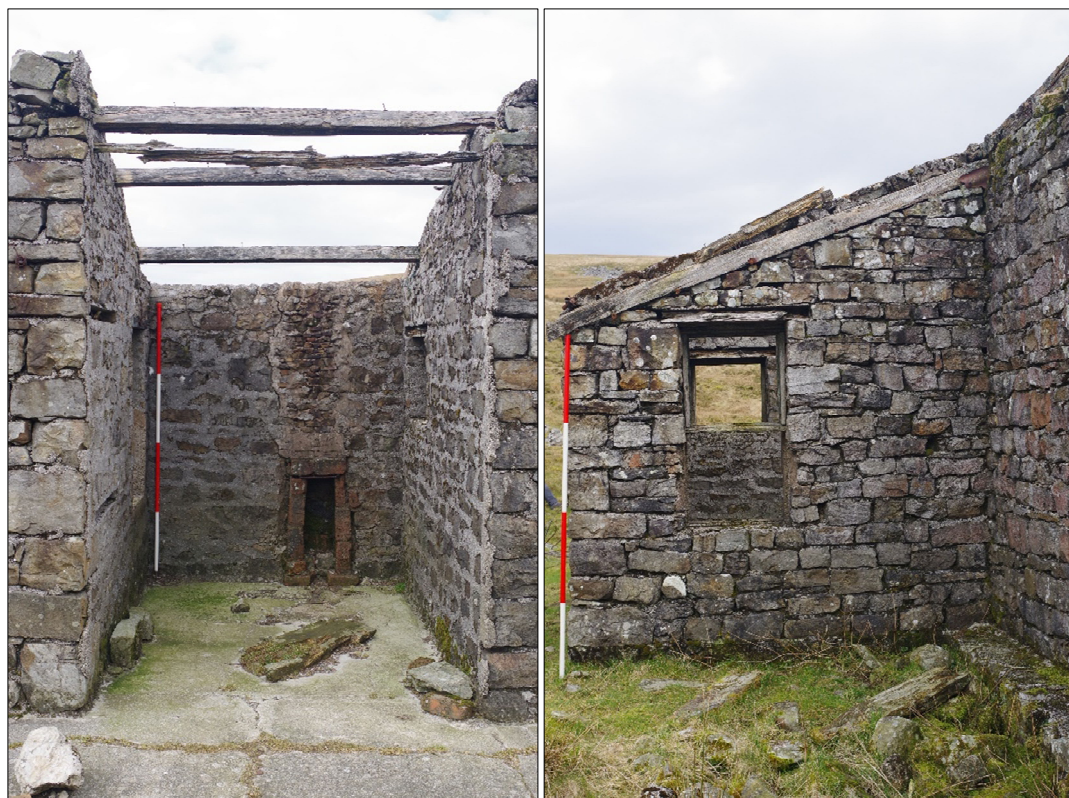
Plate 17: interior (left) and south-west facing elevation (right) of the brakesman's hut.

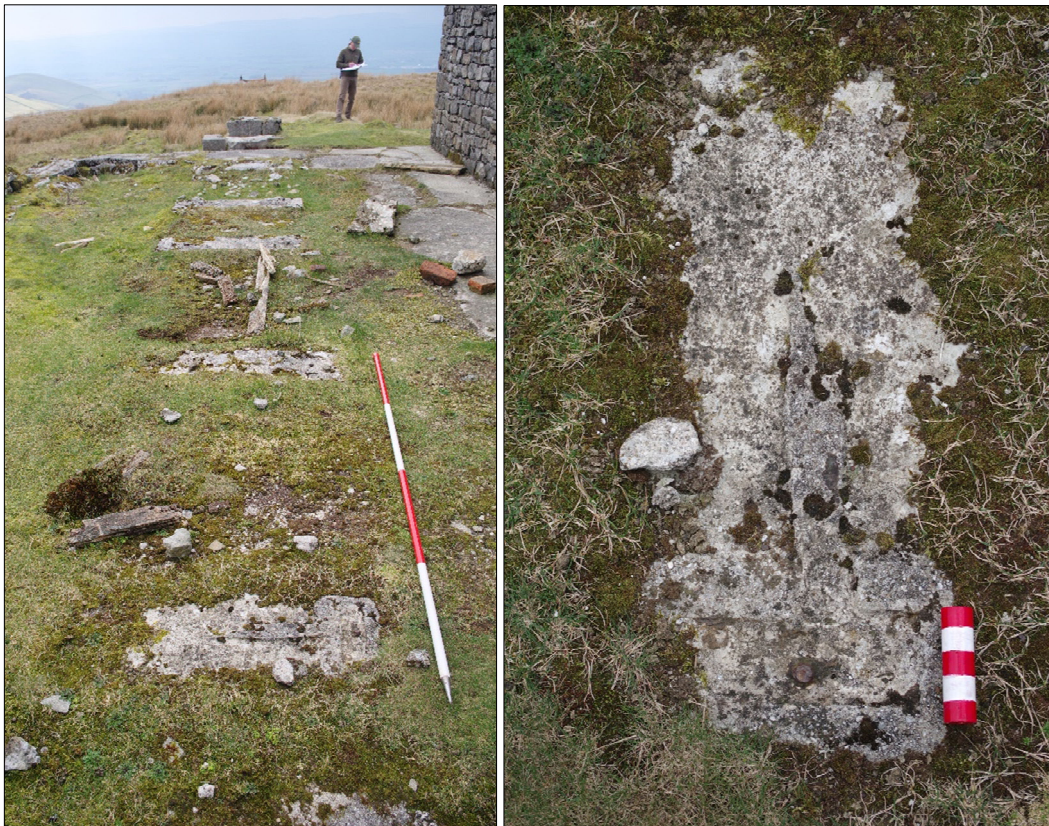
Plate 18: the rectangular mounting blocks, facing south-west (left) and plan view (right); note rectangular impressions and iron fixing pins

- 3.2.6 The floor of the Brake House included 7 concrete mounting blocks set into the surface, each measuring 1.25m by 0.45m, with rectangular impressions in the surface spaced 0.75m apart; a further two blocks, free-standing and quite damaged, were located to the south-west and external to the building on the same alignment (labelled 'B' on the plan – Figure 3). Associated

3.2.7 The rectangular impressions appear to have been impressions from the trestles within the building, which carried the buckets through, with each impression associated with iron pins set within the blocks. The blocks appear to be set in pairs, approximately 1.6m apart, with each pair 0.85m from the next, though there very minor variations to this (see Discussion). The arrangements suggest a further block is likely to survive under the turf north-east of the building, and not currently visible. No other fixtures or fittings were evident within the interior of the building.

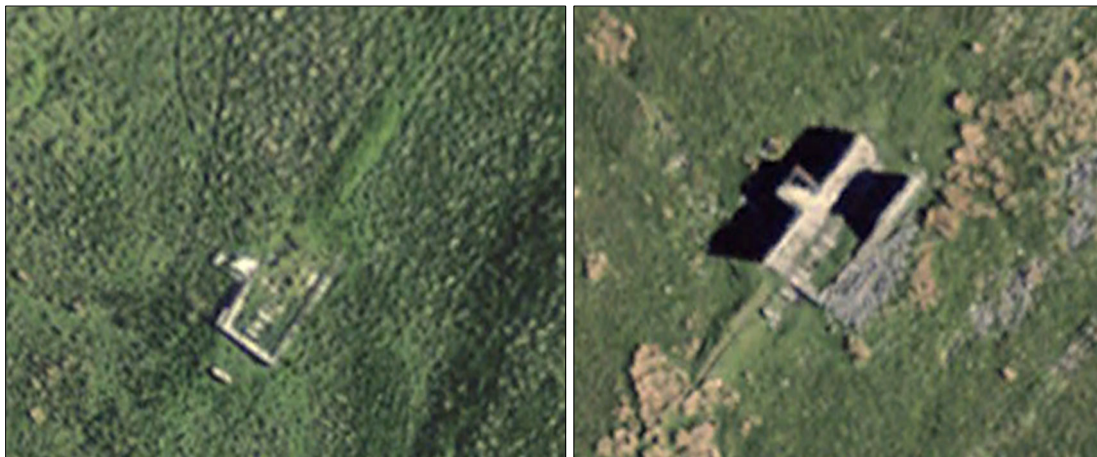
Plate 20: the 'shed' (left) and Brake House (right) taken from Google Earth digital imagery.

- 4.1.2 There is a second building on the line of the ropeway, which is referred to in the Scheduled Monument listing as a “*shed*” and described thus: “*at NY69113023 there is the stone and concrete base of a shed which accommodated a workman who oversaw the progress of the buckets on the ropeway*”. This building, which was not surveyed, is identical in floorplan to the Brake House and aerial photographs (Plate 20) show a similar arrangement of mounting blocks within the interior of the building and extending out south-westwards. This building does not seem to survive beyond its foundations and appears to have been robbed for building stone. A corresponding turfed over dump of spoil is evident leading up to the building, suggesting the buckets may have lurched as they reached the bottom of the slope and changed gradient.
