16th September 1974

NEWS LETTER No. 101. GENERAL1.1 Contents of this issue

2. CANTERBURY PLATED HEAD

### 3. ISOTHERMAL GLAZING: MORE DETAILS

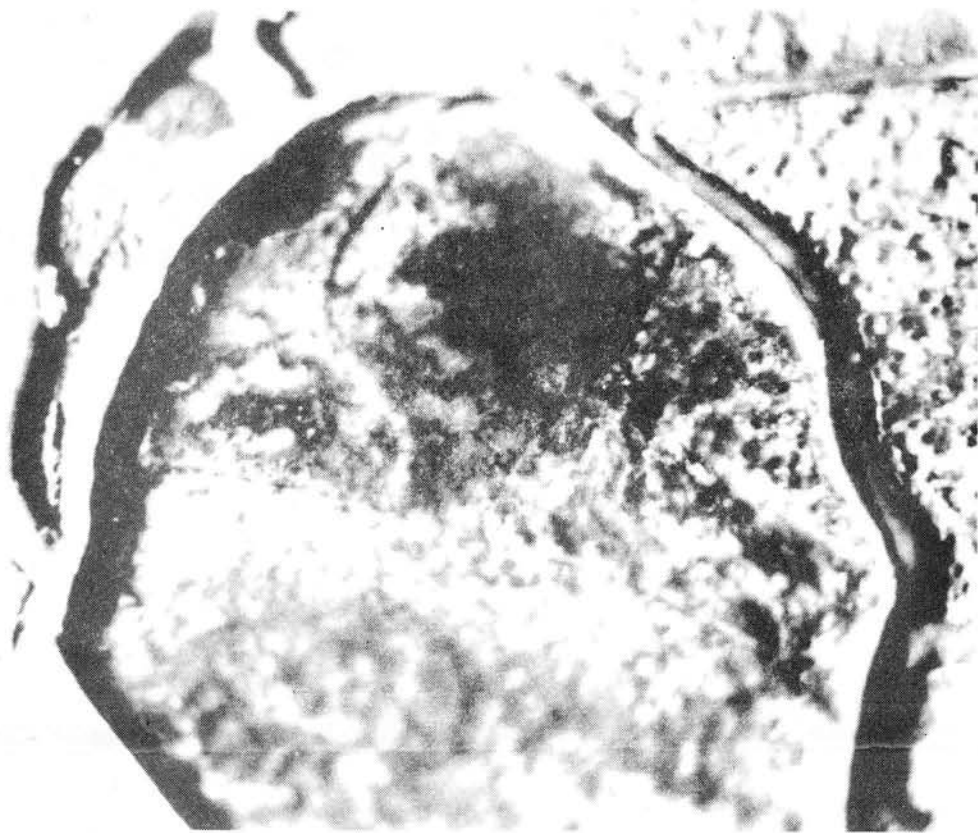
Fig. 1

On 8th August 1974 Mr. Frederick Cole placed a panel on view in the Canterbury workshop for discussion by some experts who were present. This had been repaired by Samuel Caldwell junior in the period 1947 to 1950 and had been mounted in a window (SXIV) of the south choir clarestory of the Cathedral for about 30 years. The cracks in the head had been edge-joined with Lepage's glue and the head had then been "plated". After 30 years the water-soluble glue had entirely disappeared and, opposite the re-opened cracks in the medieval glass, it could be seen that there were white or grey deposits on the inside of the plating which closely followed the lines of the cracks in the medieval head (see Fig. 1). From the outside some of these deposits had a fuzzy appearance and it was not possible to decide their nature although three hypotheses seemed tenable:- (1) the fuzzy lines might be fungal growths or (2) they might be lines where the modern glass had weathered as a result of moist air passing through the cracks in the medieval head or (3) they might merely be lines of "dust" borne in the air which passed through the cracks as the air in the plated cavity alternately expanded and contracted in a daily rhythm.
