# NEWS

# LETTER 29

comite technique du corpus vitrearum

30 AVRIL 1979

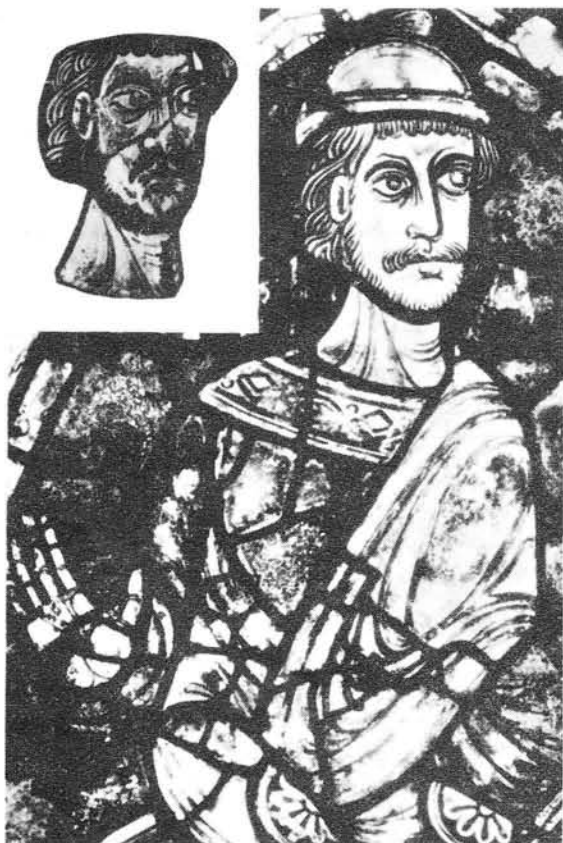
1. Detail of Abia from the clerestory, ca. 1200; head replaced by Austin, ca. 1860 (photo: Victoria & Albert Museum). Inset: Original head, now lost (after Rackham).

was expert in his rendering of pastiche late Romanesque styles, but now his work appears dated; in some cases, for instance where Rackham published the original head of Abia, since lost, it is possible to see how far the painter interpreted the original design in his copy (fig. 1).<sup>2</sup>

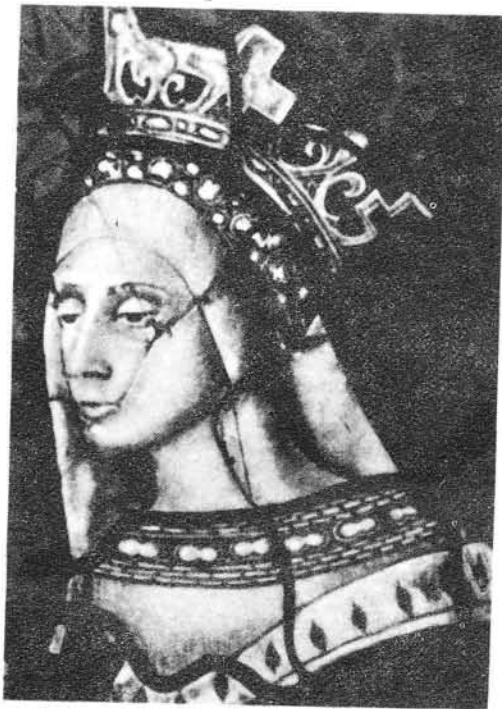
2. Portrait of Queen Elizabeth Woodville, ca. 1485; state in 1945 (after Rackham).

occurred at the upper lip at the time of the fracture (fig. 2). Mr. Cole elected to clean and re-fix the edges, using araldite for the bond, which he cured at 100° F in the kiln. He then repainted the mouth, principally touching in the deficient upper lip (fig. 3). Extant contemporary portraits were not consulted. It is not known whether the pigment used, though applied cold, is reversible without damaging the original paint.

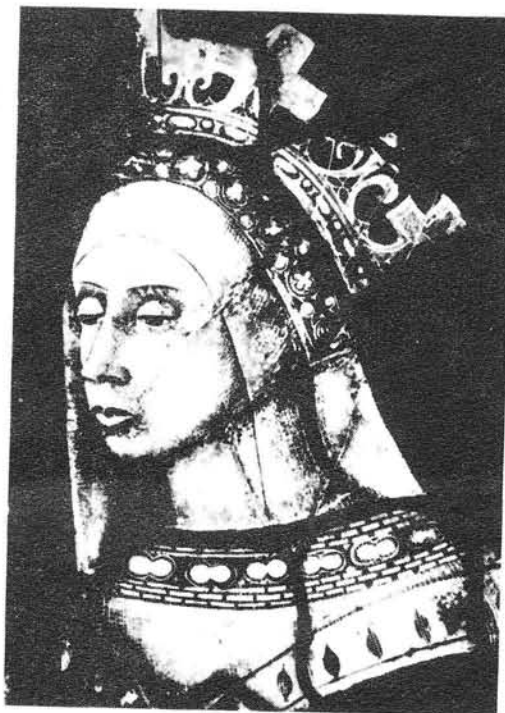
3. The same, after cleaning, refixing, and repainting in 1975.

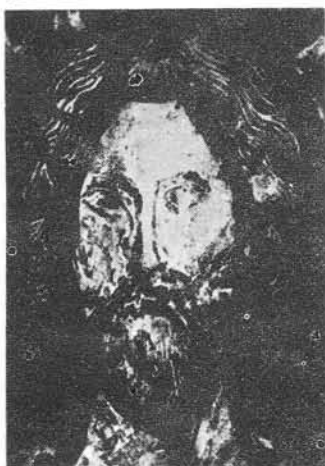
4. Head of Joanna from the clerestory, ca. 1180, prior to restoration.

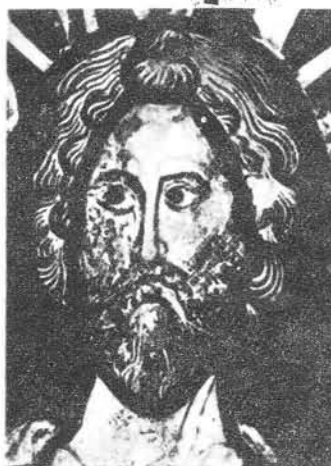
5. The same, after restoration.

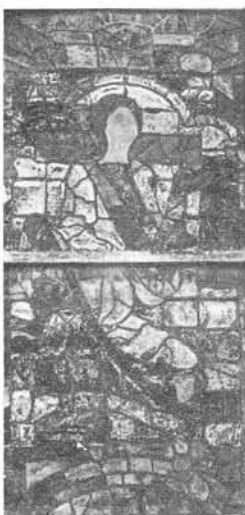
7. Figure of Phares from the clerestory, ca. 1180, exterior before cleaning; note the modelling which defined the knee, since removed.

The methods of cleaning in use in 1975 were fully published in the Smithsonian;<sup>6</sup> they were a revelation to several members of the Advisory Committee. The full process involved: 1) Soaking in deionized water 2) Removal from the leads 3) Cleaning in an ultrasonic bath with ammonia and deionized water 4) Airbrasive cleaning of the outer surface. This stage was often entrusted to volunteer helpers, and no indication was given to them whether back-painting was present; a great deal of paint was removed in this era, for instance from the drapery of Phares (figs. 7, 10). 5) The

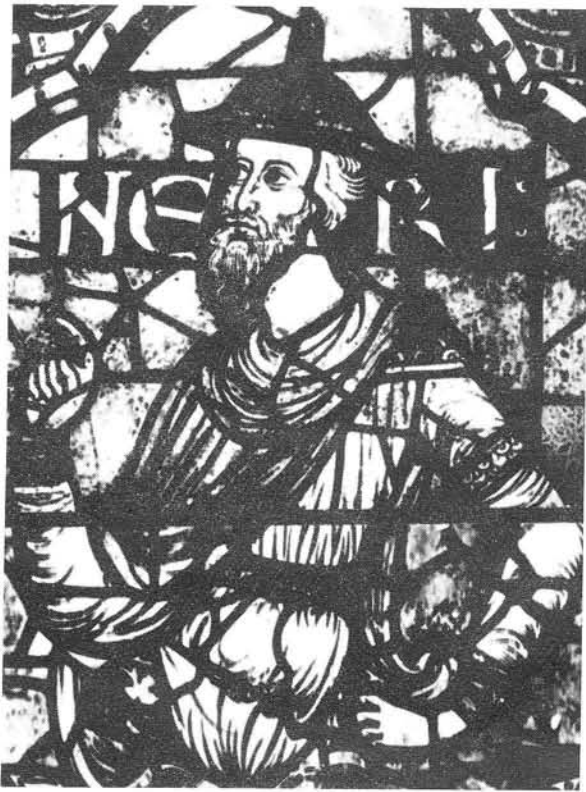
8. Detail of Neri from the clerestory, ca. 1180; after restoration, 1975 (photo: Canterbury Cathedral Restoration Centre).

which had been used in Neri's lower stomach was strengthened in this way, though it had no meaning in the design (fig. 8).

The practice of supplying lost detail on backing glasses has continued. In many cases these glasses are colored or "tinted" to restore the supposed original color; for instance the hat of Neri, a flashed ruby that had become almost white, was restored to brilliant red (figs. 8, 9). The faces, too, are now to be tinted.

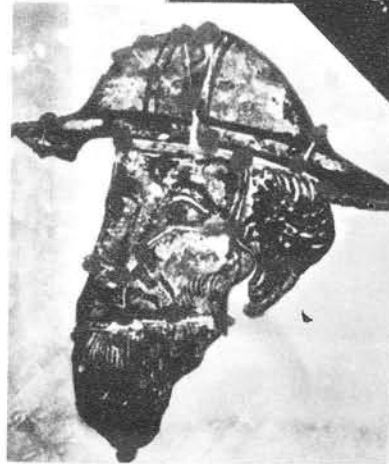
10

9. Head and hat of Neri during restoration: before cleaning. 10. The same, exterior; note the paint on the beard and hair (after Nature/Science Annual, 1978,
