# NEWS

# LETTER 30

comité technique du corpus vitrearum

## **2.conserva-tion and resto-ration of the medieval stained glass windows in freiburg cathedral**

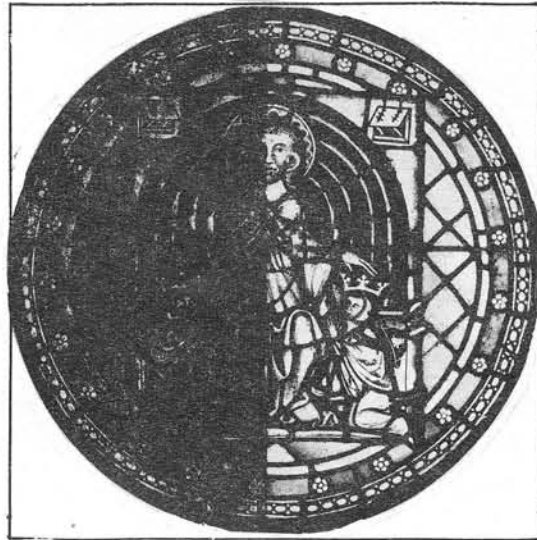
1. Schmiede-Fenster. Hl. Jakobus Pilger segnend, um 1320 (halbseitig gereinigt).
1. Blacksmiths' window, St. James blessing pilgrim, about 1320 (half-cleaned).

der Regel mit einer Acetonlösung problemlos wieder entfernt werden. Wie nachteilig diese Uebermalung das Erscheinungsbild der Langhausfenster beeinflusst hat, zeigt das zur Hälfte "freigelegte" Medaillon mit dem Pilger krönenden Hl. Jakobus aus dem Masswerk des Schmiede-Fensters besonders eindrucksvoll (Abb.1).

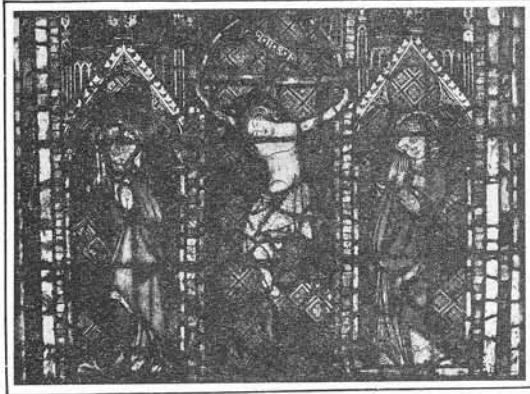
2. Konstanzer Fenster. Kreuzigung Christi, um 1320 (Zustand vor Restaurierung).
2. Constance window. Crucifixion of Christ, about 1320 (before restoration)

Scheiben dieses Fensters befunden hatten (Abb.2,3): Das Bleinetz war so brüchig geworden, dass die einzelnen Farbgläser sich nicht mehr in einer Ebene befanden, was eine starke Verschmutzung der Gläser zur Folge hatte.

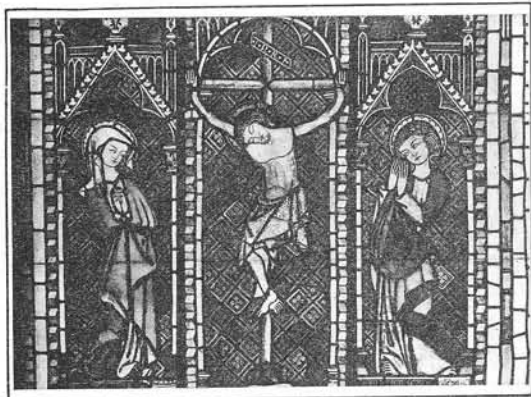
3. Konstanzer Fenster. Kreuzigung Christi, um 1320 (Zustand nach Restaurierung).
3. Constance window. Crucifixion of Christ, about 1320 (after restoration).
