# CV NEWS LETTER 33/34

comité technique du corpus vitrearum

JANUARY 1982

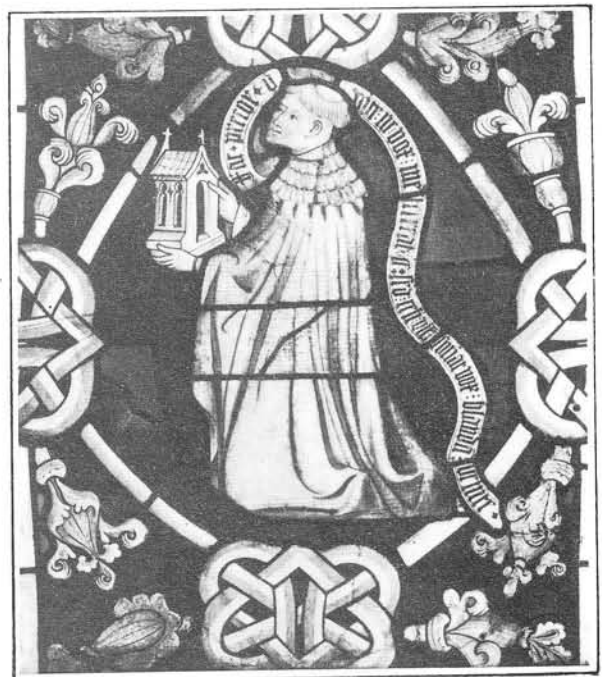
Abb. 1 Uelzen, Heiligen-Geist-Kapelle, Chorn II, 2 b. Der Stifter Rupert von Nortlo (1981)

Schon 1946 wurden die Glasgemälde wieder eingebaut. Ehe jedoch die Schutzgitter montiert werden konnten, brachten Steinwürfe schwere Schäden. Ausgerechnet die schönste Scheibe mit dem Verkündigungengel (Abb. 7) und die historisch wichtigste mit dem Stifterbild des Rupert von Nortlo (Abb. 1) wurden dabei am stärksten getroffen. Notdürftig ausgeflickt und von außen mit Drahtgittern gesichert standen seither die Scheiben in den Fenstern.

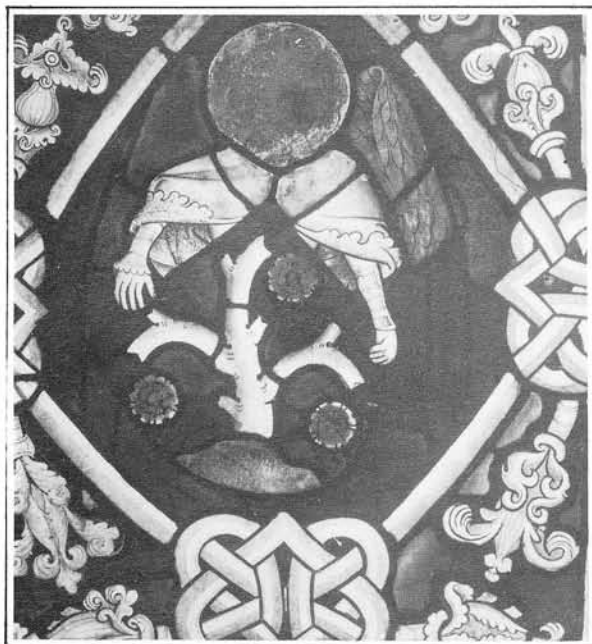
Abb. 2 Uelzen, Heiligen-Geist-Kapelle, Chor I, 2 a: Engel mit Wappen (1942)

die mit einem wappentragenden Engel (Abb. 2) nur noch im Grund des Medaillons, in der Engelsfigur und im Wappen einige alte Gläser enthält, also weitgehend erneuert ist. Diese "Unverdächtigkeits" auf den ersten Blick" spricht zugleich für Freystadts Sorgfalt bei den Ergänzungen. Auch die Scheiben, die sofort als seine Neuschöpfungen zu erkennen sind (Abb. 3), zeigen deutlich das Bemühen, das Stilbild der Glasmalereien des Weichen Stils aufzunehmen und sich ihm anzupassen.

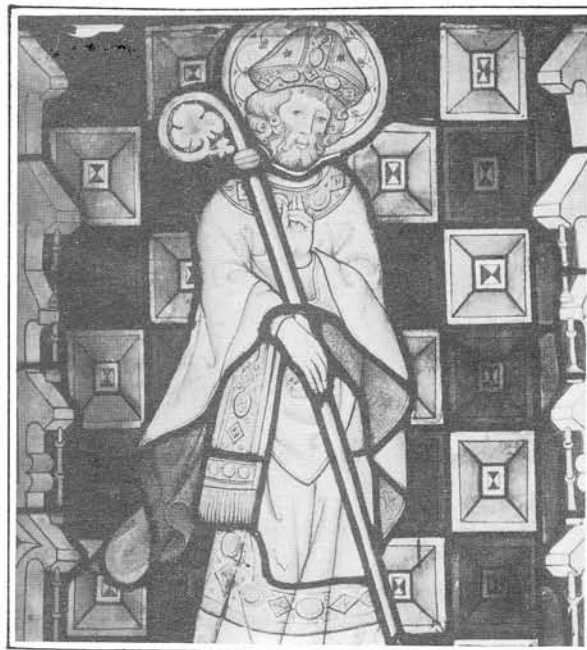
Abb. 3 Uelzen, Heiligen-Geist-Kapelle, Chor s III, 3 a: Hl. Bischof, 1890 von Freystadt geschaffen (1942)

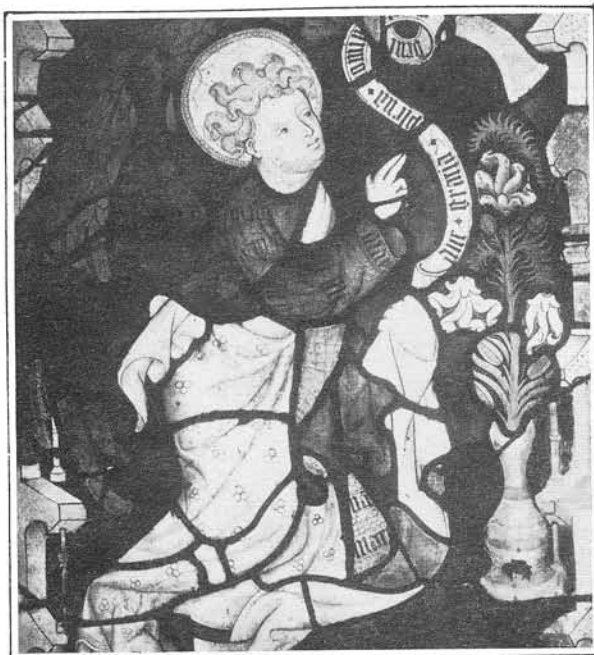
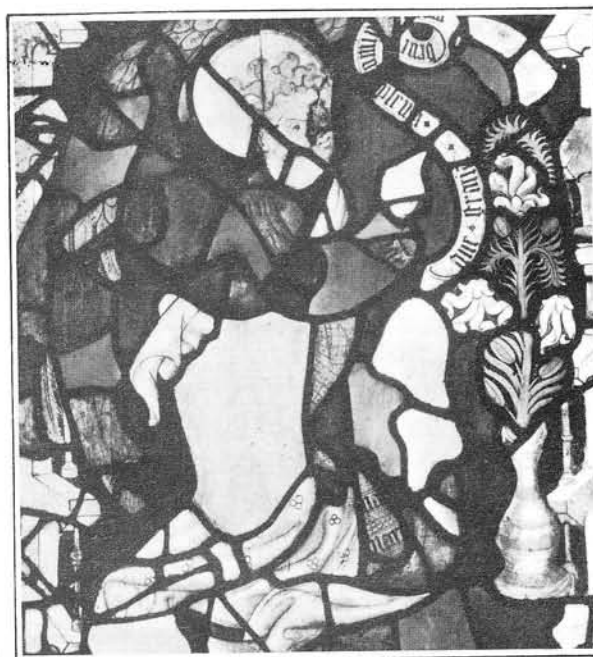
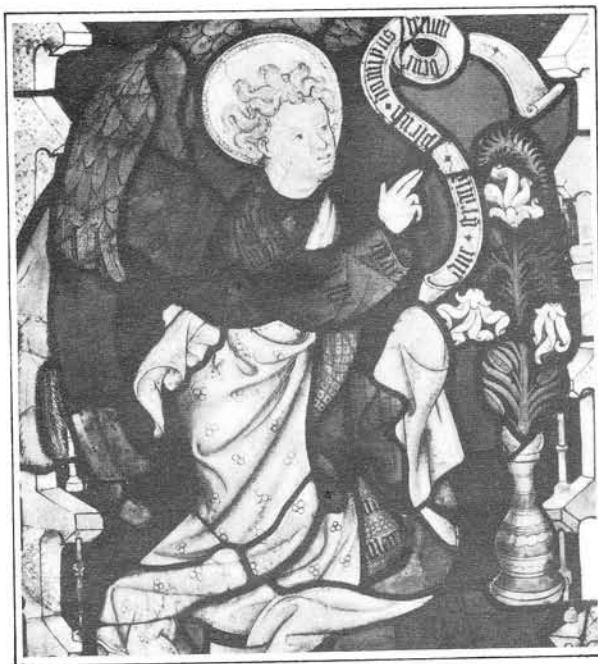
Abb. 6 Uelzen, Heiligen-Geist-Kapelle, Chor n III, 2 a: Verkündigungselengel (1942)

Abb. 7 Dieselbe Scheibe nach der Reparatur von 1946 (1972)

Abb. 8 Dieselbe Scheibe nach der Rekonstruktion (1981)

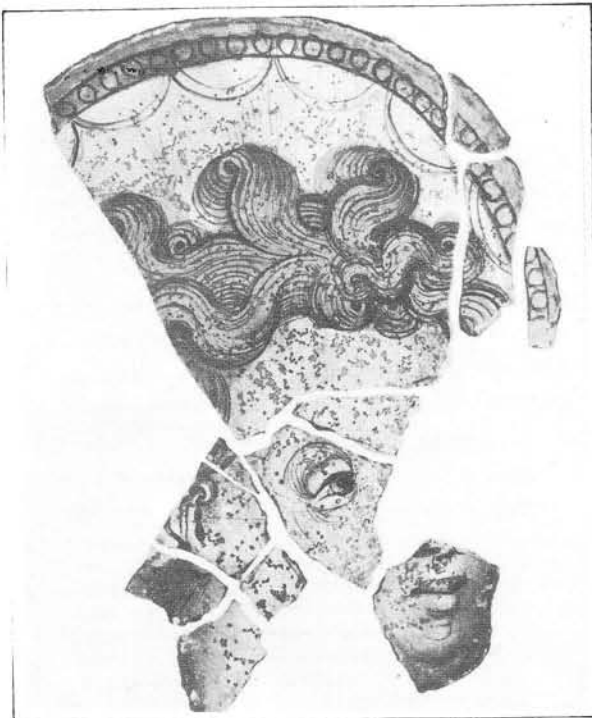
Abb. 9 Kopf des Verkündigungsengels (1942)

Abb. 10 Die originalen Reste des Kopfes (1980)

Abb. 11 Der rekonstruierte Kopf (1981)

das Unternehmen der weitgehenden Rekonstruktion von vornherein unmöglich gewesen. Reproduktionsvergrößerungen im Maßstab 1 : 1 dienten als Karton und erlaubten die minutiöse und genaue Kopie der zerstörten Originalstücke. Es ist dem besonderen künstlerischen Geschick, der kritischen Sorgfalt und dem Engagement des Werkstattleiters Heinrich Ziemons zu verdanken, daß diese rekonstruierenden Ergänzungen so vorzüglich gelungen sind. Der Engelskopf z. B. war nur noch aus Scherben zusammengestückt; Hals und Hinterkopf, das linke Auge und die Nase fehlten (Abb. 9 – 11). Nach der Ergänzung wird dem Betrachter kaum auffallen, daß mehr als ein Drittel dieses Kopfes nicht aus dem frühen 15. Jahrhundert stammt, sondern 1980/81 rekonstruiert wurde.

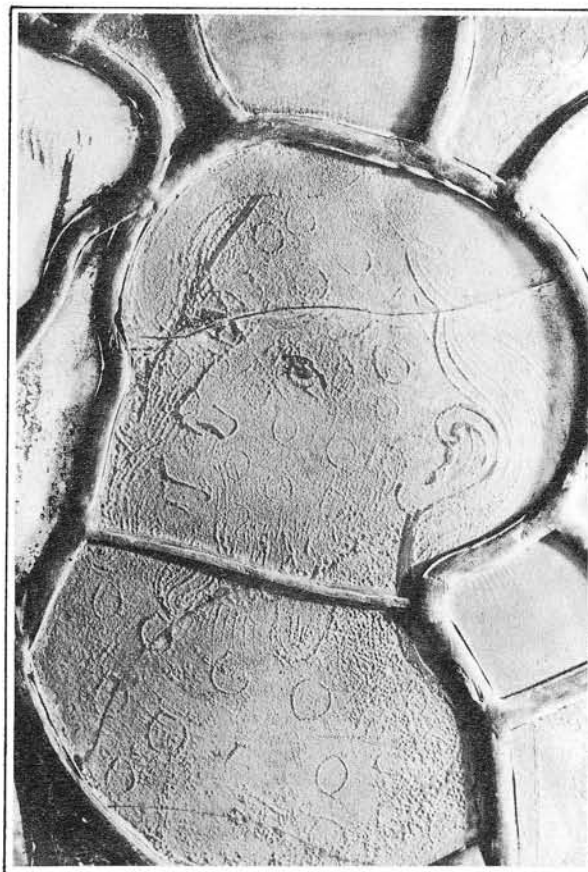
Abb. 12 Uelzen, Heiligen-Geist-Kapelle, Chors III, 3 b, Detail: Verwitterungsrelief im Seitenlicht (1980)

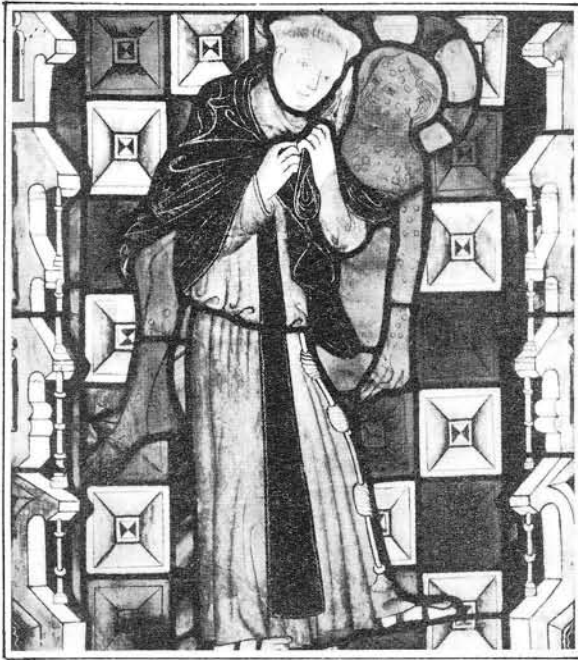
Abb. 13 Uelzen, Heiligen-Geist-Kapelle, Chor  
s III, 3 b: Franziskus mit aussätz-  
igem Christus (1981)
