THE PENN DOOM

E. CLIVE ROUSE, F.S.A.

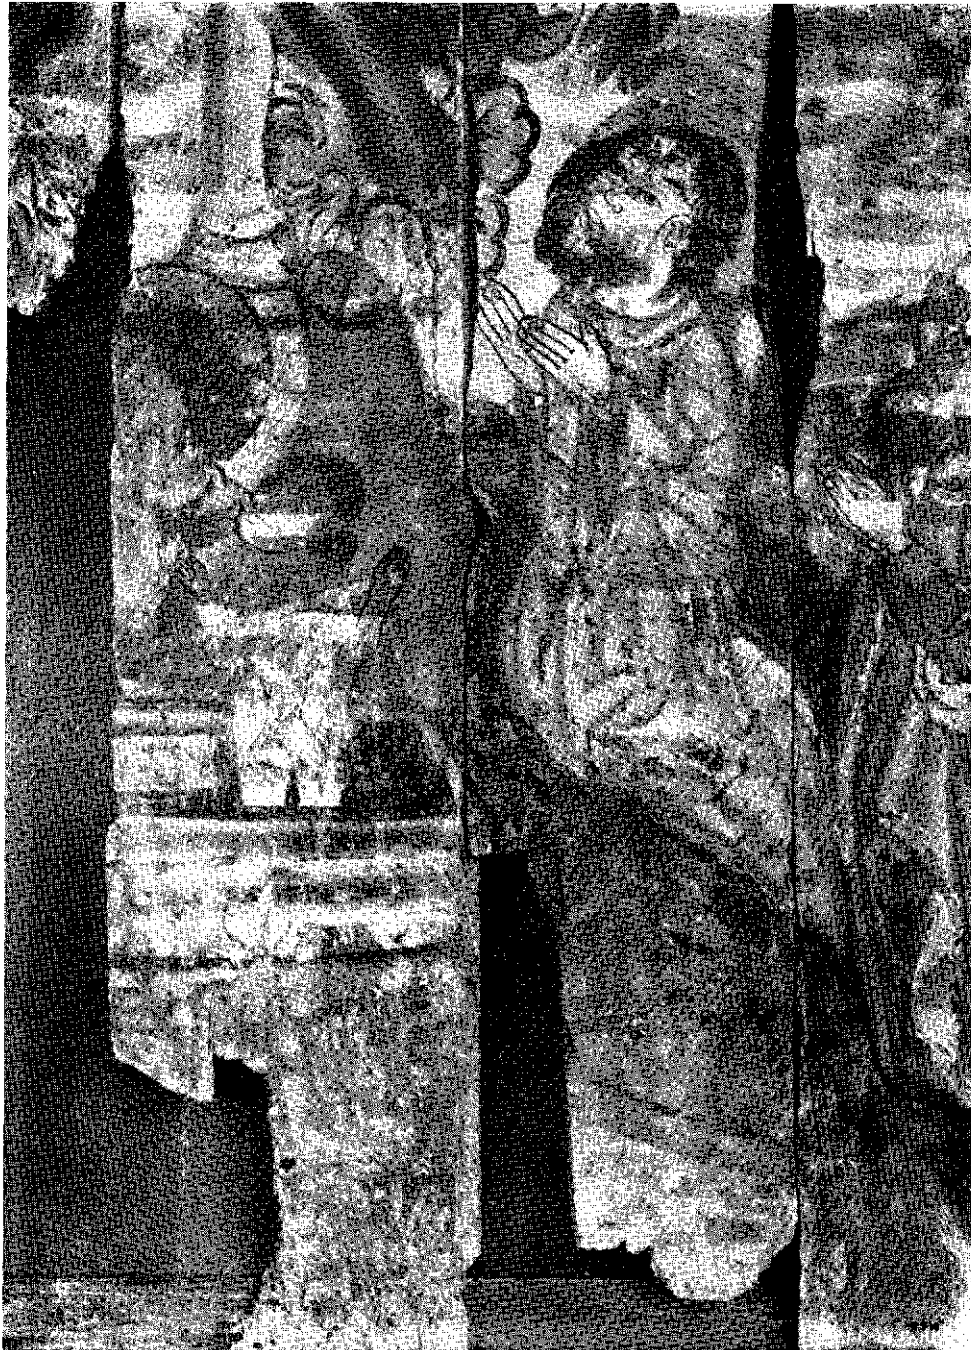
PLATE V. Detail, showing St. John Baptist, resurrecting figure, and earlier painting of St. Michael weighing souls, beneath.

In the course of cleaning and treatment it was possible to reveal a part of this scene by removing the later green foreground and other parts where they did not materially affect the later composition. The scene was placed in the lower centre, immediately beneath the sphere on which our Lord’s feet rest; but the lower part of the central board is missing. Just in front of the figure of St. John Baptist is the figure of St. Michael (Plate V). The top of his wing touches the cloud at one end of the rainbow, and his head and halo can be seen against the left-hand base of the pillar Passion Symbol. The Virgin’s inclined head and halo are just to the right of the other end of the rainbow: and the folds of her cloak extend down below the grave of the resurrecting priest (Plate VI). Here also can be seen one pan of the scales held by St. Michael. The beam of the balance rises at an angle,

and the other pan is suspended from it, beneath one of the upraised hands of the other resurrecting figure, by three cords. They can be seen passing down through this figure's grave (Plates V and VI).

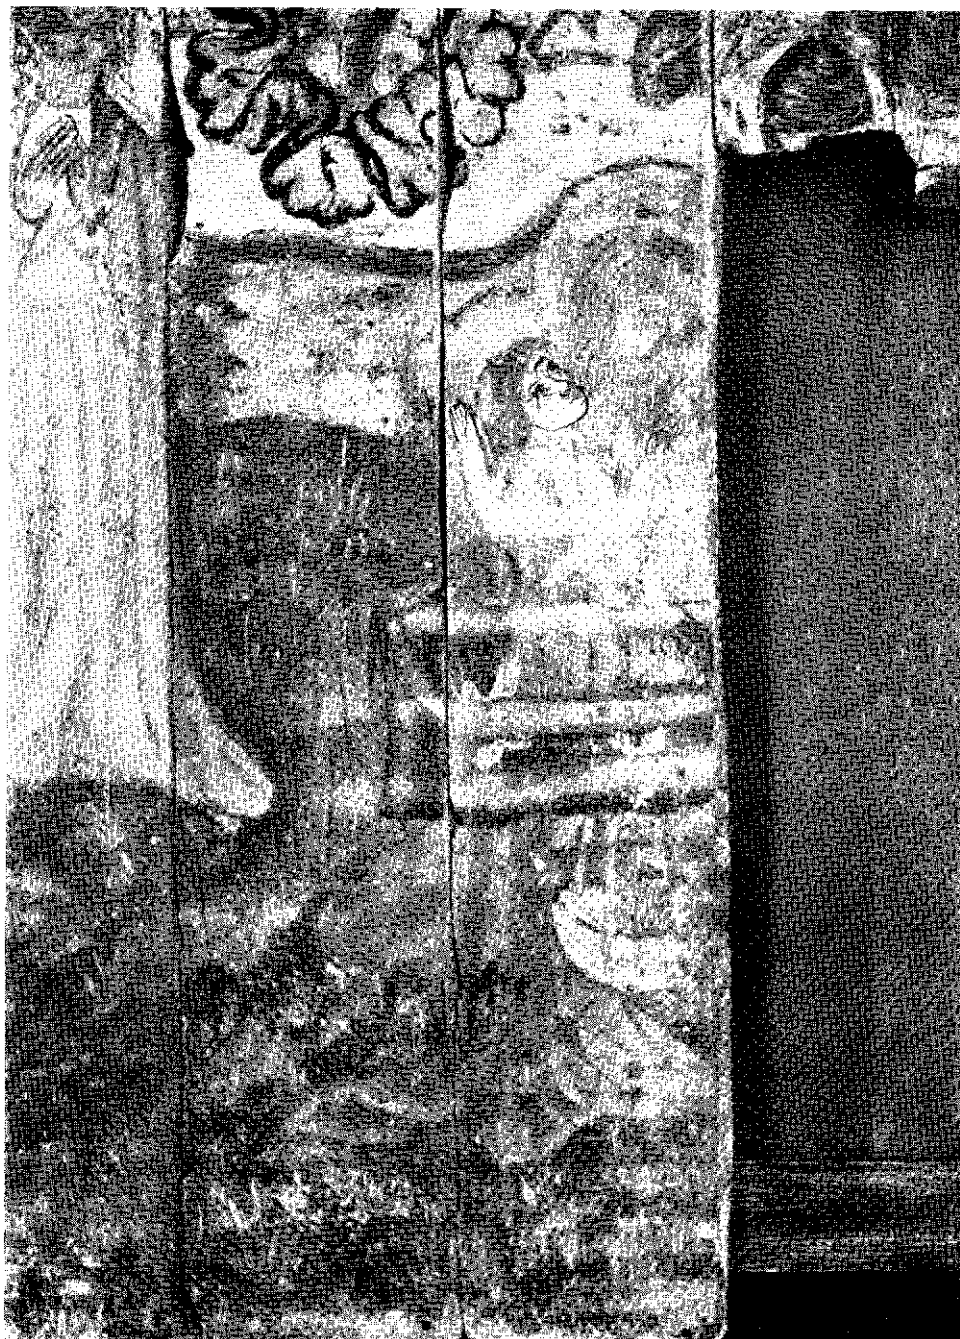
PLATE VI. Detail showing part of figure of the Virgin, resurrecting priest, and earlier head and robe of the Virgin in the weighing of souls scene.

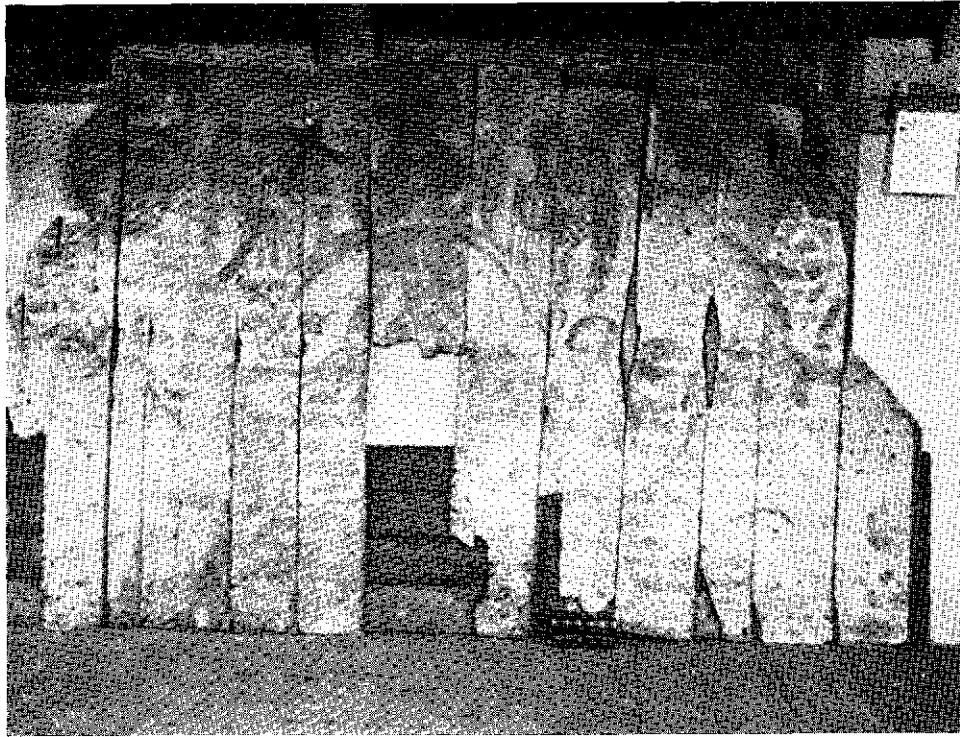
PLATE VII. The boards of the Penn Doom roughly re-assembled and freed of laths and plaster and some whitewash immediately after discovery, but before cleaning.

The painting had then to be freed of its coat of whitewash (received presumably at the Reformation) and subsequent dirt. This presented no serious difficulty and was accomplished by a combination of flaking, gentle scraping and brushing with a sable brush. The painting partly in this state is shown in Plate VII. Much care had to be exercised in a number of areas, where the underlying paint layer was detached, or liable to flake. The whole was then cleaned with damp swabs of cotton wool and a mild solvent where necessary. It was not found possible altogether to mitigate the curious horizontal banded appearance left by the laths and plaster, as these had alternately bleached and darkened the wood and pigments, and in some cases corroded the paint layer down to different levels. The clearance of some of the features of the earlier, underlying painting has already been referred to.

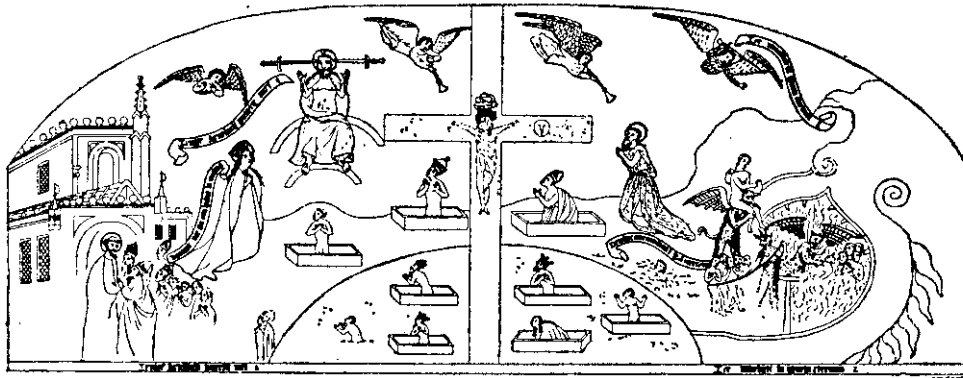
The painted wooden fragment in St. Michael's Church, St. Albans, now preserved in the vestry, found in 1808, originally filled the top of the Norman Chancel arch, and only shows six souls rising from graves or coffins, with the silhouette of the cross in the centre.⁷ The rest of the composition, now destroyed but luckily recorded, was painted on the plaster of the wall above the chancel arch (Fig. 3).

FIG. 3. ST. MICHAEL'S CHURCH, ST. ALBANS, Herts. Doom partly on wall above chancel arch, and partly on boarded tympanum. Only the latter survives. From an engraving after Henry Cook in the possession of the Society of Antiquaries.

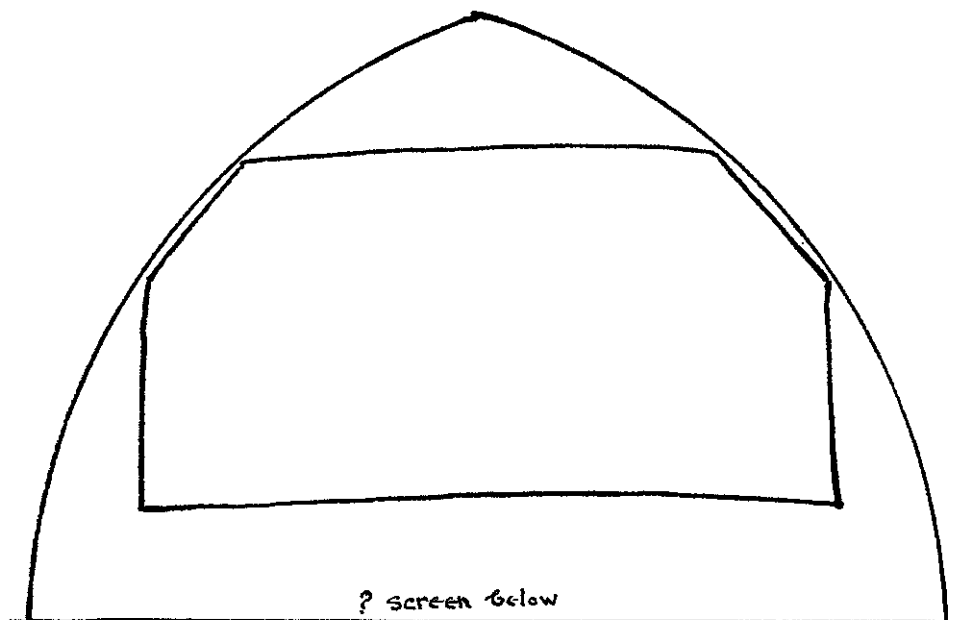
FIG. 4. Rough diagram to show how the present shape of the Penn Doom would have fitted into a medieval pointed arch, thus giving additional space at sides and bottom if it had been cut down from a full tympanum. Compare fig. 3.

To conclude, therefore, it seems likely that the original painting was executed at the end of the fourteenth century, and was a true tympanum, filling the upper part of the medieval chancel arch, which would have been wider at the base than the present boarding, and would have extended upwards to an arched apex. It would thus have been able to embrace a more extensive treatment of the subject (Fig. 4).

For some reason unknown, this was removed, cut down to fit the roof space and repainted something like a century later. This is suggested by the fact that the present top edge of the boarding cuts the outer angels' wings and touches the inscribed scrolls. The lower sides also have clearly undergone some modification. It would thus have remained undisturbed when the medieval chancel arch was replaced in 1733, but may well have been lathed and plastered at that date to cover decay in the boarding, since it was only whitewashed at the Reformation.
