HITCHAM OLD BARN

A POSTHUMOUS STUDY

A. H. Packe and J. D. Broadbent, A.R.I.B.A.

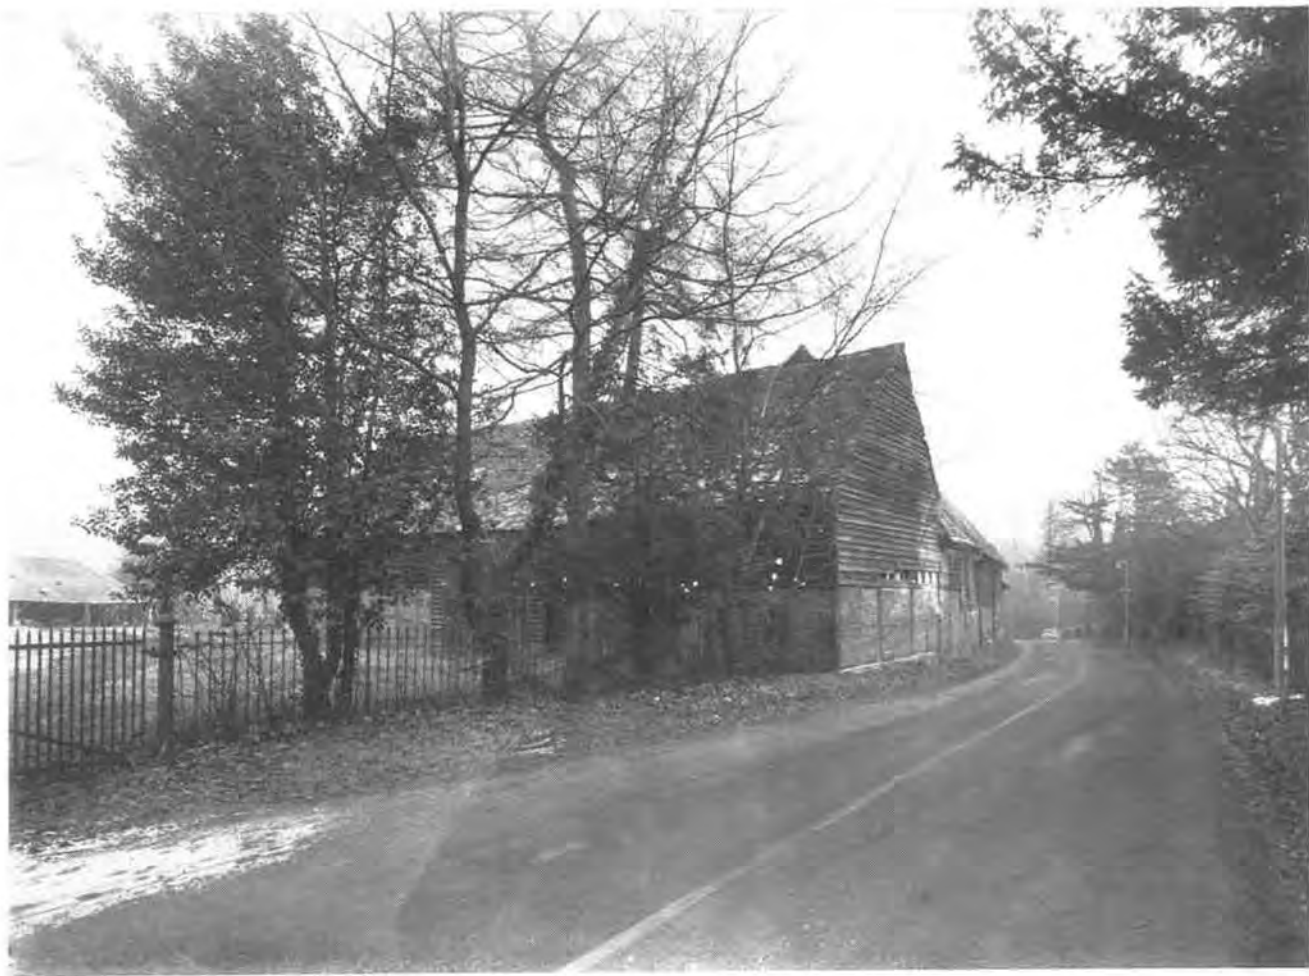
PLATE VI. Hitcham Barn from the South West

Fortunately, the Barn had been photographed by the National Monuments Record and these records have been used to illustrate this study. Plate VI (NMR. BB. 66/1638) shows the Old Barn with the later additions lying along the road beyond it. It is taken from a point on the south side of the road, roughly in line with the east boundary wall of the churchyard.

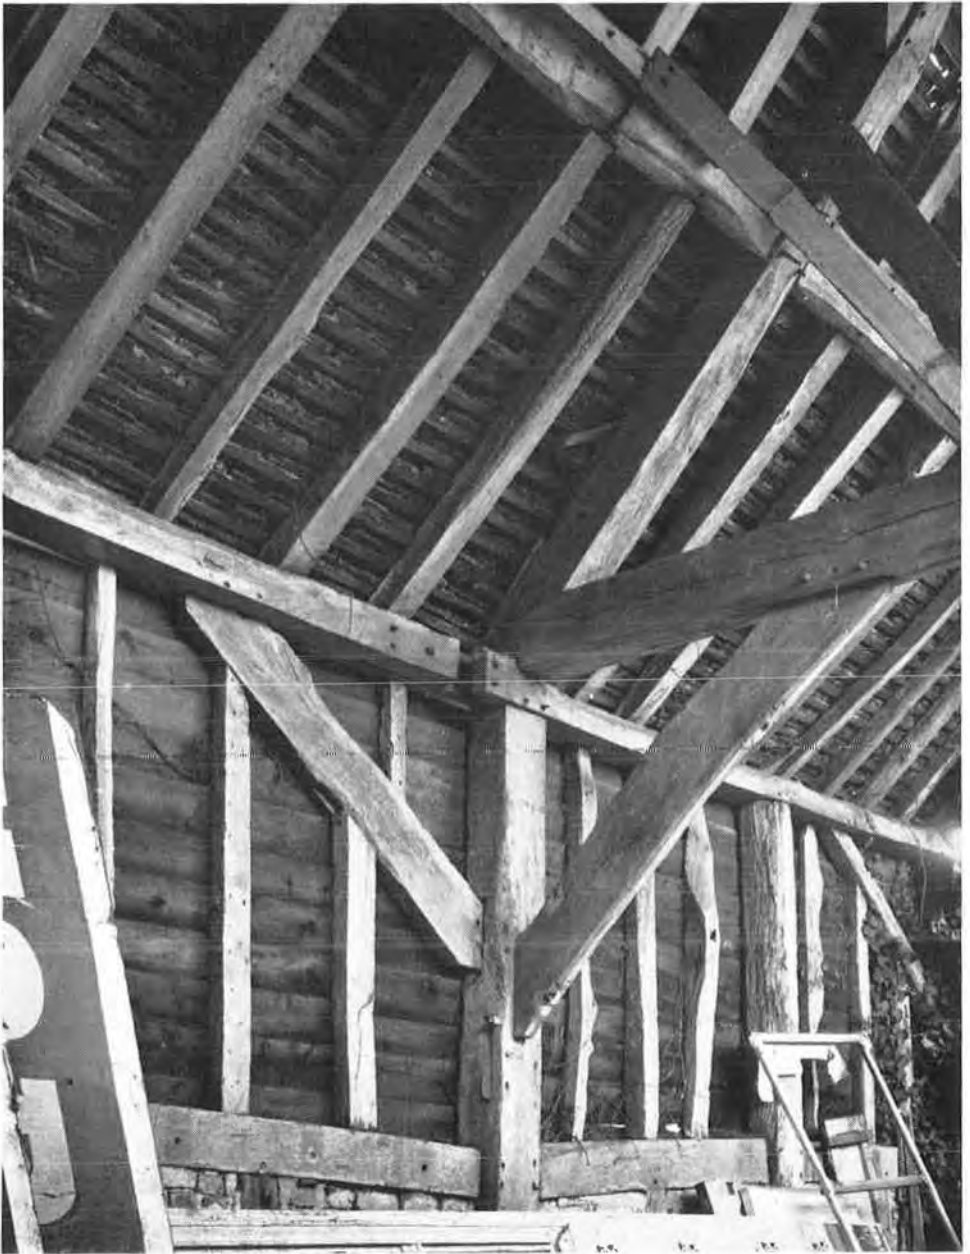
PLATE VII. Hitcham Barn, Interior.

Consider Plate VII (NMR./BB.66/1647): Starting at the top, it will be seen that the lower line of purlins (one of which has snapped) are deeply morticed into the sides of the principal rafter of the truss and held by pins driven in from outside. Although it cannot be seen from the photograph clearly, the common rafters above and below are separate pieces of timber, each morticed into the sides of the purlins.

The knee-brace to the truss tie-beam is solidly morticed to this and the main upright. The wall plate carrying the bottom of the rafters is morticed over the main uprights and from the curious fish-plate joint in the length it can be seen that the right-hand section (north end) was built first and that the bays working southward must have been added in order.

The middle rail of the wall is again properly jointed to the uprights and the rough-hewn uprights are deeply morticed top and bottom. The two modern soft-wood uprights in the foreground are merely "tosh" nailed to the old knee-brace. An examination of the original uprights since the collapse convinces me that they have only been covered with nailed boarding twice or three times, and there is no evidence of other fixings, so that this area must have been open when the barn was originally built.

Coming to the lower (brick) panels, the vertical filling members are properly morticed to the middle rail but not to the wall plate at ground level. The horizontal members are crudely socketed into the main uprights, but a simple experiment convinced me that each square of framing could have been sprung in at a later date.

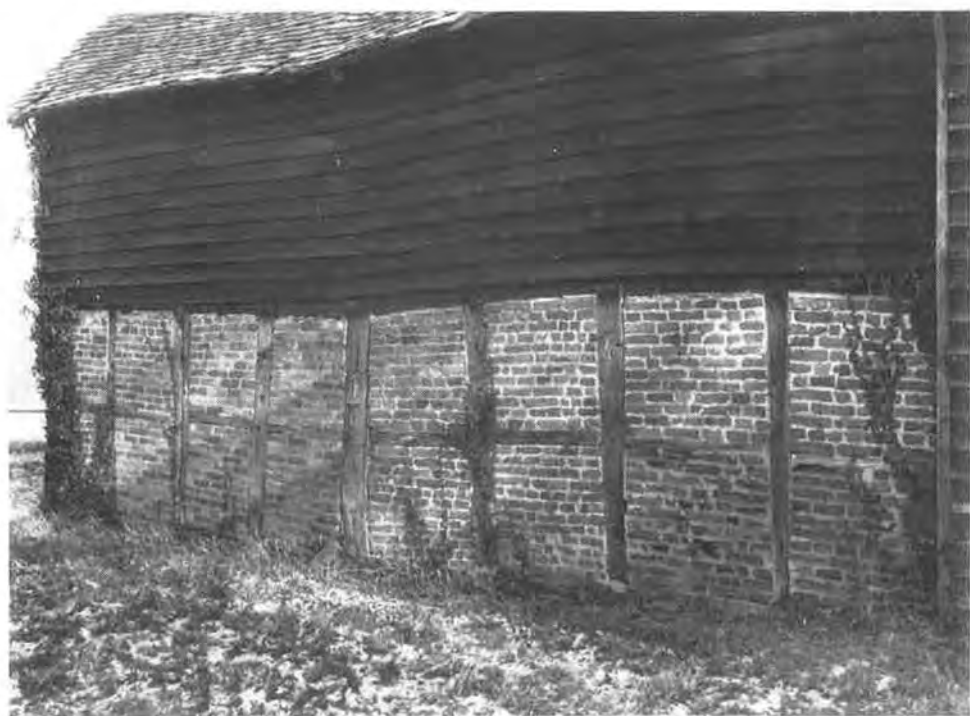
PLATE VIII (b). Detail of West Elevation.
Brick filling built after settlement of foundations.

Plate VIII *b* (NM R.BB.66/1642) shows these panels. It will be seen that drastic settlement of the second main column has occurred before the framing was put in, and the filling uprights have been fixed out of plumb to simplify the brickwork. This convinces me that originally the lower parts of the wall were completely open. It is interesting that the modern dutch barn has very much the same layout.
