THE OLD MANOR, ASKETT

GUY BERESFORD

SUMMARY

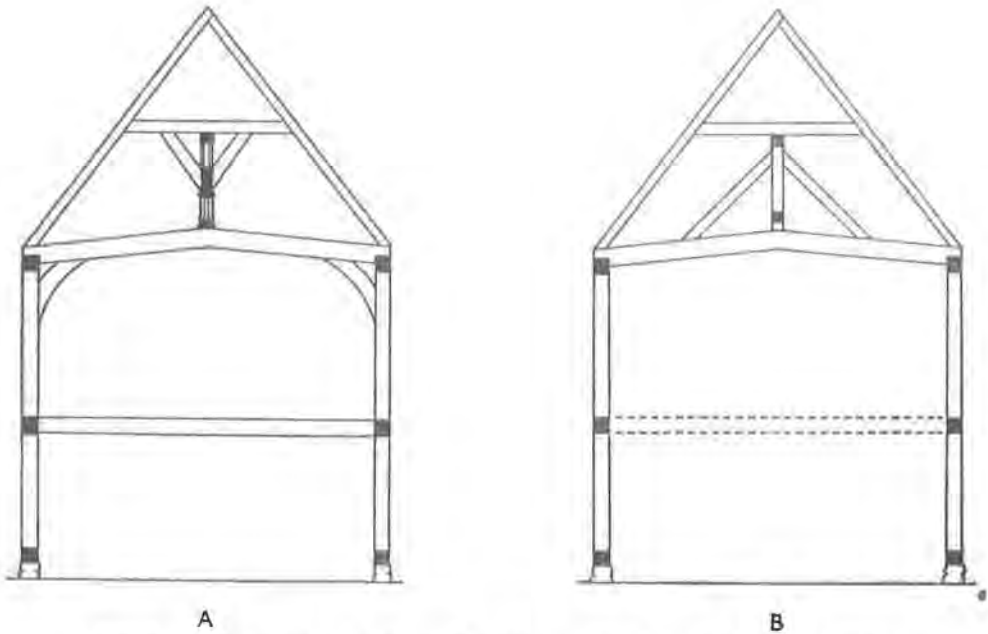
Fig. 6. Sections of solar wing. A central truss. B north-east gable-end.

SOLAR ROOF. The solar roof, which was divided by a tie-beam and crown-post, was assembled without the use of a principal rafter or main truss. The common rafters, set 13 ins. apart, were tongued together at their apices and joined by collars. Their lower ends were let into, and dowelled to, the top-plates. The crown-post and collar-purlin, provided to give longitudinal stability, were developed in the second half of the 13th century,¹² the roof of the chapel of the Prebendal, Thame, being an early example.¹³ The crown-post was 3 ft. 9 ins. high and was mortised to a cambered tie-beam. (Fig. 7 & Plate Ib). It was octagonal and had roll mouldings on the base and capital. Four straight braces

sprang from a point approximately one third of the way up the post, two supporting the collar and the other two the collar-purlin. The crown-post was comparable to those of the early 14th century.¹⁴ The undecorated crown-post at the gable end of the roof was braced down on to the tie-beam and one upward brace supported the solar purlin. There was neither a ridge-piece nor a wind-brace (Fig. 6).

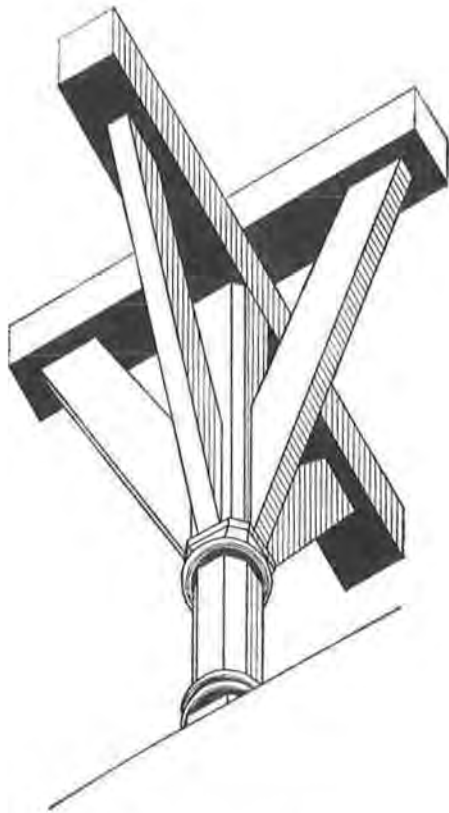
Fig. 7. Crown-post.

PHASE 1. The first structural phase is ascribed to the first half of the 14th century. The crown-post (Plate Ib & Fig. 7) suggested an early date. The post was short and the braces sprang from a point approximately one third of the way up. It was octagonal and there were roll mouldings at the base and capital. It was comparable with the crown-posts at Tiptofts Hall, Essex, early 14th century,²⁷ Merton College, Oxford, circa 1290,²⁸ Lady Chapel, Blewbury Church, Berkshire, circa 1330,²⁹ the Old Parsonage, Marlowe, circa 1340,³⁰ and those set out in phase 3 of Dr. Fletcher's and Mr. Spokes's classification of crown-post roofs, circa 1310-1360.³¹ The crown-post at the north-east gable-end of the roof was comparable to that at the north end of the hall at Middle Farm, Harwell, circa 1365.³²

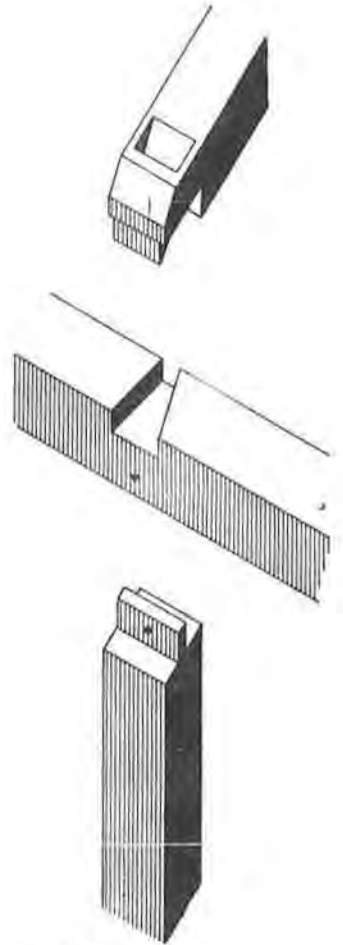
Fig. 8. Joint of principal-post, top-plate and tie-beam in solar.

The principal and corner posts had no jowls. The top-plates were mortised and tenoned on to the top of these posts. The tie-beams were secured to the top-plates with a true lap-dove-tail joint. (Fig. 8) Approximately 3 ins. from the principal posts, the top-plates were joined by 'Trait-de-Jupiter' joints (Splay-and-tabled scarf-joints) (Fig. 9). This was a usual method of extending horizontal timbers in the 13th and early 14th centuries. The development and distribution of the crown-post roof has been fully discussed by Dr. Fletcher and Mr. Spokes.¹⁵ HALL ROOF. HAMMER-BEAM TRUSS. The Pilgrims Hall in Winchester,¹⁶ circa 1325-6, and Tiptofts Hall in Essex,¹⁷ built during the early part of the 14th century, are the earliest true hammer-beam roofs surviving in this country. The cumbersome appearance of timber aisled-halls led the master carpenters of the 14th century to construct a truss to span buildings of more than 30 ft. in width, without the aid of aisle-posts. The hammer post of a true hammer-beam roof has the same structural significance as an aisle post of an aisled-hall, but instead of the post extending from the roof to the floor, the base of the post rests on a braced hammer-beam, protruding from the wall-plate. The purlin, hammer-post and collar have the same structural significance as the arcade-plate, aisle-post and tie-beam of the aisled-hall.

The assembly of the jowless principal post and tie-beam would seem to be more consistent with the 14th than the 15th century.

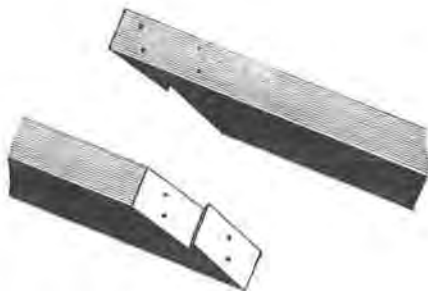
Fig. 9. Splayed and tabled scarf-joint (trait-de-Jupiter).

The top-plates were joined with a splay-and-tabled (*Trait-de-Jupiter*) scarf joint, a feature usually associated with the 13th and 14th centuries.³³ Examples are to be found in Montagu's Great Chamber, Bisham Abbey, mid. 14th century,³⁴ Pilgrims Hall, Winchester, circa 1325,³⁵ and Abingdon Abbey Barn, circa 1275.³⁶

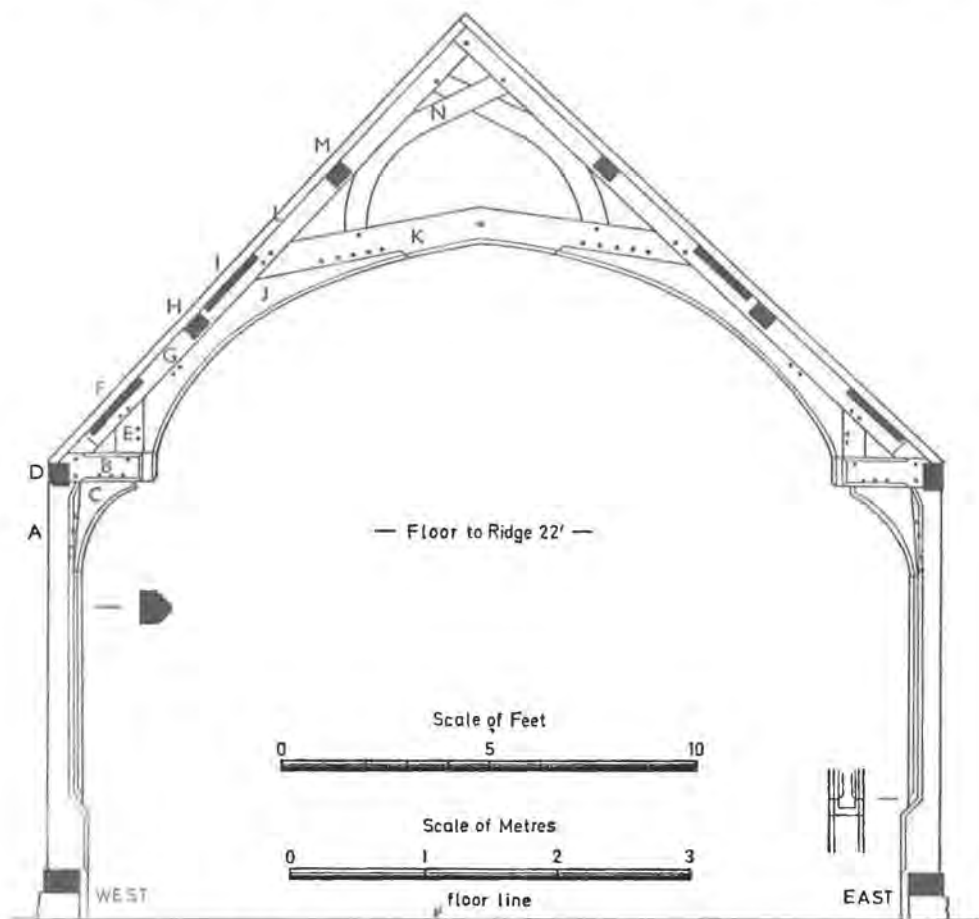
Fig. 10. Hammer beam truss in hall (phase 2).

The section of the hammer-beam truss and the assembly of the hammer-beam joint are shown in Figs. 10 & 11, Plate II. The hammer-beam (B)

was rebated on to, and mortised and tenoned into, the side of the top-plate (D). The top-plate (D) and the hammer-beam (B) were mortised and tenoned on to a jowled principal post (A). A principal rafter was not used in the construction of this truss. Principal rafters were used in the trusses at the upper and lower ends of the hall. If a principal rafter had been used in the construction of the truss described, it would have been necessary for it to have been mortised

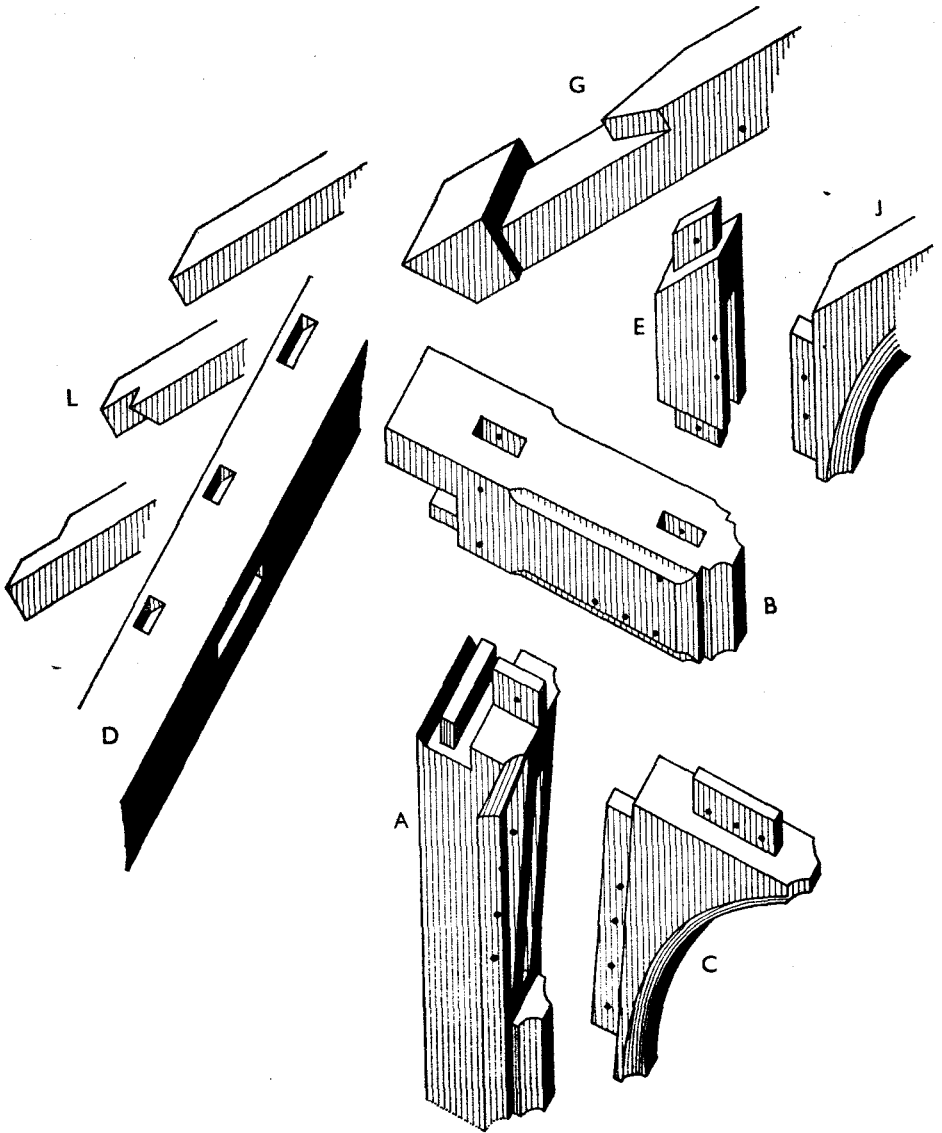
Fig. 11. Exploded drawing of hammer-beam joint. A principal post, B hammer-beam, C hammer-beam brace, D top-plate, E hammer-post, F Lower wind-brace, G truss-blade, H lower purlin, I upper wind-brace, J Collar Brace, K collar, L rafter, M upper purlin, N crossed brace.

into the hammer-beam at a point at which it was halved over the top-plate, thus making a weak joint. The use of a common rafter and a truss-blade enabled the base of the latter to be mortised into the full thickness of the hammer-beam. The collar was secured to the truss-blade with a sleeping mortise-and-tenon joint. The cross-bracing above the collar had little structural significance and was so placed to relieve the plain appearance above the tie-beam. (Plate IVa.)

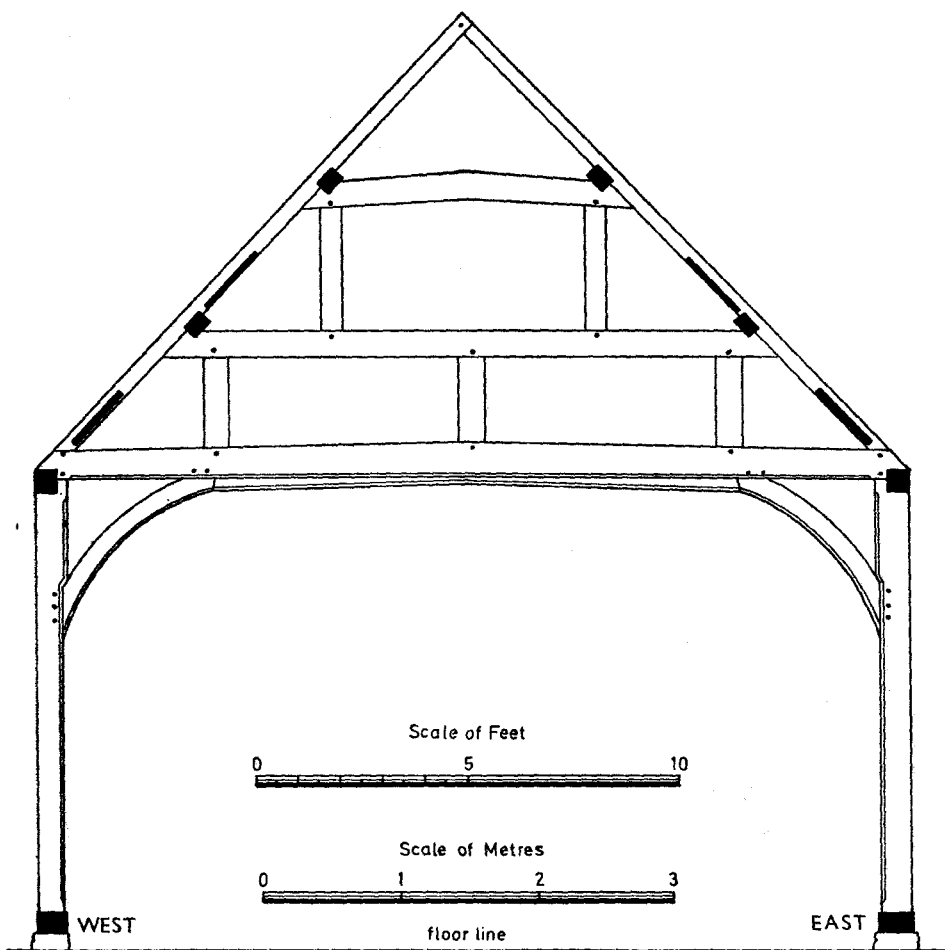
Fig. 12. Truss at north end of hall.

TRUSS AT THE UPPER END OF THE HALL. The truss was situated behind the dais. There was no framing behind the tie-beam, as the wall of the hall was formed by the side of the solar wing. The slightly cambered tie-beam, with a moulded soffit, was braced. The truss and the assembly of the jowled angle-post, top-plate, tie-beam and principal rafter are shown in Figs. 12 & 13. The construction of this truss can be compared with that of many to be seen in Berkshire, where the use of two collars was common. The truss closely resembles one in the thatched out-house at Middle Farm, Harwell,¹⁹ and it is similar to one in Mapledurham House.²⁰ On this truss, as on the spere-truss, a principal rafter was used, instead of a truss-blade and common rafter. The housing of the ends of the purlins between the collars and the principal rafters may have given greater stability than would have been obtained if the purlins had been mortised and tenoned into a truss-blade.

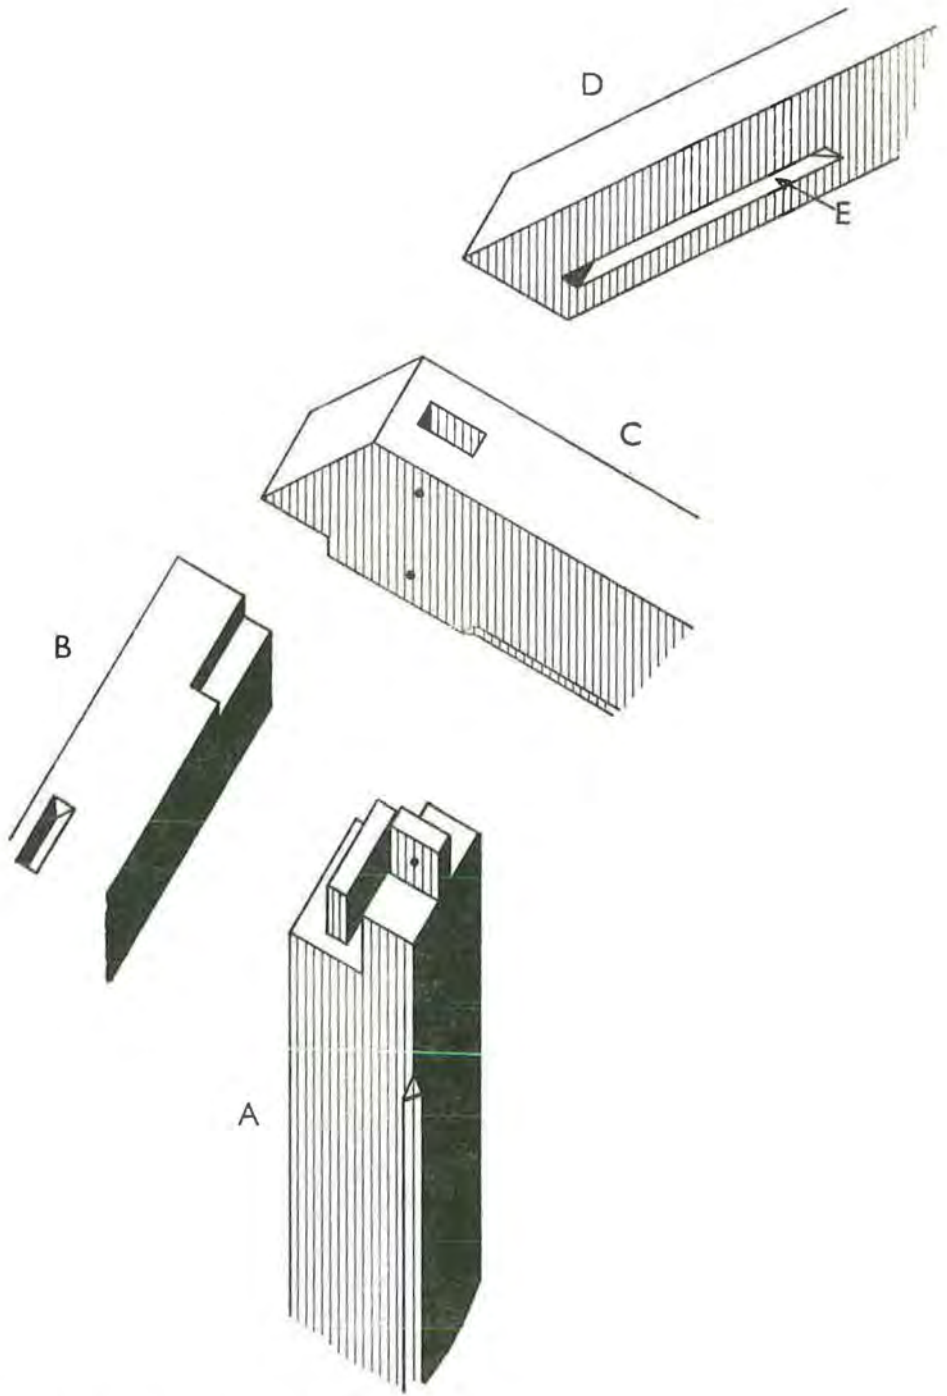
Fig. 13. Wind-brace mortise E. Truss north-west end of hall, phase 2. Joint of principal-post A, tie-beam C, top-plate B, principal rafter D.

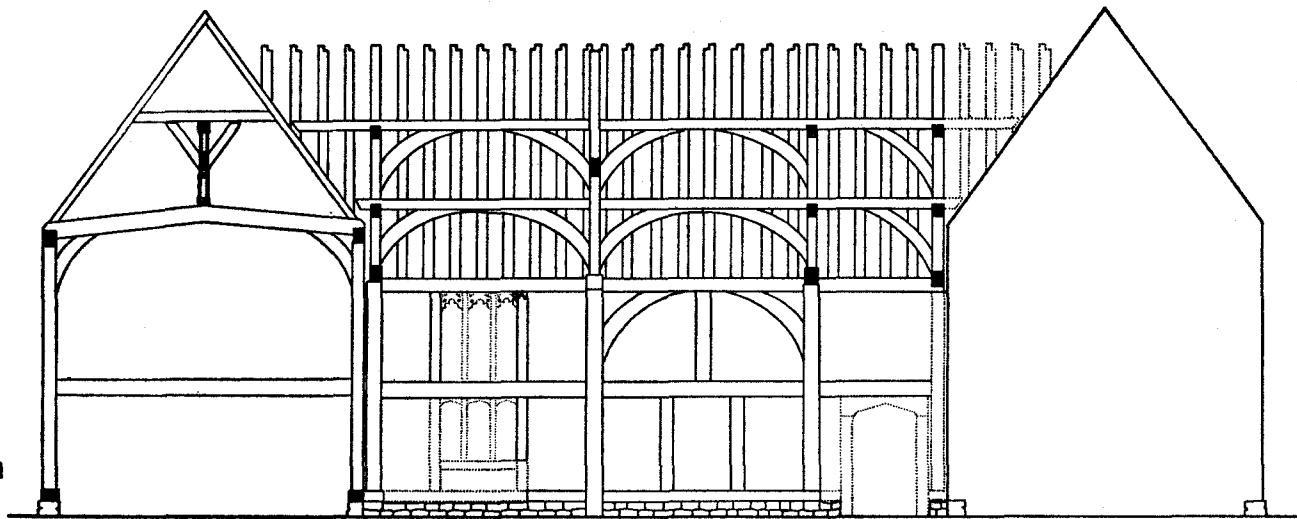
Fig. 15. Section through house (phase 2). Dotted lines denote reconstruction.

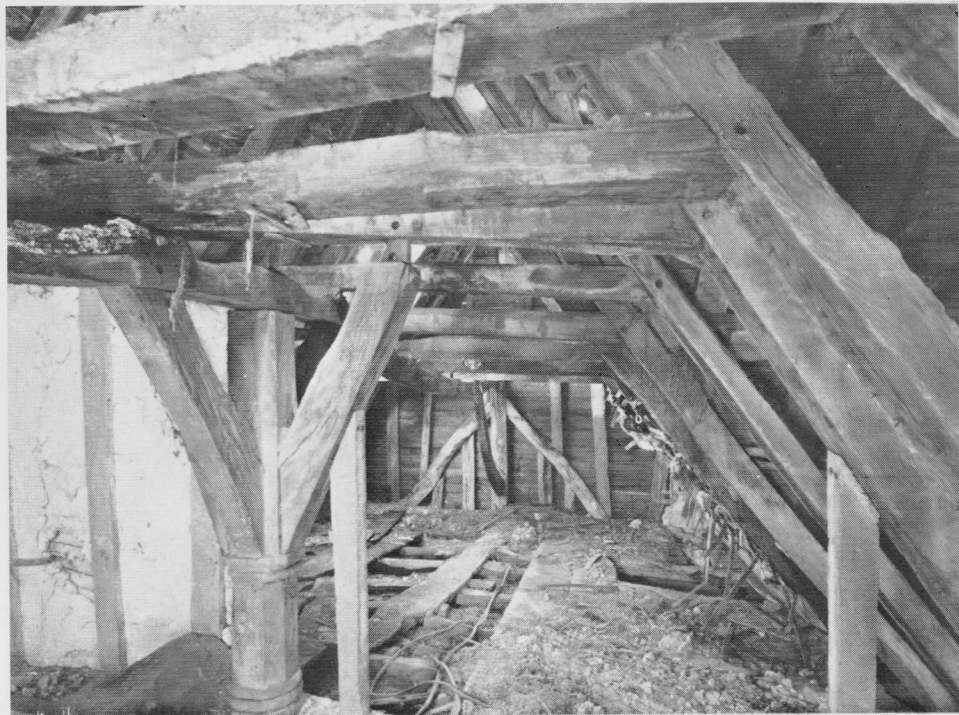
(b) Crown-post in 14th century wing.

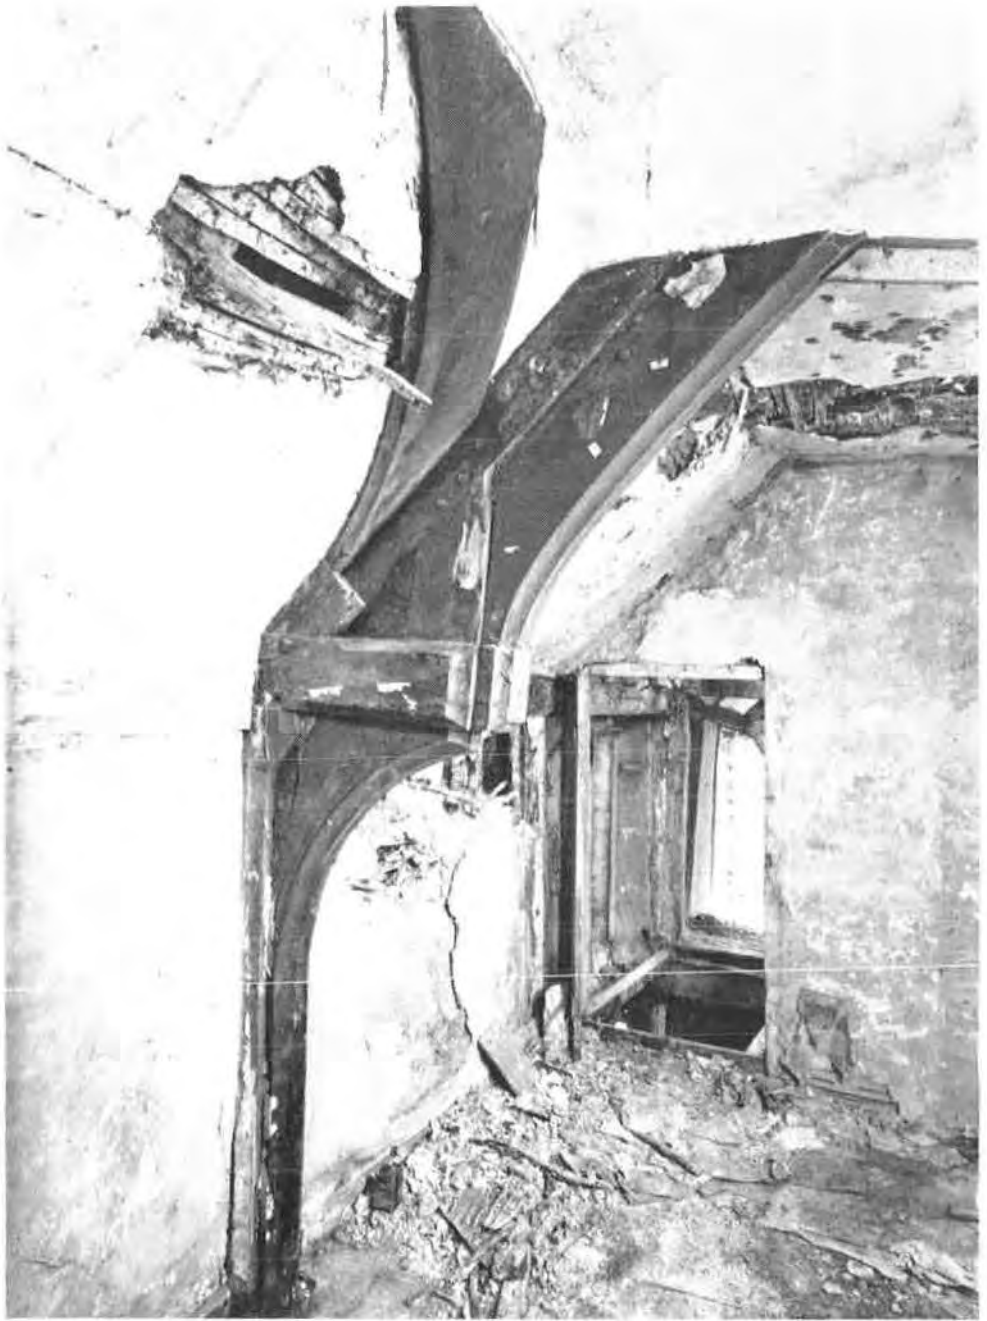
PLATE II. Hammer-beam joint (phase 2).

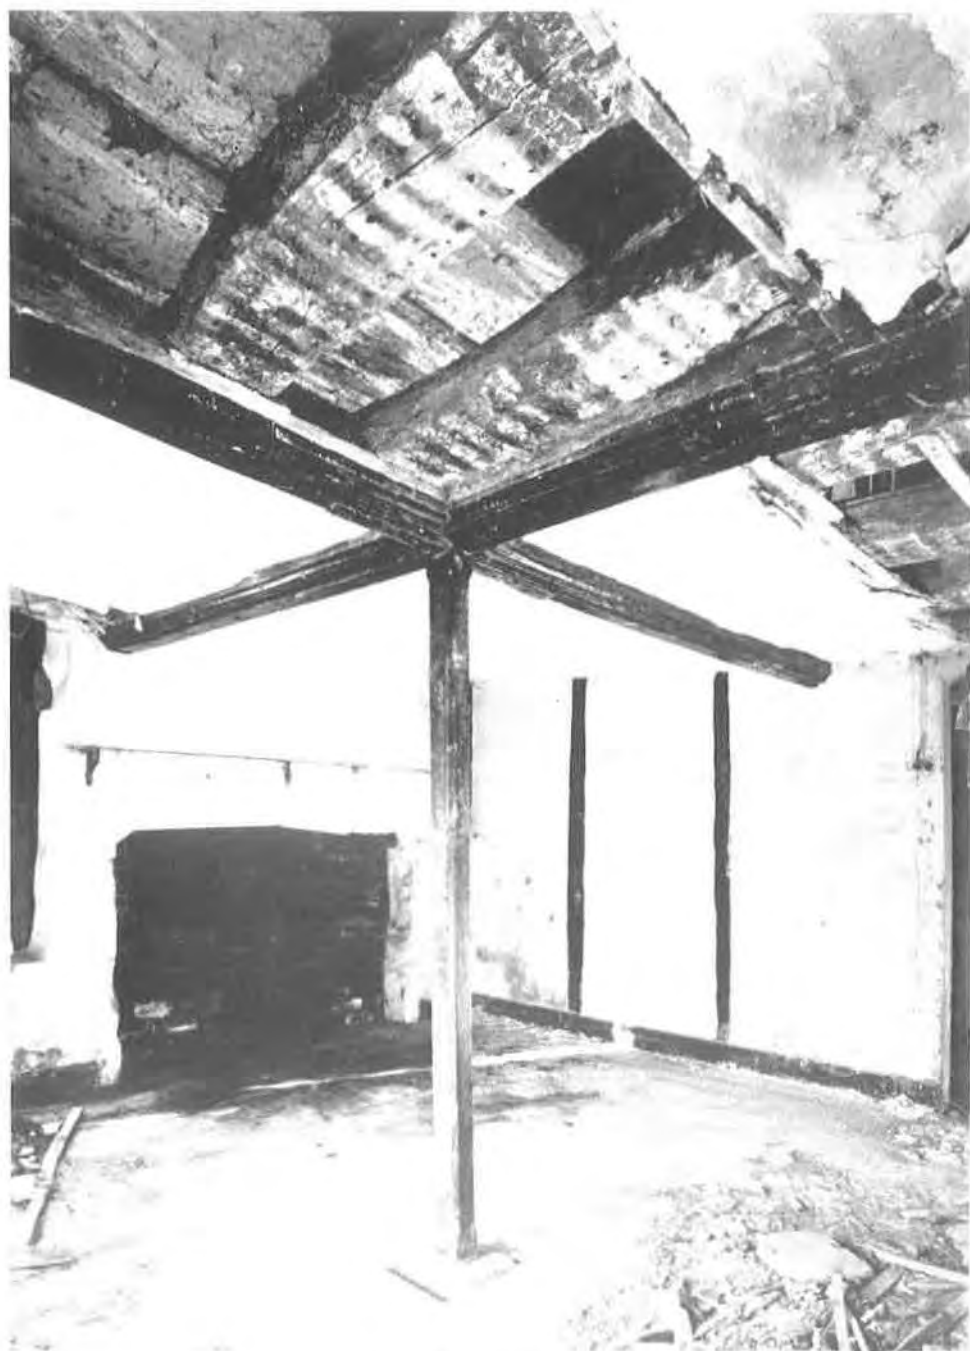
PLATE III. Parlour ceiling.

MID. 16TH CENTURY—PHASE 3. About the middle of the 16th century, the parlour was converted into a room of sophistication and comfort. (Fig. 4 & Plate III). It was enlarged by moving the partition, previously mentioned, 12 ft. in a north-easterly direction. Joists, with well moulded soffits, were fitted into the ceiling, purely for decorative purposes. They had no structural significance. Stone fire-places were put in the parlour and the solar. The ladder was replaced by a newel stair.

In the third structural phase, the parlour was subjected to extensive alterations to make the room more sophisticated. (Plate III) A ceiling was constructed to conceal the 14th-century joists. Two well moulded heavy transverse joists were inserted between, but slightly lower than the existing joists. Another joist, with the same moulding, was mortised transversely into them. The mortice and tenon joint showed the elaborate profiles, meeting at right angles. It was not, however, an efficient one—the tenon had little support on which to rest. The joint became weak and was supported by a central prop. (Fig. 16a) These moulded joists had no structural significance. They were crudely let into the middle-rails and had bearings of little more than an inch. They were inserted purely for decoration.

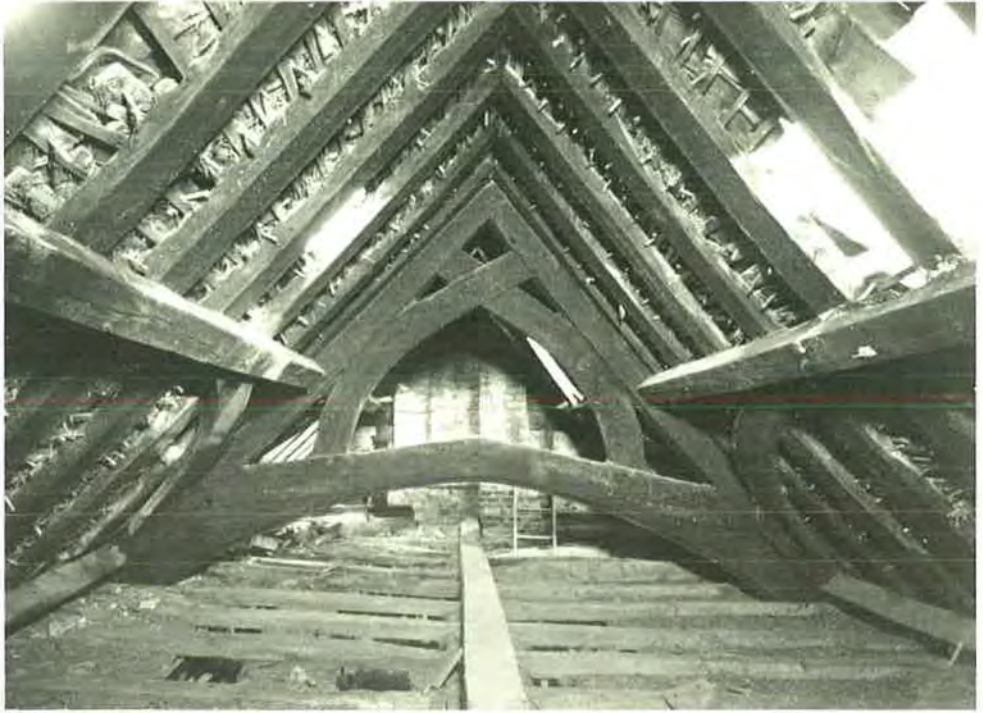
PLATE IV (a). Bracing above the collar on the hammer-beam truss.

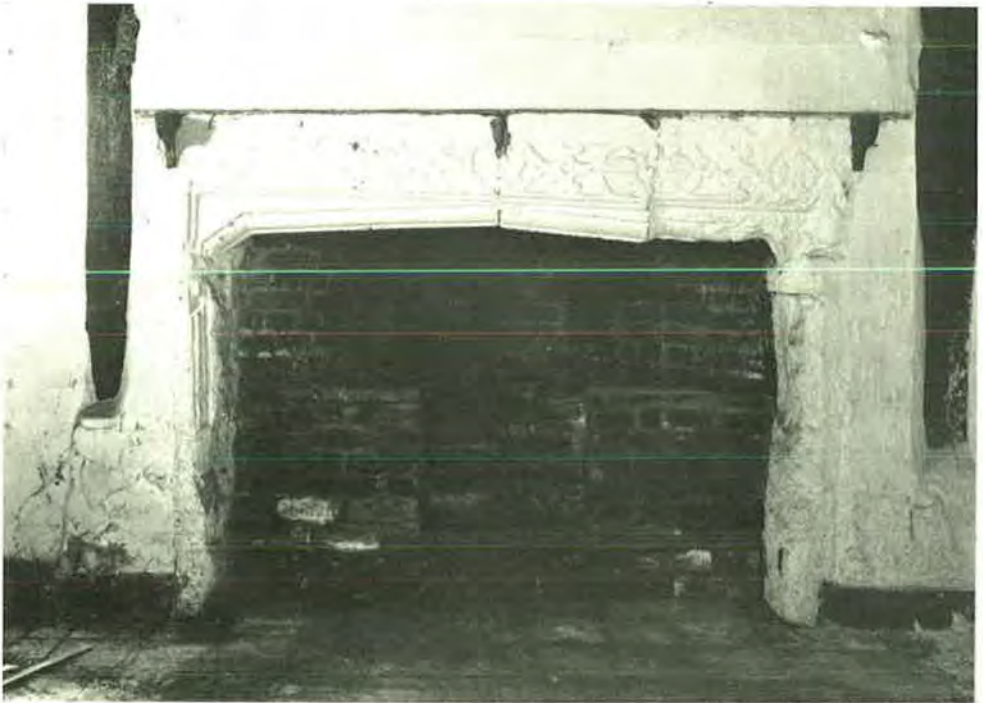
PLATE IV (b). Parlour fire-place.

FIRE-PLACES. During the third structural phase, in the mid 16th century, stone fire-places were built in the parlour and solar (Plate IVb). They had stop-moulded jambs and moulded four-centred heads. The heads had friezes, carved in low relief, with arabesque patterns, commonly found in houses of the 16th and 17th centuries.

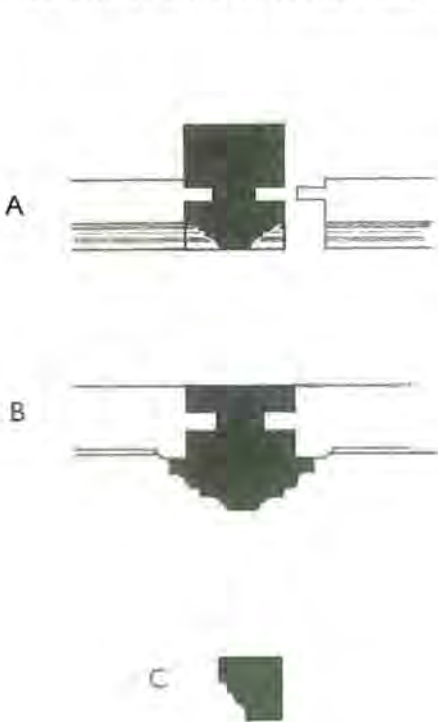
Fig. 16. Sections of moulded joists.

DOORS. None of the medieval doors had survived. The lintel of a door inserted in the south-east wall of the hall, at its upper end, during the 4th structural phase, remained in position until demolition. (Fig. 16 C.)

It was not possible to ascribe a precise date to the chambering over of the hall, but it would seem probable that this was effected when the new service-wing was built. The moulded door-lintel in the north-west wall of the hall tends to confirm this date (Fig. 16c).

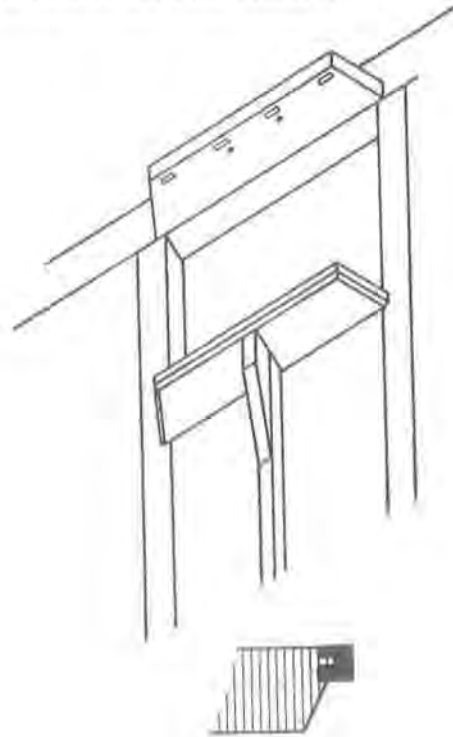
Fig. 17. Oriel window.

WINDOWS. An oriel window in the solar (Fig. 17), 44 ins. high and 37 ins. wide, has been blocked, but the sill and head survived. The mullions, four in number, had been destroyed. Their positions could, however, be determined by the mortices in the head and sill. The date of the window is uncertain. It was probably inserted with the close studding, during the third structural phase.

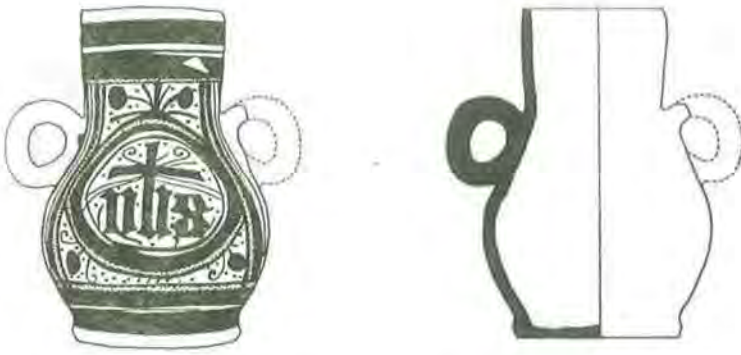
Fig. 18. Majolica altar vase.

Fig. 18, Flower vase, tin-glazed buff fabric with decoration in dark-blue (solid black) and orange (stippled). Cylindrical neck with plain rim, pear-shaped body with two loop-handles on the shoulder, one of which is broken off; footed base. In the centre of each side the sacred monogram IHS in a plain medallion bounded by vertical bands and containing decoration of foliage and dots.

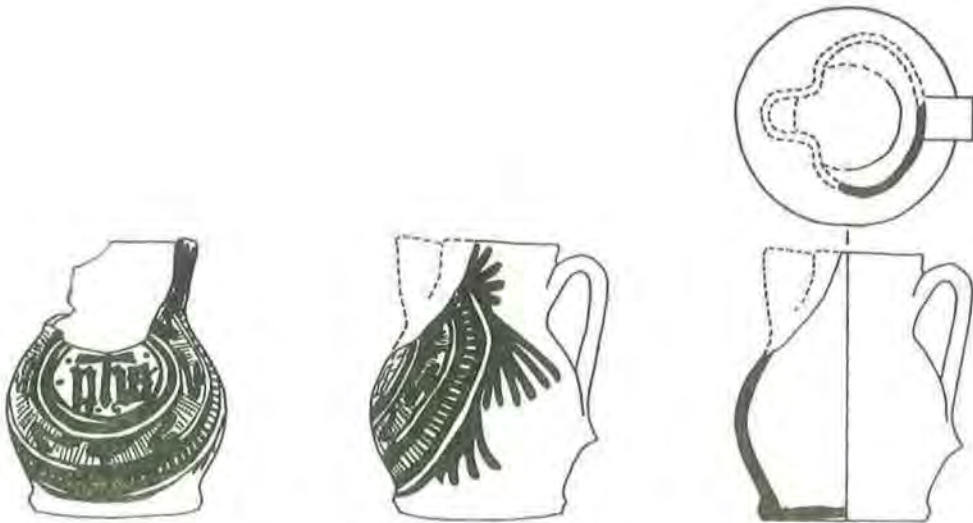
Fig. 19. Majolica altar jug.

Fig. 19, Globular jug, tin-glazed buff fabric with decoration in dark-blue only (solid black). Slightly splayed neck. The front has been broken off but the rim is starting to turn upwards and inwards at the break showing that there was a trefoil spout. Globular body with kicked-up strap handle opposite the spout with spur-like projection at the base; footed base. In the centre of the front of the jug the sacred monogram IHS in a medallion with rays radiating out from this to an outer medallion with a ladder pattern.

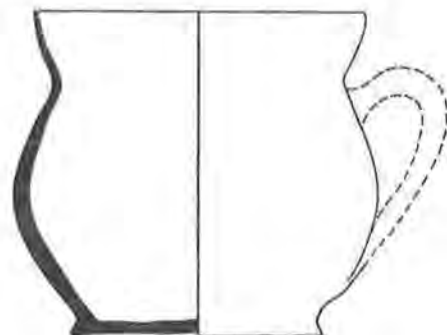
CISTERCIAN TYPE CUP (Fig. 20)

Fig. 20. Cistercian type cup.

The cup has a green glaze and is of the Cistercian type. It is $3\frac{1}{2}$ ins. high and a little over $3\frac{1}{2}$ ins. wide. The handle, broken a little above its base, and approximately one third of the side are missing. The cup has a globular body, with a splayed rim, and a plain-footed base. The well-fired mica-free fabric is grey, with a red core.

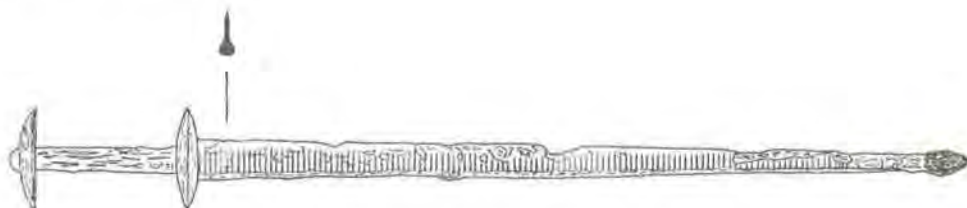
RONDEL DAGGER (Fig. 21)

Fig. 21. Rondel dagger.

The rondel dagger was first developed in the second quarter of the 14th century. It remained in use until the early 16th century.⁴⁷ This type of dagger is recognised by the guard, which is formed by a solid disk, through the centre of which the tang of the blade passes. On this particular dagger, as in many others, the pommel is formed by a similar disk. It was essentially a "knightly" weapon. The blade has a single edge and is hollow ground, with a ridged back. The length of the blade is $17\frac{1}{2}$ ins. The overall length of the dagger is $21\frac{1}{2}$ ins.

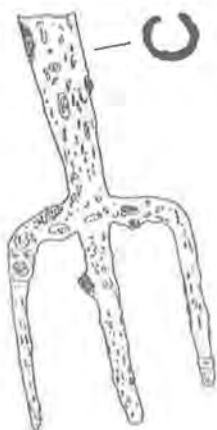
GARDEN FORK (Fig. 22)

Fig. 22. Garden fork.

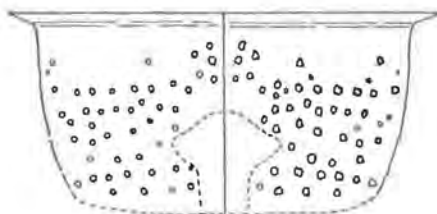
Fig. 23. Colander.

Fragments of a copper colander were found. It was 8 ins. wide and $3\frac{3}{4}$ ins. deep. The holes had been crudely perforated from the inner side. The rim was a little wider at one place. At this point, a small piece of copper had been riveted to the inner side of the colander, just below the rim. This suggests that there had been a handle.
