EXCAVATIONS AT THE MOTTE, WESTON TURVILLE MANOR, 1985

PETER A. ST J. YEOMAN

Limited rescue excavation bisected part of the Motte ditch. An E-W profile of the ditch was obtained. This was 8 m wide × 2 m deep, with stepped sides and a dished base. The primary filling contained waterlogged organic material and two dressed voussoirs of twelfth-century date. The castle mound is in a good state of preservation, standing to a height of 4 m with a circular summit, 23 m in diameter. The ceramic evidence from the ditch coupled with the nature of the ditch infilling would seem to uphold the documented slighting of the defences in 1173-74 by command of Henry II. Further dumps were deposited during the later manorial development of the site in the thirteenth and fourteenth centuries.

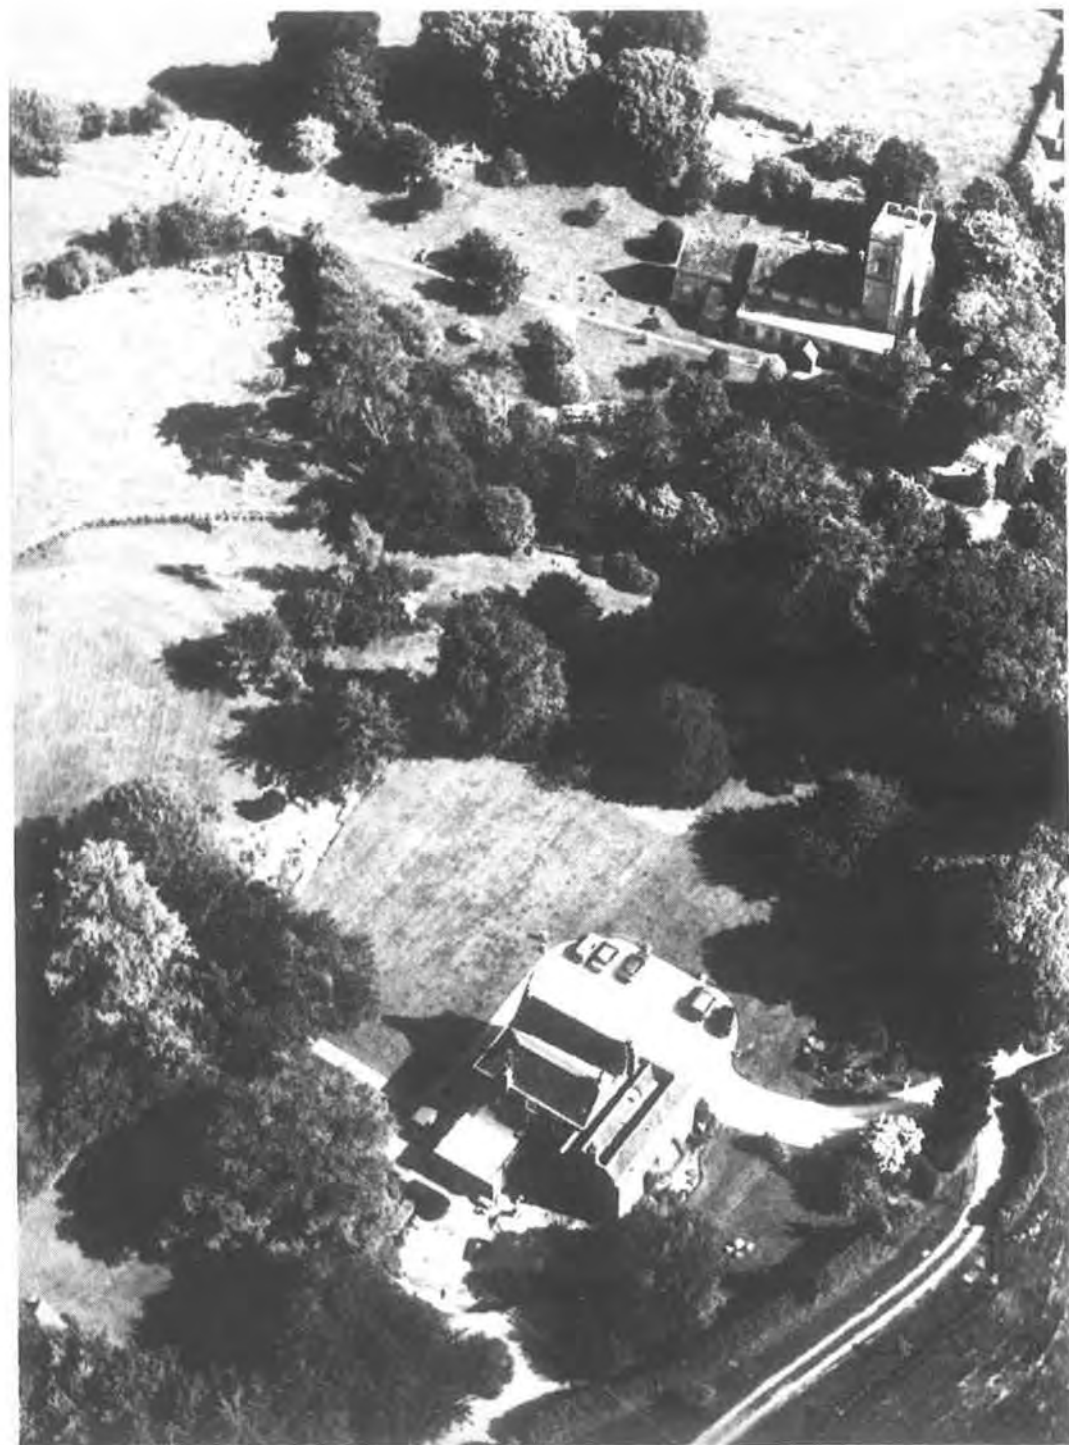
Plate XV. Motte (bottom left, among trees), manor house, church and moats (left of photograph): aerial view, looking S. The excavation can be seen between the house and the bottom of the photograph.

One of the finest motte and bailey castle earthworks in the county is situated a few metres from the Manor House at Weston Turville (SP 859104) and 150 m from the parish church of St Mary's (Pl. XV). The site is 6 km SE of Aylesbury on the E side of the Vale, close to the edge of the Chilterns (Fig. 1). Although sited on Gault Clays the motte lies at the edge of a gravel spread, on which the main area of the village is sited. It stands in the flood plain of a large stream which separates it from the large modern village of Weston Turville to the NW.

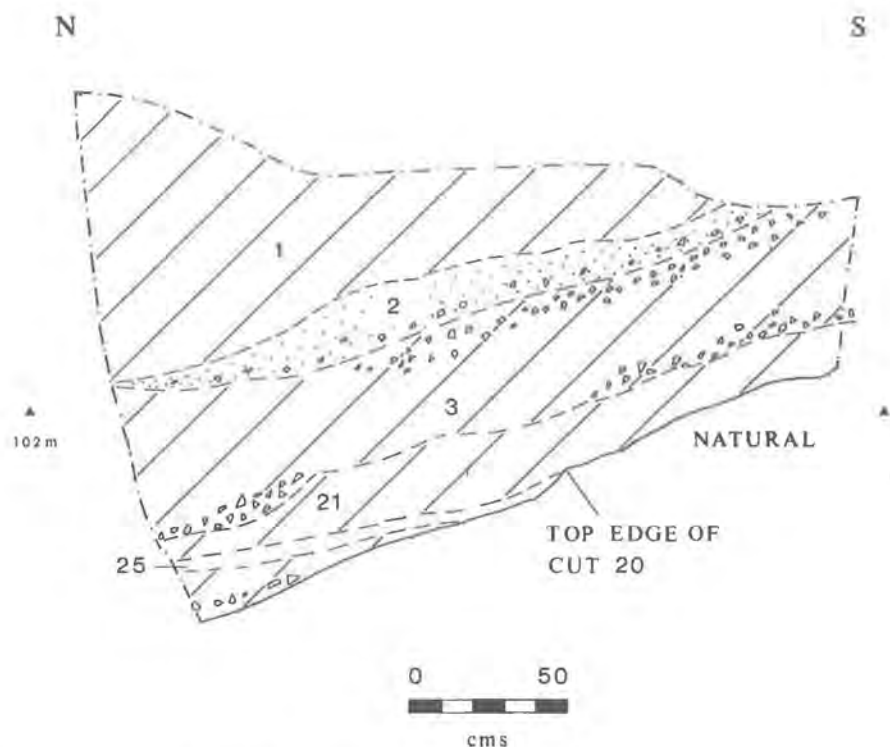
Fig. 4. Section at base of motte (location Fig. 1).

Two parallel gullies/ditches had been truncated by the construction of the castle defences. Their alignment was at variance with the motte ditch which cut the outer gully (26). This gully, 0.08 m in width, was 2.70 m W of the inner cut (20), a much more substantial feature with a reconstructable width of at least 2 m. Silting was absent in both features, which were found to have been backfilled with mound dump material, indicating an origin in the period immediately preceding motte construction. It is therefore likely that they represent remains of a temporary enclosed encampment, destined to be the manorial *caput*.

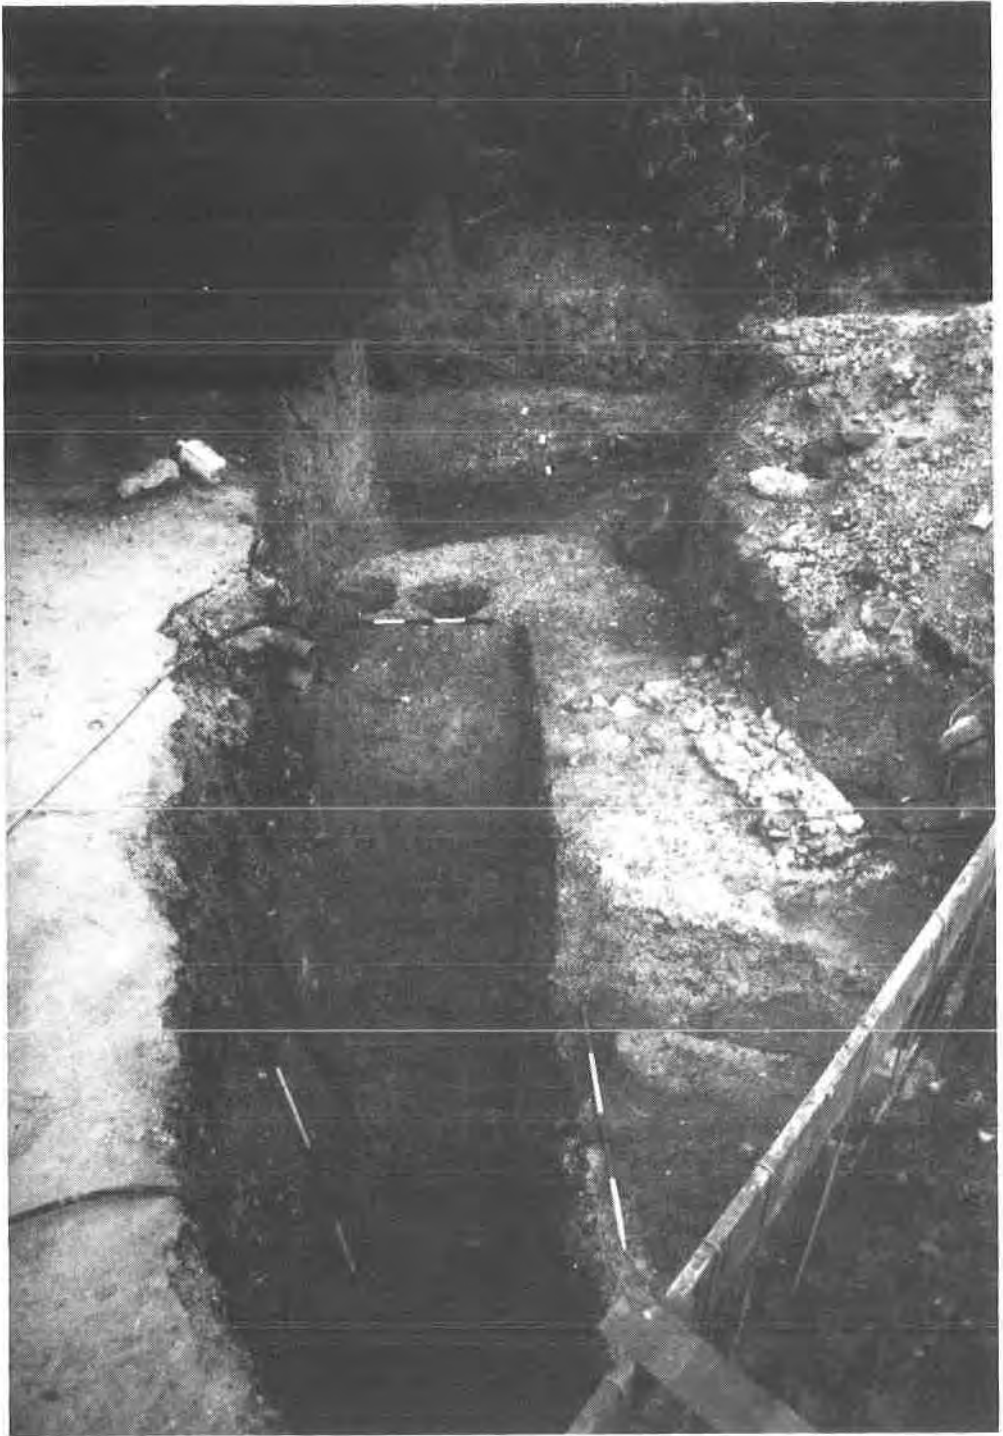
Plate XVIII. Section ditch and mound material, looking E.
