THE COUNTY MUSEUM BUILDINGS, CHURCH STREET, AYLESBURY:

JOHN CHENEVIX TRENCH & PAULINE FENLEY

The County Museum buildings in Church Street, Aylesbury are described and dated, and their history discussed. The former Grammar School is shown to embody part of a seventeenth-century precursor, and Ceely House to have been originally a timber-framed, jettied building, dated by dendrochronology to 1473. It is argued that it started life as the 'Brother House' of the Fraternity of the Virgin Mary, founded in 1450 and dissolved along with the chantries in 1547. In the seventeenth and eighteenth centuries the Brother House was occupied by a succession of ecclesiastical lawyers in the Commissary Court of the Archdeaconry of Buckingham. In the late seventeenth century the front of the building was probably altered to bring it into line with contemporary notions of fashion; it was also extended at the back. In mid eighteenth century it was further altered inside and fronted with Georgian brickwork, producing essentially the appearance the building presents today.

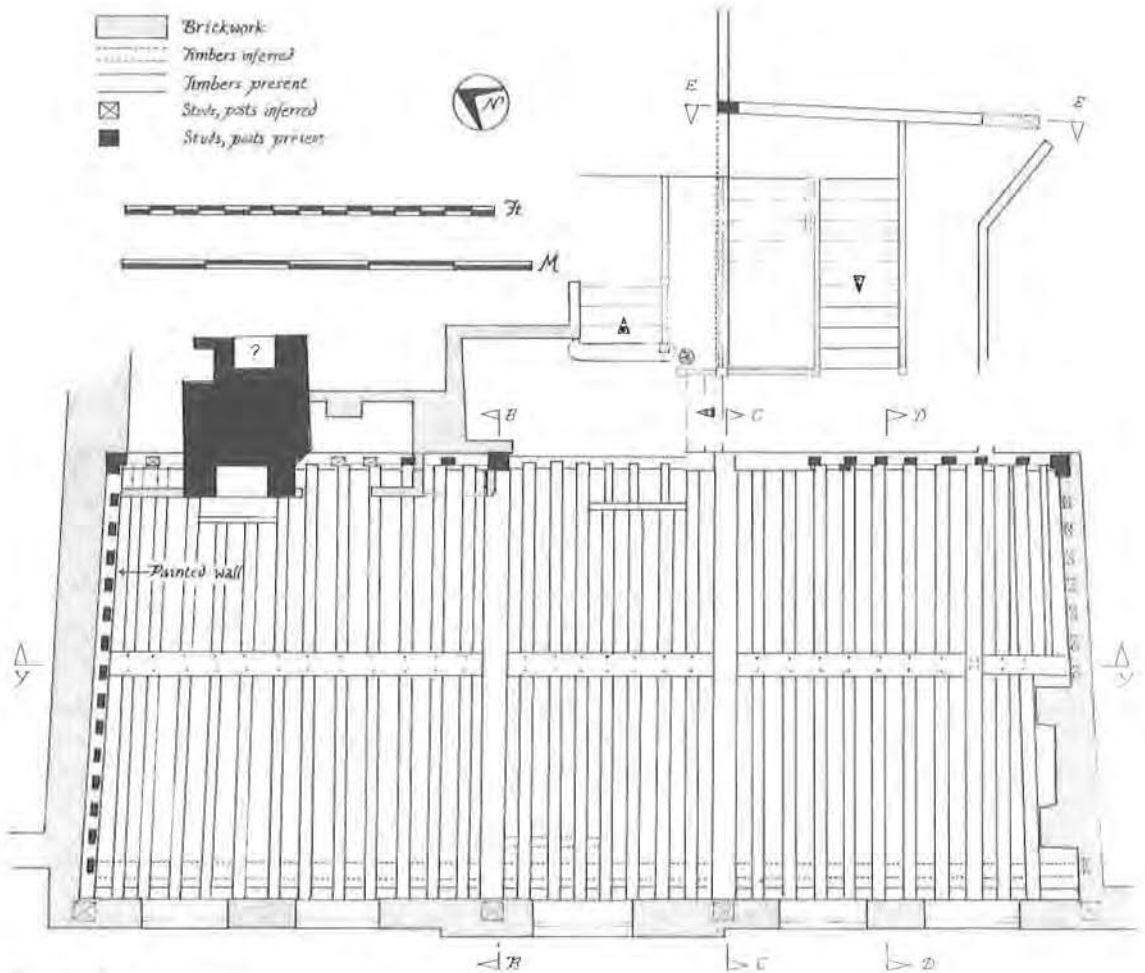
Fig. 3. Ceely House, first-floor plan.

The building had a two-storey jettied range of five bays fronting the street, and behind, projecting to the E, a part single-storey, two-bay wing, (Figs. 3 & 10), which has not been securely dated, but appears roughly contemporary. The ground floor of the main range is strikingly lofty: 10ft 4ins (3.1 m) to the soffit of the moulded spine beam. It was divided into two rooms, of two bays and three, connected by a rather narrow door: the studs of the partition are at 15-inch centres (325 mm), and only one of these was dispensed with to accommodate the door (Fig. 6). If this door resembled that into the wing, in the middle of the long side of the larger room, extra width was won by reducing the

It was in the bearer beam that prompted this discussion that unequivocal evidence for a jetty was found, in the form of a trench in the soffit to fit over the jetty plate (Figs. 3 and 7). When the boarding over the head of the southern window was removed, the jetty bressumer was exposed. It shows that the floor joists were tenoned into the back of the bressumer, and that the first floor front was close studded.

trimmer beam in the ceiling joists (Figs. 3 and 6). But it may never have been built, and if it was it was soon replaced. The joists that now span the gap behind the trimmer beam are of the same heavy scantling as the others, and in fact are distinguished only by not bearing assembly marks. This change seems to have taken place when the rear wing was built. There was a door into the wing from the first floor (Fig. 4) (indicated by rebates in the flanking studs, and by the infill stud being an insertion). It is therefore likely that the replacement stair was built in the wing.

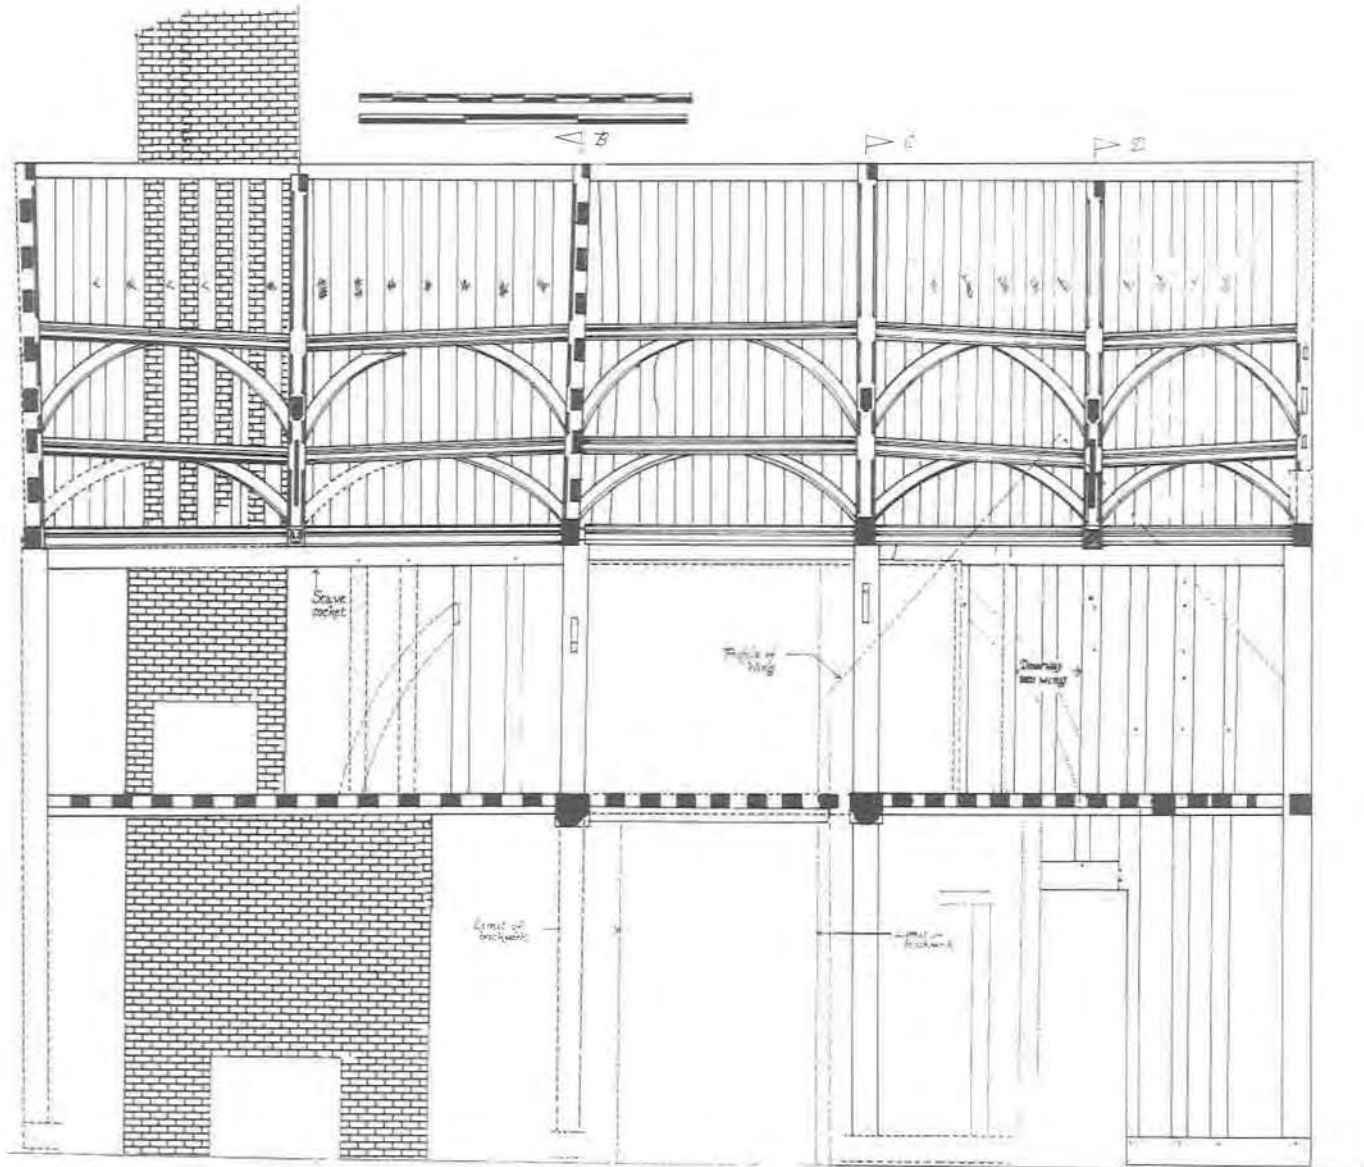
Fig 4. Ceeiy House: Long section (Y - Y).

width of the flanking studs below the lintel (Fig. 4). No evidence survives to suggest where the entrance from the street lay.

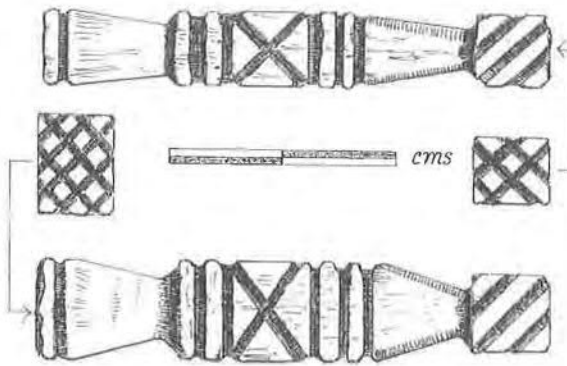
Fig. 5. Bone object from Ceely House.

In 1952 four gold coins of Edward IV were found during work on converting the first floor to museum use,³ and a story grew up that they were in a mortice in a post. The facts are less romantic: they were found among dust and rubbish on the floor while an old cupboard was being removed.⁴ They are gold coins of the kind known as rose nobles, supposed to weigh 120 grains at a value of ten shillings,⁵ and are now in the Museum's collection. There is one of type VII, with a crown as mint mark, one of Type VIII, also with a crown, and two of type IX, with a long cross fitchee as mint mark. All were minted between 1464 and 1470, during Edward's first reign. Found at the same time, and in the same context, was a bone object resembling a bobbin or toggle, but of square section (Fig. 5); the ends bear a pattern of incised lines.⁶ It is likely to be a post-medieval artefact.

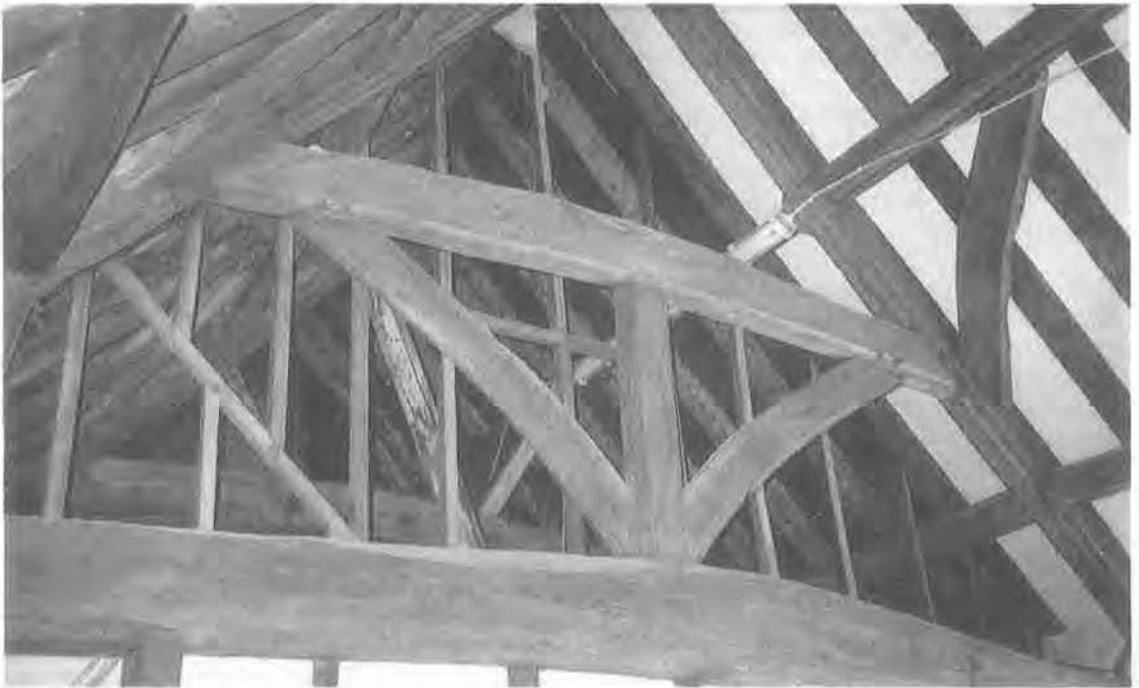
Plate I. Ceely House, central bay, looking W.

The two gable ends were close-studded, at least down to the girding beam (first-floor wall plate), and their roof trusses are of tiebeam-and-collar form. The roof is of butt-purlin type with two purlins and two rows of windbraces. All the principals, and all the surviving purlins, have double-ogee mouldings (Fig. 10). The trusses flanking the central bay have tiebeams and collars; that to the south of the central bay had in addition a timber resembling a

crown strut, braced laterally to the collar (Plate I). The trusses intermediate between these and the gable ends are of arch-braced collar form with stub ties, and it was probably these trusses that led the RCHM to think the roof had been re-set: the collars appear lower than in the other trusses; the mortices for the purlins do not align with those on either side; perhaps most striking of all, a ridge piece has been inserted, which certainly forms no part of the original structure, and the rafters have manifestly been reset – those on the W have been turned round to present their weathered faces to the interior, while those on the E are not in their original order as indicated by assembly marks. Moreover the arch-braced trusses have their apexes below the inserted ridge (Fig. 8).

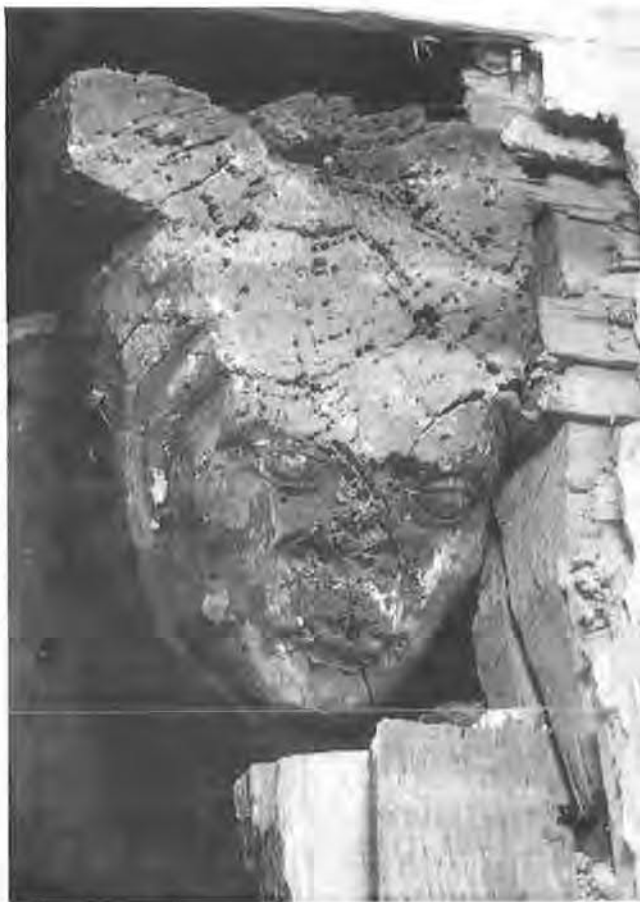
Plate II. Ceely House: The carved head from the N room, first floor. (Photo County Museum)

The original form of the stub is to be seen behind the plaster in the N room. It bears the mutilated remains of a carved female head (Plate II). No doubt the other three were similarly treated.

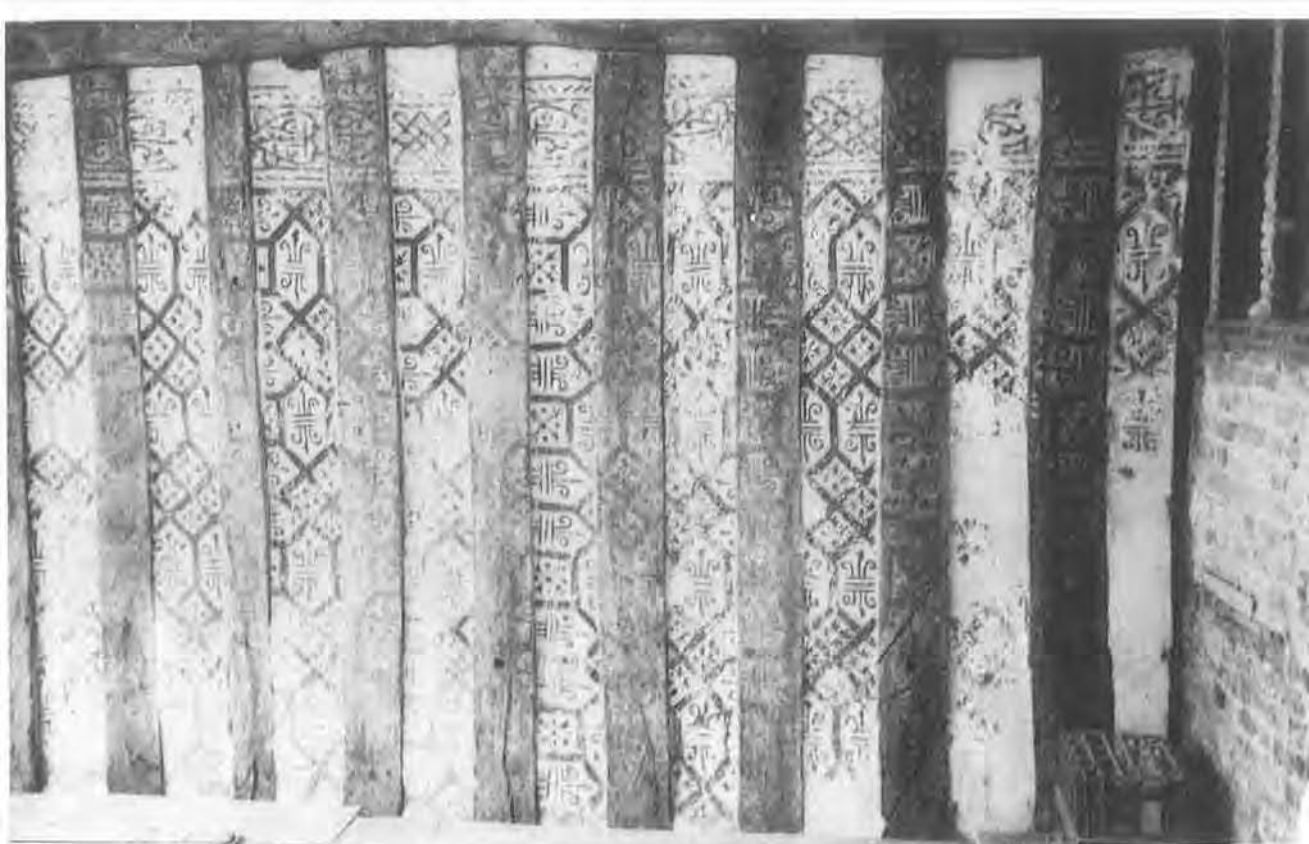
Plate III. Ceely House: wall painting on N wall, first floor.

The N room also contained in its N and E walls the only original plaster. A false wall of lath and plaster had been built in front of both walls in the eighteenth century. The lath and plaster covering the N wall was removed, and it was found that behind this the close-spaced studs had been limewashed, and they and the plaster panels between them had been covered with a repeating geometrical scheme of painted decoration in black and white (Plate III).

large regular hexagons. From the style of its carpentry, Byeballs has been dated to between 1550 and 1600⁷, but it seems certain that the Aylesbury painting is a good deal earlier. The painting has been conserved by Elvira Pluta, who also removed layers of mortar and lime wash to reveal the complete scheme, almost intact.

Ann Ballantyne, formerly assistant to Dr Clive Rouse and now herself a leading conservator, kindly reported on this find. She writes: 'It is interesting to note that the painted plaster does not seem to have any hair in it. I have been told by Dr Rouse that the earliest hair plaster he has ever found (with a date supported by documentary evidence) was a ceiling in one of the houses in the close of Gloucester Cathedral, which was plastered ten years before Elizabeth I came to the throne; hair was commonly added to plaster from the reign of Elizabeth I until the First World War, when materials such as asbestos started to be used in place of animal hair. The fact that a number of the timbers in Ceely House have been dated to 1473, and that this painting is found on the first layer of the earliest (hairless) plaster in this part of the building, as well as on the wooden studs, all contribute to dating this painting rather earlier than might otherwise be the case, probably a little before 1500; I think that one can reasonably safely refer to it as being of the late fifteenth century⁷.

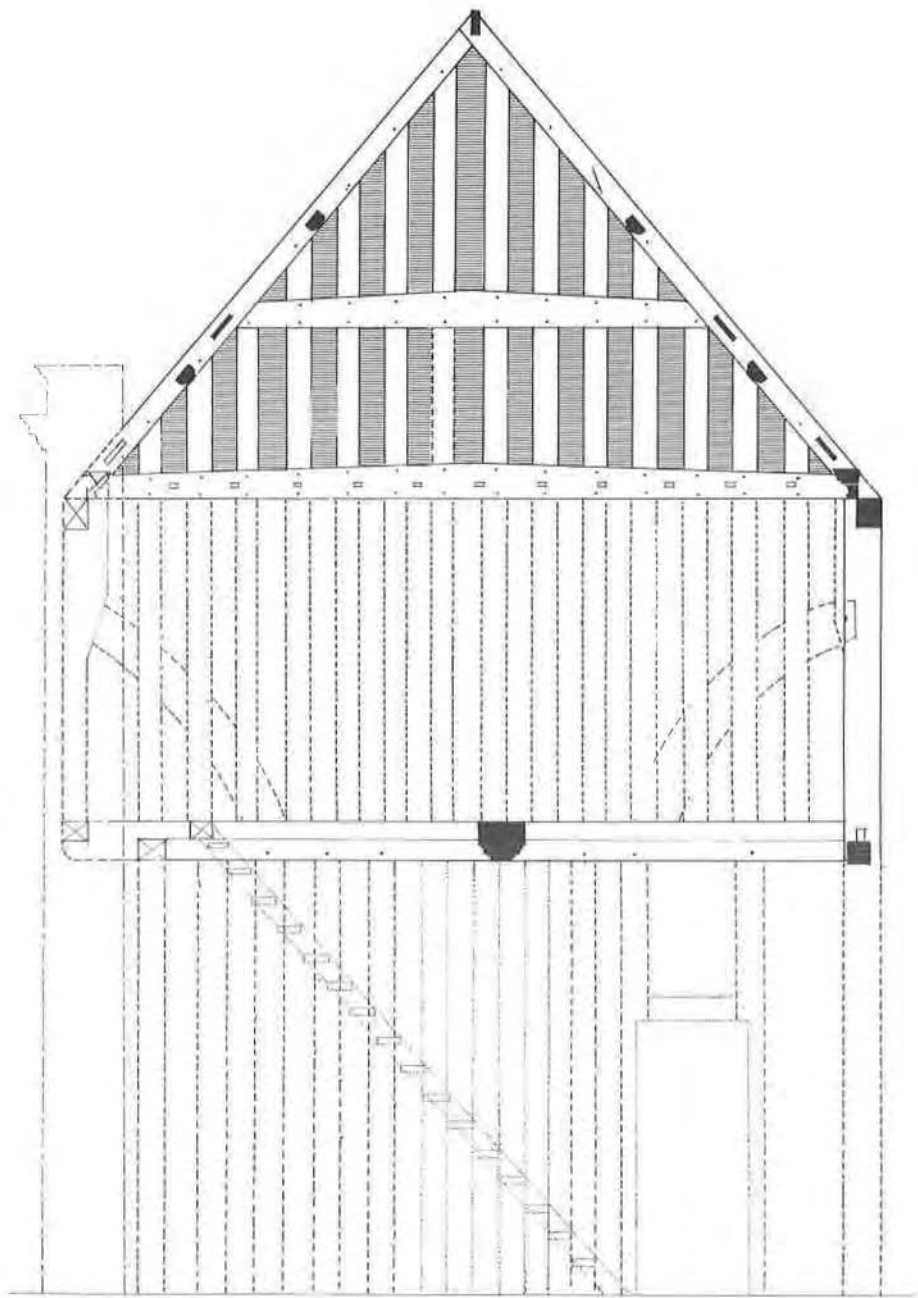
Fig. 6. Section at B, looking north,

At the N end of the three-bay room provision was made for a wide stair to rise to the first floor. The intention and the dimensions (3 ft 8 ins = 1.1m) are attested by mortices for a

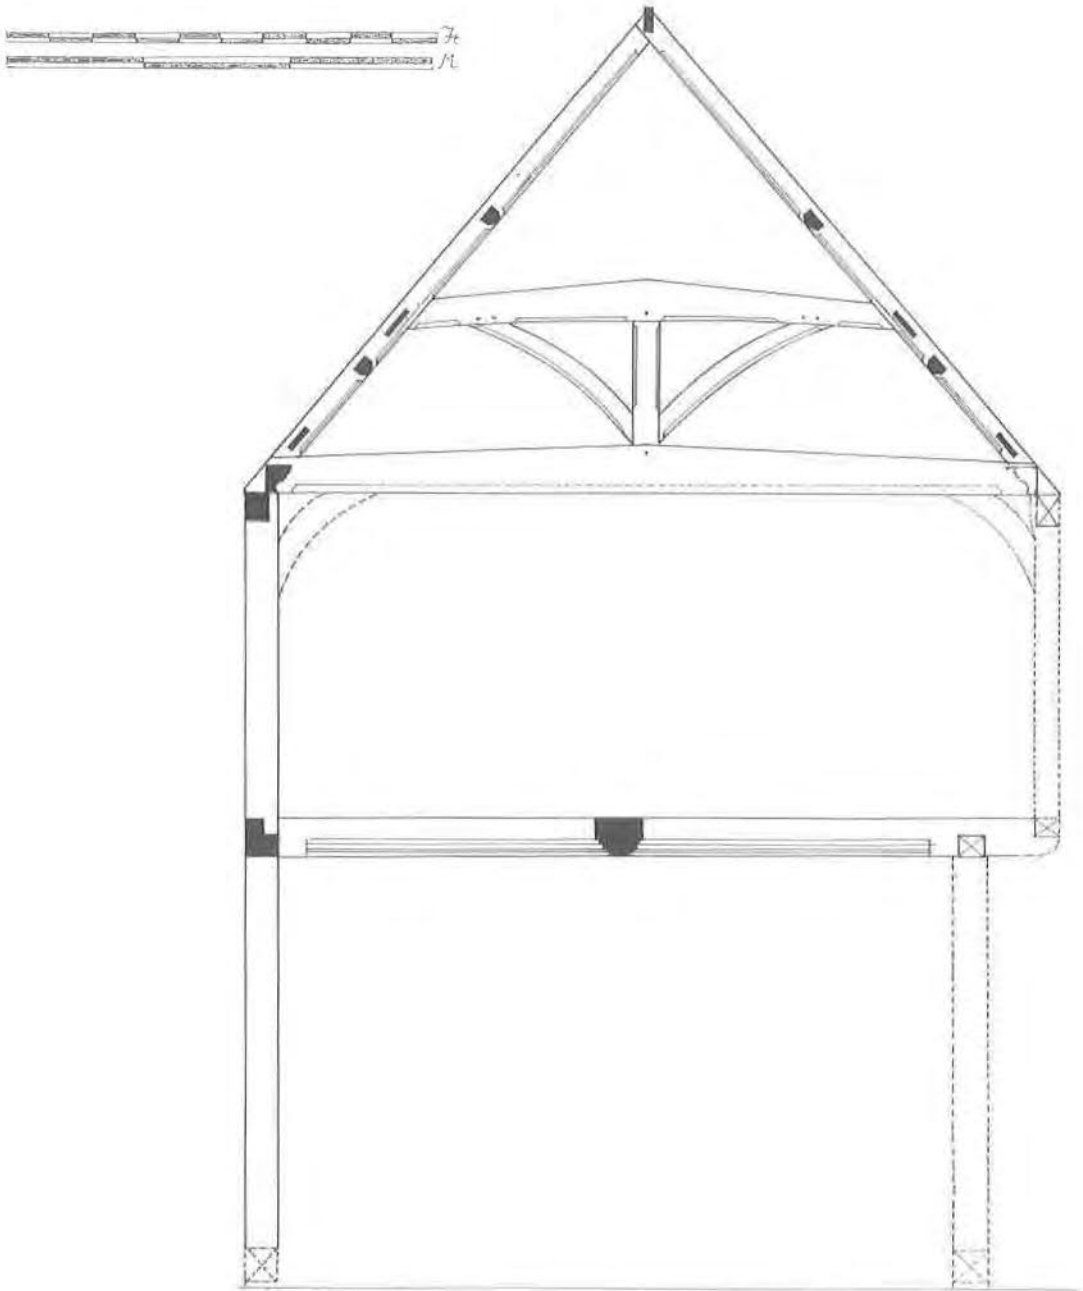
Fig. 7. Section at C, looking south.

These anomalies are to be accounted for by a collapse of the W ends of these trusses, which have sunk about a foot (c. 300mm) (Figs. 7 and 9). This was evidently caused by mutilation of the timber frame when the masonry carcass was put on. The mutilation

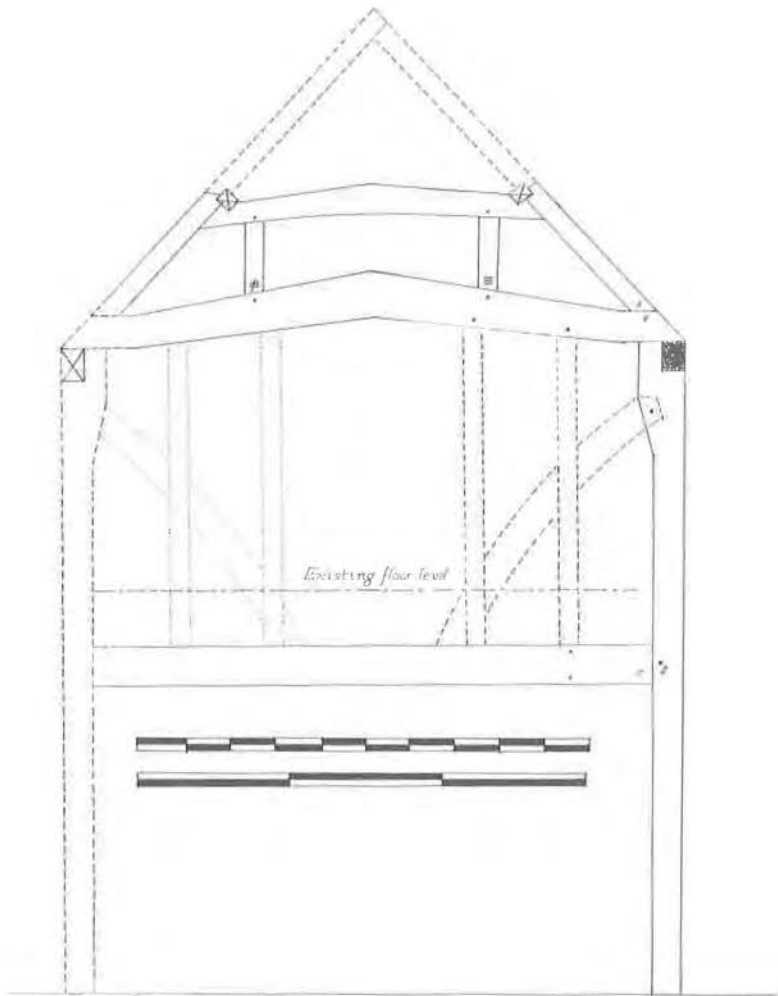
Fig. 9. Ceely House, section of medieval wing

Of the medieval rear wing only part of one truss survives; the truss has lost about a metre (3 ft 4 ins) from its southern end. The tie and the collar are both sooted on the W side. There were studs under the tiebeam, and a substantial rail. Evidently the wing was chambered over E of the tie; it seems reasonable to suggest that the other half was a kitchen. The sooting is the only evidence for the use of fire anywhere in the medieval building.

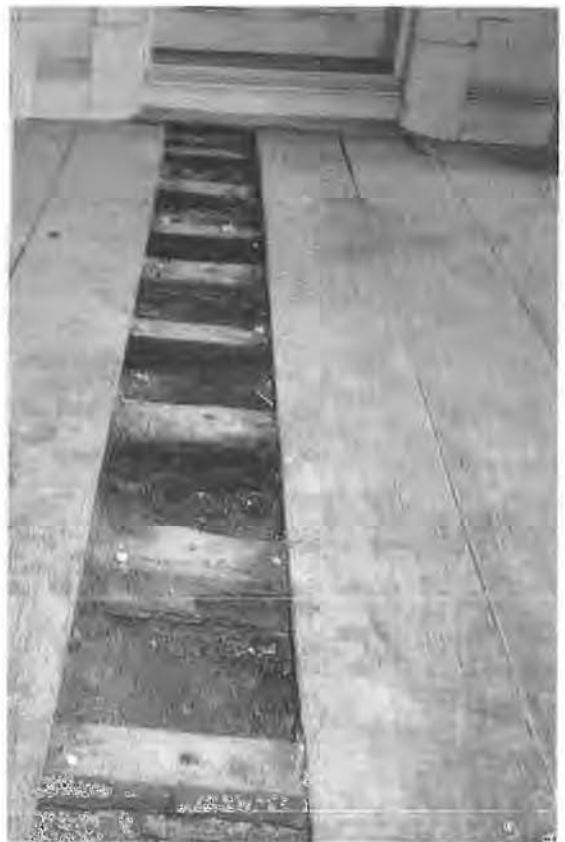
(Photo County Museum)

in the middle bay (See Appendix A). In other words the building of the wing allowed the abandonment of the original stair (which had perhaps been found inconvenient), and the construction of a new one (for which the only direct evidence is the doorway at its head). Of the roof of the wing only the collar of the principal truss, and the lower parts of the principal rafters survive. It is probably the common rafters of this roof that were re-used as floor joists in the Grinnell Room (A1); they have peg holes for sprockets, which carried the eaves out beyond the line of the wall (Plate IV). No doubt the entire roof was sprocketed.

Plate IV. Rafters re-used as floor joists, Grinnell Room, showing peg holes for sprocket.

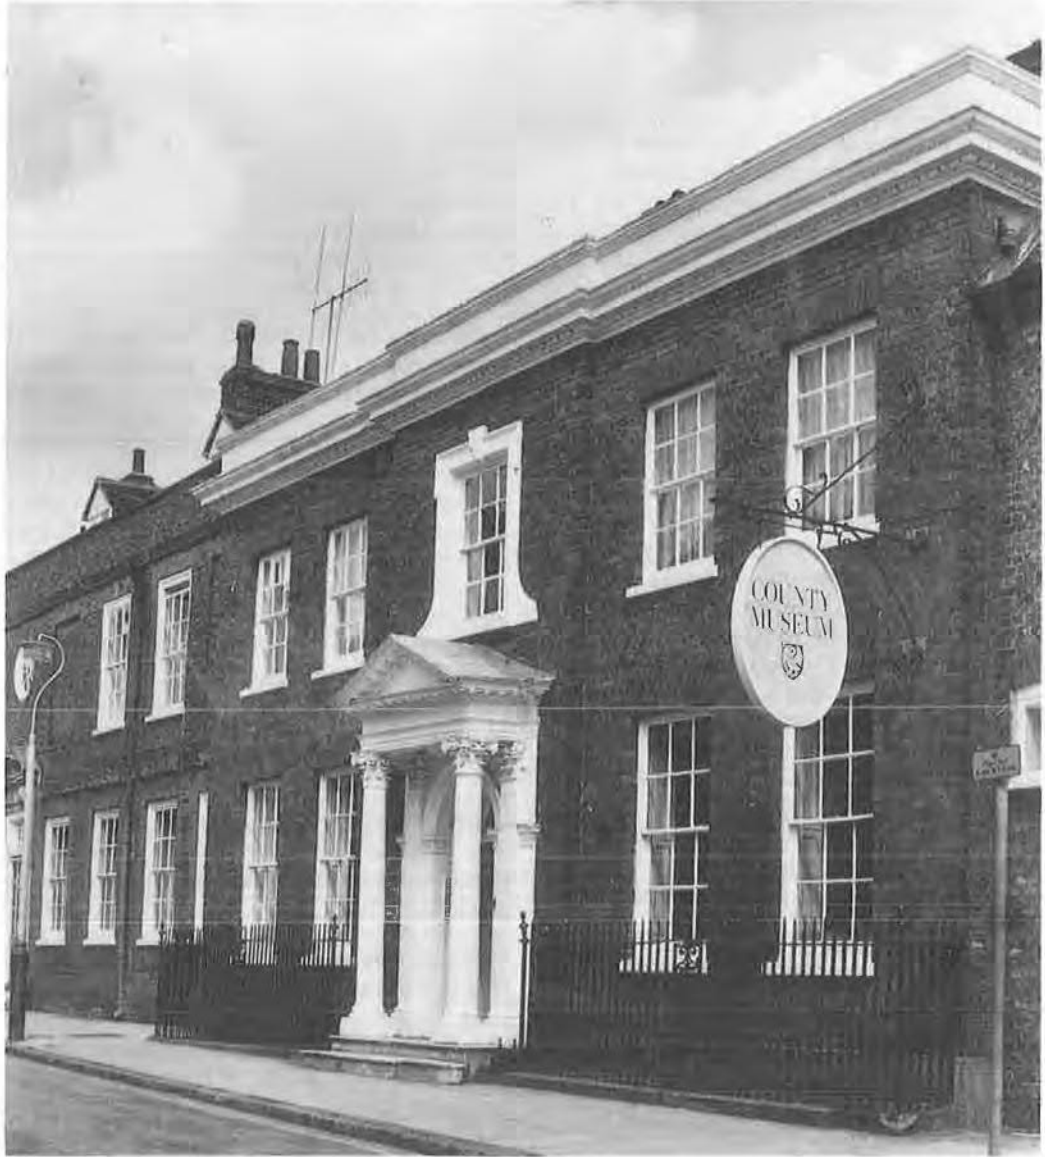
Plate V. Ceely House today, as Georgianised c. 1755/6.

In the newly-designed façade the central bay would be the focal point, so it was given prominence by a slight break forward, and the central window, above the door (which may or may not have been central before) was given a stone entablature of unusual 'artisan' design, its keystone bearing a mask. There seems to be no record of the doorcase, which must have been smaller and shallower than the present porch, whose date and provenance are not known. An uncorroborated tradition has it that it was brought from Eythrope House, which was demolished in 1810.⁶⁵ It has the effect of largely masking the window above it. The anomalous stone parapet cornice may likewise be a later embellishment; it covers a parapet of brick.

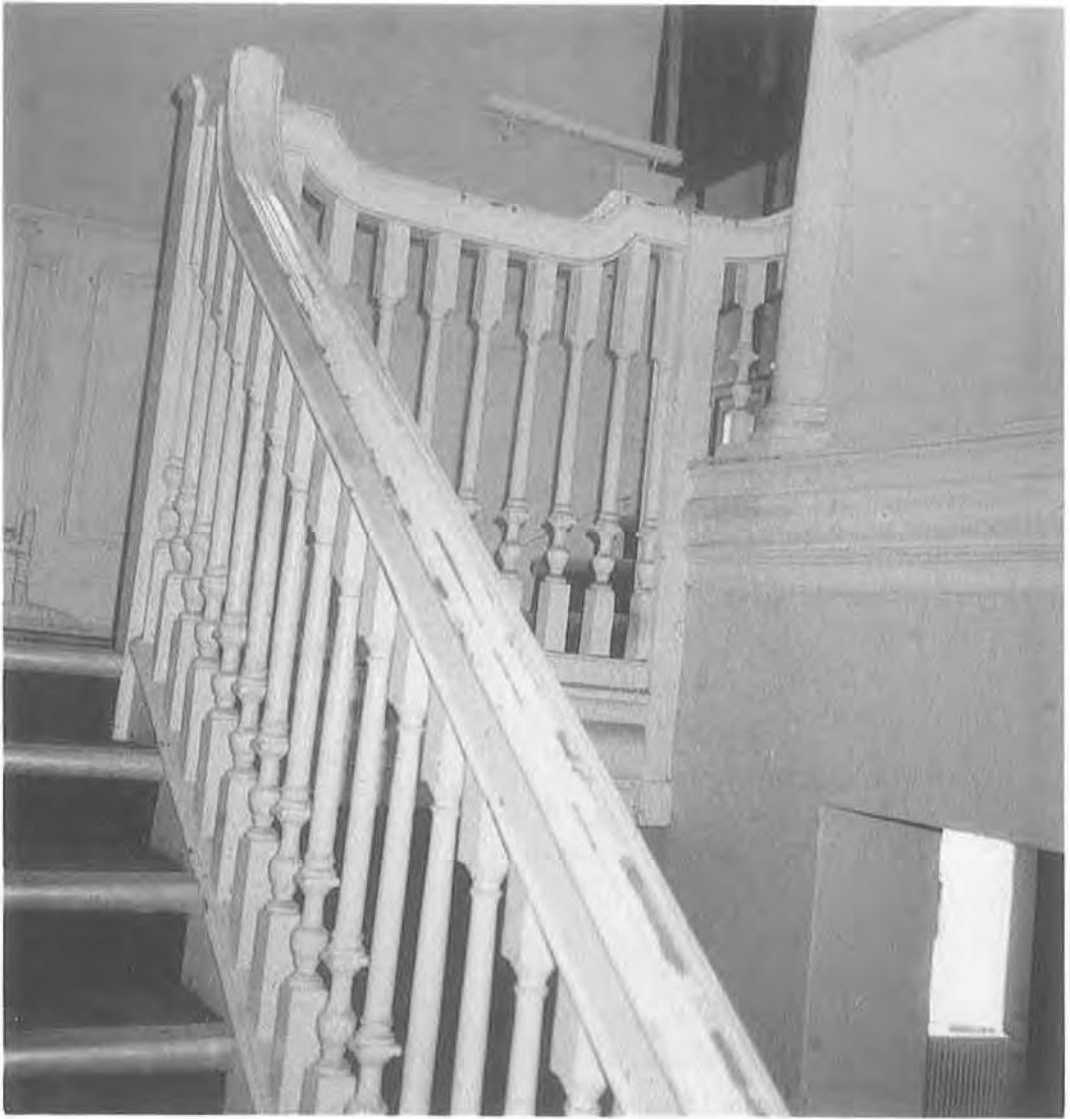
Plate VI. Ceely House: the staircase, c. 1755/6.

It was now possible to insert a new staircase (Plate VI) in the western end of the medieval wing, whose roof was destroyed to create a barrel ceiling above. The strings of the stairs were formed from lengths of medieval moulded cornice from the W side of the upstairs rooms, and as noted above there was at least one cleat cut from late seventeenth-century panelling. The downstairs front rooms were now given their second ceiling, entirely concealing the original moulded spine beam. The large panels, framed with egg and dart moulding, in the ground-floor room to the N probably also belong to this period, as does the coved cornice and lath-and-plaster walling on the N and E wall of the room above. The medieval decoration was now to be effectively and permanently hidden – or so it must have been thought. It is not suggested that this was the first lining of the room; both the upstairs rooms, originally open to the roof, will certainly have been ceiled over during the seventeenth century.

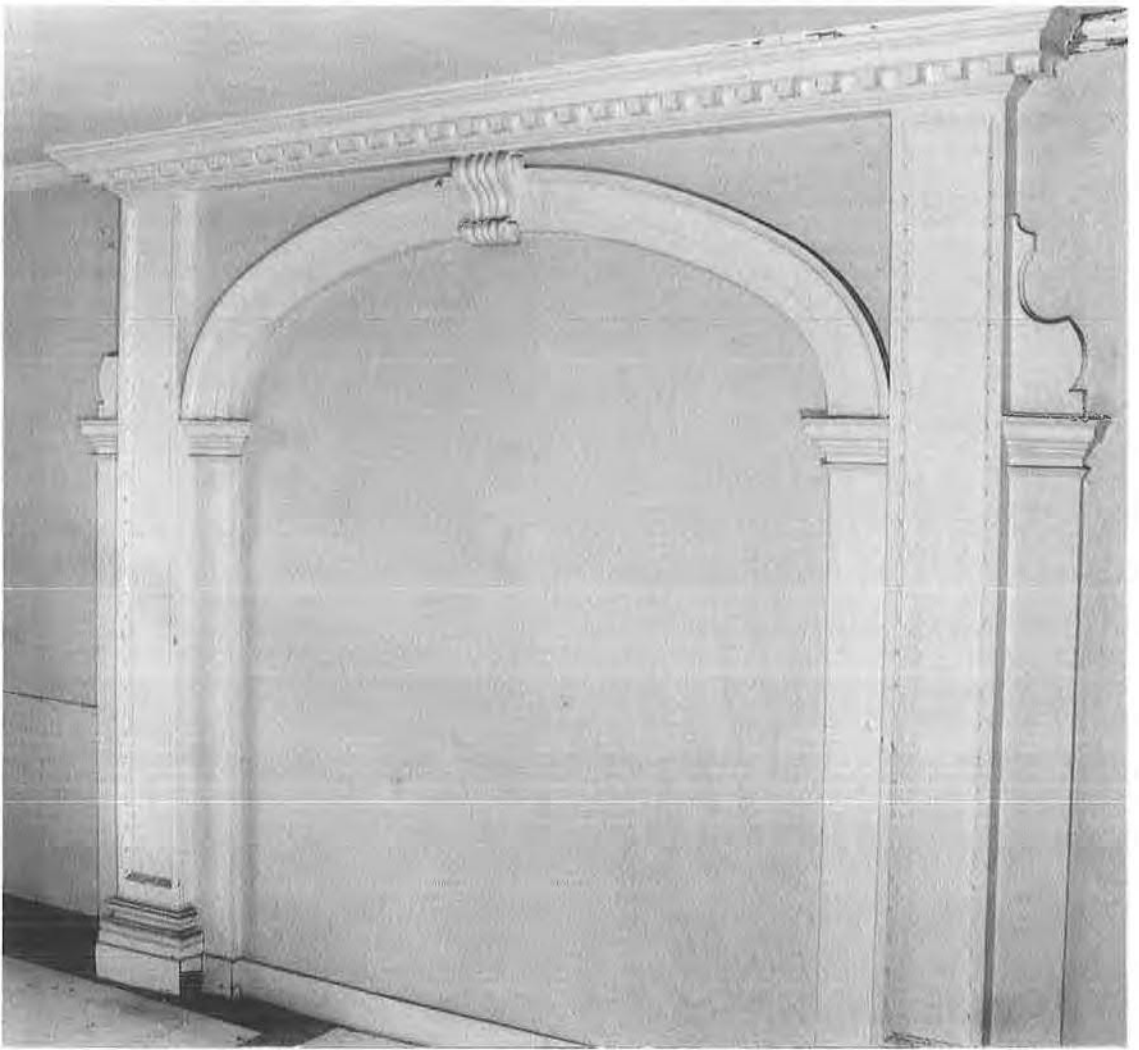
Plate VII. Ceely House: the arched opening to the bed alcove, with later filling. (*Photo County Museum*)

occupying the central bay of the house (c.f. Colen Campbell's design for a house in Grosvenor Square, 1725).⁶⁶ Its arched opening, with egg-and-dart moulding, can be seen under the second truss from the south (Plate VII); it is now blocked by a partition inserted in 1950.⁶⁷ The alcove would have allowed for closets on either side of the bed, one light and one dark. These changes produced a heated 'master bedroom' with a touch of style and privacy.

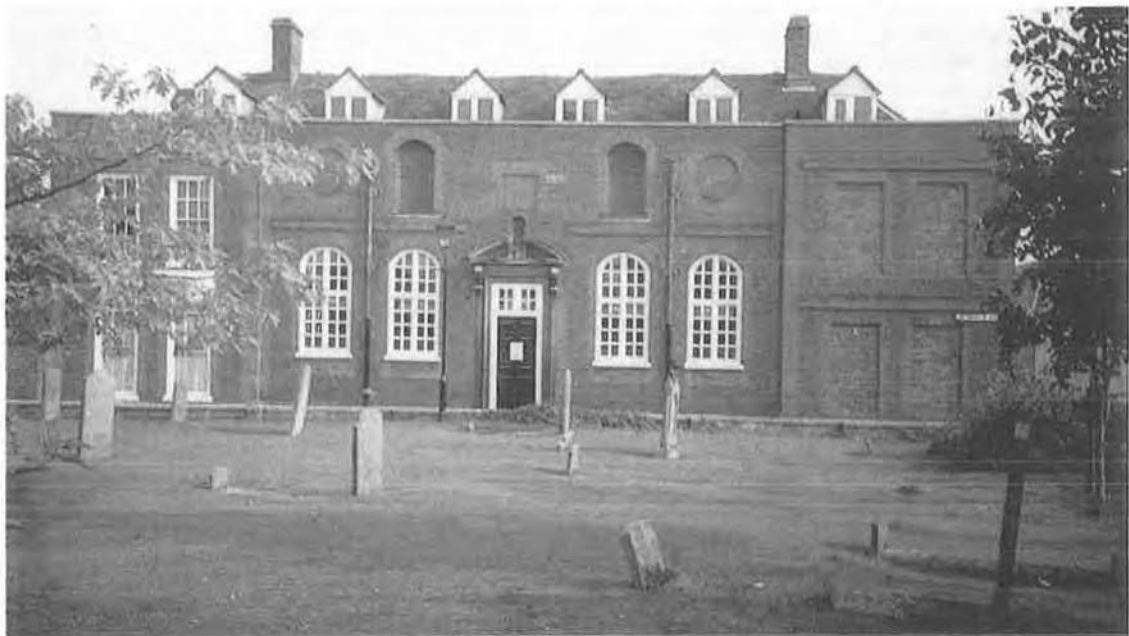
Plate IX. The former Grammar School, north front. (Photo County Meseum)

At an unknown date the windowsills of the schoolroom were raised six courses; possibly it had been found that the height of the original sills had allowed the boys' attention to wander to what was going on in the churchyard.

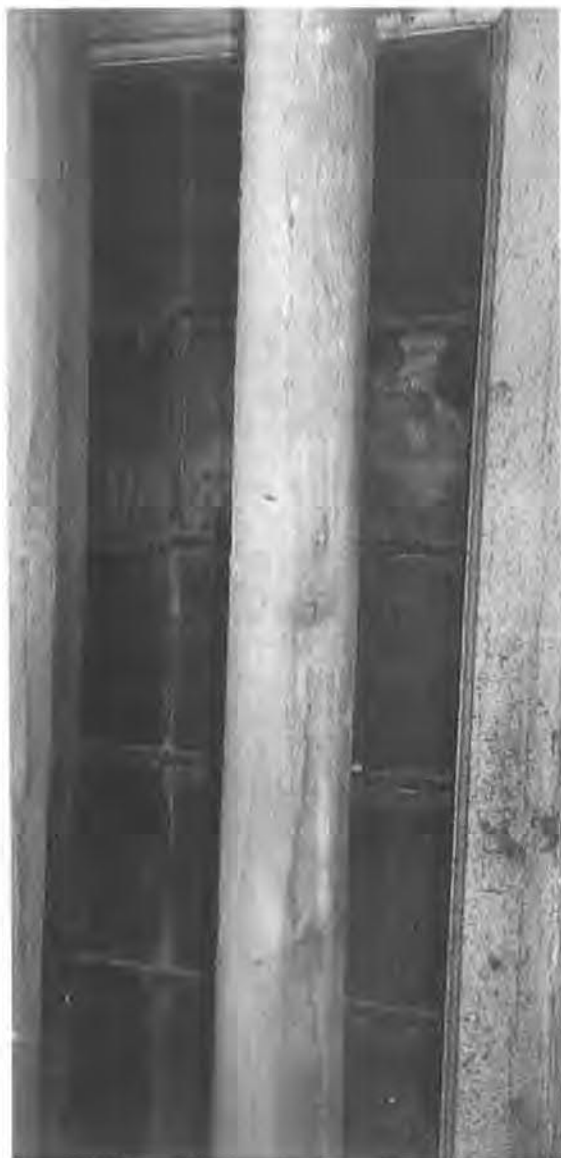
Plate X. The former headmaster's house; seventeenth-century window, behind later studs.

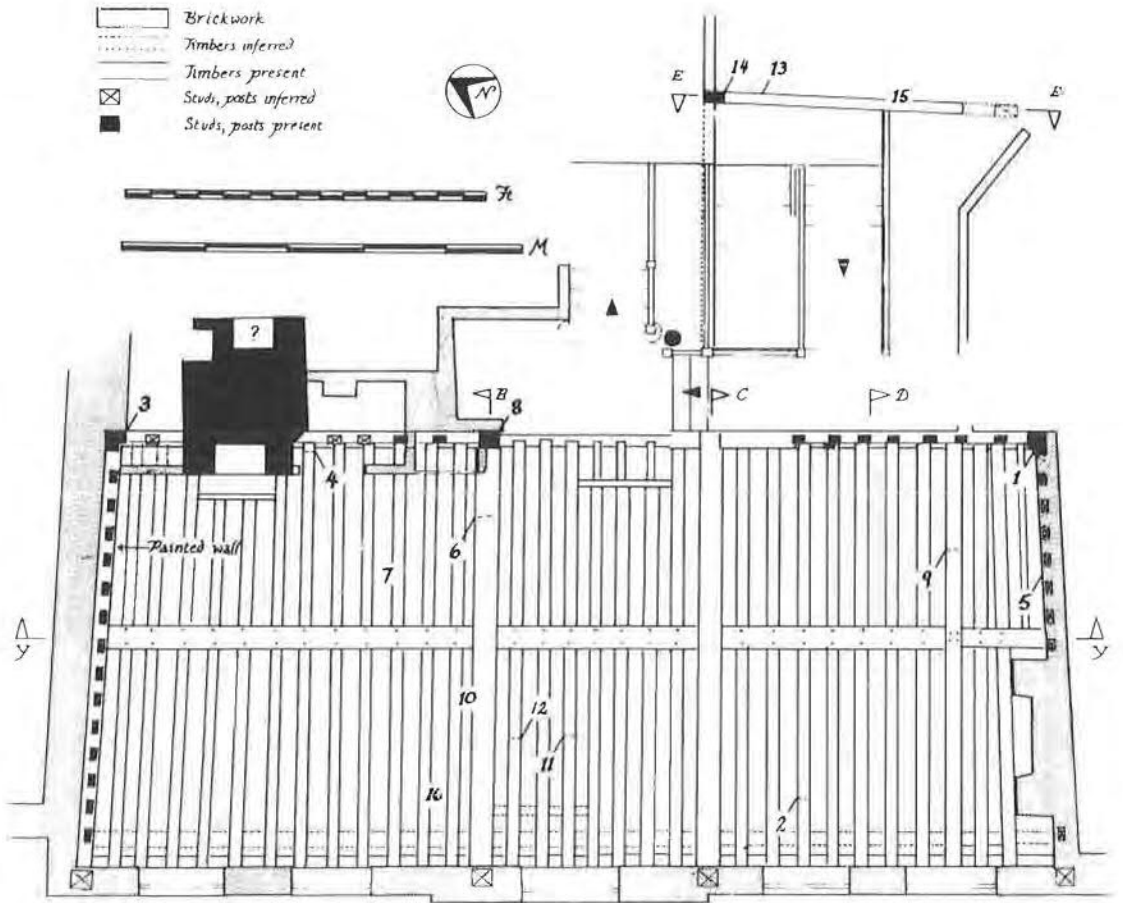
Fig. 14. Ceely House, showing positions of samples taken for tree-ring dating.
