# THE PENN DOOM

MILES GREEN

*In 1938, Clive Rouse, a former editor of Records of Buckinghamshire and a leading expert on medieval wall paintings, reported the fortuitous discovery in Penn churchyard of the broken-up remains of a medieval painting of the Last Judgement in the form of a wooden tympanum that had originally been set below Penn's chancel arch. After re-assembling all the pieces he could find and removing layers of whitewash and laths and plaster, cleaning and restoration revealed a second painting underneath the first. A Penn Church Millennium project has now funded further conservation work as well as a detailed analysis using the most modern techniques of paint analysis, infra-red, X-Ray and dendrochronology. The resulting insights have been combined with fresh architectural and historical evidence to provide as complete an account as possible of the painting and its setting. It is one of only five surviving medieval paintings of this type and, in Rouse's expert view, incomparably the richest in colour. It was exhibited at the recent V&A exhibition, The Glory of Gothic: Art in England 1400-1547.*

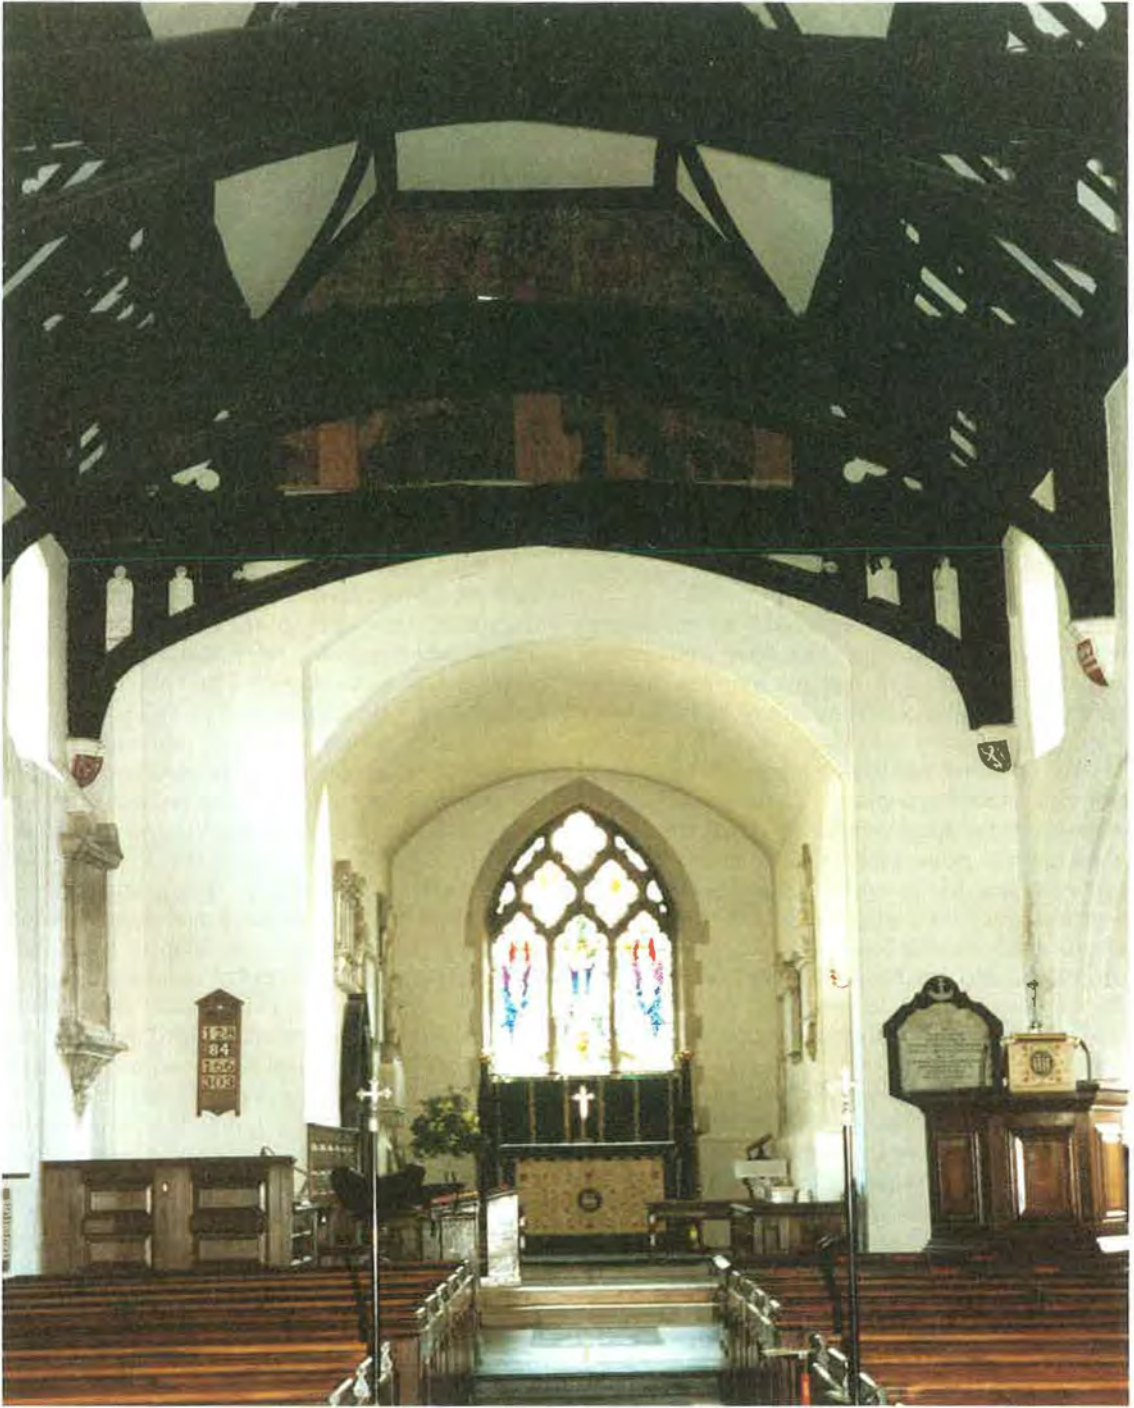
FIGURE 1 The Doom *in situ* above the chancel arch before the recent renovation. It was found in this position, in 1938, covered by whitewash and laths and plaster.

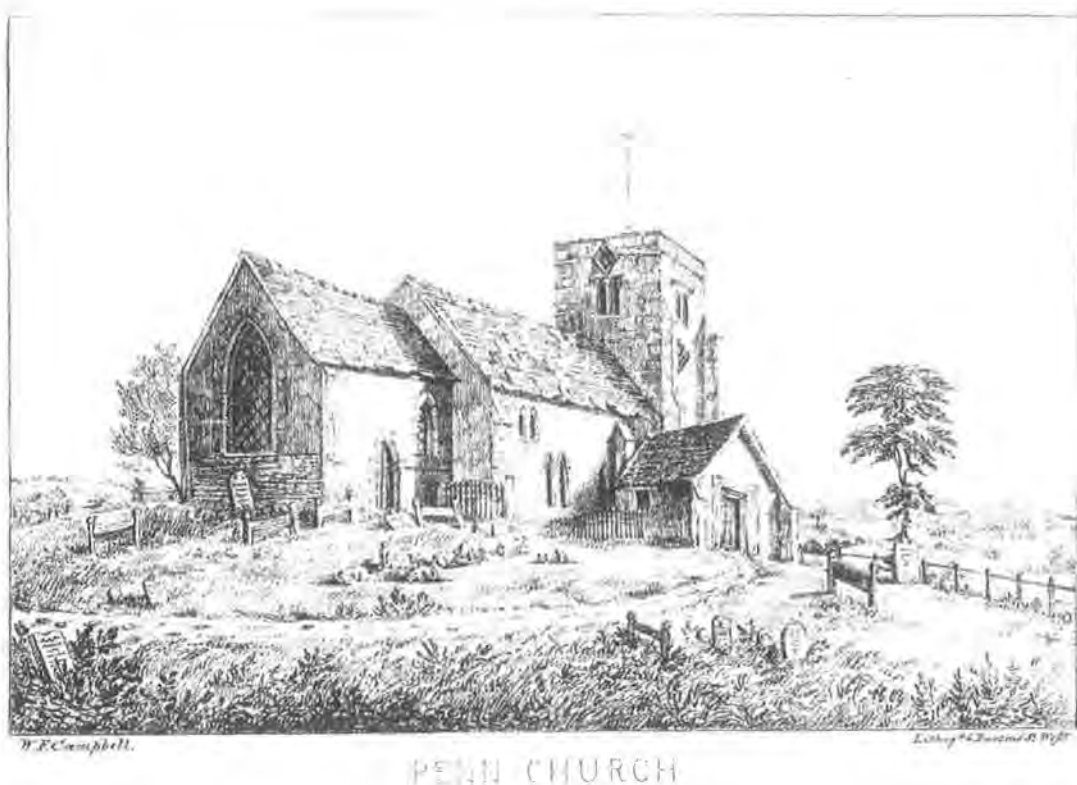
FIGURE 4 A seventeenth-century drawing of Penn Church reproduced in an early nineteenth century lithograph. (Penn PCC).

A lithograph of the exterior of Penn Church (Fig.4), which was published in about 1800, is based on an earlier drawing of the church made at what appears to be some time in the seventeenth century.<sup>4</sup> It may well have been taken from the framed picture which used to hang in the Vestry, described in 1929

The seventeenth century view (Fig.4) shows that the ridge of the nave was over 3ft lower than it is now, whereas mid-eighteenth and nineteenth

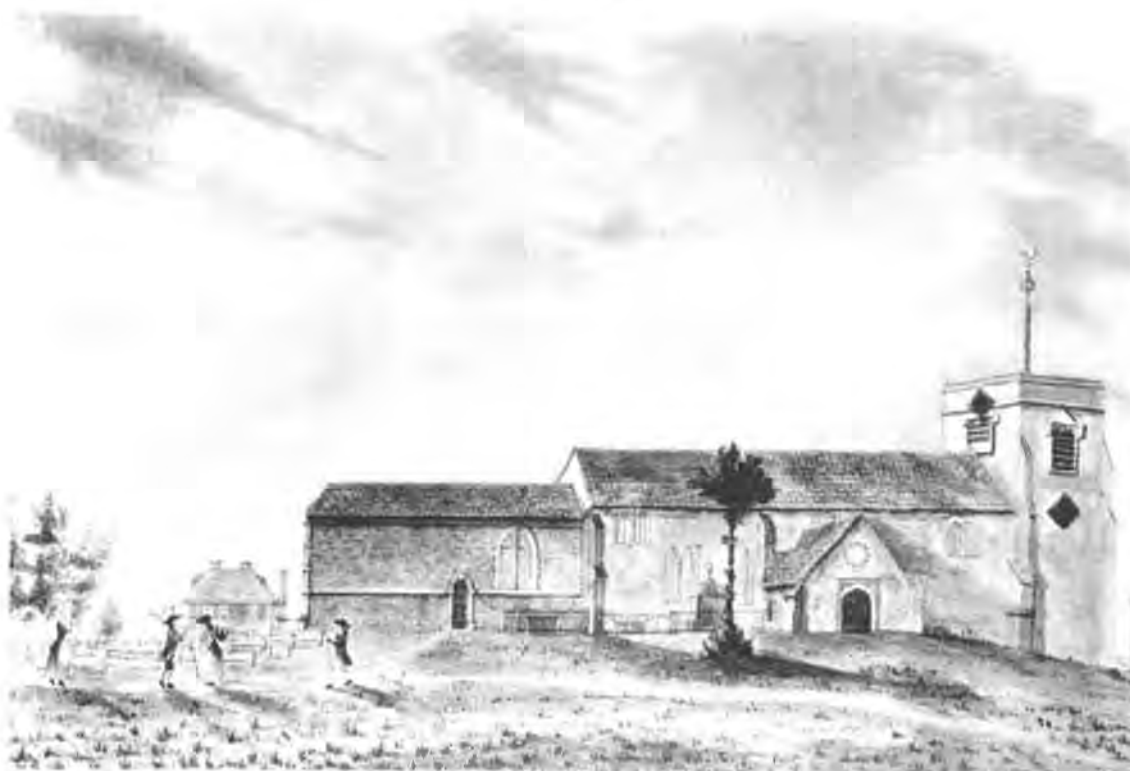
FIGURE 5 Mid-eighteenth century print of Penn Church (from Jenkins' 1935 *History of Penn*).

century views (Figs 5 & 6) show the ridge at its present height.<sup>7</sup> Therefore, it must have been during the major restructuring of the church, shortly after Sir Nathaniel Curzon inherited the proprietorship of the church, in 1731, that the ridge height was raised. This allowed the nave roof to be continued over the south aisle, presumably in order to raise the height of the roof of the south aisle, in which the pews of the Curzons and other leading parishioners were to be newly positioned. It also made the roof more weather proof – the 1637 Visitation had reported 'It rains into the S. aisle!!!'. It had the disadvantage of covering over all the clerestory windows of the nave on the south side (Fig.7e).

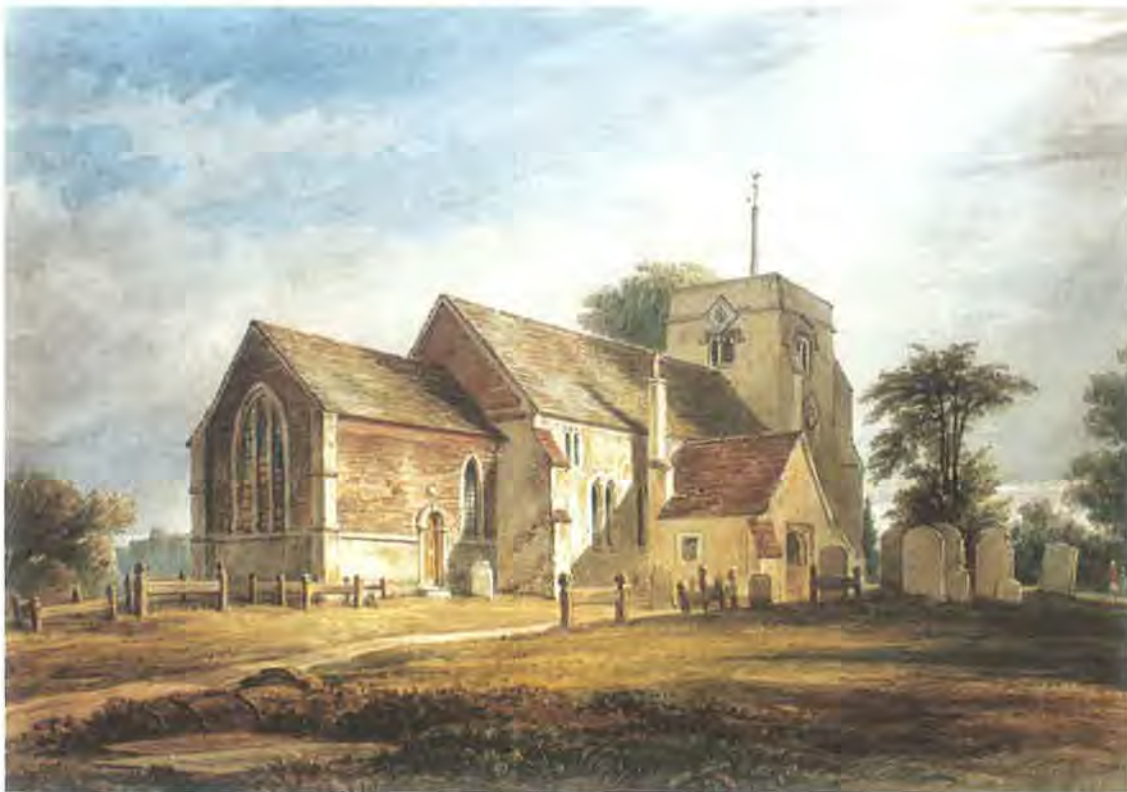
FIGURE 6 Mid-nineteenth century painting of Penn Church by H.B.Ziegler. (Photo by Eddie Morton of original painting owned by Earl Howe).

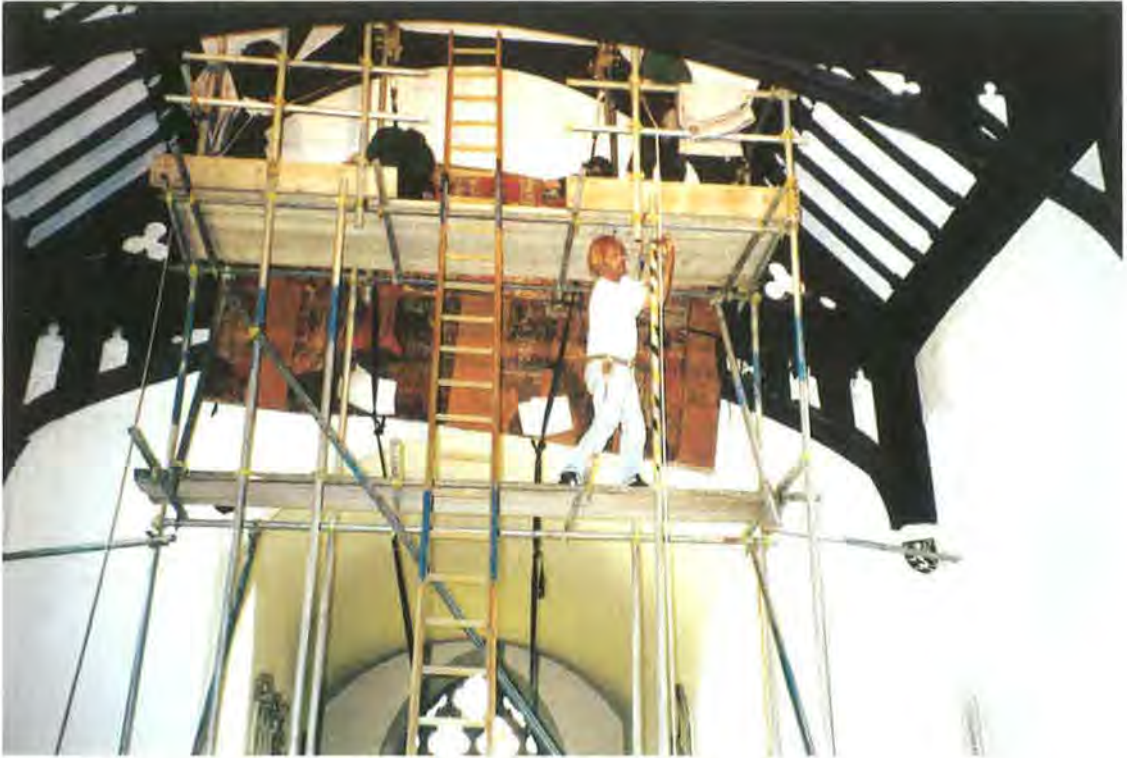
FIGURE 10 The Doom being taken down from above the chancel arch prior to its recent examination and conservation. To the right can be seen the Rood loft entrance set between the corbel supporting the tie beam and a clerestory window. (Photo by John Wood).

In 1999, the Penn Trust, a local charity, offered to pay for a technical examination and full report on the Doom to establish whether any conservation measures were needed and to find out more about the painting. This work was carried out *in situ* by Ruth E. Bubb, a conservator of paintings. In the light of her report it was decided to remove the Doom to her studio near Banbury in order to facilitate cleaning and treatment and allow a close analysis using all the modern techniques available (Fig.10).

We know that Penn had a Rood loft. This is confirmed by two wills of 1513 and 1549<sup>14</sup>, which left money to 'the Rood light of Penn', and by the discovery, in 1951, of the narrow (about 1ft 8ins wide and 4 ft 6ins high), entrance to the loft through the east end of the south nave wall, at the same level as the clerestorey windows (Fig.10).

In order to give enough room for the Doom, the loft platform must have been about a foot or two below the rood loft entrance, from which wooden steps would have descended. It was not structurally possible to put the loft entrance level with the loft platform since it would have meant removing the wall just below the load-bearing corner corbel as well as below the new clerestory window. Its position on top of the old wall, level with the window, avoided these structural problems (Fig.10).

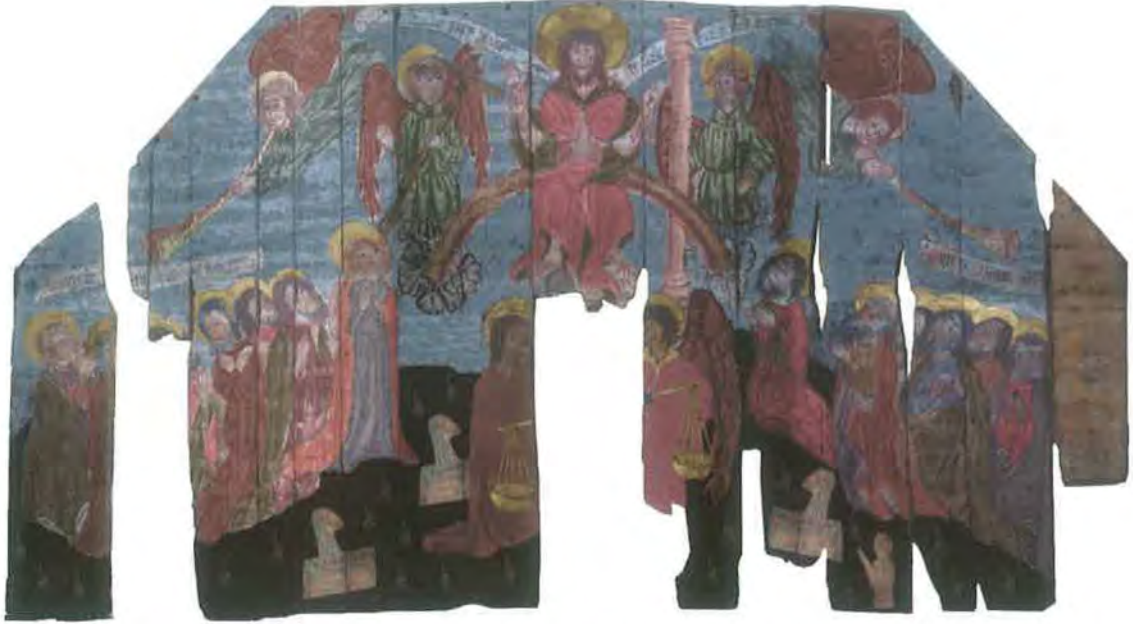
FIGURE 11 A digital impression of the main features of the first Doom painting by Clare Richardson. (Ruth Bubb).

Fig. 11 gives an impression of this first colour scheme, reconstructing the main features of the first composition where they differ significantly from the second scheme, but elsewhere using the features of the second scheme. It does not pretend to be an accurate reconstruction.<sup>22</sup>

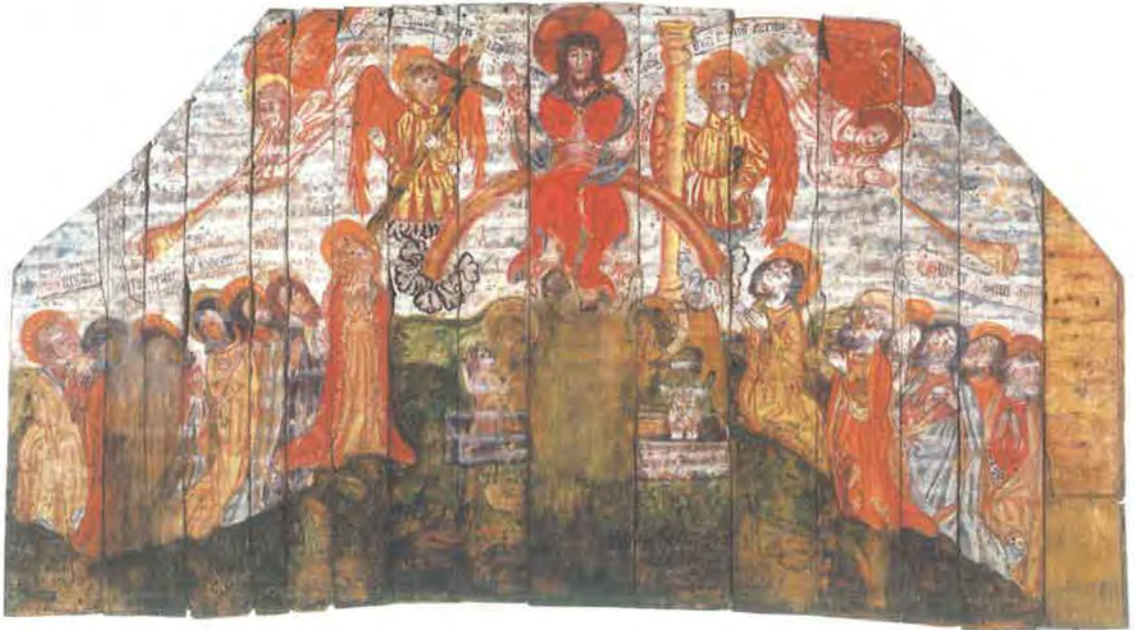
FIGURE 12 The Doom in colour after its recent restoration. The lighter horizontal barring is a result of the laths and plaster that covered it. (Photograph by V&A Images, but copyright Penn PCC).
