AN ARCHAEOLOGICAL SURVEY OF THE MANOR HOUSE AND GARDENS, STANTONBURY, MILTON KEYNES.

HELEN BAMFORD, DAVID WENT & DAVID McOMISH

The earthwork remains of the manor and associated features cover an area of approximately 4.8 ha and were assessed at 1:2500 scale; Level 2 standard (as defined in RCHME 1999, 3–4.)

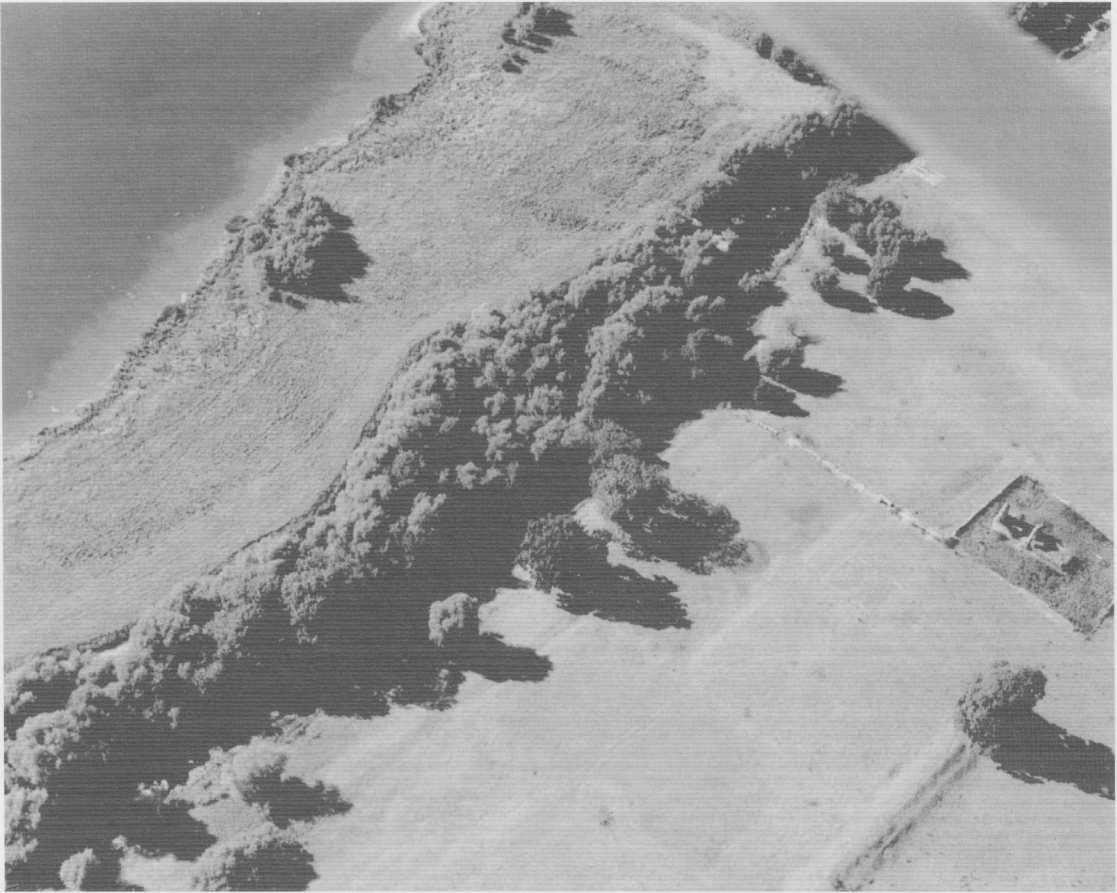
PLATE 3 1995 aerial photograph showing the church and the earthworks to the south. The faint, parched, outline of buried structures can be seen on the platform to the south of the church. © Mike Farley.

Aerial photographs taken in August 1995 (**Plate 3**) show parchmarks outlining the buried foundations of a rectangular range aligned parallel to the southern boundary of the churchyard, with one clearly defined wing projecting southwards at the western end. The site of the recorded parchmarks is a low, raised platform (**B**), measuring approximately 45m by 20m. A southward projection at the western end corresponds to the wing seen in the parchmarks, and there is a smaller projection, perhaps a stepped entrance, or porch, towards the centre of the main east-west range. The surface of the platform is uneven, suggesting a spread of demolition material, and fragments of tile, plaster and mortar appear in molehills across this area.

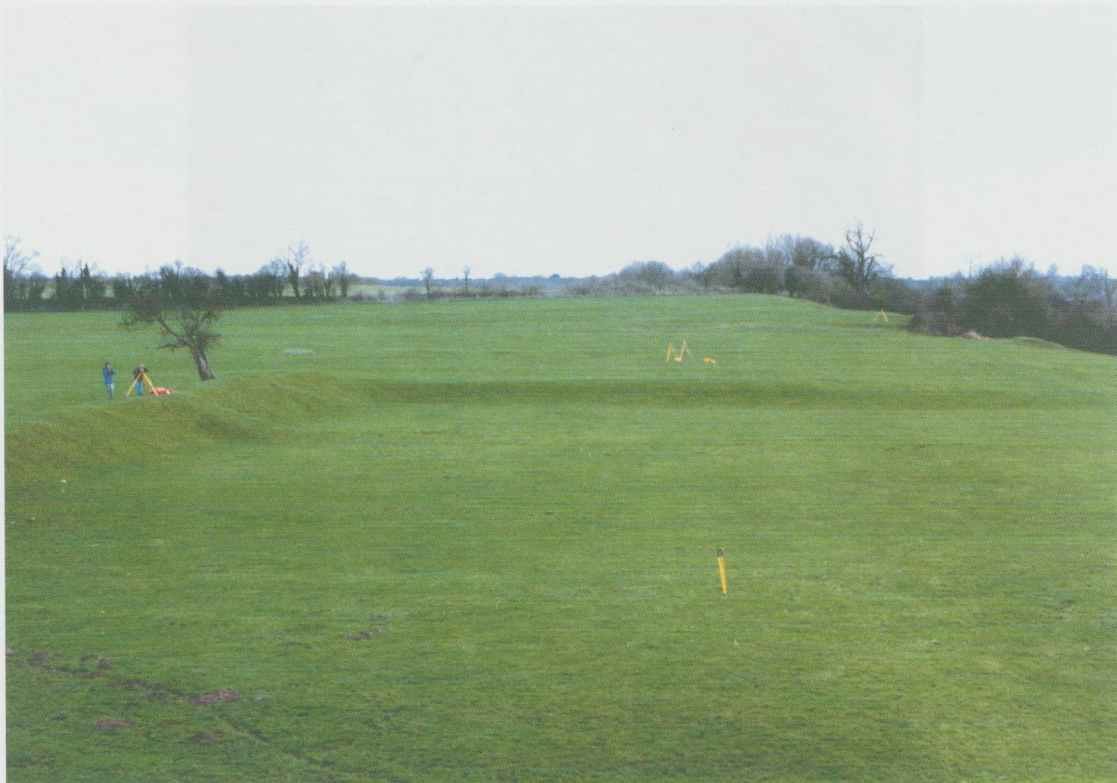
PLATE 4 View looking south from the church. The terminal scarp at the southern edge of the lower garden platform is prominently highlighted by the shaded area, as is the bank on the east side of the terrace

The area immediately to the south of the site of the mansion has been levelled over a distance of nearly 70m, terminating at a north-facing scarp cut to a

depth of some 1.2m into the hillside (**Plate 4**). This area (**C**) is bisected east-west by a low bank approximately 4m wide and 35m in length, and further sub-divided by shallow scarps to north and south – features which are consistent with the remains of formal parterres laid on the axis of the garden and separated by a central raised pathway. The area to the north of the of the east-west bank and nearest to the site of the mansion contains a large circular depression in the precise centre which could have been an ornamental pool or fountain.

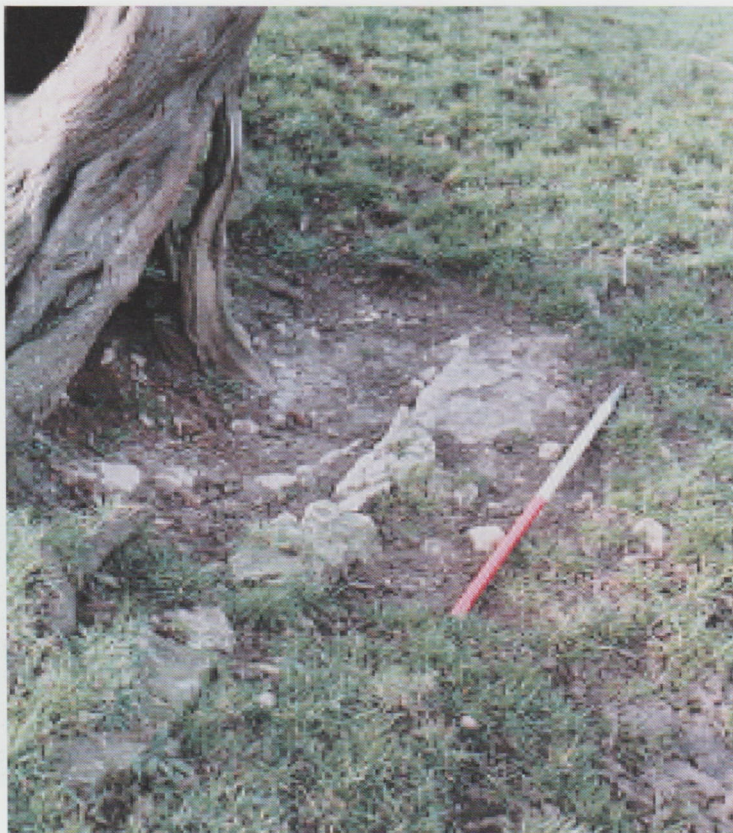
PLATE 5 Detail of the exposed wall facing on the crest of the bank flanking the western side of the lower garden.

enclose the garden and to act as a raised walkway from which to enjoy the prospect. Slight knolls at either end of the bank suggest the locations of relatively insubstantial arbours or summerhouses, and at the mid point of the bank a sloping, semi-circular projection probably marks the site of a flight of steps linking the east-west garden path to the flattened summit. The eastern, or outward face of the bank has a single terrace running mid-way along the slope for most of its length. This seems merely to be a product of erosion, although its position appears to reflect the line of a buried retaining wall of roughly dressed stone, now only visible in cattle scrapes at the extreme ends of the bank (**Plate 5**).

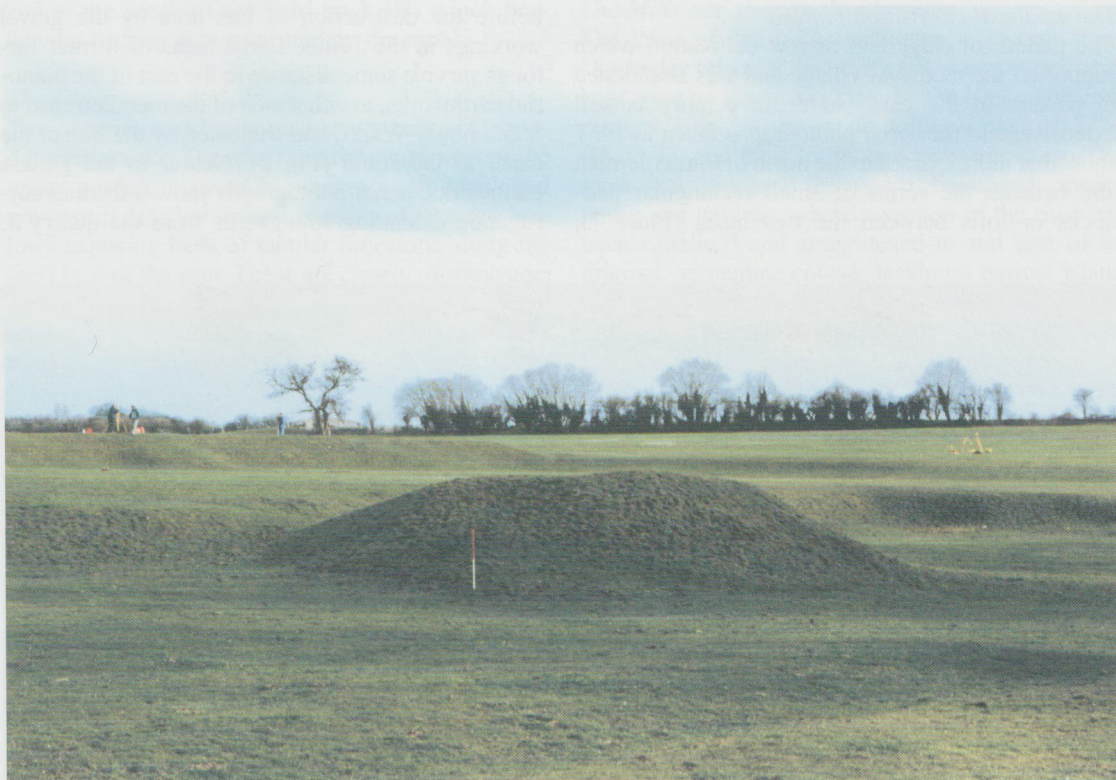
PLATE 6 View of the garden prospect mound from the north-east.
