FIRST WORLD WAR PRACTICE TRENCHES IN PULLINGSHILL WOOD, MARLOW

AN INTERPRETATION AND EVALUATION

DANNY DAWSON

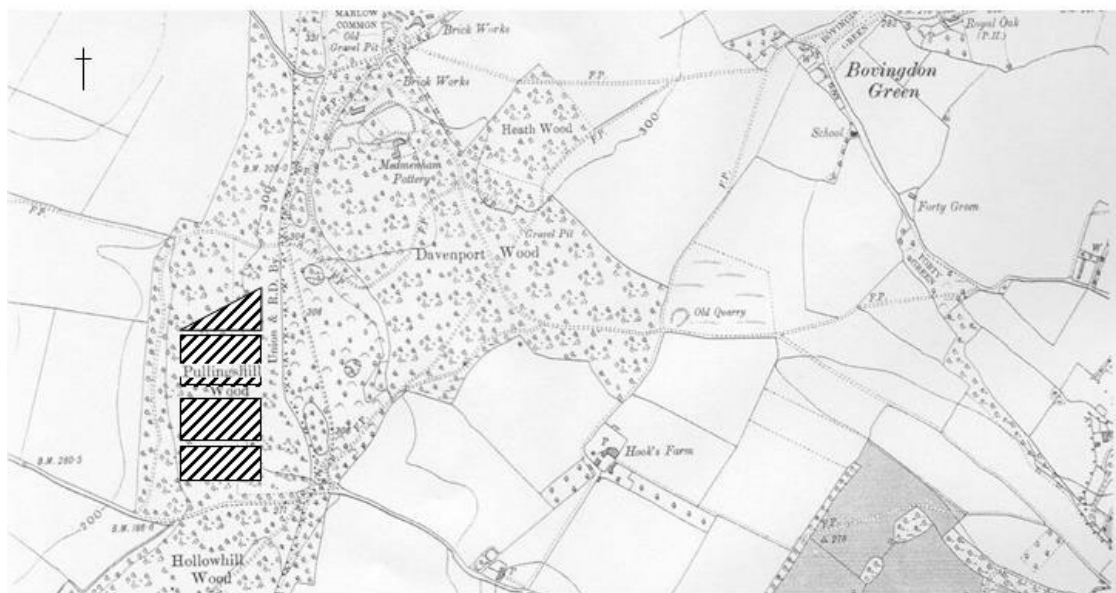
FIGURE 3 Pullingshill Wood 1913 (6" Map edition). Note (i) the approximate location of the Trenches, dug in 1915 shown with diagonal shading (ii) the ancient parish boundary between Medmenham and Marlow (wood bank). (iii) Bovingdon Green where troops were encamped.

system were made in 1915. The extensive felling at Pullingshill is seen on a map and an aerial photograph produced 30 years apart (Figs 3 and 4).

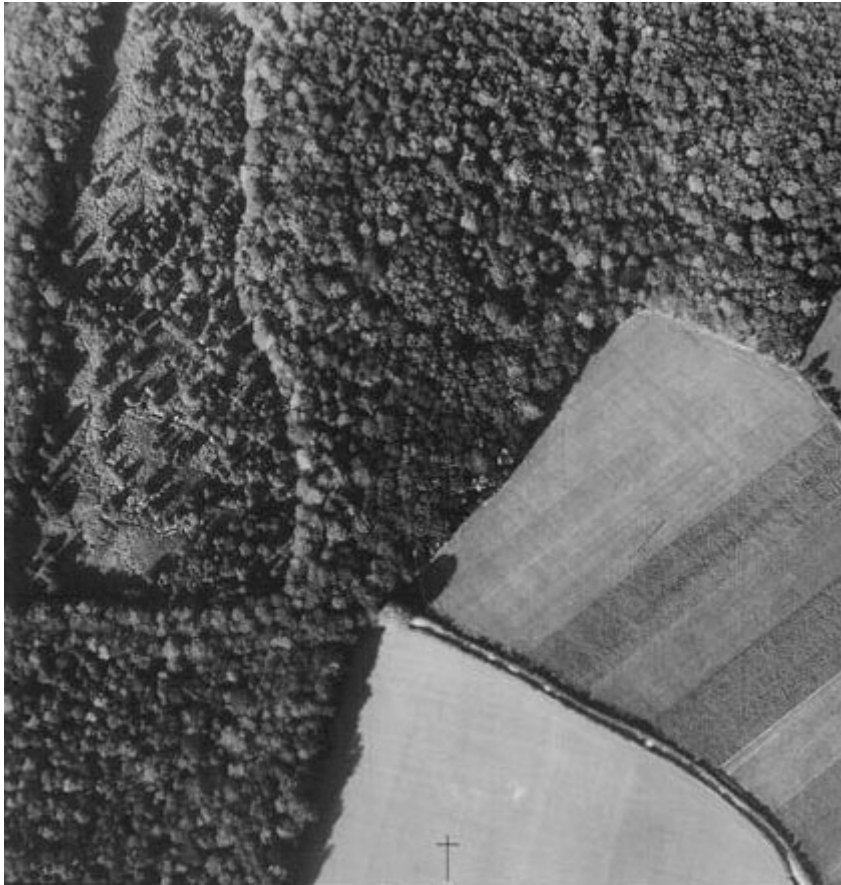
FIGURE 4 Pullingshill Wood 1945. On close observation the outlines of the First World War Trenches remain visible. Reproduced courtesy of the National Monuments Record (Ref: RAF/106G/UK/911 re:1072).

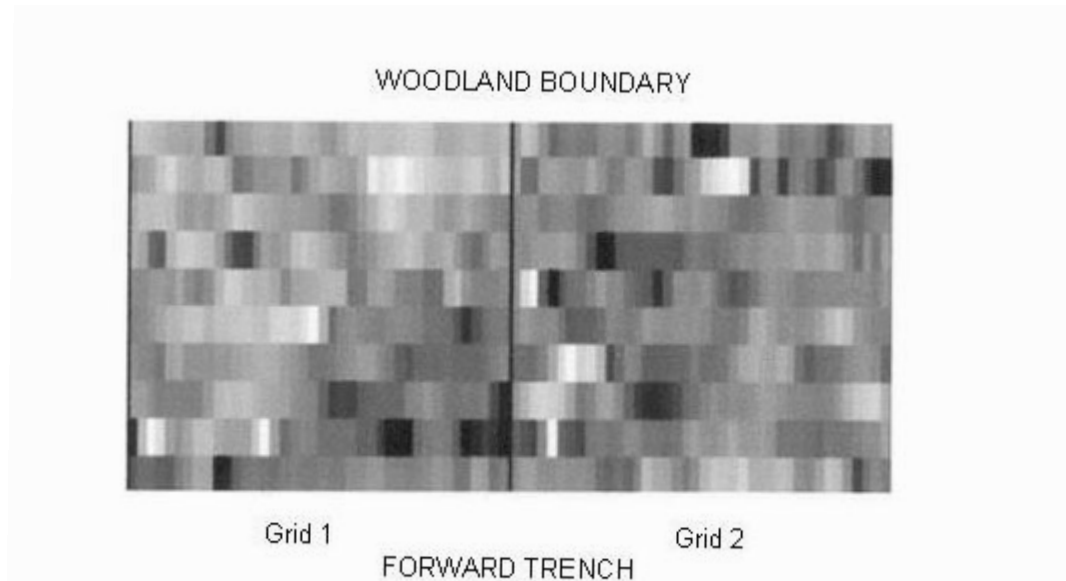
FIGURE 7 Magnetometry Results (1+2), Clipping +5 to -5
