A HIDDEN LANDSCAPE REVEALED: ARCHAEOLOGY IN THE LAKES AND STREAMS AT WEST WYCOMBE PARK, BUCKINGHAMSHIRE

GARY MARSHALL

INTRODUCTION

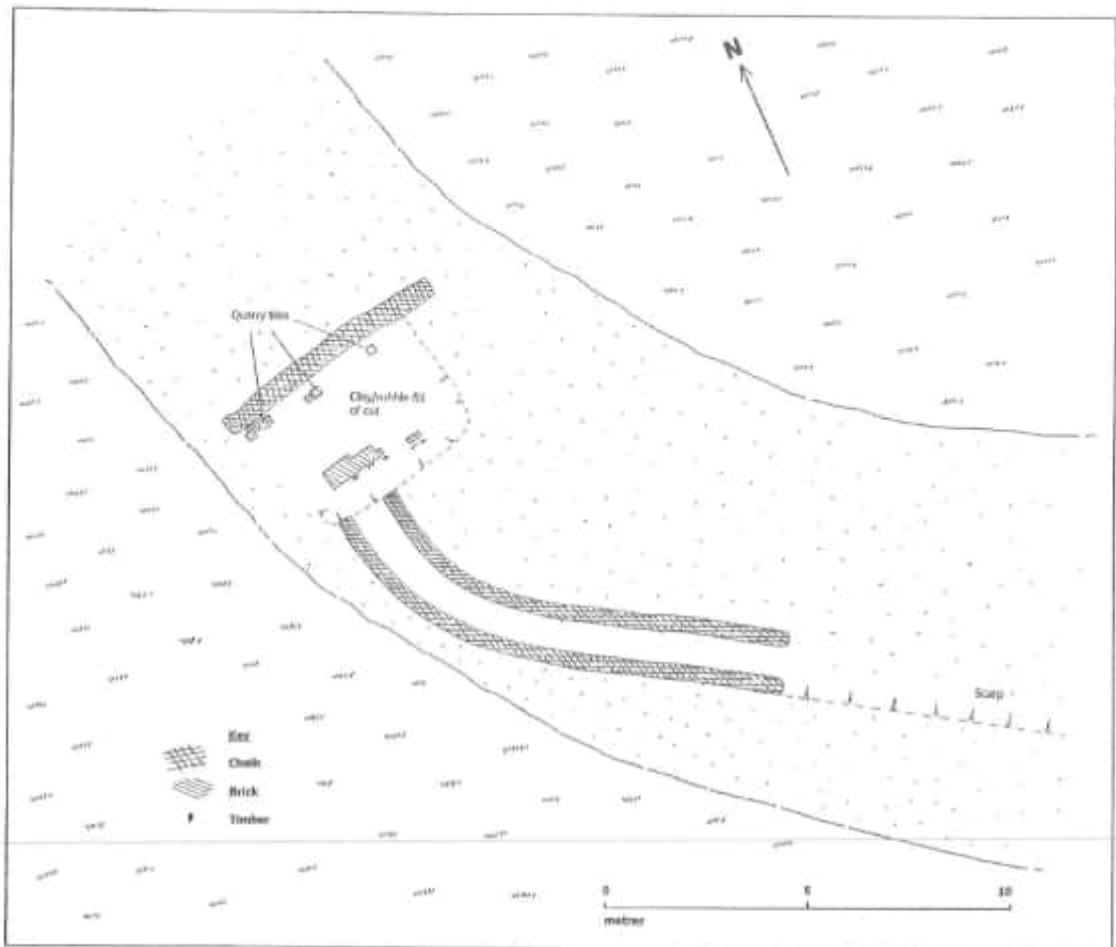
FIGURE 5 Area 1, plan of the chalk and brick footings in the south stream

Situated within the elbow of the south stream, close to the south bank, two parallel chalk block walls measuring just over 11 m long were excavated and recorded in 1991 (Figs. 4 and 5). The walls assume a gentle curve and are separated by an internal gap of 0.75m and measure 0.35m in thickness. Their continuation in a downstream direction can be assumed since there is a slight scarp within the stream-bed, coinciding with the outer face of the more southerly wall. The opposite upstream ends of the block walls terminate at a shallow cut filled with dark grey clay and rubble. This cut contains the remnant of a brick wall 0.46m thick aligned at 90 degrees to the chalk block walls. Two large wooden stakes 0.2 and 0.15m in girth about the

downstream face of this structure, with two smaller 0.06m diameter stakes between. A second short section of brickwork slightly to the north, also abutted by three wooden stakes, suggests that this structure continued further across the width of the stream.

Situated 2m upstream of the brickwork a band of chalky white clay approximately 6 m long and 0.5m wide was noted running across the width of the stream. Three large quarry tiles measuring 21 inches square and 4 inches in thickness (0.53 x 0.1m) were recorded in front of this chalky clay, spaced at intervals of between 1.5 and 1.65m. Fragments of in-situ brickwork were noted around these tiles.

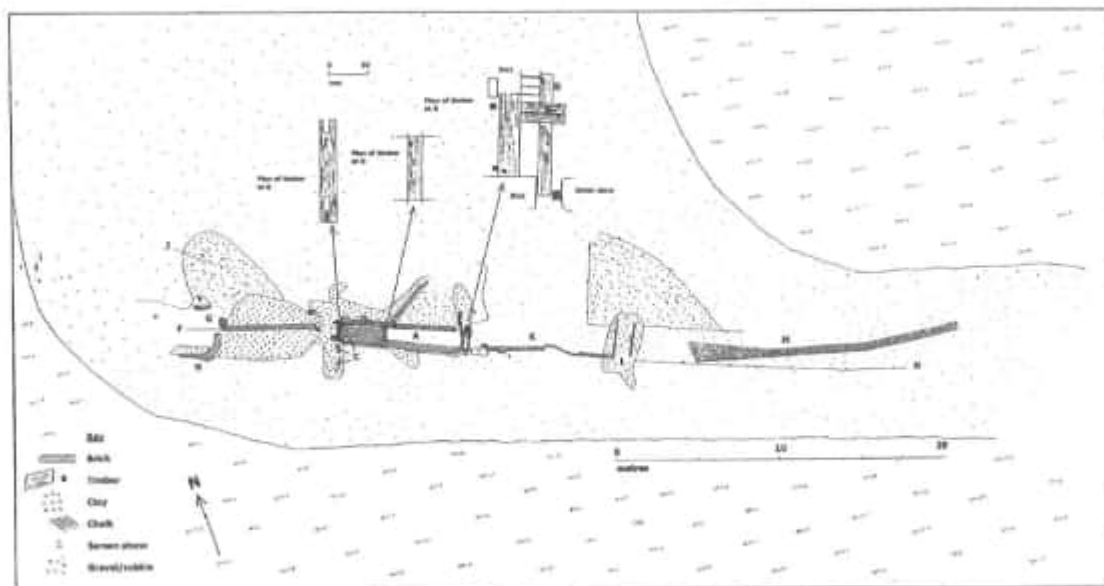
FIGURE 6 Area 1, plan of the brick channels in the south-west corner of the lake

a tenon at either end – part of the tenon for an upright timber still remained within one of the mortises. Two short sections of timber were recorded leading away from the south face of the channel at this point (C). At the opposite (east) end, two timbers of similar length were noted (E). The more westerly of this pair continues under the brickwork and is held in place by an iron nail driven into an underlying timber that was not exposed. It is given additional support by short timber posts driven against its west face. A mortise at the north end, matching the timber at B, suggests the presence of a vertical timber, now lost. The east timber of the pair is much narrower and still retains the bark. It is similarly anchored by driven posts. The remains of several timber planks nailed to its upper surface, remained in-situ.

The presence of a fourth timber within the channel (D), corresponding with the diagonal return on the north wall, has already been noted. This is notched on its east face and carries a small off-centre mortise, together with a second mortise at its north end.

The central channel is flanked at either end by further sections of brick wall, continuing the alignment of the central channel. To the west, continuing to the south-west corner of the lake, there is a section surviving to a height of three courses (F). This measures 6.2m long and is separated from the end of the central channel by a gap of 1.05m. At the west end of this section, there is a truncated remnant of a northerly return (G), while on its south side there is a curved section of brickwork measuring 2.5m (H) that appears to have been buttressed on its south face. The curved section of brick has been laid within a cut and is set in a distinct orange clay containing flecks of chalk. The fill of the cut is contemporary with the brickwork and consists of a dark-grey clay, gravel, brick rubble and garden soil. Several detached sections of brickwork lie to the north, and appear to be associated with a cluster of timbers consisting of a short length of plank and four posts arranged to form an approximate rectangle (J).

The section of brickwork on the east side of the central channel (K) consists of several short lengths of brickwork. The first part measures 3.8m long and is buttressed on its south face; it is also buttressed at its west end around a large block of sarsen stone measuring 1x 0.5m. Close to the south face there is a post. The central part measures 2.1m

long and assumes a kink in its alignment. The third part measures 2.2m long. It is abutted by one of a pair of timbers (L), measuring respectively 2.3 and 2.1m long and 0.18 and 0.15m in girth, which extend at right angles to the north face of the wall. These two timbers were sampled for tree-ring dating; the results are described subsequently.

The final section of the construction of the channel consists of a foundation formed of chalk blocks measuring at least 16m long (M). This feature measures 0.5m wide but increases in size at its west end where it widens out to a maximum width of 1.2m. Running roughly-parallel with the south face of the blocks there is a slight scarp (N), which continues the line of the easternmost section of brickwork.

The 1711–16 date range for the sampled timber, gives a strong indication of when the structure in the south-west corner of the lake was created, though it is possible that the timber was recycled at a later date. One can only hazard a guess as to why the structural evidence was configured in such a manner. The author's view is that the curved section (H) was designed to reduce the speed of the flow of water along the south stream before it entered the central section A. The system of sluices, implied by the crosswise timbers in section A, suggests that the flow of water could be controlled, with some of the water passing northwards against the angled section of brickwork, perhaps into the main body of

the lake, with the remainder passing along the continuation of the channel suggested by sections K and M. The chalk blocks at M presumably represent the floor of the channel, as similar chalk blocks between timber edging were found on the west side of the lake. The brightness of the chalk may have given clarity to the water flowing through the channels, although it is not clear whether these channels were covered over.

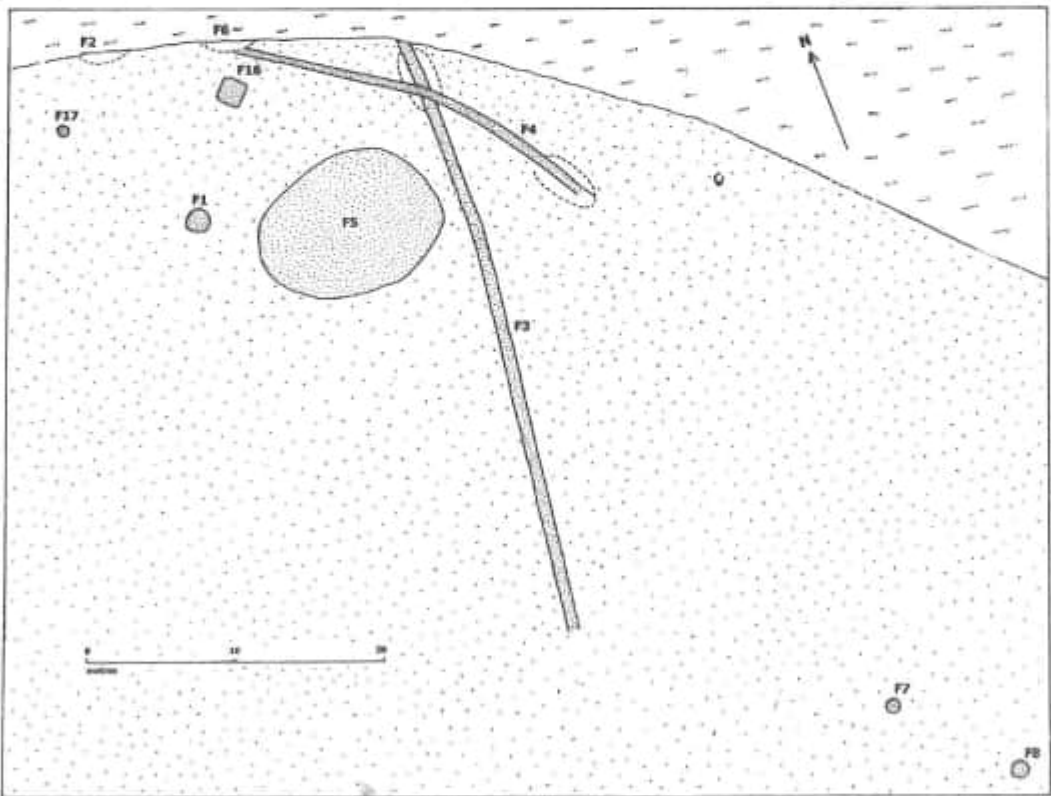
FIGURE 7 Area 3, plan of silt-filled features in the northern part of the lake

Several distinctive cut-features, filled with dark grey silts, were observed within the northern section of the lake bed in 1991. Wainwright recorded these, applying a feature numbering system (F1-F8, F16, F17, F18), which was continued to include

finds spots elsewhere in the gardens and park. These features had all been cut into the natural clay and flint forming the base of the lake. They produced a significant assemblage of Romano-British pottery, amounting in total to about 8 kgs in weight, (see Description of Finds). Together with a substantial number of coins found in the north-east corner of the lake, this suggests that the northern area of the gardens must have been the focus for Roman occupation, associated with a villa or settlement. The largest of these features consisted of a roughly oval, silt-filled hollow, measuring 12.5 m long and 9.3m wide (F5 on Fig. 7). Several smaller pits were noted to the west of this oval. F1 is a circular cut 1.6m in diameter and 0.3m deep, filled with dark-grey silt, containing a large amount of charcoal. 3.4 kgs of Roman pottery were recovered from this feature. F16 is a square cut, measuring

1.7 x 1.7m. F17 is a small circle 0.8 m in diameter and 0.15m deep.

Two further cuts (F2 and F6), filled with dark grey clay, were noted in the north bank of the lake. F6 was recorded as a cut 0.35m deep and at least 3.6m wide, continuing into the lake bank. The grey clay fill contained a large amount of charcoal. Only the outline of F2 was recorded.

Two isolated, circular pits, 0.85m and 1m in diameter (respectively F7 and F8) were observed 26m south of the north bank of the lake (Fig. 7).

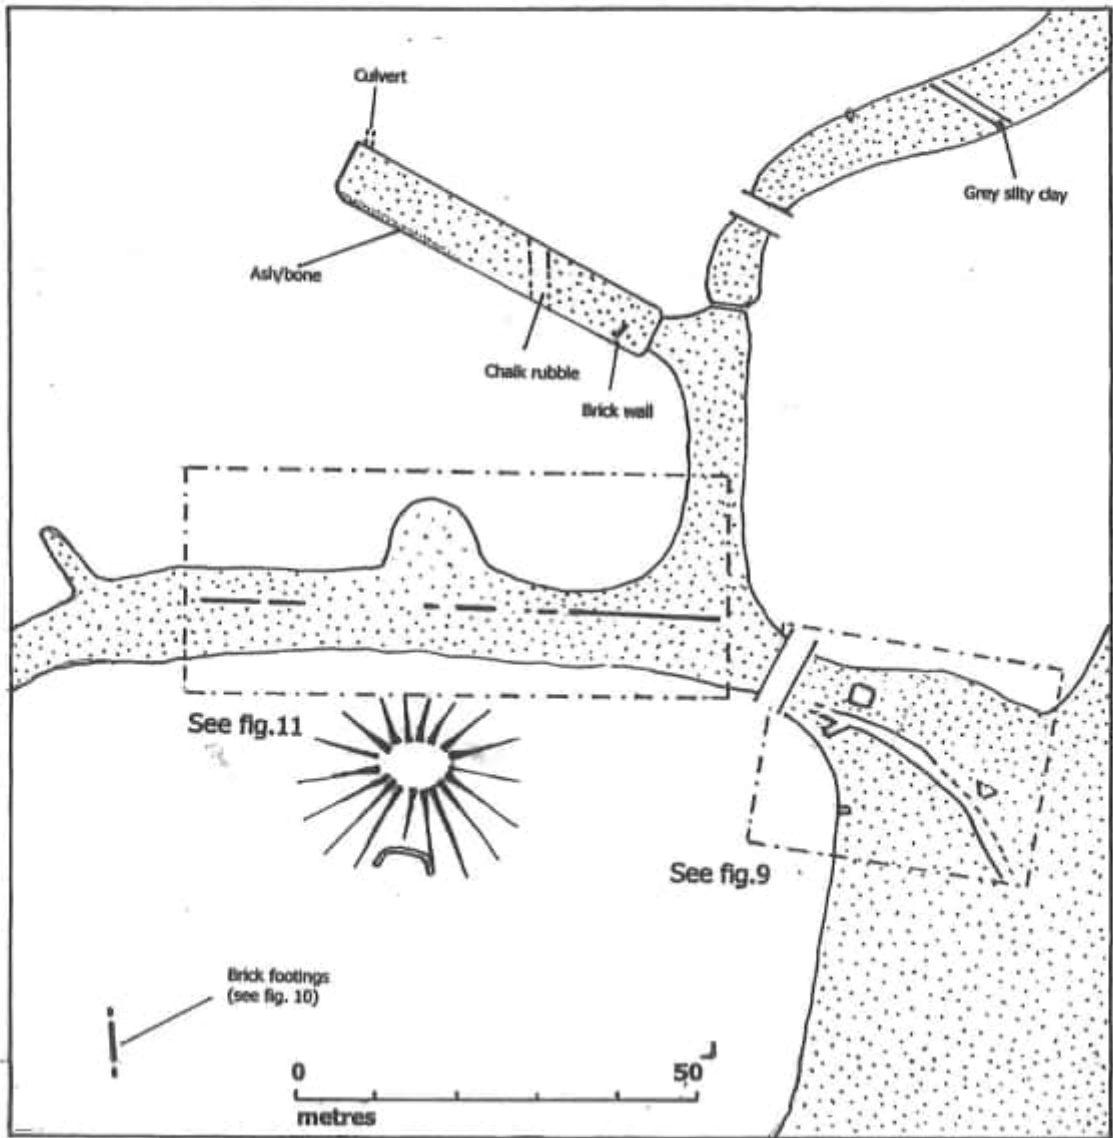
FIGURE 8 Area 4, plan showing features in the north stream and west edge of the lake

A cluster of features on this side of the lake (Fig. 8) was recorded as part of the work carried out in 1991. An area of peat 2.5m square was noted in the bed of the lake, 9m east of the bridge across the east end of the north stream. This area of peat (Fig. 9) lies adjacent to the remains of what was, at one stage, evidently a well-engineered stream channel emerging from the south bank of the north stream and continuing towards the centre of the lake. This feature was traced over a length of 30m (Fig. 9). The surviving evidence consists of a series of planks laid on edge, supported externally by timber posts forming two sides of a channel 1.5m wide. A series of chalk blocks appeared to have been laid to form the floor of the south side of the channel, the north side consisted of grey silt, flint gravel and rubble, placed perhaps to in-fill the channel after it had gone out of use.

An area of chalk rubble between 2 and 3m wide, running across the width of the pool on a north-south alignment, was exposed in the base of the pool in 1991 (Fig. 8). It was suggested by Wainwright that this might possibly be the foundations of a path.

Towards the southern end of the pool a brick wall 1.3m long and 0.23m wide was observed, set into a band of orange clay. The brick dimensions were recorded as 0.22 x 0.102 x 0.06m.

A bank of grey silty clay, 1m wide and 5.2 m long, was observed in 1991 emerging from the south bank and crossing the width of the north stream (Fig. 8). It overlies the natural orange clay and gravel. Eighteen pieces of Roman pottery were recovered from this feature (see Description of Finds).

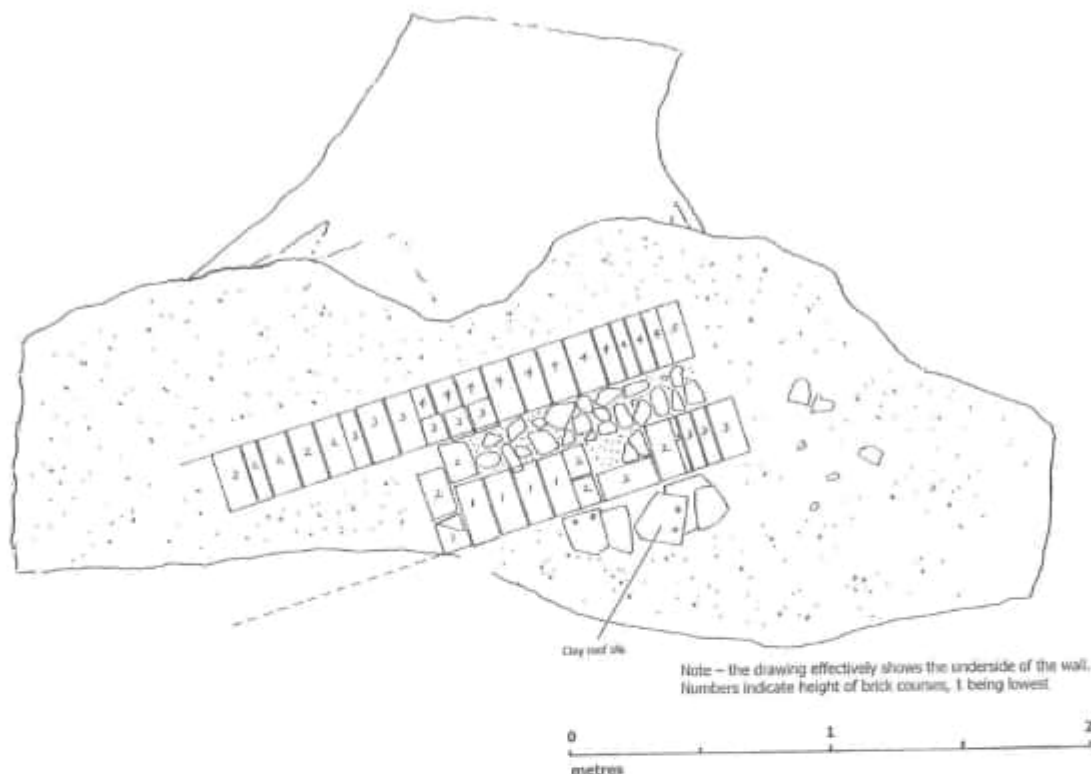
FIGURE 10 Area 4, plan of the brick footings beneath the fallen ash tree

During January 2007, strong winds felled two large ash trees on the north side of the 'Broad Walk', 100 metres south-west of the Temple of Venus (Fig. 8). The smaller tree, nearest to the temple, pulled up in its root plate the footings of a substantial brick wall, measuring 0.65m wide and at least 2.5m long (Fig. 10). The north end of the wall remained within the ground, thus truncated from the uprooted section. The orientation of the wall was difficult to determine due to the rotation of the fallen tree but it appeared to be aligned roughly north-south. Five courses of the wall were evident, the bricks arranged in a predominantly header bond, though with occasional bricks laid edge on within the face of the wall. The bricks had an orange to light red fabric and appeared to be hand-made with dimensions of 0.23–24 x 0.10–11 x 0.055–6m. Part of a glazed header in the loose soil and further evidence of a vitrified header in the actual wall construction, might suggest that the wall incorporated some sort of chequered or

diaper pattern, though this evidence remains inconclusive. The nature of the bricks and the light creamy-coloured lime mortar used in the construction of the wall, suggest a late 17th or early 18th century date.

Evidence that this may have been a substantial garden wall comes from a moulded coping brick subsequently found loose in the soil at the base of

the wall. The coping has a half-round projection along its upper surface (see Description of Finds) and gently sloping shoulders, though unfortunately it is quite badly damaged. One end has been crudely tooled to form a 60 degree bevel, suggesting that it formed a mitred joint with an upright coping. Identical copings – probably of 18th century date – survive on the retaining walls of the

fallen ash tree in area 4, since the moulded coping brick recovered at its base matches those on the garden walls at nearby Bradenham Manor. This wall points in a northerly direction towards the north stream, where there is a longer section of wall within the stream-bed, possibly at right angles to the aforementioned wall. The section in the stream must pre-date the formation of the stream channel, but it is difficult to suggest why it lies more than a metre below the stream banks. Either the wall had very deep foundations, or, more likely, the previous ground level was considerably raised when the present outline of the stream was created prior to 1752.

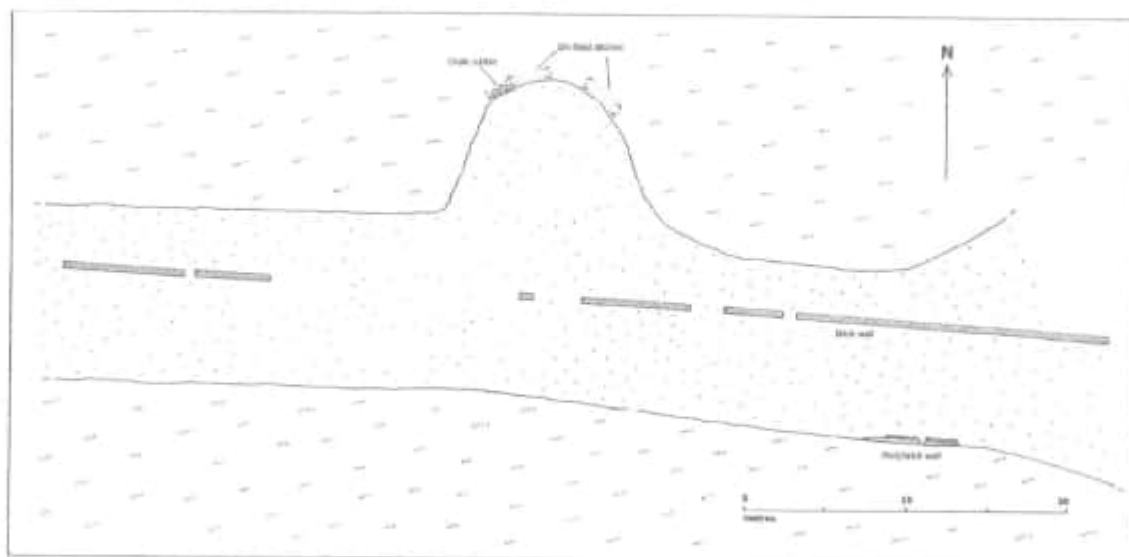
FIGURE 11 Area 4, plan of features in the north stream

Two separate structures – the first of brick construction, the second brick and flint – were excavated and recorded in 1991. The largest is a substantial length of brick wall running parallel with and along the centre of the stream channel. The total recorded length of the wall amounted to 66m, beginning 12m west of the bridge and continuing in 5 broken sections, the longest measuring 20m long (Figs.8 and 11). A large block of limestone 0.6m long and 0.33m wide was noted at the westerly tip of the westernmost section in 2006,

The second structure within the south bank of the stream is on a parallel alignment to the first section of brick wall. It consisted of a brick face 4.5m long built up against a section of mortared flint set into the embankment. The brickwork acted as a facing wall against the flintwork, which in turn acted as a retaining wall.

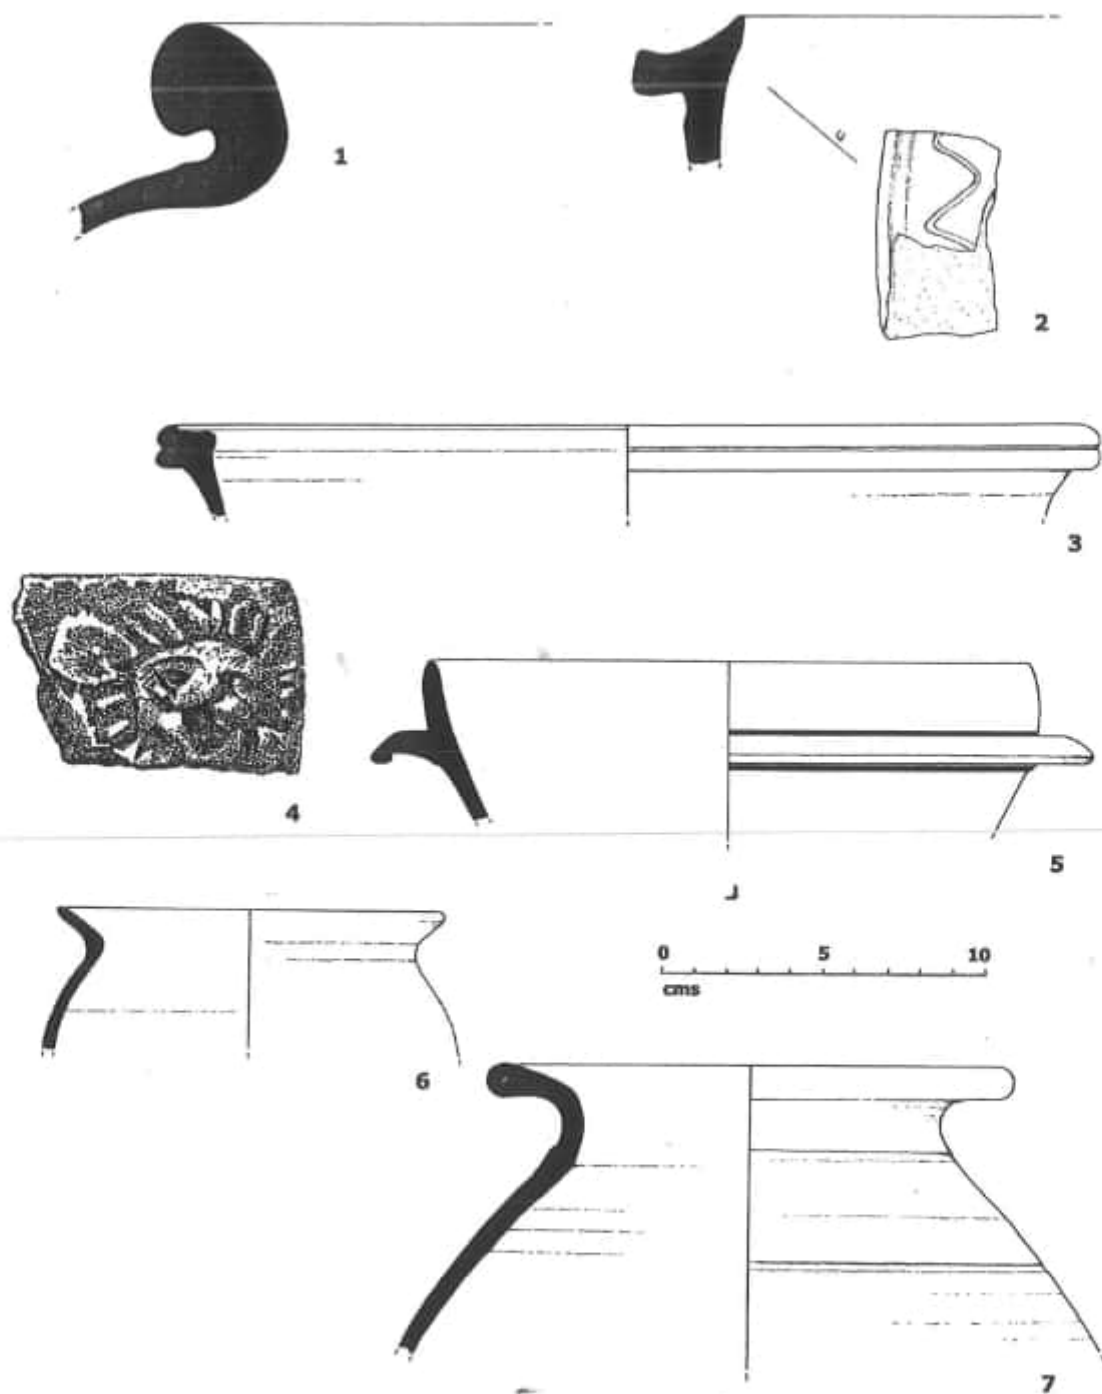
FIGURE 17 Romano-British pottery

(F13) 1 rim and 17 sherds of a large grey narrow-necked jar (Fig. 17/7), this is likely to be a product of the Fulmer/ Hedgerley kilns (Tarrant 1972 and Stainton 1987); the base and rim of fine grey-ware beakers; 1 jar rim (Fig. 17/6). The narrow-neck jar and beaker date to the second century.

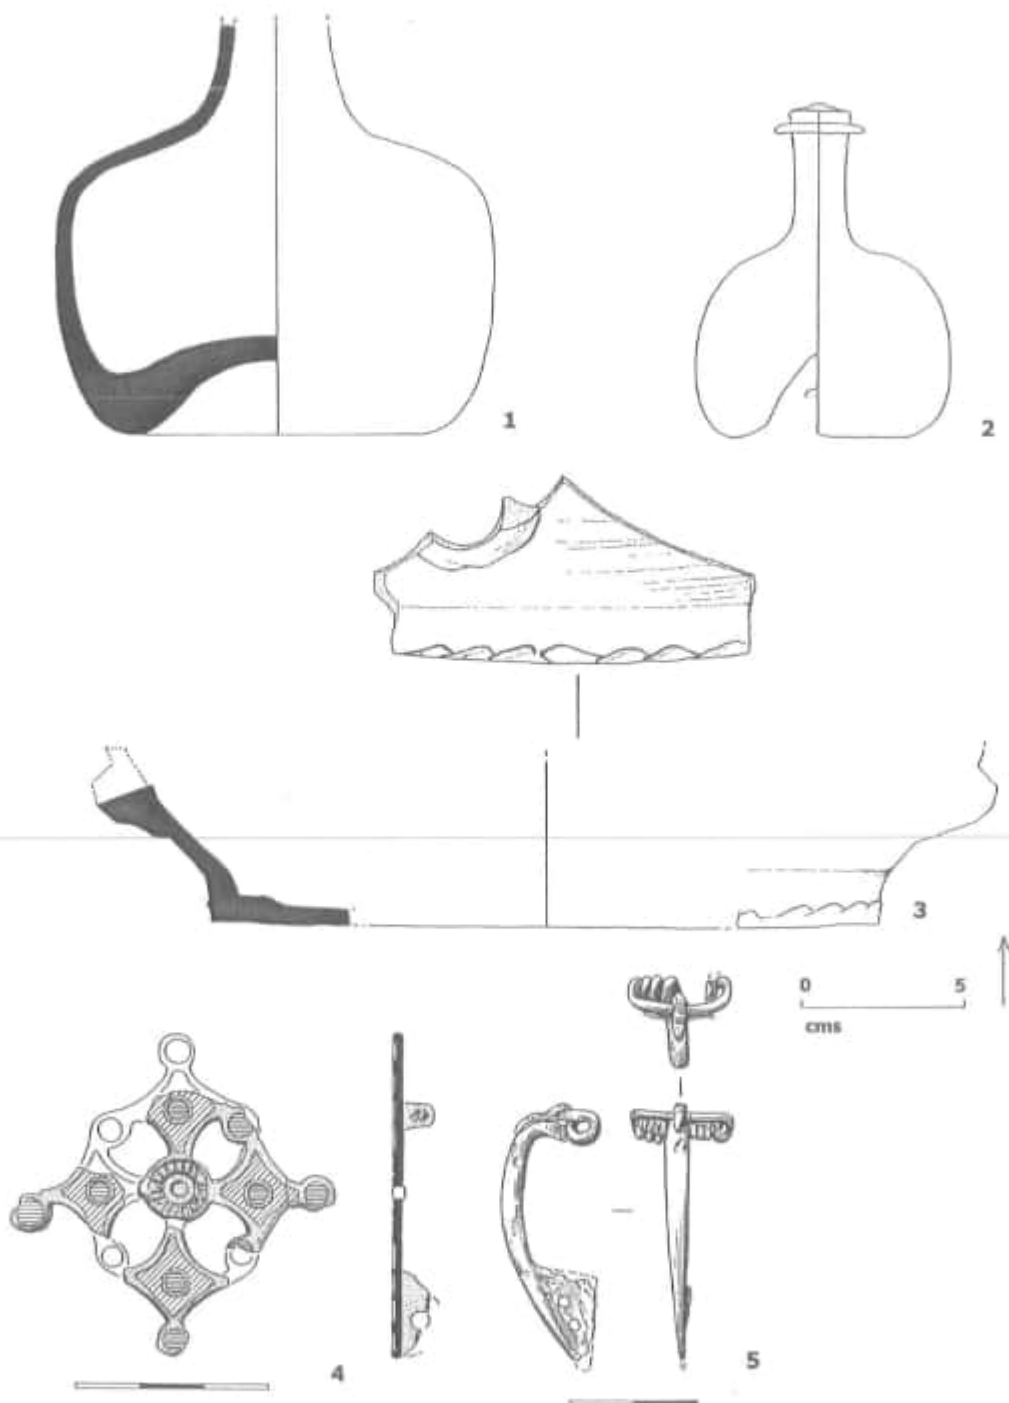
FIGURE 18 Glass, post-medieval pottery and Romano-British brooches

Openwork plate brooch in three fragments dating to 50–200 AD (Fig. 18/4). It has a central disc with 'rope' border supporting four diamond-shaped arms with terminal discs; the centre of each diamond has a circular cell filled with blue glass (glass present in two cells only), pin and three linking pieces missing.

Colchester type bow brooch dating to 40–70 AD (Fig. 18/5), 2 holes pierced in catch plate, pin and part of catch plate missing.

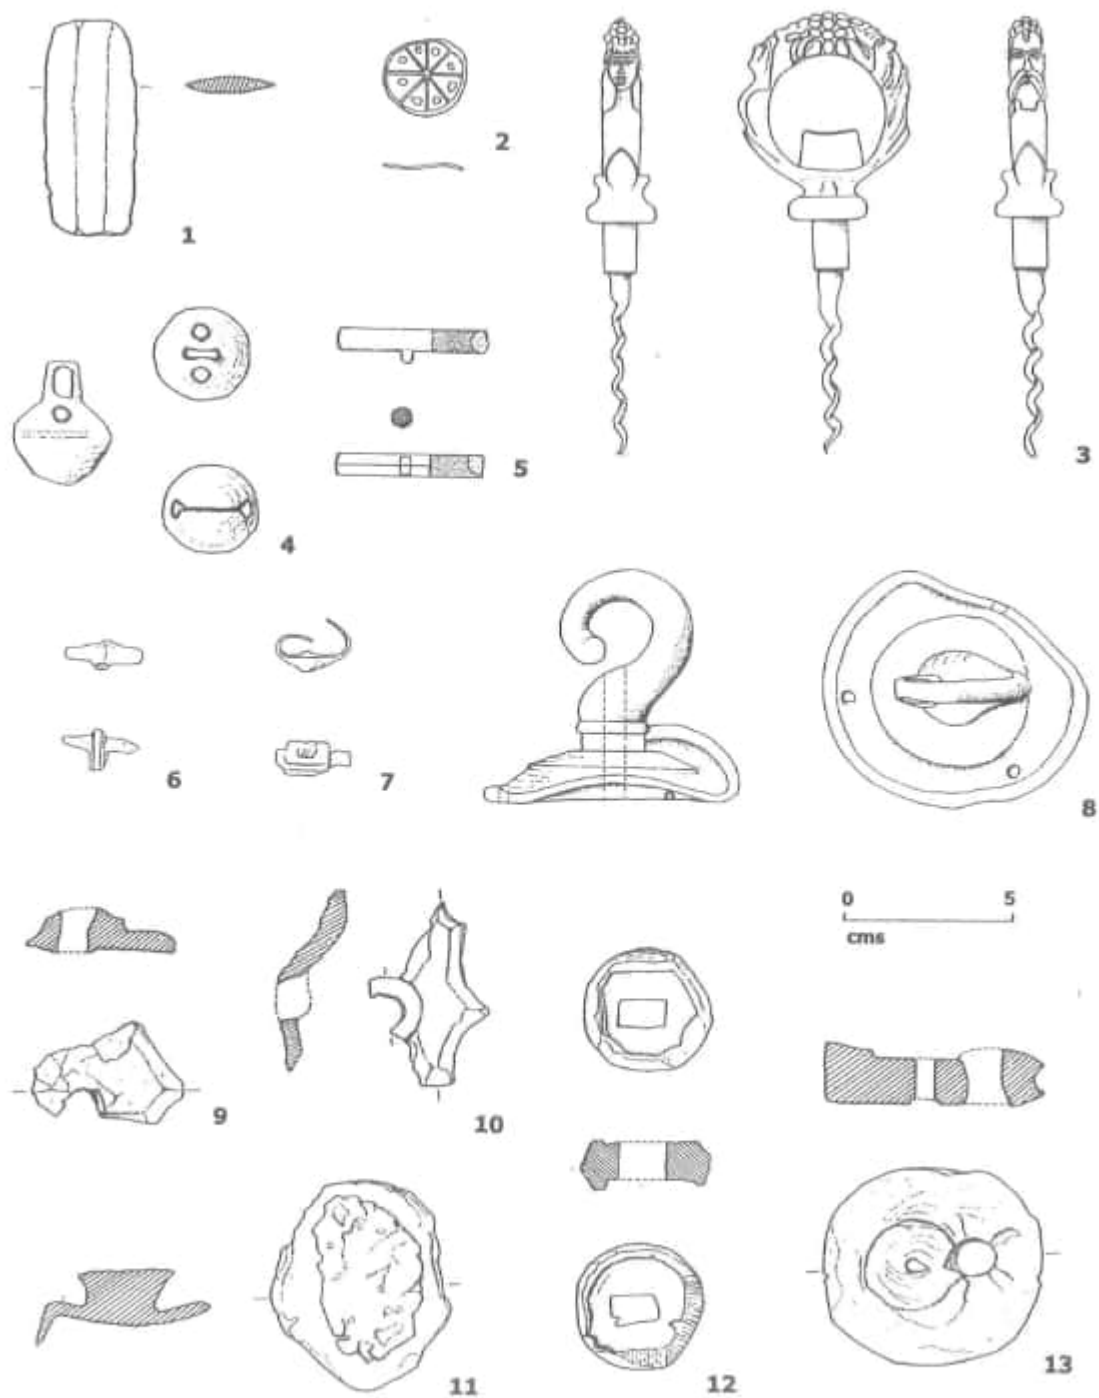
FIGURE 19 Metalwork

Copper alloy knife blade (Fig. 19/1), 63 x 23mm, broken at either end, probably Bronze Age, found at the foot of the dam forming the main lake (SU 83269448).

Lead token (Fig. 19/2), 23mm diameter, stamped on one face with eight radial arms dividing the token into eight segments, each segment containing a small raised circle.

Copper alloy cork-screw (Fig. 19/3), lower section ferrous, the upper part forming the handle copper alloy. The upper part forming the handle is a circular ring, which has an elaborate moulding along its upper edge, consisting of the heads of separate male and female classical figures with the hair merging at the centre to form a bunch of grapes. Within the ring there is a raised lip, presumably for removing crown caps from bottles, implying the

Lead cylinder (Fig. 19/5), 43mm and 6mm in diameter, lug on lower edge, painted white but with blackened tip, found in main lake.

Brass hook, 40mm diameter, attached to circular base plate 80mm diameter (Fig. 19/8). Base plate is pierced by three small holes. Possible fitting for hanging a chandelier, or alternatively boat fitting? Found in lake.

Lead fragment, a flat disk with chamfered edges and point on one end measuring 45 x 30 x 12.5mm (Fig. 19/9). At its centre there is a circular hole 10mm in diameter within a raised square panel. Found in lower stream.

Lead fragment, 55mm long 12-35mm wide and 6-10mm thickness (Fig. 19/10). There are two 'arms' each, with chamfered edges, and at the junction of the arms a raised point, also with chamfered edges. At its centre there is a circular hole 10mm in diameter set within a slightly raised panel. Found in the lower stream.

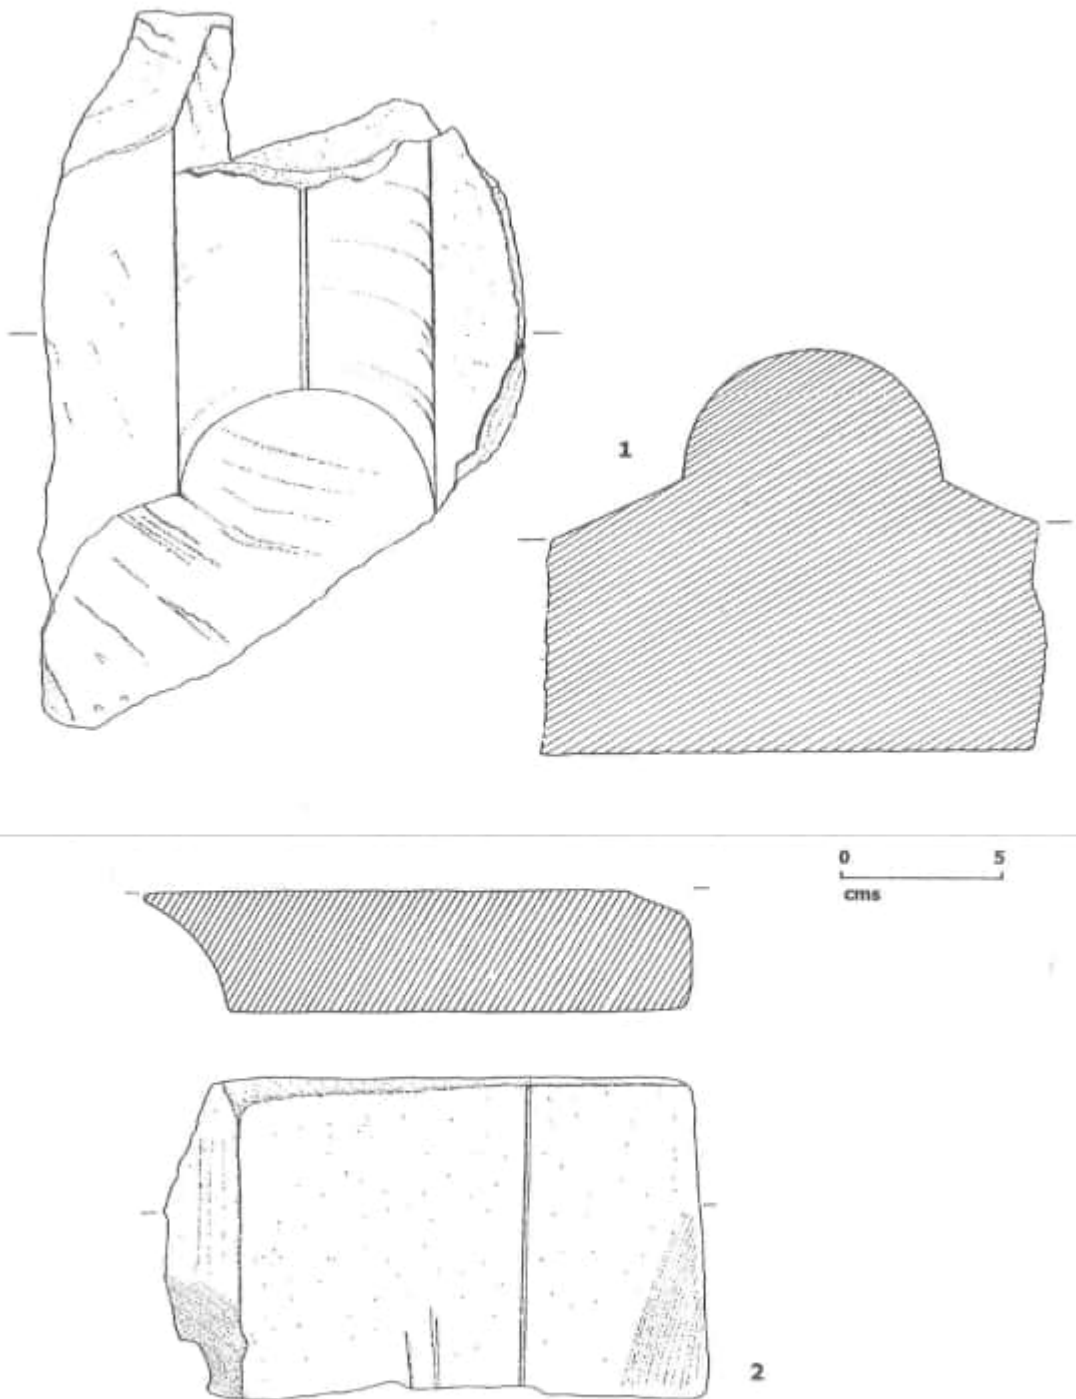
FIGURE 20 Moulded brick coping and moulded stone

Moulded brick coping – found at the base of the fallen ash tree in area 4 (Fig. 20/1). Soft sandy pink fabric with large 'grog' inclusions, the brick measures 225mm (incomplete), 145mm wide (incomplete) and 125mm in depth (probably the full depth of the brick). One end has been cut back at an angle of about 60 degrees to form one half of a mitred joint – edge of tool marks can be detected across the mitred section. The upper surface of the brick carries a half-round projection and on the highest point of this projection there is a very narrow moulding mark 2mm wide and 1mm in height. This may have helped with the alignment of the copings when they were placed on the wall.

Part of a flat stone with a quarter round moulding was found on the south bank of the south stream in 2005. The stone measures 165 x 100 x 32mm and may be part of a stair tread (Fig. 20/2).
