# ROSE COTTAGE, TYLERS GREEN: EXCAVATION OF A 15<sup>th</sup> TO 17<sup>th</sup> CENTURY TILERY

*Archaeological evaluation and excavation were undertaken at Rose Cottage, Tylers Green, in advance of housing development. The site was found to contain three tile kilns, with associated stoke-pits and workshops or drying sheds. Two of the kilns contained evidence of rebuilding, and appeared to have been in use for relatively long periods. Archaeomagnetic dating revealed that the earliest kiln had last been fired between 1445 and 1485, and the latest between 1535 and 1670. The structures on this site provide the first physical evidence, apart from its products, for the Penn tile industry, known to have been in operation between the 14th and 18th centuries.*

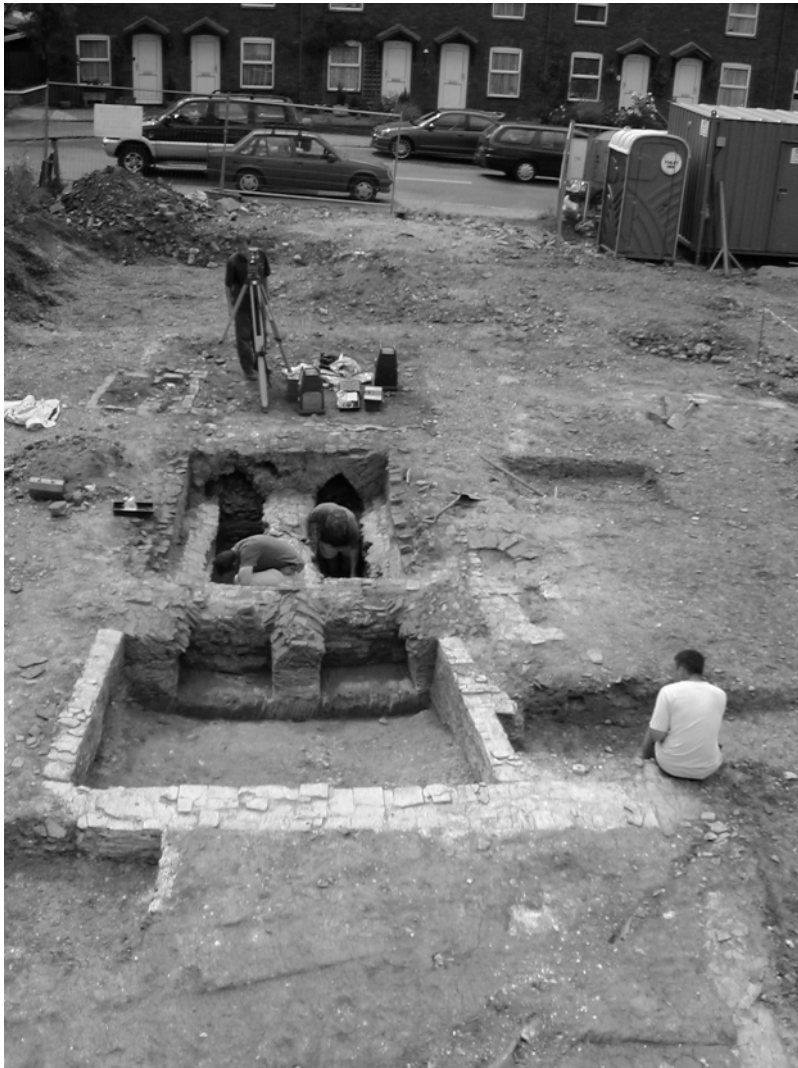
FIGURE 3 Kilns 2 & 3 under excavation, from east.

The excavation (Figs 3, 4) revealed three tile-kilns, two of which had been rebuilt during their working lives. Adjacent to the kilns were the remains of two structures, either drying sheds or workshops. A small number of later features, mostly associated with drainage, were also identified. To simplify description, the results of the excavation have been divided into three broad periods: 'Medieval', 'Post-medieval' and 'Victorian & Modern'. These periods are illustrated in Fig. 5.

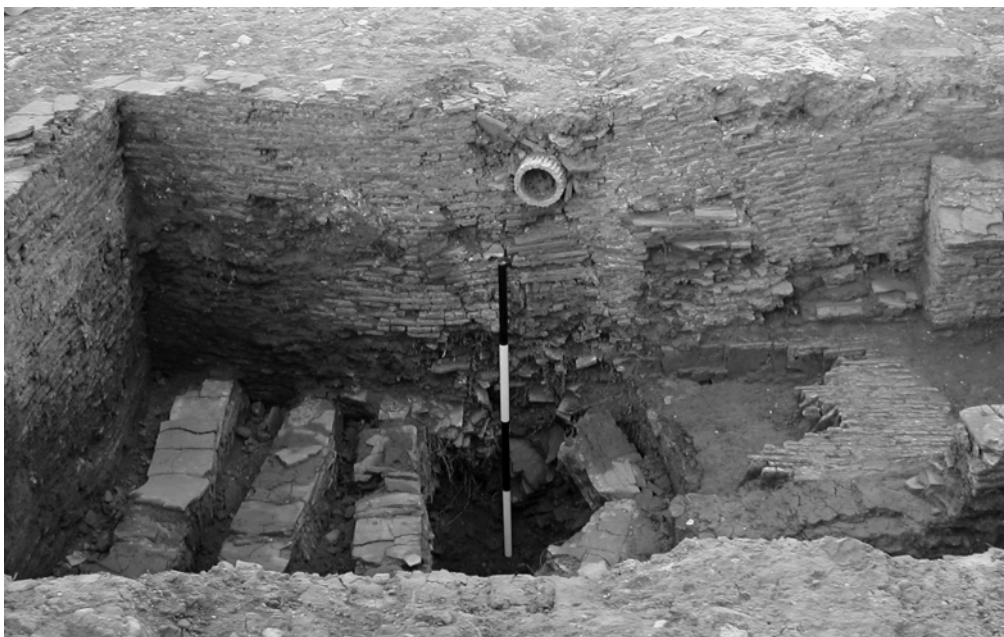
FIGURE 11 Kiln 1, looking east.

As originally built, the kiln structure (Figs 6–8, 9–11) comprised two parallel flues, aligned north-south, with a firing chamber above. Overall internal dimensions were 1.65m by at least 3.5m: the flues measured c.0.62m in depth. The floor of the flues (383) was constructed from edge-set, mortar-bonded rectangular roof tiles, laid on 382, a foundation deposit of light brown firm coarse sand. The tiles measured 275 × 175 × 15mm. The exterior walls (353, 355 and 357), and the spine wall separating the flues (380) were constructed from stretcher coursed, clay bonded roof tiles. Some appeared to have been seconds, broken prior to their use in the kiln, though this could have been caused by frost or fire. Complete tiles in the walls measured 290 × 170 × 15mm. The inward-facing edges of the tiles had all been vitrified, showing that the kiln had seen frequent use. The floor of the firing chamber was carried above each flue by a row of at least eight parallel arches (364, 366, 368, 370, 372, 374, 376, 378), constructed of peg tile at 100–150mm intervals. Some of the arches had been contorted due to the effects of firing, and subsidence of the kiln following abandonment.

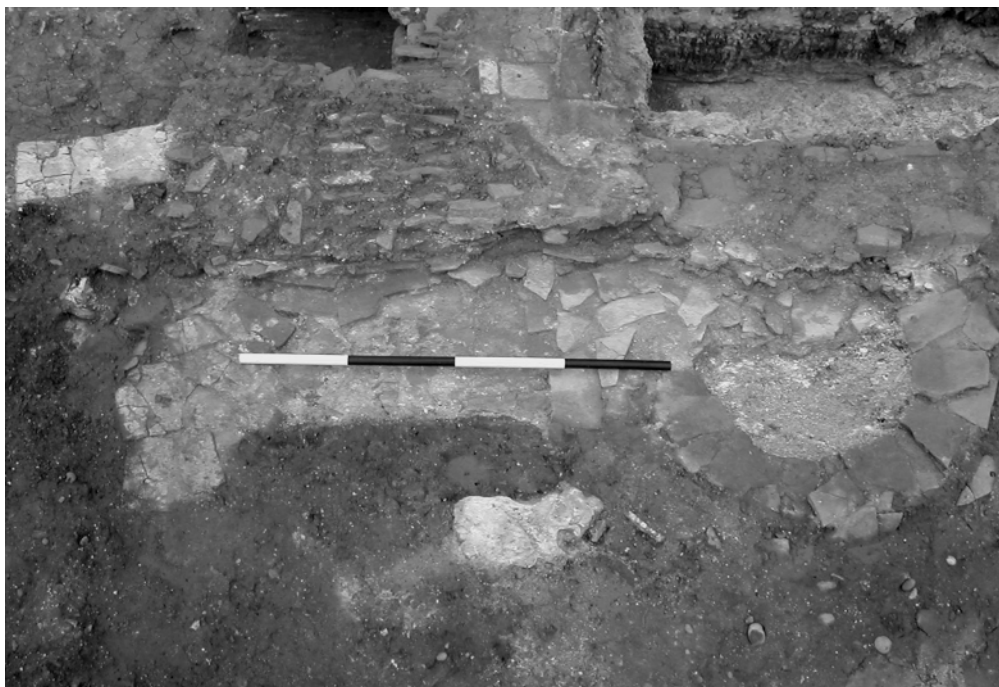
FIGURE 12 Oven 292 and Wall 305, looking south.

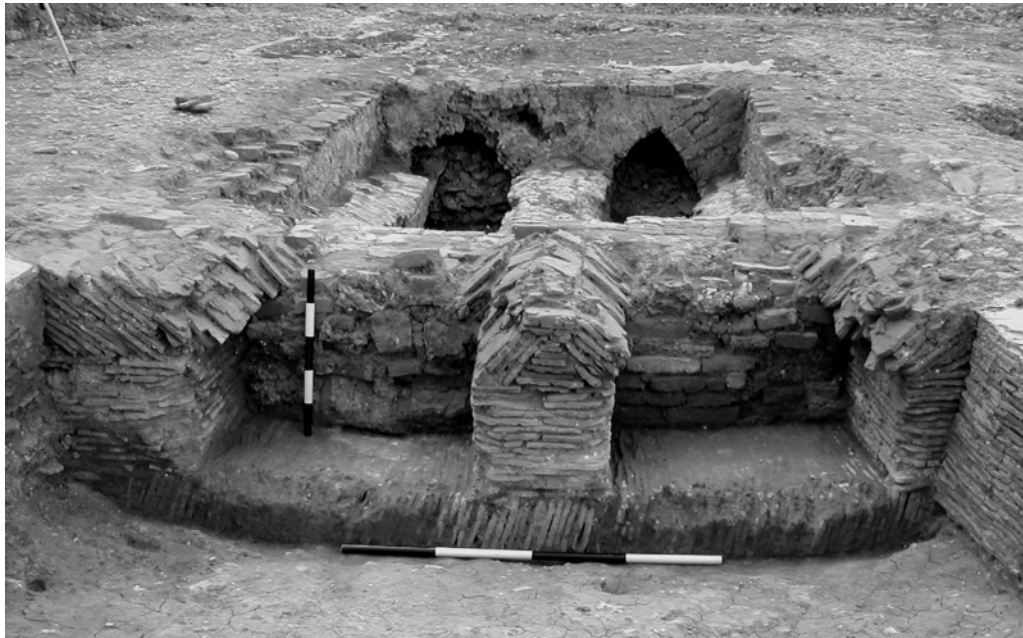
FIGURE 13 Kiln 2, stokepit and blocked flues, looking west.

constructed from header-coursed, clay bonded peg tiles set on the kiln floor. These walls survived to a height of 0.6m: springing for the flue arches commenced at a height of 0.32m (Fig. 13). On this basis, it is estimated that the flues were *c.*0.75m in height. Examples of whole tiles from the structure measured 290 × 180 × 18mm. The edges facing into the flue had been scorched black. The west end of the structure was truncated by the east wall of Kiln 3. The overall width of the kiln was 2.15m.

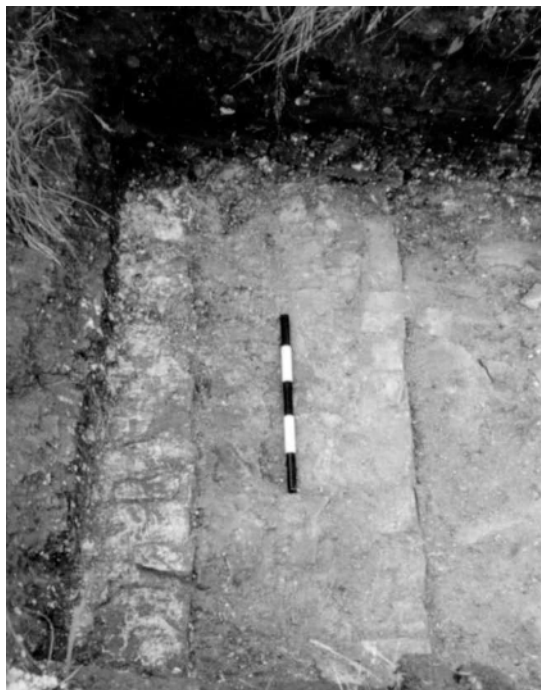
FIGURE 18 Wall 107 (209), from north.

ments. Its west end was butted by 249, and its east end terminated short of the north-east corner of the building, leaving a gap of *c.*0.9m. It is not certain whether this represented a doorway, or truncation by recent groundworks. The east wall (107) had been severely truncated: in the evaluation report it was described as 0.75m wide, constructed of courses of plain floor tile fragments, bonded with a cream-coloured sandy mortar (Fig. 18). The south wall survived only as a footing trench (201) 0.45m wide, containing deposits of sand and clay with chalk pebbles and tile fragments. The floor consisted of two layers: 237, a compacted chalk layer 50mm thick, above which was 239, a layer of compacted mid orange clay, 80mm thick.

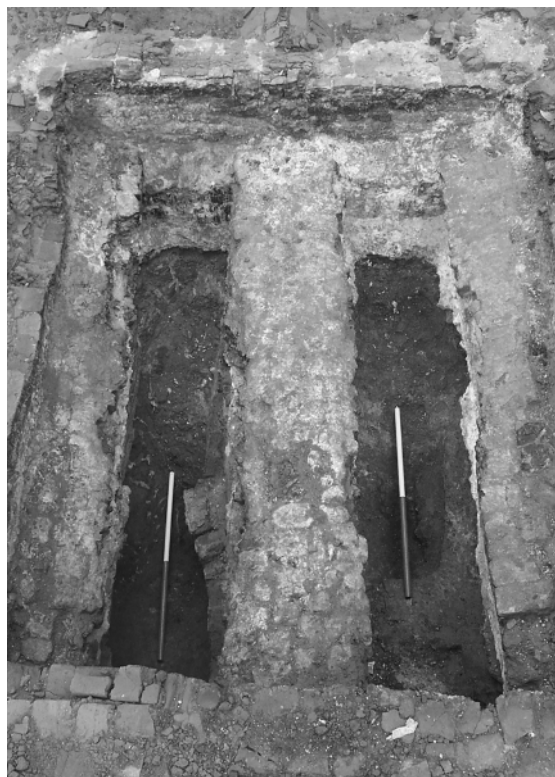
FIGURE 20 Kiln 3, interior, looking east.

The firing chamber of Kiln 3 (Fig. 20) measured  $3.03 \times 2.21$ m internally. The two flues, each *c.*0.6m wide, ran across it from west to east, separated by a spine wall (265), a mortar-bonded structure 0.5m wide and 0.4m high. Wall 308 formed the north side of the north flue. This was constructed from stretcher-coursed bricks, 0.35m deep. The south side of the south flue was formed by Wall 310, which was of identical construction to 308, and was also 0.35m deep. The bases of the flues (315) were constructed with un-bonded edge-set purple/black bricks measuring  $230 \times 110 \times 40$ mm. The floor of each flue was concave, rising at either side. In contrast to Kiln 1 there were no flue arches: presumably the flues in Kiln 3 were bridged with kiln bars when in use.
