# Heaton Lane, Stockport

Post-excavation Assessment and Updated Project Design

Planning Ref: DC/071417  
Ref: 234592.01  
December 2022

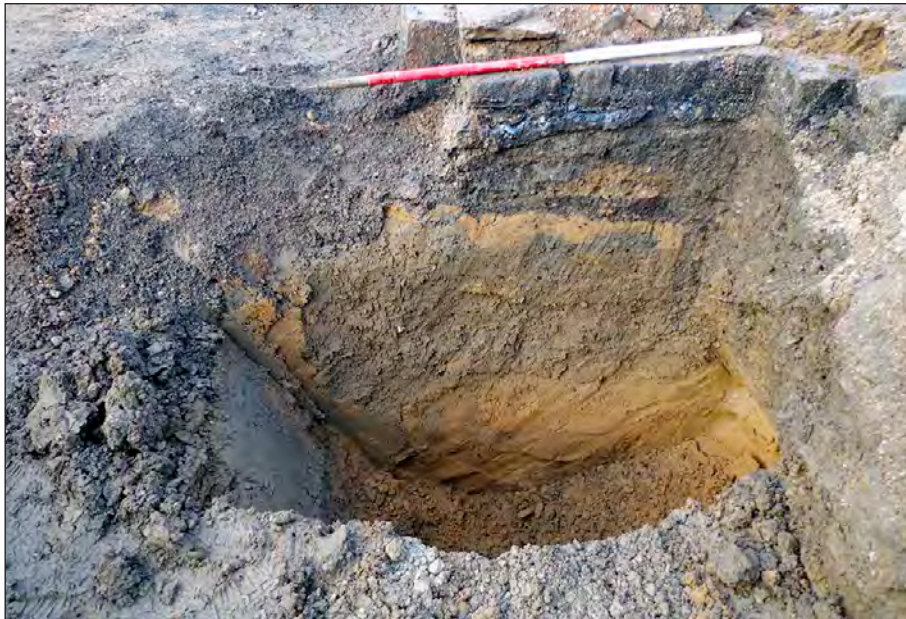
Figure 8: Machine sondage showing natural 713 overlaid by disturbed natural 714, silt and sand levelling layers, and road surface 684. 1 m scale. View from south

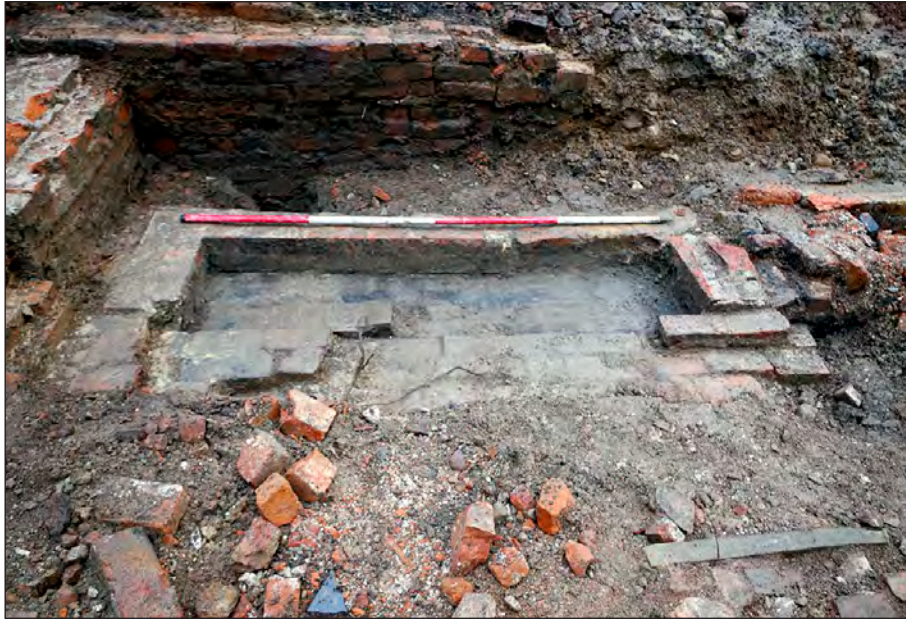
Figure 10: Trough 609–614. 2 m scale. View from south

- 5.3.5 Walls 609 and 610 partly enclosed a 2.3 m long and 0.46 m wide shallow trough of unknown function (611, 612 and 614; **Fig. 10**) floored with ash-stained bricks (613).

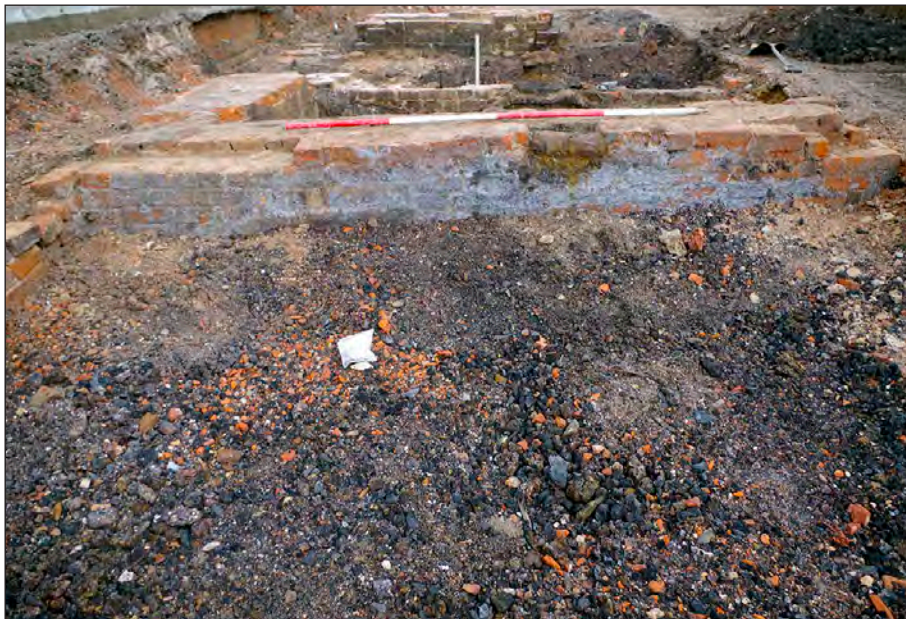
Figure 11: Lime washed east face of wall 628/630. 2 m scale. View from east

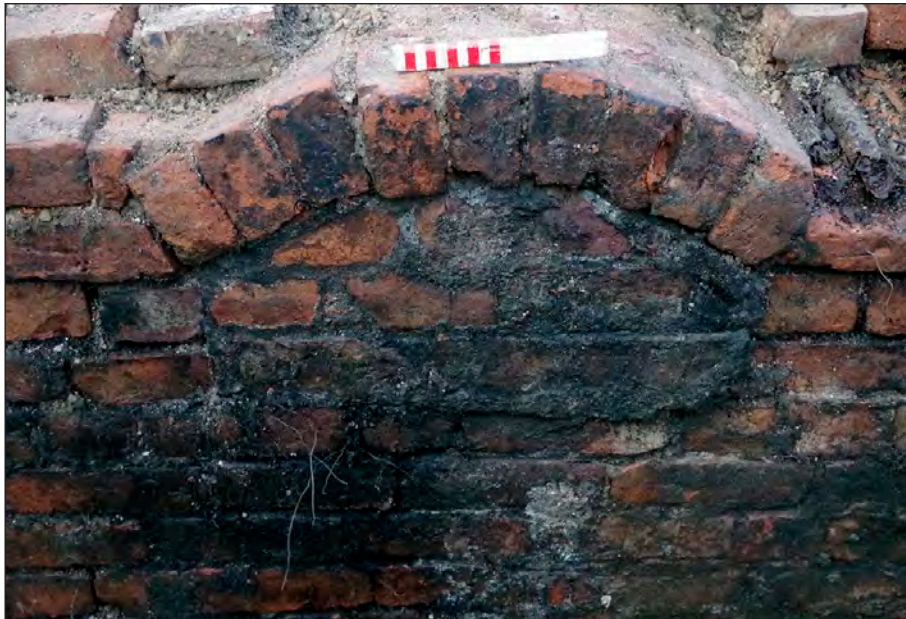
Figure 12: Blocked arch 777. 0.2 m scale. View from east

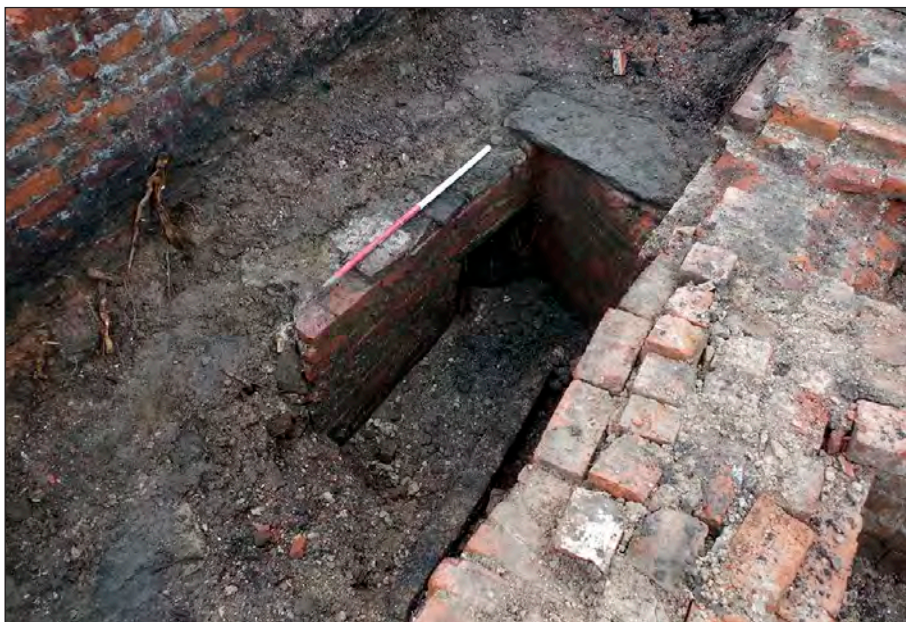
Figure 13: Oblique view of culverted drain 773–776. 1 m scale. View from north-west

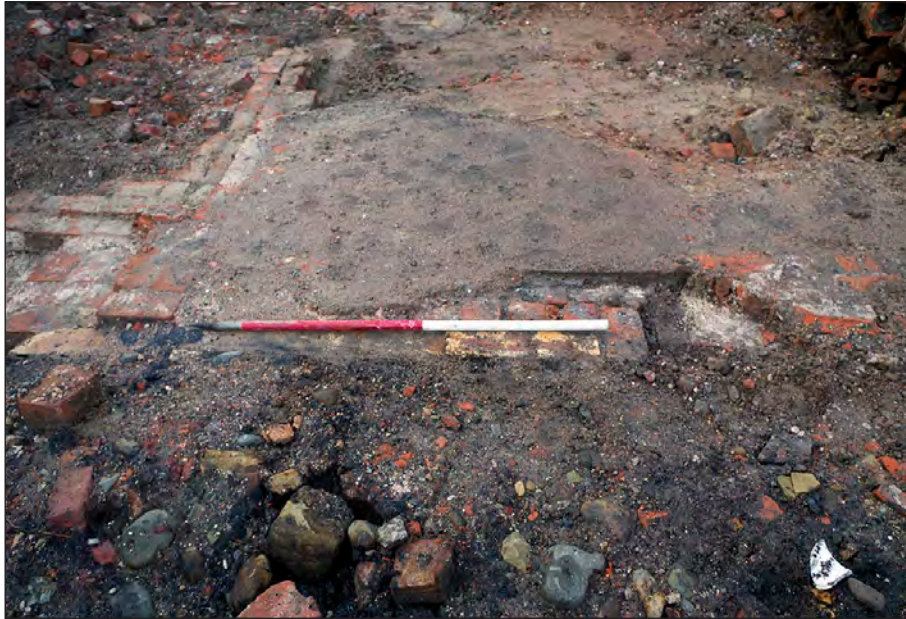
Figure 14: Firebrick wall 617 and concrete surface 645. 1 m scale. View from east

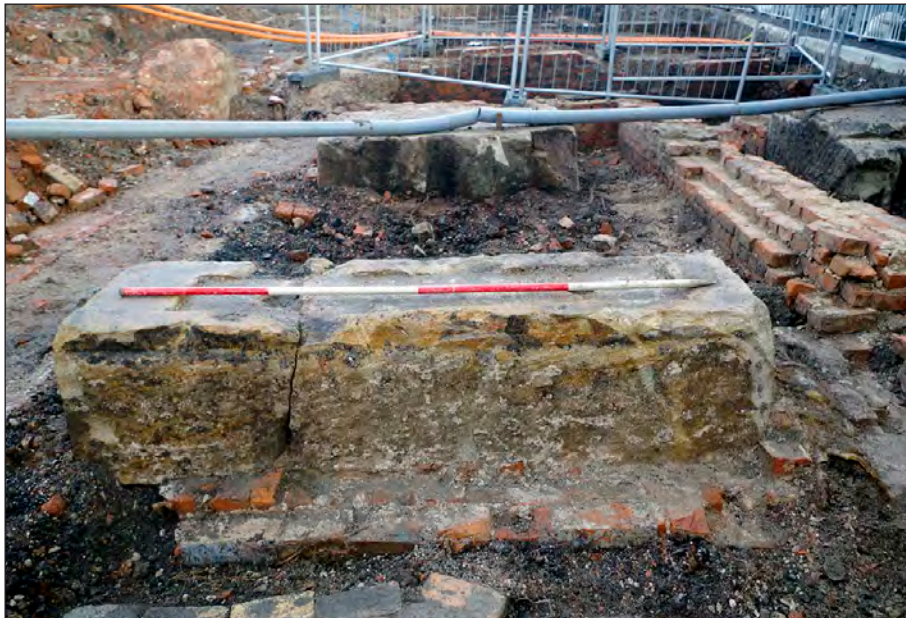
Figure 15: Stone foundation bed 634. 2 m scale. View from west

- 5.3.10 There were four large similar stone bases (634, 647, 648 and 649; **Fig. 15**) in the east of the Wellington Bridge Mill. Stone foundation bed 634 (**Fig. 15**) was contained within partially preserved brick walls 633, 635 and 636. The top of foundation bed 634 contained a rectangular locating depression with two sockets that would have accommodated metal fixings. The base was flanked to the south by an iron pipe. The further stone foundation beds (647, 648 and 649) contained locating depressions and iron pin fixings. Bases 647 and 648 were in the area mapped in 1851 as 'Engine Ho.' (**Fig. 3**) and could potentially have carried a steam engine. Bases 634 and 649 were instead in the south of the main mill hall but could have carried a continuation of either the steam engine or power transmission equipment associated with it. The total area of bases 634, 647, 648 and 649 was about 5 m square, however they continued to the south beyond the area of excavation.

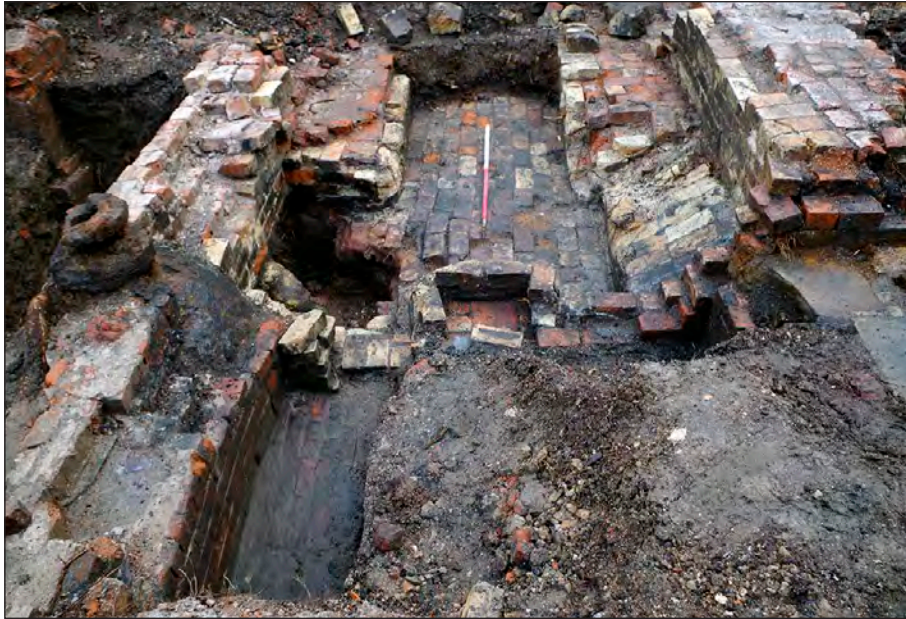
Figure 16: Boiler base potentially carrying Cornish boiler. Cistern 641 in left of shot. 1 m scale. View from north

- 5.3.13 A cistern (641; **Figs 16–18**) capped with a valve (734, not drawn) was built into masonry 640, 651 and 652. The tank had a rusted circular fitting for a badge on the west side. The cistern was probably a reservoir associated with the potential Cornish boiler. Its position built into a masonry structure is curious. There were no signs of heat transformation on the surrounding masonry; the cistern may not have been hot during use. An attempt was made to preserve the cistern however the rusted object disintegrated when lifted. The remains were not retained. We believe that this was communicated to Greater Manchester Archaeology Advisory Service at the time.

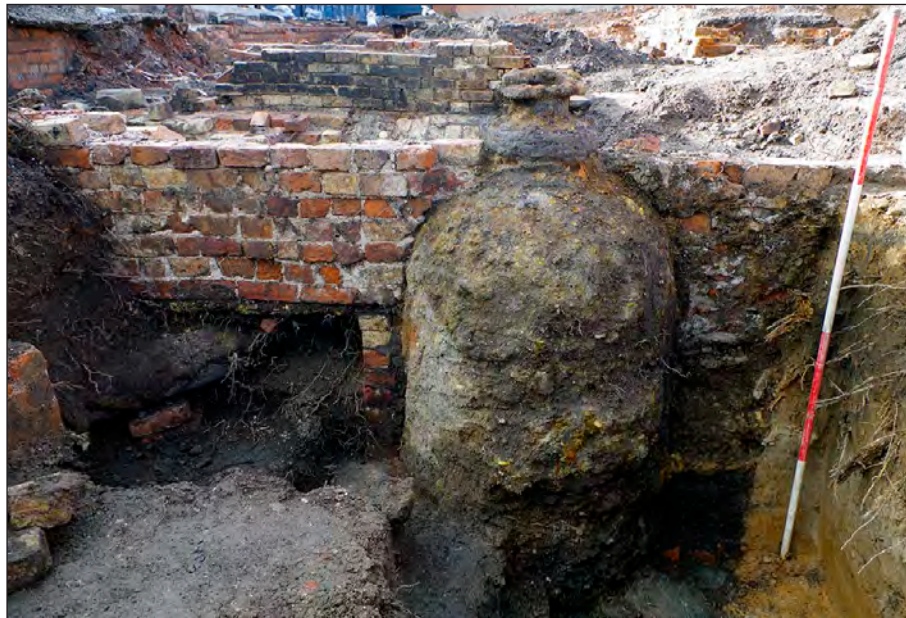
Figure 17: Cistern 641. 2 m scale. View from east

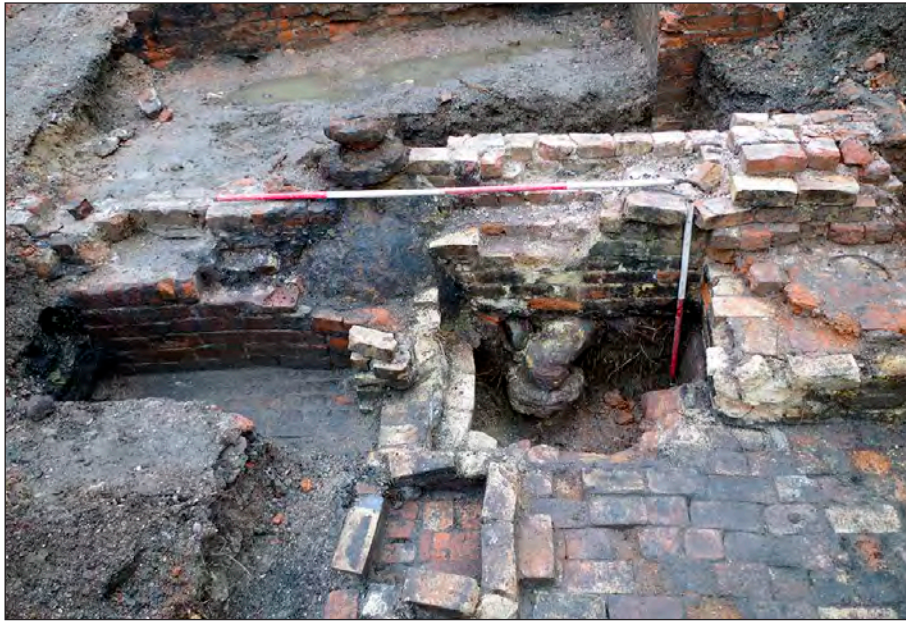
Figure 18: Cistern 641 and environs including pipe 655. 2 m and 1 m scales. View from west

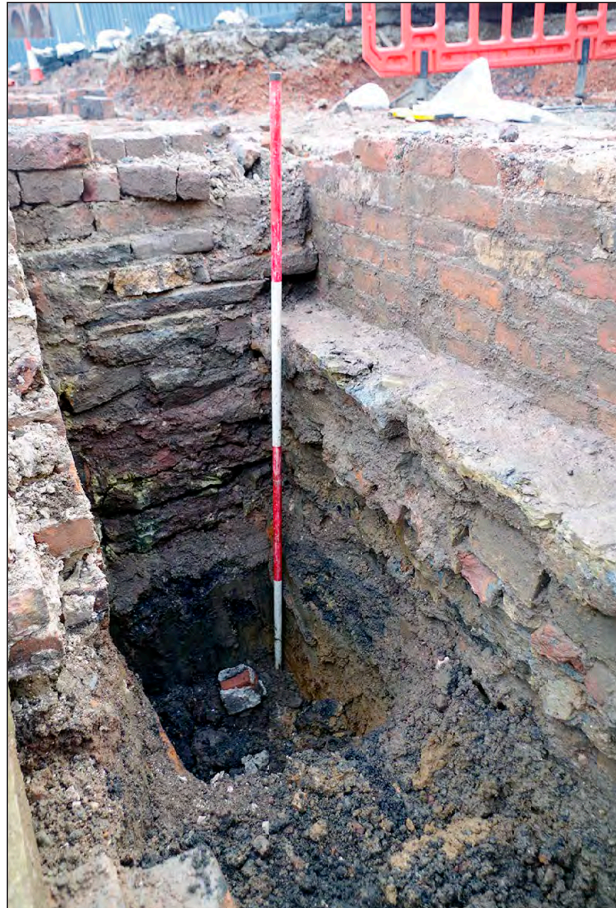
Figure 19: Sandstone foundation 683 carrying brick wall 548 (right of scale) and later wall 549 (left of scale). 2 m scale. View from north-north-east

- 5.3.17 A series of stratigraphically early pre-construction levelling layers were exposed below the remains of back-to-back housing fronting John Street (**Figs 7** and **19**). An environmental sample from the lowest layer reached (707, brownish yellow loam with red brick fragments) contained clinker and charcoal. It may represent the disturbed upper surface of the natural, similar to layer 714 seen elsewhere. Layer 707 was overlain by dark ashy, gritty silt (708) and a bed of lime mortar with fragments of brick (709) carrying stone foundation 683. Nearby, wall 549 was also bedded on a layer of sandy silt (711).

- 5.3.18 The truncated wall foundations of back-to-back housing fronting the east side of John Street were revealed. The wall fronting John Street comprised a substantial sandstone foundation 0.67 m wide (665; **Fig. 20**). The foundation carried a two-skin handmade red brick and lime mortar wall (669; **Fig. 20**). The continuation of this brick wall was seen further north (205, 534, 548, 561, 588 and 591; **Fig. 21**; see also **Fig. 36**), as was the continuation of the sandstone foundation (683; not drawn in plan; **Figs 7** and **19**). Handmade brick and lime

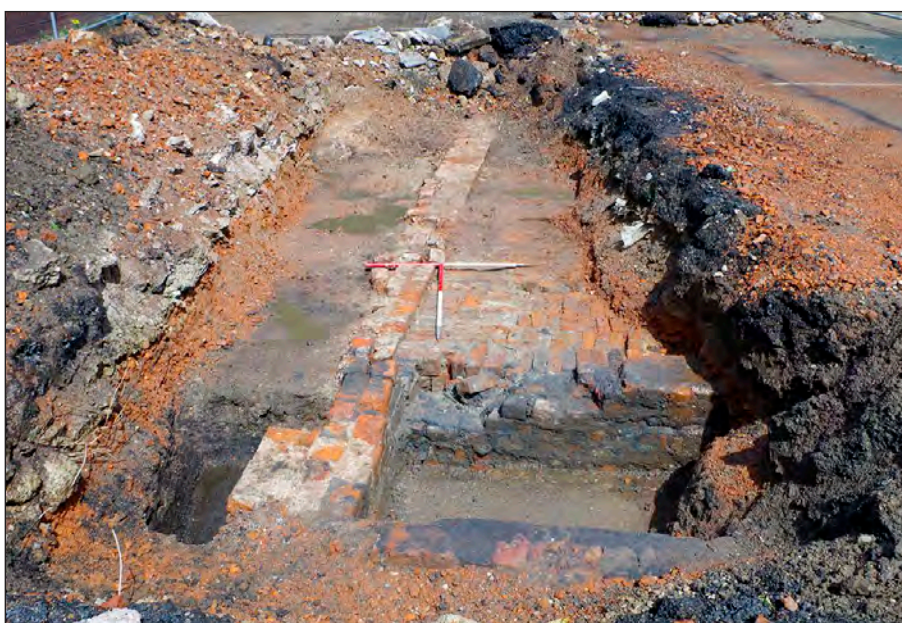
Figure 21: Evaluation trench 2 showing floor 207 (middle of shot) and black ash mortar modifications 204 and 206 (foreground). 2 x 1 m scales. View from south

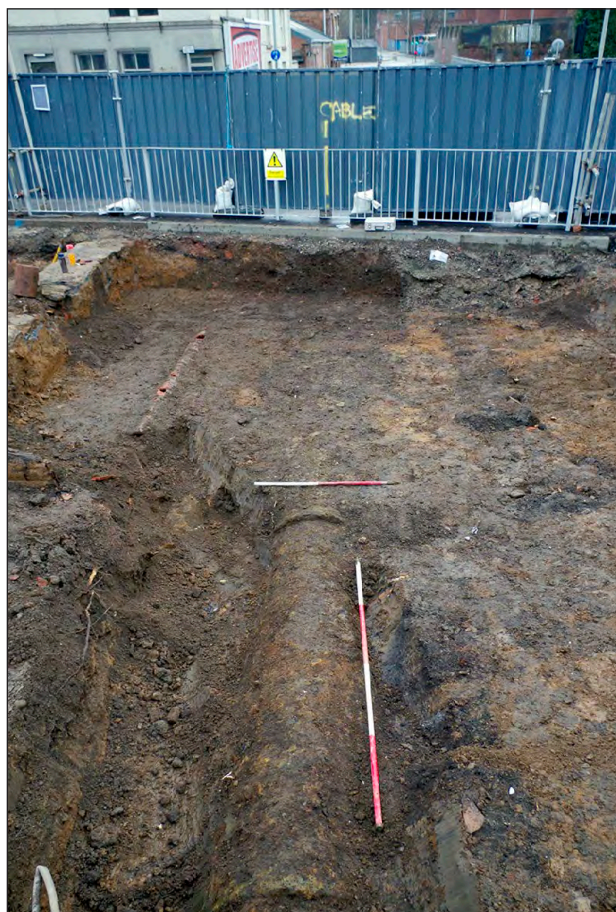
Figure 22: Iron pipe 756 below John Street. 2 m scale.  
View from north

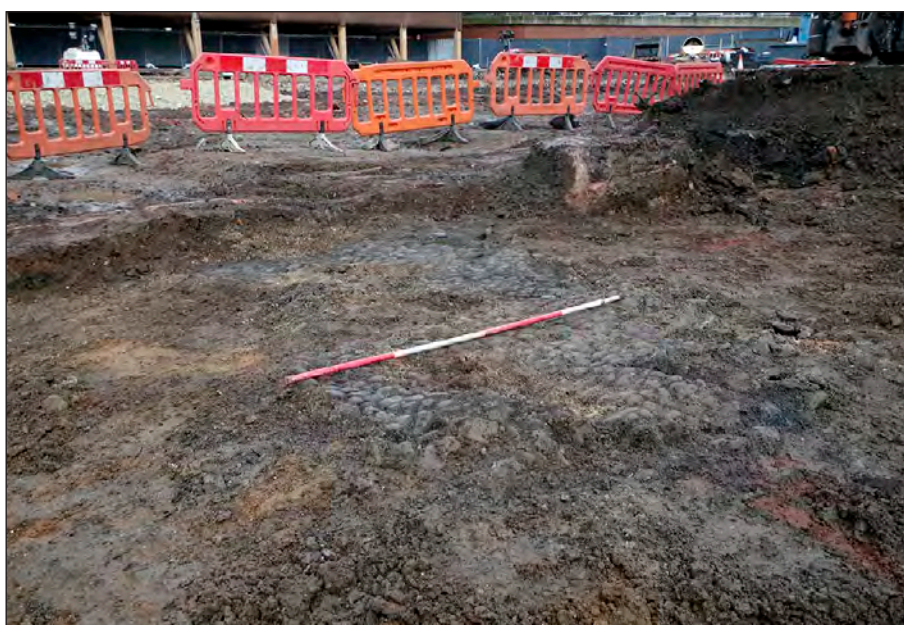
Figure 23: Truncated cobble surface 757 (Union Street). 2 m scale. View from south-west

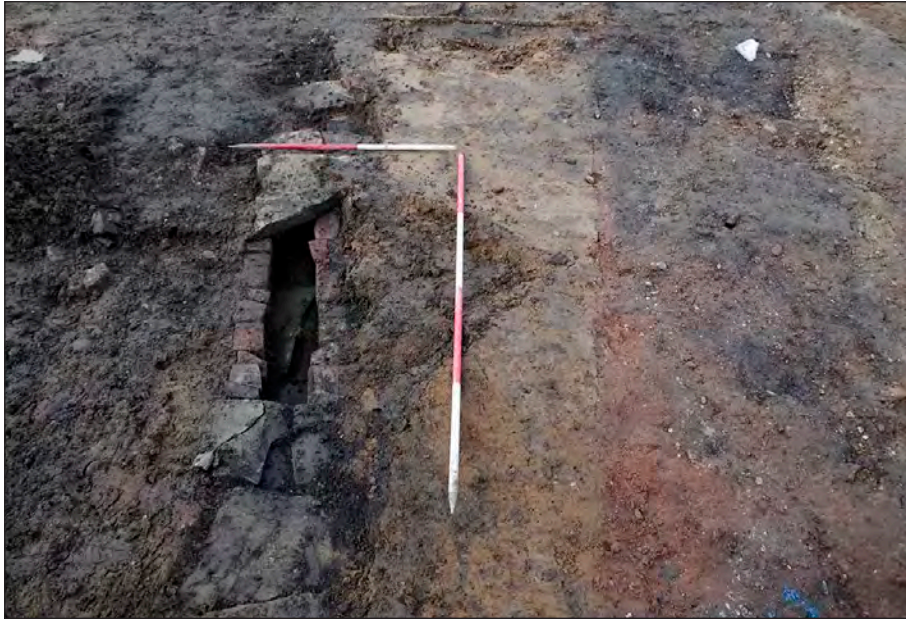
Figure 24: Culverted drain 768 (below Henry Street/Jacques Street). 1 m and 2 m scales. View from south

- 5.3.29 A culverted drain (768; not drawn in plan; **Fig. 24**) was also cut through these layers (including 704) in a trench along the west side of Henry Street/Jacques Street. The drain comprised rough walls of reused, broken, handmade bricks bonded with black ash mortar and capped with flag stones (767). A deposit of brown and black fine sand (769) was present within the drain.

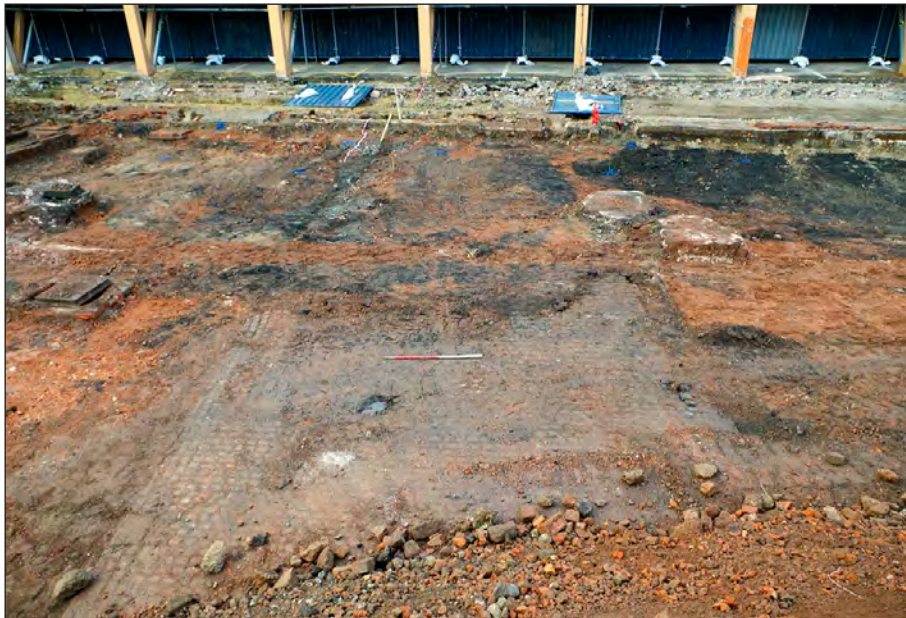
Figure 25: Cobble surface 542 (Henry Street/Jacques Street). 1 m scale. View from south

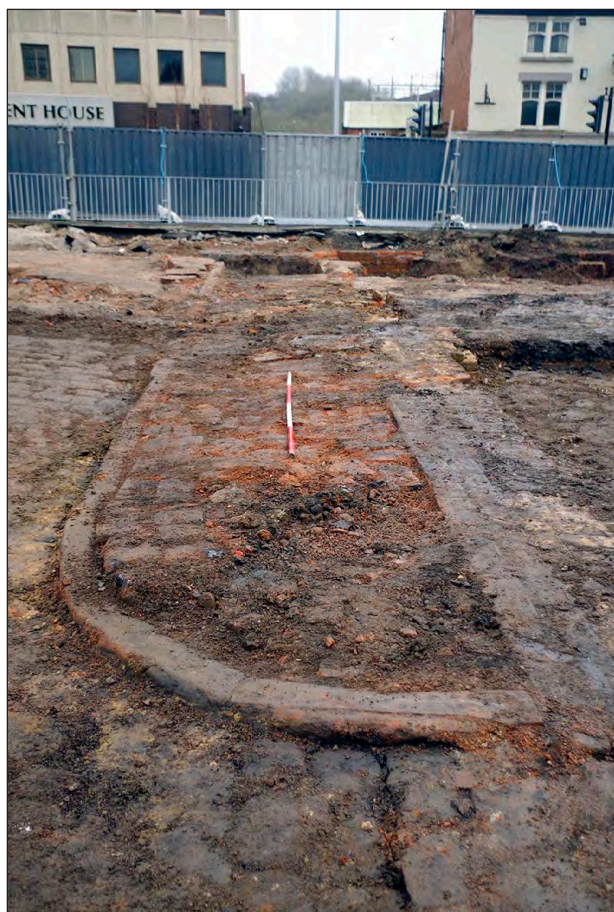
Figure 26: Kerb 690 and pedestrian pavement 691 west of Henry Street/Jacques Street. 1 m scale. View from north

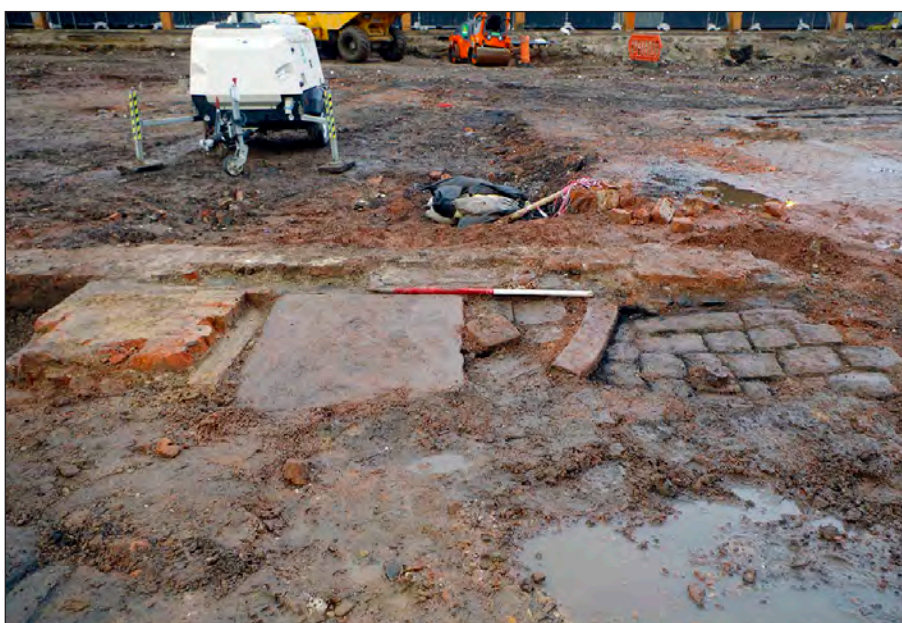
Figure 27: (From left to right) wall 694–696, pedestrian pavement 698, kerb 697, part of cobble surface 684 and metal fixing 765. West of Henry Street/Jacques Street. 1 m scale. View from south

- 5.4.17 Walls 559, 573, 664, 671 (**Fig. 37**) and 694–696 comprised handmade bricks and lime mortar. They formed the foundations of a narrow west to east aligned range. One element in this was a robust wall (694–696; **Fig. 27**) a total of eight skins wide (outer skins 695 and 696 were stretchers, the rest, 694, comprised headers). A fragment of a stone surface bonded with white crumbly lime mortar (676) survived adjacent to the south of the range (**Fig. 37**). A clay deposit (677) had been packed around the foundation of wall 573.

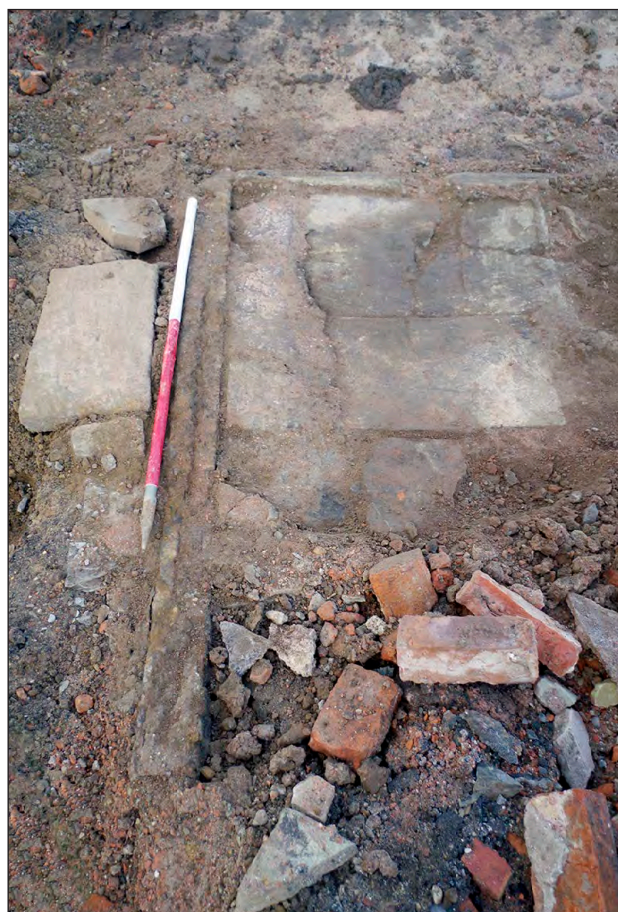
Figure 28: Pedestrian pavement 715 east of Henry Street/Jacques Street and metal rail 716. 1 m scale. View from west

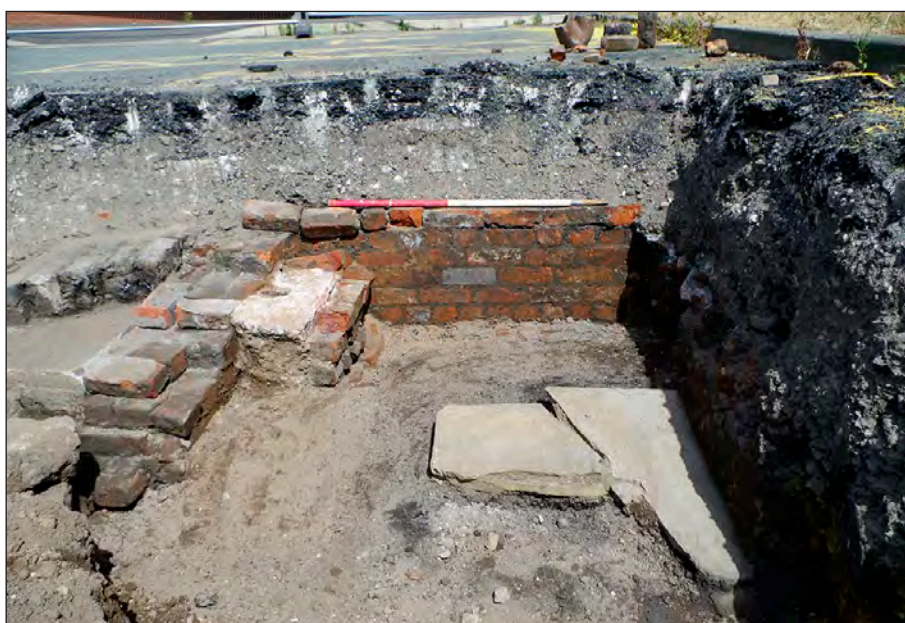
Figure 29: Evaluation trench 3 showing handmade brick and ash mortar walls 304 and 305, and stone surface 309. 1 m scale. View from west

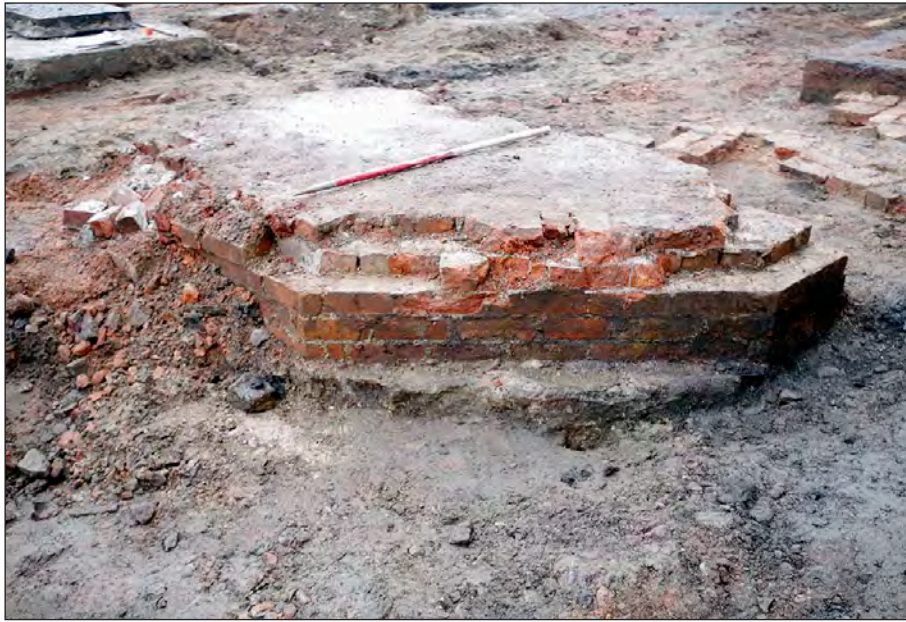
Figure 30: Sub-octagonal structure 510 built on concrete base 517. 1 m scale. View from north-east

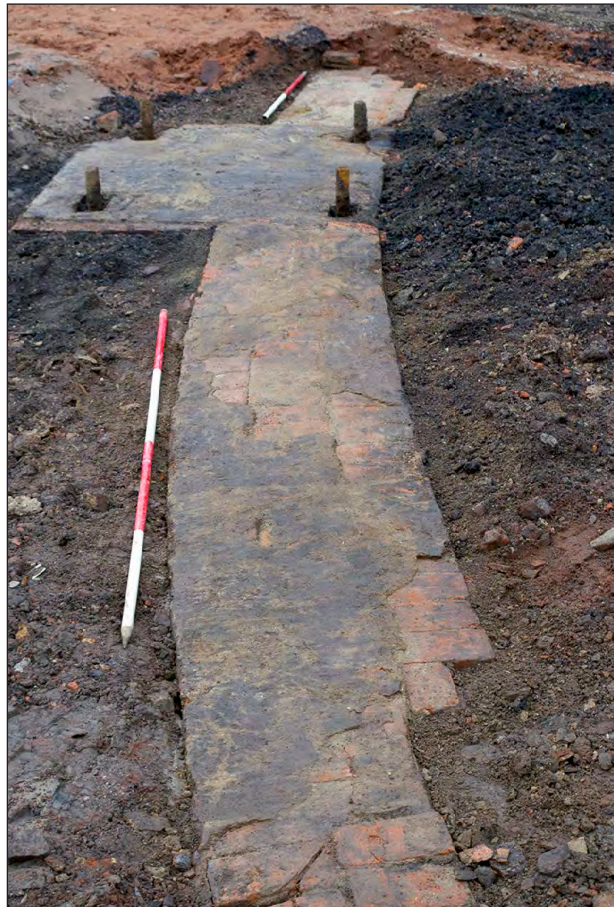
Figure 31: Gasometer wall 536–538. 2 m and 1 m scales. View from south-east

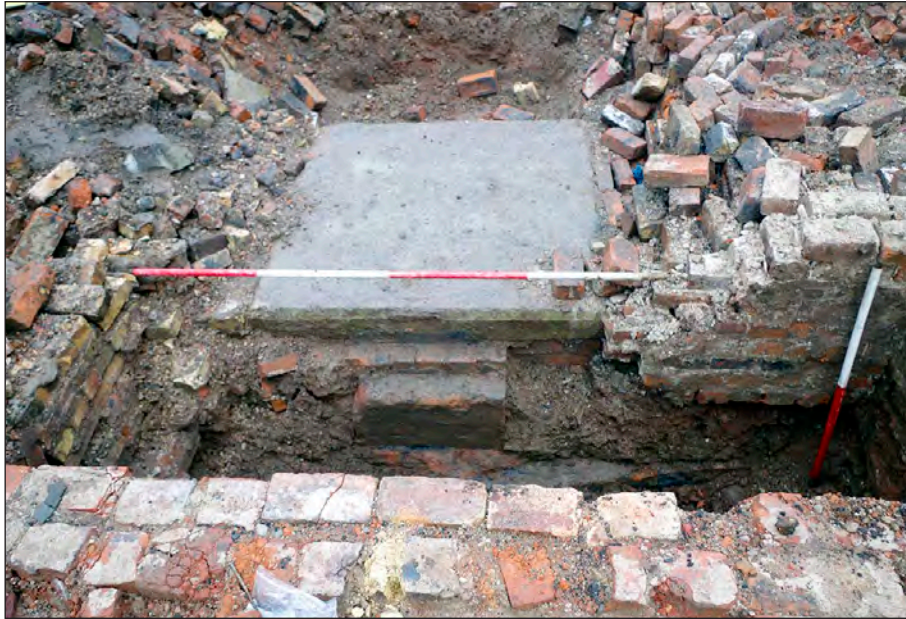
Figure 32: Black ash mortared brick foundations 685 and 686 supporting sandstone flag 682 inserted partially below earlier lime mortar wall 549. 2 m and 1 m scales. View from west

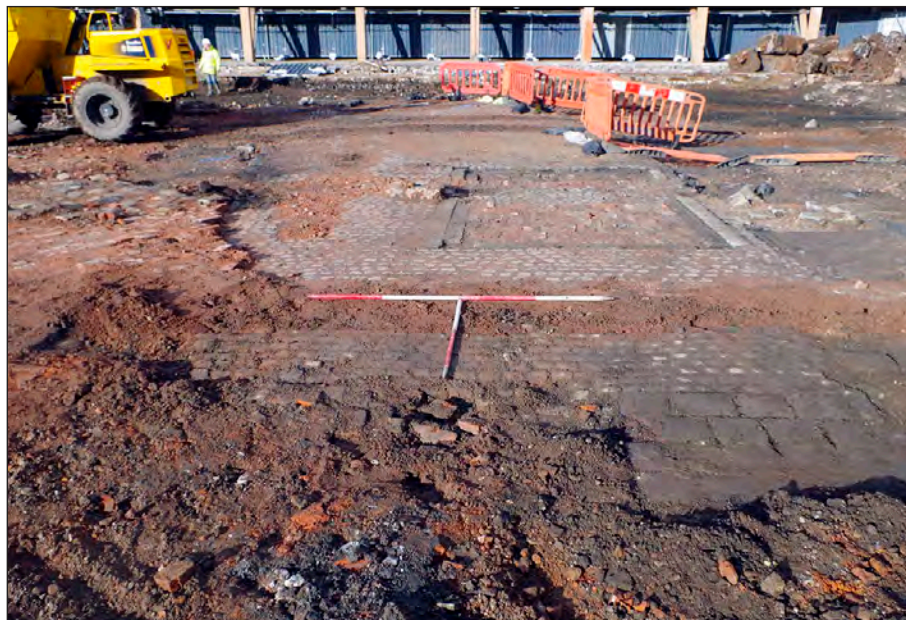
Figure 33: Weighbridge 577=737. 2 m and 1 m scales. View from south

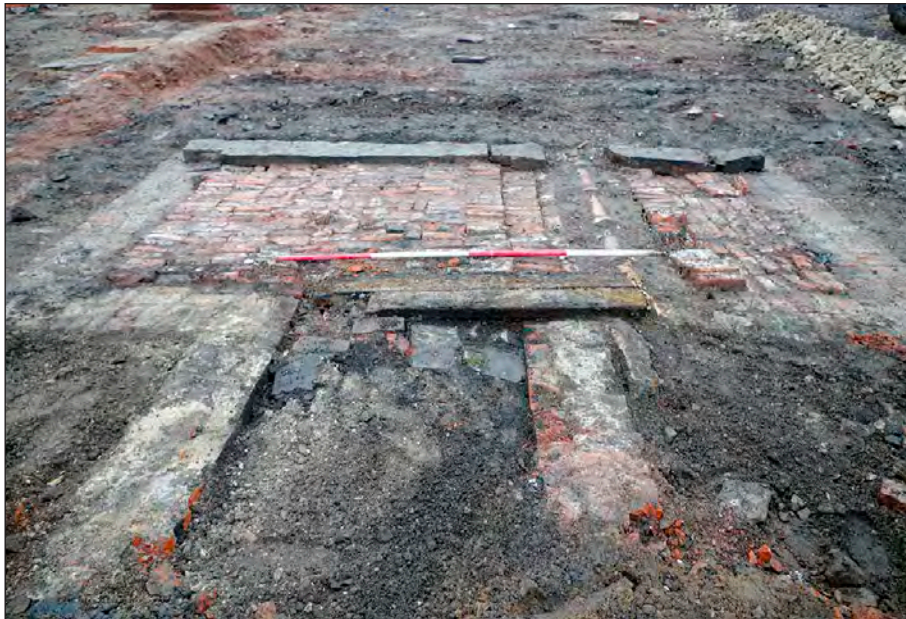
Figure 34: Weighbridge 577=737 and brick annexe 748 (foreground). 2 m scale. View from east

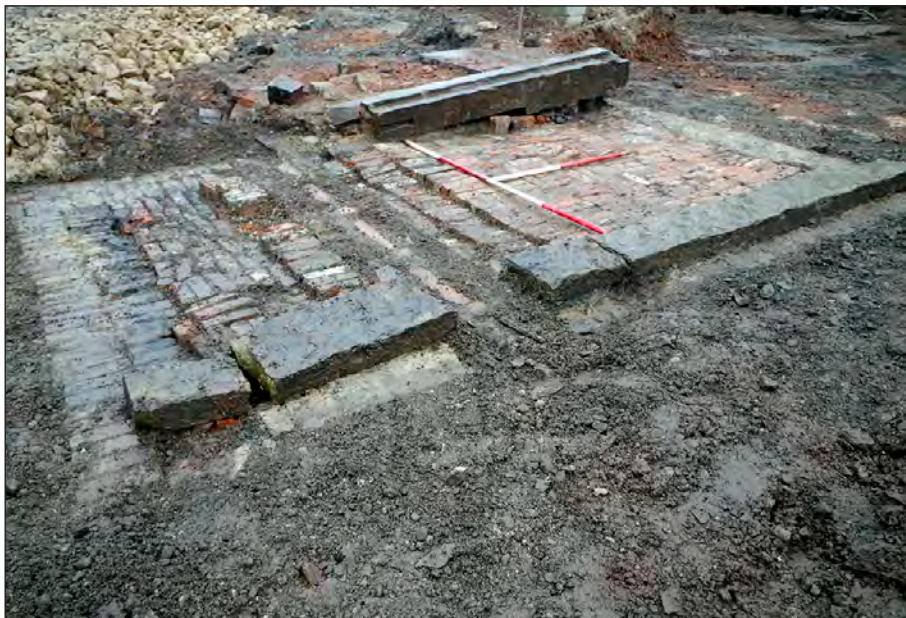
Figure 35: Weighbridge 577=737, later surfaces 568 and 724, cut by drain 595. 2 m and 1 m scales. View from north-west

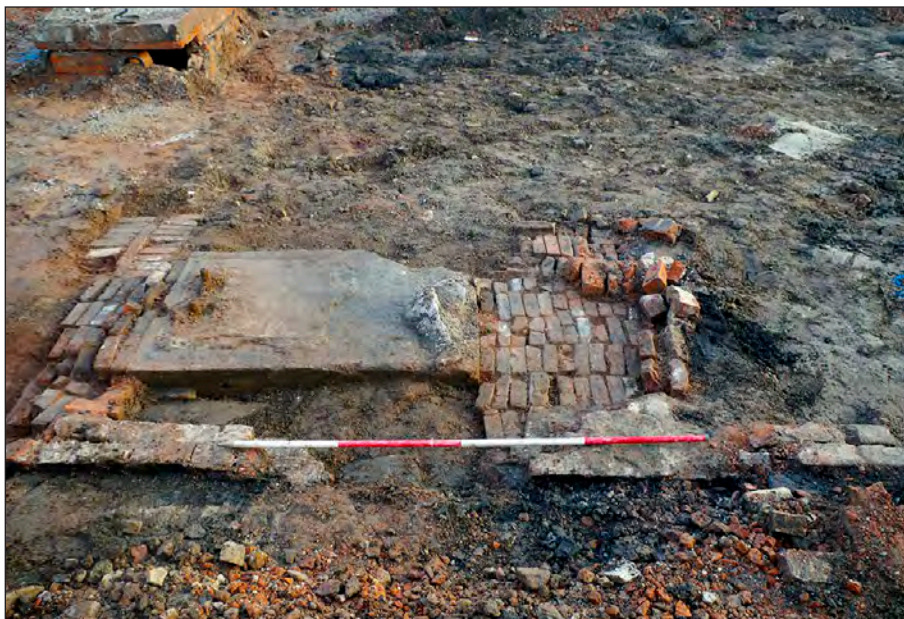
Figure 36: Machine base 589, brick surfaces 587 and 590, and earlier walls 588 and 591 (under scale). 2 m scale. View from west

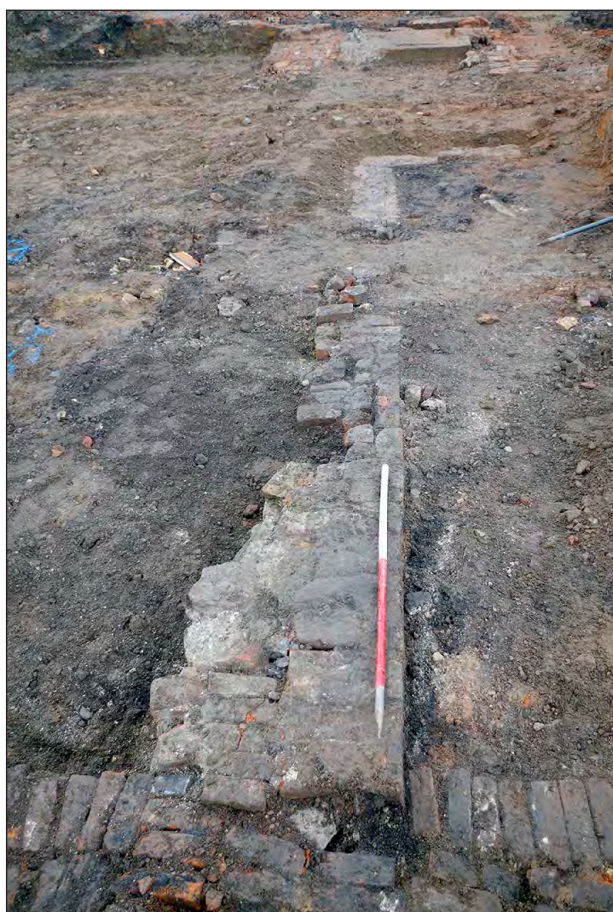
Figure 37: Wall 671 and surface 676. 1 m scale. View from east

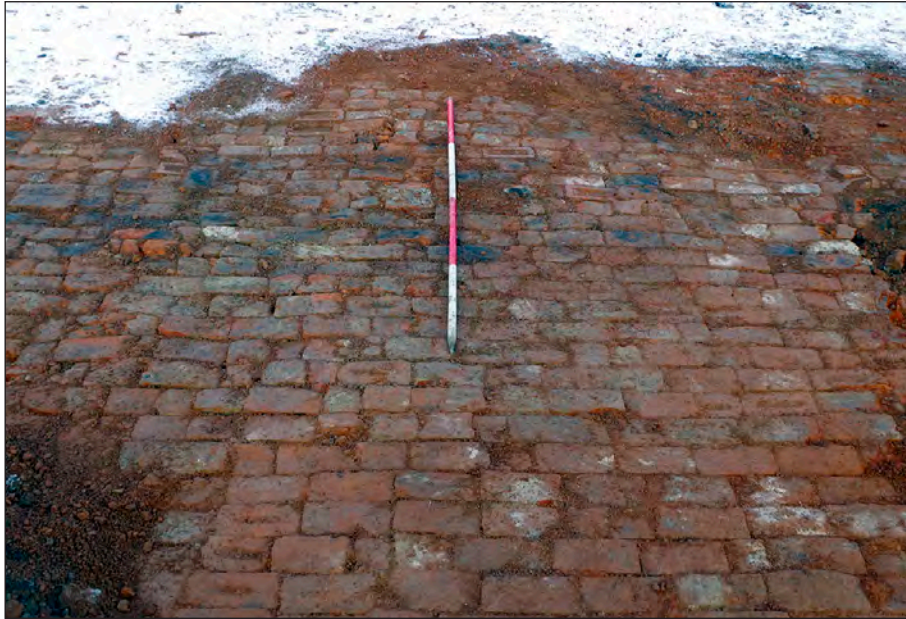
Figure 38: Brick surface 571. 2 m scale. View from north

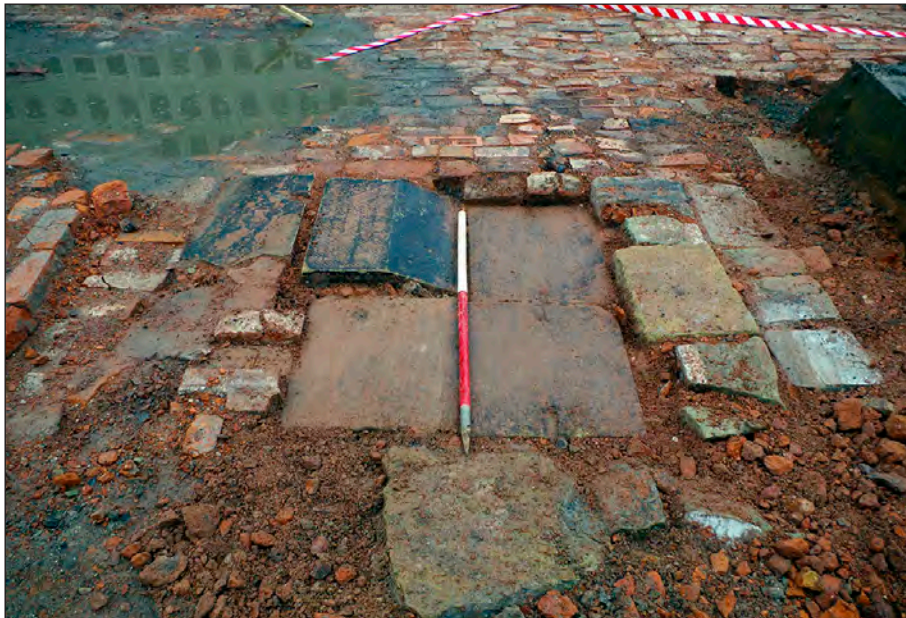
Figure 39: Ex situ rubble surface 569. 1 m scale. View from south

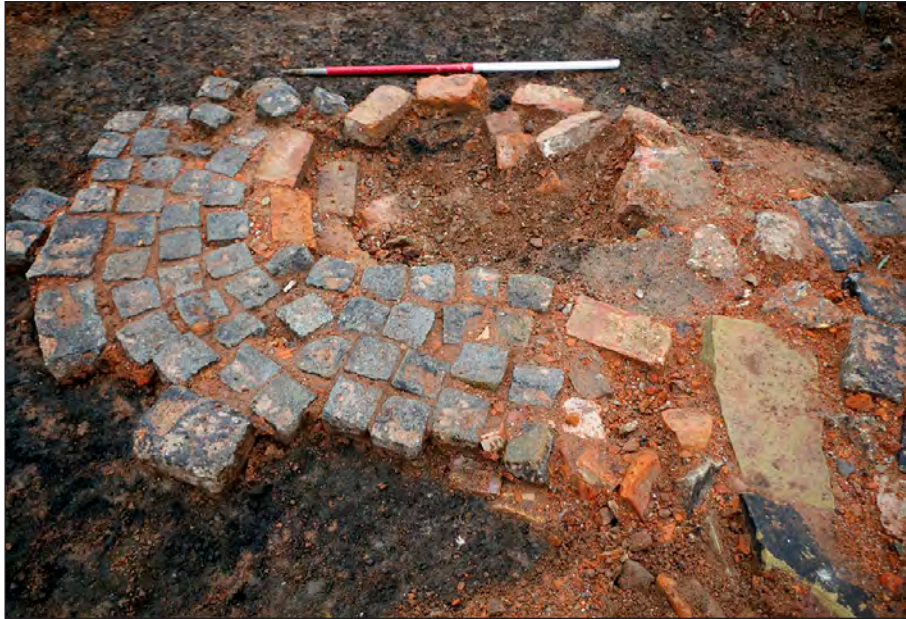
Figure 40: Structure 541. 1 m scale. View from east

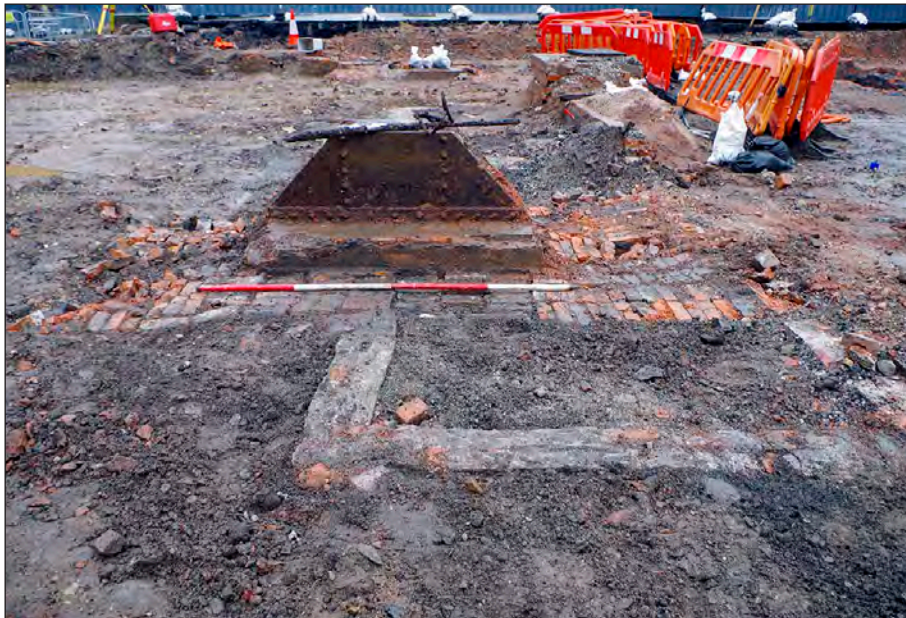
Figure 41: Stanchion 572/672/740. 2 m scale. View from east

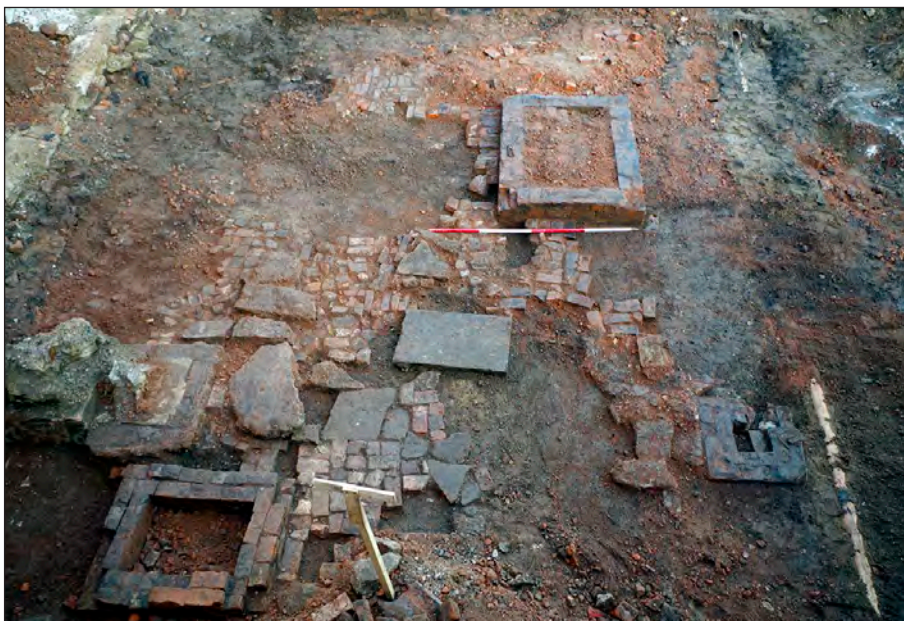
Figure 42: North-west corner of site including inspection chambers 521, 526 and 539. 2 m scale. View from west

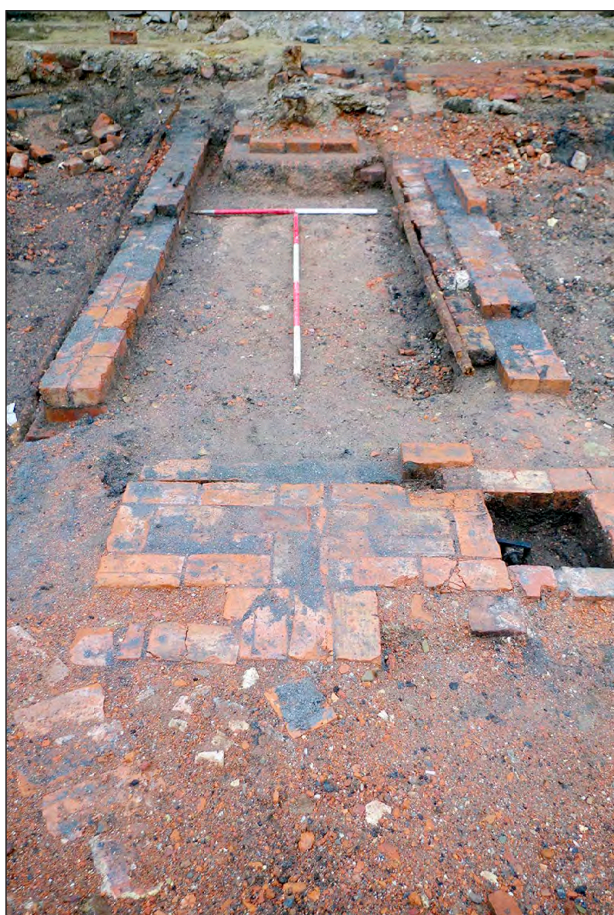
Figure 43: Conduit 531–533. 2 m and 1 m scales. View from south
