# CPAT TRENCH RECORDING FORM

| Project No | 2647 | Trench No | 01 |
| Project Name | Shingborough Car Park | Record by | JS |

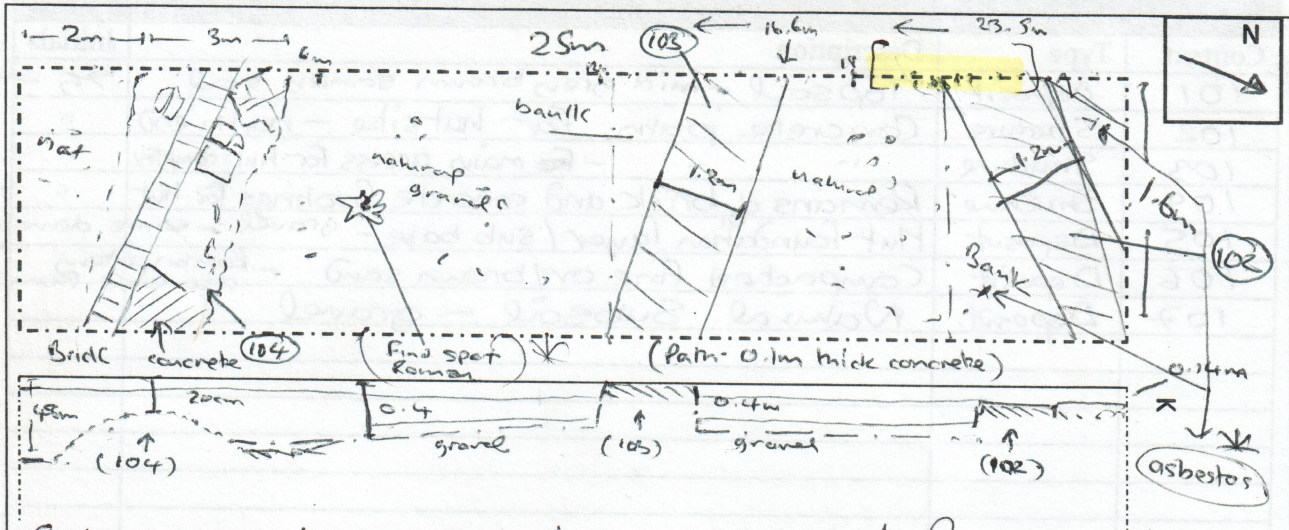
Trench located to ascertain whether or not remains of hut complex (c. WWII) present. Visible evidence of paths to the individual huts remains at surface level. (See 102 & 103 above). To the south, brick & concrete remains of building footings or drainage network possible. Geophysics result & subsequent trench location is extremely accurate. Demolition rubble mixed in somewhat with the original gravel construction sub base (105)

Underlying sub-base, a fine compacted sand (106)  
(interface with natural subsoil). This pre-dates the  
WWII hospital complex. ~~A~~ Sherd of Roman amphorae <sup>from this!</sup>  
Asbestos (from WWII huts) present in the topsoil and  
destruction.

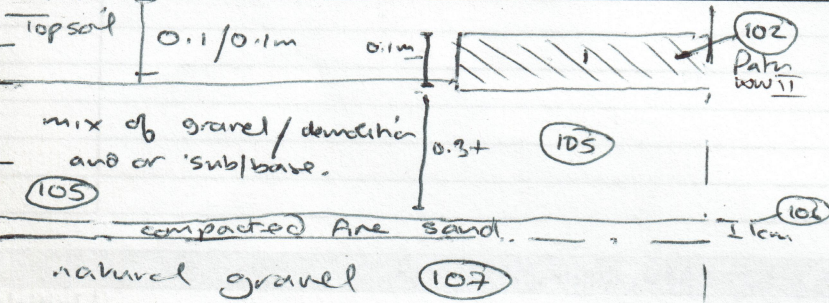
## Matrix

| | 101 | | |
| 103 | 102 | 104 | |
| | 105 | | |
| | 106 | | |
| | 107 | | |

[ ] = location of sample section
