# ARCHAEOLOGICAL MINOR MONITORING REPORT

## The church of St John the Baptist, Farnham Rd, Snape: Groundwork excavations for a new WC building in the churchyard.

<b>PLANNING REF:</b>	DC/20/1670	<b>HER PARISH NO.</b>	SNP 028 (the church)
<b>SIZE:</b>	Small scale (under 20sqms)	<b>OASIS REF:</b>	davidgil1-415692
<b>GRID REF:</b>	TM 39530 59380	<b>LISTED BUILDING NO.</b>	(Grade II*) 1231174
<b>SCCAS officer</b>	Dr Hannah Cutler	<b>FIELD WORK DATES:</b>	Nov-Dec 2022

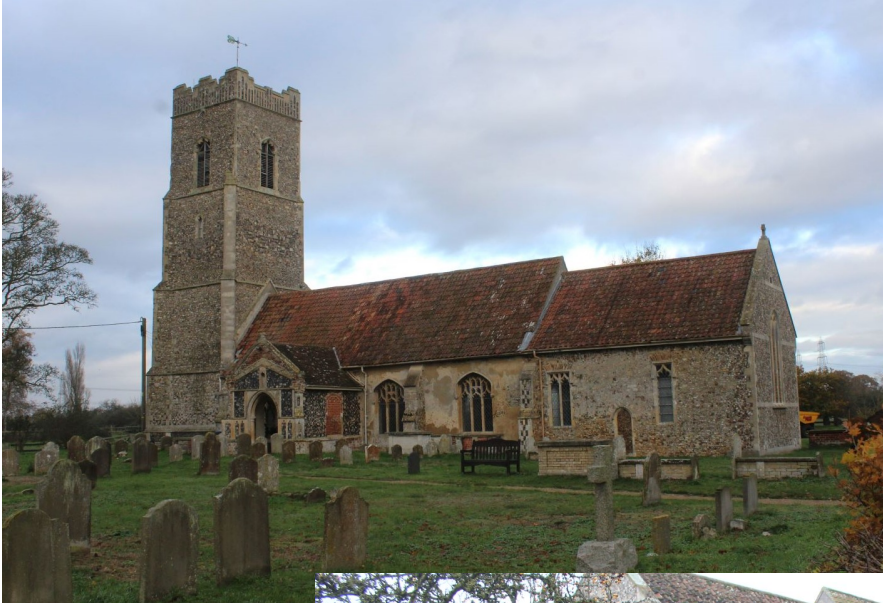
Plate 1 (left) The church of St John the Baptist viewed from the SE. The nave and chancel have 13th century origins, the porch was added in the late 14th and the 'new' tower added in the mid-15th centuries. The church is set back from the road within a large churchyard set out predominantly to the south

Plate 2 (right). Excavation of new WC site which was located in the NE corner of the churchyard and c.12m from the church; it was situated in an area where there were no extant gravestones

This report provides a record of the archaeological monitoring of the groundworks for the construction of a small WC outbuilding in the churchyard of St John the Baptist in Snape. The site of the new building was located in the NW corner of the churchyard and close to the west boundary, which until relatively recently fronted the Sternfield road (the re-alignment of the junction occurred sometime after the publication of the 1970 OS map). The main trench excavations were between 7m and 12m from the medieval church and in an area of no extant gravestones (Fig.2 and Pl.2).

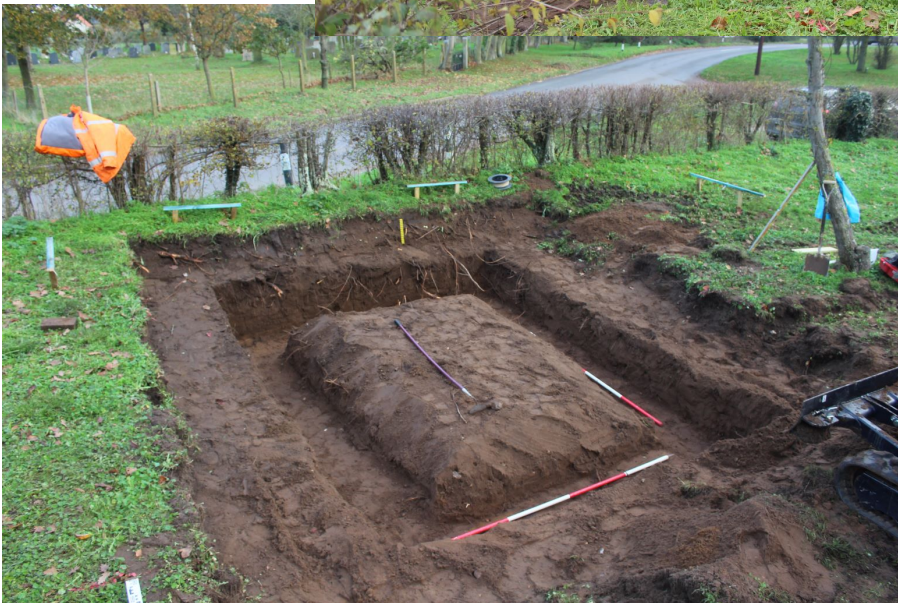
Plate 3 (left). Trench 1 groundworks. The WC was to have a raft foundation measuring 4m x 3m with a deep 'toe' around its perimeter (the slit trench); it was centred in a larger stripped area, measuring 5m x 5m, to enable the construction of timber formwork in which the foundation would be cast.

Photograph taken looking east, scales 2m. The additional graveyard, opened in 1954, can be seen on the opposite side of the road

Trench 1 was completed in two stages: firstly, an area of 5m x 5m was opened by a machine fitted with a toothless ditching bucket, excavating to a depth of 300-400mm, to create a working easement into which the timber formwork to cast a concrete raft foundation would be built; a further strip footing comprising trenches 600mm wide and 4m x 3m long was then excavated at the centre of the stripped area which would form a deeper 'toe' at the perimeter of the foundation (Pl.3).

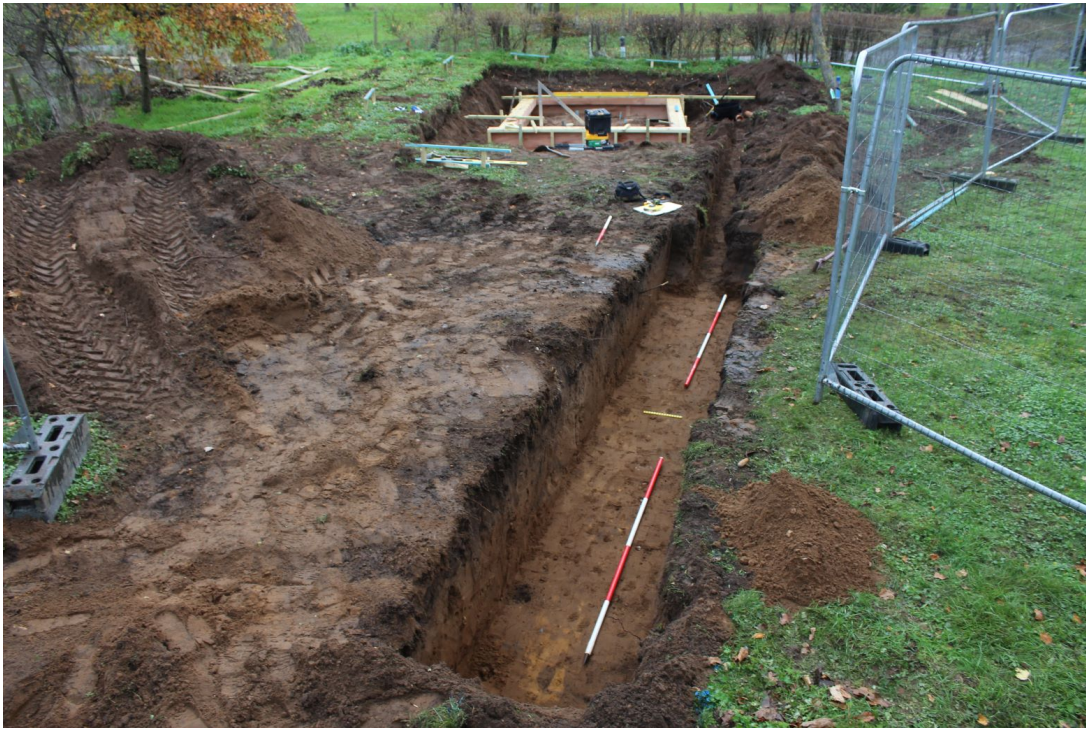
Plate 4. The arch drain trench was west of the site of the new WC (seen in the background). The arch drain trench was 7m long and 1m wide, increasing in depth from 600mm to 850mm, east to west. The scales are 2m long.

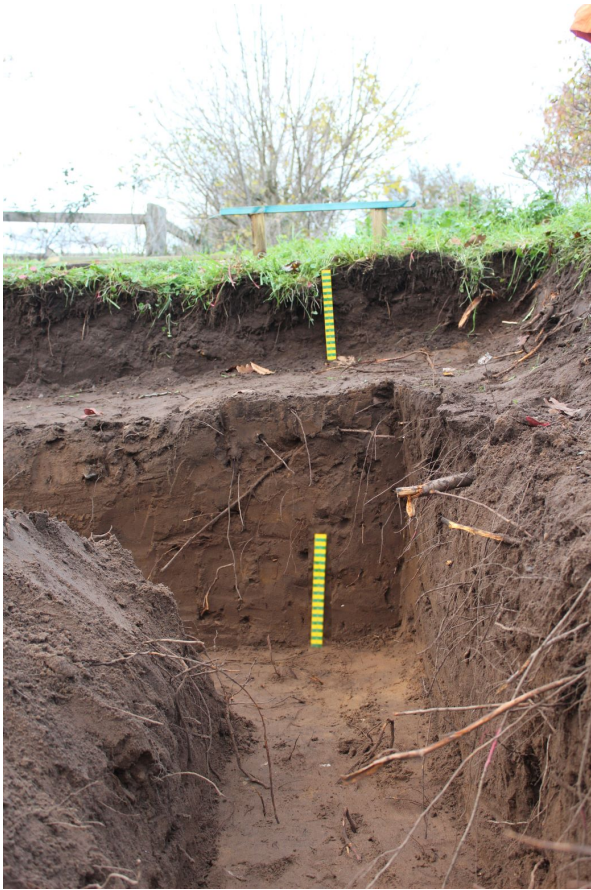
Plate 5 Section showing the depth of brown sand (grave upper backfill) in section S1, Trench 1. Scales 30cms

The excavations were entirely within the depth of a re-worked soil; a mid-brown sand that was interpreted as the upper backfill of closely spaced and intercutting unmarked graves. The burials were likely to have occurred in the distant past as the outline of grave cuts were no longer visible at the higher level. The shape of individual graves could be identified, however, in the bottom of the deeper trench excavations, 700mm below the current ground surface. Here, small areas of natural sand between the graves was intact and the outlines of 5-6 graves were recorded in plan (Fig.3). The individuals buried within the graves were below the 'finished dig-level' and no *in-situ* articulated human remains were uncovered by the work. Only two pieces of disarticulated human bone were found during the excavations of Trench 1, this suggested that primary graves had not been disturbed by subsequent burials, as is the case when areas are used repeatedly, and there was only one visible instance of a grave being intercut.

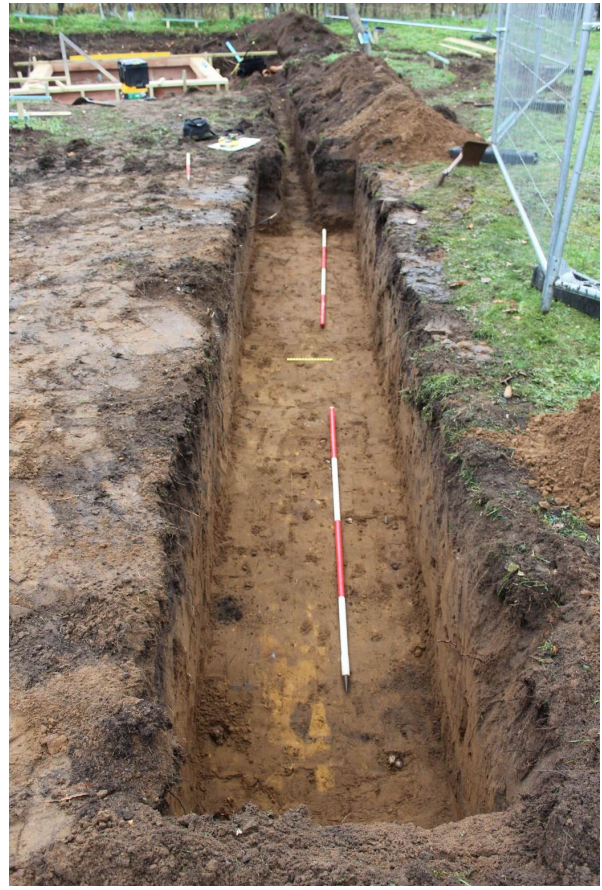
Plate 6. The excavation of Trench 2 shows largely undifferentiated grave fills across the complete length and depth of the excavation. The small patch of yellow sand is the undisturbed natural between two graves

The trench for the arch drain sewerage system was 7m long and 1m wide; to create the necessary fall, its depth increased from 600mm at the east end to 850mm at the west, with a step down to a depth of 1000mm in the final metre (Fig. 3 and Pl.6). The excavation over much of the trench length was within the depth of mid-brown sand, similar to layer 002 seen in Trench 1, and identified as upper grave fill. The trench depth was too shallow to distinguish the outlines of individual graves apart from at the western end, where a step down in the base of the trench revealed the edges of two graves. In one of these the top of a skull (facing east and therefore possibly an undisturbed *in-situ* burial) was uncovered at 1m below the ground surface (004, Fig.3). The burial lay just below the dig level, and it was left in place and the exposed bone covered over. As with Trench 1 there was a near absence of disturbed disarticulated bone within the upper fills suggesting that the area had not been continuously and repeatedly used for burial in the recent past. Small fragments of roof tile, plus a struck flint flake were the only finds recovered.
