MINOR ARCHAEOLOGICAL MONITORING REPORT

Abbey Gardens Bury St Edmunds: Re-ordering of the gardener's compound.

PLANNING APPLICATION REF:	DC/21/2261	HER PARISH CODE.	BSE 709
		OASIS ID:	davidgil1-508393
NATIONAL HERITAGE LIST NO.	1021450	SCHEDULED MON CONSENT REF:	S00242119
GRID REF:	TL 85673 64325	SIZE:	Small scale (c.160sqms)
PROJECT DATES:	5th-22nd May 2022	SCCAS officer	Dr Abby Antrobus

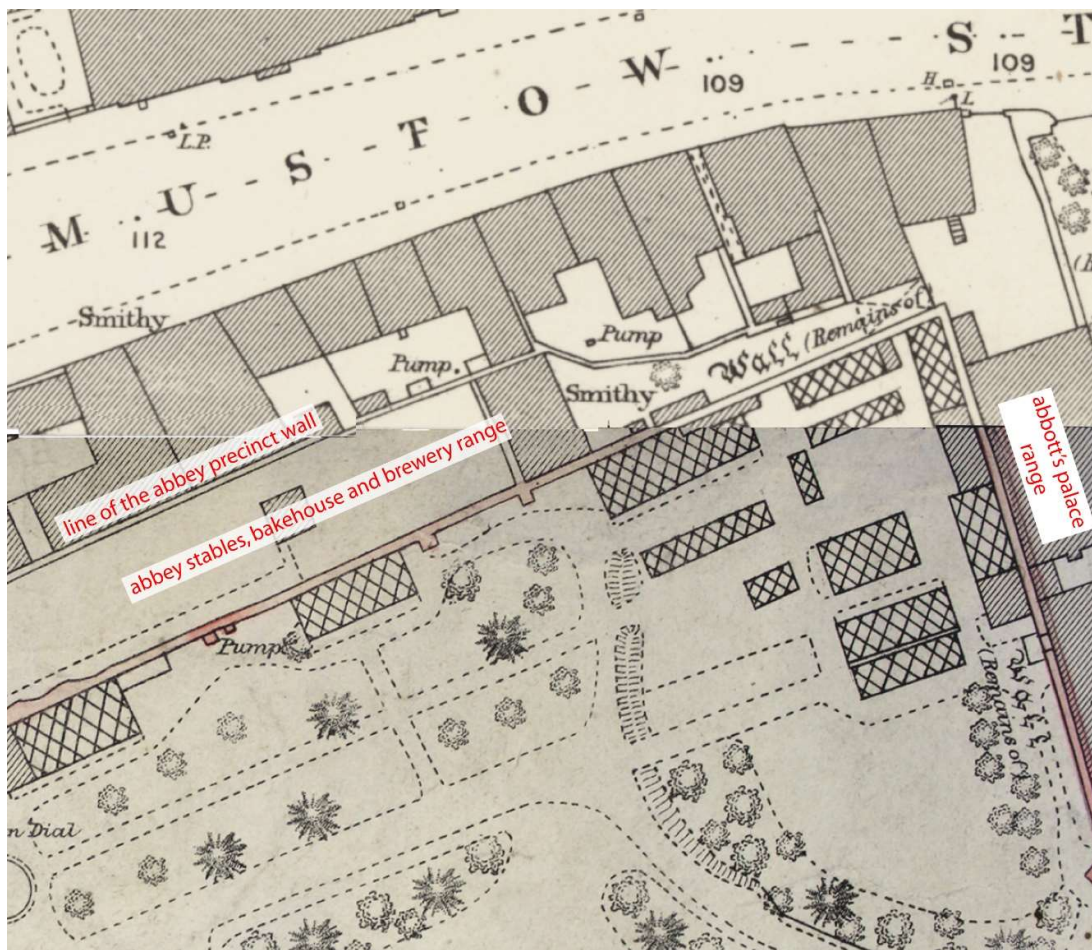
Figure 5. First edition Ordnance Survey (1885) showing the site crowded with eleven glasshouses and enclosed behind a bank. Similar buildings are shown on the 1953 edition of the Ordnance Survey suggesting that the glasshouses remained in use until the creation of the Eastgate Nursery on an adjacent site (the new tennis courts)

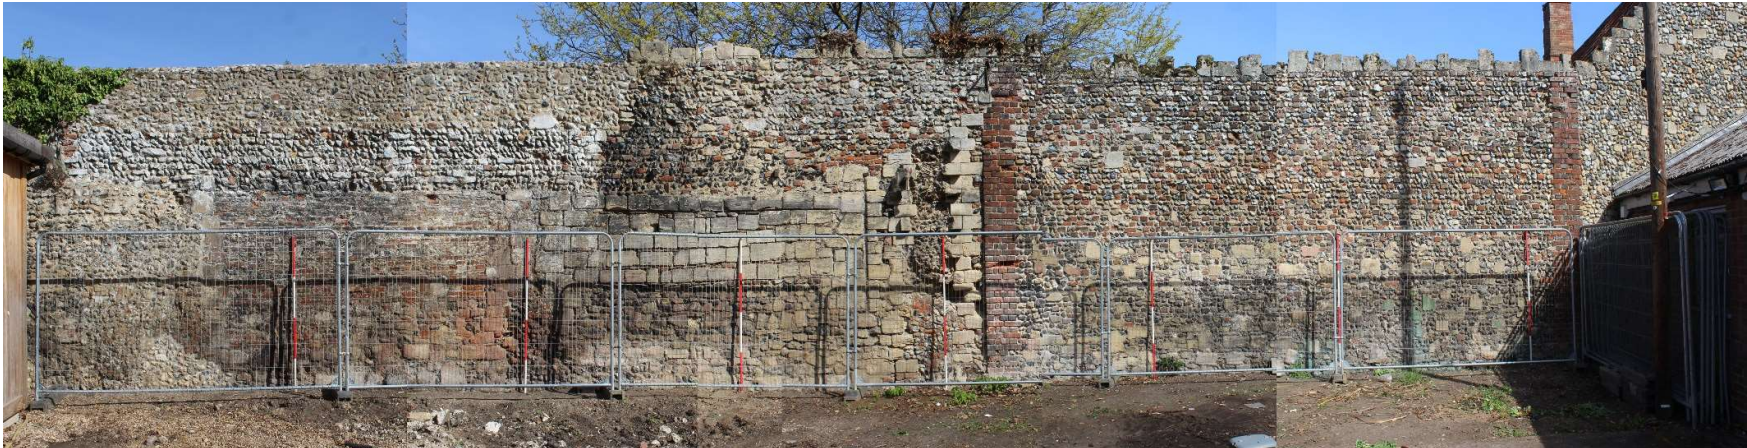
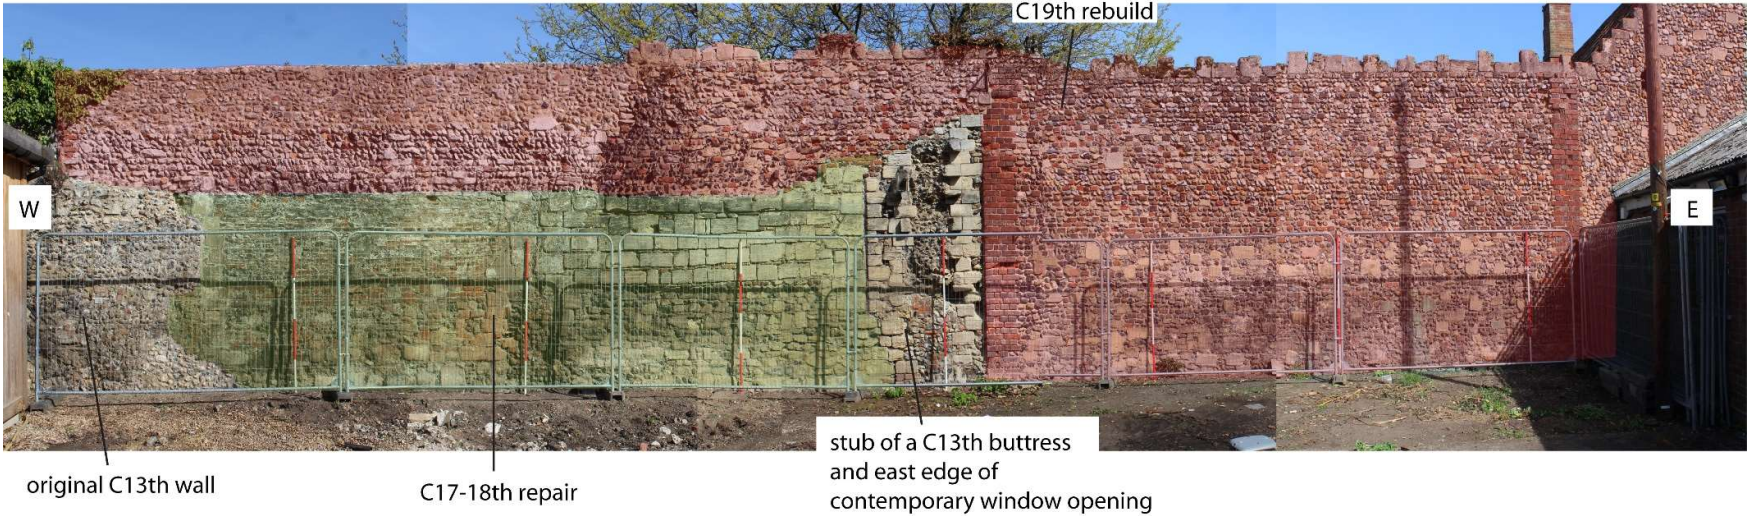
The removal of the existing concrete garage, greenhouse and assorted clutter provided an unimpeded view of the abbey wall remains which were recorded by photograph (Pl.1). The wall is largely made up of rebuilt and repaired lengths but at its centre are the remains of an original buttress and the edge of a contemporary window opening alongside it, (Pl.2). The buttress and window retain some of their original *Barnack* stone dressings, they are contemporary with the architectural features recorded in the back wall of the aviaries (Gill 2009) and probably date from the 13th century. The repairs represent several different phases of reconstruction where the wall has either collapsed or had been knocked through to create access into, or enlarge, the properties on Mustow Street. The extensive use of 'Tudor' bricks (and the absence of later ones) implies that the earliest rebuilding could date from the 16-17th century, whereas the use of a large number of 'abbey stone' blocks in a subsequent repair (Pl.2) may be linked to the sudden abundance of this material following the demolition of the town's Eastgate or Abbott's palace in the first half of the 18th century (Gill 2018). The section of wall from the medieval buttress to the NE corner of the compound has been completely reconstructed, the rebuilt section is delineated by brick-built piers and the brick sizes suggest a 19th century date (first half) ; the repair included raising the wall height, and castellating it with re-used stone, across the entire recorded length.

Plates 1 and 1A. Composite photo of the much-repaired abbey wall on the north side of Gardener’s compound and showing phases of repair below. 2m scales

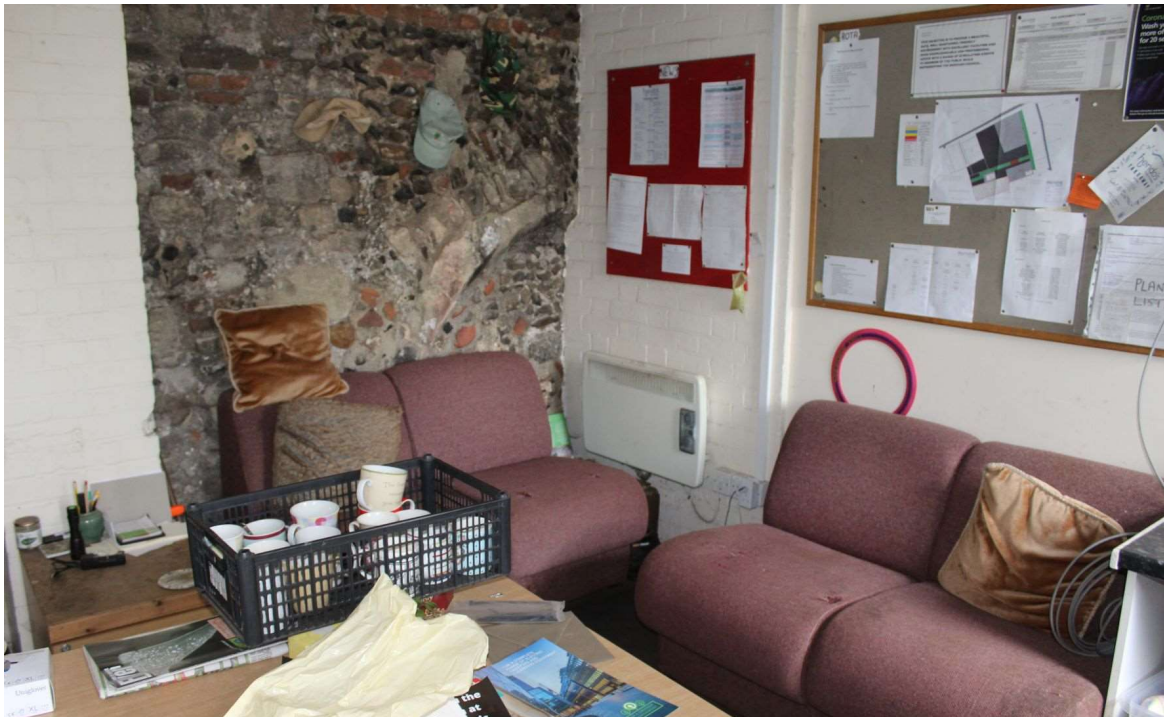
The range of modern lean-to buildings along the east side of the compound were constructed against the remains of a medieval wall, once part of the Abbott's palace range that enclosed the east side of the Great Courtyard. Within the Gardener's mess room is the top of a blocked, arched opening (Pl.3). The arch is a two-centre 'gothic' type dating from the 13-14th century; its apex is only c.1.2m above the mess room floor and is a strong visual indication of how much the ground levels have risen in this part of the abbey.

Plate 3. A blocked door in the rear wall of the gardener's mess room. The lower half has been buried by the rise in ground level and the top of the door is now only 1.2m from floor.

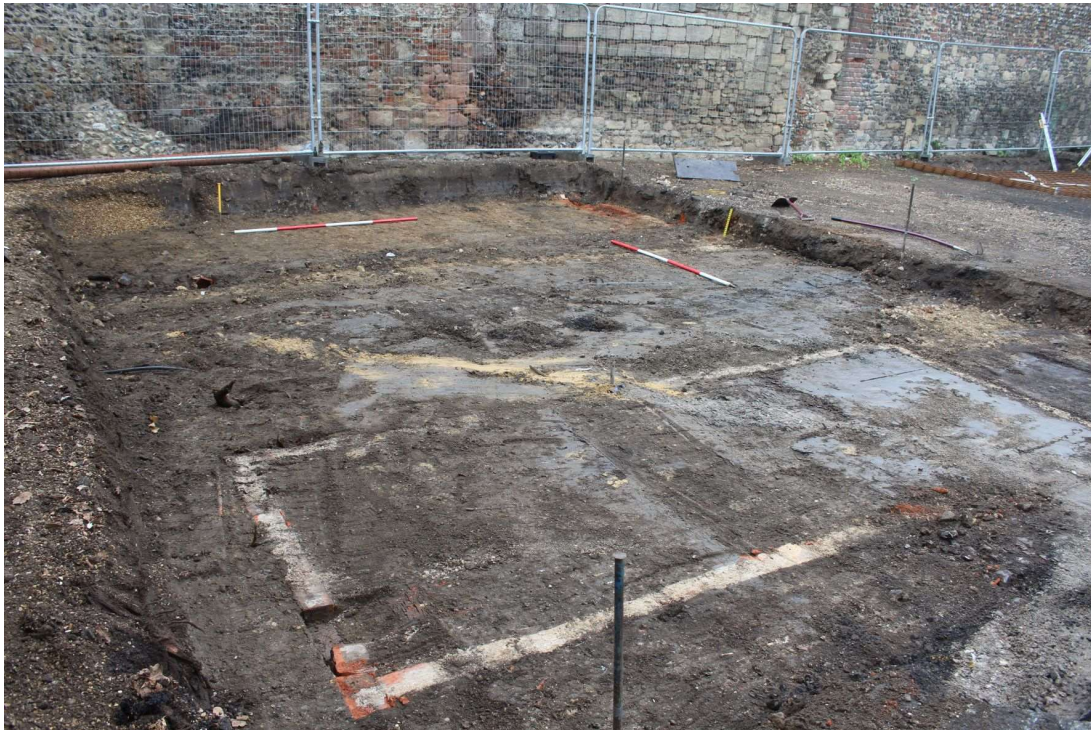
Area 1 measured 58sqm (8.5m x 6.8m); it was excavated in two spits which removed a mixed demolition rubble within a matrix of dark grey black silts with modern debris: charcoal, pieces of china and coal etc. At the north end of the site the rubble element was made up of flint and lime, whilst at the south it was largely brick. The 'reduced-dig' level (300mm below current ground level) coincided with the top of a buried soil, a post-medieval/modern made-up ground level, composed of a dark, charcoal rich, muddy clay silt (006 and 002 Fig. 6). Set within the soil were the remains of a rectangular brick-built structure (007, Fig, 6) and the stub of a bonded rubble wall (004). Both were orientated SW-NE and paralleled the line of the abbey wall on the north side of the yard, and their locations matched the positions of the glasshouses shown on the first edition Ordnance Survey (Fig.5). The rubble wall, thought to be the south wall of a glass house constructed against the abbey wall, was 0.5m wide and composed of mainly flint, but included some broken brick, that was bonded with a pale brown, coarse sand, lime mortar; this had decayed so that the flints were loose and dry. A mix of brick and reused limestone blocks (Abbey stone) formed a corner quoin, and the fragmentary remains of a return wall (009) ran alongside the east edge of excavation. The bricks within the wall corner were 2½" thick (the modern 'common brick' size) and similarly sized bricks were used to create two narrow channels (003, Fig.6 and Pl.5) that ran between wall 004 and the Abbey wall bounding the yard. The channels were interpreted as the remains of what had been under floor heating flues, and they aligned with areas of heat damage on the abbey wall where the stones and mortar had been burnt red (Pl. 5). Within the area enclosed by wall 004, was a fine rubble layer of lime mortar and flint (001), this was interpreted as a sub-base for the glass house floor, and the flues were set into this deposit.

The base of the smaller glasshouse (007) measured 4.5m x 1.90m and was a lightweight structure built on a narrow dwarf wall (a single brick width - a 4" wall). The bricks were laid directly onto the earth without foundations and the wall was truncated so that only the base course remained. The excavations were below what had been the ground level when the glass houses were built; no evidence of the floor survived and the buried soil layer (006) underlying the greenhouse was visible both inside and out. At the east end of greenhouse 007 was the remains of an associated structure, a base or (?)hardstand, which survived as a neat rectangular block of masonry comprising a brick facing and a rubble core (005); a concentration of clinker and ash were recorded in the adjacent area to the south (008).

Plate 4. Area 1 the excavation for the 3-bay garage looking north. The excavations were 300mm deep and wholly within modern made-up ground. In the foreground is the brick base for a 19th century greenhouse. The front wall and floor sub-base of a larger lean-to glasshouse, which was constructed against the face of the abbey wall can be seen as a pale mortar strip at the far end of the site. Scales 2m

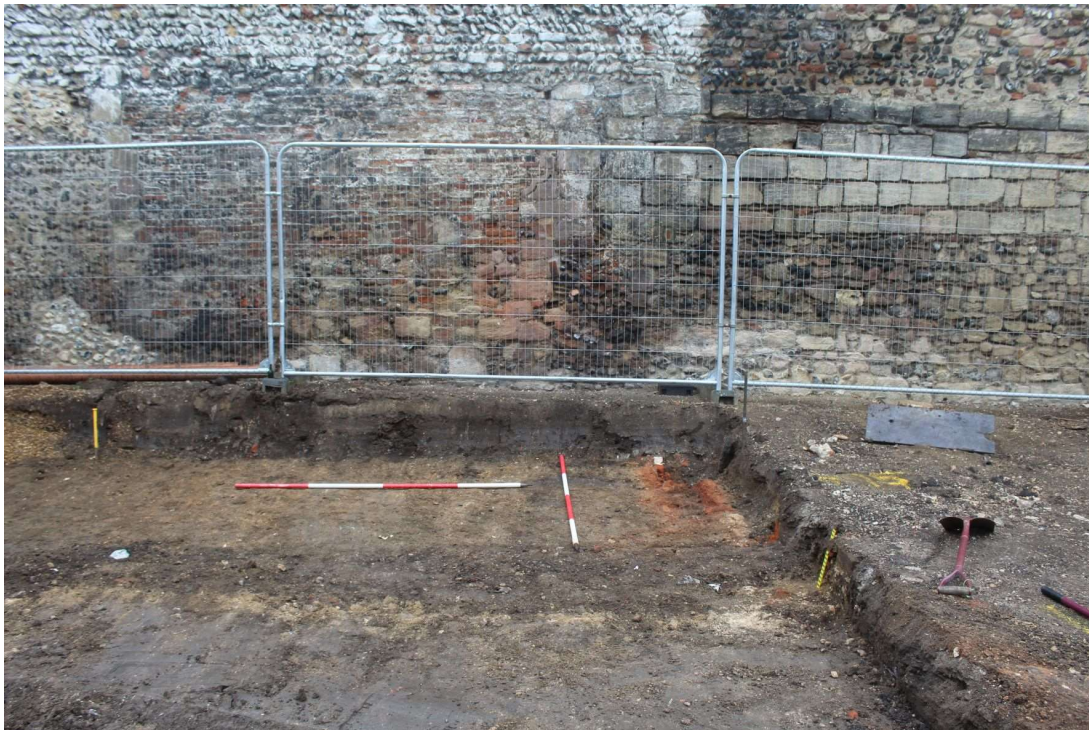
Plate 5. The larger of the two glasshouses was heated; one of the below floor flues can be seen in the corner of the site, and the stones of the abbey wall behind it have been burnt red. The pale mortar strip running across the site is the remains of the front wall of the glasshouse and its inside edge has been cut by a later water main (the band of darker soil); the small yellow scale (30cms) on the right rests on the SE corner of the glasshouse and the east wall follows the right-hand edge of the site

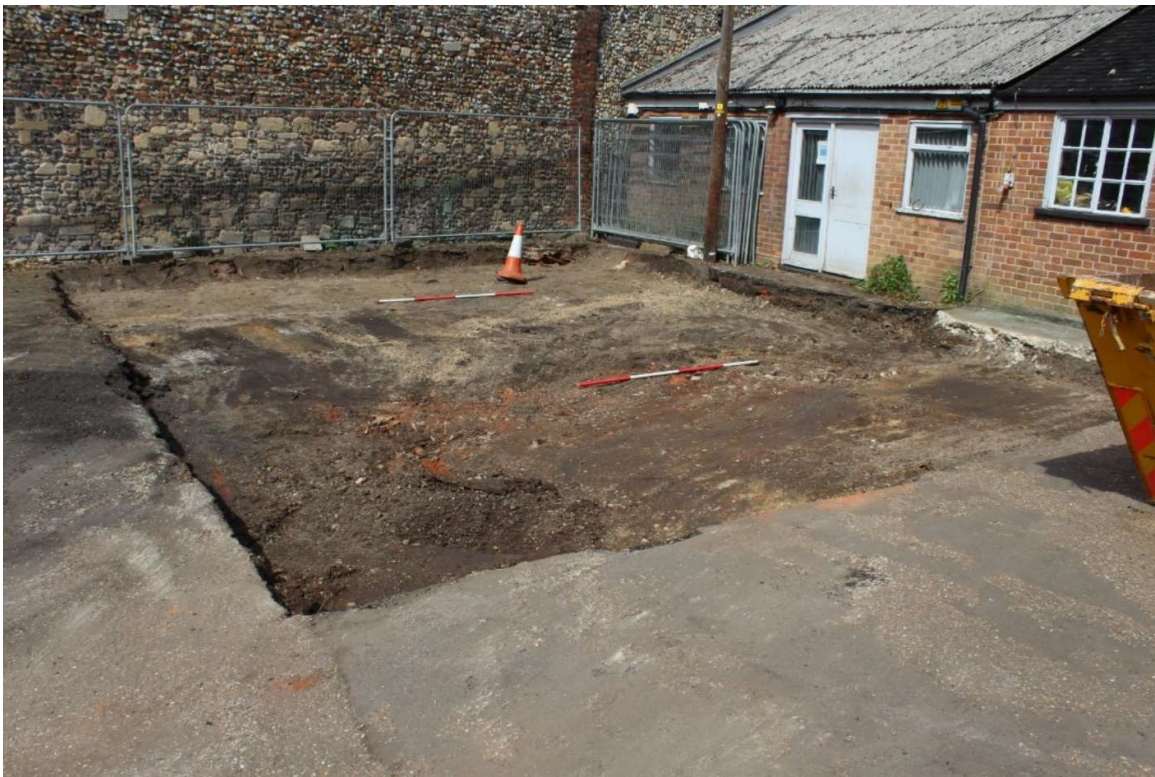
The area of hardstand (Area 2) measured 78sqm (10.05m x 7.80m). Mixed, redeposited dark silts with crushed brick rubble (010 and 011) similar to the layers recorded in Area 1 were observed across the site and the remains of a brick-built greenhouse base (012) existed alongside its north edge. At the centre of

Plate 6. Area 2, excavation of the skip hardstands looking NE, scales 2m.

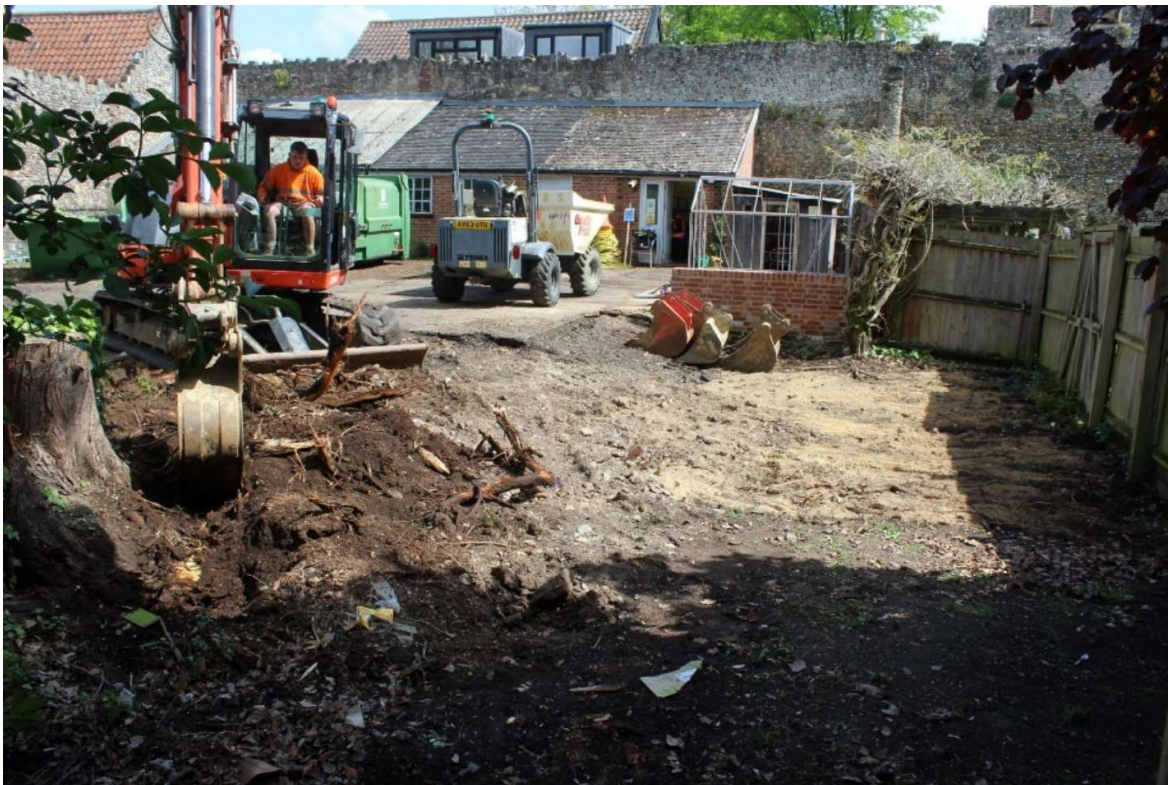
Plate 7. Area 3 the site of the Efford bed during the grubbing out of the trees and prior to excavation. The location was a soft-dig area beyond the edge of the tarmac yard and low-lying, where the ground fell away to the level of the adjacent garden, which is 300-400mm lower

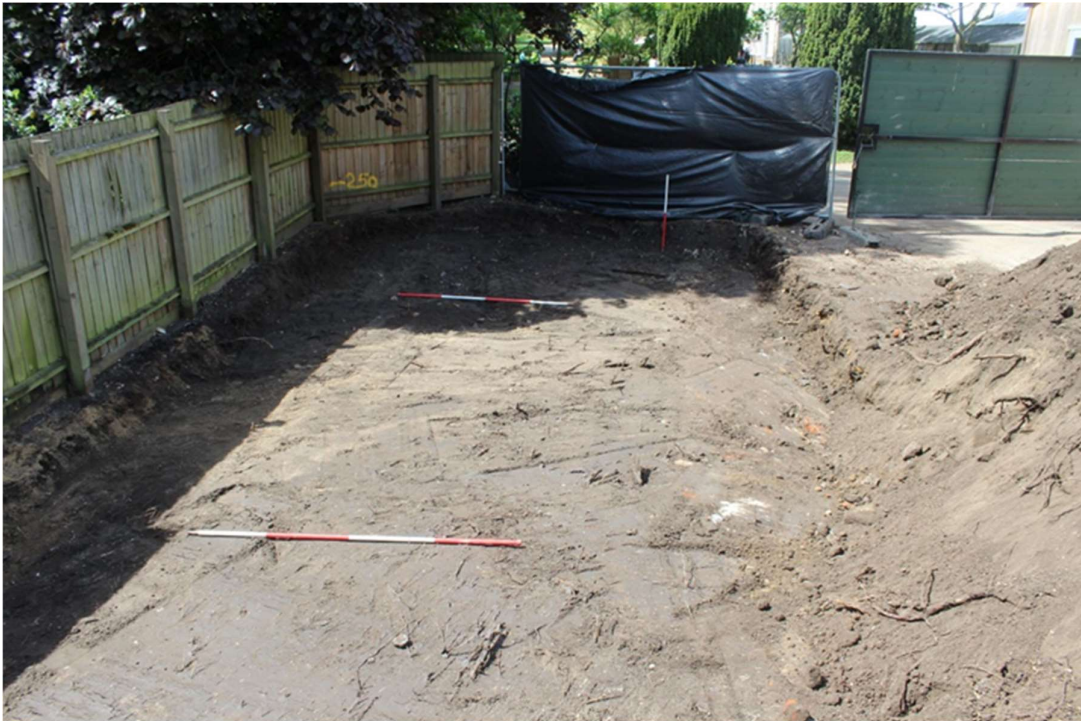
Plate 8. Area 3 (the efford bed) following excavation looking west. The depth of the ground level reduction coincided with the top of a dark earth layer, 016, an extensive layer of town rubbish deposited across the site sometime during the 17-18th century.

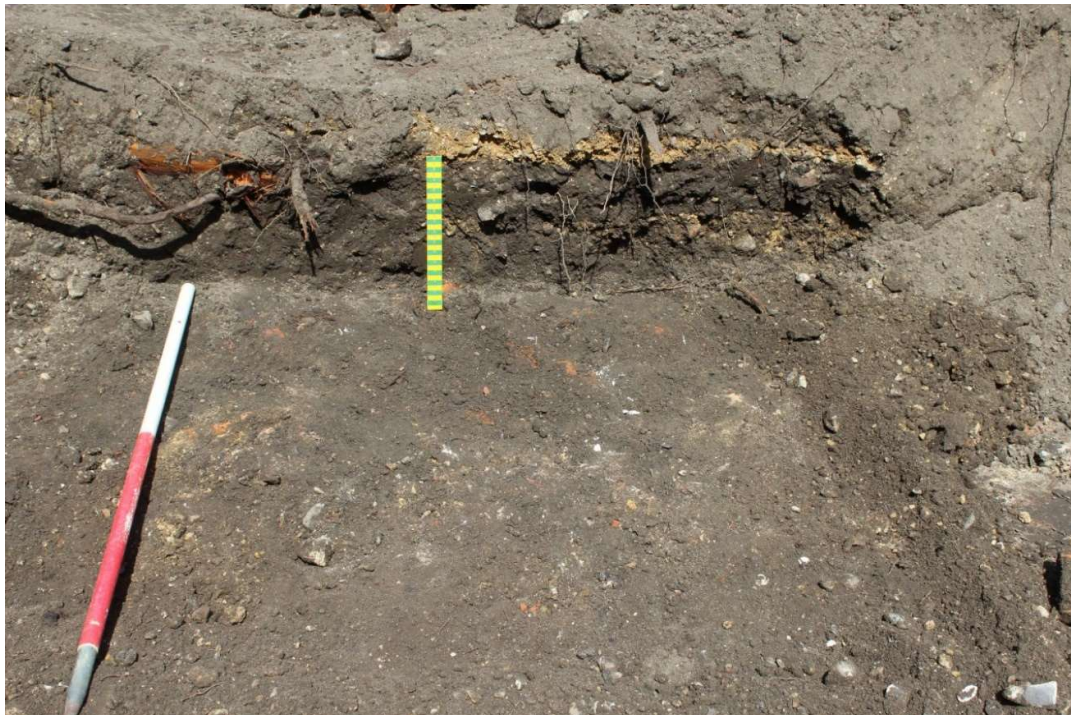
Plate 9. The north edge of Area 3 (section S3), the soil profile shows layers of lime mortar rubble, which lay on the former ground surface. Across the base of the excavation is a buried dark soil, 016, a charcoal-rich, organic occupation soil which contained building material and food waste. Soil layer 016 is in effect the uppermost archaeological deposit and is similar to an extensive dark-earth layer that has been recorded across this part of the Abbey gardens in the past and which has been interpreted as an early post-medieval rubbish dumping event.
