# ARCHAEOLOGICAL RECORDING OF GASHOLDERS AT RIBBLETON LANE, PRESTON TECHNICAL APPENDIX MAY 2020

Document Title	Archaeological Recording of Gasholders at Ribbleton Lane, Preston, Technical Appendix
Prepared for	Atkins Ltd
Prepared by	TEP - Market Harborough
Document Ref	8065.002

<b>PROJECT DETAILS:</b>		
Short description	<p>The Environment Partnership (TEP) carried out archaeological observation during the demolition of Gasholders 1 and 2 at the former Ribbleton Lane Gasworks, Preston, Lancashire. Gasholder 1 was a spiral-guided gasholder built in 1955, replacing a column-guided gasholder of 1869 and utilising the below-ground tank of the earlier holder. The gasholder was typical of this type and period with trussed crown frame, riveted crown sheets and top curb and welded lift sheets, and square cup and grips. The replacement of a column-guided gasholder with a spirally-guided one was a very common development on gasworks and allowed the site's storage capacity to be considerably increased within the existing site boundaries.</p> <p>Gasholder 2 was a giant single-order, single-tier column-guided gasholder built in 1855 by Thomas Piggot &amp; Co. of Birmingham and indicates the f

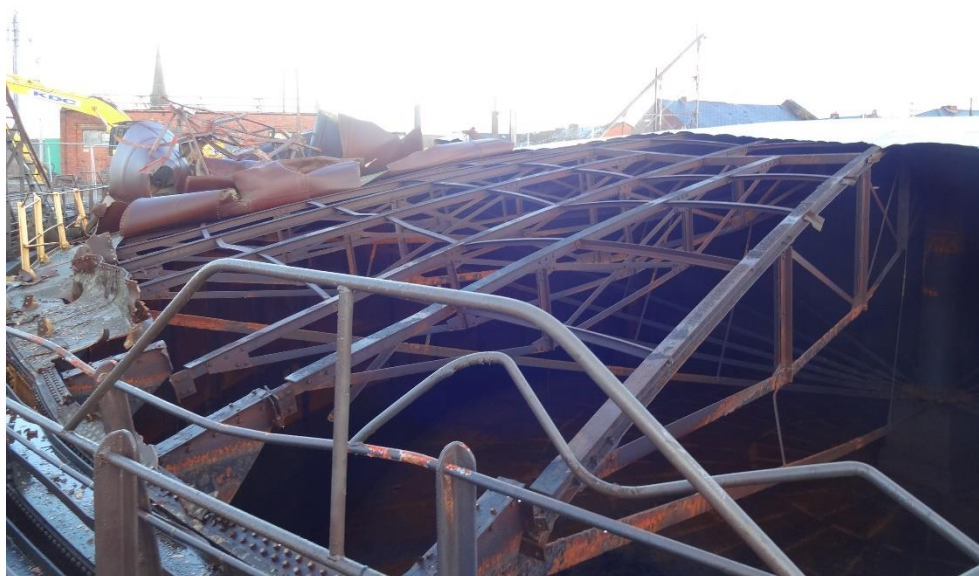
*Figure 1 Gasholder 1, view of the crown frame, showing trusses spanning between the central pipe and gusset plates attached to vertical stiffeners*

- 2.3 The crown frame arrangement was typical for a spirally-guided gasholder of the mid-20th century, comprising 30 primary and secondary radial trusses springing from a central pipe to meet vertical stiffeners on the inside face of the inner lift. The upper chords were comprised of Tees joined by angles to the underlying flat bar lower chords. The trusses were joined to each other with flat bar purlins which support the crown sheets. Tapered gusset plates were used to join the trusses to the vertical stiffeners and flat bar braces spanned from the gusset plates to the bottom of the central pipe.

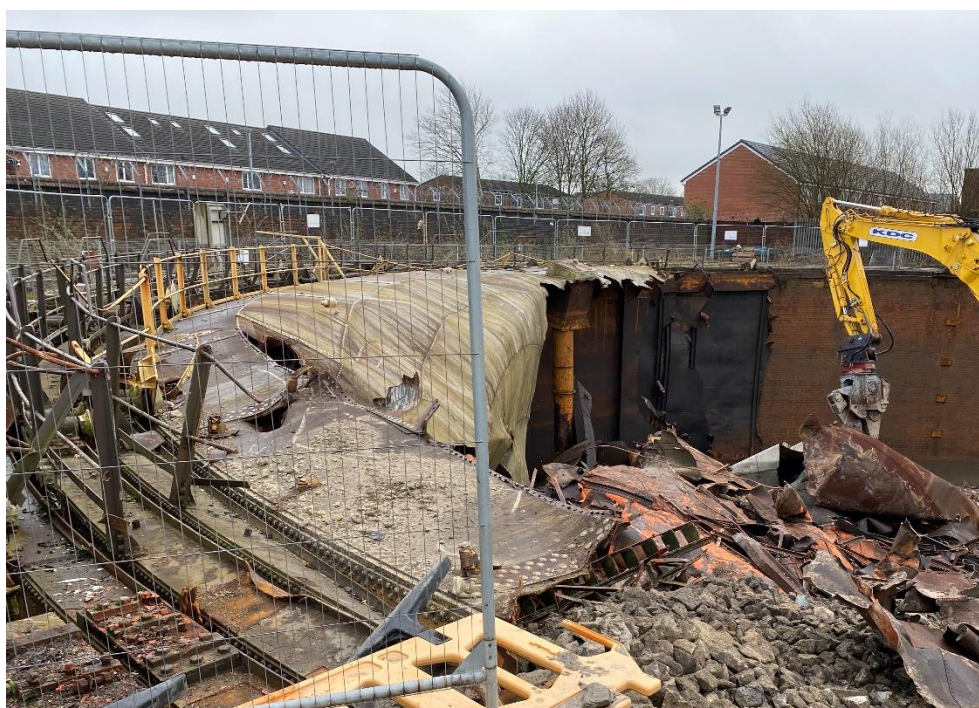
*Figure 2 Gasholder 1, the crown during removal. Note hydraulic lid to pipe*

- 2.2 At the time of recording the majority of the crown sheeting, crown frame and lifts had been removed. A small section of the inner lift on the north east side of the tank remained in place with a section of crown sheeting and supporting frame still attached. The crown sheeting comprised concentric rings of steel sheets, riveted at the edges and with hydraulic lids to the inlet / outlet pipes.

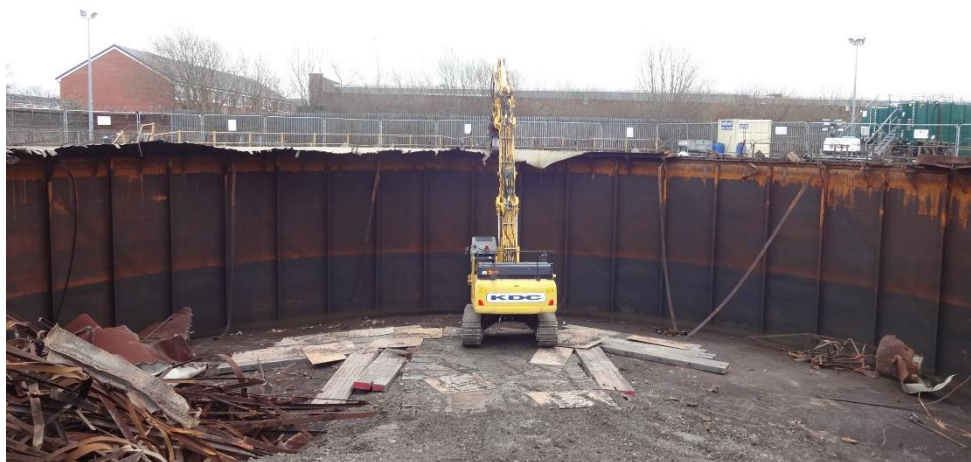
*Figure 3 Gasholder 1, the gasholder interior with crown frame removed*

- 2.7 The gasholder lacked a prominent dumpling and was effectively flat with slight declines around the edges to form the annulus. No rest blocks were visible.

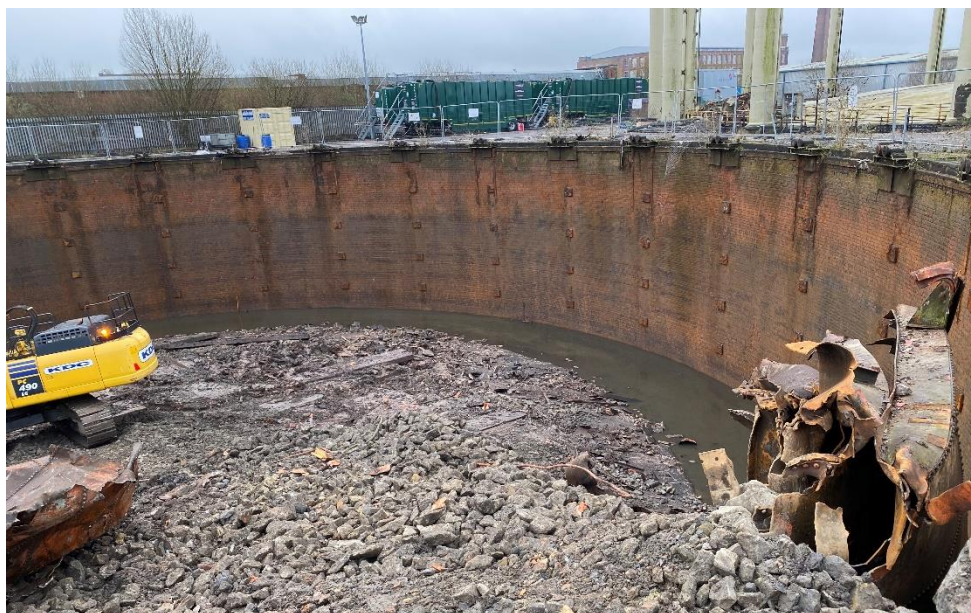
*Figure 4 Gasholder 1, view of the brick tank with lifts removed*

- 2.5 The tank was observed to be faced with red brick in English bond with regularly spaced masonry blocks corresponding with the position of vertical roller guides for the former early column-guided gasholder. Other examples tanks of this period were noted as having small relieving arches at the base of the tank but due to the level of water within the annulus this could not be confirmed here.

- 2.6 The former column pads were utilised to carry the later roller carriages; the intervening roller carriages were set onto concrete pads at the tank kerb and secured to the tank by long anchor bolts for which straps were fixed to the face of the tank.

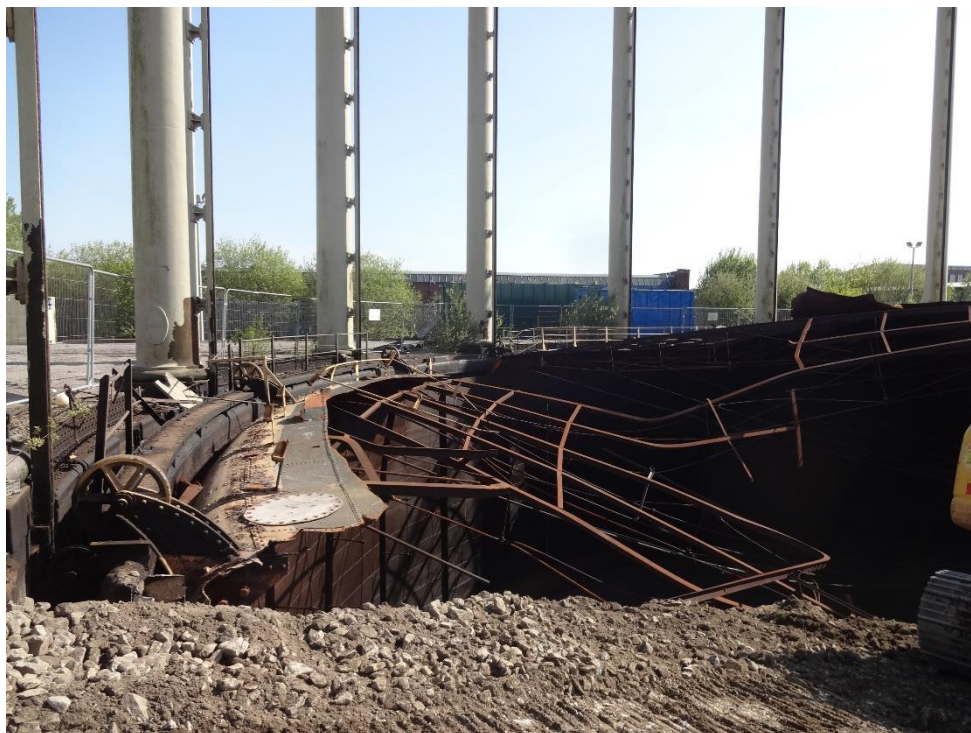
*Figure 5 Gasholder 2, the crown frame during demolition*

- 3.3 The crown frame was comprised of primary and secondary rafters radiating from a central post to join stiffeners on the inside face of the first lift. The rafter upper chords comprised steel Tees joined to the circular bar lower chords with perpendicular angle struts and diagonal circular braces. The rafters were joined by regularly spaced lines of angle purlins. The crown top curb was provided additional support by closely spaced tapered gussets of which three were set between each rafter.

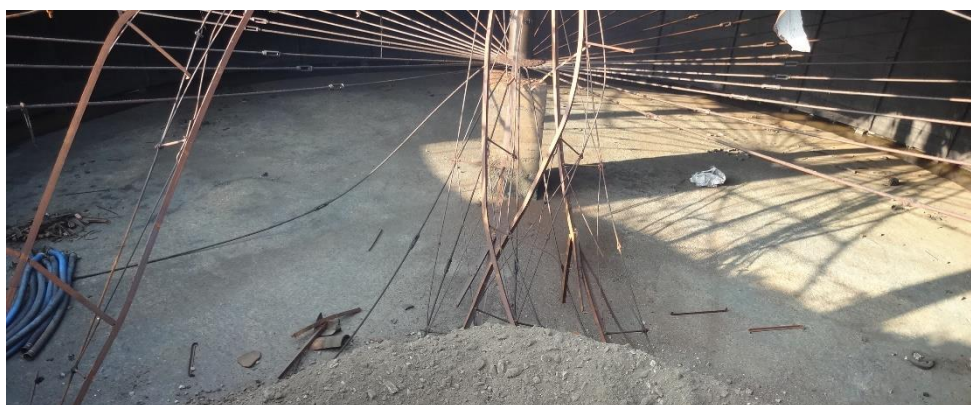
*Figure 6 Gasholder 2, view of the central crown frame supporting column*

- 3.2 As also observed in Gasholder 1, the base of the tank was essentially flat with no annulus and with a slight depression around the edge of the tank. At the centre of the gasholder was a square column of concrete blocks which served to support the crown frame when at rest. The rest blocks were comprised of simple rectangular blocks of stone or concrete.

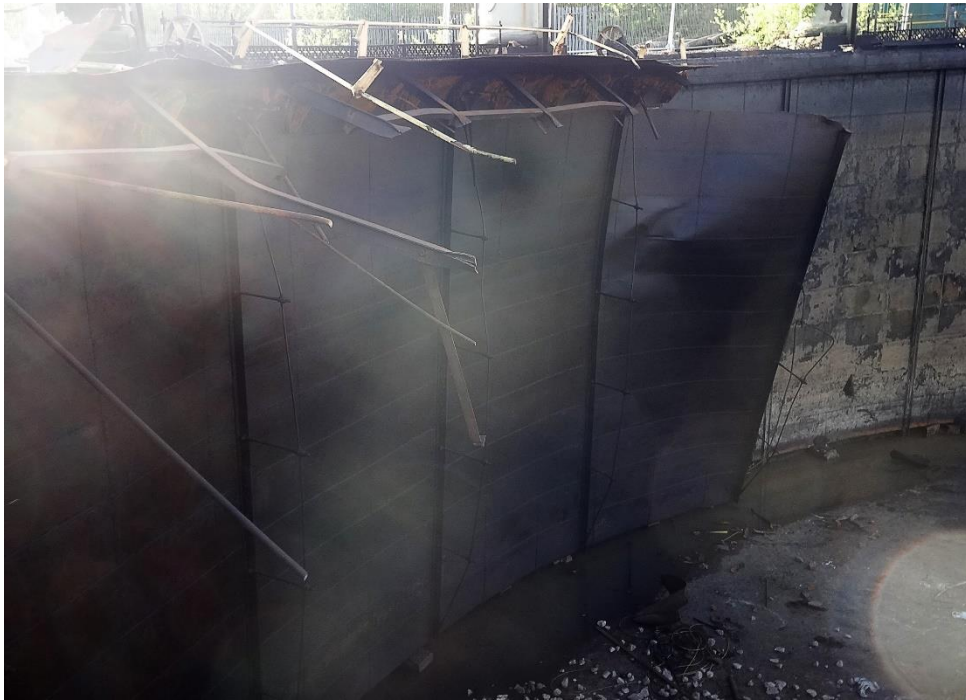
*Figure 7 Gasholder 2, view of the inner lift showing the top curb and vertical stiffeners*

- 3.4 The lifts were formed of c12 courses of small riveted sheets. This form of sheeting is more typical of 19th century gasholders and in later gasholders, particularly spirally-guided examples, lift sheets became taller and much wider. On the inner or first lift an uncommon arrangement was utilised for the vertical stiffeners comprising a vertical bar attached to the lift, rising from the bottom of the lift to the rafter gusset plates. From this were projected outward a series of perpendicular arms joined together by a vertical tensioning bar. On the outer lift a more typical form of stiffener comprising shallow channels were used.

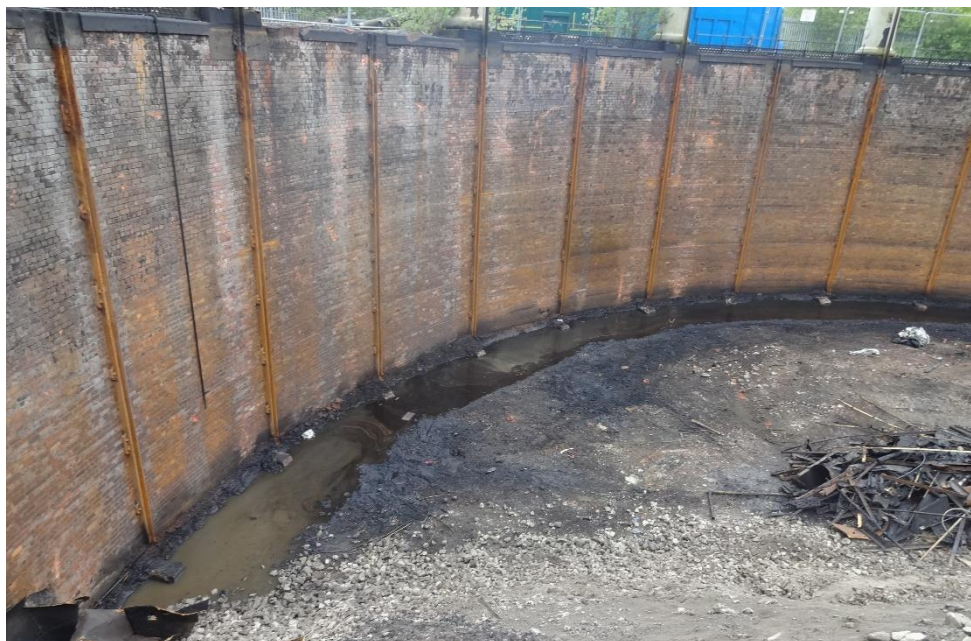
*Figure 8 Gasholder 2, view of the brick tank following removal of the ifts*

- 3.5 The tank was faced with red brick in English Garden Wall bond with the kerb formed of stone blocks. The column footing pads were set flush with the brickwork and the vertical guide channels were bolted to small masonry blocks set into the tank.

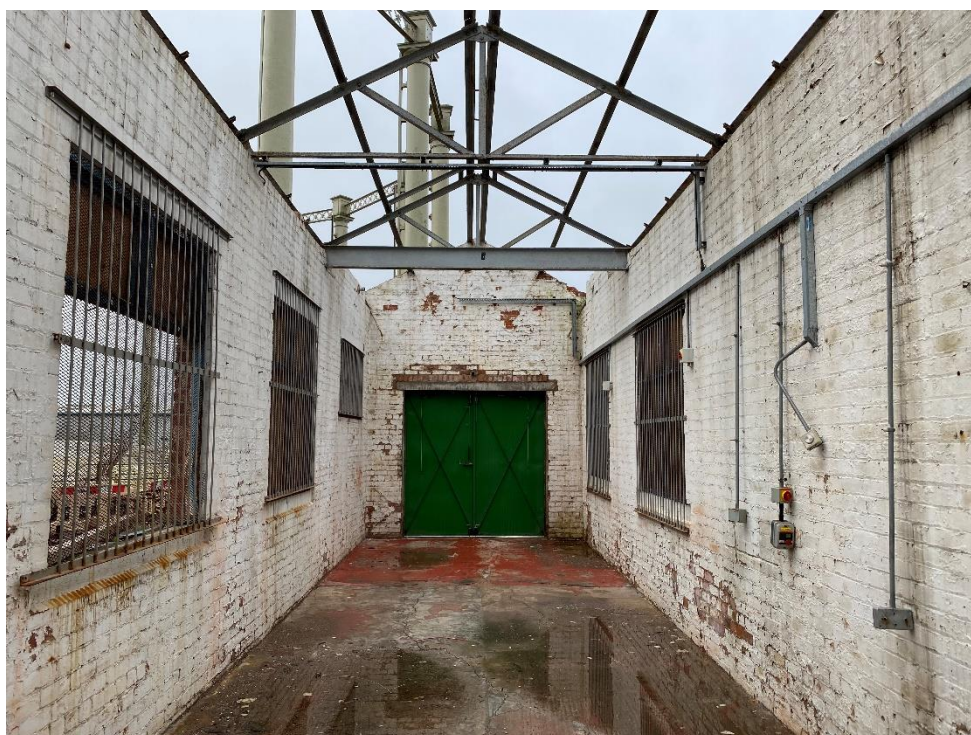
*Figure 9 Interior of the Workshop*

- 4.3 The workshop occupied a simple rectangular open plan and was open to the roof. The large windows included metal grills on the inside face and had concrete lintels and sills. The building had a concrete floor and the roof was supported on modern steel trusses. No fixtures or fittings remained within the building.

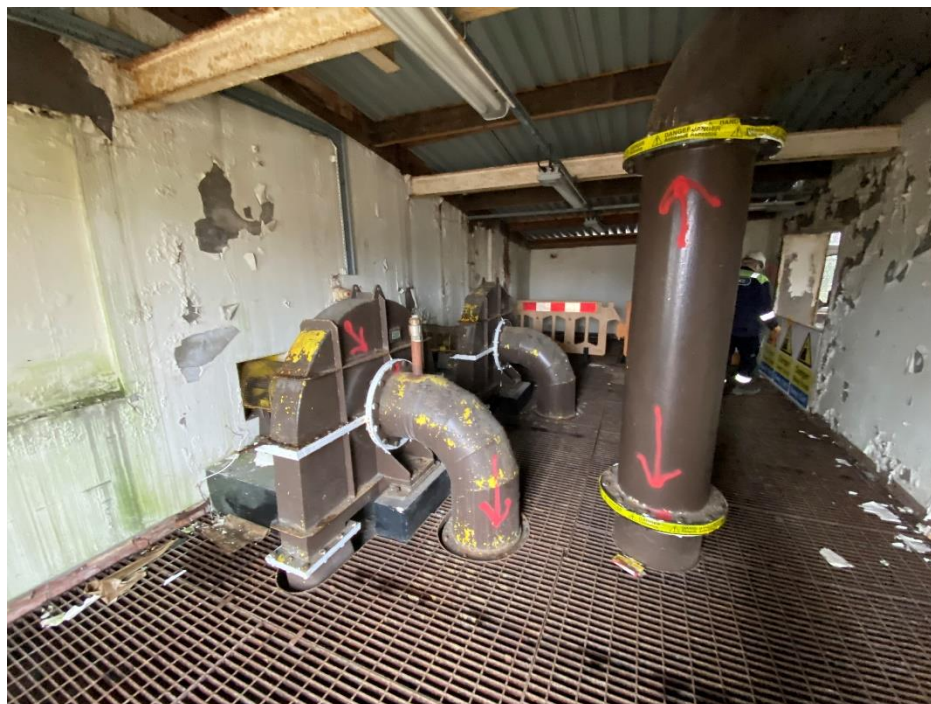
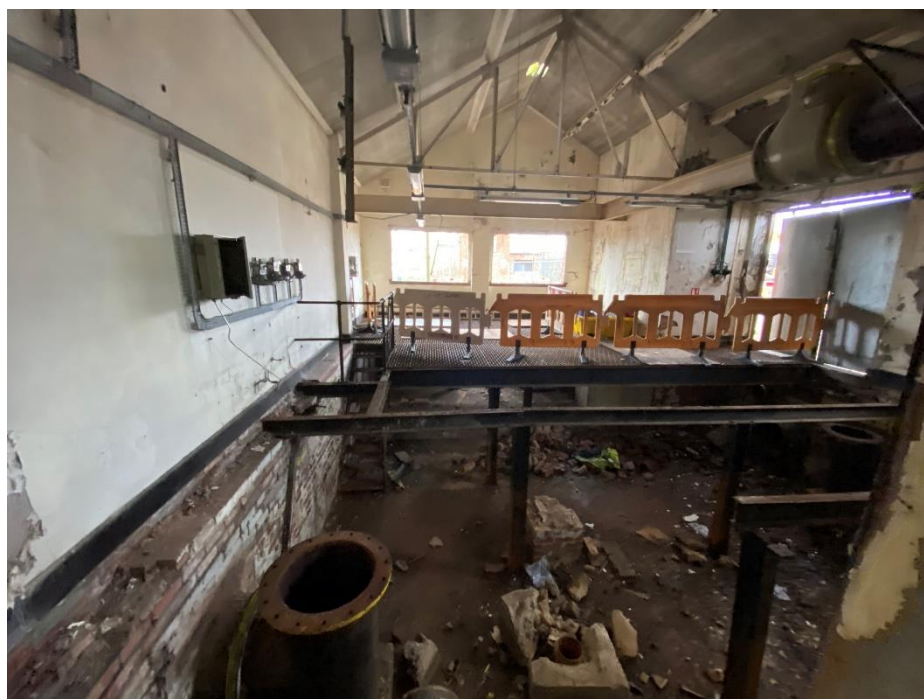
Figure 10 Interior of the Governor House

Figure 11 Interior of the Governor House with floor removed

- 4.2 The Governor House was a brick building with gabled roof and with smaller extensions housing an electrical switch room. The building was fairly plain with no decoration and included a number of visible alterations to the fenestration. A number of gas mains and valves remained connected to the building. A sub-basement level allowed access to the underside of the iron grate floor, providing access to the lower part of the pipes. RSJs spanning between the walls allowed for moving of heavy equipment in the room and for suspending of pipes or equipment. The roof was comprised of wooden and steel trusses.
