365 LONDON ROAD HEMEL HEMPSTEAD HISTORIC BUILDING REPORT

Document Title	Historic Building Report
Prepared for	St William Homes LLP
Prepared by	TEP - Warrington
Document Ref	8911.002

Job Number:	8911
Project Name:	365 London Road, Hemel Hempstead
OASIS Number:	Theenvir1-425716

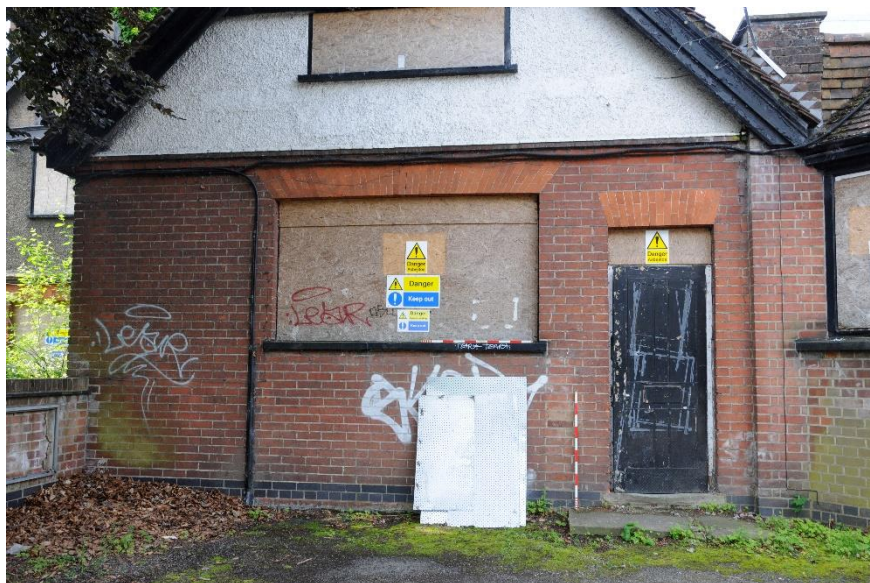
Figure 3 View of the north elevation and entrance 1

- 5.6 The entrance doorway was offset to the west to accommodate the central window and was raised off the ground with a stone step and had a flat arch of bricks. The adjacent window also had a flat arch lintel of rubbed bricks and was comprised of four casement windows each of six lights. The ground floor was of red brick in stretcher bond. The gable was covered with painted pebble render and included a central window of three casements, each two lights, with central being side hung and with monkey tail stay and leaf-shaped window latch. Above the window were Tudor-style exposed gable timbers including collar, central post and splays. The edges of the gable were covered with simple fascia boards.

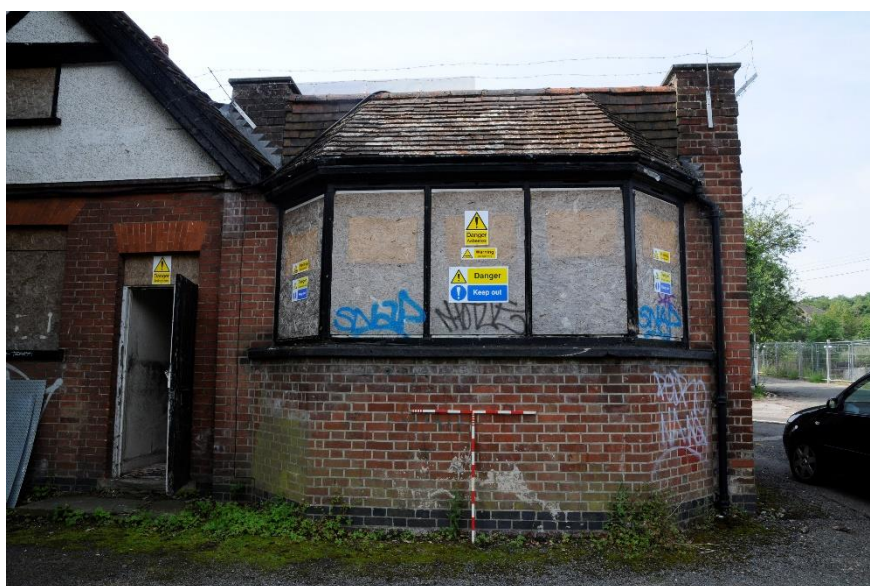
Figure 4 The north bay window of the single storey block

- 5.2 A single storey block projected out from the western side of the building. It had a flat roof hidden behind parapets; the two bay windows had separate clay tile roofs that joined the parapet coping. The block was built of red bricks in Flemish bond and included a band of dark bricks at the base which were also continued across the main building. The north-facing parapet was faced with hanging tiles and the parapet was finished with half-round tiles. The bay window was comprised of five casements, each with six lights and included security bars on the inside face.

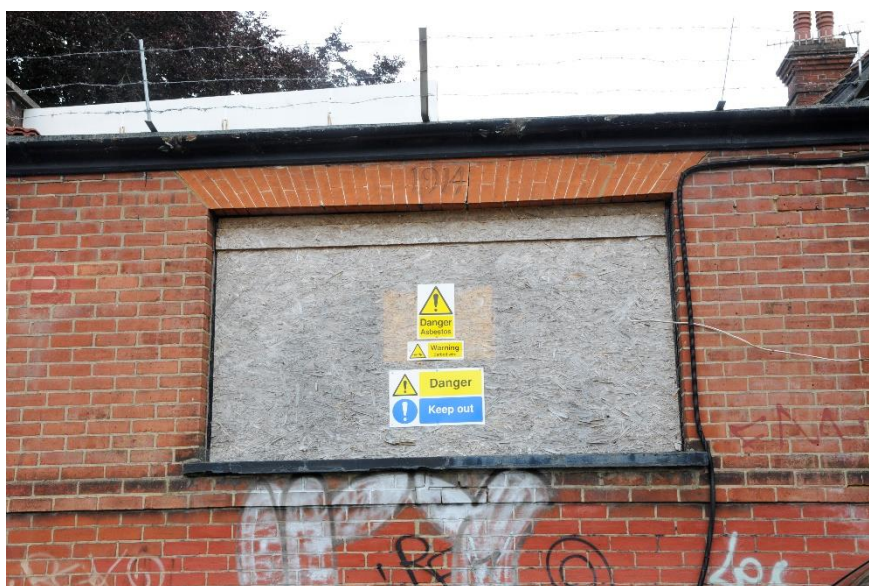
Figure 6 The west-facing window of the single-storey block

- 5.3 On the western wall was a high level / clerestory window set just above head height. The window was the same style as the bay, comprising multiple casements each with six lights. The window surround was simple and had a flat arch lintel of rubbed bricks (soft bricks cut to shape). At the centre of the lintel was a carved date of '1914'. The font style was naturalistic with an informal font characteristic of the Arts and Crafts aesthetic. There was a slightly projecting string course of two bricks width running below the window. At either side of the window were diamond shaped decorative blocks comprising crossed blue-black tiles with header bricks at the corners.

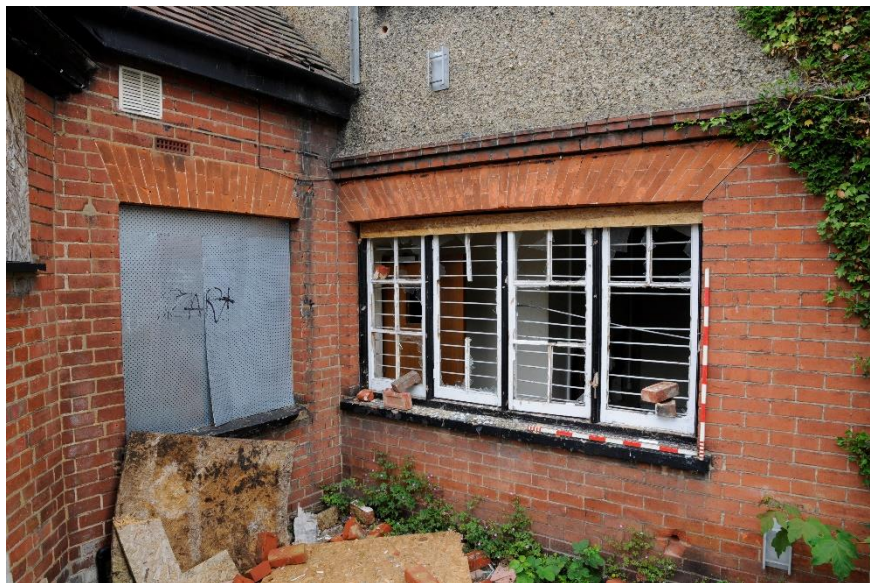
Figure 10 Detail of windows on the west elevation and single-storey block

- 5.12 At ground level was a former doorway, blocked in brick, with the lintel exposed. Adjacent to this was a window comprised of four casements, each of six lights, and with a flat arch lintel of rubbed bricks. The north edge of the lintel was cut or interrupted by the neighbouring single storey block; it is likely that the single-storey block was a later extension and this truncation of the window lintel appears to provide some evidence for this. At first floor was a central window of side-hung and fixed casements, of the same style as elsewhere on the building. Within the upper part of the gable were exposed timbers including a collar and upright posts. Simple fascia boards were placed along the gable edge.

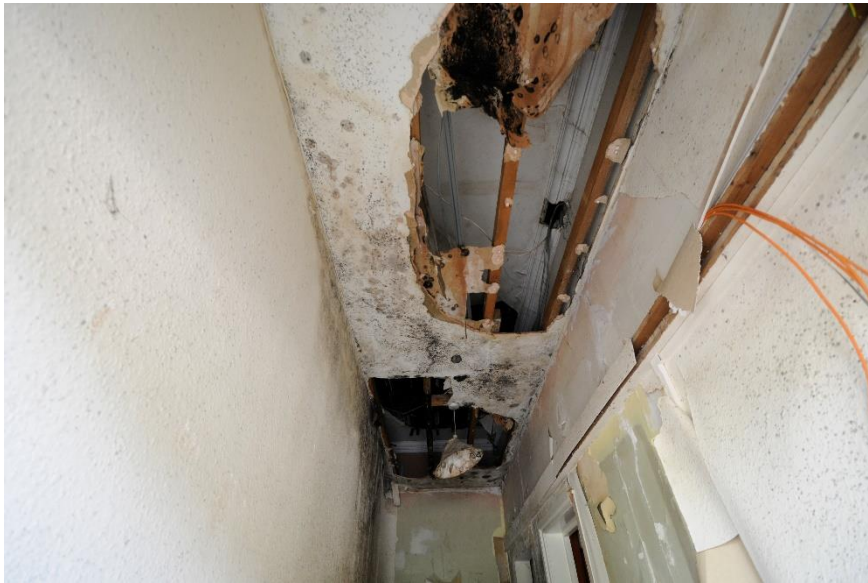
Figure 15 Detail of original ceiling over modern lowered ceiling

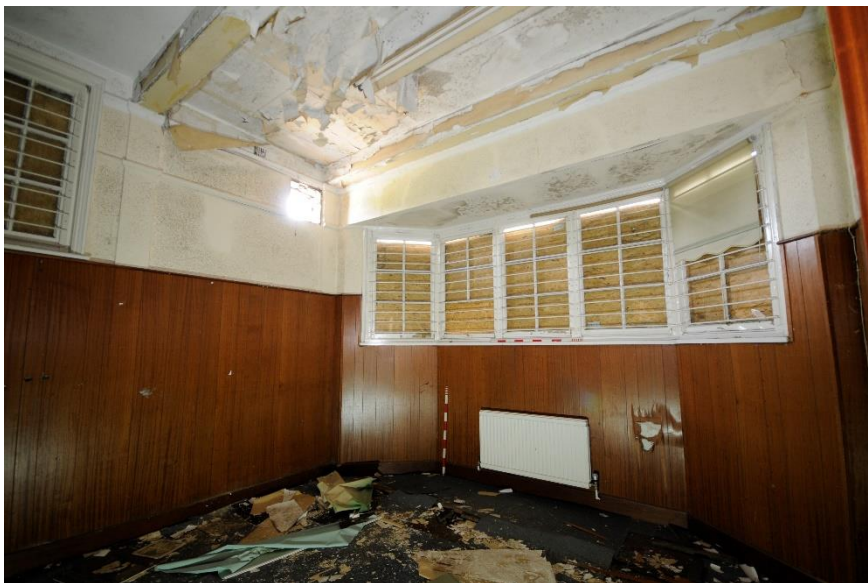
Figure 16 Room G1, looking north

- 5.17 The single-storey western block comprised two rooms, G1 and G2. Room G1 was the larger room and appeared to function as an office or meeting room. The walls were partly clad with dark wainscot. The higher ceiling level was partly retained in one half of the room and included moulded architraves. Lighting was provided by the bay window, clerestory window and fluorescent strip lights. Room G2 served as men's WC and retained sinks, urinals and other bathroom fittings. Room G3 was also a men's WC, but was separate from G2.

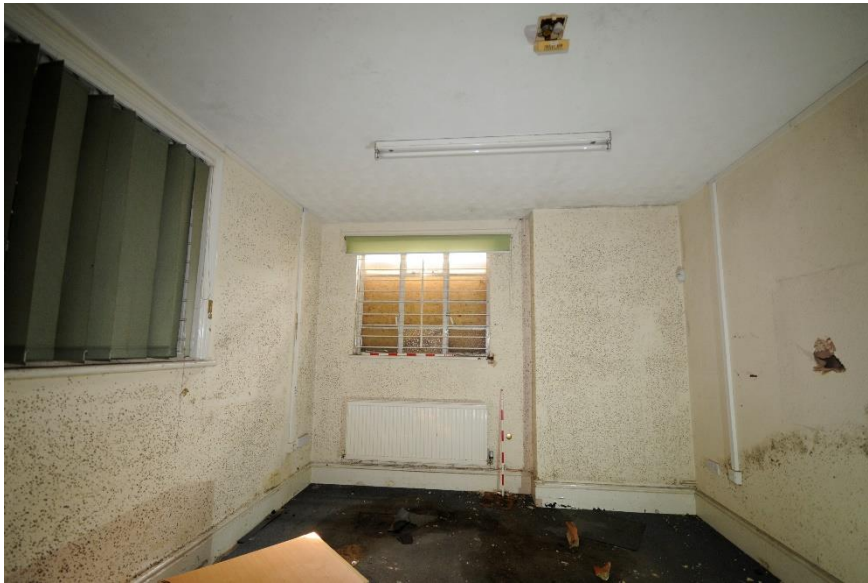
Figure 19 Room G4, looking east

- 5.18 Room G4 was a small office with modern lowered ceiling. The room was plain with a simple skirting scheme. Around the north window opening was a moulded wood surround. The south wall of the room met the projecting chimney piece but no fireplace was present; this wall may have been an insertion and a former fireplace blocked / removed. Room G5 had recently served as a server room and retained the server cabinets. The south wall of the room included a large internal window and adjacent was a modern fire door. Within the dogleg corridor the ceiling was a modern lowered ceiling with modern cable runs along the wall edge. At the east end of the corridor were a set of double fire doors.

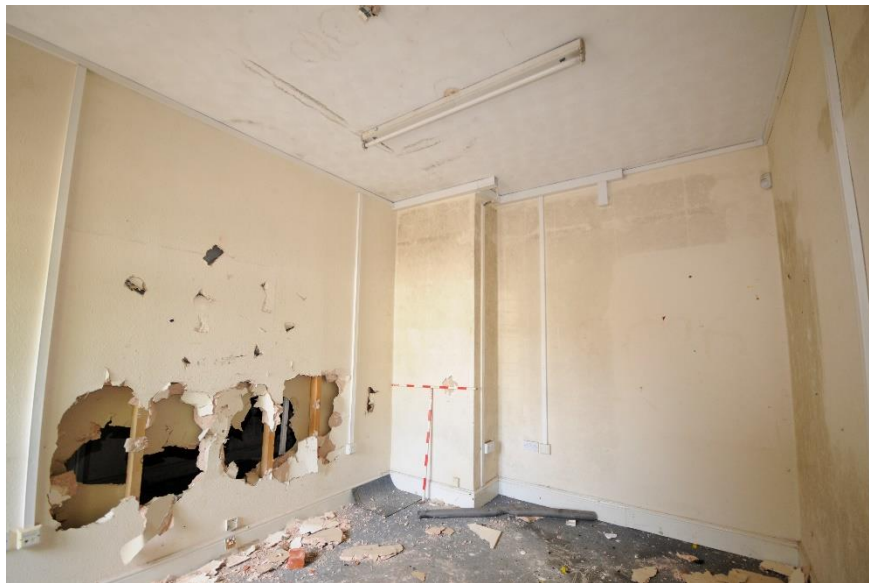
Figure 23 Room G6, looking north-east showing corner chimney breast

- 5.19 A short branch of corridor led southwards into room G6 which also served recently as an office. The room was plain with skirting and moulded door surrounds and had a modern lowered ceiling with florescent strip lights. The north wall was a stud partition and may have been a modern insertion. In the north-east corner of the room was a chimney stack but no associated fireplace was present. Southwards from G6 were two defunct spaces, one with a blocked door to the west.

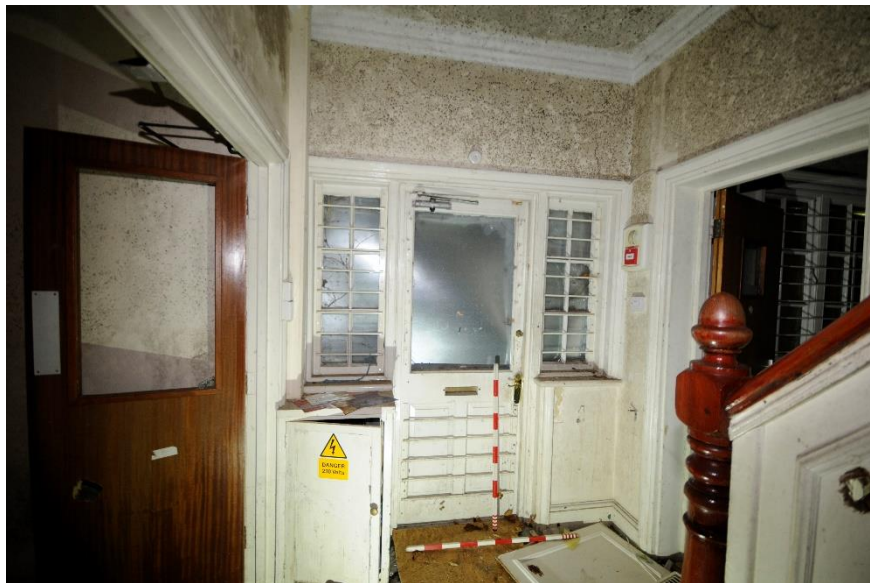
Figure 25 Entrance 2, showing the door and flanking windows

- 5.8 The offset entrance doorway included flanking windows within the same opening; the door was a fairly simple with a large pane in the upper half and the windows were each of six lights. Over the door and flanking windows was a single flat arch of rubbed brick. The adjacent window is off-set slightly from centre and includes a flat arch lintel of rubbed bricks. It is comprised of three casements, each of six lights, the outer two being side hung with simple latches and stays.

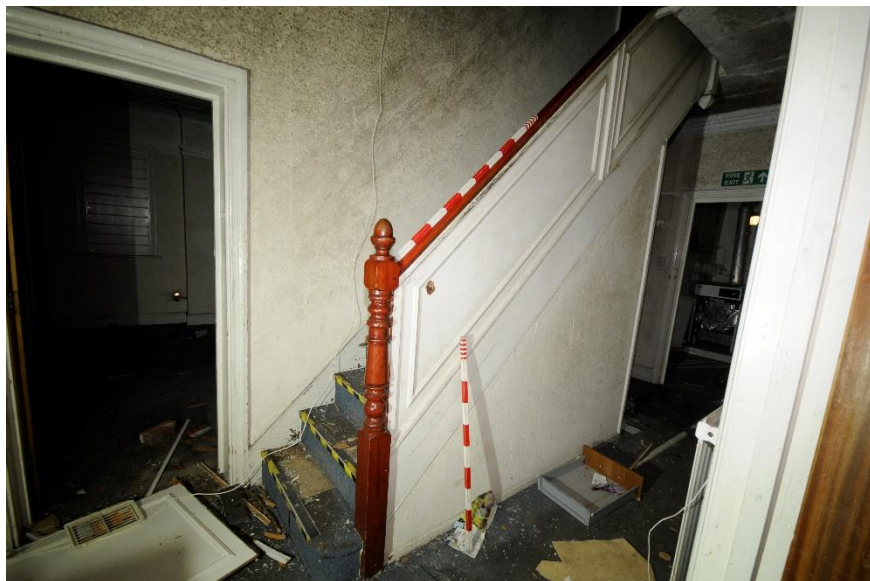
Figure 26 View of the stair

- 5.21 The second entrance opened into a corridor / stair landing. The stair included a decorative newel post with acorn finial and the balustrade comprised flat panels with moulded edges under a simple hand rail. The underside of the stair was enclosed with a door for storage space.

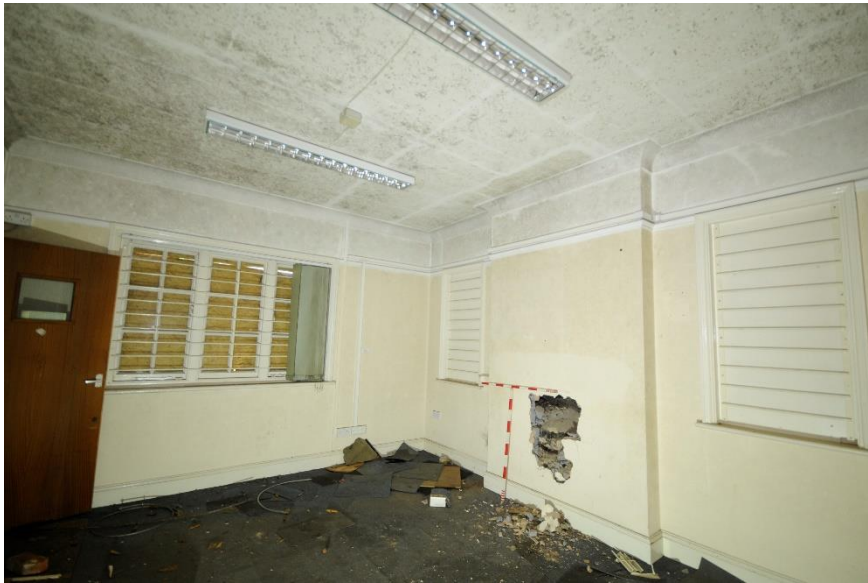
Figure 27 Room G8 showing blocked fireplace

- 5.22 Room G8 retained the original higher ceiling level with moulded architrave and a moulded rail over the windows. At the base of the walls were simple moulded skirting. The windows included modern blinds and various cable runs were installed along the walls to serve office equipment. The room was lit with modern strip lights. From the east wall projected the chimney breast; the former fireplace had been removed and the opening covered over.

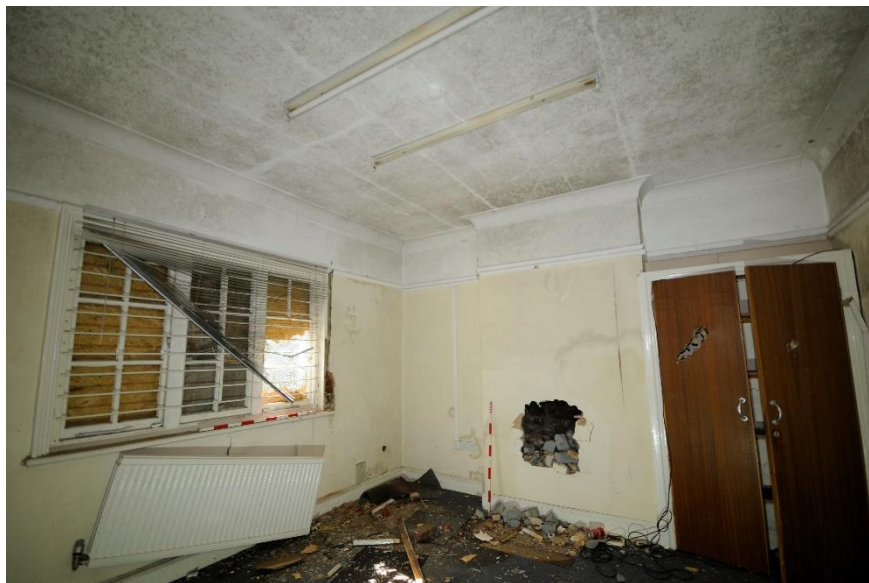
Figure 28 Room G9, looking south and showing blocked fireplace

- 5.23 Room G9 was of the same dimensions as G8 and also formerly had a fireplace which had been removed / blocked. The room retained the original higher ceiling with moulded architrave and decorative rail over the window. A cupboard was built into the corner adjacent to the fireplace.

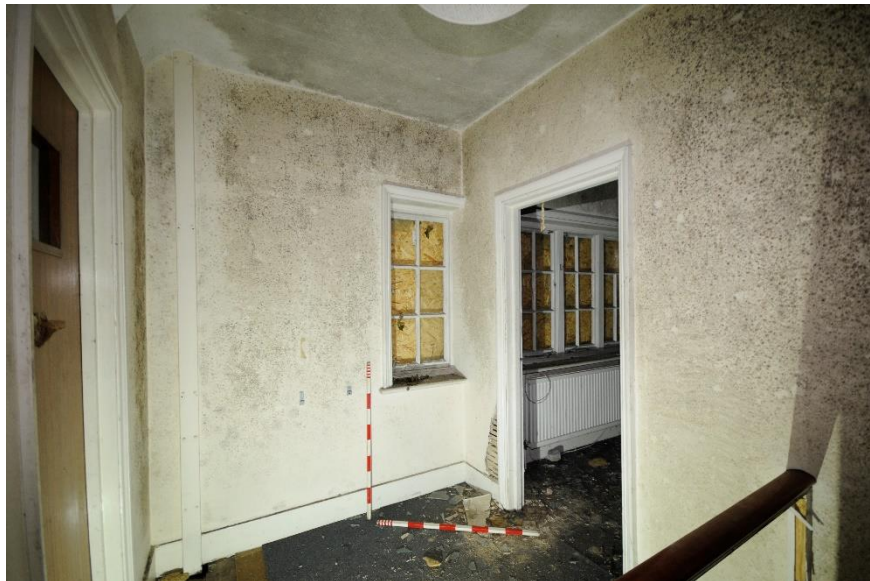
Figure 30 The north side of the first floor landing showing intersection of window and partition wall

- 5.9 The first floor window included five casements of six lights each, with the central two being side hung. It was noted that the western casement was interrupted / separated by an internal partition wall which separated the first floor stair / landing; this did not appear to be a later insertion but was a practical compromise intended to accommodate a centrally placed window as well as an off-centre internal partition.

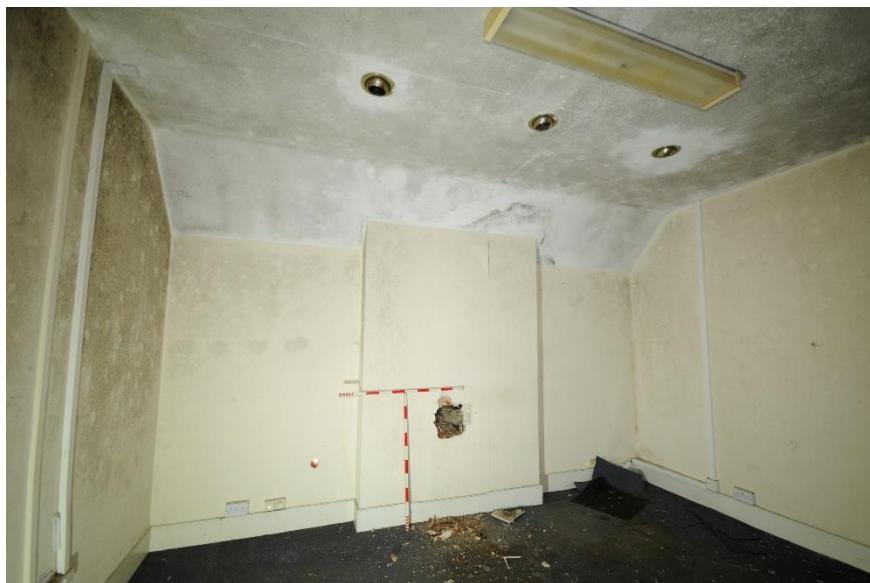
Figure 31 Room F1, looking east, showing blocked fire opening

- 5.26 Room F1 occupied the north-east corner of the building and was accessed from the landing and also had access to the adjacent Room F2. The partition wall to the stair landing intersected the northern window which was positioned to be central to the elevation when viewed from the road. There were no historic fixtures or fittings present and the ceiling appeared to be a modern suspended ceiling with modern lights installed. On the east wall was the projecting chimney breast but no fireplace or fire opening were present.

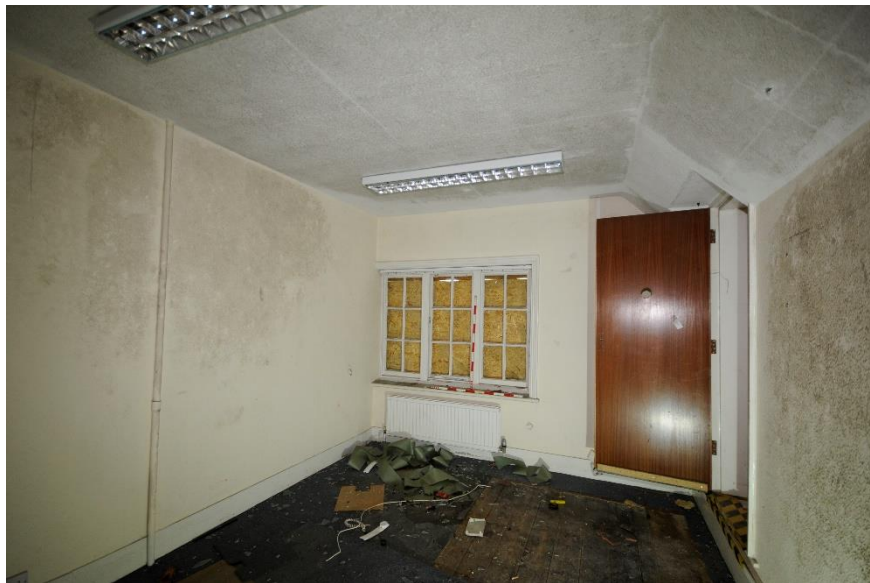
Figure 35 Room F5, looking west, showing the position of the window and partition wall

- 5.30 Room F5 occupied the north-west corner of the building and provided the only means of access to Room F6. A chimney breast projected into the corner of the room but no fireplace or chimney opening were present. In the west wall was a casement window which was intersected by the WC partition wall so that the southern casement lit the WC. The WC partition is likely a later addition dating to the 1930s as indicated by available planning records.

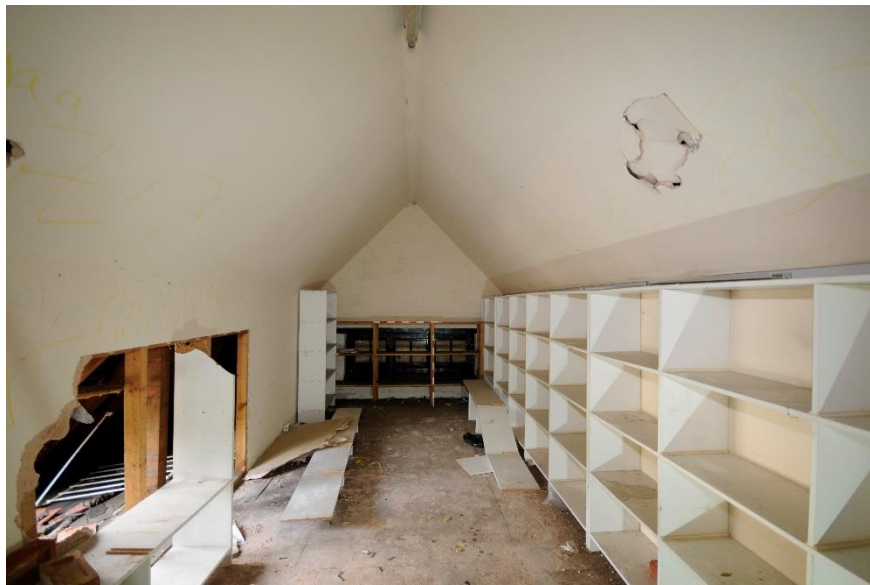
Figure 37 Room F6, looking north, showing the construction of the stud partition wall

- 5.31 In the north-west corner of the room was a step up into Room F6 which occupied the gable space of the western block. The room had latterly served as storage and included modern shelving along the walls. The side walls were stud partitions and it is uncertain whether this gable was originally intended as a room or was converted for such use at a later date. A small window was located in the north gable wall.
