GASHOLDERS 1 AND 2 BENGAL STREET, CHORLEY, LANCASHIRE TECHNICAL APPENDIX

Document Title	Technical Appendix
Prepared for	Atkins Ltd
Prepared by	TEP - Market Harborough
Document Ref	8068.002

PROJECT DETAILS:		
Short description	TEP carried out historic building recording during the demolition of Gasholders 1 and 2 at the former Bengal Street Works, Chorley, Lancashire. Gasholder 1 was spirally-guided with below-ground tank and was built in 1953, replacing an earlier column-guided gasholder. Gasholder 2 was a spirally-guided gasholder built in 1931 with an above-ground tank.	
Project type	Historic building recording	
Previous work	Historic building recording	
Current lane use	Industrial, derelict	
Future work	Unknown	
Monument type and period	Modern gasholder	
Significant finds	None	
PROJECT LOCATION:		
County	Lancashire	
Site address	Bengal Street, Chorley, PR7 1EX	
Easting Northing	SD 358575 418097	
Area (sq ,/ha)	-	
Height aOD	-	
PROJECT CREATORS:		
Organisation	The Environment Partnership (TEP) Ltd	
Project brief originator	Montagu Evans	
Project design originator	TEP	
Director/Supervisor	Amir Bassir

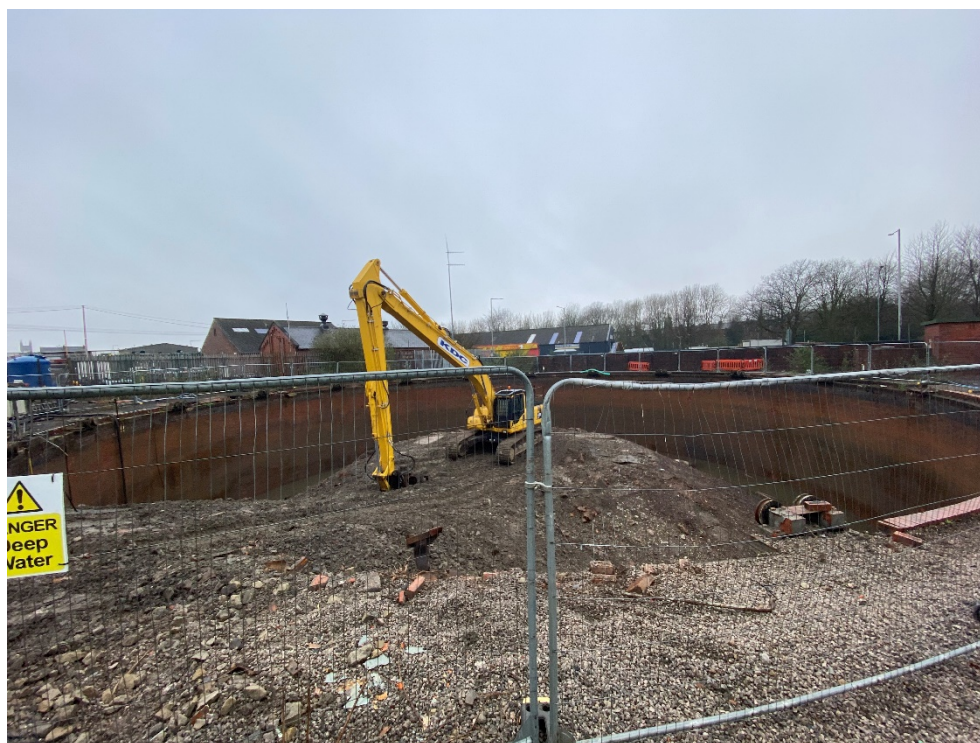
Figure 1: View of Gasholder 1 at time of survey with brick tank and dumping visible.

- 2.2 At the time of recording the entirety of the crown frame and sheeting had been removed, as had the four lifts. The exposed tank brickwork was faced in standard English bond and displayed areas of damage from the removal of vertical guides associated with the previous gasholder. The annulus was filled with water and so could not be examined, but was observed to measure c.2m in width. The dumping rose a short distance below the level of the tank and comprised a flat platform approximately 10m wide with sides extending down to the annulus at a c.45 degree angle. The construction material for the dumping could not be seen due to demolition rubble, however it likely comprised puddled clay over bricks. The annulus was filled with water however concrete rest blocks for subsequent lifts were observed within it at regular intervals throughout the structure.

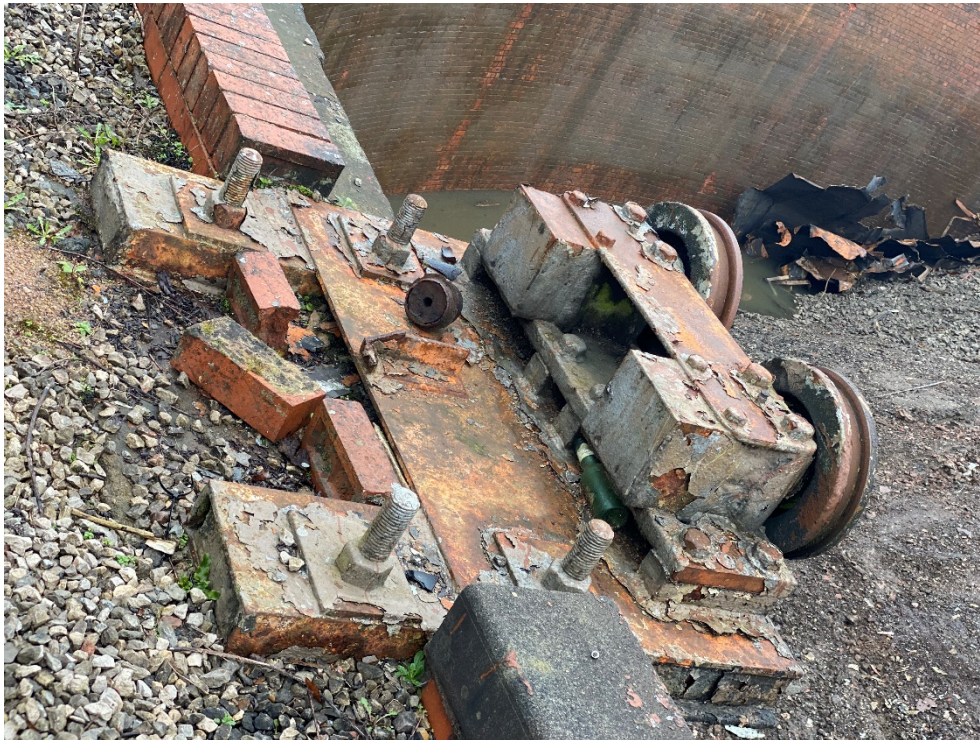
Figure 2: Extant Roller Carriage for Gasholder 1 projecting over the perimeter of the tank.

- 2.3 The stone edging and kerb around the perimeter of the tank remained extant at the time of the site visit, as did the outer roller carriages which projected slightly over the tank face and interrupted the kerb at regular intervals. The roller carriage footings comprised short pairs of I-section beams held together by flange plates.

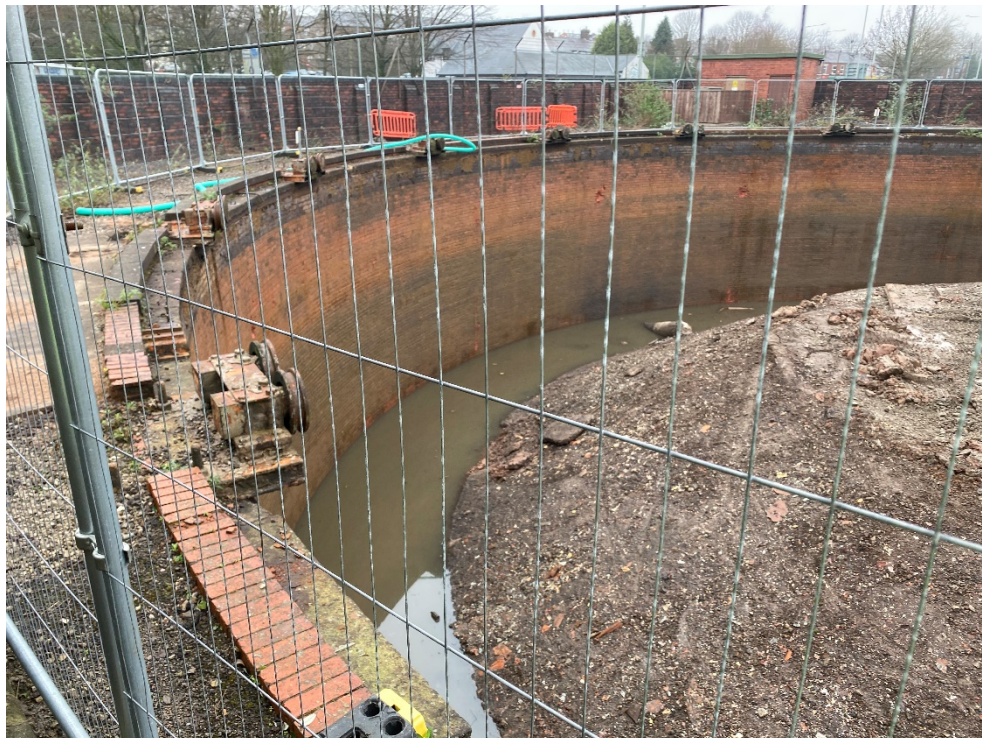
Figure 3: View of Gasholder 1 concrete and brick curb, roller carriages, brick tank, water filled annulus and dumping.

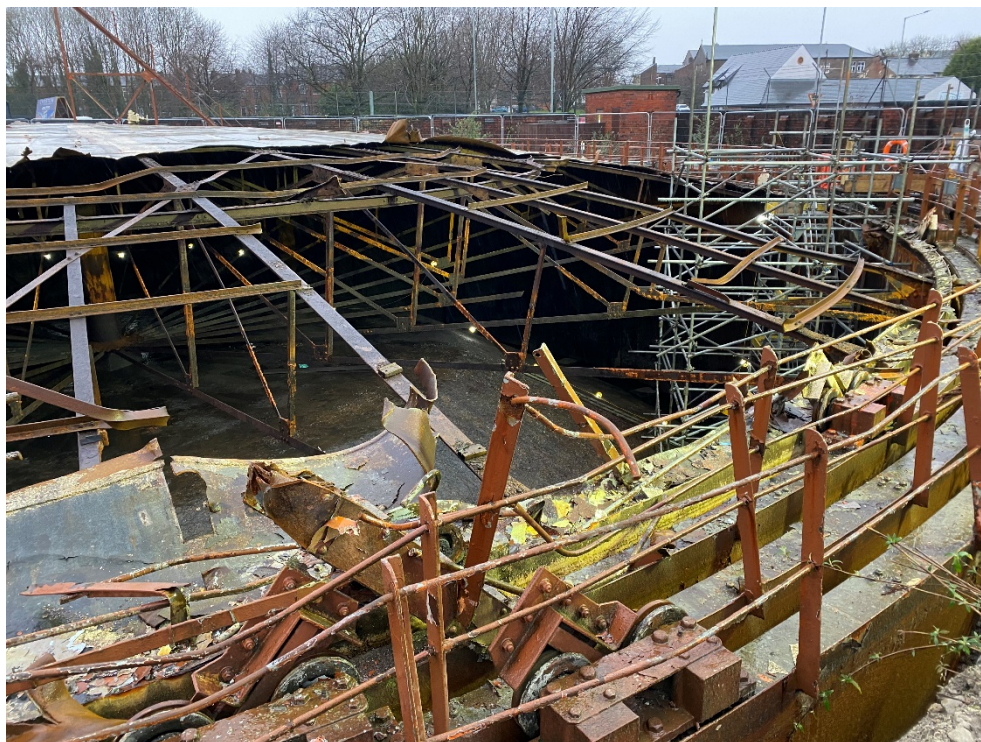
Figure 4: View inside Gasholder 1 showing trussed crown frame. Provided by demolitions contractor.

- 2.5 The crown frame was observed to comprise a central crown post with both lower and upper chords, and struts in between. An anchor collar at the top of the central crown post provided a point of attachment for the upper chords, which were observed to comprise of steel tees. The lower chords were similarly attached by a second collar at the base of the central post, however these, like the struts in between, comprise flat steel bars. The twenty-four main rafters that made up the crown frame were attached to vertical stiffeners on the lift sheeting by means of bolted gusset plates.

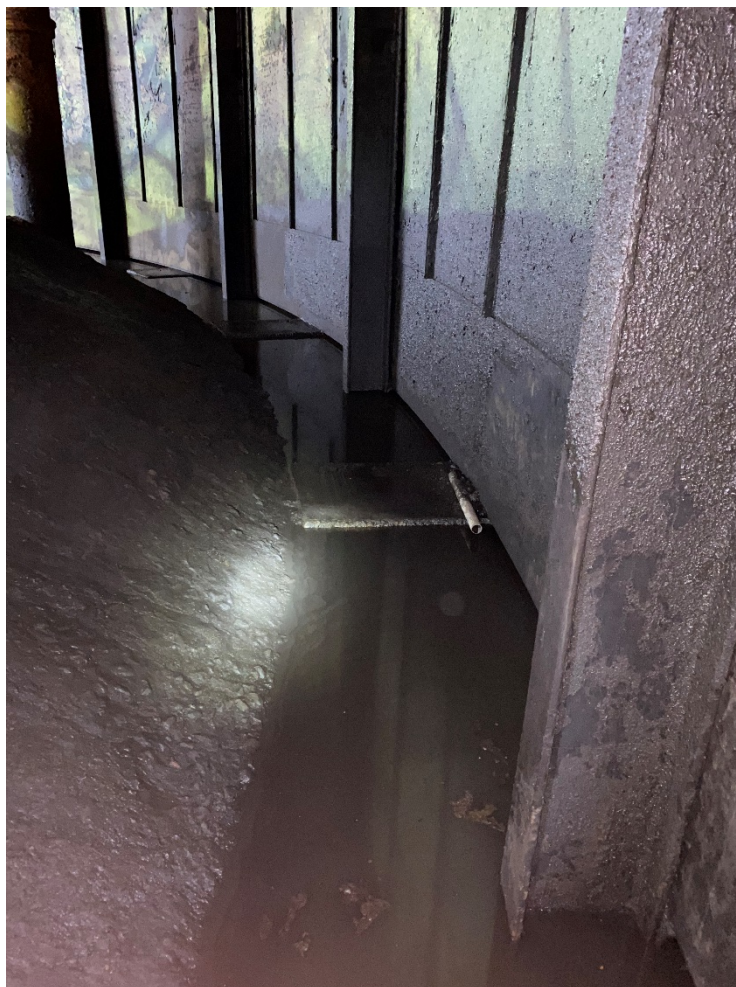
Figure 5: View of concrete rest pads within annulus of Gasholder 1. Provided by demolitions contractor.

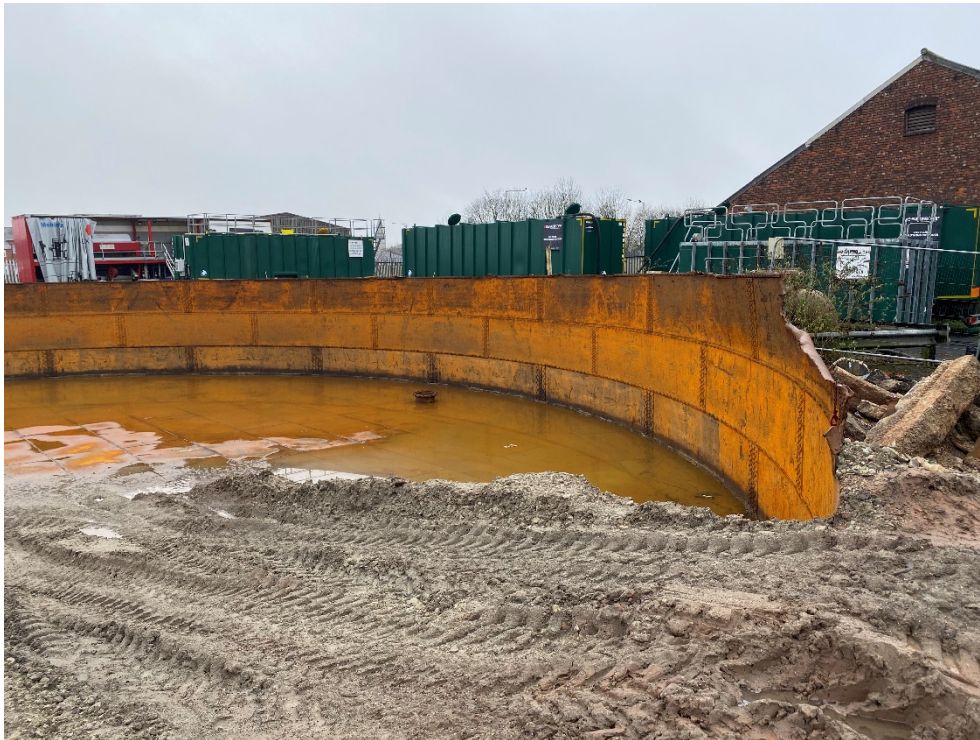
Figure 6: Extant lower courses of the tank at Gasholder 2. Base of inlet/outlet pipe visible.

- 3.2 At the time of recording only the lower courses of the tank remained standing with the crown frame and lifts having been removed prior to the survey. The tank was built on a concrete pad and was observed to be fabricated from staggered courses of rectangular steel sheets with riveted construction. The sheets had been overlapped at the seams with an extra overlapped sheet riveted on top to create an airtight seal. The floor plates were likewise formed of riveted steel sheets with an angled bracket riveted to the floor and walls to join it to the tank. The lowest part of an inlet or outlet pipe was visible near to the western edge of the base of the tank at the time surveying.

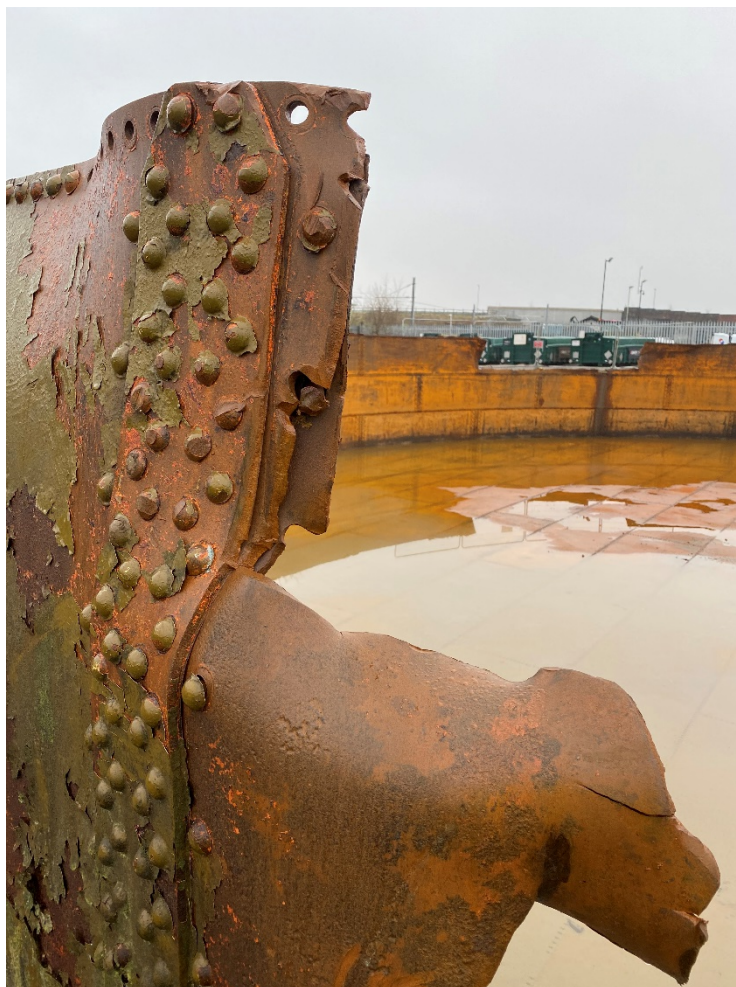
Figure 7: Riveted steel sheet construction of Gasholder 2.

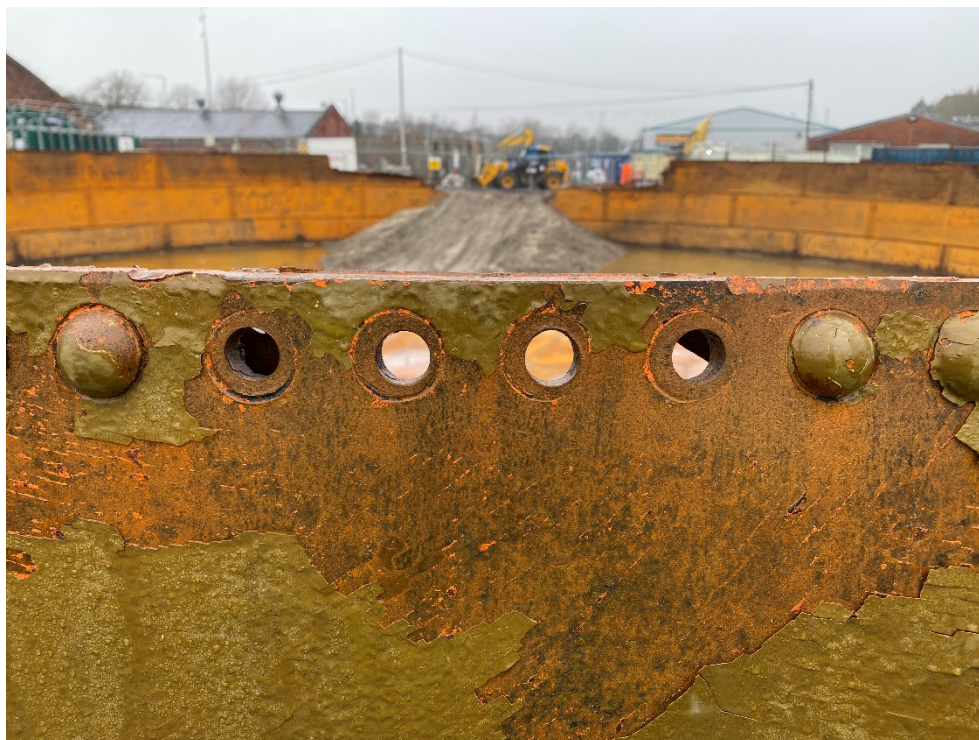
Figure 8: Detail of rivets in the steel tank sheeting.

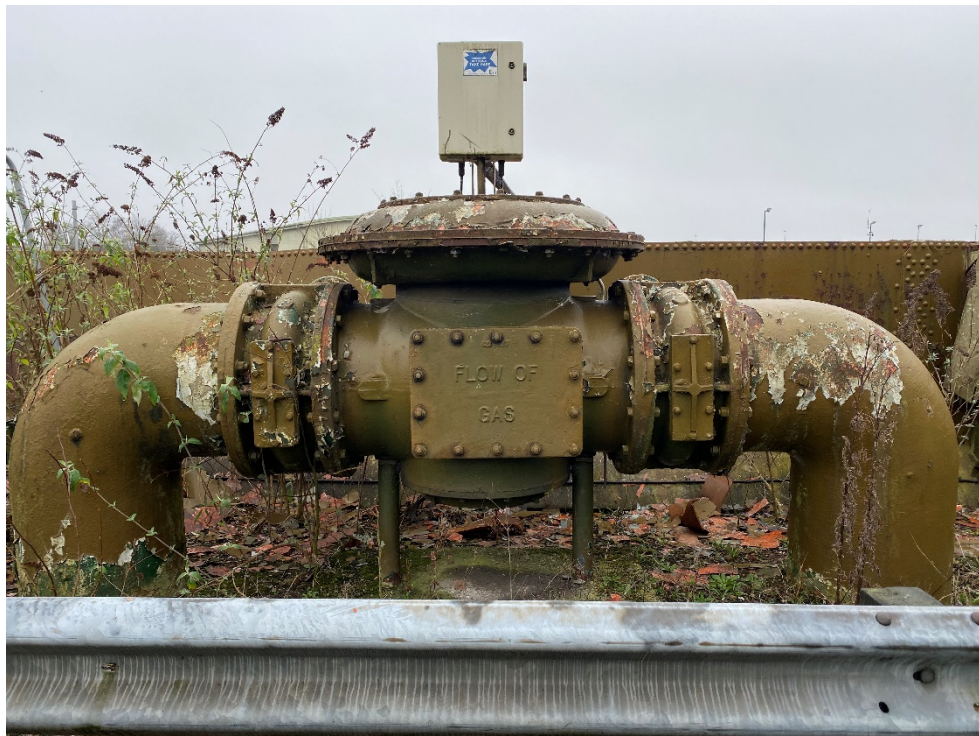
Figure 9 Flow Valve for Gasholder 2.

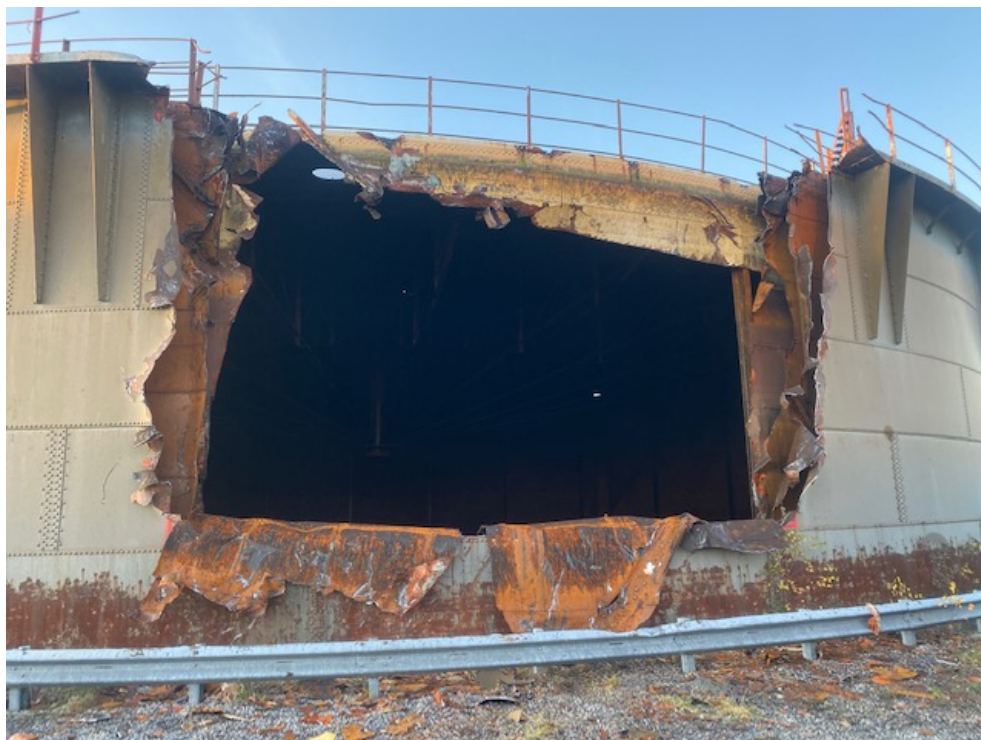
Figure 10: Demolition of Gasholder 2, crown frame visible inside innermost lift. Provided by demolitions contractor.

- 3.4 The crown frame was observed to comprise a central crown post extending from the crown sheeting down to a height in line with the main rafters, which in turn were attached to the central post with an anchor collar. The rafter attachments to the corresponding vertical stiffeners was not visible on the photographs provided by the contractors.

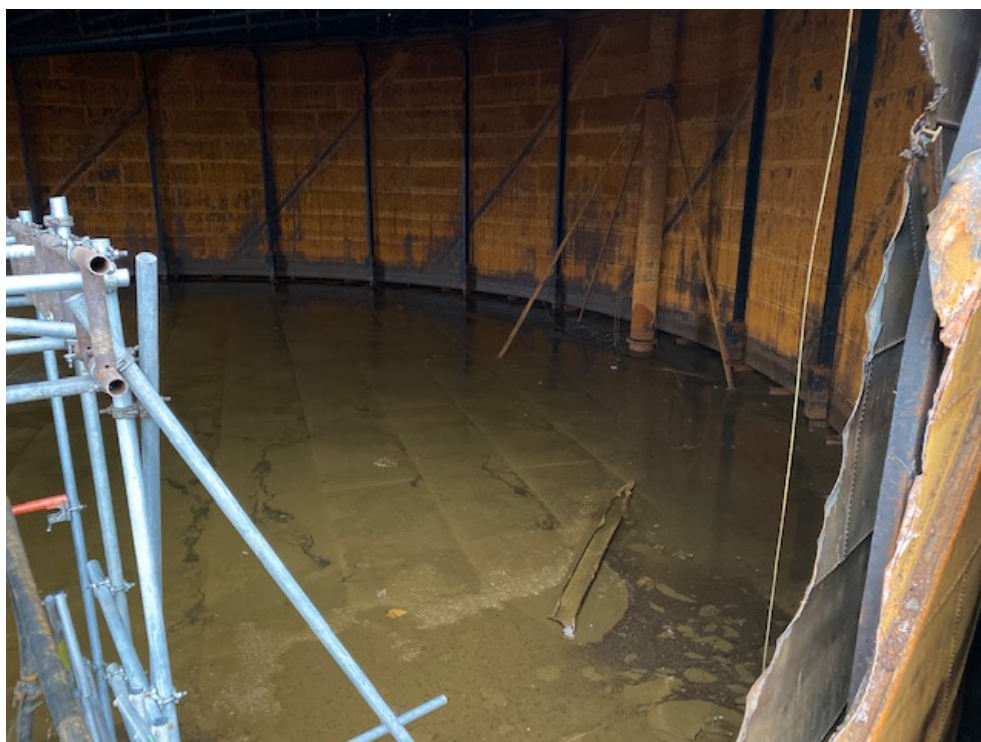
Figure 11: Interior of Gasholder 2 innermost lift. Inlet/outlet pipe visible.

- 3.3 Photographs provided by the contractors during demolition works show further detail of the gasholder construction. Regularly spaced vertical stiffeners were located around the perimeter of the tank, and the location of the external spiral rails were visible from the interior of the innermost lift. Two inlet/outlet pipes can be seen inside the structure, both extending from the base of the tank up to the crown sheeting, and each braced by three flat tees joining the pipes approximately half way up their height.
