## 2 MILL COTTAGES, NENE WAY ASHTON, PETERBOROUGH HISTORIC BUILDING RECORDING REPORT

Event No. ENN110828

Document Title	Historic Building Recording Report
Prepared for	Mr Chris Shaw
Prepared by	TEP - Warrington
Document Ref	9614.002

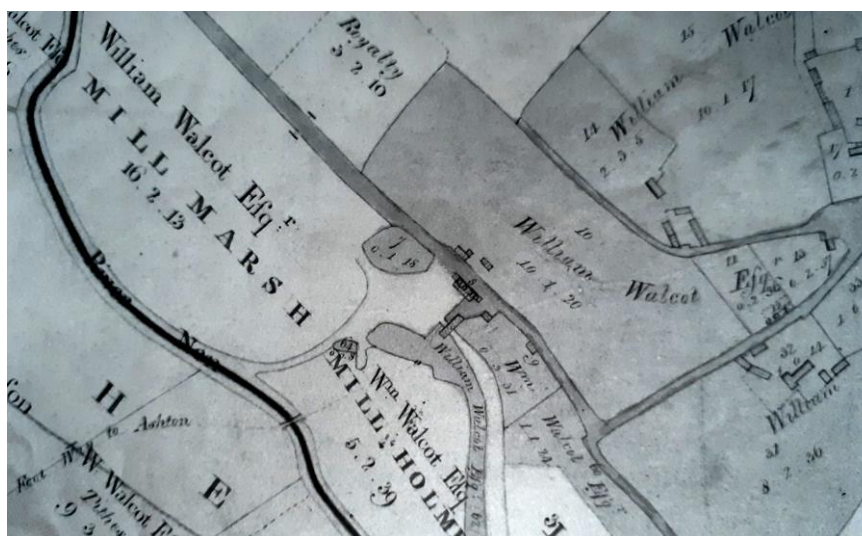
Figure 3 Extract from 1810 Enclosure Map of the Lordship of Oundle (NRO ref 2858)

- 3.10 The Mill and associated buildings are shown on the enclosure map as occupying their present general arrangement with Mill Cottages comprising a linear range with an extension or small enclosure on the west side of the building, in the area of the buildings surveyed as part of this recording project. The map appears to show extensions to the rear of the house. A building with rear extension and separate outbuilding is shown on the north side of the road. The area to the north-west of the of the Mill, between the road and river is labelled as Mill Marsh, and the area to the immediate west of the Mill is labelled Mill Holme. Further south the riverside land is labelled as Lammas Closes.

- 3.9 Ashton was enclosed in 1807 with Oundle. An Enclosure Map (Figure 3) provides a detailed overview of the village, showing closes and created fields, including the arrangement of principal buildings, and minor buildings including cottages. The survey was prepared for Dr William Walcott, then owner of the Ashton Estate who had inherited the village from his mother Mary Creed (Izzard 2018). The map shows a linear arrangement to the settlement with dwellings situated to the side of the principal road. The Conservation Area Appraisal notes that the boundaries of many enclosure fields still survive though several have been infilled with woodland and later development. The principal surviving buildings of this period include Ashton Mill, The Manor, Chapel, Public House, Green Farm and The Cottage.

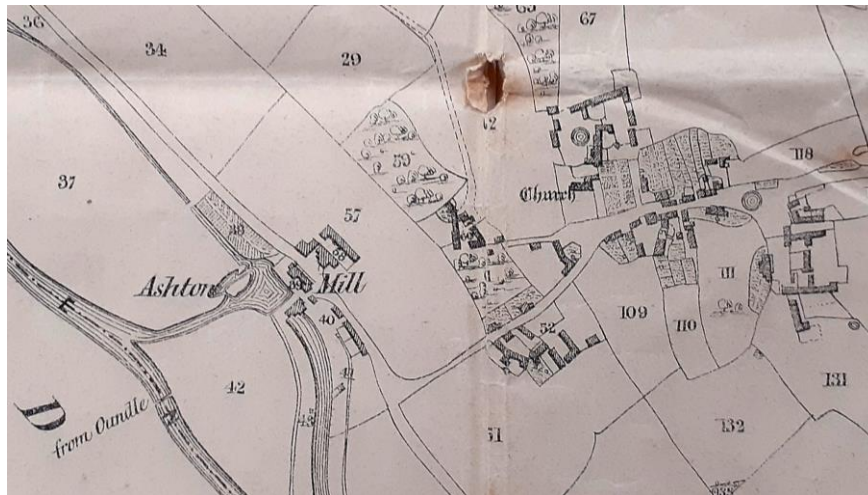
Figure 5 Extract from the Aston Estate Sales Map of 1858 (ZB706/24)

- 3.16 The 1858 Map shows little change in the area of the mill. The western outbuildings at Mill Cottages are shown as a simple block. On the plan (Figure 5) Mill Cottages is numbered 39 and described in the sales particulars as "site of house and garden"

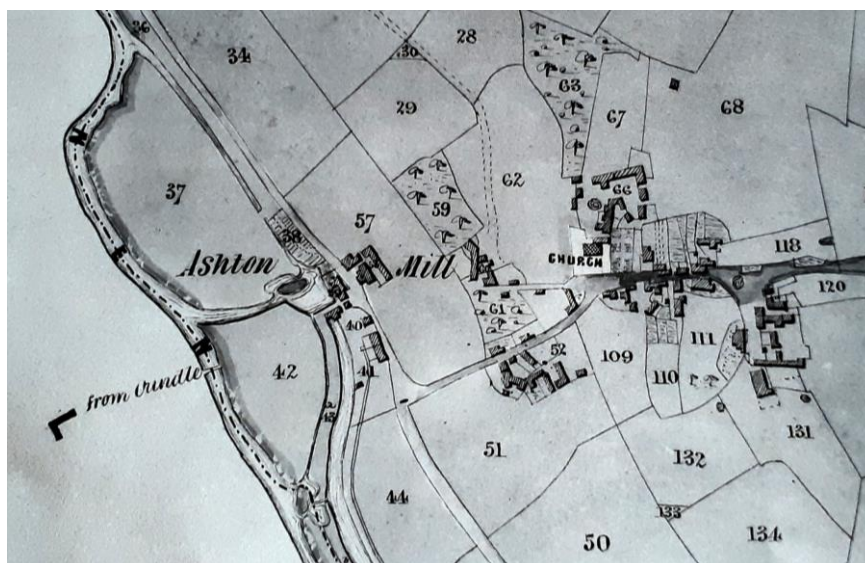
Figure 7 Ashton Estate map of 1860 (NRO ref 5173)

- 3.19 The Ashton Estate Map of 1860 (Figure 7) provides a very similar view to the 1858 map; no change is evident at the Mill and Cottages.

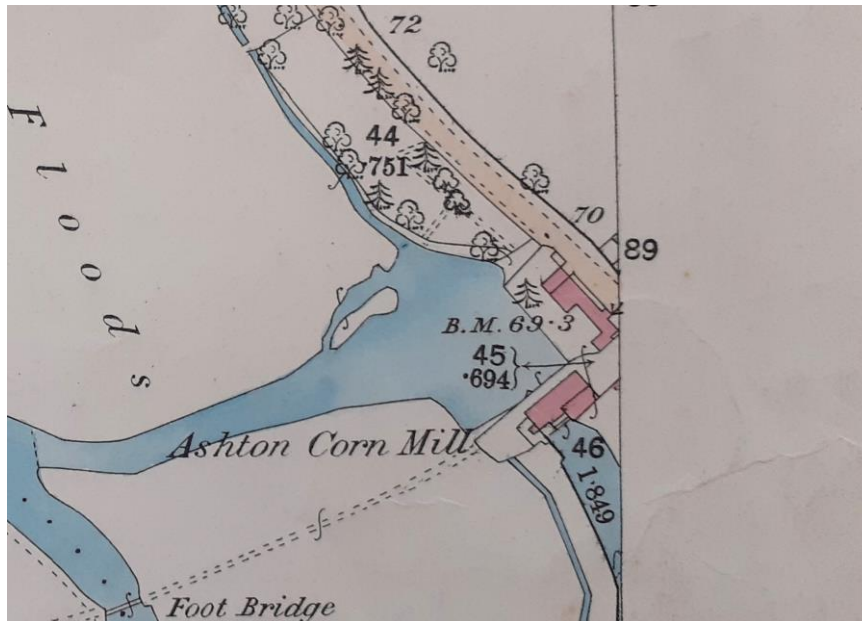
Figure 8 1:2500 First edition Ordnance Survey map of 1885

- 3.20 The first edition Ordnance Survey map of 1885 (Figure 8) shows 1 and 2 Mills Cottages in approximately their present arrangement with the outbuilding on the north side of 2 Mills Cottage shown as a simple block. Extensions are shown at the rear of the building and a single porch is located at the access to no.1. The 1901 Ordnance Survey map (Figure 9) provides a greater level of detail of the outbuilding, showing it in its present arrangement of two ranges enclosing a yard and enclosed by a wall towards the road.

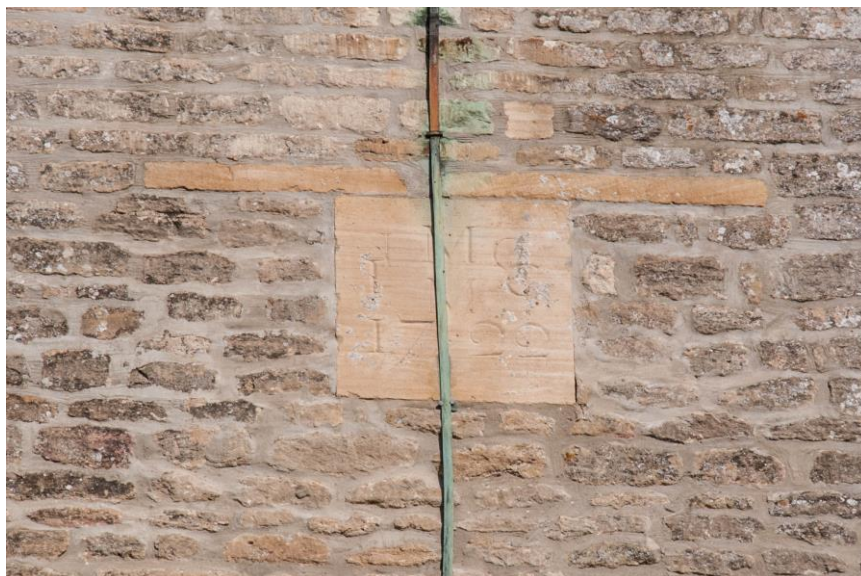
*Figure 13 Detail of date stone with date of 1722 on south gable*

- 5.2 A datestone of 1722 is located at the apex of the south-eastern gable (Figure 13). It is in the form of a square block of fine-grained limestone and includes two sets of initials I.M.C. and J.M.C. with the two C's being joined (*note that the Listing incorrectly states 1729*) (Fig 13). The datestone may represent the date of construction of the building, however it may also indicate a phase of renovation rather than original construction. It has been noted that such commemorative datestones may also record marriages which may also be accompanied by a phase of building renovation.

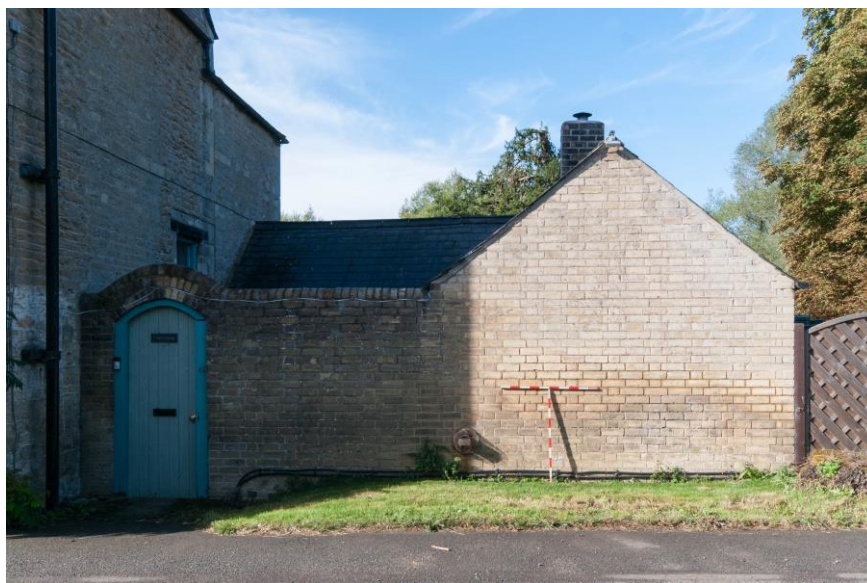
- 5.9 To the east the courtyard is bound by the gable end of the northern range which is connected to the house by a wall with a door for accessing the yard from the road (Fig 14). The wall and ranges appear continuous and contemporary. The east and north-facing walls of the northern range are constructed of gault brick, each measuring 220mm x 110mm x 70mm, with five courses measuring 390mm in height, and set in a coarse lime mortar (Fig 15). Many of the bricks show horizontal striations and skintle marks from their manufacturing process. The wall is capped with half-round coping bricks which form a well-built arch above the doorway. The wall butts up against the stone-built wall of the house.

*Figure 14 The eastern courtyard wall and gable end of outbuilding*

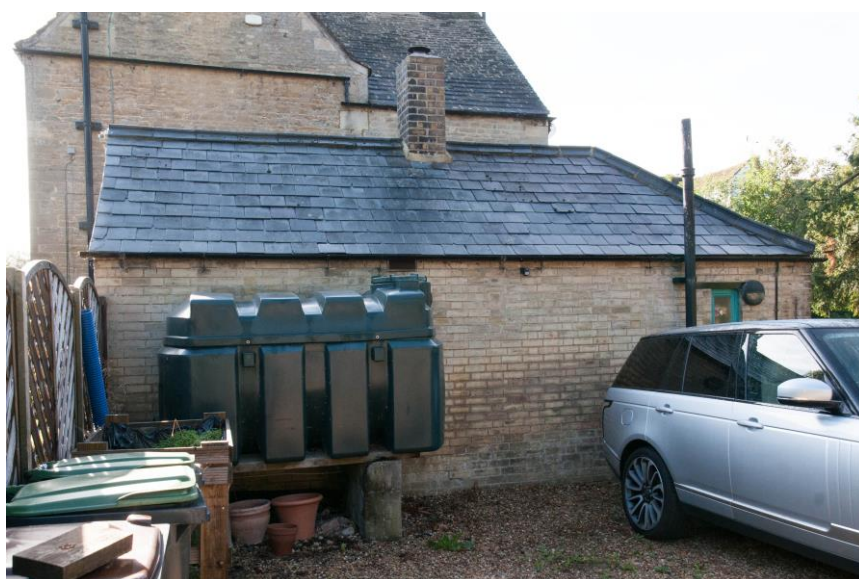
*Figure 16 North elevation of the outbuilding*

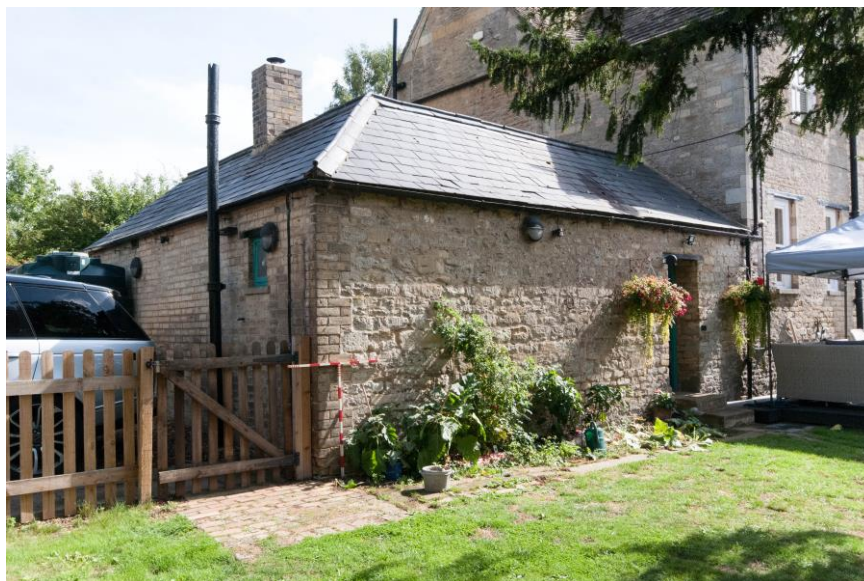
*Figure 17 The join of the north and west ranges showing change between stone and brick walls*

- 5.10 The west-facing wall of the western range is constructed of coursed stone rubble into which the brickwork of the adjacent range is keyed (Fig 17). There appears to be a continuation of this stonework into that of the adjacent extension whose gable wall is flush with the smaller range. Internally there is a brick skin. This presents possible interpretations for phasing: the current courtyard ranges may be of two phases, one phase indicated by the stonework which appears contemporary with the extension and a second later phase in which brick-built ranges were created to replace or incorporate an existing structure or enclosing wall. The brick skin is also continued against the north side of the extension wall where it supports the ends of the roof wall plates.

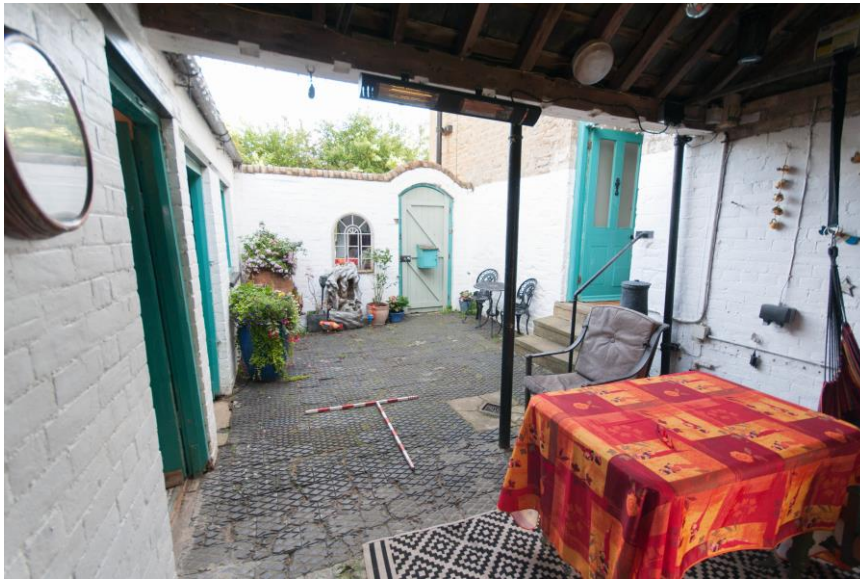
*Figure 21 View of the courtyard, looking east*

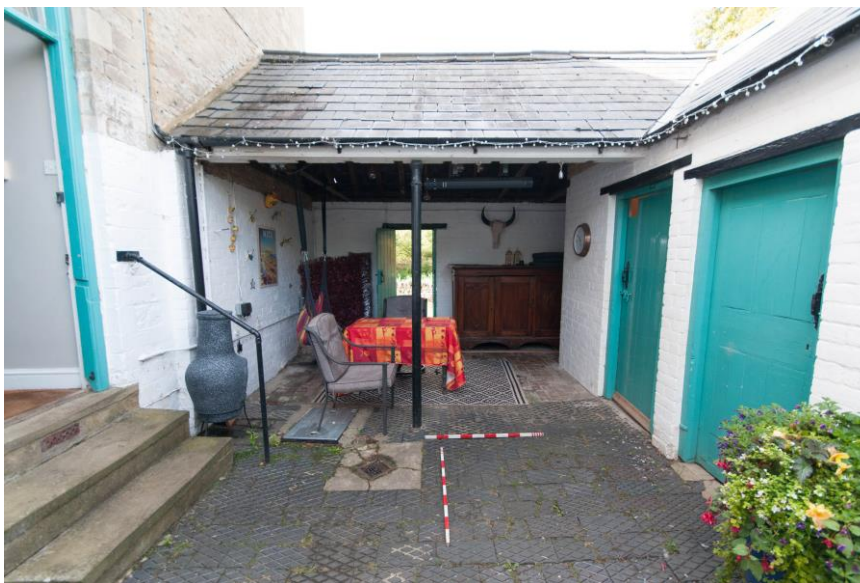
*Figure 22 View of the courtyard, looking west*

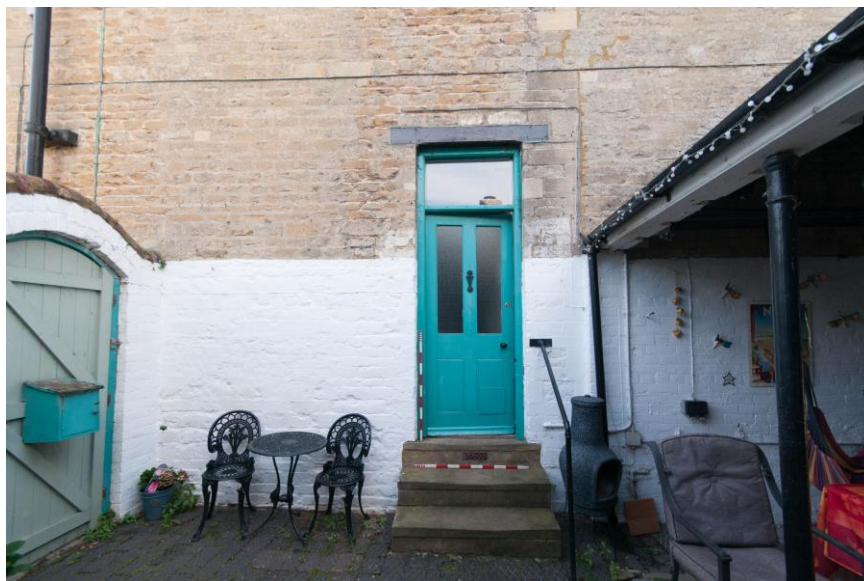
*Figure 23 Stepped entrance to the Hall. Note adjacent join to extension*

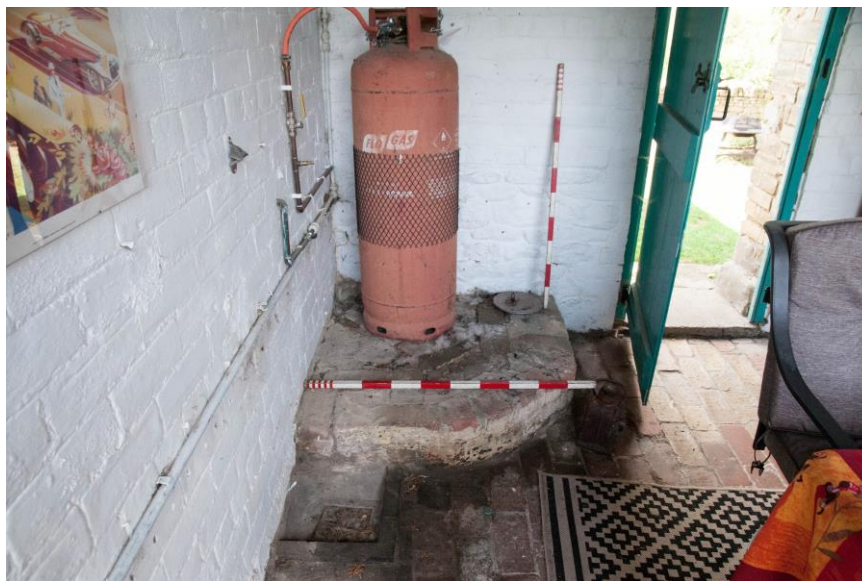
*Figure 26 The remains of a former copper*

- 5.16 The remains of a probable former copper (a historic water heater comprising a low brick structure with a vessel under which a fire could be lit or coals burned) can be seen at the south-east corner of the west range (Fig 26). These remains comprise two courses of brickwork forming a short plinth or platform. Immediately adjacent to this is a drain. Within the west range the floor is surfaced in red brick pavers.

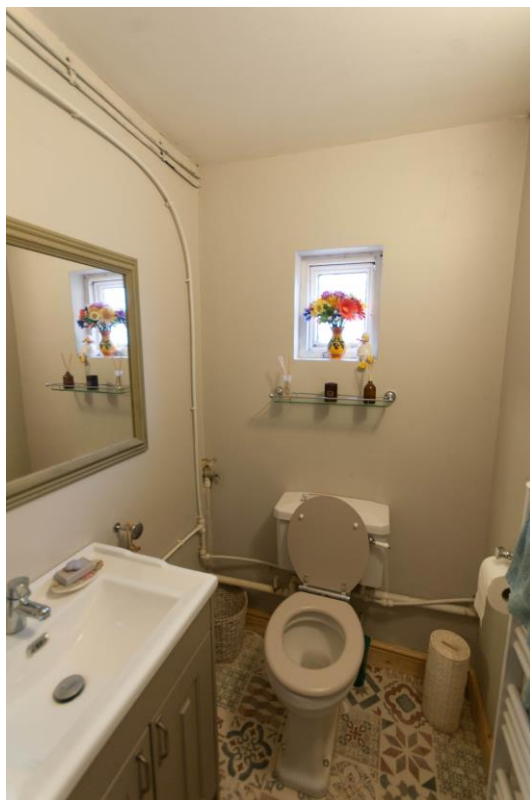
*Figure 29 The WC*

- 5.15 The WC appears to be of a contemporary construction with the brick ranges and is enclosed with gault bricks of the same type. Two short collars span between the feet of the common rafters to meet the end wall of the utility room above the entrance to the WC. Nothing of historic interest was noted in the WC (Fig 29).

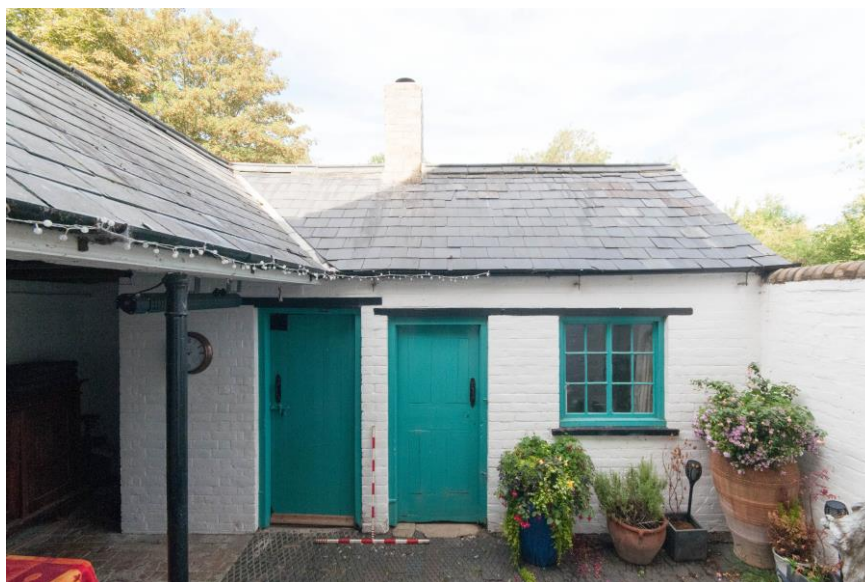
- 5.13 The north range includes a storage room and adjacent utility room. A small WC is located at the north-west corner of the two ranges (Fig 30). The storage room is a roughly square space measuring 3m x 3.3m and includes a chimney breast with fireplace located centrally to the western wall (Figs 35, 36). The door is a four-panel door with thumb latch (Fig 37). A single casement window of two lights, each with six panes, opens into the courtyard. The window includes a small decorative cast or wrought iron latch (Figs 38, 39). The door and window share a continuous common timber lintel. The walls are white-painted brick and the underside of the roof is hidden under modern boards. The chimney breast is constructed of brick and there is a segmental arch over the fire opening. A modern wood burner is within the fireplace. The wall between the storage and utility rooms does not rise to fully partition the rooms, hence the modern ceiling over the storage room. The brickwork of the chimney seen above this wall appears relatively modern and it is possible that the chimney and partitioning wall are later additions to create two rooms.

*Figure 30 View of the north range, looking north*

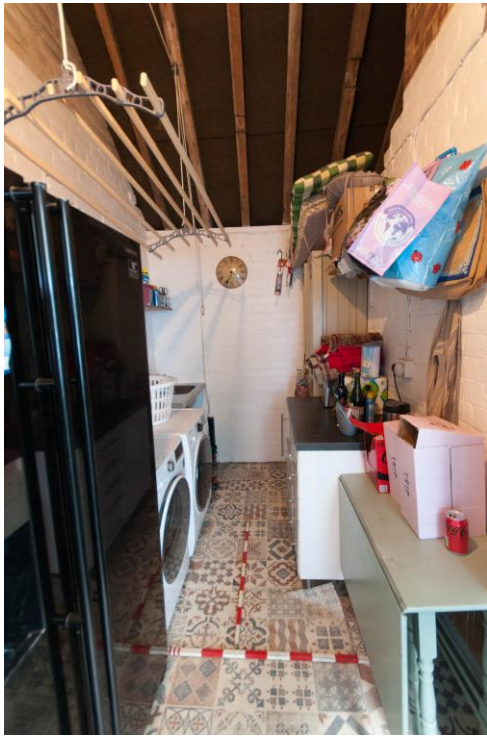
*Figure 31 The utility room*

- 5.14 Little of interest was noted in the utility room; the western wall is a full height partition wall that fully encloses the end of the range (Fig 31). The valley rafter for the roof turn is visible in this space (Figs 33, 34). Several of the common rafters include nail holes suggesting a former lath surface however it is possible that there has been re-use of the timbers used for construction. The door to the utility room is a simple plank and ledge door with thumb latch (Fig 32).

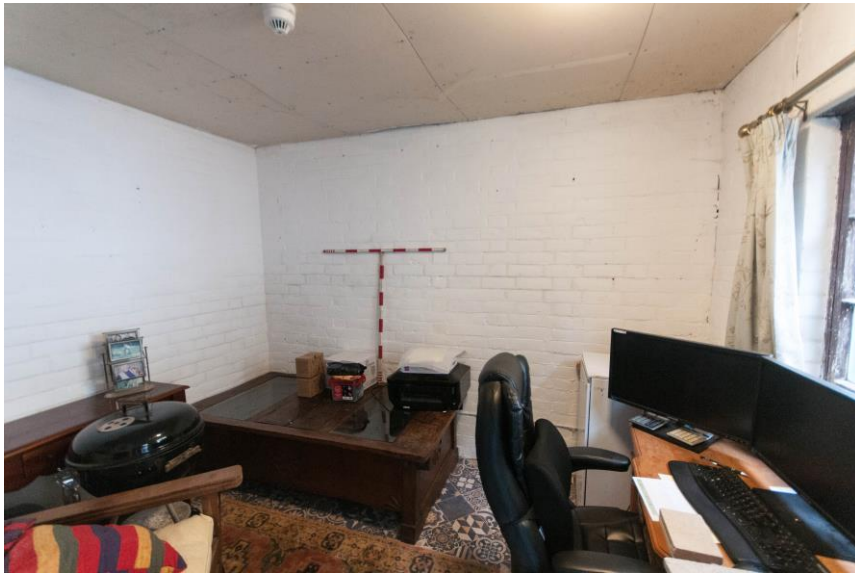
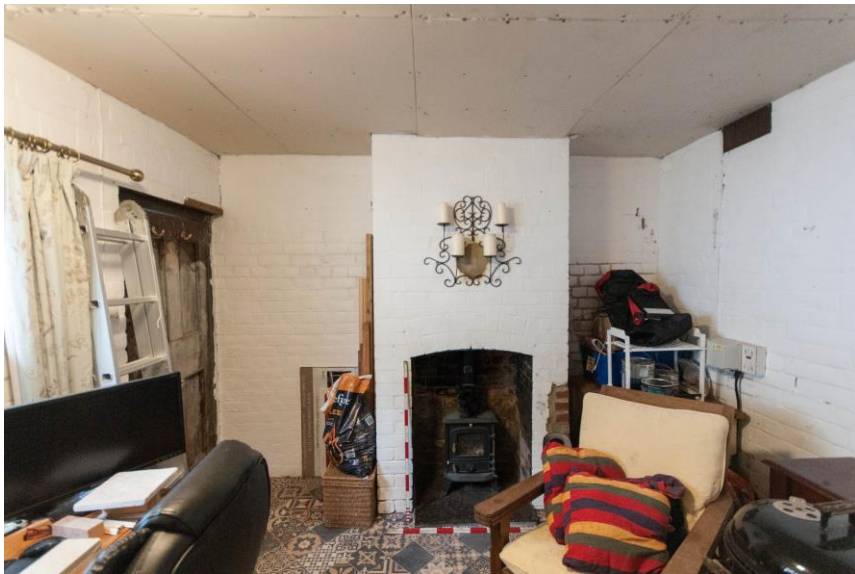
*Figure 35 The storage room, looking east*

*Figure 36 West wall of the storage room*

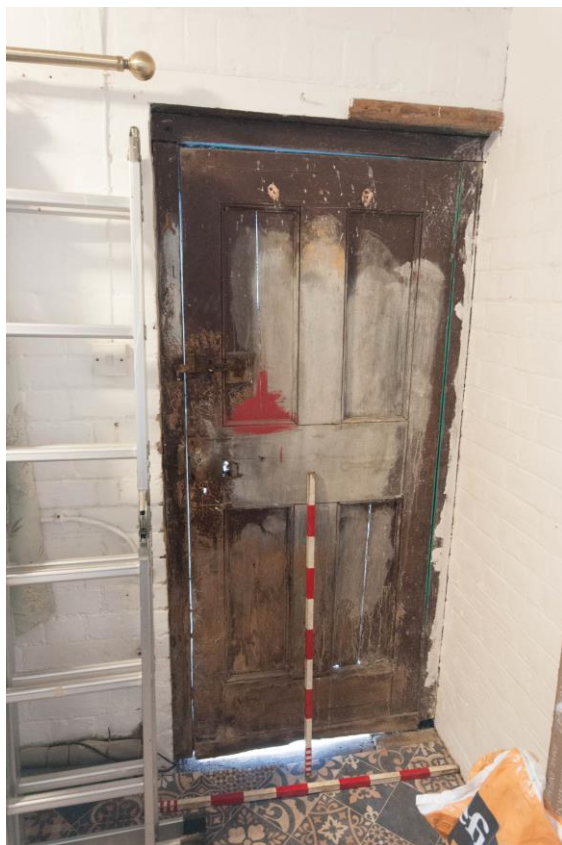
*Figure 37 Detail of door to storage room*

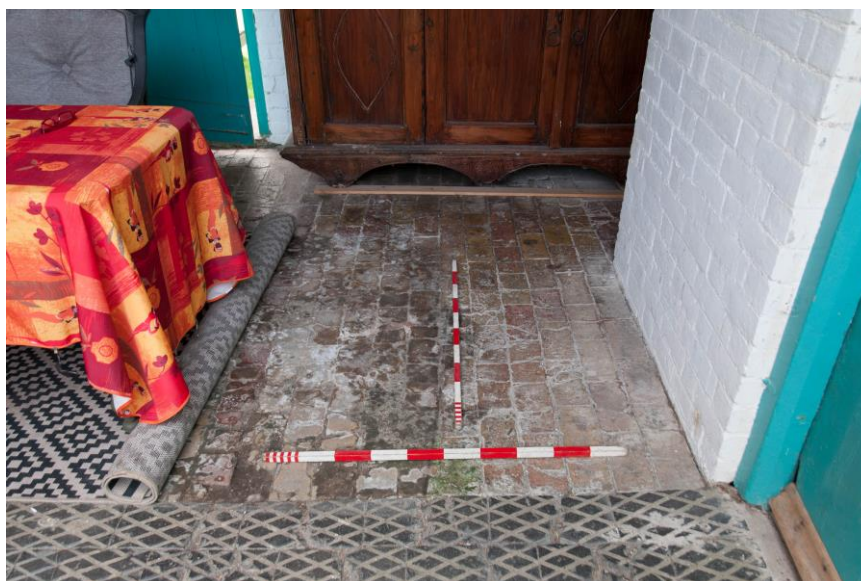
*Figure 40 Detail of floor surface in the west range*

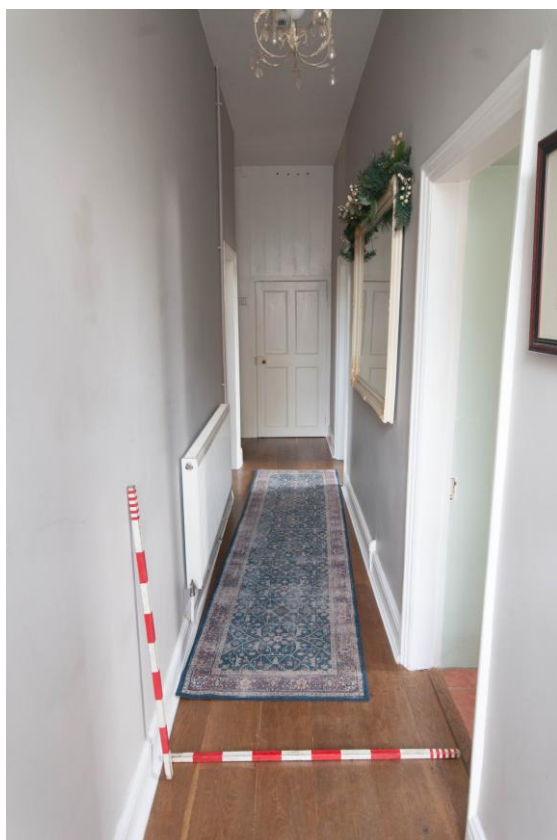
- 5.20 The hallway measures 0.9m in width and is surfaced with modern engineered wood tiles. A modern scheme of skirting and door framing has been installed (Figs 42, 43). There are two doorways to the kitchen of which one has been blocked.

Figure 42 View within the hall, looking south

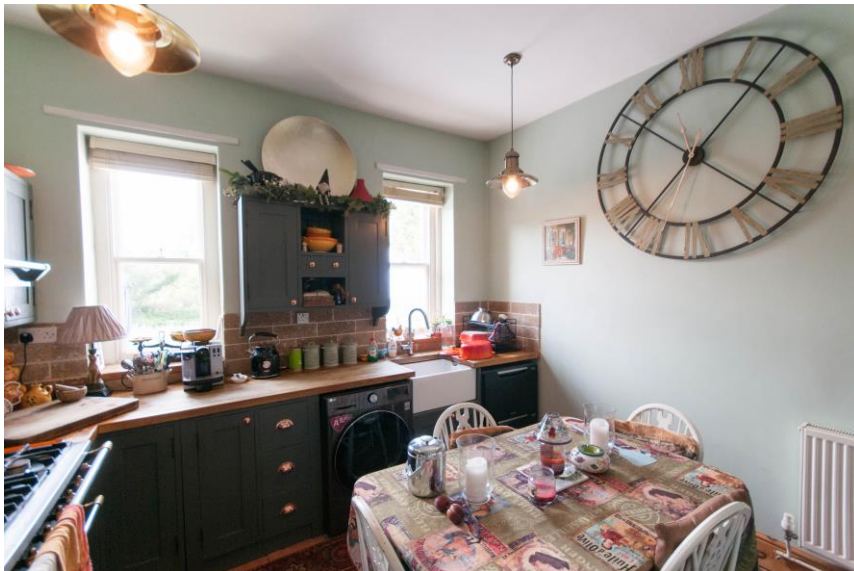
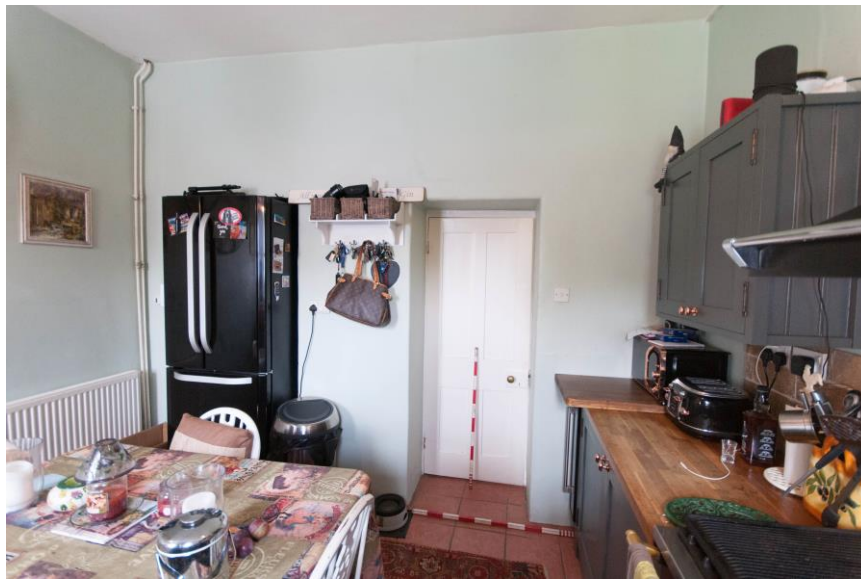
- 5.23 No historic features are visible in the kitchen which includes a fully modern layout and fittings (Figs 44, 45).

*Figure 44 View within the kitchen*

*Figure 45 View within the kitchen, the east wall*

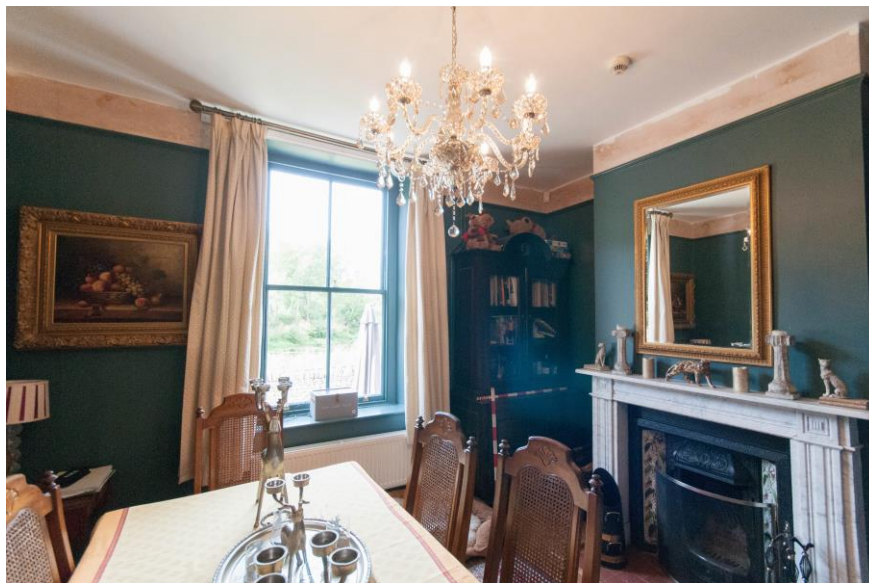
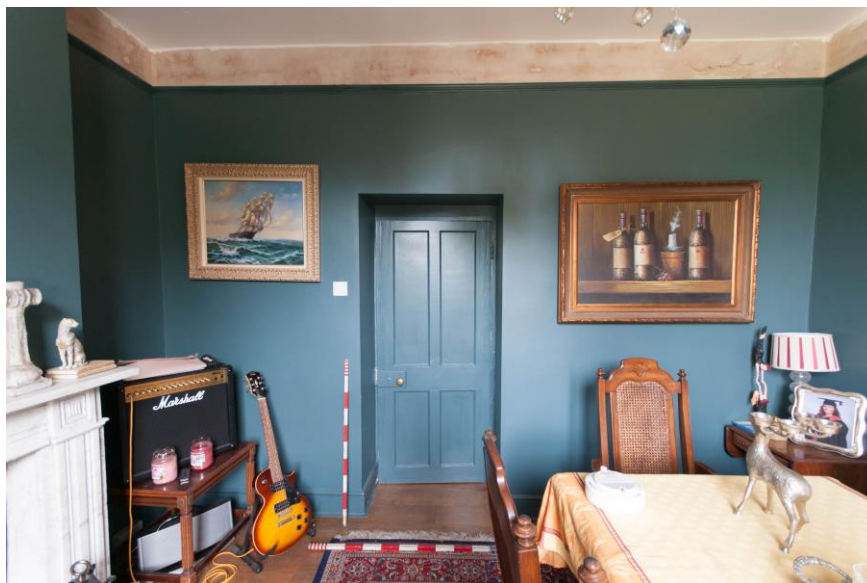
- 5.22 The snug room has a modern decorative scheme with modern fireplace and surround in a traditional style (Figs 46, 47). The floor is of modern engineered wood and the room has a modern skirting scheme in traditional style. The fireplace hearth is of red tiles. Due to plastering there is no evidence visible for a former doorway in the area of the sash window.

*Figure 46 The Snug, looking north-west*

*Figure 47 The snug, east wall, looking east*

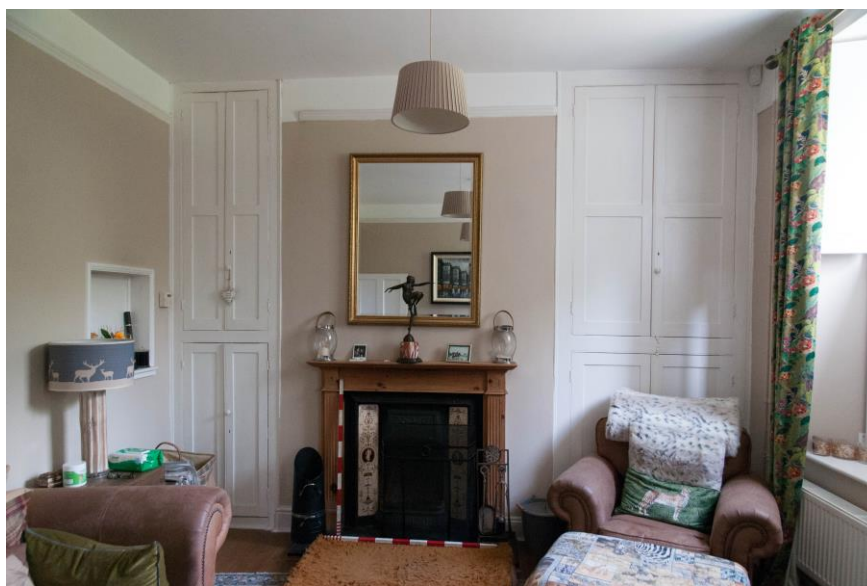
- 5.21 The living room is lit by two east-facing sash windows which have internal wooden shutters. A chimney breast projects into the room from the northern wall and wooden cabinets enclose the space to either side (Fig 48). The fire surround and cast-iron fireplace are modern installations in a traditional style. The floor is likewise modern engineered wood. The wall which divides the living room from the hallway is a plaster and timber stud wall (Fig 49) in contrast to the heavier walling elsewhere in the house and may be of a later date as supported by the apparently later insertion of the hallway door.

*Figure 48 The living room, looking north*

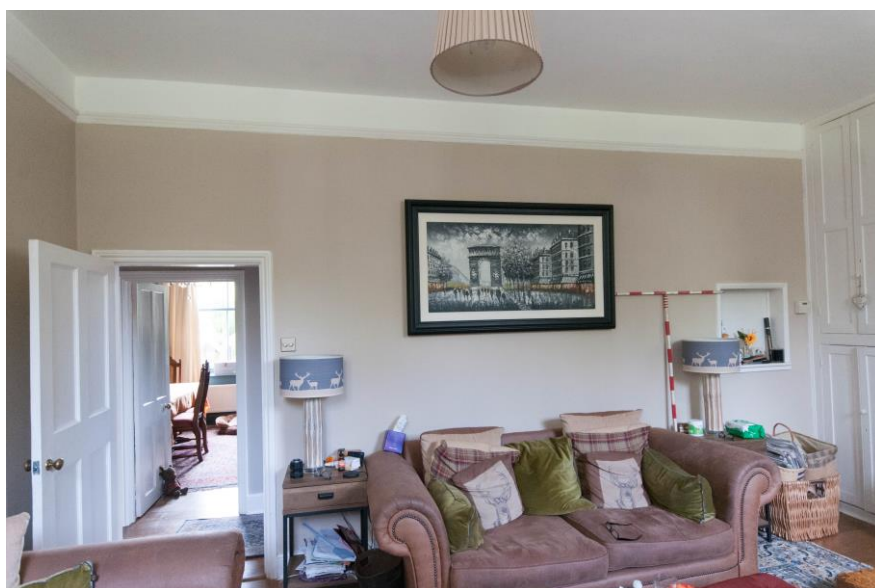
*Figure 49 The living room, view of the west partition wall to the hall*

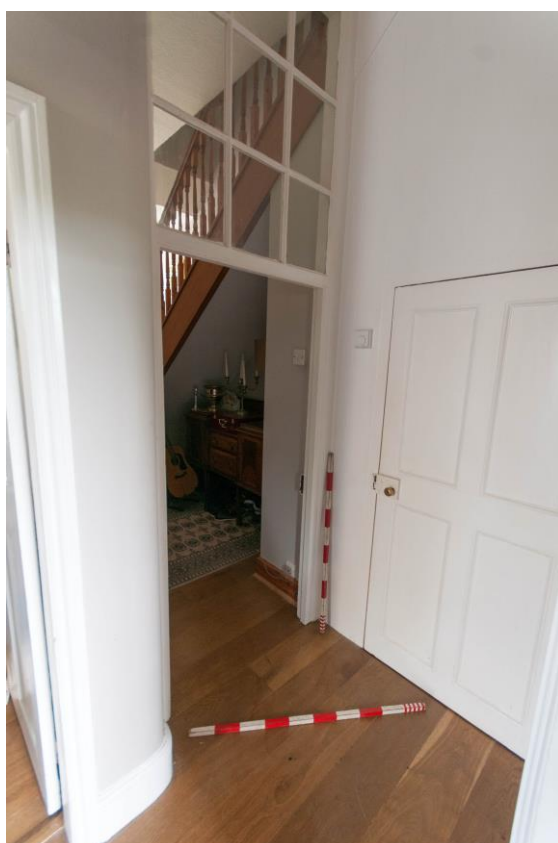
*Figure 50 Transition between hall and staircase at south end of the hall*
