**THE CHURCH OF ST NICHOLAS
HINXWORTH
HERTFORDSHIRE**

**ARCHAEOLOGICAL OBSERVATION
AND INVESTIGATION**

Project: HC1749

Document: 2011/81
Version 1.0

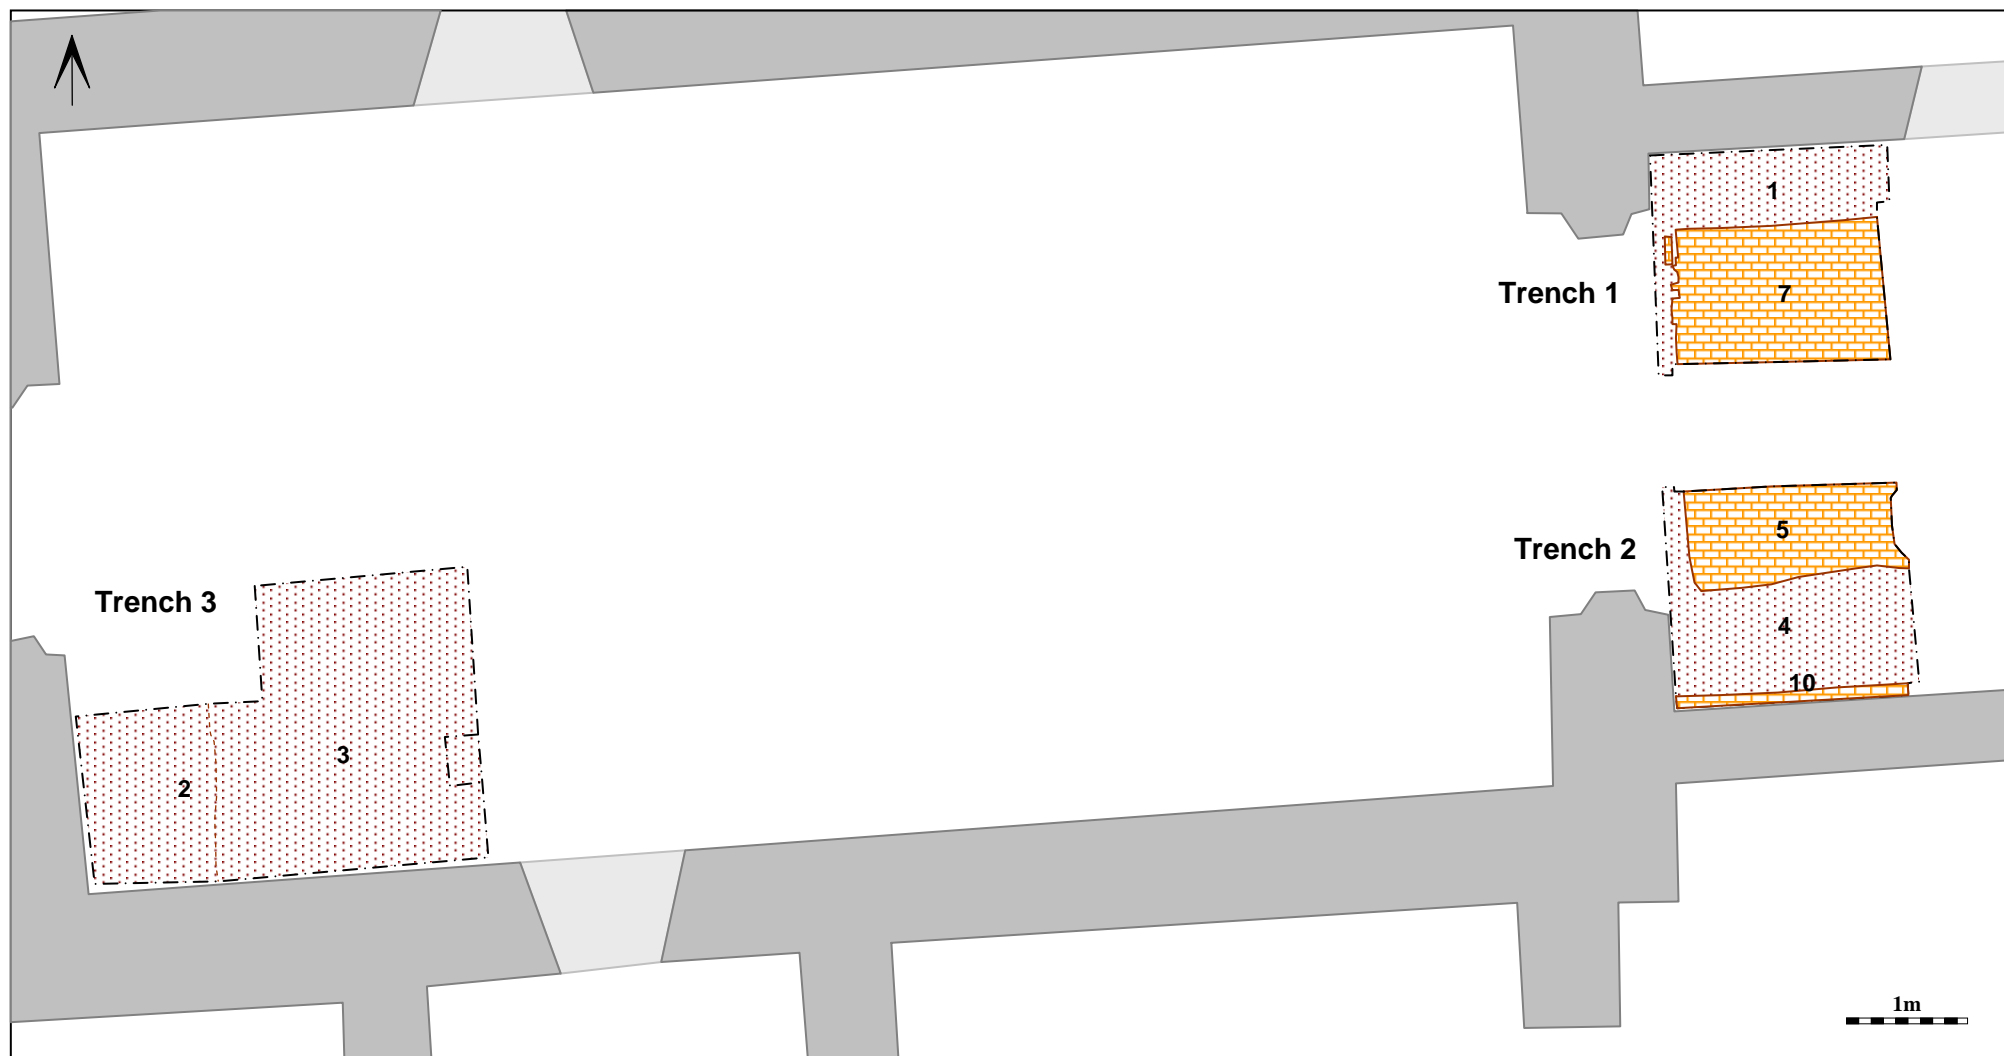
Figure 2: Groundworks plan

The building works requiring monitoring comprised two excavations (Trenches 1 and 2) at the west end of the chancel and one (Trench 3) at the west end of the nave (Figures 1 and 2). The works comprised the removal of the existing floors and the reduction of the ground level by approximately 0.3m in the chancel and 0.2m in the nave.

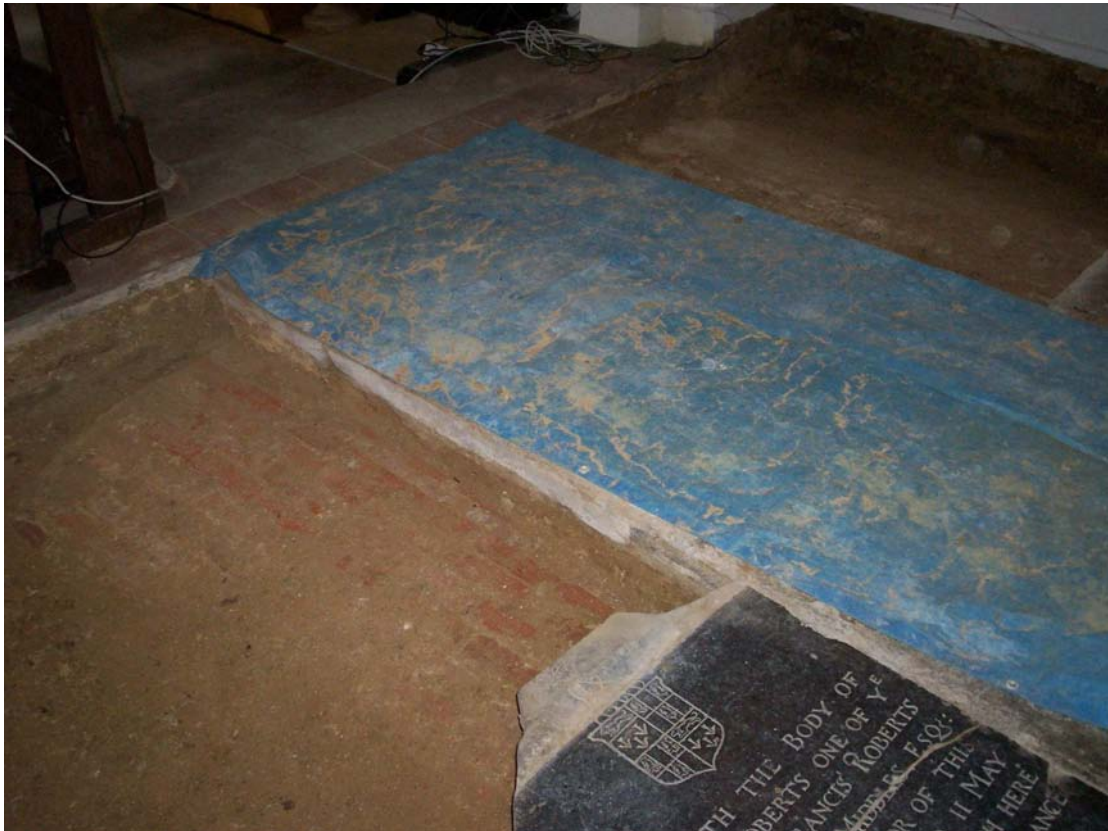
The two areas of excavation (Trenches 1 and 2) were situated at the west end of the chancel (Figure 2 and 3). They were square in plan, *c.* 2m by 2m and up to 0.3m deep. The works initially involved the removal of timber flooring and metal frames which held the timber. A further 0.1m of soil was removed below the metal frames in order to reach the required level, 0.3m below floor level.

Figure 3: View north-west of Trenches 1 and 2.

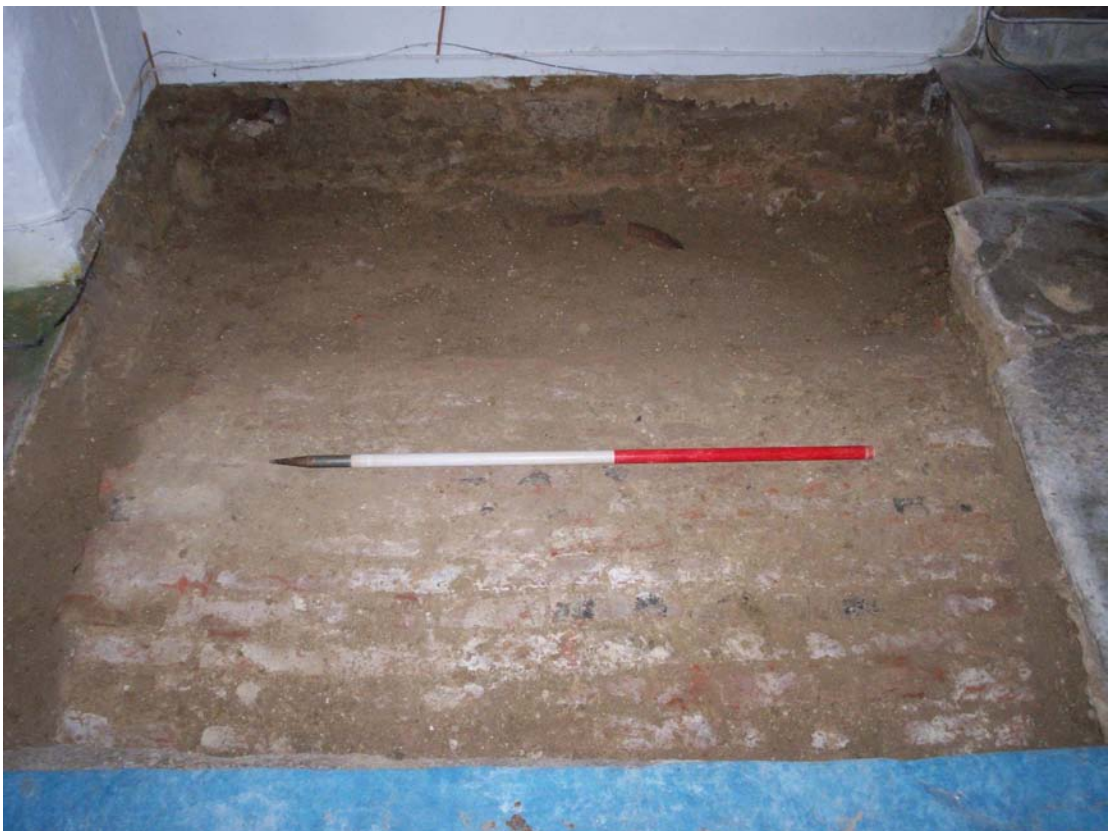
The arched roofs of two brick-built, probable burial vaults (7, 5) were uncovered in Trenches 1 and 2 respectively, at a depth of 0.21m (Figures 4 and 5). Backfill deposits (1, 4) surrounding the vaults comprised light grey chalky silt and contained occasional pieces of building material including several bricks. The bricks were of probable 18th-century date, hand-made and typically measured 220mm x 110mm x 60mm with a reddish orange matrix and a dark red or black exterior. They were similar to those making up the vaults and the chancel walls (Figure 7). The vaults were left intact and unbreached by the groundworks and subsequent backfilling.

A small amount of disarticulated human bone was found within backfill (1) in Trench 1. A larger amount of disarticulated bone and two corroded iron, probable coffin handles were found in Trench 2. Collectively, the bones from Trench 2 possibly represent the disturbed remains of a single individual.

Figure 4: View north of Trench 1 showing brick vault

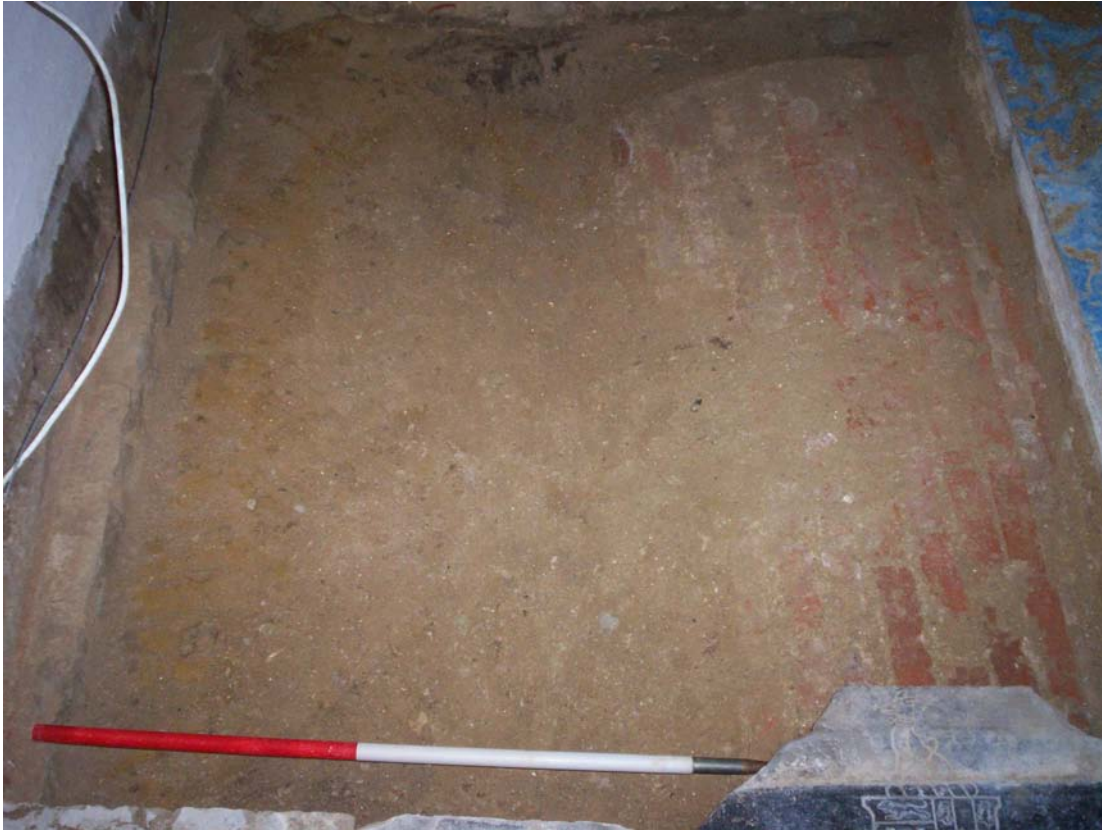
Trench 2 also revealed a stone footing (10) for the southern wall of the chancel which was slightly wider than the wall itself (Figure 5). The footing comprised a course of unmortared, squared stones which were generally 150mm deep, at least 110mm wide and up to 420mm long.

Figure 5: View east of Trench 2 showing brick vault and stone footing

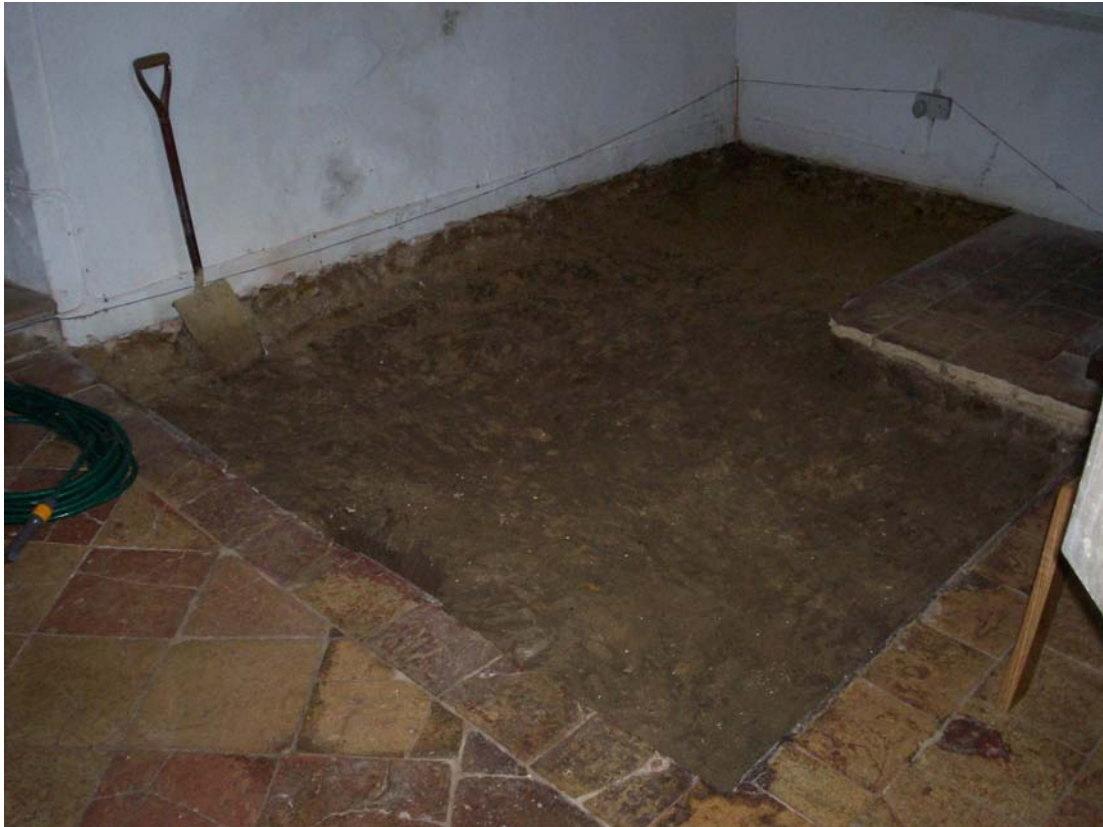
Trench 3 was L-shaped and situated in the south-west corner of the nave (Figure 6). It measured 3.3m by 2.6m and was mostly up to 0.2m deep. The excavation of the trench involved the breaking-out and removal of 0.15m of concrete. A further 0.05m of soil was then removed to reach the desired level, 0.18–0.2m below floor level. A 0.38m deep pit was excavated at the east end of the excavation in order to accommodate a drain from the repositioned font.

Two deposits (2, 3) were recorded under the concrete. Deposit 2 comprised a mixture of light yellow grey sand and clay. Deposit 3 comprised dark grey brown sandy silt and was mainly derived from topsoil. It contained a chocolate bar wrapper made of foil. Anecdotal evidence suggests that the concrete floor was installed in the 1950s. It seems likely, therefore, that the backfilled deposits directly below the floor were laid down around the same time.

Figure 6: View south-west of Trench 3

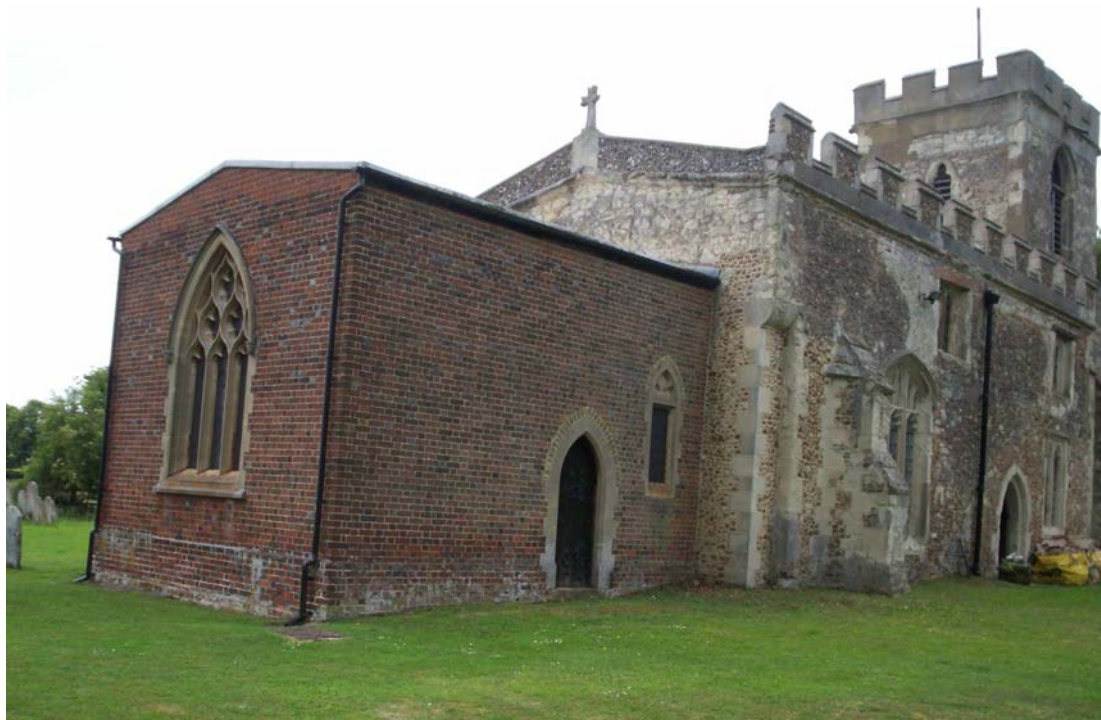
Figure 7: View of chancel
