**CHURCH OF ST MARY
STOCKING PELHAM
HERTFORDSHIRE**

**ARCHAEOLOGICAL MONITORING,
RECORDING AND REPORTING**

Document: 2013/85
Version 1.0
Issue date 15th May 2013

Albion Archaeology Project Code: SP1954
OASIS ID: albionar1- 149504

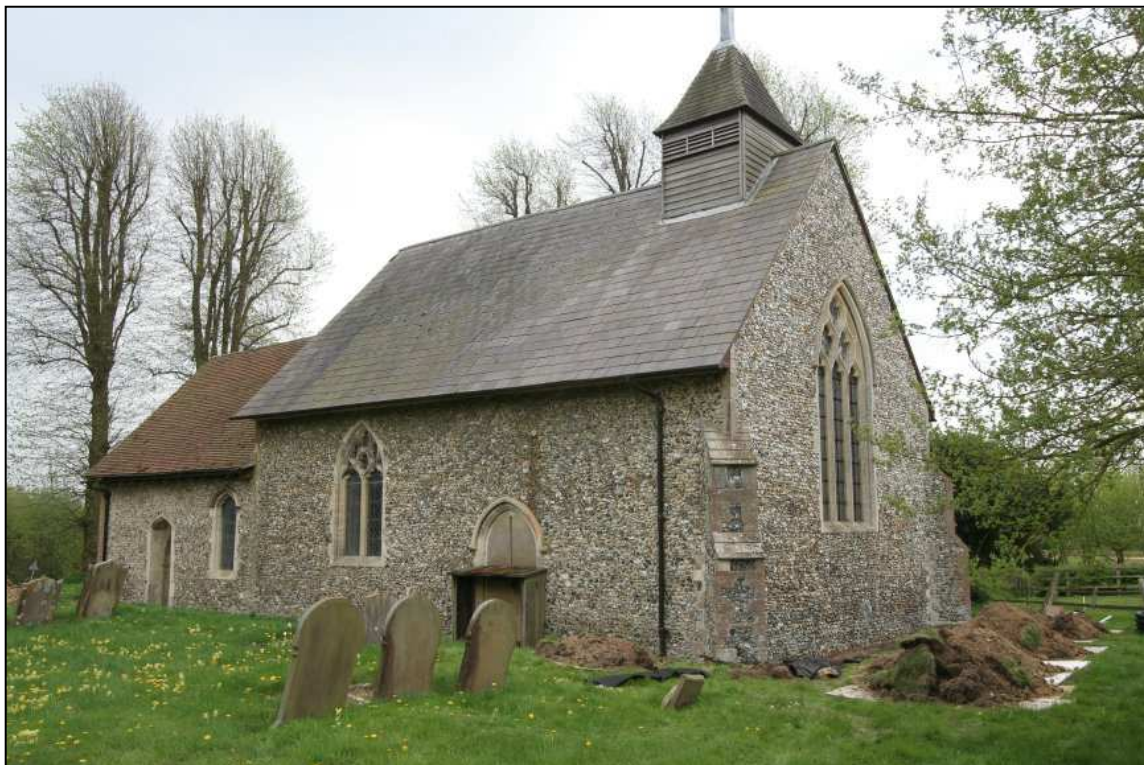
This trench extended from the end of the buttress on the south-west corner of the nave, along the west wall and around the north-west buttress to finish at the north wall of the nave a short distance beyond the buttress (Image 2). The main part of the trench was 0.7m deep and 0.5m wide (Image 4). The trench became shallower at its northern end where it encountered a plastic drain pipe. It was not excavated flush with the face of the wall; instead a baulk approximately 0.3m thick was left next to the foundations with its upper part being reduced and sloped towards the trench. Following the machine excavation, the base and the east side of the trench were cleaned by hand.

Image 2: View of north side and west end of church, showing location of trench at west end

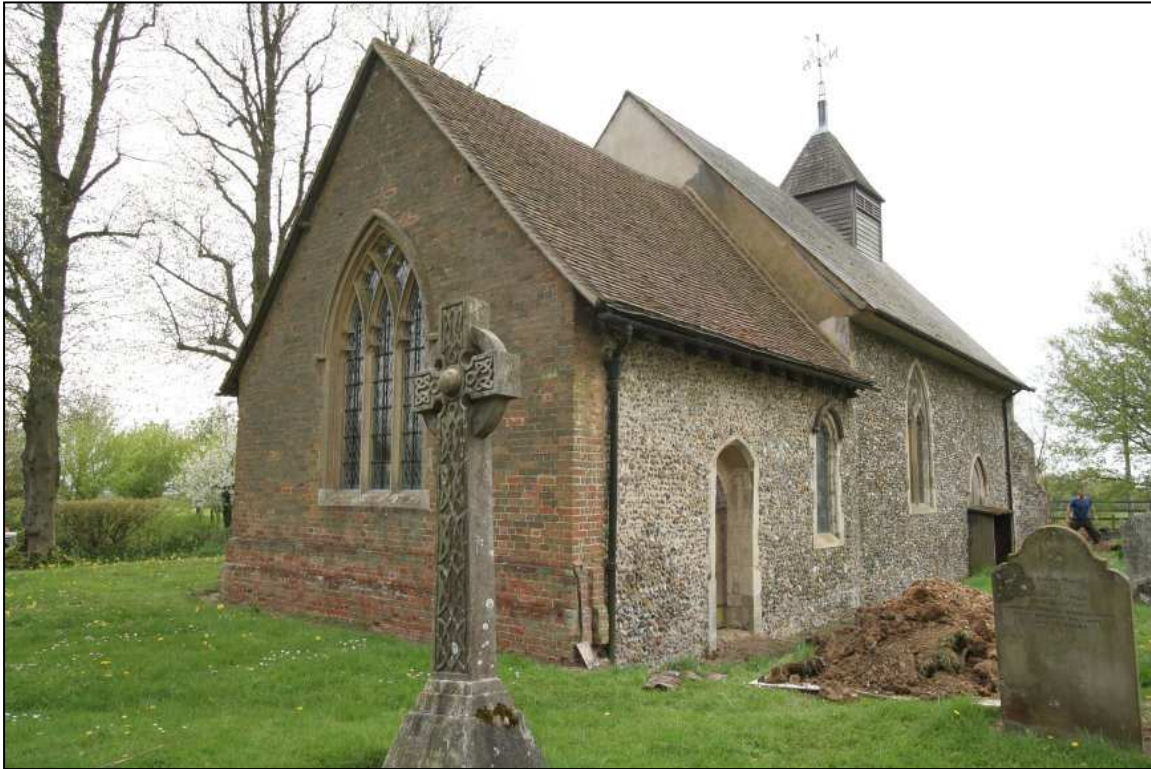
A soakaway pit was excavated close to the north-east corner of the building to take water from a downpipe on the north side of the chancel (Images 3 and 6). It consisted of a shallow trench for a pipe and a deeper soakaway pit. The pit was cut into the edge of a bank where the ground has been terraced away along the north side of the church (Image 7). The trench was up to 1.3m deep and 0.5m wide.

Image 3: View of north side and east end of church, showing location of trench at north-west corner of chancel

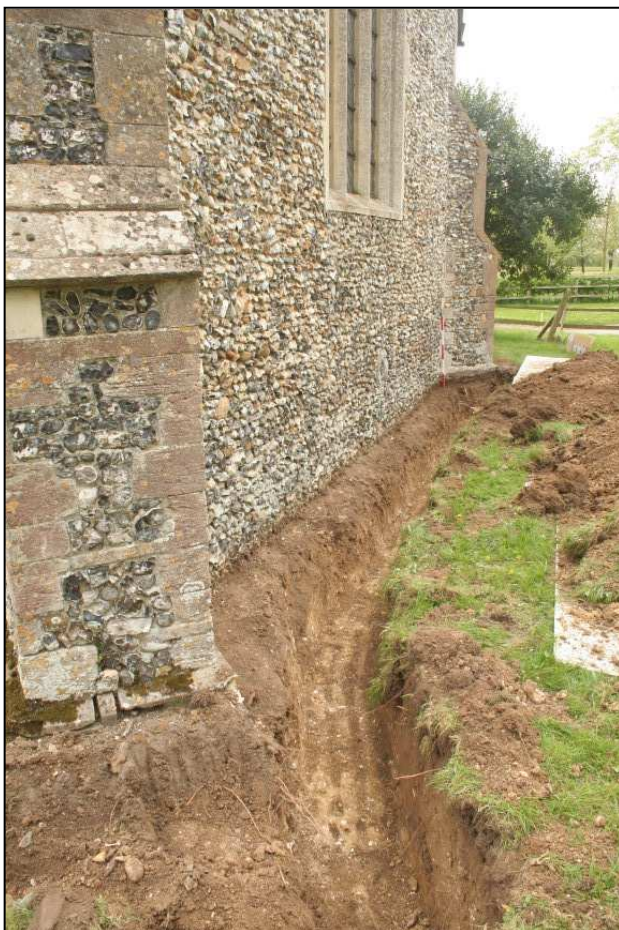
The deposits consisted of a soil layer above geological deposits. The soil layer was up to 0.5m deep and comprised mid grey brown clay silt with occasional small stones and a small number of fragments of modern tile. The lower part of the trench extended into undisturbed Boulder Clay (mid yellow brown clay with chalk fragments).

Image 4: Trench along west end of church, looking south

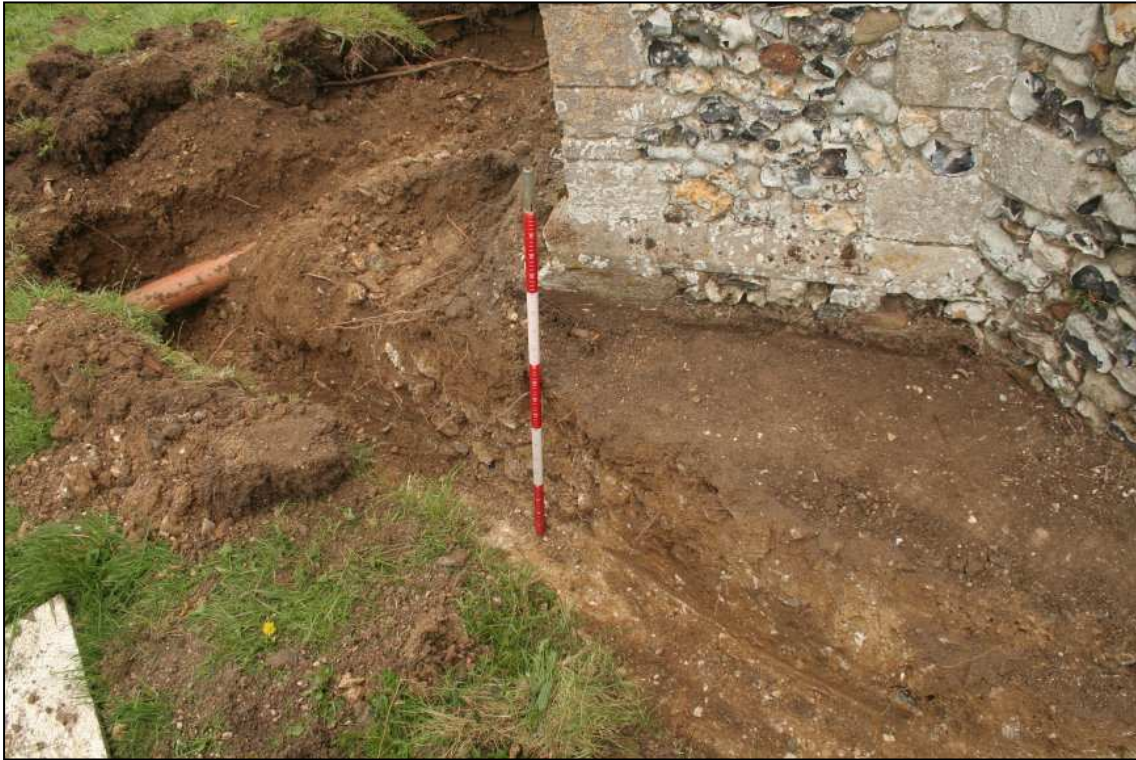
No cut features were observed in the base or sides of the trench. The eastern section next to the north-west buttress contained a concentration of flint nodules and mortar indicating the probable location of a foundation for the buttress (Image 5). No artefacts other than recent tile (not collected) were found. No human bone or burials were observed in this trench.

The results of the observations were largely negative. No artefacts, cut features, burials or disarticulated bone were identified in the trenches. A small section of disturbed flint foundation was visible in the trench at the west end of the nave adjacent to the north-west buttress.

Image 5: Trench at west end of church showing area next to the north-west buttress, showing flint and mortar of foundation visible in section (scale 1m)

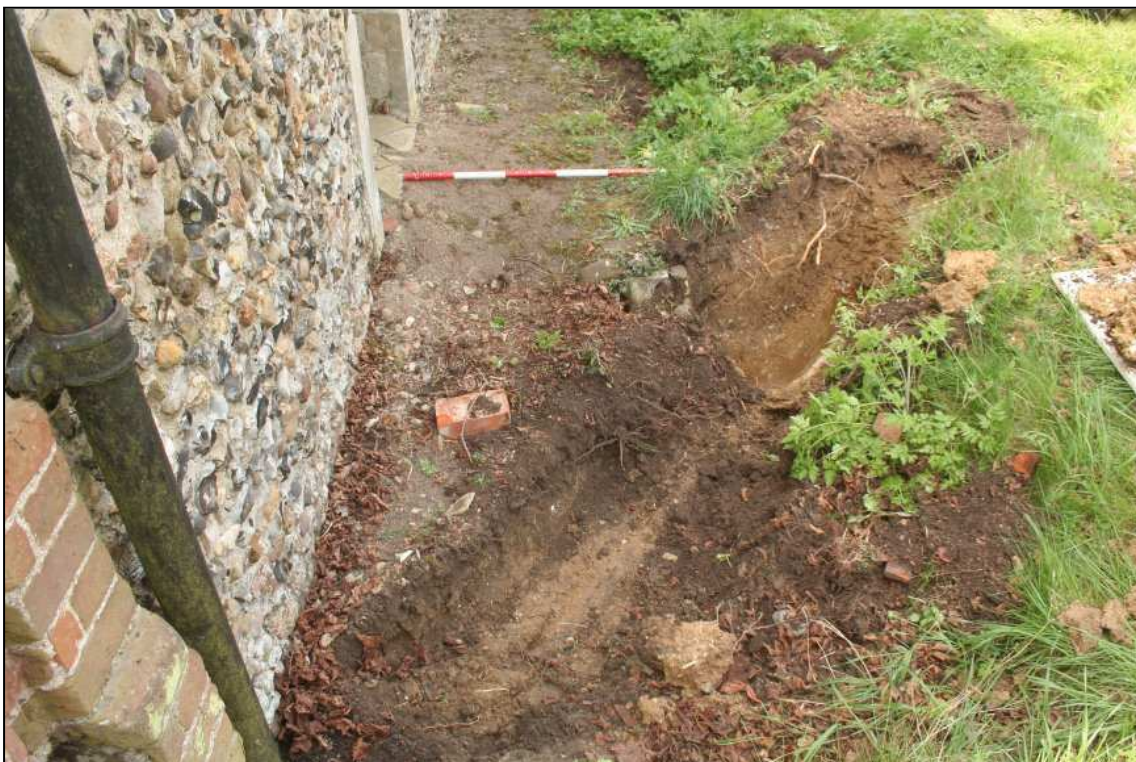
Here, the upper soil layer was up to 0.4m deep and consisted of mid grey brown clay silt with occasional stones and small fragments of brick and tile. The natural geological deposit below consisted of Boulder Clay (mid yellow brown clay with chalk fragments and occasional flint nodules). The density of chalk fragments increased towards the base of the pit.

Image 6: Trench for soakaway near north-east corner of chancel, looking west (scale 1m)

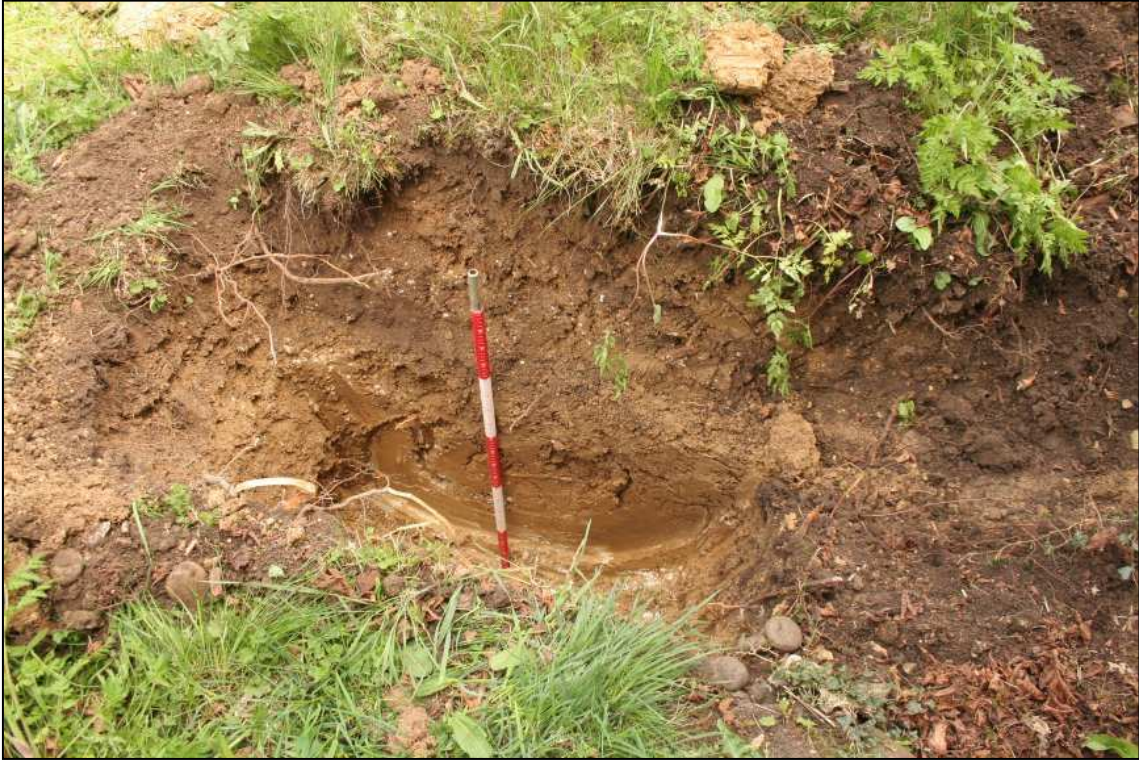
Image 7: Trench for soakaway near north-east corner of chancel, showing SW-facing section (scale 1m)
