**MAYLANDS GATEWAY
HEMEL HEMPSTEAD
HERTFORDSHIRE**

**ARCHAEOLOGICAL
OBSERVATION AND RECORDING
OF
GEOTECHNICAL TEST PITTING**

Project: MG2847

Document: 2016/43
Version 1.0

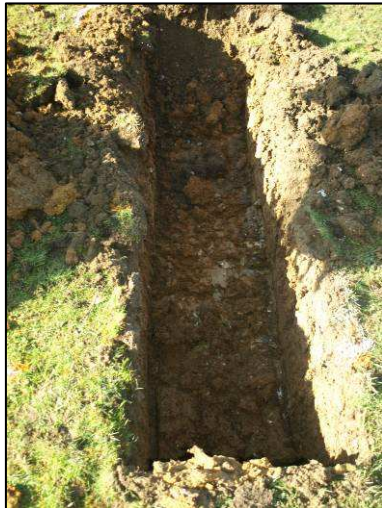
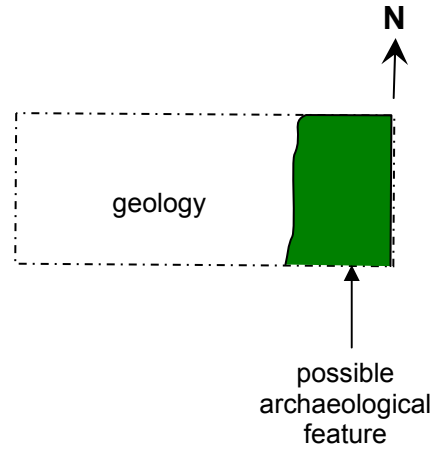
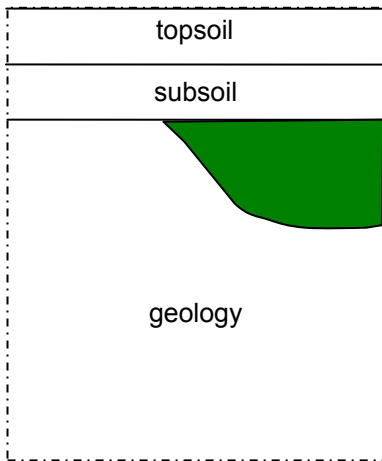
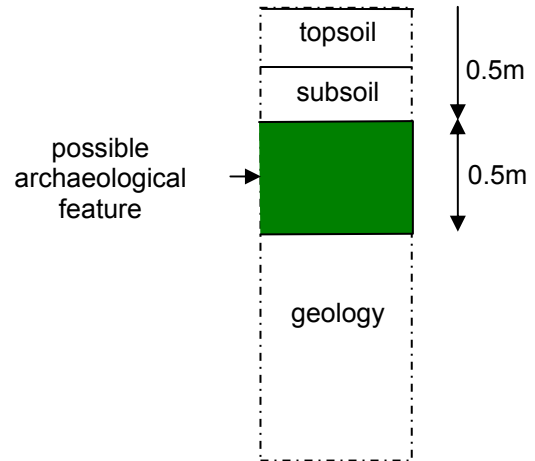
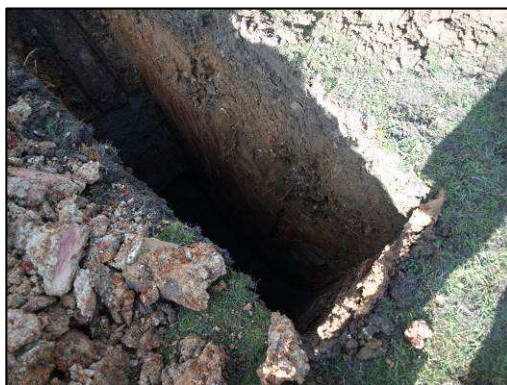
Figure 6: Possible archaeological feature in test pit 12

Only TP12 contained a possible archaeological feature (see Figure 6). It was observed as a disturbance to the geological strata at the eastern end of the test pit. The feature was at least 1m long, 0.6m wide and 0.5m deep, with a concave profile. Its fill was virtually identical to the mid-orange-brown silty clay subsoil and did not contain any artefacts or datable material. It is likely to have been a ditch, or a pit, that has been filled by natural silting. The small size of the test pit precludes the definite identification of this feature and any further interpretation.

**Feature as first seen
(looking west)**

Plan

S-facing section

W-facing section

**Possible feature in section
(looking north-west)**

TP5, TP6 and TP7 confirm that there has been little impact to what appear to be typically natural soil profiles along the northern boundary of Area C. TP12, TP19 and TP22 along the eastern part of the field also appear to be undisturbed. This conclusion is further supported by the identification of a potential archaeological feature within TP12.

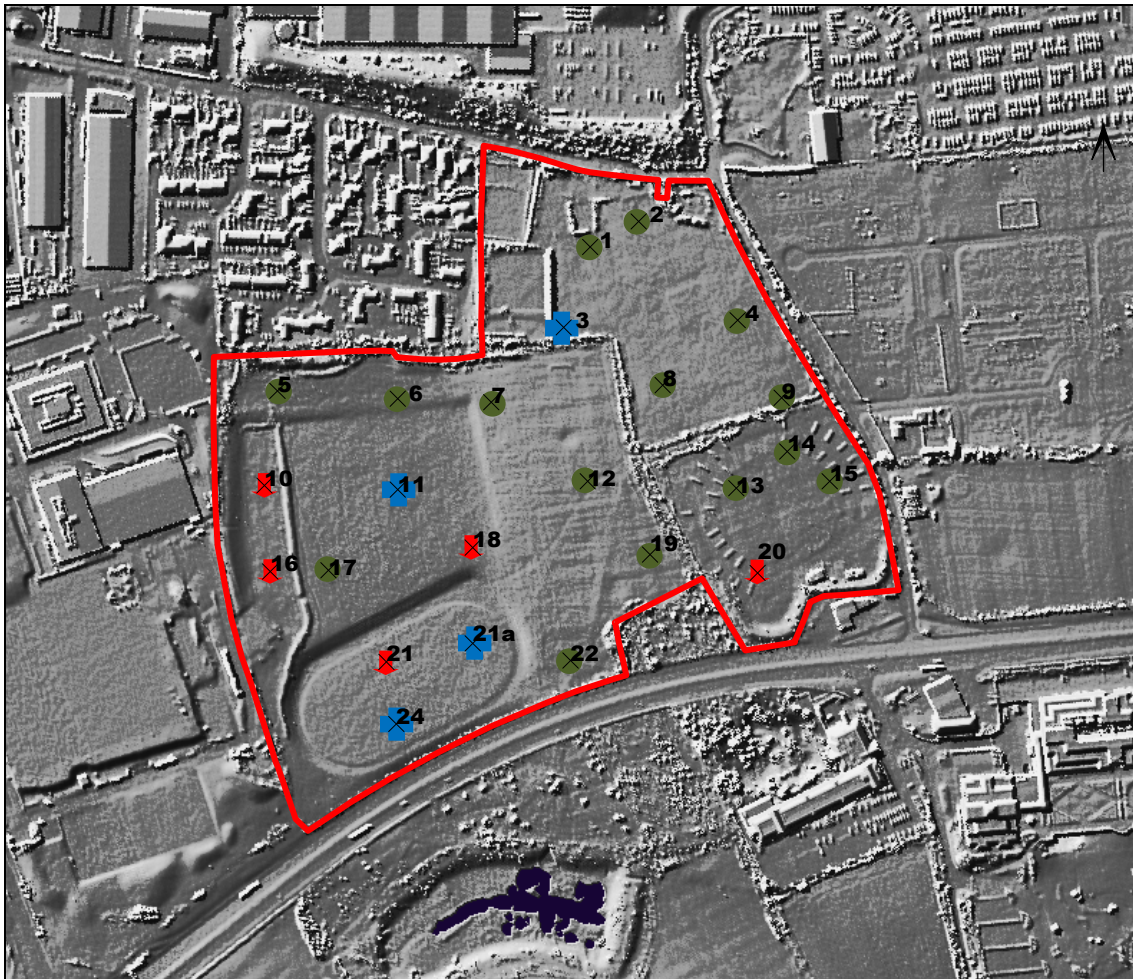
Figure 7: Location of test pits overlain on LIDAR digital surface map
LIDAR data from Open Government from Environment Agency (DSM 1m)
Source: <https://houseprices.io/lab/lidar/map> (accessed 24/2/16)

This section attempts to assess the likely impact of previous land use on the potential survival of archaeological remains within the PDA. This assessment is based on the information available from observation of the geotechnical test pits and omits potential impacts from services, buildings, roads and sewers in areas that were not sampled by the test pits. The location of the test pits in relation to the site topography, and whether they exhibited evidence for truncation or ‘made’ ground, is shown in Figure 7.

in the LIDAR data (Figure 7). The eastern part of the field appears to have been unaffected.

In summary, the sampled areas of the eastern part of the PDA, comprising the paddocks, former Kodak Sports ground and former caravan park, exhibited little sign of landscaping, except for an area of potential terrace build-up in the area of TP3. The impact of previous land use in these areas appears to be slight. In contrast the south-western part of the PDA, the former Lucas sports ground, appears to have been heavily landscaped. However, the impact of the terracing is likely to be mixed with only slightly more evidence for truncation than ground-raising. The test pits suggest that substantial truncation of the archaeological horizon is likely to be confined to the area of the western car park/compound and the northern halves of the two terraces (Figure 7).
