**BECHERS  
NAGS HEAD LANE, HARGRAVE,  
NORTHAMPTONSHIRE**

**ARCHAEOLOGICAL OBSERVATION,  
INVESTIGATION, RECORDING, ANALYSIS  
AND PUBLICATION**

Project: BH2890  
Event no: ENN108311  
OASIS ref: albionar1-248352

Document: 2018/26  
Version 1.0

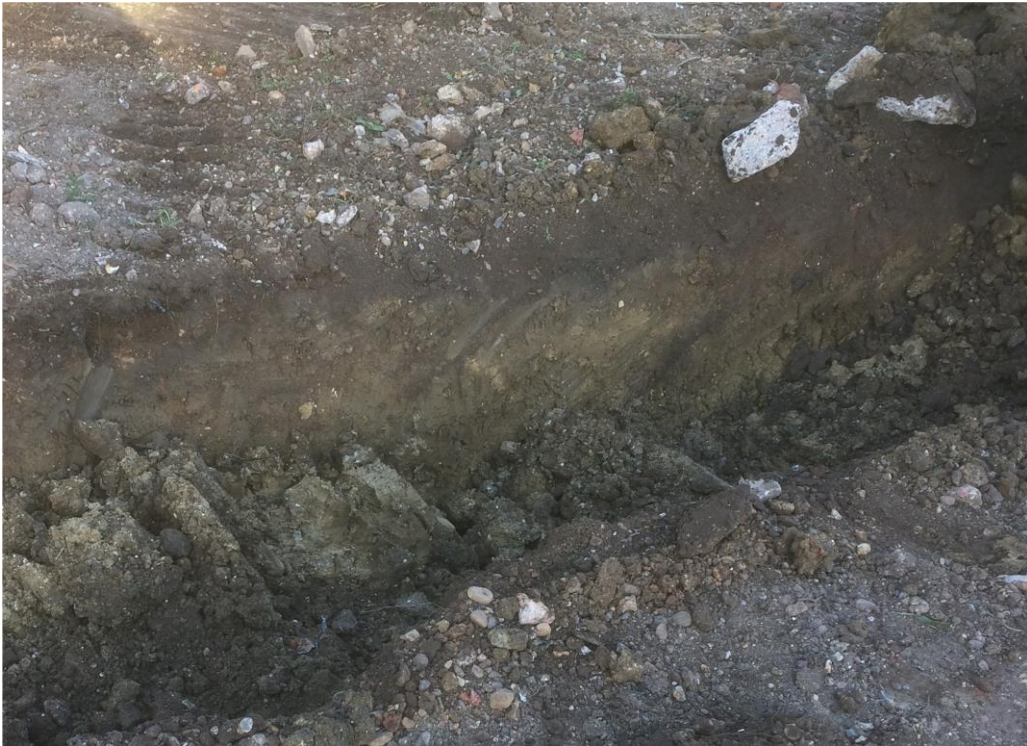
Revealed in the sides of these excavations was a soil profile that was similar for both buildings. The upper 0.4–0.6m comprised made-ground, consisting of:

- friable dark grey-black silt (01) up to 0.25m thick — disturbed former topsoil containing fragments of modern building material
- firm mid-yellow-brown clay (02), which ranged from 0.4–0.5m thick and included patches of topsoil (01) — a disturbed / mixed subsoil incorporating some topsoil (Figure 3: Image 1).

**Image 1:** Section through the disturbed soil profile following removal of the footings for the existing garage.

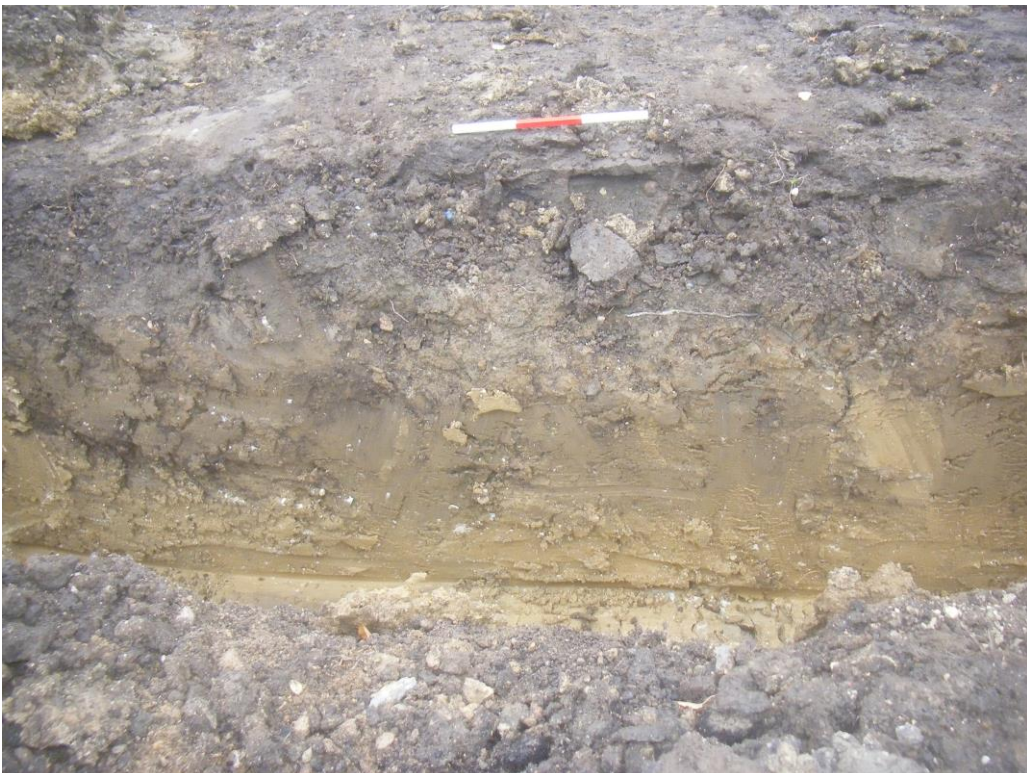
To the rear of the property, away from the lane, small areas of an undisturbed soil profile were exposed comprising friable dark grey-brown silt topsoil (05) up to 0.2m thick, above mid-yellow-brown silt subsoil (04) up to 0.1m thick (Figure 3: Image 2). This profile would appear to be a former cultivation soil.

**Image 2:** Truncated remains of a former cultivation soil profile, revealed to the rear of the existing property below modern disturbance. Scale 0.3m in 10cm intervals.

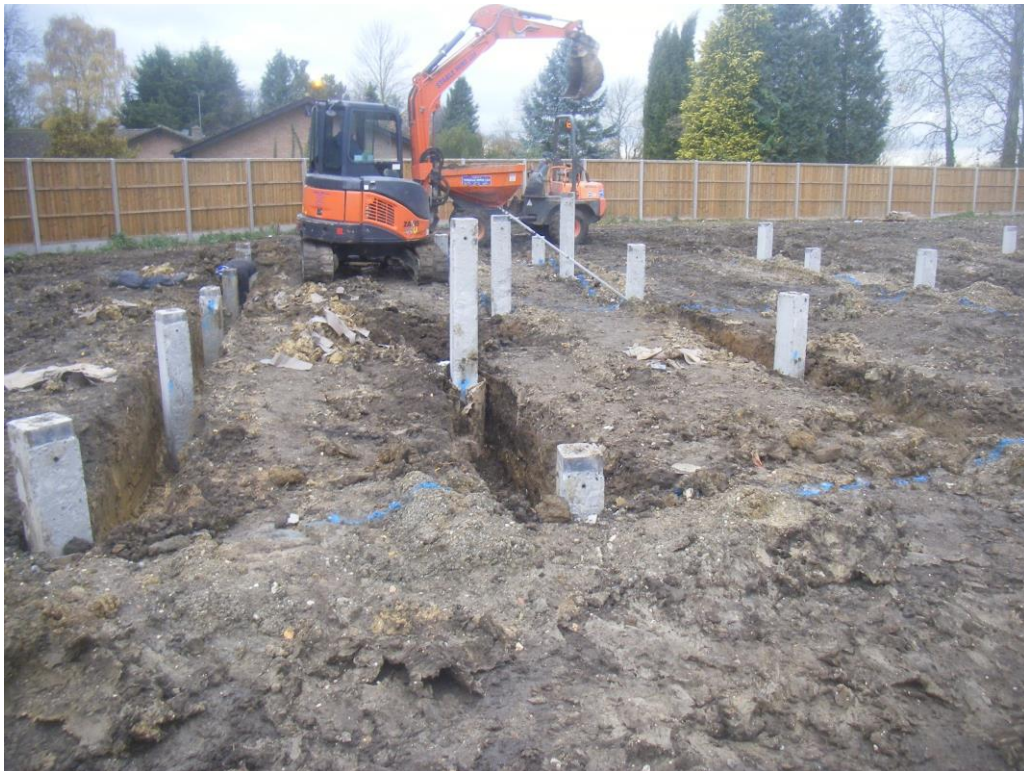
**Image 3:** Trenches under excavation to link the piles for the two buildings.

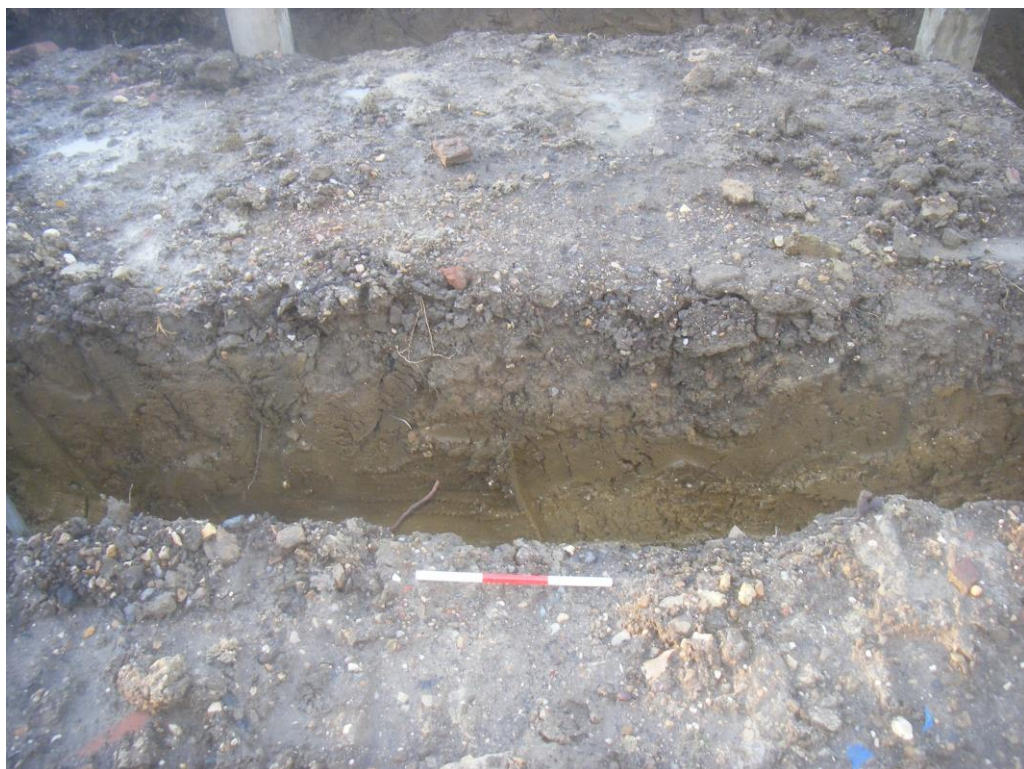
This work resumed in mid-November 2017, with the monitoring works revealing a similar disturbed profile across most of the area (Figure 4: Image 4). No archaeological features were revealed where the geological stratum was exposed.

**Image 4:** Traces of a former cultivation soil revealed in a trench linking the piles situated towards the rear of the property. Scale 0.3m in 10cm intervals.

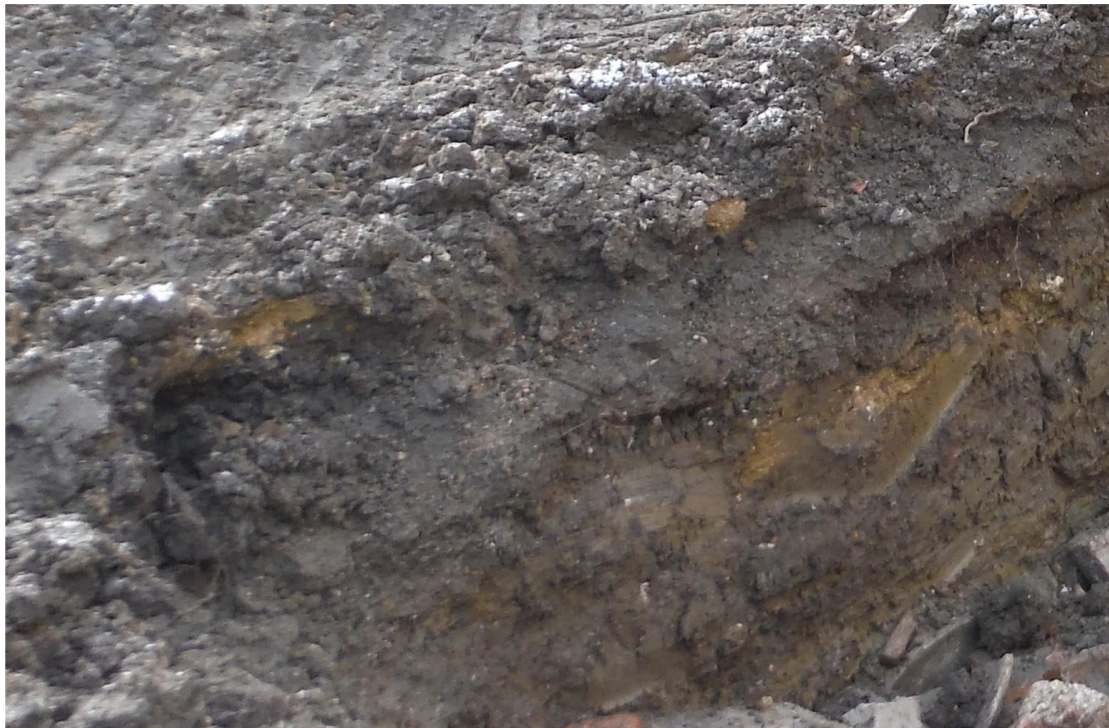
- topsoil (05) 0.2–0.25m thick
- subsoil (04) up to 0.4 thick, merging into the undisturbed geological stratum (03) (Figure 5: Image 5).

**Image 5:** Section of the soak-away, revealing traces of the former cultivation soil profile below modern disturbance.
