**69-71 HIGH STREET, CODICOTE,  
HERTFORDSHIRE**

**HISTORIC BUILDING  
RECORDING AND ARCHAEOLOGICAL  
MONITORING**

Document: 2016/59  
Version: 1.0  
September 2016

Albion Archaeology Project Code: HSC2433  
OASIS ref: albionar1-220214

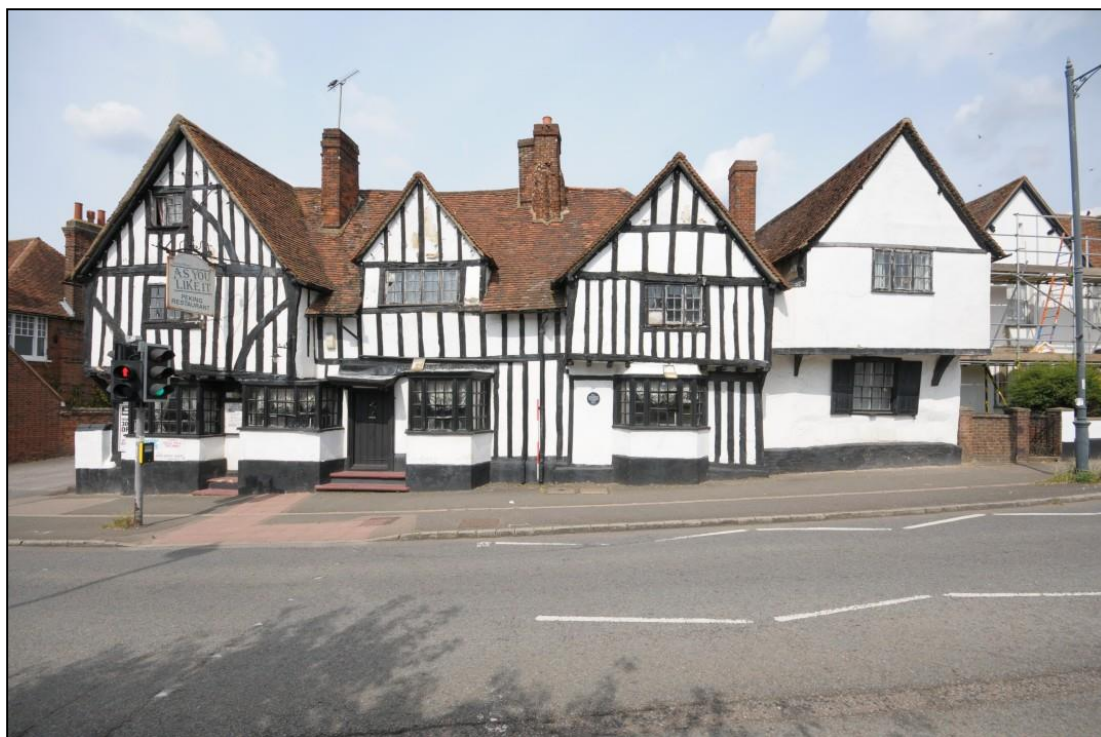
Image 1: South-west elevation of Nos. 69 and 71

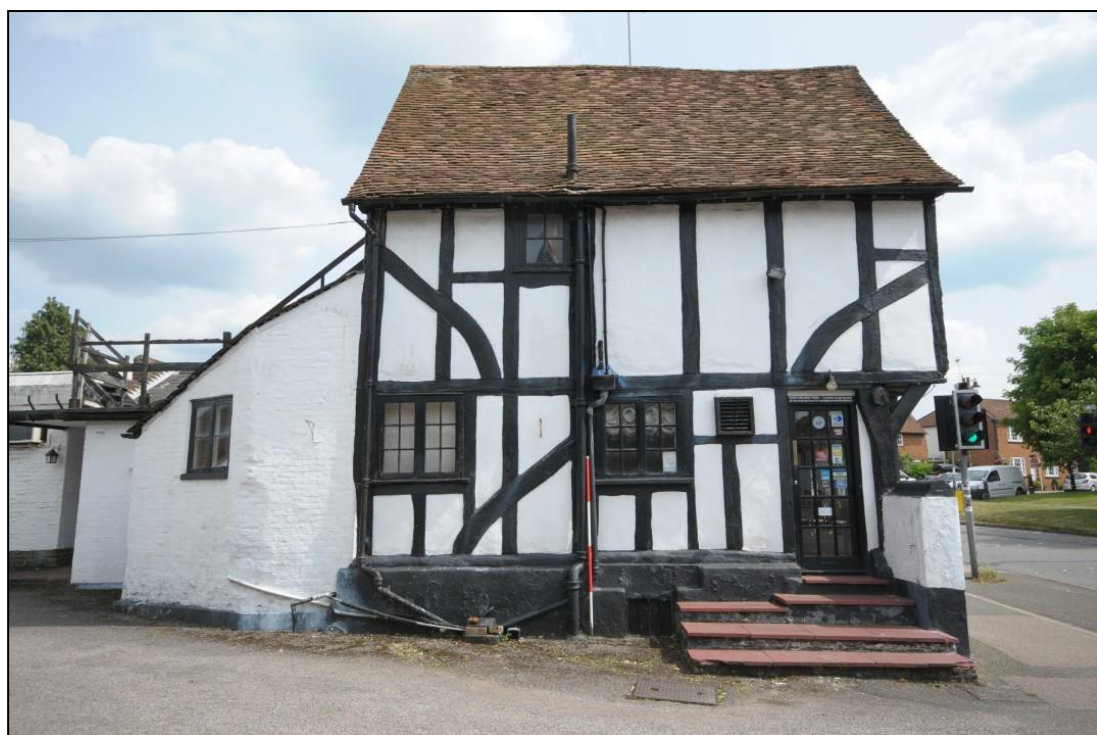
Image 2: North-west elevation of No. 69

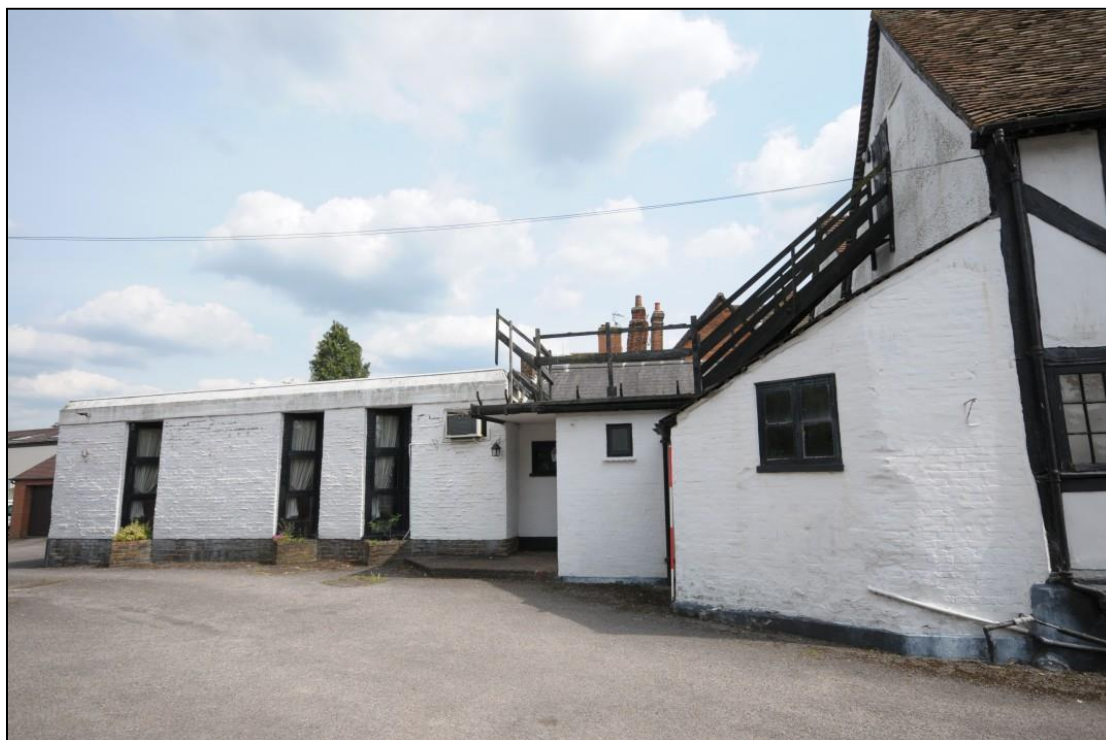
Image 3: North-west elevation of No. 69, showing modern extension at rear

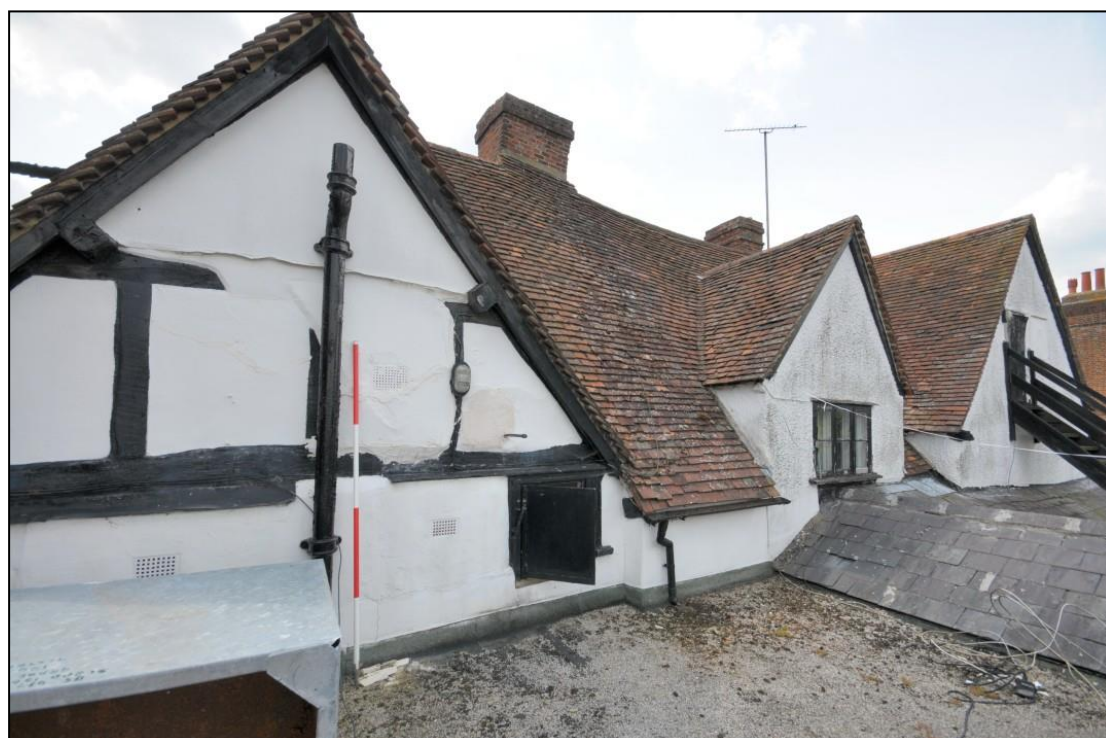
Image 4: North-east elevation of No. 69 at first floor level  
Seen from flat roof of modern extension at rear of property

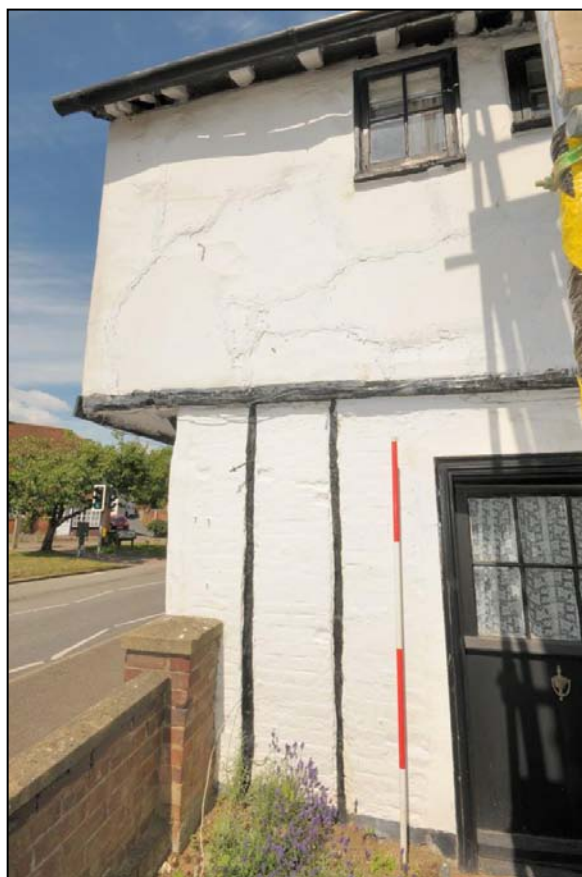
Image 5: South-east elevation of No. 71

Shows under-built jetty on this side

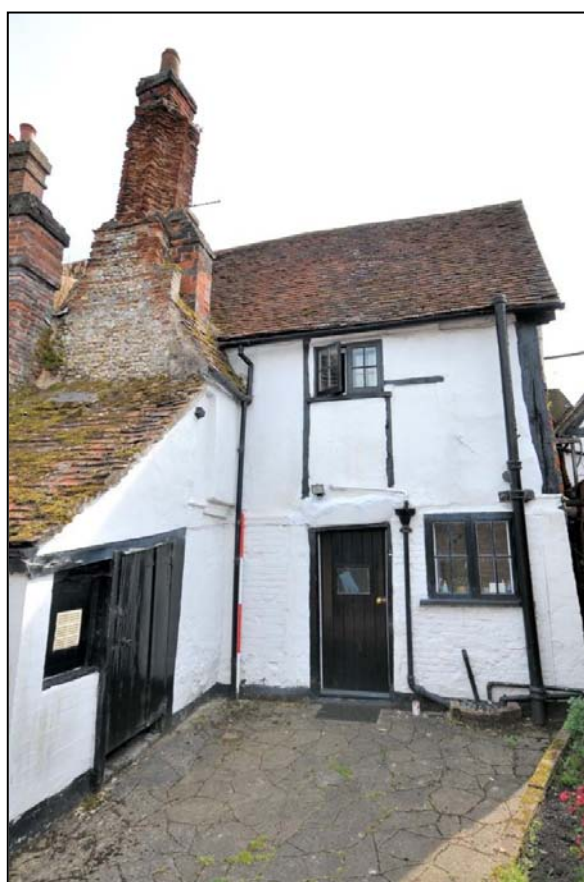
Image 6: Rear elevation of No. 71

Shows flint and tile external chimney stack and the north-east side of the rear range

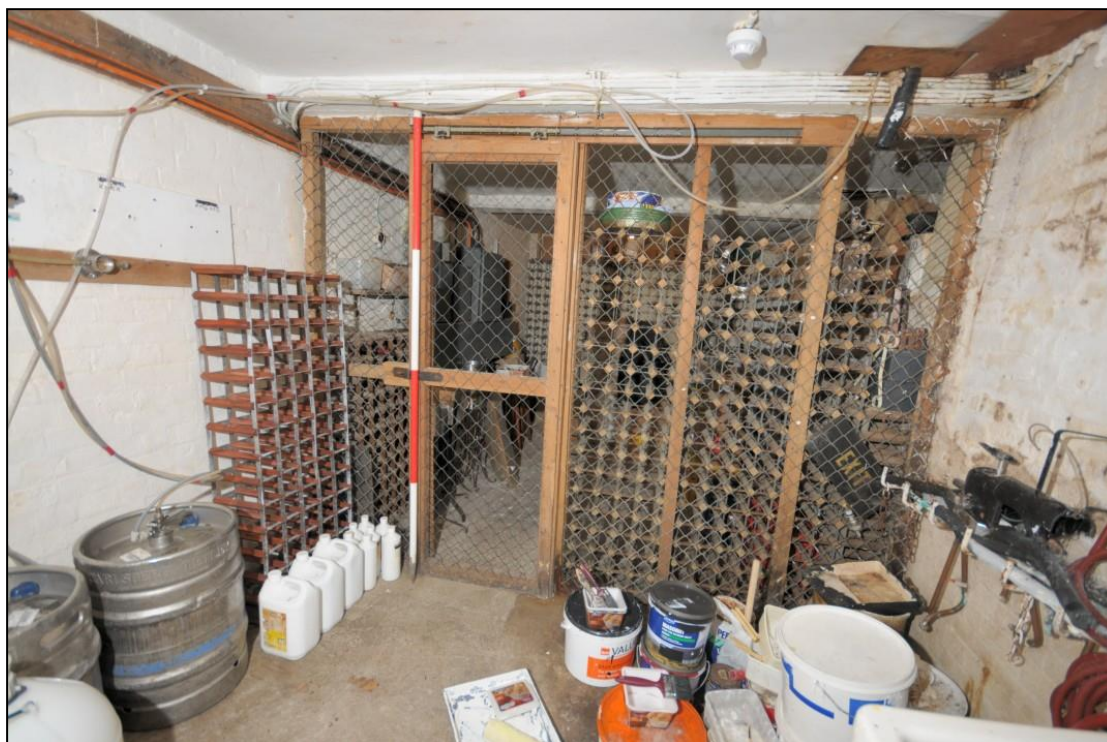
Image 7: Cellar below the north-west cross-wing of No. 69

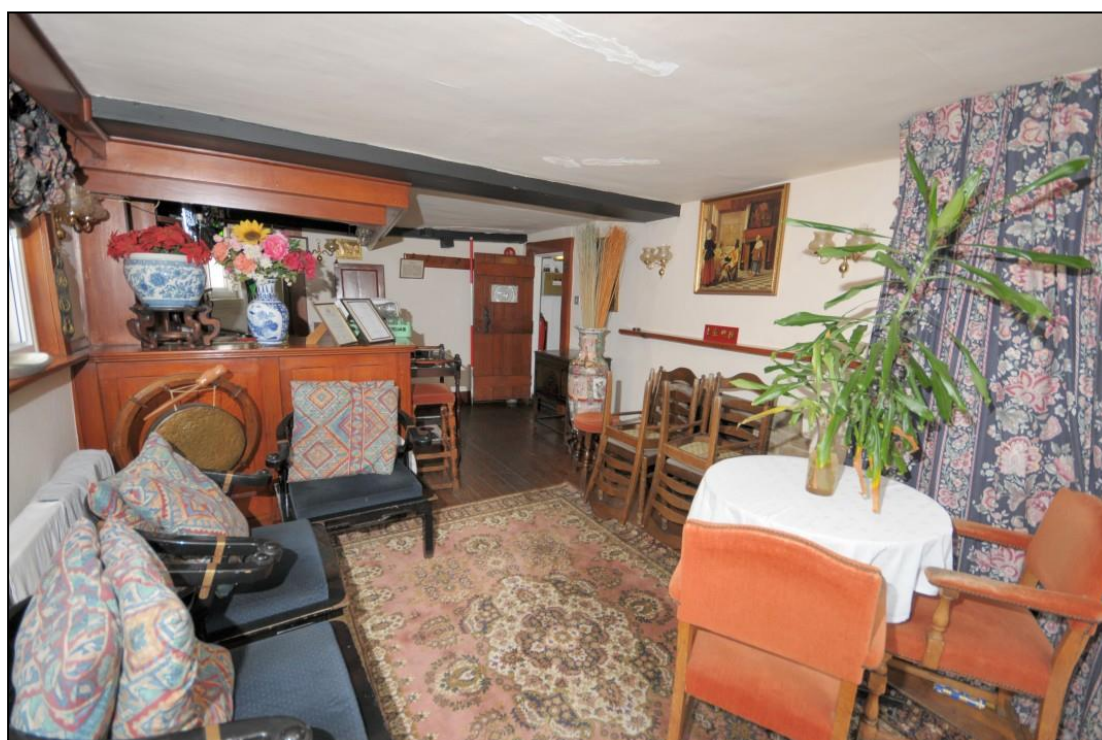
The ground floor contains a single room (G1) which serves as a bar and entrance to the restaurant (Image 8). A stair next to the chimney stack gives access to the first floor.

Image 8: No. 69 north-west cross-wing, ground floor G1

View looking east towards door to G2

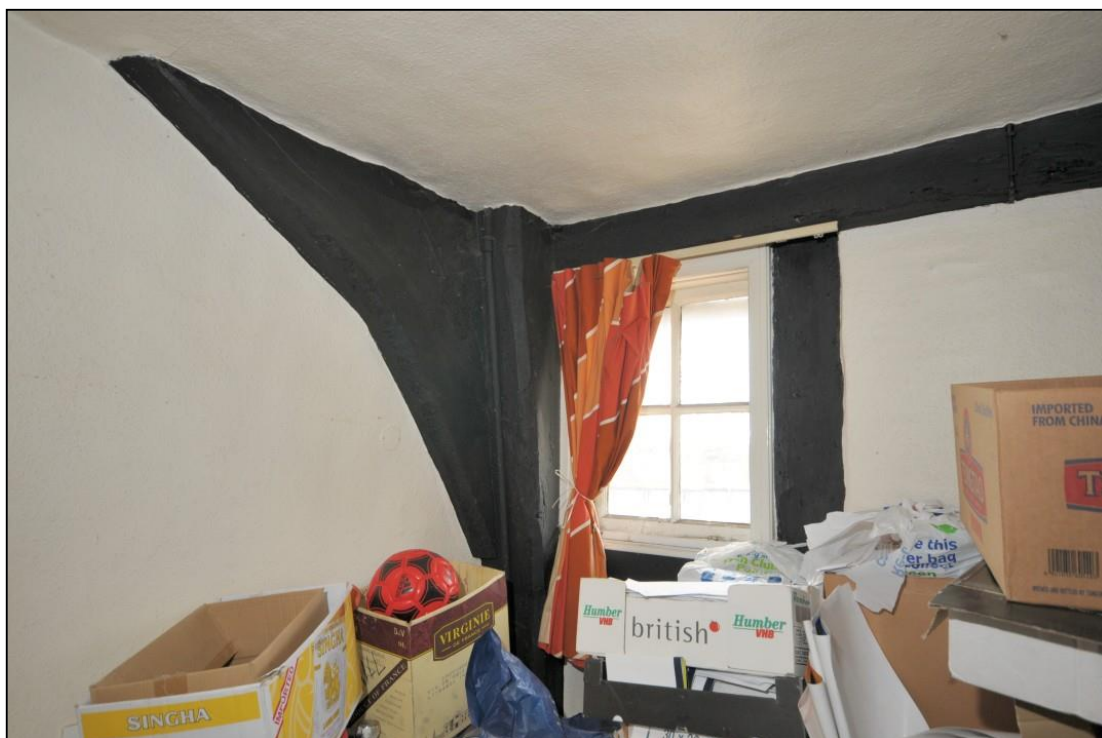
Image 9: No. 69 north-west cross-wing, first floor F2

View looking towards western corner showing arch brace

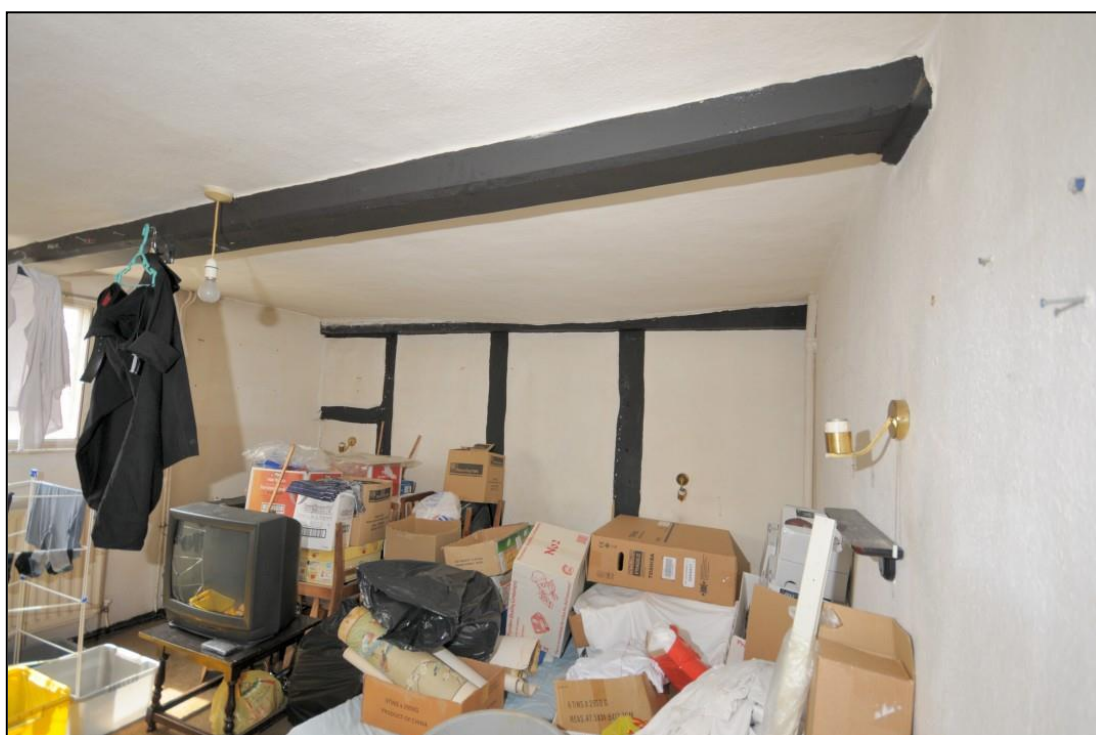
Image 10: No. 69 north-west cross-wing, first floor F1

View looking towards western corner showing frame in north-west wall and ceiling beam with scroll stops

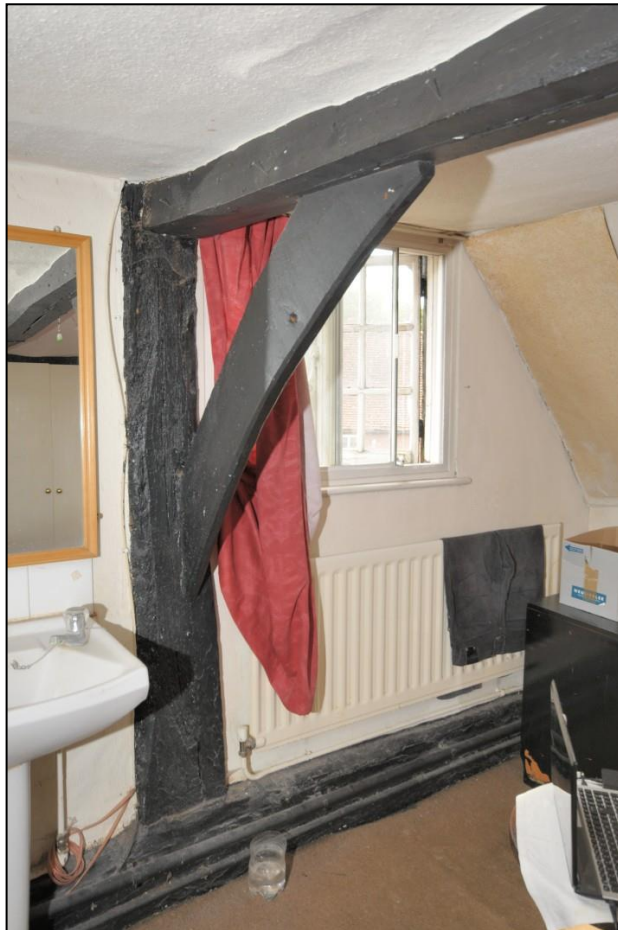
Image 11: No. 69 north-west cross-wing, second floor S1

Looking west, showing south-west gable end with tie-beam, post, crown-plate in ceiling and brace

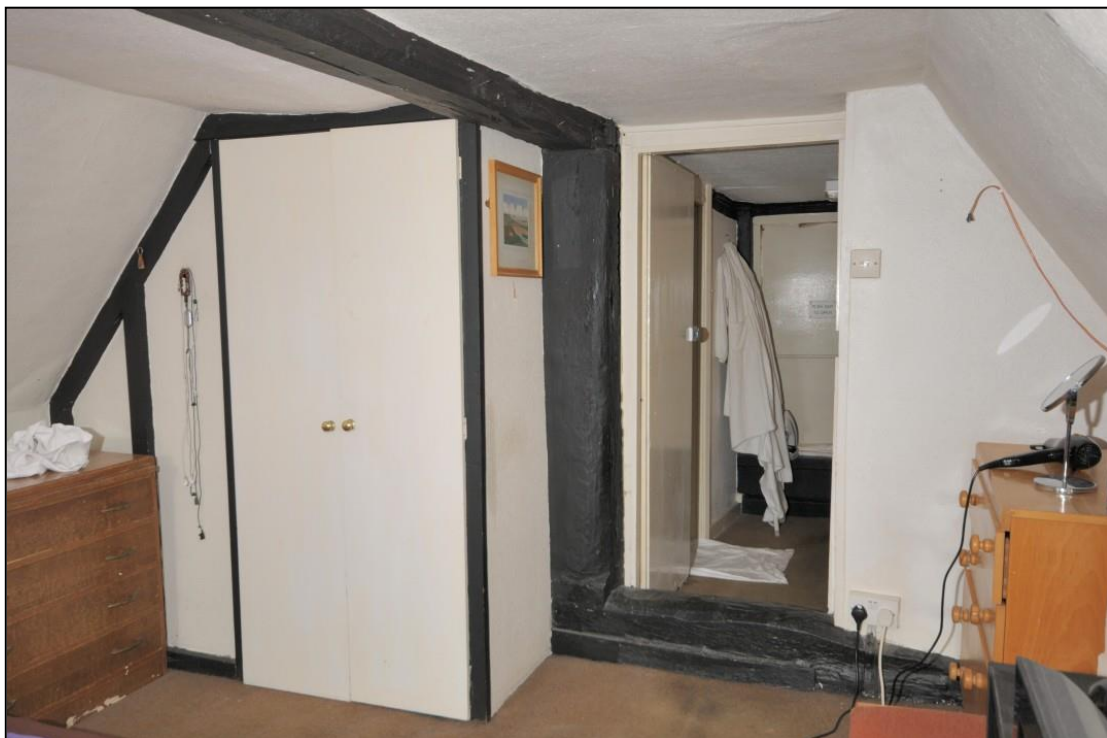
Image 12: No. 69 north-west cross-wing, second floor S1

Looking north, showing tie-beam at floor level, plain crown-post next to cupboard and crown-plate in ceiling

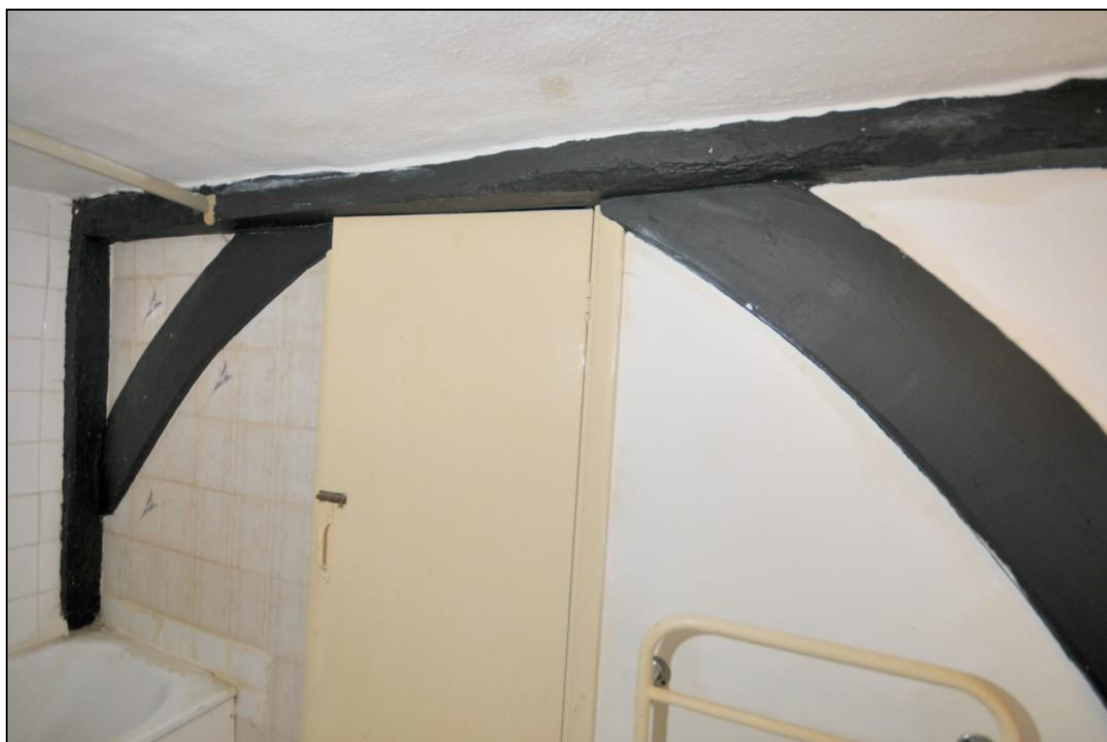
Image 13: No. 69 north-west cross-wing, second floor S2

Looking east, showing braces and crown-plate at ceiling level

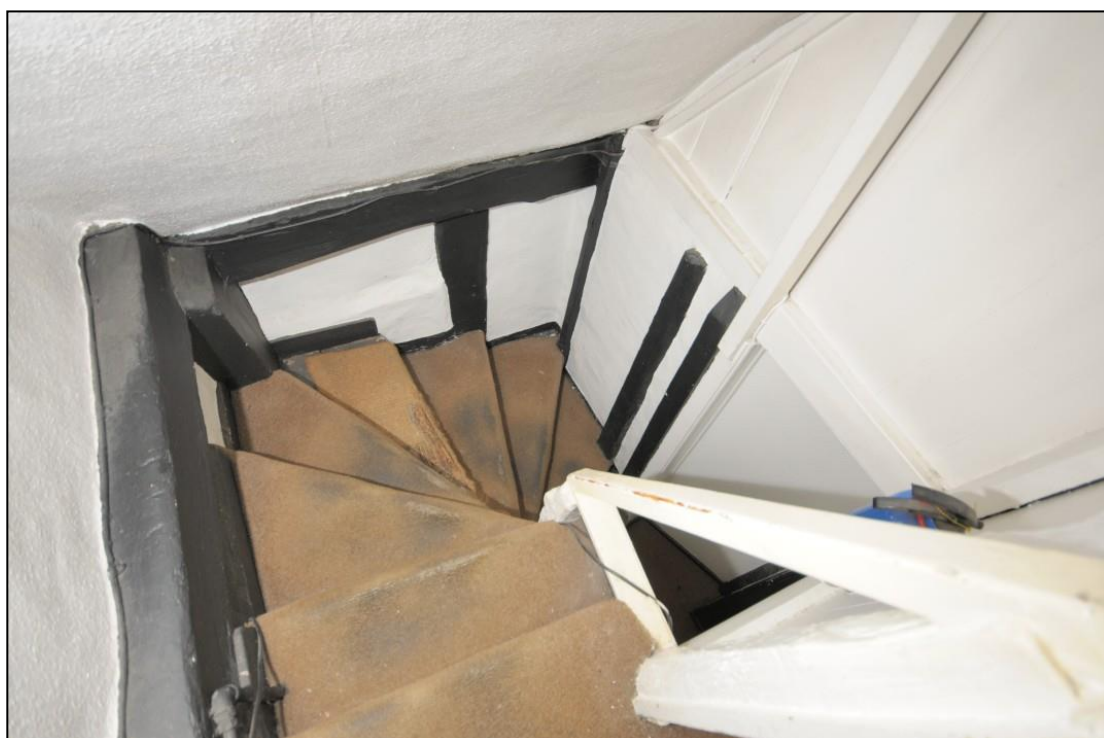
Image 14: No. 69 north-west cross-wing, second floor stairs

Looking down from second floor landing, the large beam at the left is the tie-beam in the north-east gable end of the cross-wing

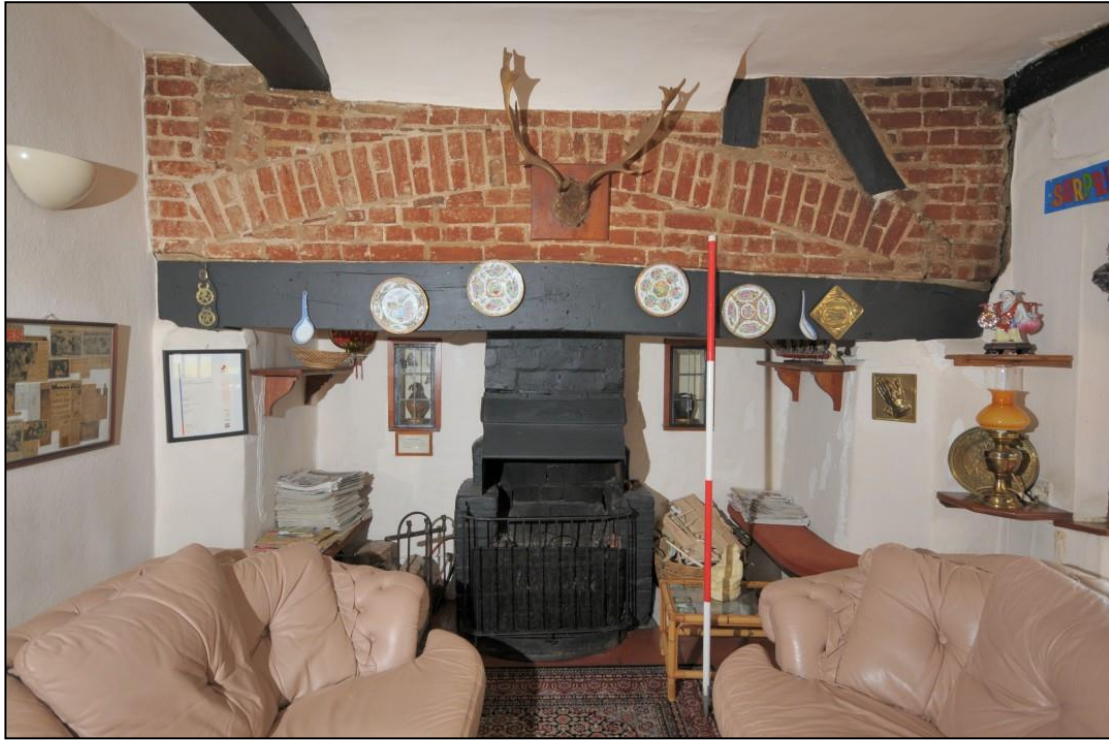
Image 15: No. 69 central range, ground floor G2

Looking south-east showing inglenook fireplace with axial ceiling beam visible at top left

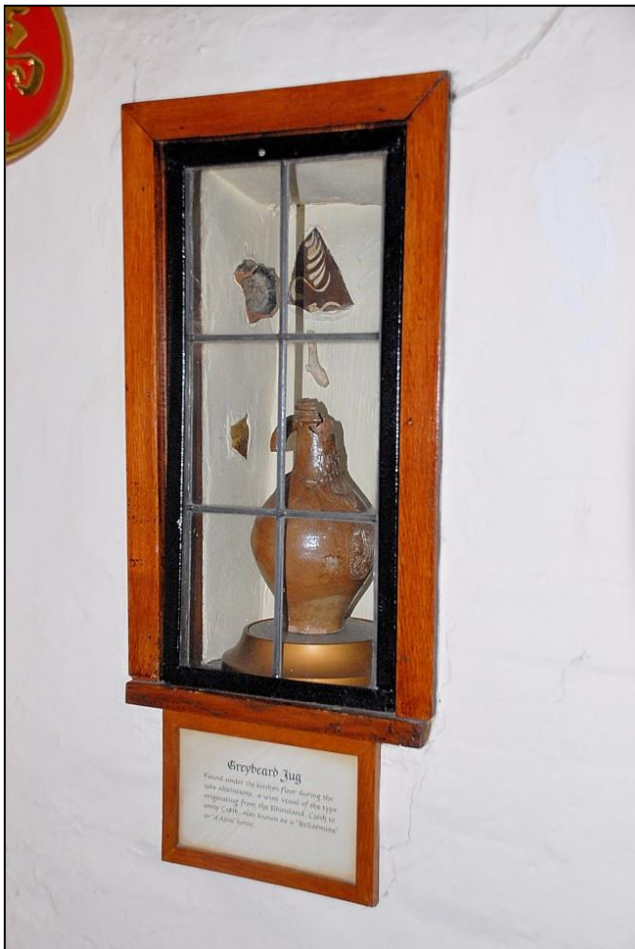
Image 16: Archaeological finds

Bellarmino jug and other finds displayed within the inglenook fireplace in G2

At the time of the building survey some archaeological finds were displayed inside the former George and Dragon in a niche within an inglenook fireplace. A label stated that these were found beneath the kitchen during construction work in 1964. The finds include a Bellarmine jug, slip decorated pottery and a clay tobacco pipe. Bellarmine jugs range in date from the early 16th to mid-18th century. The ovoid form of this example suggests a probable 17th-century date (Jackie Wells, pers. com.).

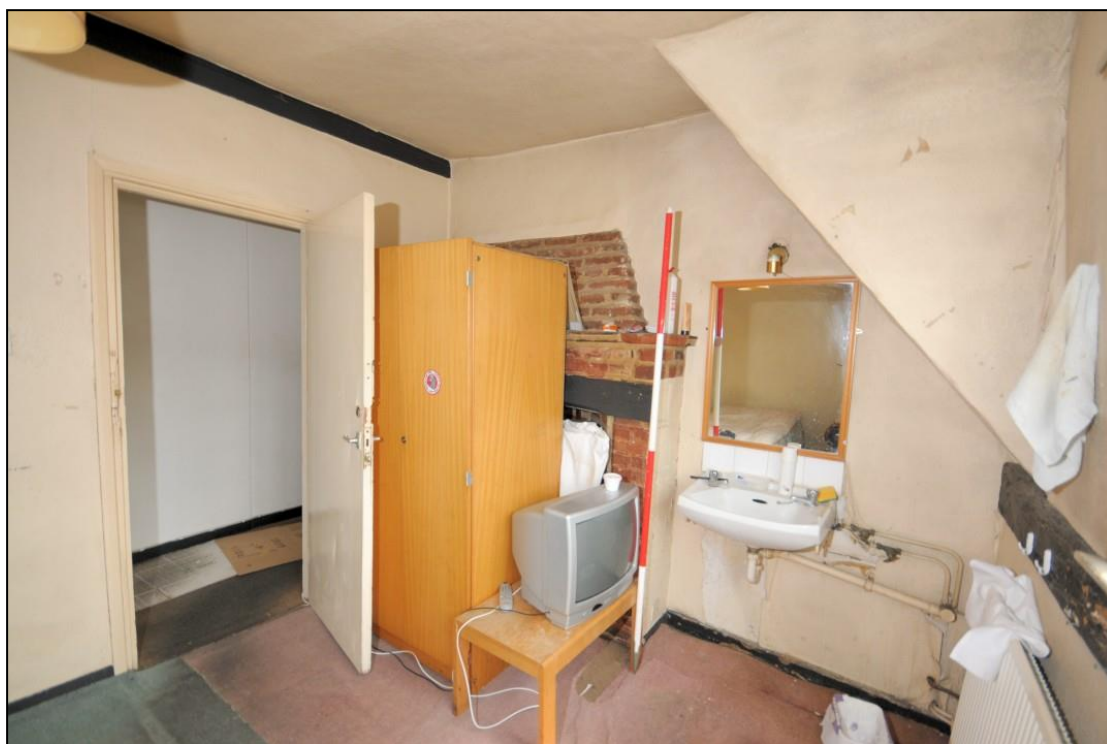
Image 17: No. 69 central range, first floor F3

View looking east, a brick fireplace is just visible behind the wardrobe and television, the wall to the left is a later insertion which cuts across the left-hand side of the fireplace

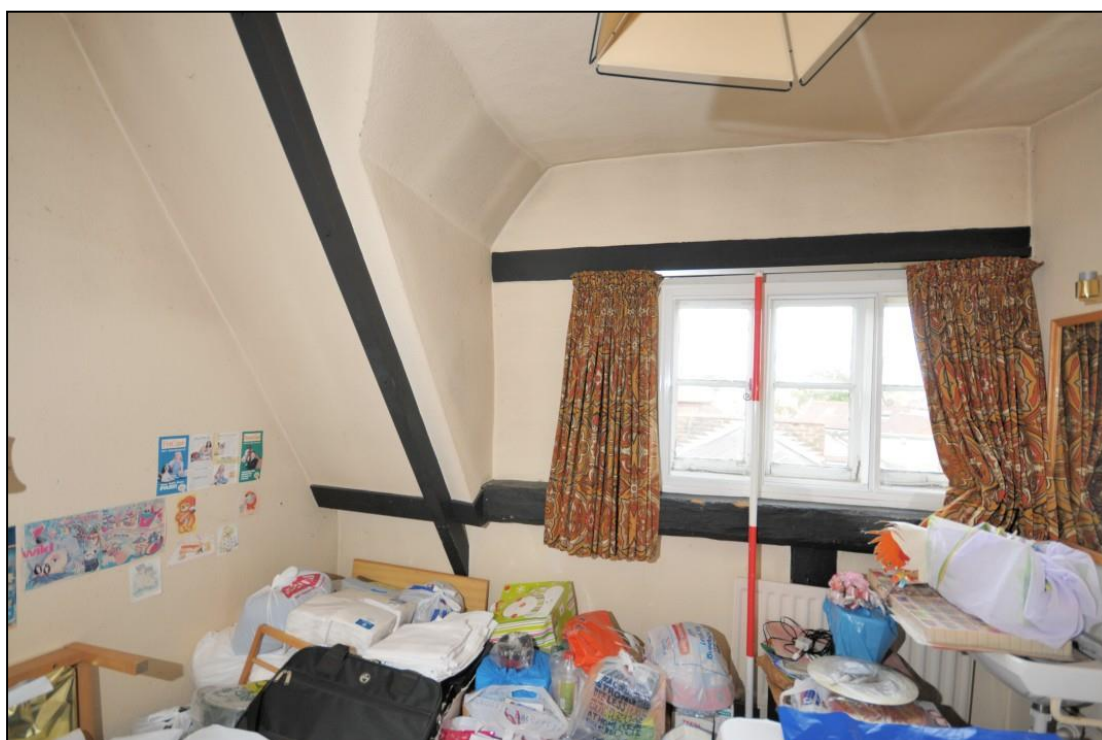
Image 18: No. 69 central range, first floor F4

View looking north, showing the wide dormer window

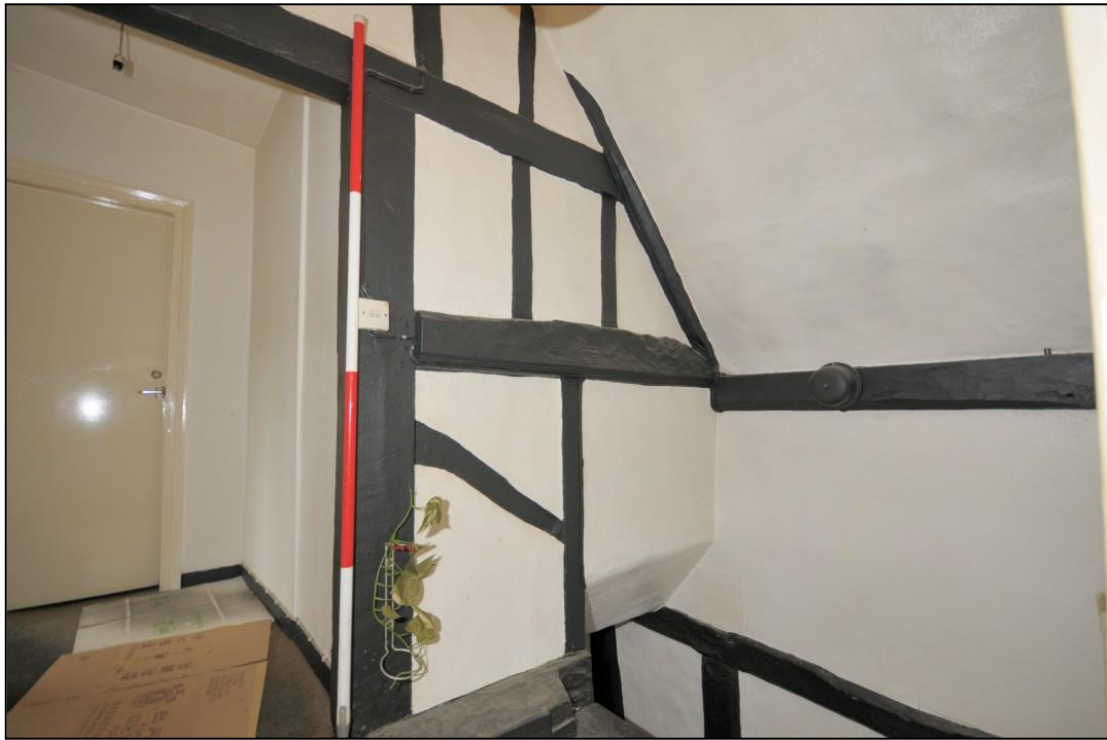
Image 19: No. 69 central range, first floor landing

Looking north, showing transverse frame above the stairs. The truncated tie-beam [level with the light switch] is moulded on its lower edge

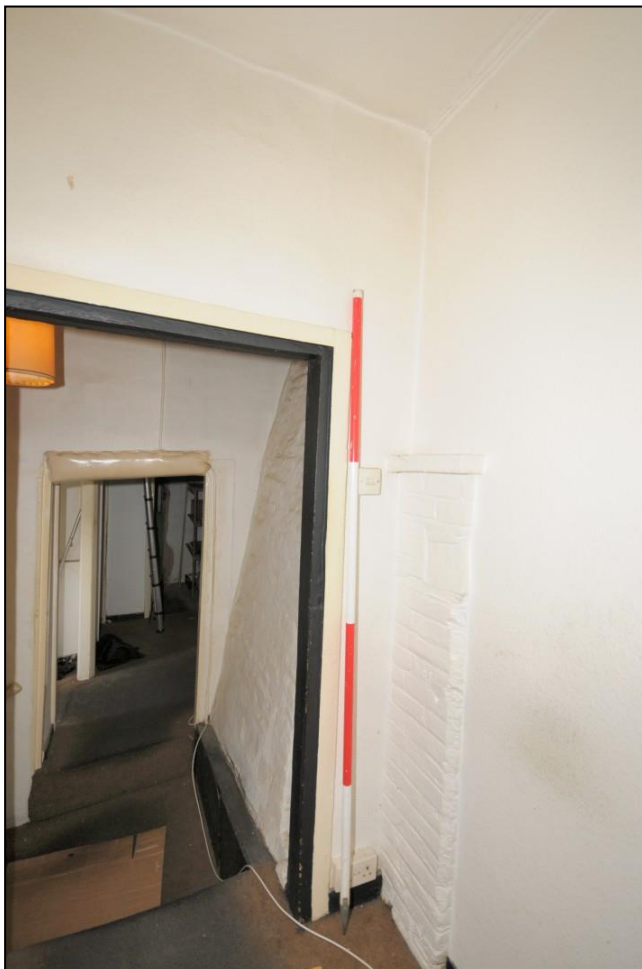
Image 20: No. 69 central range, first floor landing.

Facing south-east. The end of a brick fireplace in F3 is just visible poking through the inserted wall at the right. Behind it, through the door opening, the sloping side of the chimney stack is visible

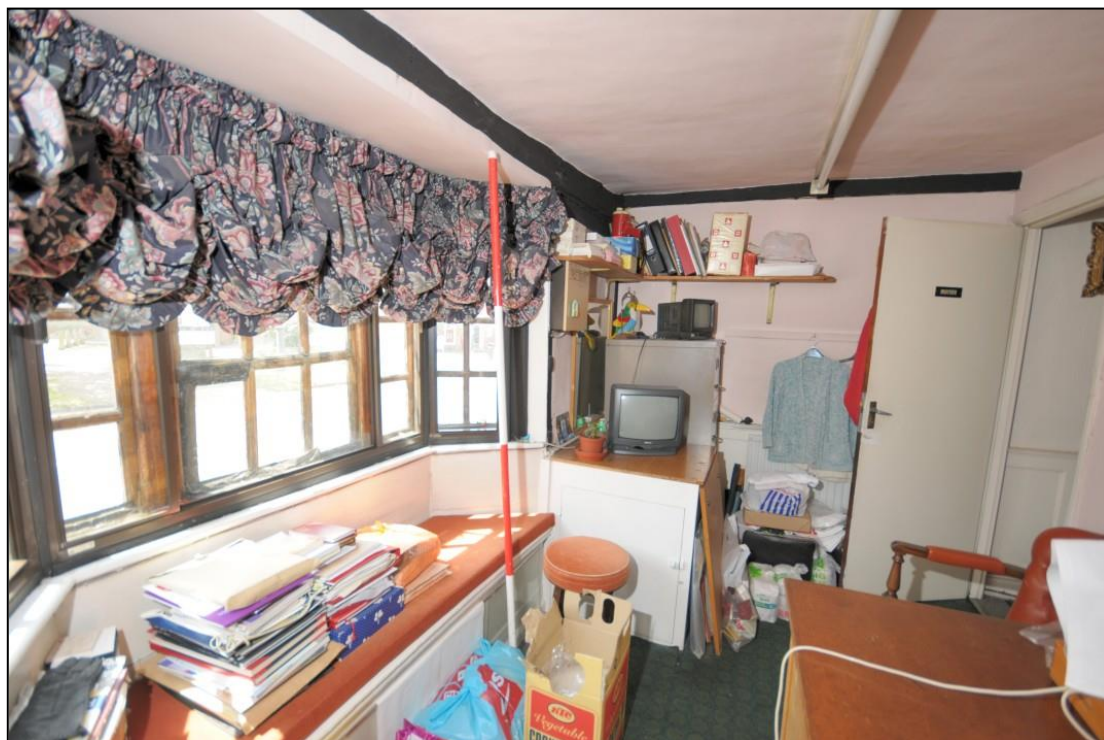
In the office parts of the girding beams on the south-west end and north-west sides of the cross-wing are visible at ceiling height (Image 21).

Image 21: No. 69 south-east cross-range, ground floor G3

View looking north-west, showing parts of the timber-frame at ceiling level

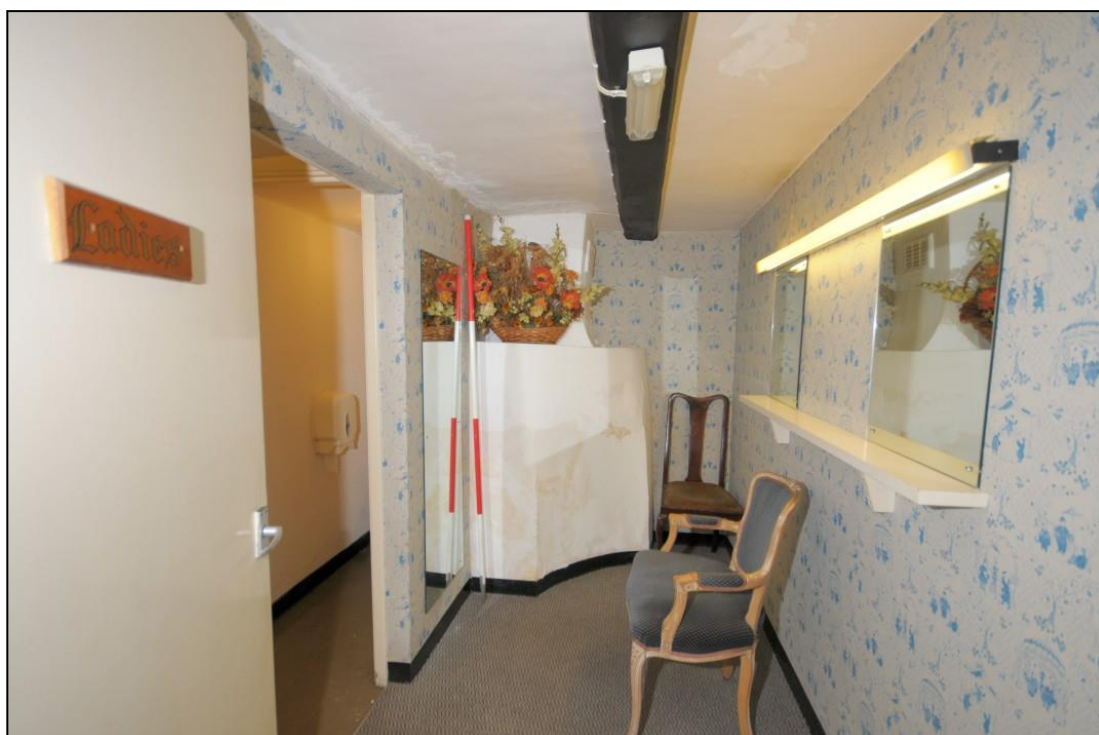
Image 22: No. 69 south-east cross-range, ground floor G4

View looking south-east showing block of masonry which abuts the rear of the chimney stack of No. 71

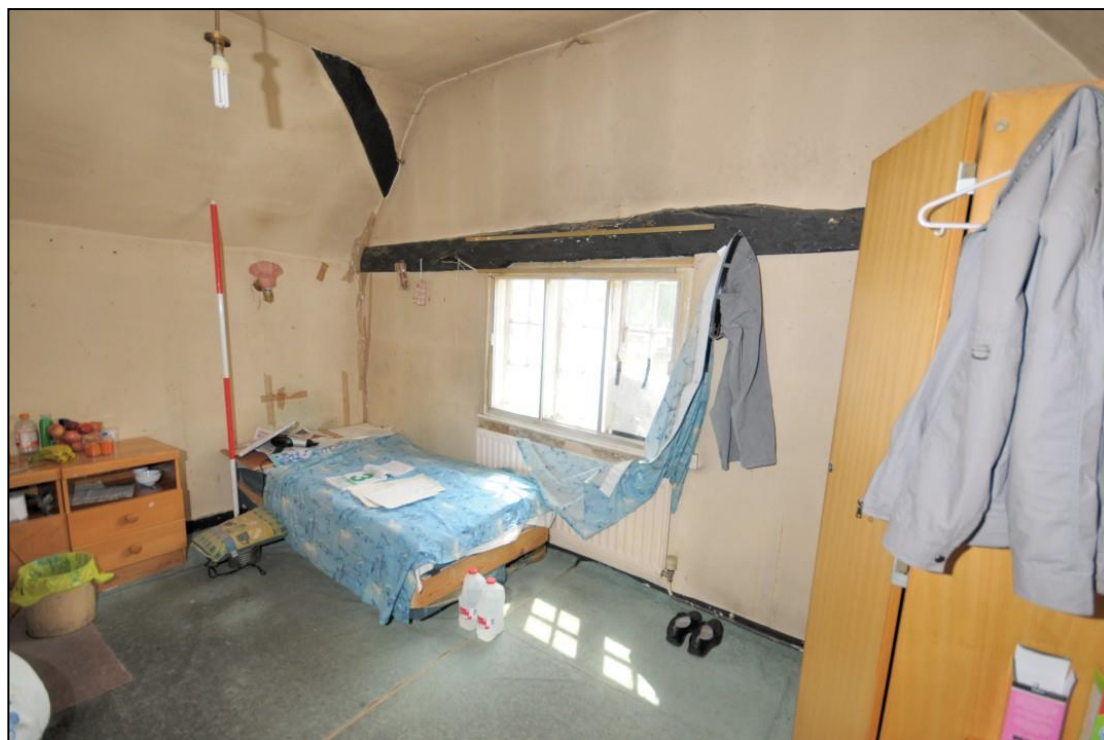
Image 23: No. 69 south-east cross-range, first floor F5

View looking south, showing the tie-beam over the window and a wind-brace above in the soffit section of the ceiling

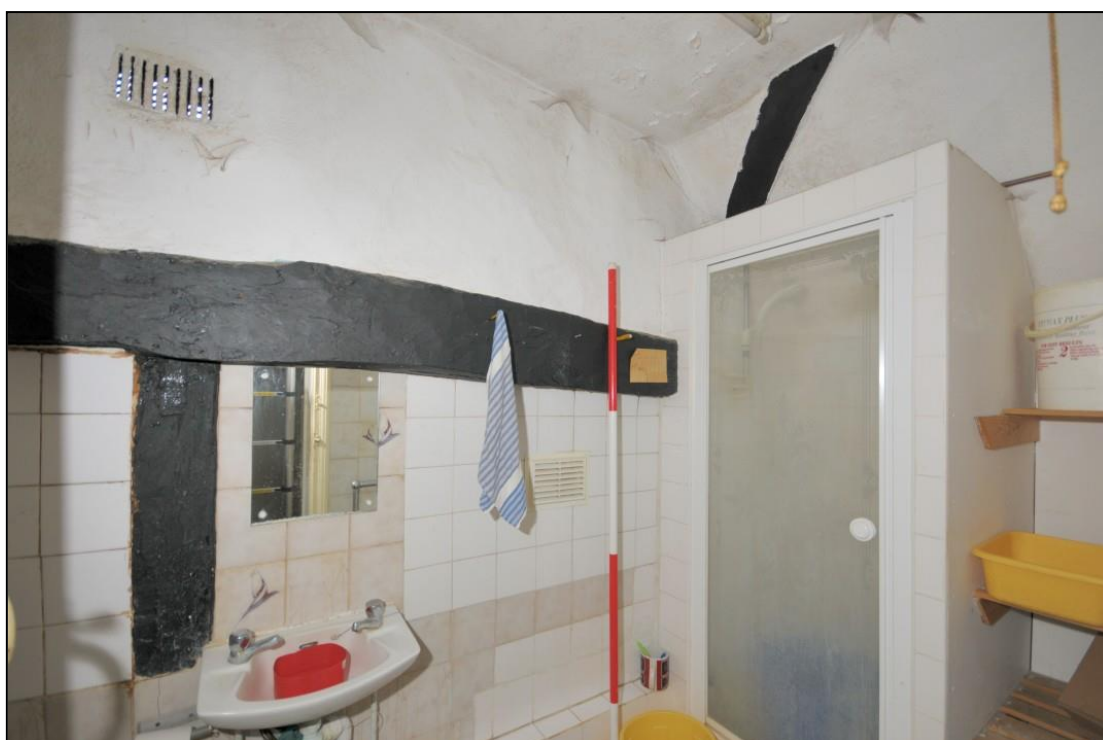
Image 24: No. 69 south-east cross-range, first floor F6

Looking east, showing tie-beam in gable end and wind-brace in soffit section of ceiling

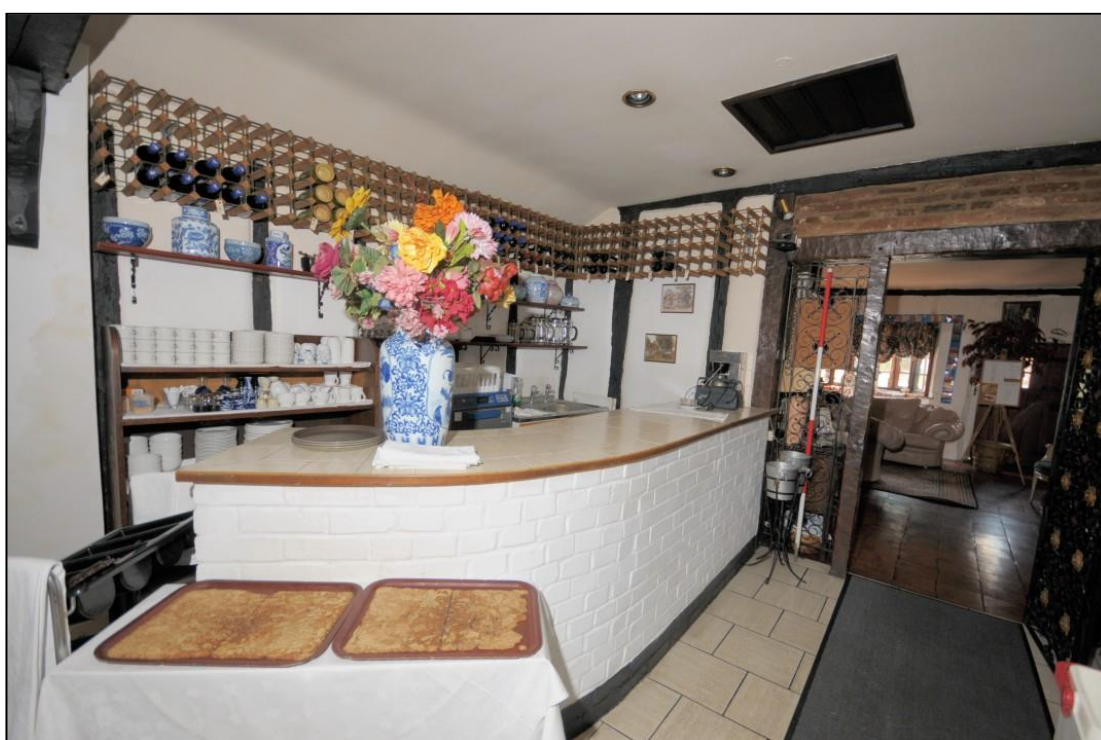
Image 26: No. 69 rear extension, ground floor G5

Facing south, showing timber studs in south-east side of room, the two timbers in the wall at the far end of the counter are part of the south-eastern side of the main building range

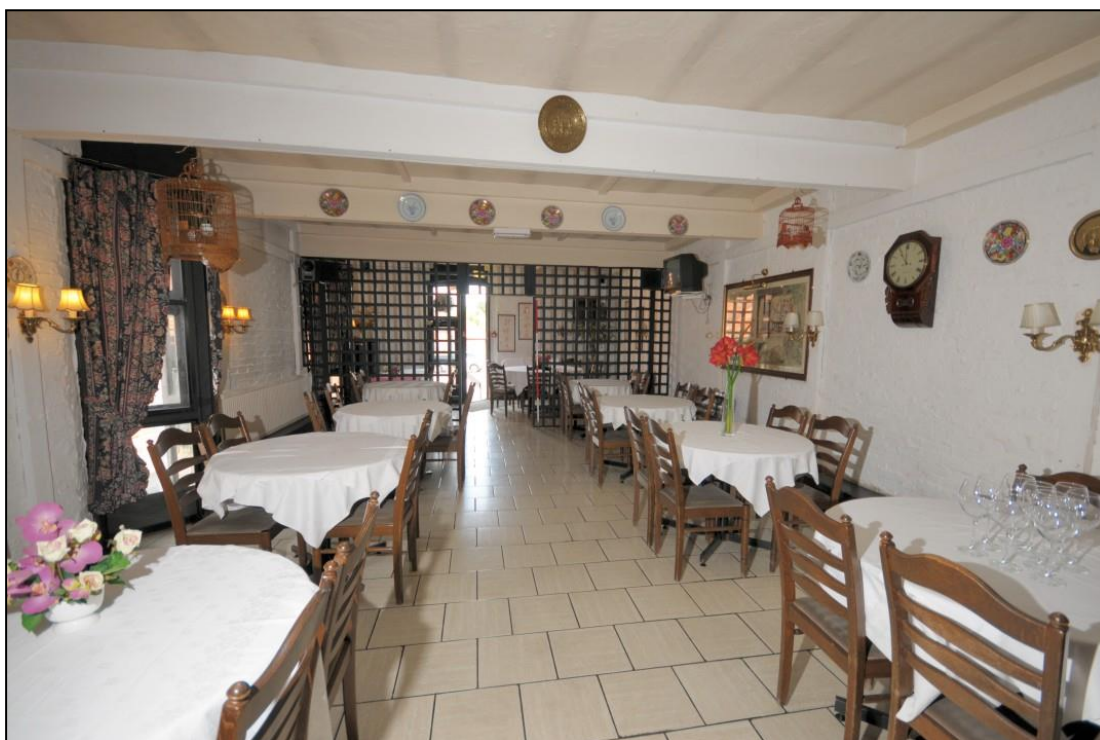
The main part of the dining room (G6, Image 27) and all of the kitchens (G7, Image 28) occupy a flat-roofed extension that was added in the second half of the 20th century.

Image 27: No. 69 rear extension, ground floor G6

Looking north-east

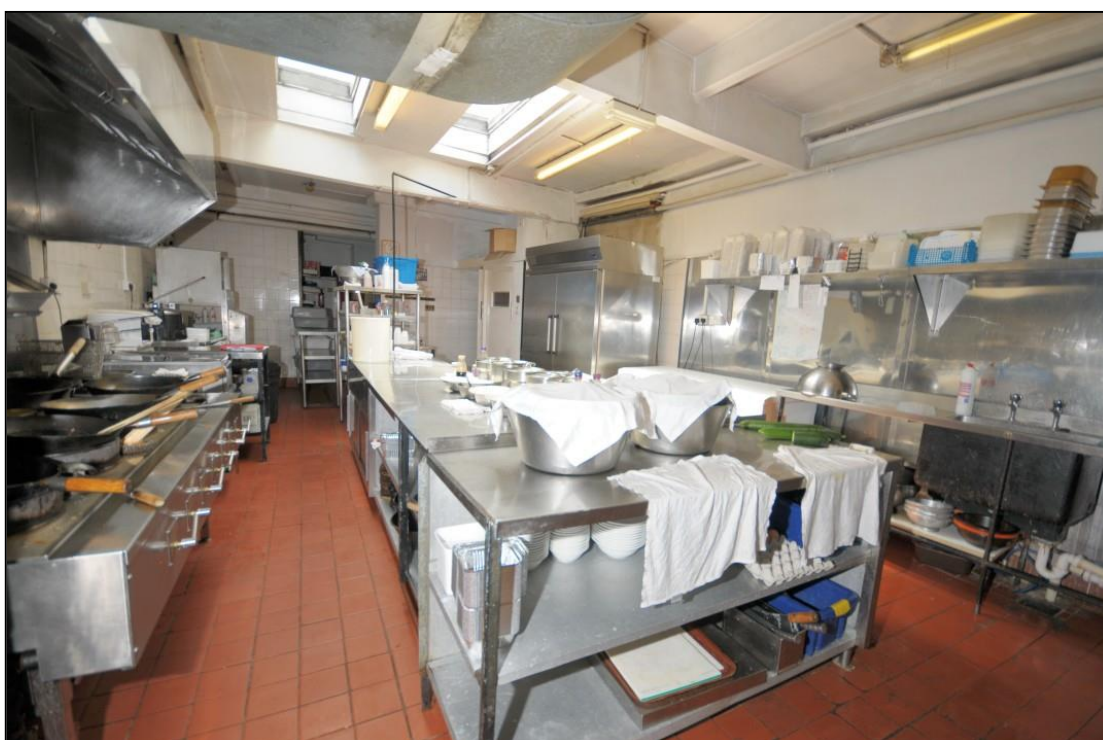
Image 28: No. 69 rear extension, ground floor G7

Looking south-west

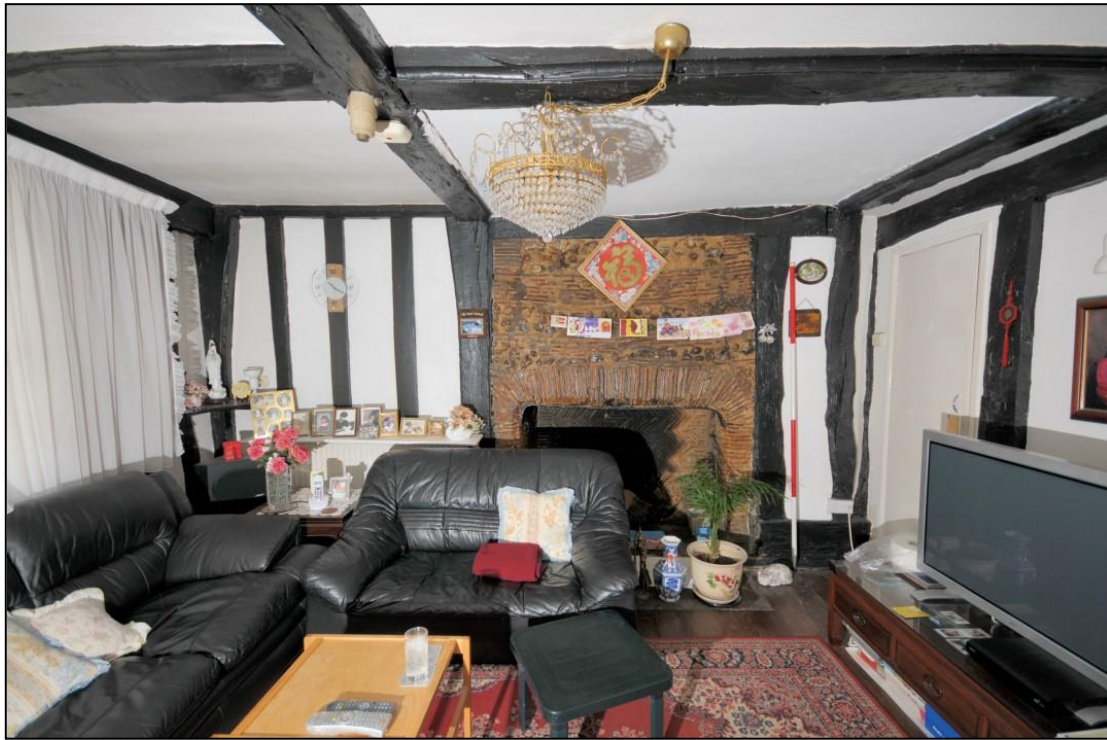
Image 29: No. 71 front-range, ground floor G8

Looking north-west. Shows fireplace, quartered ceiling, close studding in north-west wall. The wider spaced timbers in the wall at the right of the image are part of the south wall of the rear range
