**69-71 HIGH STREET, CODICOTE,  
HERTFORDSHIRE**

**HISTORIC BUILDING  
RECORDING AND ARCHAEOLOGICAL  
MONITORING**

Document: 2016/59  
Version: 1.0  
September 2016

Albion Archaeology Project Code: HSC2433  
OASIS ref: albionar1-220214

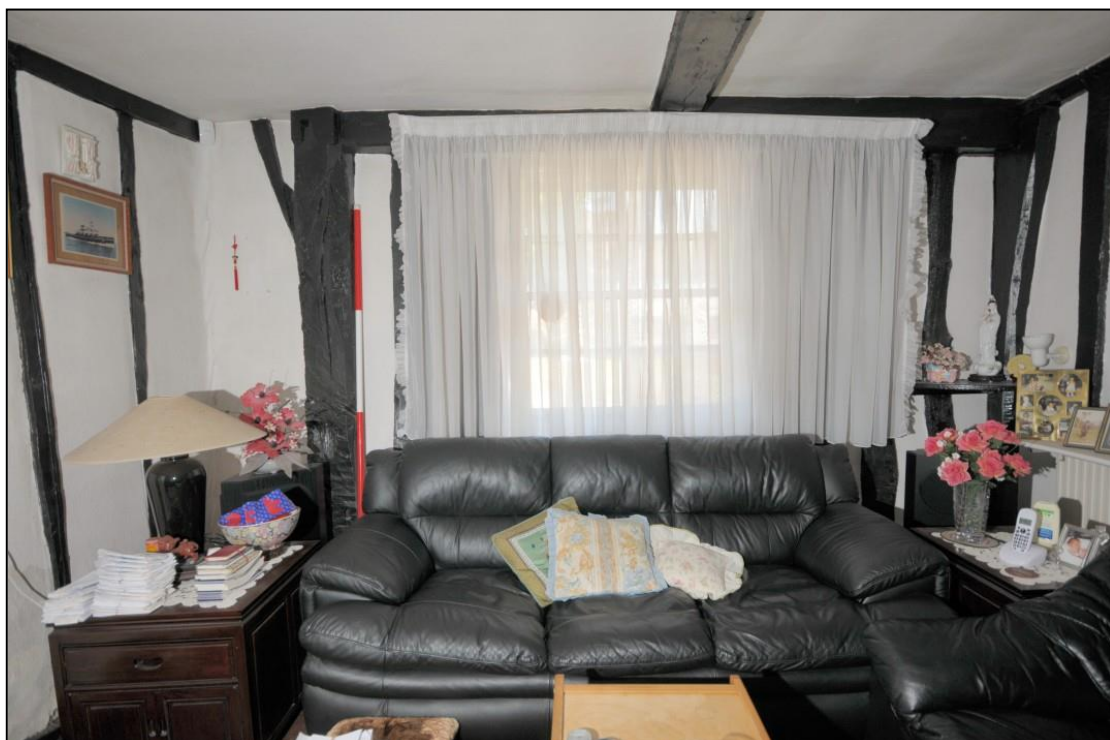
Image 30: No. 71 front-range, ground floor G8

Facing south-west. The post to the left of the window is a corner post, the timber at its top-left being part of a jetty bracket. The wall on the left was formed by under-building the jetty on the south-east side of this range

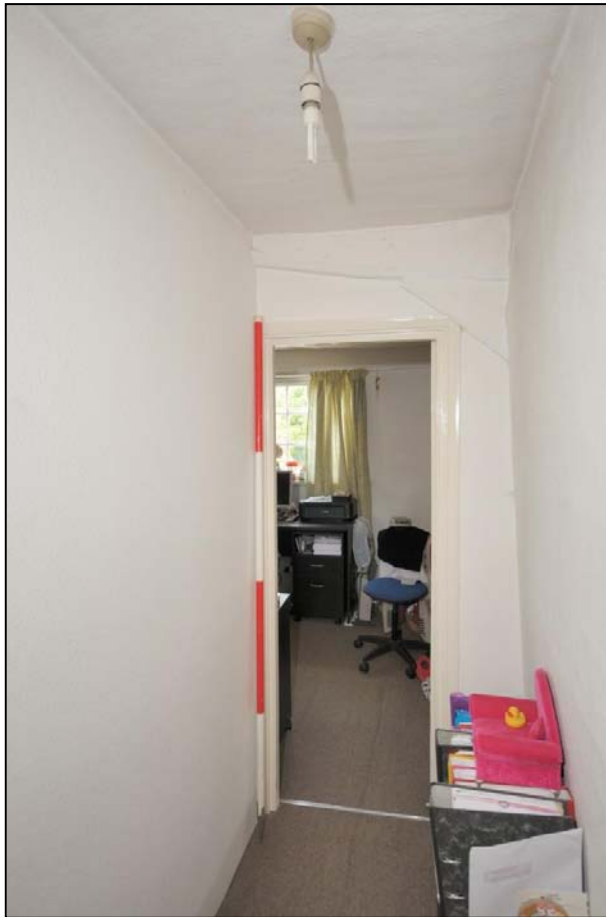
Image 31: No. 71 front-range, first floor landing

Looking south-west, showing door to F7. The end of a curved, tie-beam in the central bay division in this range is visible above the door frame.

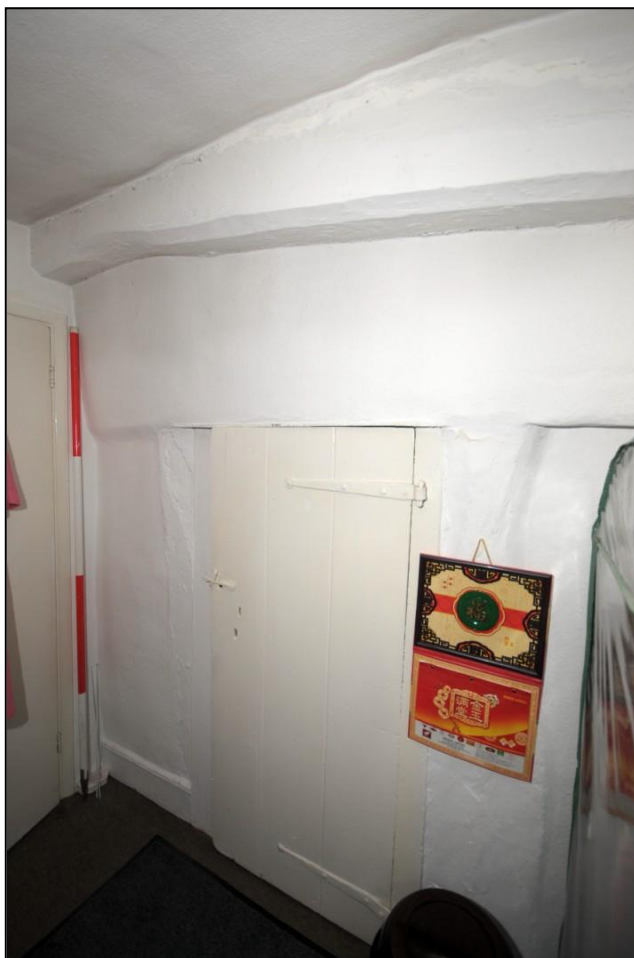
Image 32: No. 71 front-range, first floor F8

Facing north, towards the top of the image is the tie-beam in the rear truss of the front-range. Below it is the wall-plate for the southern wall of the rear-range. The post to the right of the door is part of the central truss of the rear range. The door is a three-plank door with hand-made strap hinges.

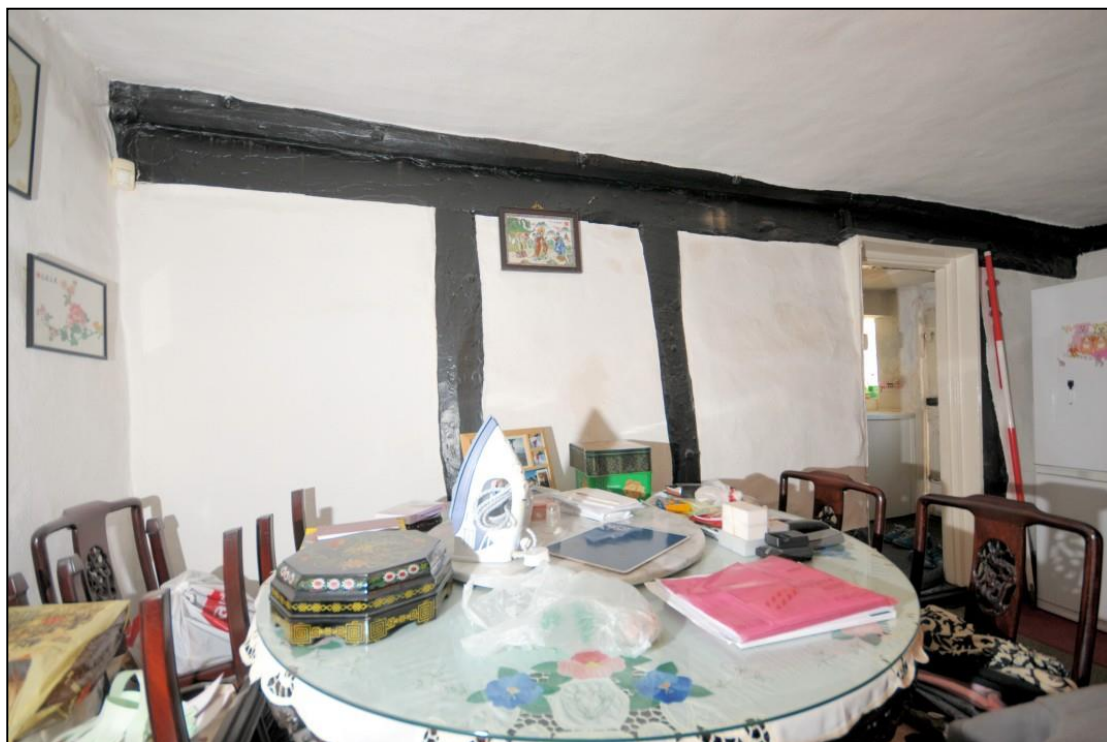
Image 33: No. 71 rear-range, ground floor G10

Looking north-west, showing frame at bay division with applied beam supporting floor over G10

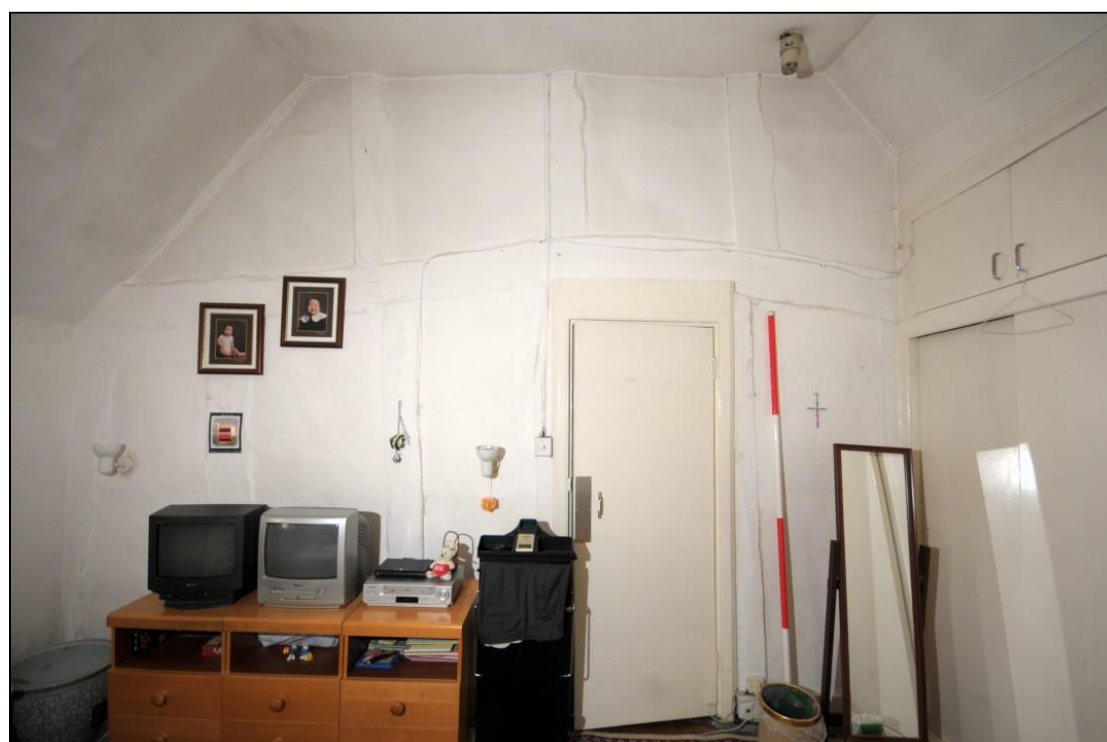
Image 34: No. 71 rear-range, first floor F10

Looking north-west showing frame at bay division with curved tie-beam above door

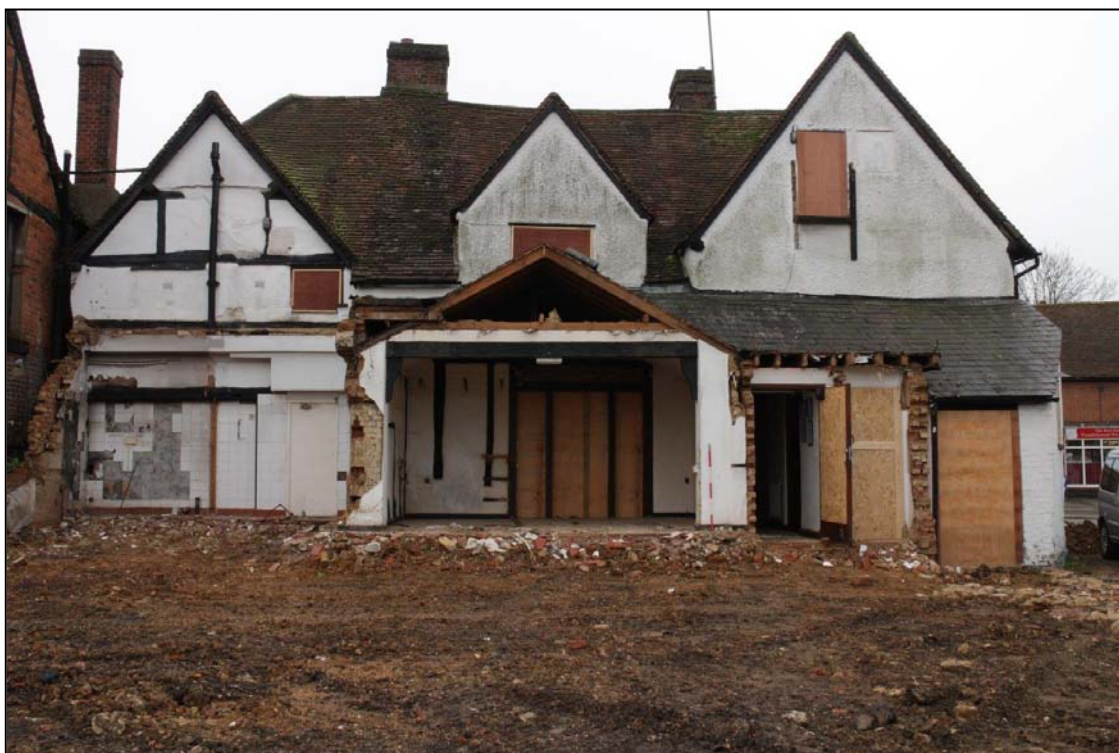
Image 35: No. 69, rear elevation after demolition of modern extension  
Looking south-west, showing rear elevation with north-west cross wing at right

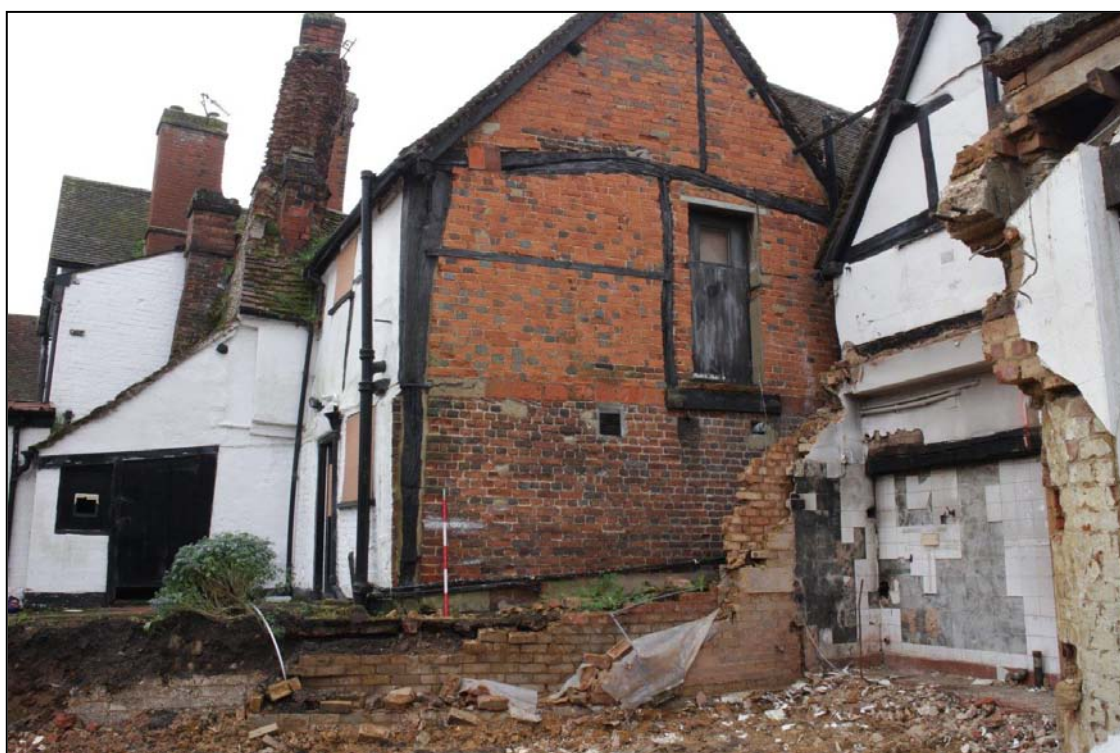
Image 36: No. 71, north-west end of rear range

The north-west end wall of the rear range is in timber frame that has been encased in brick (Image 36). The lower part of the wall has brick infill consisting of old red brick in English bond. Immediately above, the girding beam (end girt) has been covered with a row of plain roof tiles, attached flat to the face of the wall. The frame in the upper part of the wall has been partly replaced or filled with fairly regular red bricks with darker blue-grey headers laid in Flemish bond.

Shows brick infill with brickwork at first floor and gable matching brickwork in front elevation of outbuilding (see below)

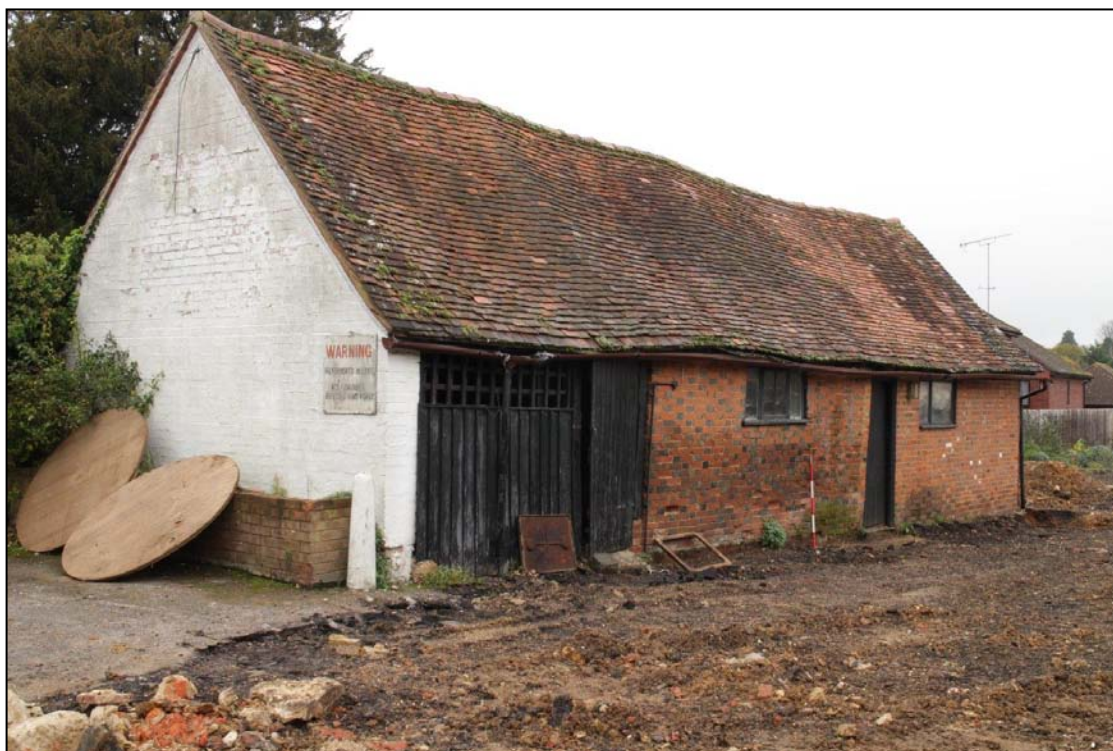
The west end of the building is made of modern Fletton-type brick (Image 37).

Image 37: Outbuilding, west end and south front

Looking north-east showing modern brick end wall at left, weatherboard on compartment C1 and brick front on C2-C4

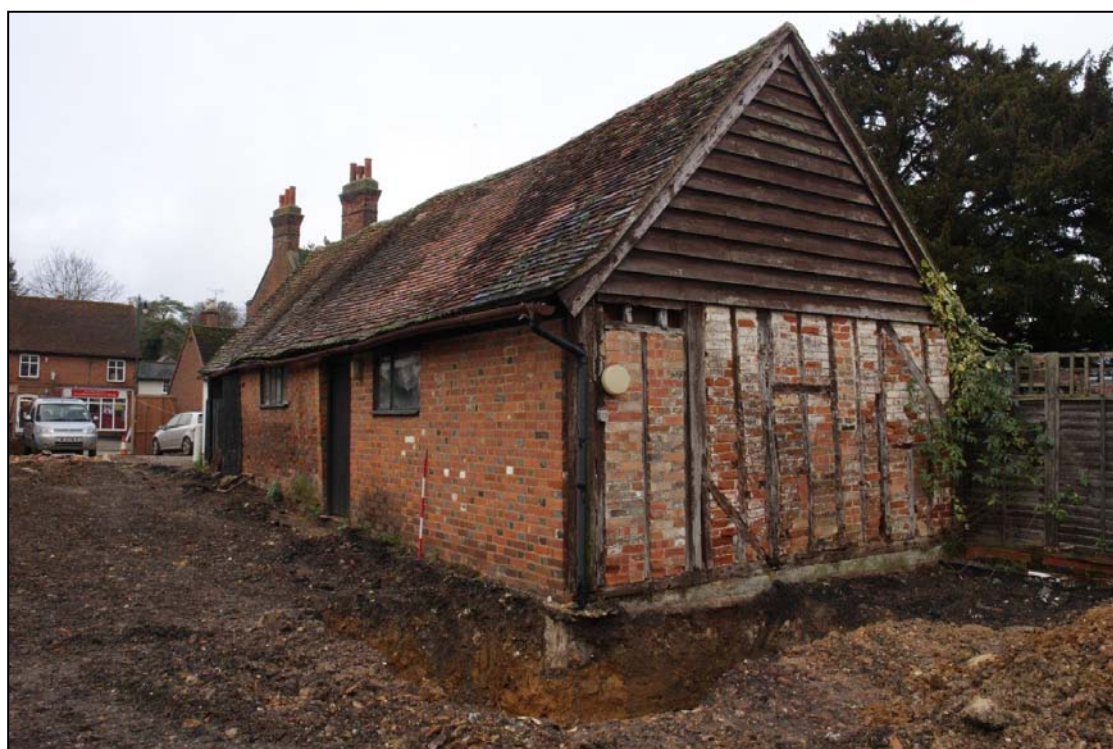
The building measures 13.6m long by 5m wide externally (Images 37 to 40).

Image 38: Outbuilding, east end and south front

Looking north-west showing timber framed end wall

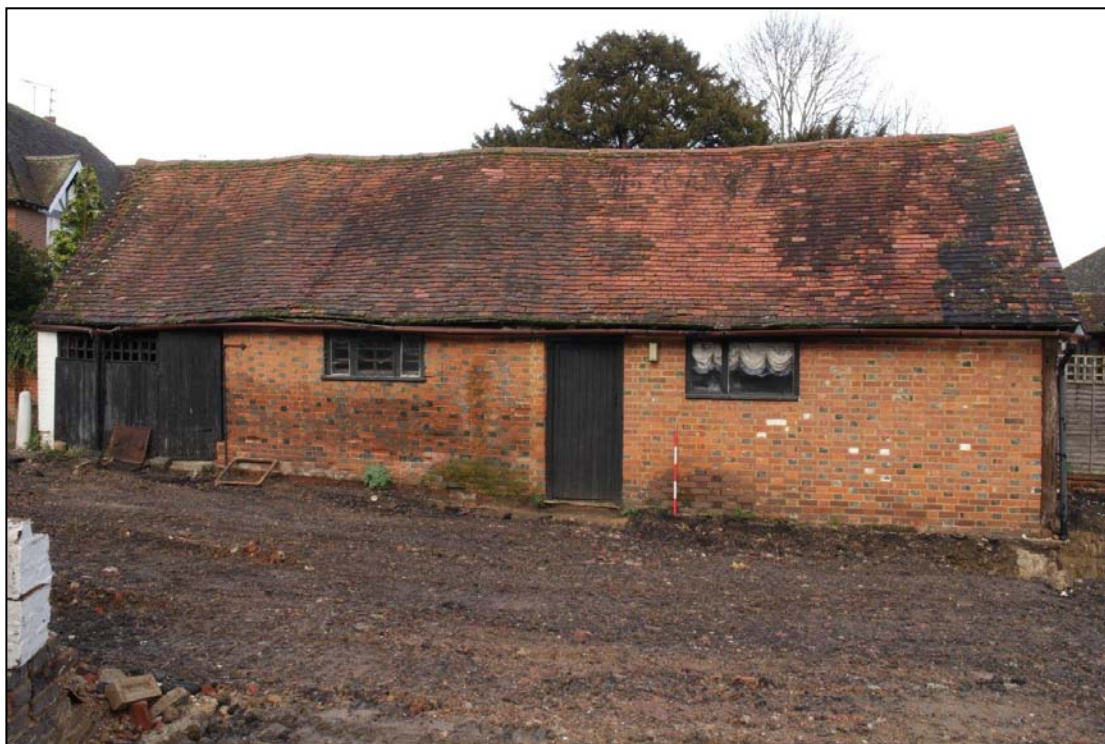
Image 39: Outbuilding, south front

The south front contains two modern plank doors and windows with modern wood frames (Image 39). Most of the wall is in brick whilst a short section on the westernmost compartment of the building is in weatherboard. The brickwork is in Flemish bond with red bricks (measuring c.220 x 105 x 60mm) and burnt headers producing a semi-chequer effect. The mortar is cream coloured with coarse grit inclusions. The brickwork in the right-hand half of the wall and in the left-hand jamb of the central door has been repaired or possibly rebuilt relatively recently. This has modern cement pointing and included some new red brick. The weatherboard at the left-hand end of the elevation is from machine sawn vertical boards with an opening below the eaves.

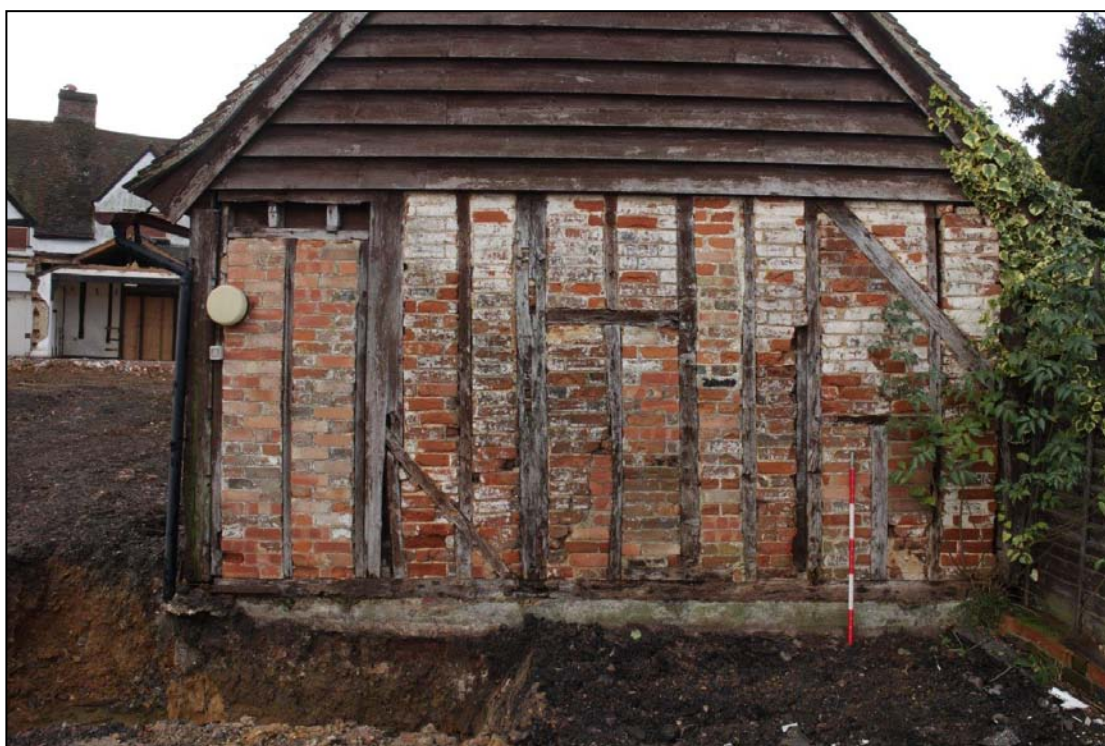
Image 40: Outbuilding, east end

The east end is in timber frame with brick infill and weatherboard on the gable (Image 40). The frame consists of posts and lightweight studs with some primary bracing. One re-used post in the central part of the wall contains empty mortise holes which have been filled with tile and mortar. The brick infill in the wall consists of weathered red brick with traces of white colourwash. Occasional Fletton bricks indicate modern repairs. Two panels on the left-hand side of the wall with infill mostly of Fletton brick appear to mark the location of a former door opening.

Timber frame with brick infill with probable former door opening at left hand side  
(scale 1m)

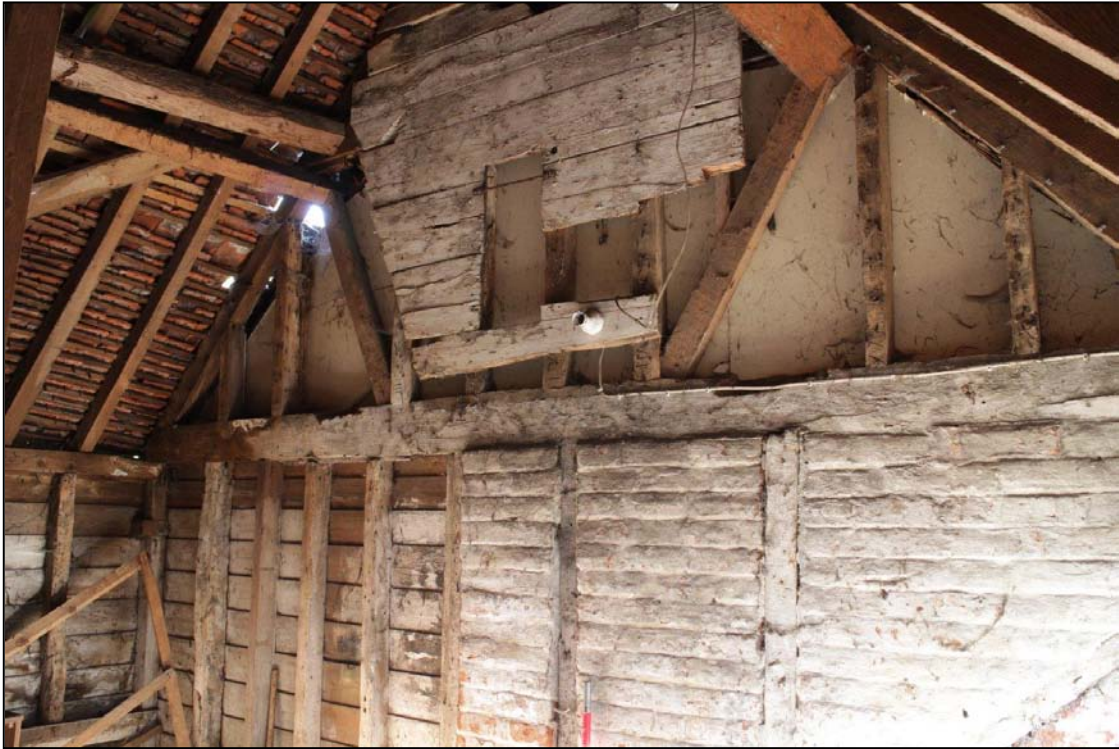
Image 41: Outbuilding, compartment C1 east wall

of an internal lining of horizontal boards. The bases of the studs are incised with assembly marks; a sequence of Roman numerals 1 to 10 running left to right. Numbers 3 and 8 are missing from the sequence where the queen struts have been removed.

Looking north-east, modern raking struts above the tie beam support inserted modern purlins. Damaged sections in the top of the tie beam indicate where queen struts have been removed. Part of the rear wall is visible at left

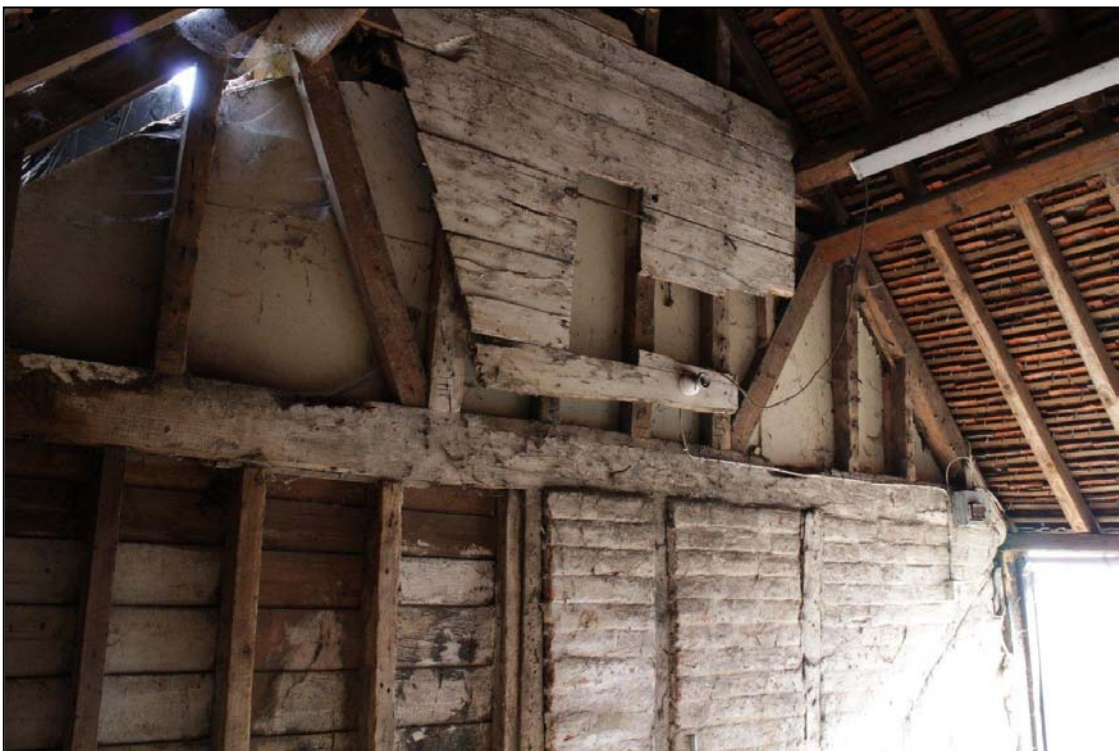
C1 at the western end of the building was used as a store at the time of the survey (Images 41 to 43). The north wall is timber framed with closely set studs and external weatherboard cladding. The south wall is modern, consisting of vertical weatherboard. The west wall is a modern brick wall. The timber framed eastern wall forms a bay division with a roof truss above (Images 41 and 42). Below the tie beam the north half of the wall is made from studs and horizontal boards, while the south half consists of primary bracing with brick infill. Above the tie beam the wall is framed with eight studs. Two damaged areas between the studs show where the queen struts have been removed from this roof truss. The studs carry remnants

Image 42: Outbuilding, compartment C1 east wall

Wall shown in previous image, looking south-east

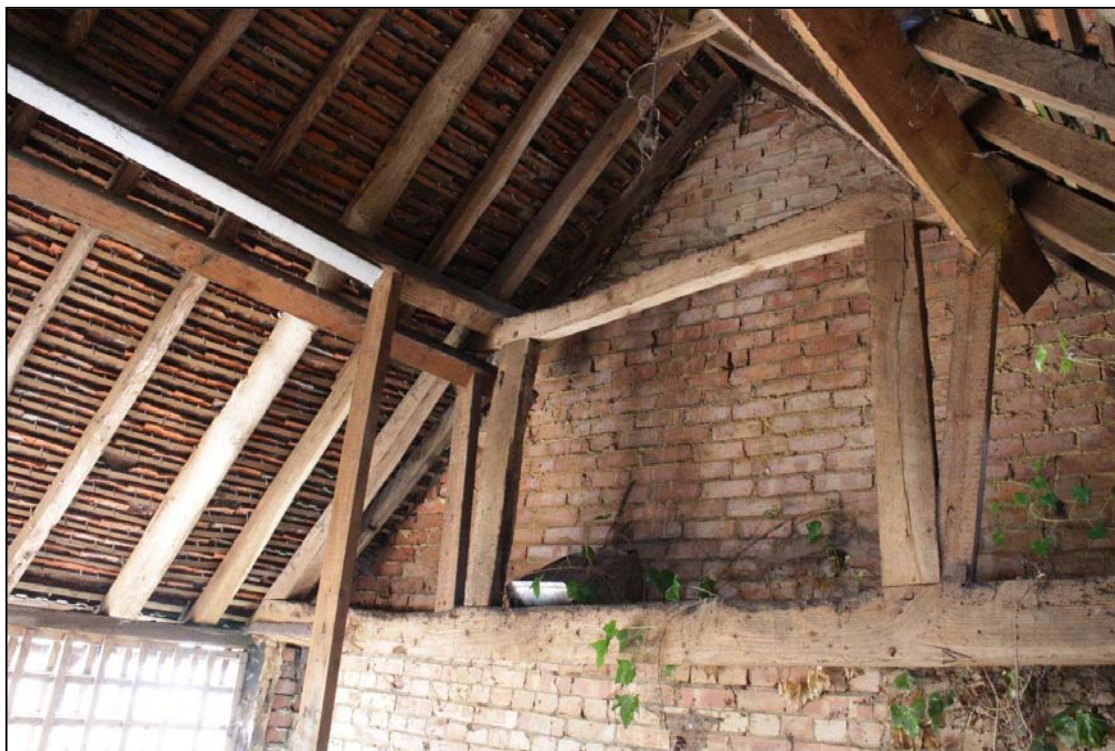
Image 43: Outbuilding, compartment C1 roof structure

Looking south-west showing clapsed purlin construction with queen struts linking the collar and tie beam. Modern purlins have been inserted below the collar to

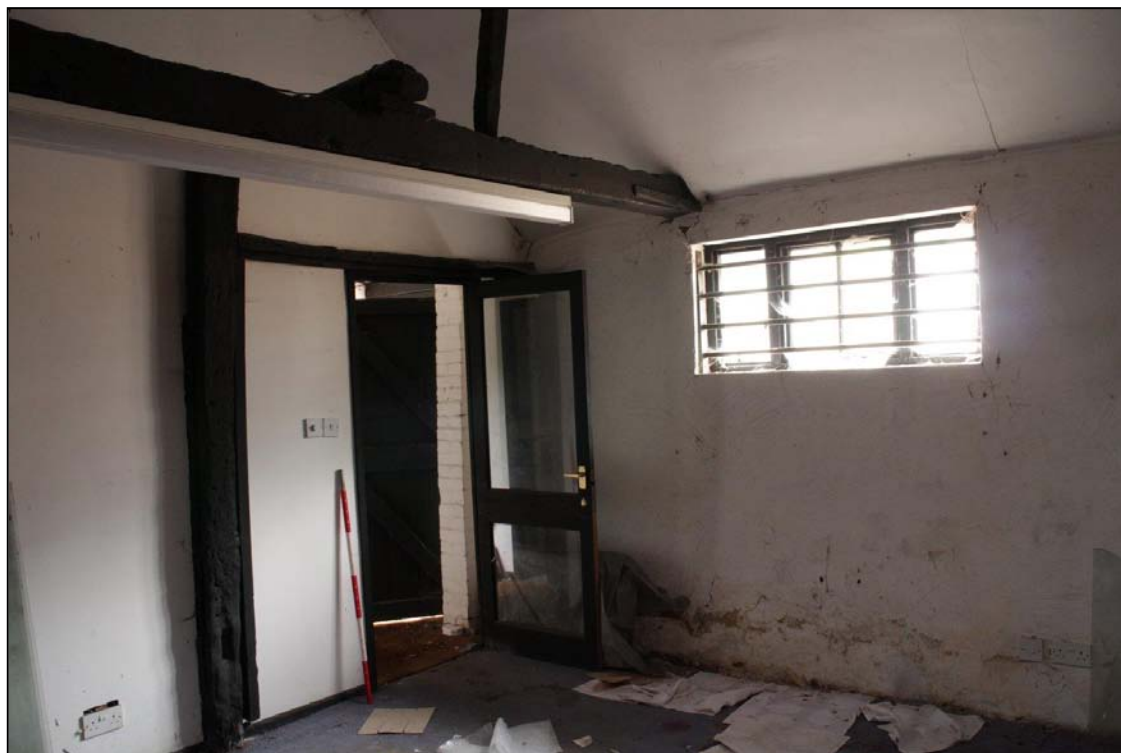
Image 44: Outbuilding, compartment C2

Looking south-east with modern stud wall partition at left (scale 1m)

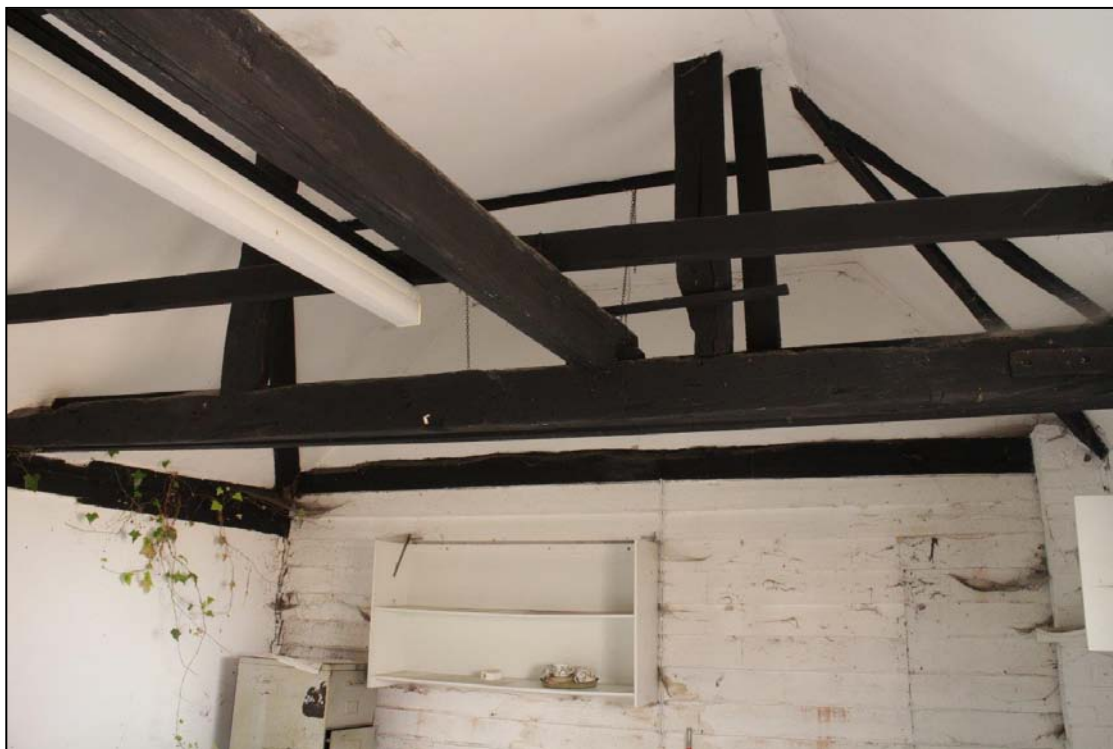
Some modern repairs had been carried out to the roof. In compartment C4 additional sections of timber (shown in blue on Figure 8) were bolted alongside the existing tie beams. In compartment C1 where the roof was visible another set of purlins had been inserted just below the level of the collar beam. These appeared to extend into the roof above C2.

Image 45: Outbuilding, compartment C4

Looking north-west showing easternmost roof truss

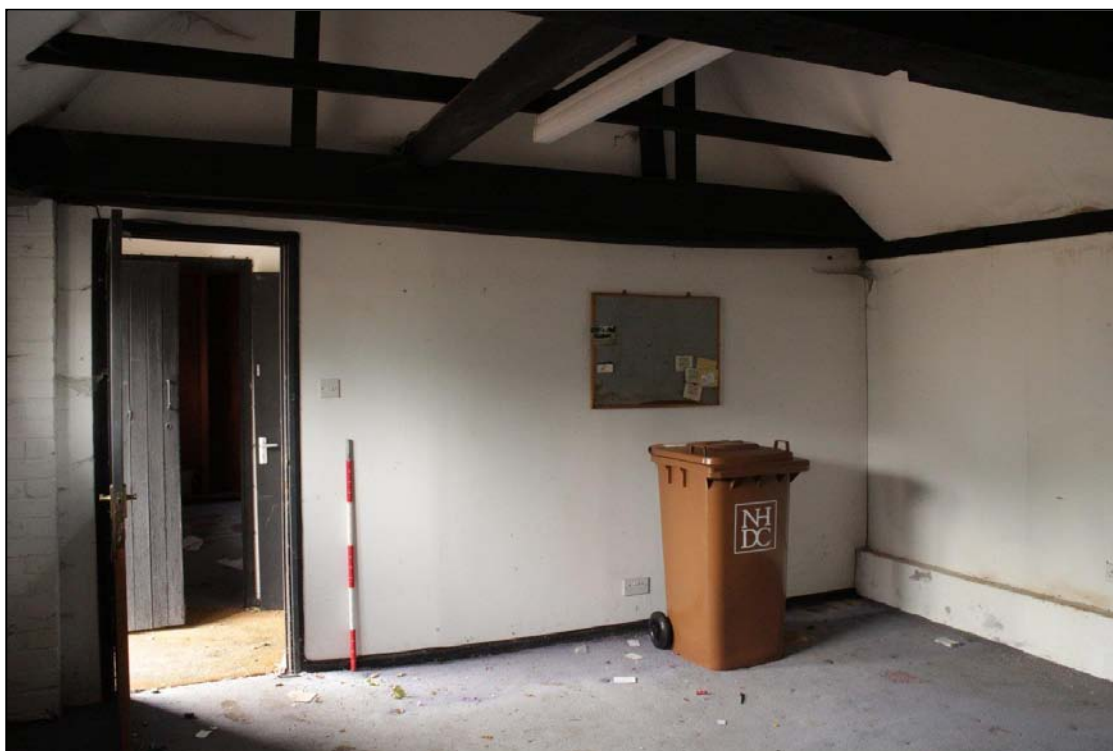
Image 46: Outbuilding, compartment C4

Looking south-west with modern stud wall partition behind bin (Scale 1m)

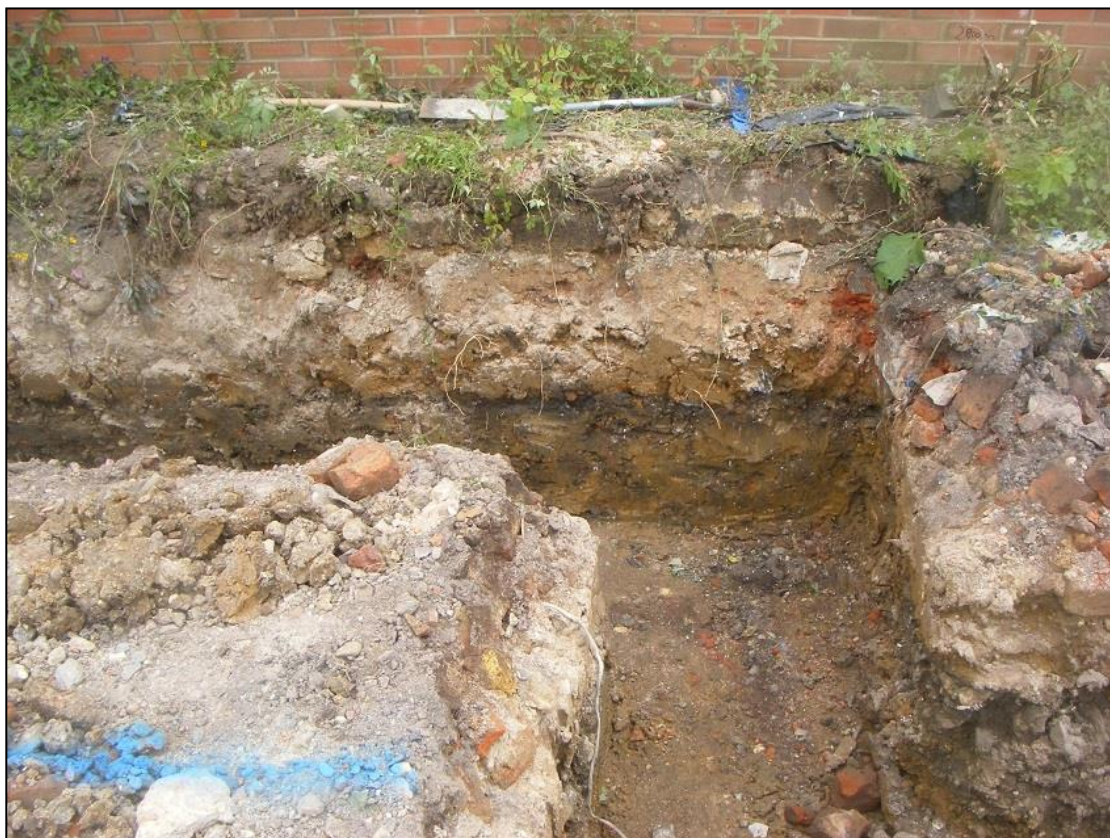
Image 47: Archaeological monitoring: house plot eastern section

The foundations were excavated to an approximate maximum depth of 0.78m from ground level. Towards the eastern site of the house plot, the deposits revealed included a brown grey buried topsoil and a brown orange buried subsoil, measuring 0.08m and 0.23m+ respectively. Overlaying this were make-up layers (0.3m thick) and a modern dark brown grey clay silt landscaping topsoil, (0.17m thick) (Image 47). These deposits correspond accurately with the overburden layers found within evaluation trench 1 (Albion Archaeology 2015b).

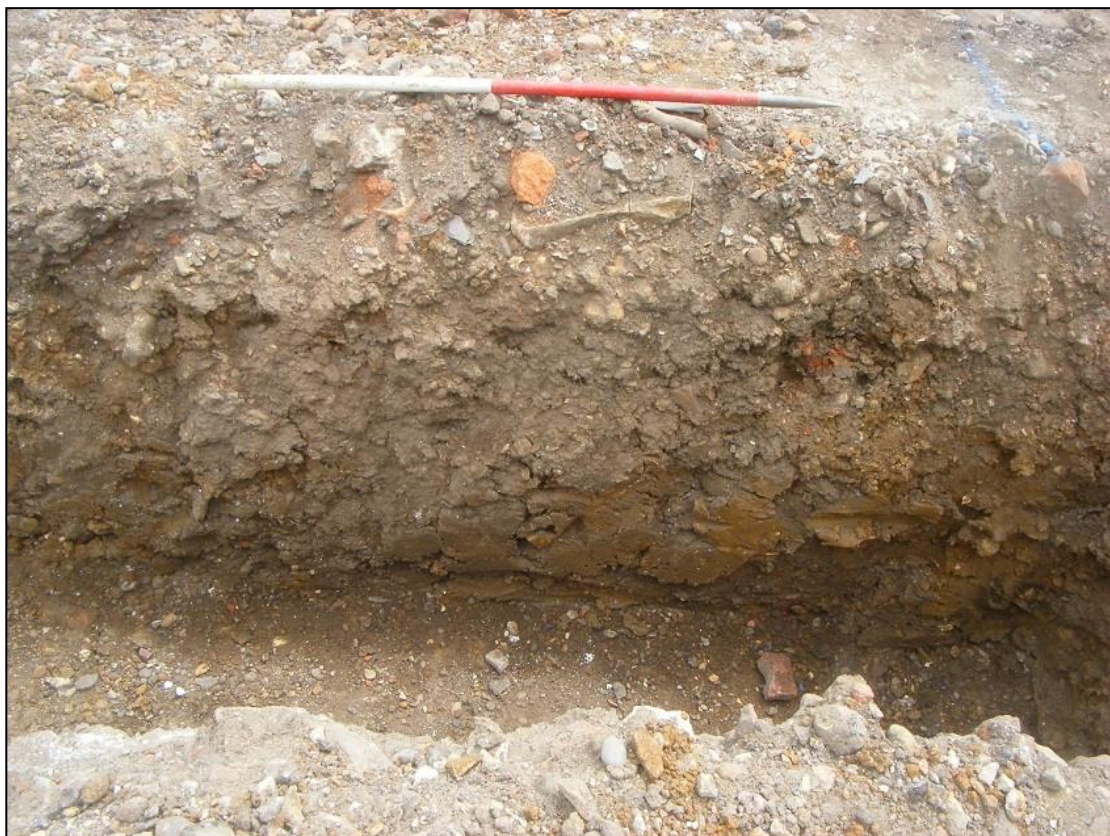
Image 48: Archaeological monitoring: house plot western section

The foundations at the western end of the building plot revealed a continuation of make-up layers and buried topsoil, again corresponding to the evaluation trenches (Image 48). A modern land drain was identified at the southern edge of the foundations. This is most likely the modern ditch [205] identified and excavated in evaluation trench 2.
