**WOOD END FARM
WOOD END, NASH
BUCKINGHAMSHIRE**

ARCHAEOLOGICAL MONITORING

Document: 2016/80
Version: 1.0
May 2016

Albion Archaeology Project: WE1995
Buckinghamshire County Museum Accession Number: AYBCM: 2013.107
Oasis reference: albionar1-253587

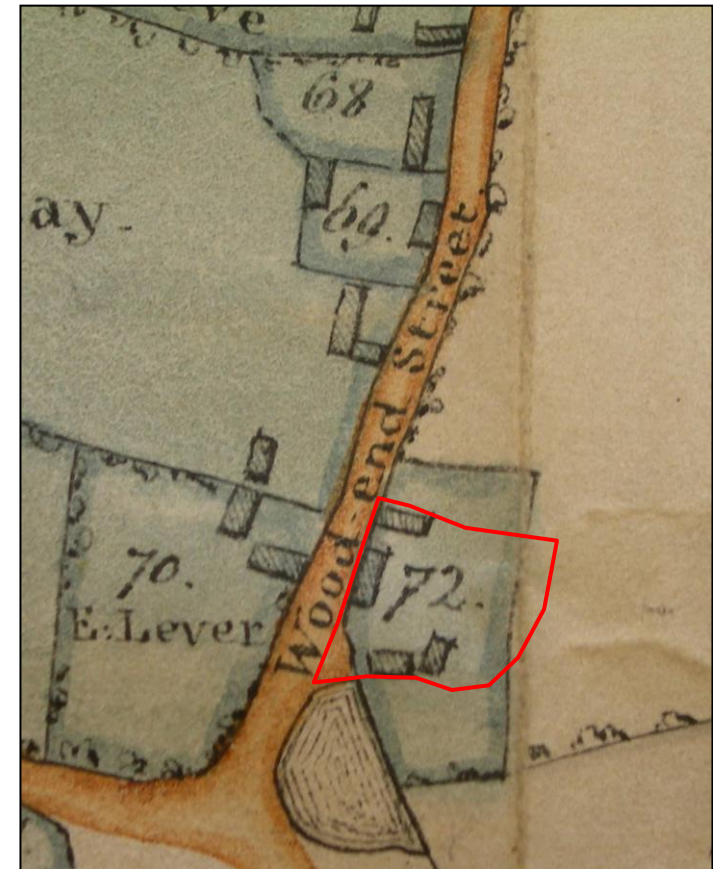
Figure 3: Enclosure plan, 1831

Detail showing Wood End Farm (Plot 72)

Note that the plan is aligned with east at the top. The present Wood End Farm corresponds to plot 72 (Centre for Buckinghamshire Studies)

This map (reference IR/49-Q) is folded and bound within the enclosure award. The map is dated 30th December 1831 and the surveyor is named as John King, an ancestor of the current owner, and it shows the area around the farm in some detail (Plate 3). The lane next to the farm is named as Wood End Street with its continuation to the east labelled New Gate Road with the “New Gate” shown at the end of the road where it becomes footpath or track. The track today appears as a hollow-way (Plate 2) suggesting the lane and the track are of some antiquity, possibly medieval. Wood End Farm (not named) appears on the enclosure map as the only house to the south of the lane whilst on the north side a series of buildings within different sized closes are shown ranged along the lane.

Wood End Farm is numbered 72 on the map and listed in the award as a farmhouse and homestead belonging to William King. The plan shows four buildings (Plate 4). The farmhouse at this time consisted of a single range aligned end on to the lane. A building of a similar size to the house is shown along the north edge of the farmyard in the location, now occupied by a similar-sized range of timber buildings (buildings 1 and 2). Two similar sized buildings at the west end of the farmyard represent the existing barns (barns 1 and 2).

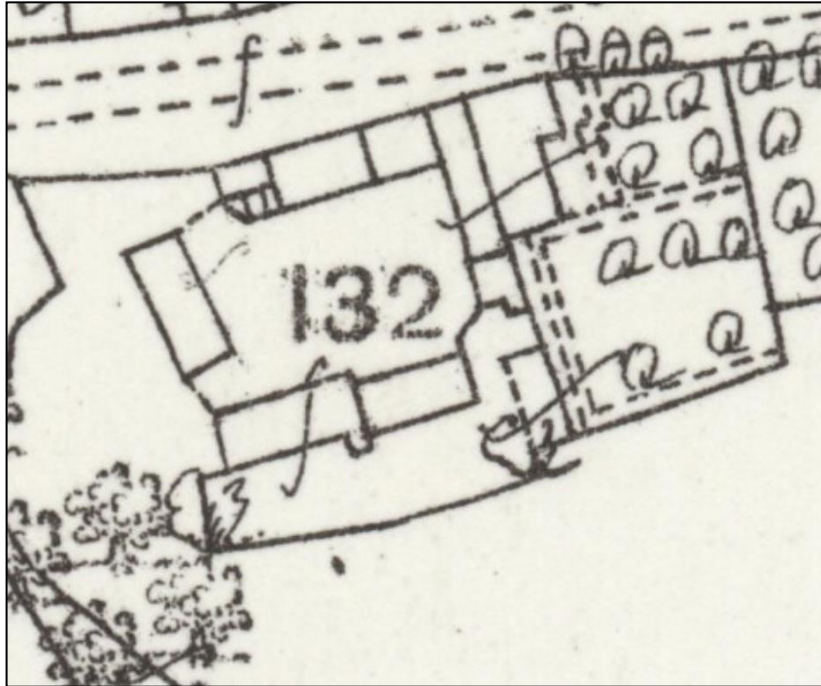
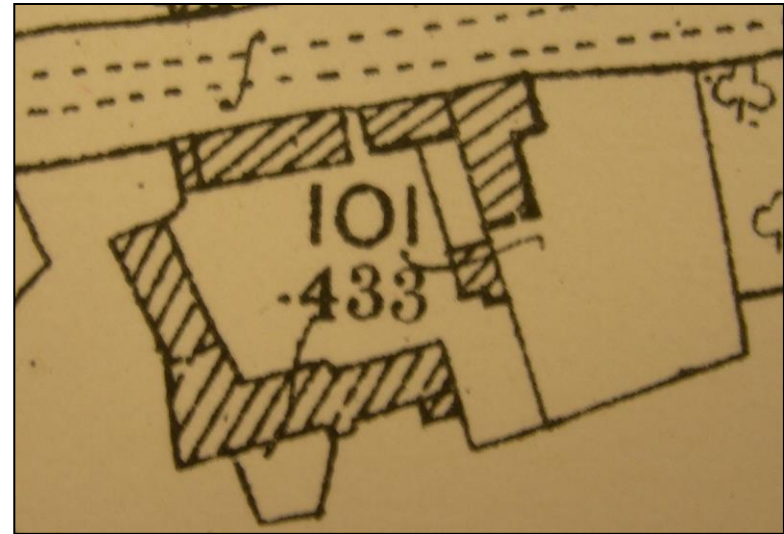
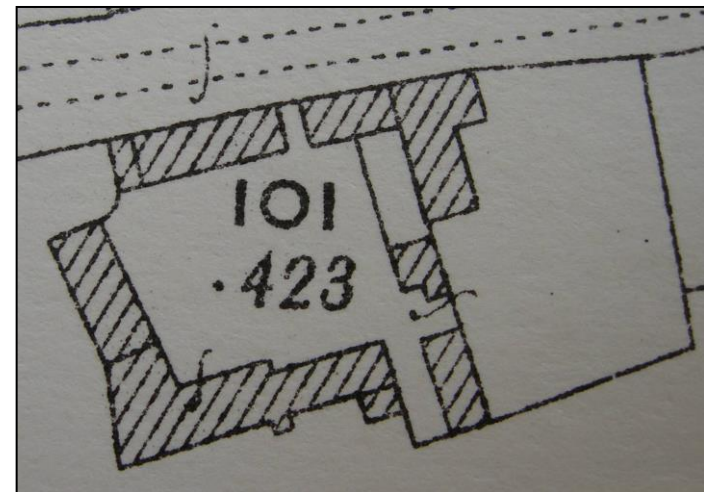
Figure 5: Ordnance Survey maps, 1881 to 1925

First edition 1881

Second edition 1900

Third edition 1925

The second edition Ordnance Survey map was revised in 1898 and published in 1900. This survey shows an east-west aligned range added to the west side of the farmhouse. This is the single story brick extension visible in Plate 9. This range overlaps the area of the building shown on the north side of the farmyard in the first edition map, indicating that this building had been shortened or replaced. Other changes include the filling in of the gap between barn 1 and barn 2, probably with lean-to structures and the disappearance of the small building in the southeast of the farmyard located where building 4 now stands.

The third edition Ordnance Survey map was revised in 1923 and published in 1925. The only change recorded in the farm on this edition is the reappearance of a building in the location of the present building 4. It does however appear longer than the present building.

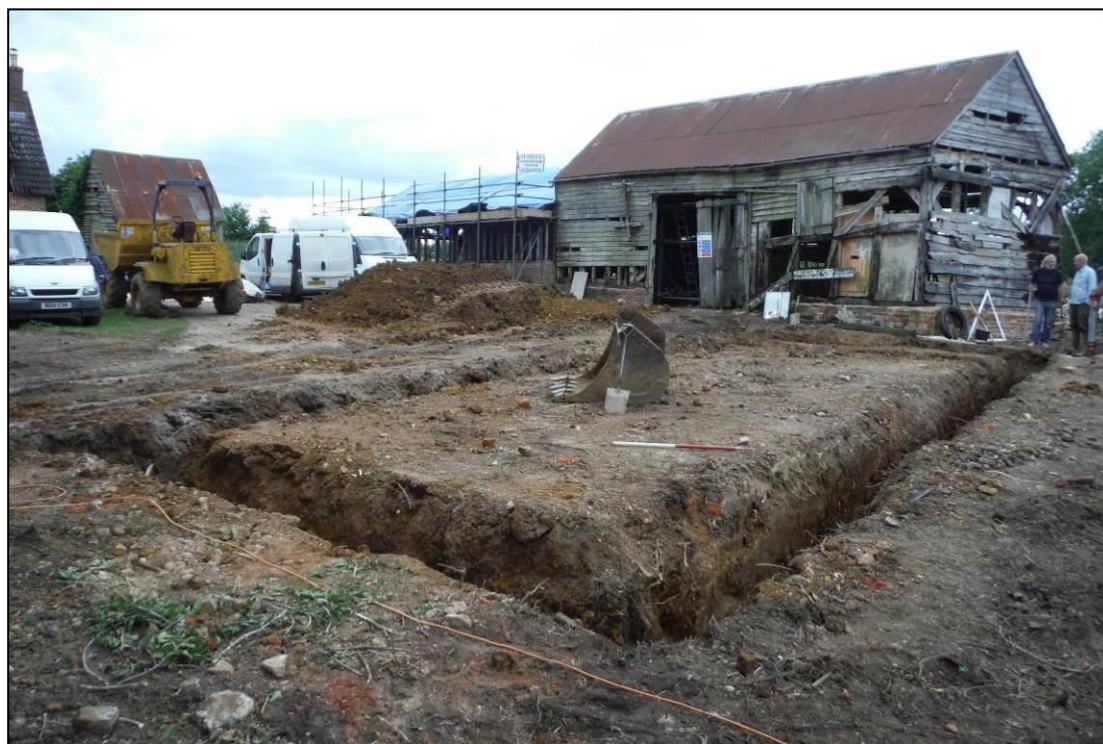
Image 1: Area 1, Pond Barn, Showing completed trenches

Looking south-east with strip foundation trenches for the replacement Pond Barn
in the foreground and the Dairy Barn in the background

Development works monitored in this area consisted of strip foundations for the new building which was constructed to replace the collapsed barn 2 (Image 1).

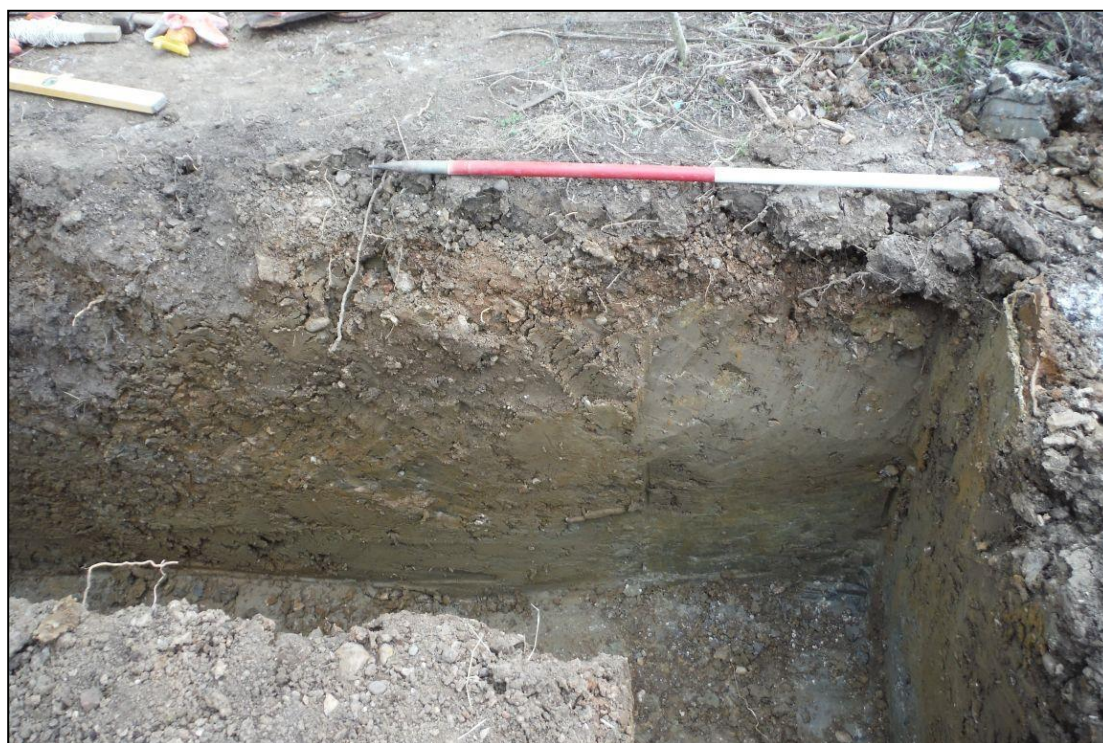
Image 2: Area 1, Pond Barn, Section 1

A pit [5] was partly exposed in the southwest corner of the foundation trench (Section 1, Image 2). It was more than 2.7m long, 1.5m wide and 0.75m deep with steep concave sides and a flat base. The lower fill (6) was mid yellow-grey silty clay and the upper fill (7) was mid grey-brown silty clay. No finds were noted in these fills. Both fills appear to be fairly closely derived from the geological deposits through which the pit was cut.

Looking south-east, showing pit [5] in section (Scale 1m)

An undated pit [5] measuring at least 2.7m long by 1.5m wide was found beneath the south-west corner of the Pond Barn in Area 1. The clay fills in the pit were closely derived from the surrounding geological material and contained no finds.

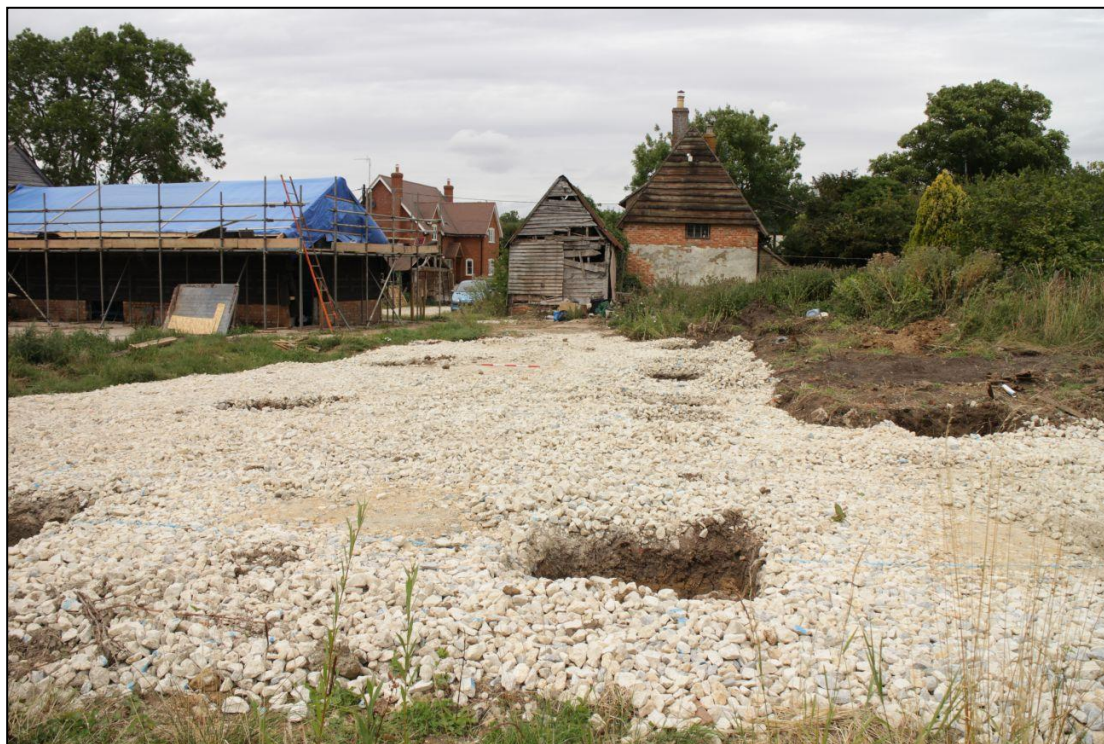
Development works monitored in in Area 2 consisted of rectangular foundation pits for new steel framed agricultural buildings (Image 3).

Image 3: Area 2, Wood End Farm, view of construction area
Looking north-east, showing foundation pits for new agricultural building

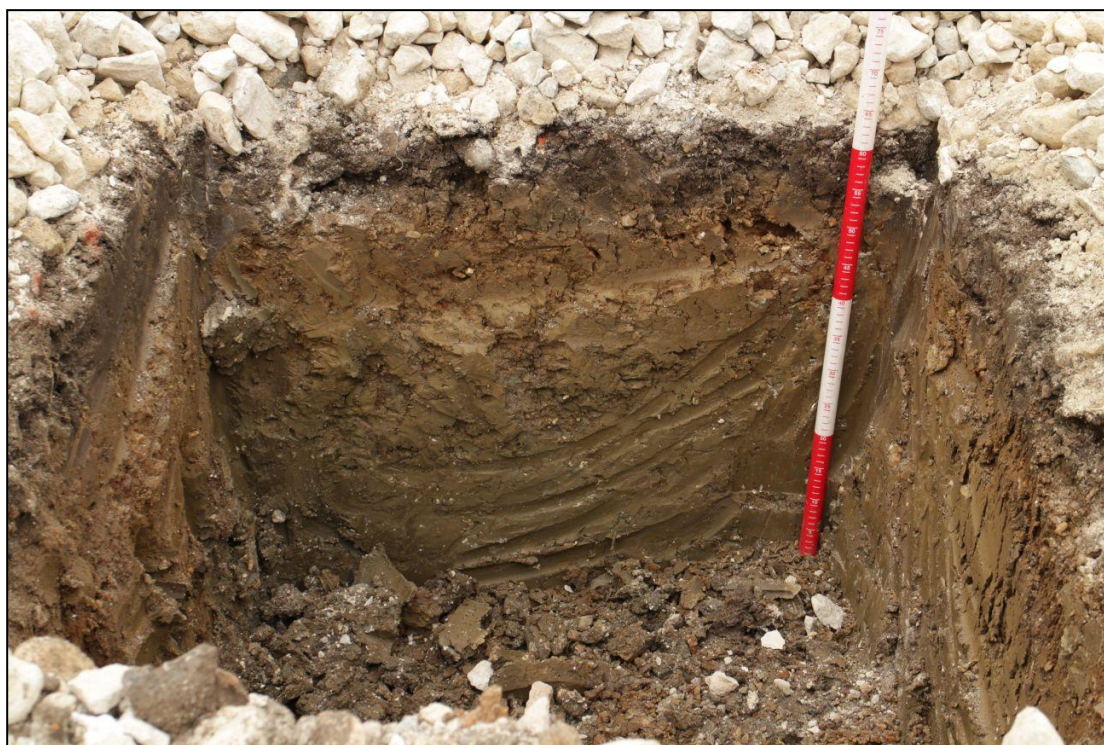
Two geological layers were recorded in Area 2. The upper layer (14) was mid red brown silty clay measuring approximately 200mm thick. It lay above a layer (15) of mid yellowish brown clay which contained flecks of chalk.

Image 4: Area 2, Wood End Farm, Section 2
Looking north-east, showing geological deposits

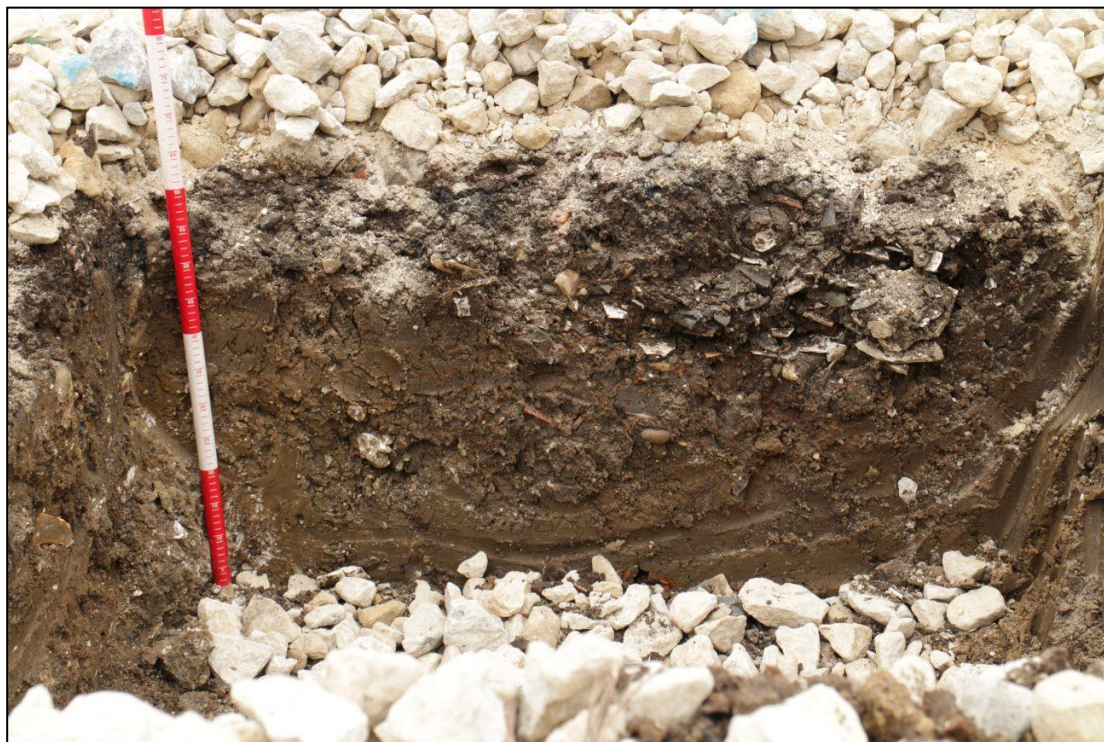
Image 5: Area 2, Wood End Farm, Section 3

Immediately beneath the topsoil in one trench was a small bowl-shaped pit [10] with a fill (110) that contained large amounts of domestic debris (Section 3, Image 5). This consisted mainly of fragments of moulded bottle glass and glazed earthenware including transfer printed pottery. The debris was dateable to the early 20th century and was not collected.

Looking south-west, showing pit [10] containing early 20th debris

The only dateable archaeological feature that was identified during monitoring was a small pit [10] located in Area 2, located 20m to south of the farmhouse. This contained a quantity of domestic debris, including early 20th-century bottle glass and transfer printed pottery which was not collected.

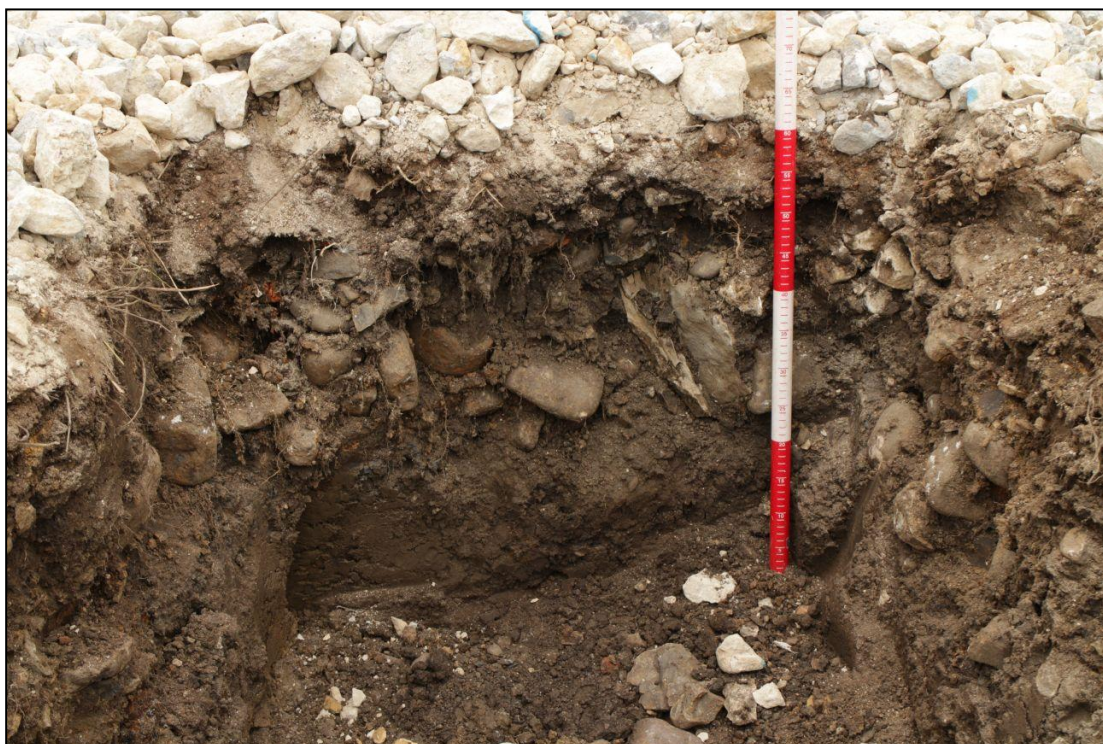
Image 6: Area 2, Wood End Farm, Section 4

One foundation trenches on the western edge of Area 2 contained deposits not seen in the other trenches in Area 2 (Section 4, Image 6). Beneath the topsoil (9) was a

layer of large, rounded stones (12). These measured up to 200mm and were densely packed, forming a layer 300mm thick. Below the stones was a layer (13) of dark brown clay-silt which continued below the base of the trench at a depth of 0.8m below the ground surface. No geological deposits were seen in this trench and it is likely that layer (13) was filling a depression or hollow which extended beyond the limits of this trench.

Looking north-east, showing layer of stones (12) above layer (13)

An undated layer of large stones (12) was identified in a trench in Area 2. The stones could have been deposited to consolidate an area of soft ground, indicated by a layer of dark brown clay silt (13) beneath the stones, possibly the fill of pond or hollow.

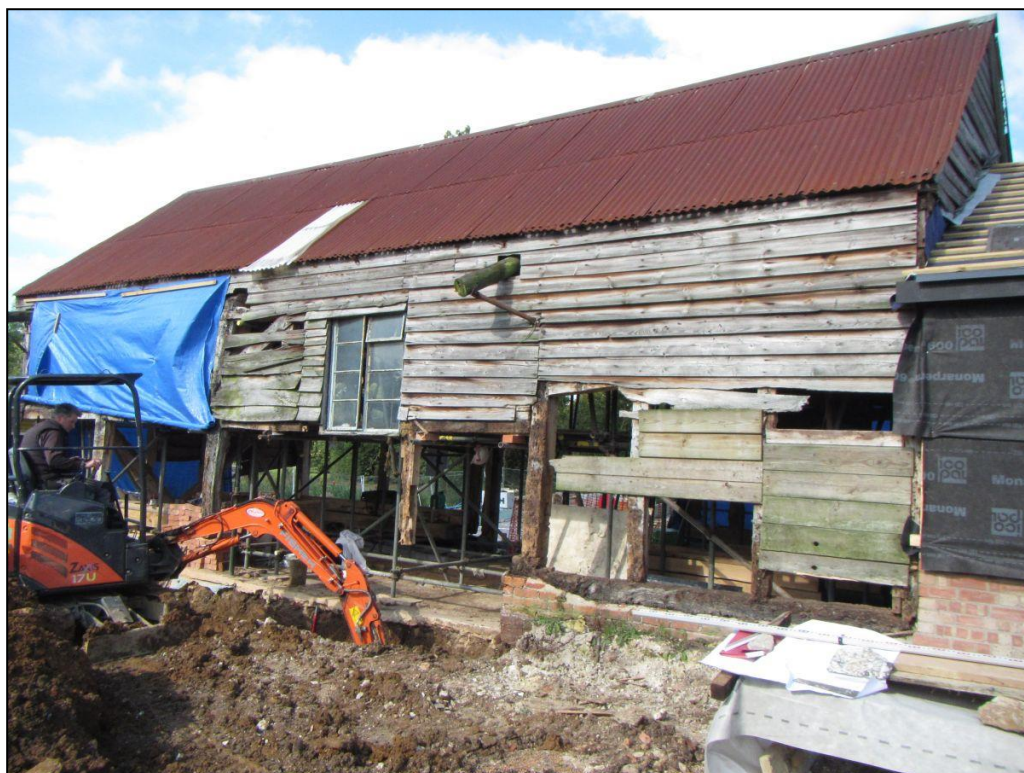
Image 7: Area 3, Dairy Barn, underpinning works

The development works monitored in Area 3 comprised floor reduction inside the dairy, underpinning of barn 1 and strip foundations for an extension on the south side of barn 1 (Image 7). No discrete archaeological features were identified in this area; the deposits consisted of either modern floor layers or geological layers.

Shows works on south side of barn

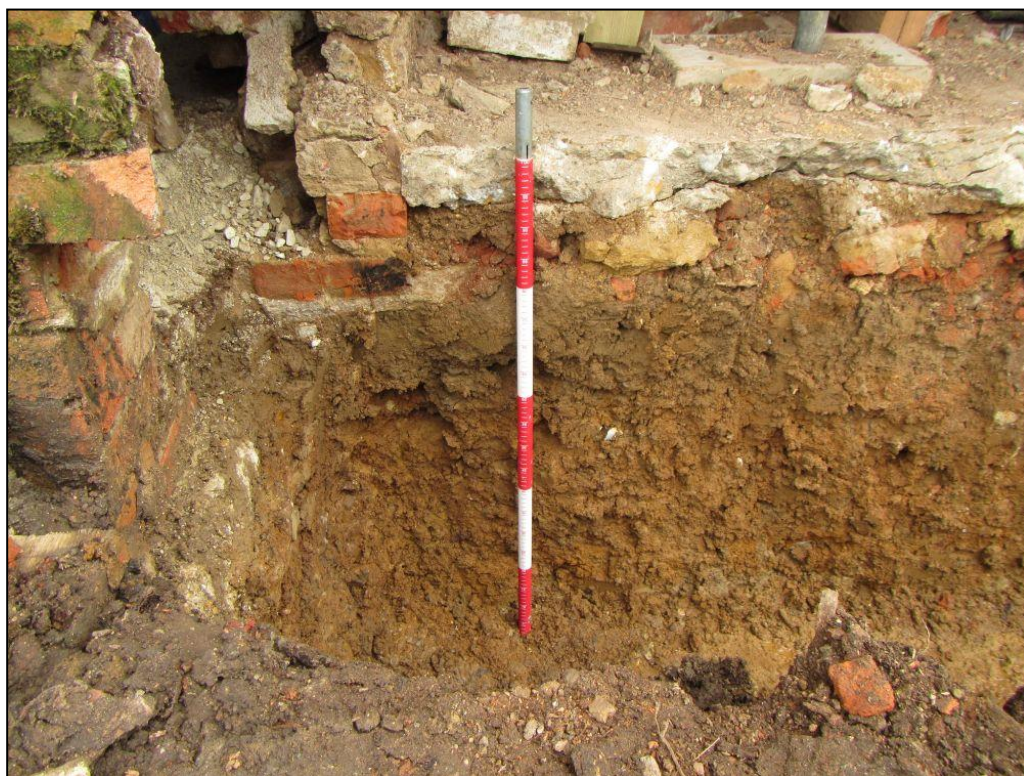
Image 8: Area 3, Dairy Barn, Section 5

Three geological or naturally derived layers were recorded in Area 3 (Section 5, Image 8).

The upper layer (18) was mid yellowish brown clay loam with occasional small stones. It was between 300mm and 500mm thick.

The middle layer (19) was mid red brown gritty/sandy clay with moderate small stones and gravel. This was between 300mm and 600mm thick. In the south of the area, where it was seen in the strip footings for the extension, the deposit contained some darker sections of mid blue grey silty clay.

Layer (20), in the base of the trench, was mid yellow brown clay with occasional flecks of chalk.

Looking south, showing geological deposits below barn floor

The uppermost layer, consisting of yellowish brown clay (18) was found only in the Dairy Barn trenches. These trenches lay closest to the south-west edge of the development area and the layer is likely to be alluvium deposited by the nearby stream.
