**CHELSEA WORKS, ST MICHAELS ROAD
KETTERING, NORTHANTS**

ARCHAEOLOGICAL BUILDING RECORDING

Document: 2016/183

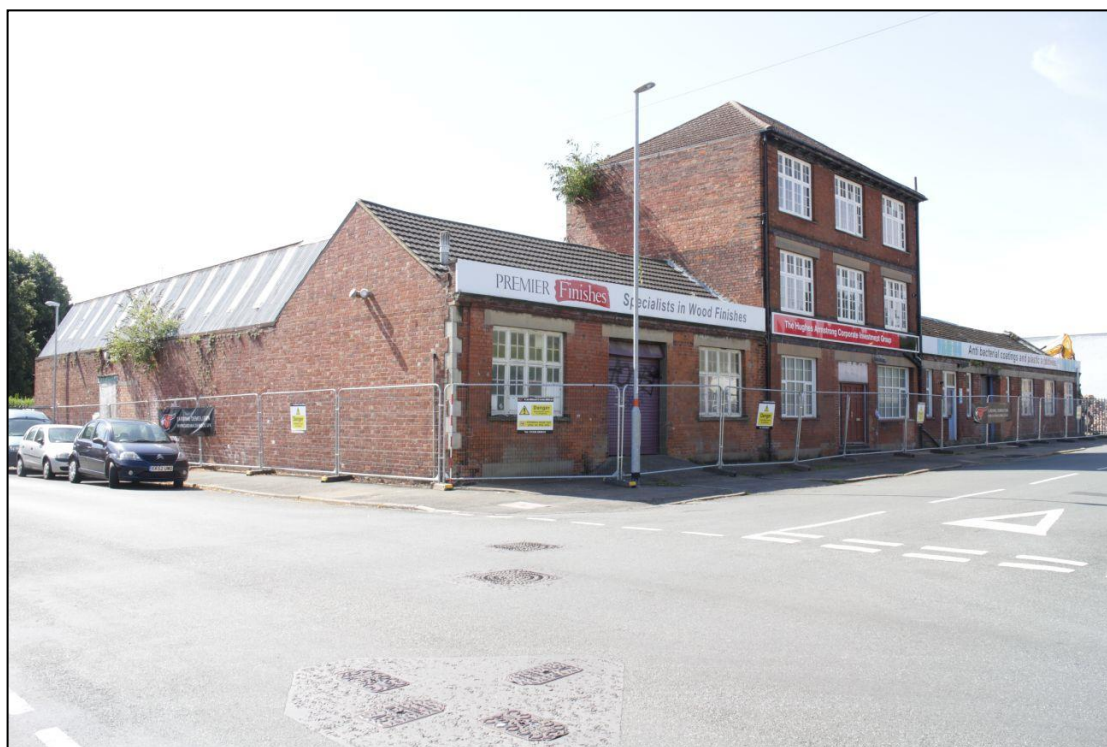
Image 1: Front and side elevations

On the left-hand corner the brickwork is slightly set back and is finished with stone quoins in Oolitic limestone (Image 1). At the base of the wall there are two concrete lintels for basement windows with light wells in the pavement that have been covered over. The left-hand section is in three bays with a central roller shutter door and four-light casements to either side. The modern roller door was fitted to a pre-existing door opening which is indicated by the concrete lintel above and rows of closers in the brickwork to either side of the opening. Detailing at eaves level comprises two slightly projecting courses of brick below a narrow stone or concrete moulding. Above this is brick parapet covered with an advertising board. The roof is covered with concrete interlocking tiles.

This elevation was in red brick but more variable in colour than the facing bricks used in the St Michael's Road frontage (Image 1). The brickwork is in Flemish garden-wall bond. The only openings are two doors located near the middle of the elevation. One of these was boarded up and has a lintel with tile creasing above. Immediately to the right is a slightly smaller door opening with a concrete lintel that has been blocked with modern machine-made brick.

Looking south-west from corner of St Michael's Road and Garfield Street

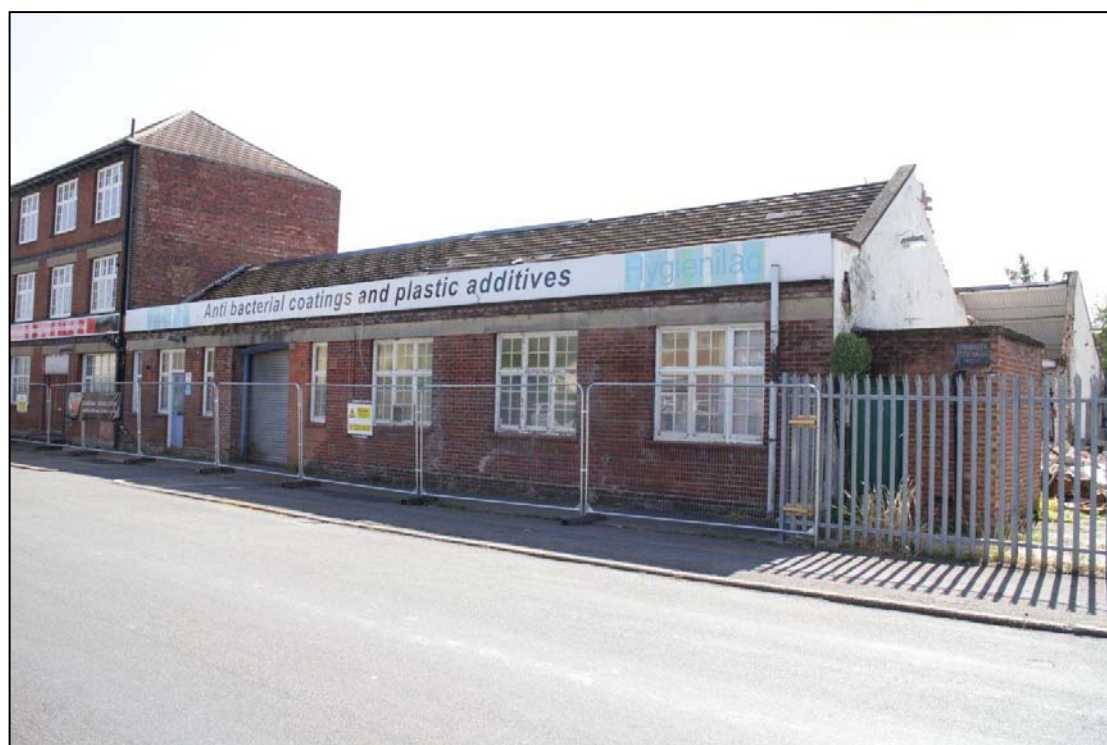
Image 2: Front elevation, west end

The brickwork in the right hand side of the frontage is in stretcher bond with a concrete lintel above the openings (Image 2). This is a single storey range. The openings in this part of the frontage form an irregular pattern. These comprises from left to right; a single-light window, a combination single-light window and door, two single-light windows flanking a roller door and three three-light windows in the right hand part. The brickwork around the eastern roller door has been rebuilt at some time with the right-hand side rebuilt in lighter coloured brick indicating alterations to this opening.

Looking south-east. The building containing the sprinkler pumps is low brick building at the right hand side of the image

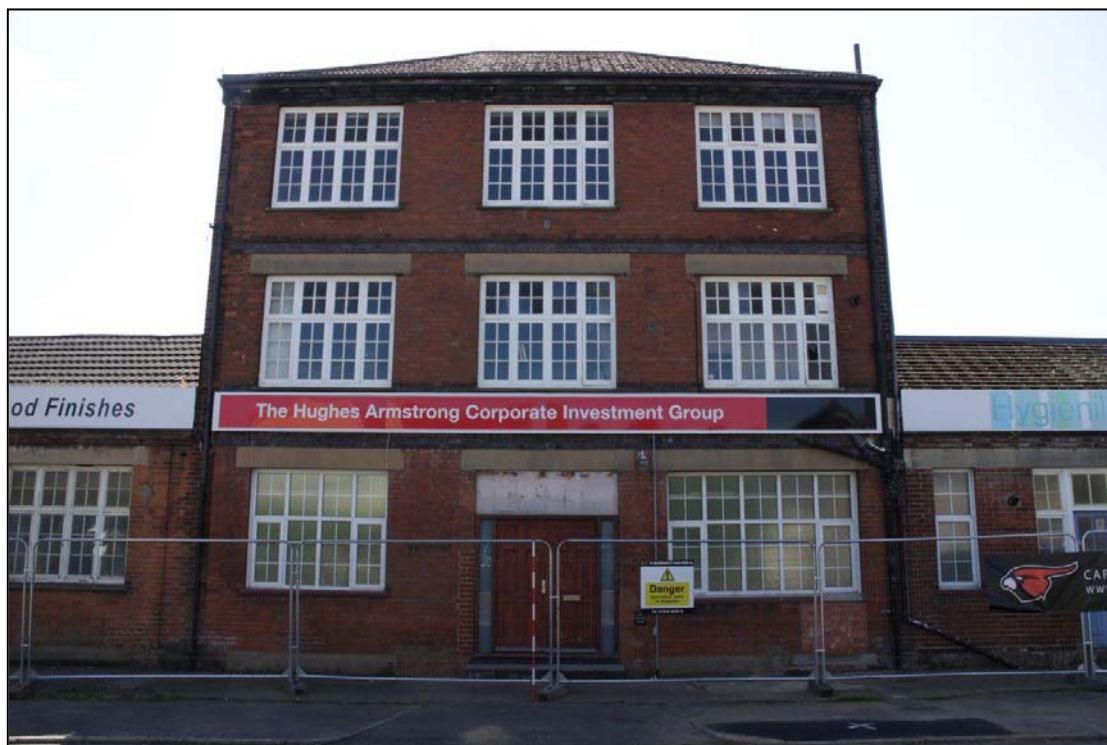
Image 3: Front elevation, three-storey block

This is in red facing brick with bands of blue bricks above the ground and first floor windows (Image 3). A narrow strip of brickwork along both sides of this section is slightly set back from the frontage. At pavement level there are two concrete lintels for basement windows with light wells that have been covered. The ground, first and second floors are in three bays. The windows are four-light casements with the exception of the right-hand ground floor window which has five lights. Some alteration is evident at ground floor level. Here the wooden windows have been replaced with UPVC and there is evidence of alterations in the door opening and the right-hand window. The door opening contains a modern six-panel double door and narrow margin lights. The brickwork in the lower parts of both door jambs has been rebuilt and it seems likely that this opening would have originally contained a window matching the other four-light windows. Beneath the right-hand window there is the bricked-up base for a former doorway indicating that this opening originally contained a window and a single width door.

Looking south (scale 2m)

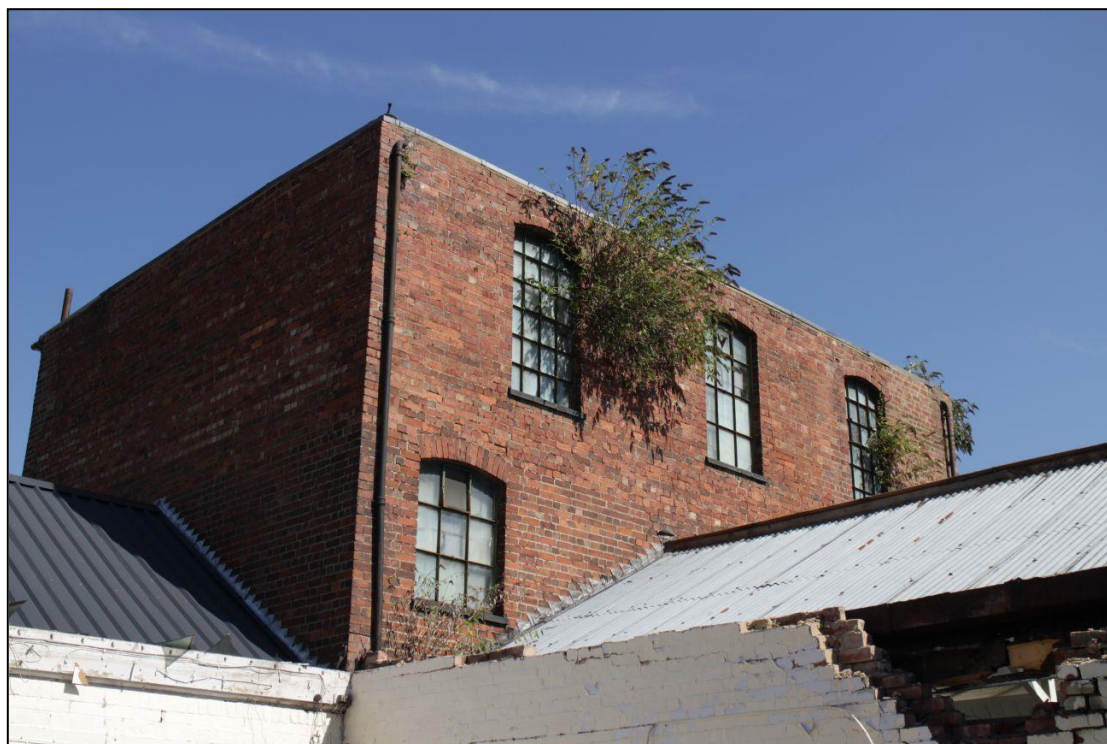
Image 4: Rear elevation of three-storey block

The side and rear walls of the three-storey part of the building are in regular English bond in lower part and become more variable towards the top with multiple stretcher courses. The rear elevation of this part of the building contained metal-framed windows beneath segmental brick arches (Image 4). These windows were not visible from inside the building because the rear wall had been lined with plasterboard.

Looking north-east showing metal framed windows

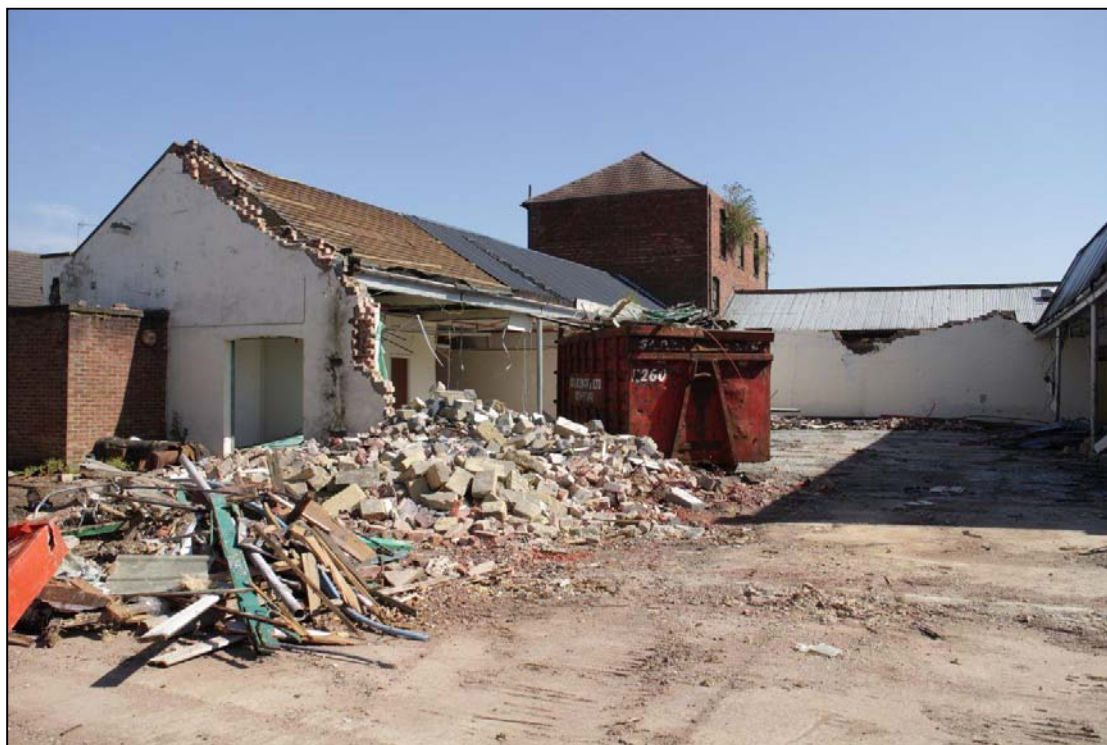
Image 5: Exterior view from yard

Looking north-east with the two demolished bays of workshop 4 in the centre of the image

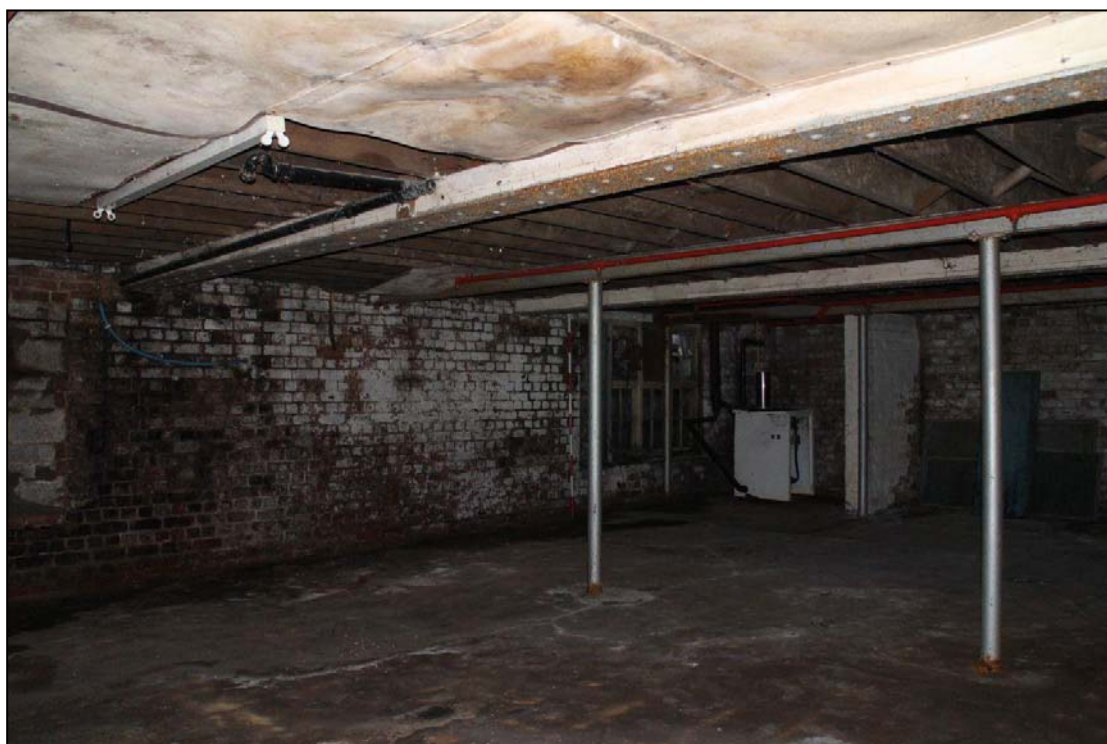
Image 6: Basement, east compartment

An east-west aligned basement lies below the north-east part of the factory (Figure 7, Images 6 and 7). It is situated below ground floor room 1 and the northern part of one of the workshops (6a). It would have been lit by four windows in light wells in the St Michael's Road frontage, although these had been blocked at basement level or covered over at street level at the time of the survey. The one surviving window has a four-light wooden frame with plain chamfered mullions and transoms.

The floor over the basement consisted of closely set east-west aligned wooden joists with herringbone strutting. The joists were supported by two large section I-beams in each compartment with additional support in the east compartment comprising two RSJs and metal pillars.

Looking north-east showing roof with secondary supports and remaining basement window in far corner to right of photographic scale (scale 2m)

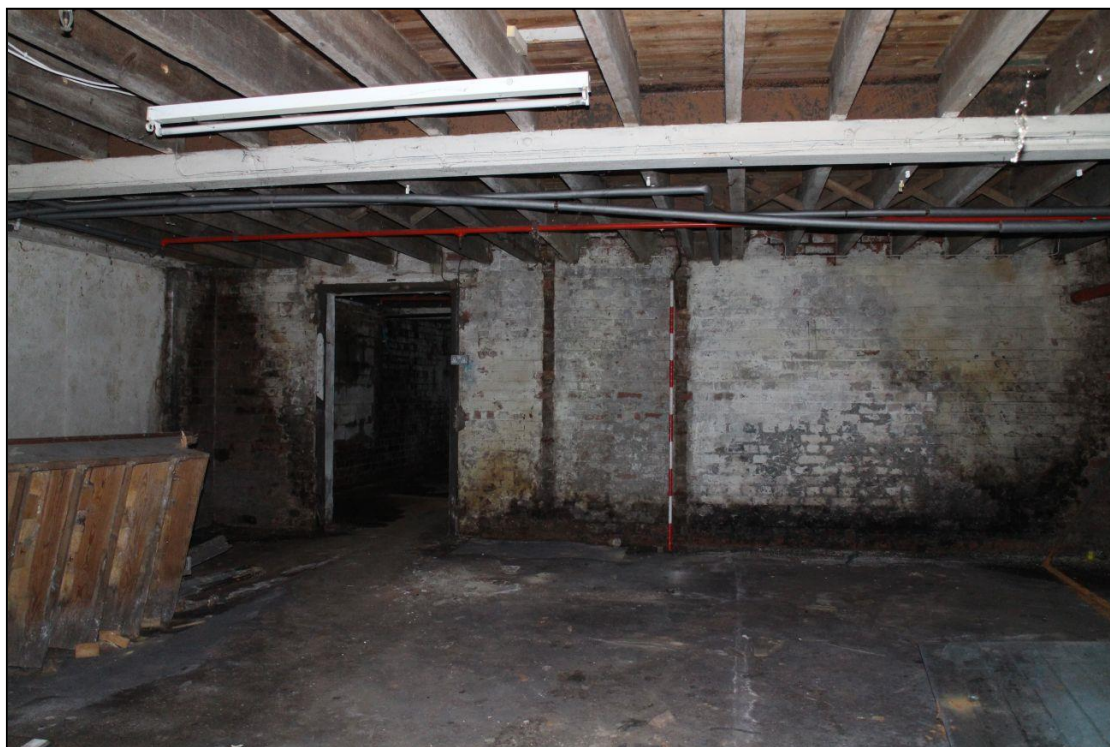
Image 7: Basement, west compartment

A boarded over hatch or trap door in the ceiling at the eastern end of the western compartment of the basement corresponds to similar features in the ground and first floor rooms above, presumably indicating the location of a former hoist extending from the basement to the second floor.

Looking east showing doorway to the east compartment. Two lines on the wall correspond to the location of the framed opening in the floor over the basement for a former hoist or trapdoor arrangement (scale 2m)

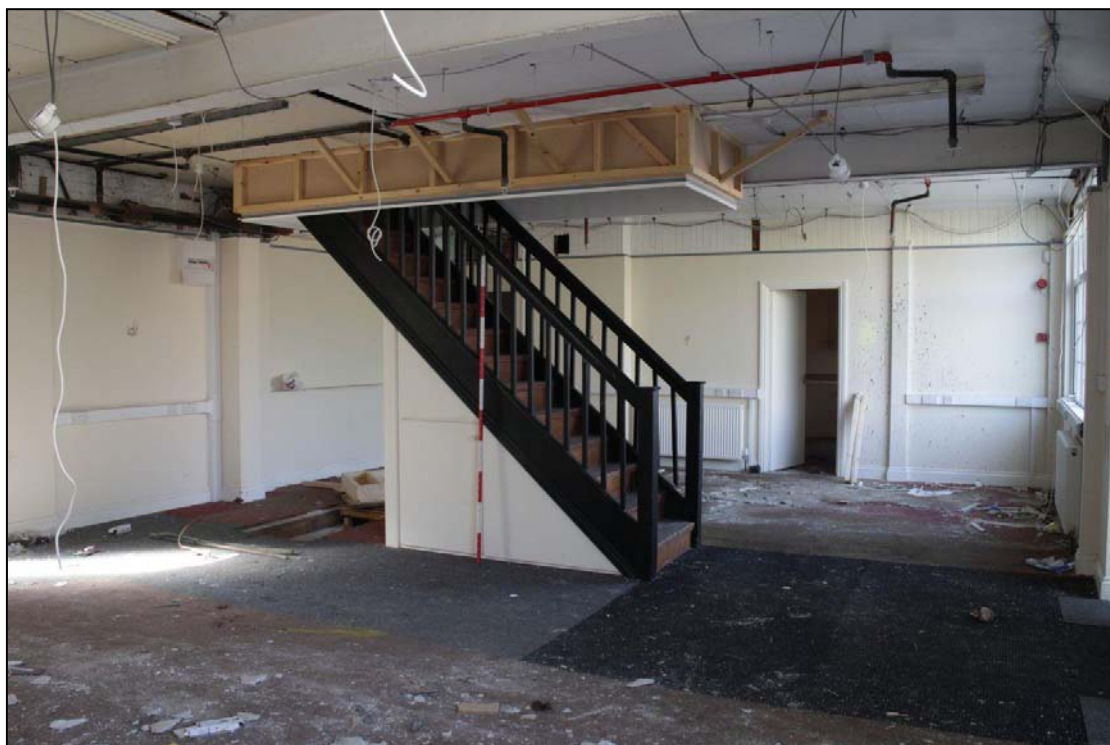
Image 8: Ground floor of three-storey block 1

In this room the walls are obscured by modern plasterboard linings, the floor is carpeted floor and the windows to the street frontage have been replaced with UPVC units (Image 8). Surface mounted cabling with numerous power sockets indicates a probable latest use as open plan office.

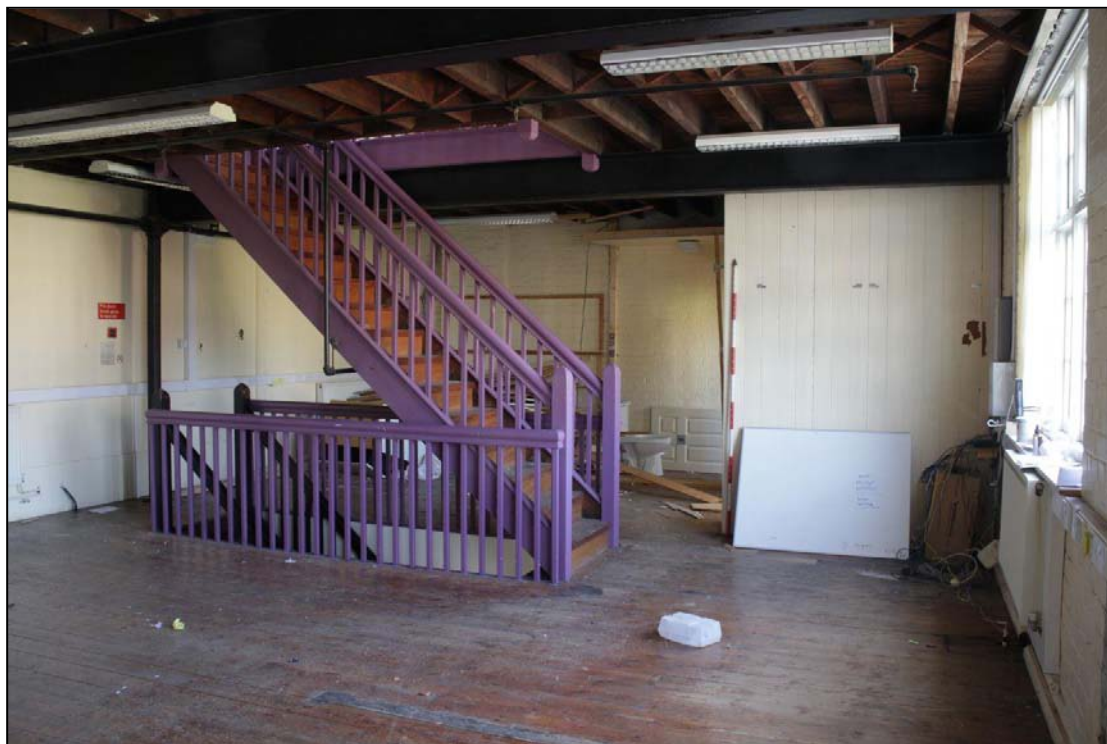
Image 9: First floor of three-storey block 1
Looking south-west (scale 2m)

On this floor the walls are finished in plain brick with a plasterboard lining to the south wall (Image 9). The lining in the south wall obscures at least one metal framed window that was visible from the exterior. Windows in the north wall are four-light wooden windows with plain chamfered mullions and transoms. The floor is in narrow pine boards with a bright, varnish finish. An area for toilets and kitchen in the north-west corner appears to be modern (late 20th C) construction in tongue and groove board. 'Shadows' in the paint on the walls and on the floor indicate the location of a removed partition in the north-east corner of the room.

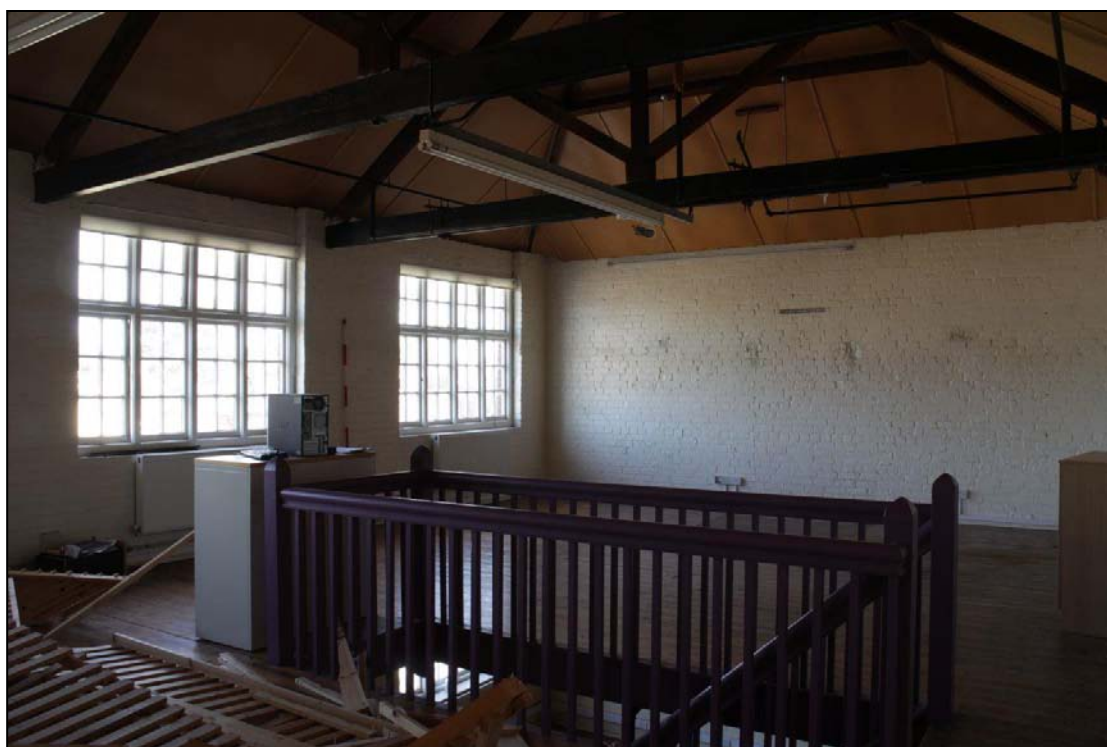
Image 10: Second floor of three-storey block 1
Looking north-east

This room has a similar finish to the first floor with plain brick walls, varnish pine floor and plasterboard lining to the rear wall which conceals three metal-framed windows which are visible on the exterior (Image 10). The hipped roof is supported by two king-post trusses and the ceiling is lined with fibreboard panels nailed to the underside of the rafters (Image 11). A small amount of office furniture, along with surface mounted cabling, central heating and strip lighting indicate a latest use of this room as an office.

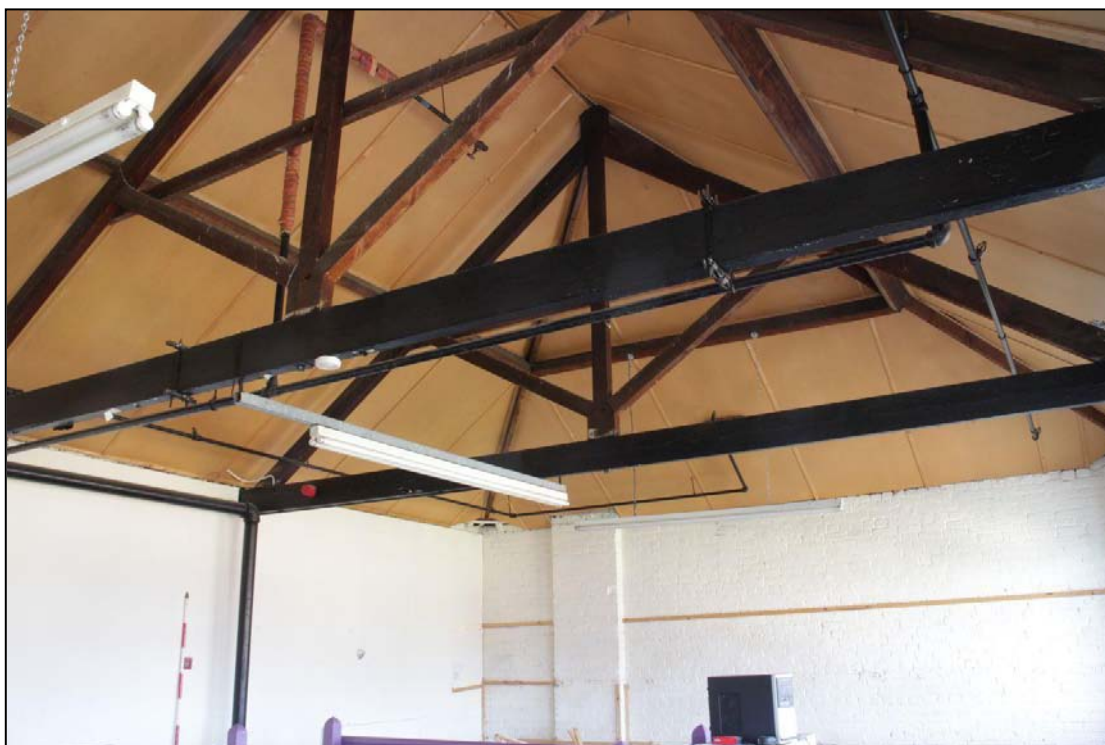
Image 11: Second floor of three-storey block 1

Looking south-west showing roof structure

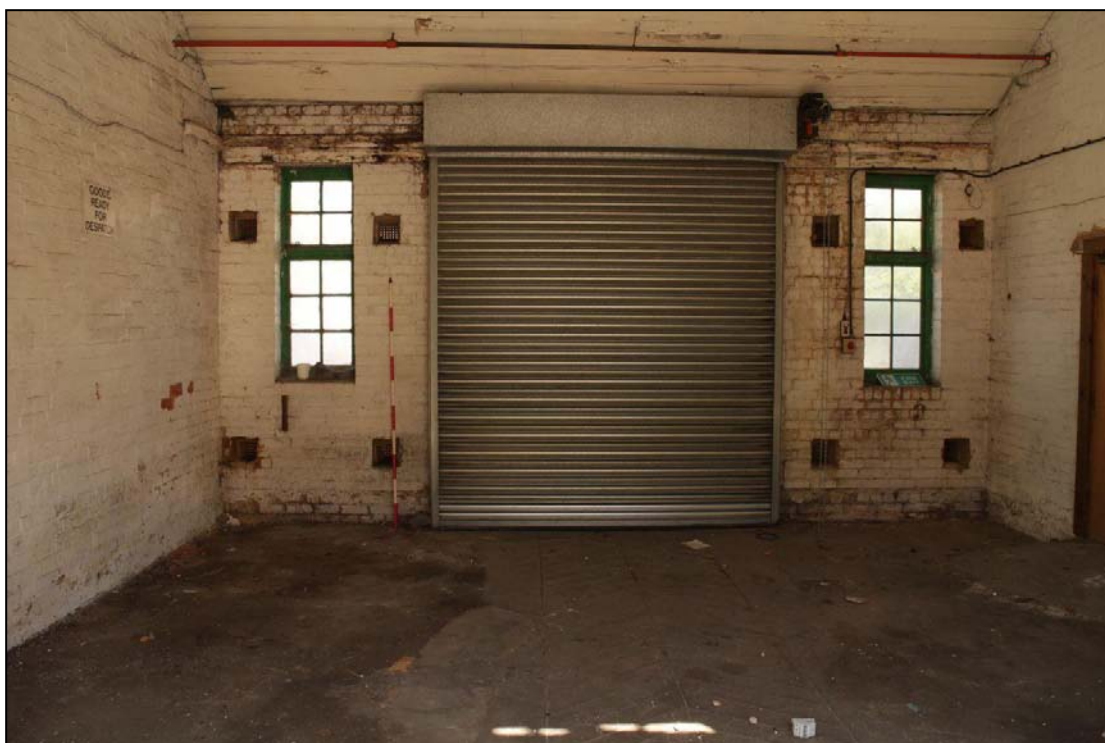
Image 12: Goods loading bay 3

This compartment in the north range of the building measures 7.1m north-south by 6.5m east-west (Image 12). The north wall has a roller shutter door flanked by two single-light windows. The south wall contains a wide opening into one of the main workshop areas (4b). A blocked opening in the west wall has brick arch over and appears to be part of the original construction. The gable roof is lined with tongue groove boards painted white. A sign on the west wall reads 'GOODS READY FOR DESPATCH' indicating the most recent use for this area.

Looking north (scale 2m)

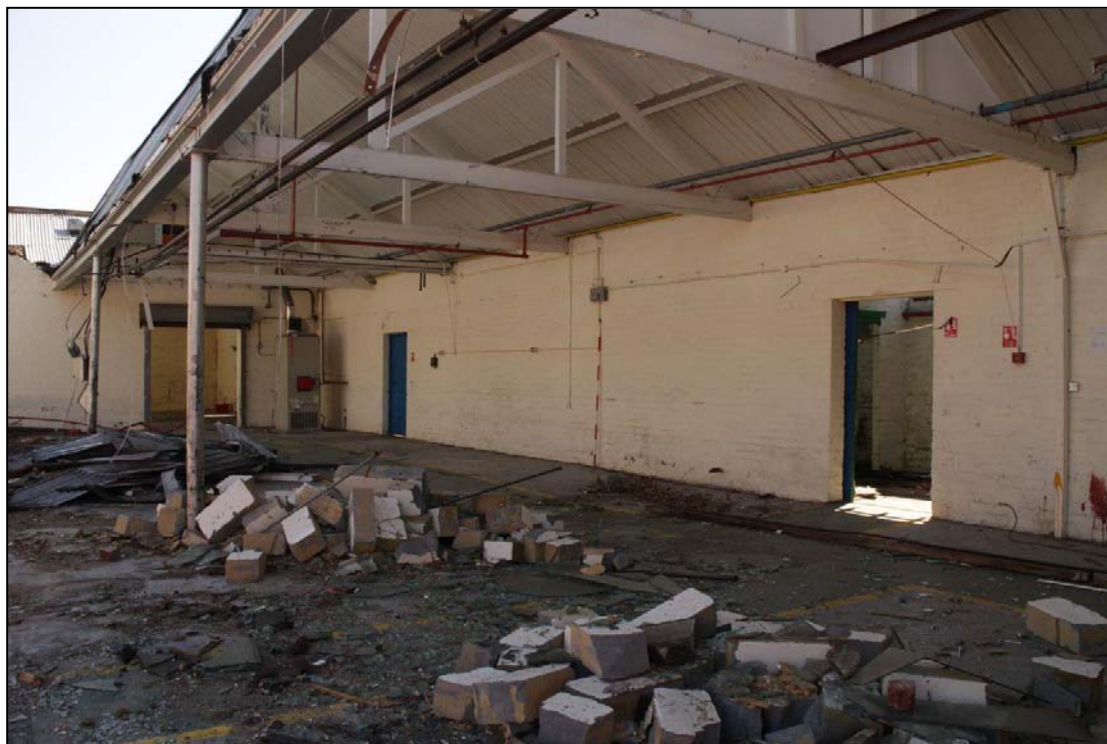
Image 13: Workshop 4, Area 4c
Looking south-east (scale 2m)

This part of the workshop was under a sawtoothed roof in three east-west aligned bays. Two bays (area 4b) had been demolished prior to the start of the survey but one bay (area 4c) on the south side of the workshop remained (Image 13).

This part of the workshop measured 21.8m east-west and 17.6m north-south with aisles 5.9m wide. The wall forming the east end of the workshop had no strengthening pilasters to support the roof on this side. This and the other sawtooth roofs in the building have cast iron pillars which support longitudinal steel beams which in turn carry the ends of the transverse timber roof trusses. These are asymmetric king-post trusses with a single raking brace to the shallower slope of the roof (Image 14). In this workshop the cast iron pillars are widely spaced, only being used under alternate roof trusses. This contrasts with the arrangement in the other workshops which have pillars at each roof truss.

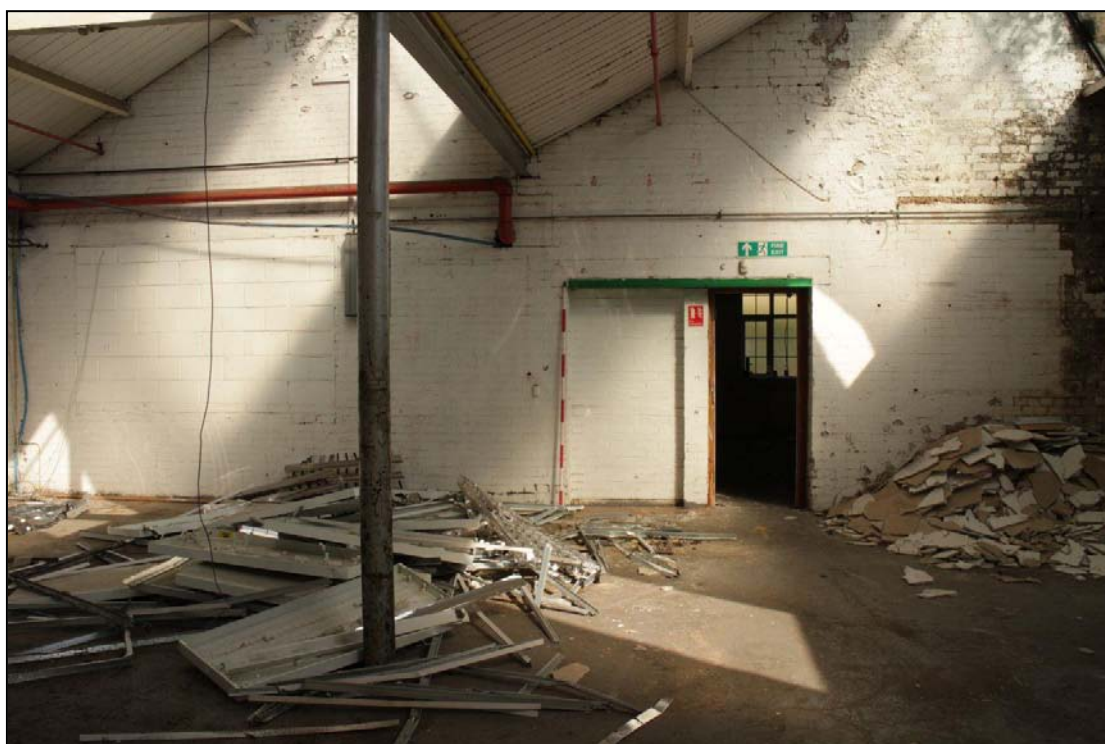
Image 16: Workshop 5, Area 5a

Various later modifications are visible in the workshop walls. In the north wall of 5a the door to the offices (1) has been reduced in width, a large window to the left of the door infilled with blockwork and a smaller window to the right infilled with brick (Image 16). In the east wall of 5a a door has been roughly cut-in to the brickwork to form an access to a subdivided workshop area (6a). In workshop 5b a small window at the west end of the south wall has been infilled with brick. Also in 5b the central roof pillar has been replaced with an RSJ beam.

Looking north showing blocked openings in north wall (scale 2m)

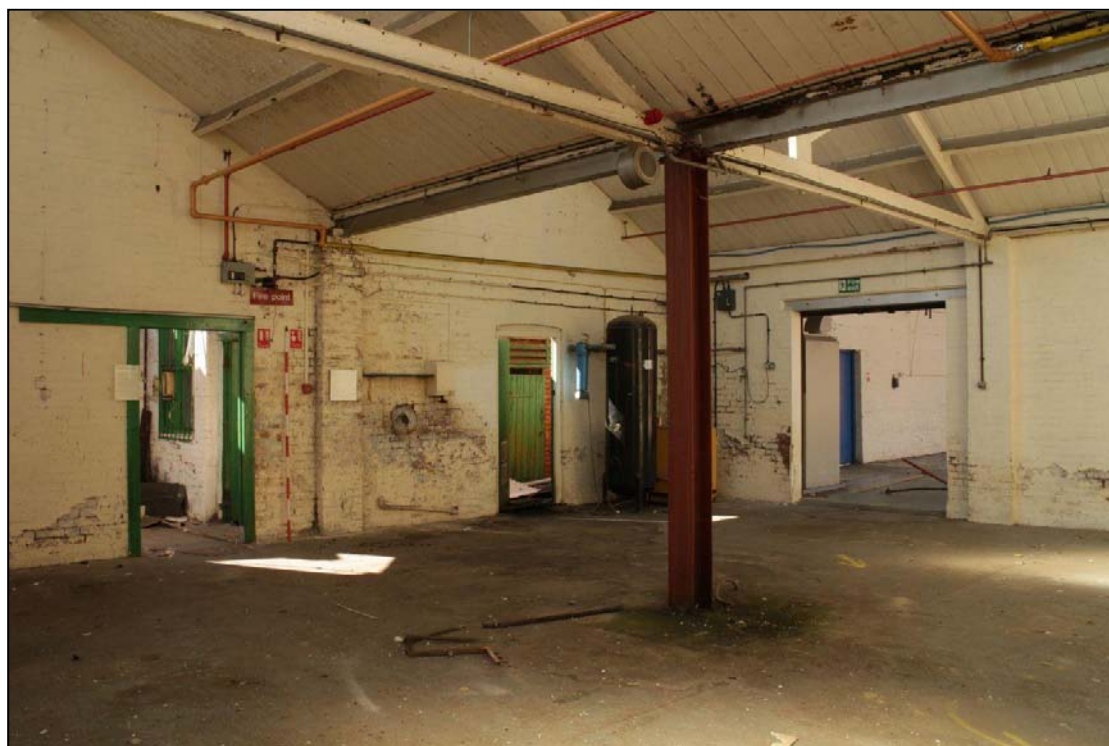
Image 17: Workshop 5, Area 5b

Looking south-west. Note pillar replaced with RSJ (scale 2m)

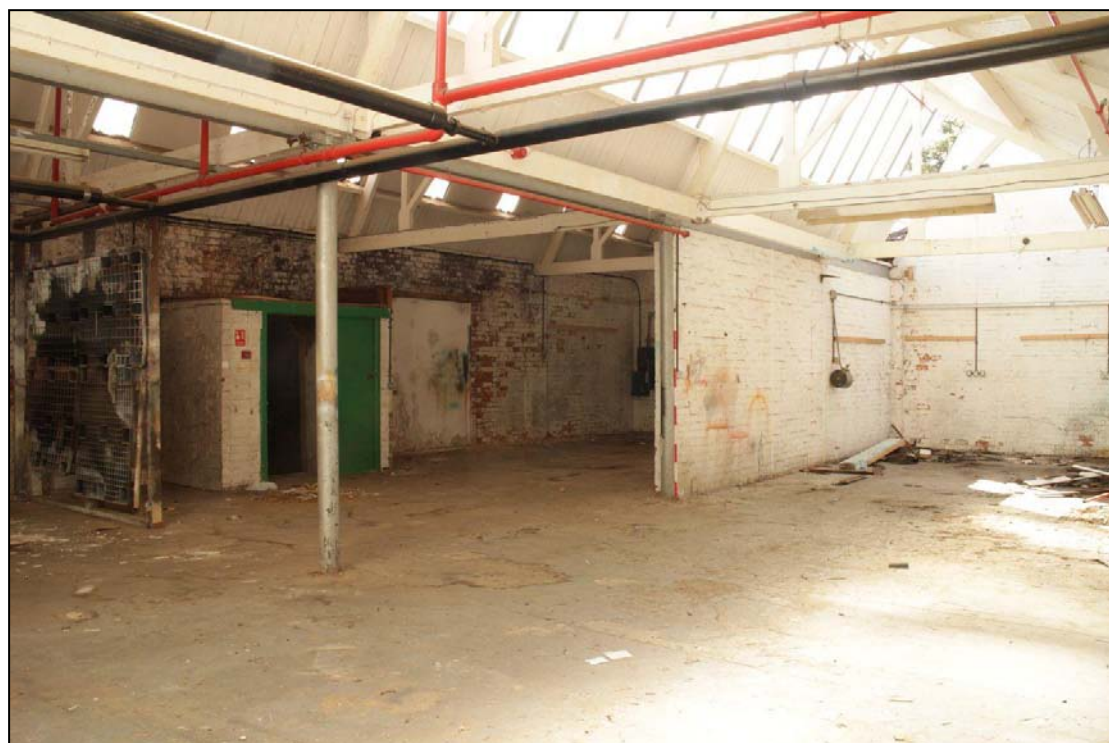
Image 18: Workshop 6, Area 6c

The remaining part of the workshop (6c) extends to the south wall of the factory. At the south end it has been partially divided by the construction of a brick wall between the cast iron pillars supporting the roof (Image 18). There are two external door openings in the east wall. One is blocked with modern brick infill. The adjacent opening has an internal brick 'lobby' with a second set of internal doors.

Looking south-east. Shows central division of bays at south end of workshop and lobby entry for door off Garfield Street at left

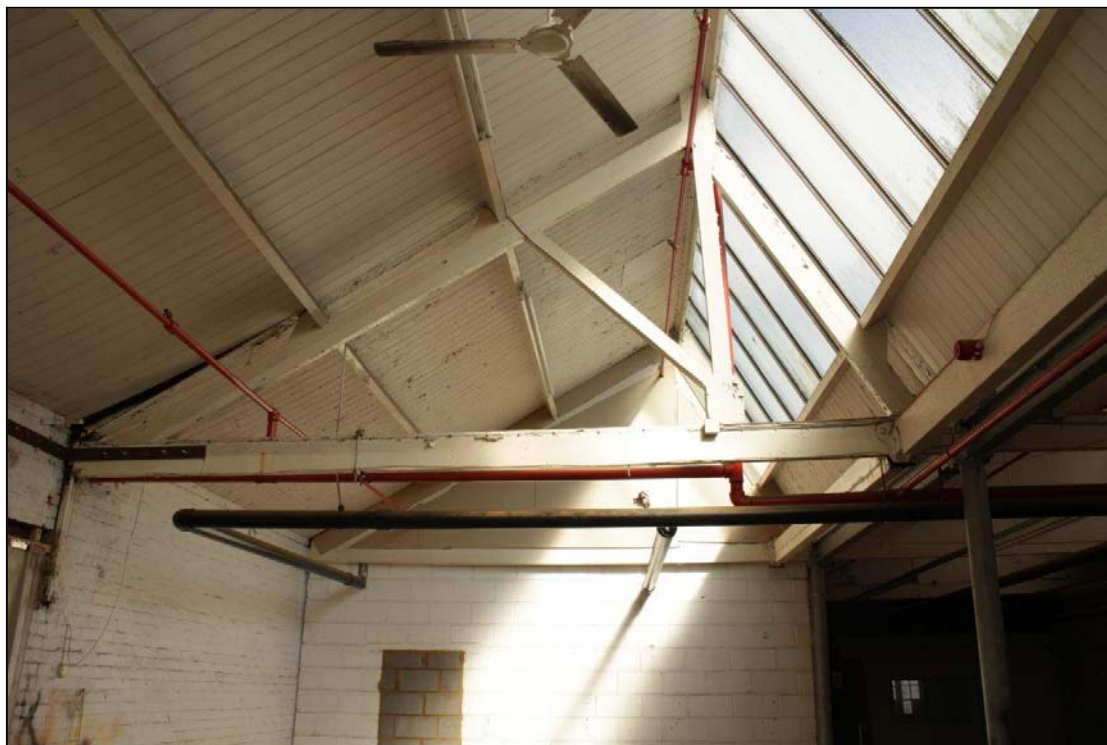
Image 19: Workshop 6, Area 6c

This section is covered by a sawtooth roof in two north-south aligned bays with cast iron pillars supporting each roof truss. The construction of the roof is similar to the other sawtooth roofs with the addition of a longitudinal beam just west of the centreline (Images 19 and 20). The beam consists of separate lengths of timber which are supported at each end by cast metal brackets fixed to the tiebeams of the

Looking north showing roof structure in west bay of workshop

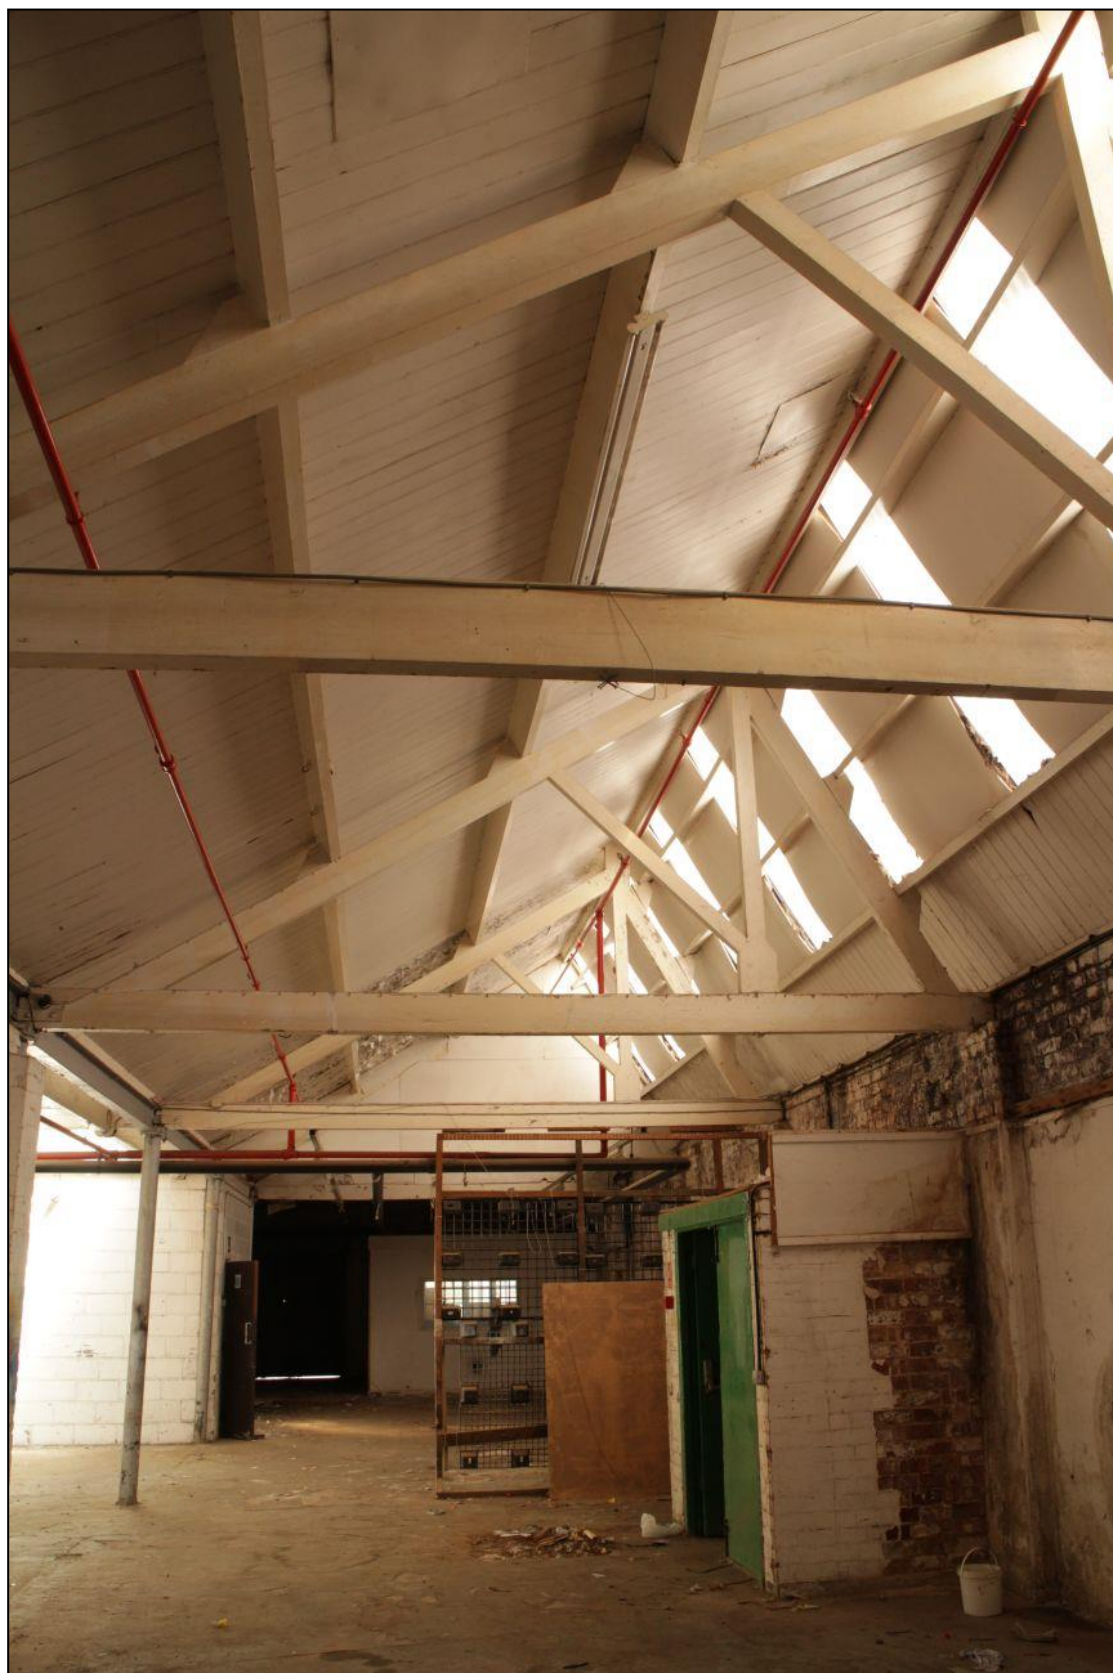
Image 21: Workshop 6c, East bay of workshop

Looking north showing details of roof construction with partial glazing in roof on Garfield Street frontage

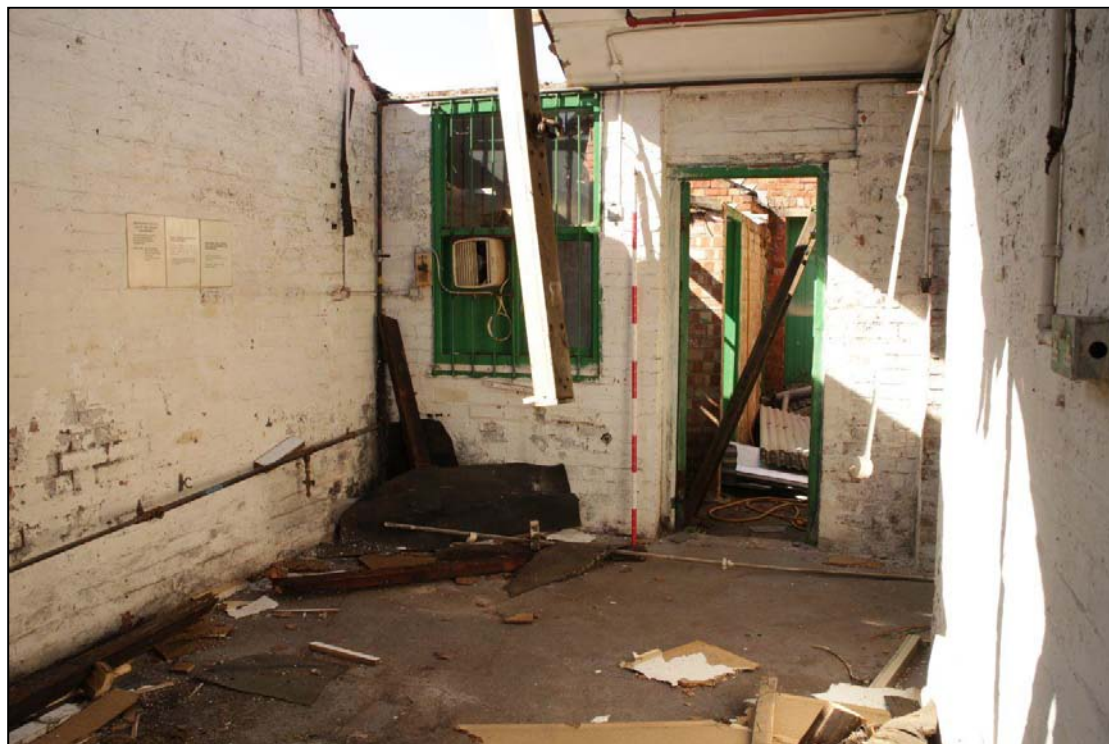
Image 22: Enclosed workshop 7

This workshop is located to the south of workshop 5 (Image 22). It is 4.6m long by 3.08m wide and is covered by a north-south aligned gabled roof. Access is via a door in the north wall from workshop 5. A door in the east wall has been infilled with blockwork. The west wall has a window and a door giving access to the outside toilets (8). This door has been reduced in width and height with Fletton brick used to rebuild the north jamb and infill an arched opening above the door.

Looking south-west (scale 2m)

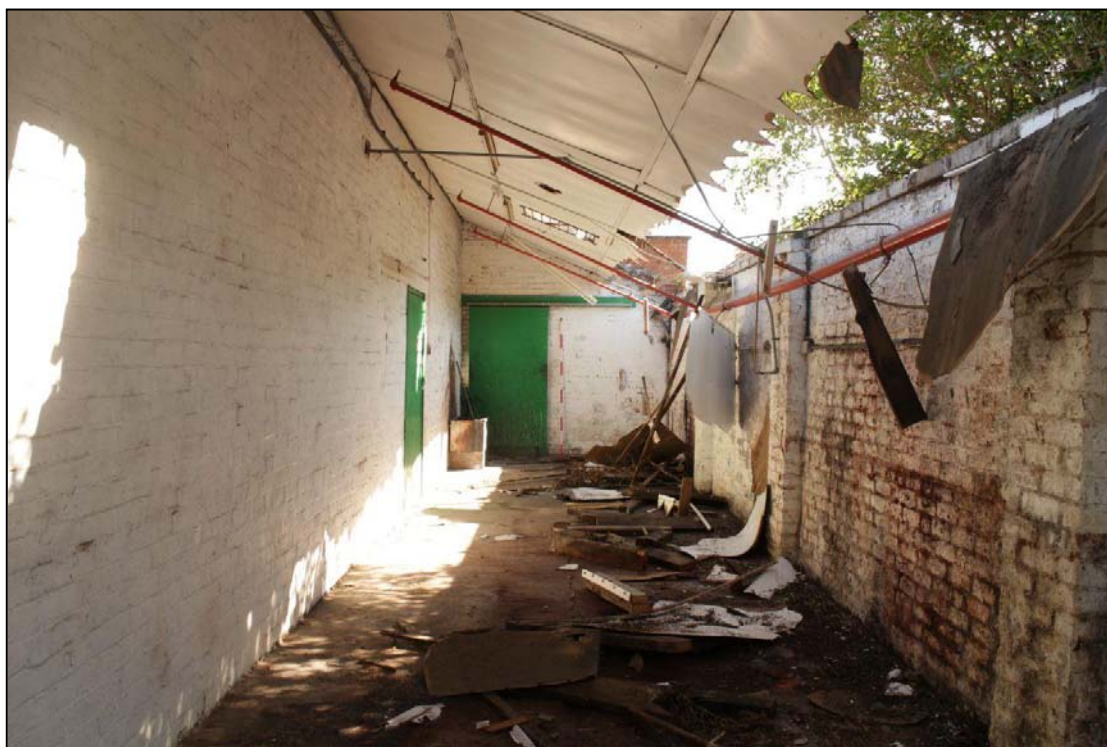
Image 24: Workshop 9, east compartment

This is a narrow workshop, 3.08m wide and 21.75m long which extends along the south side of workshop 4 (Images 24 and 25). It is subdivided into two parts by a brick partition with a wide door opening. The eastern compartment is accessed via a sliding timber door the east end and plank and batten door in the north wall. The smaller western compartment has steel door in the west end and a sliding timber door in the north wall. The latter had been clad on its interior face with relatively small, overlapping metal plates, presumably as a form of fire protection.

Looking east with mixing tank in front of green door in distance

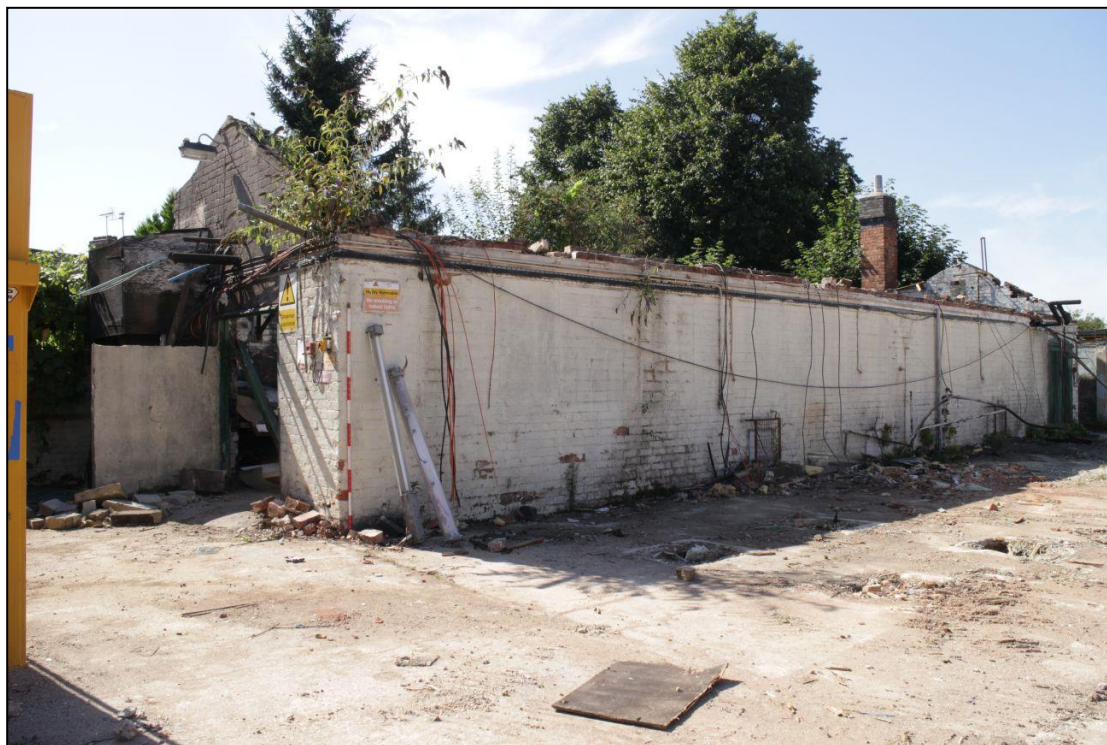
Image 26: Detached workshop 12

Exterior view looking south-west (scale 2m)

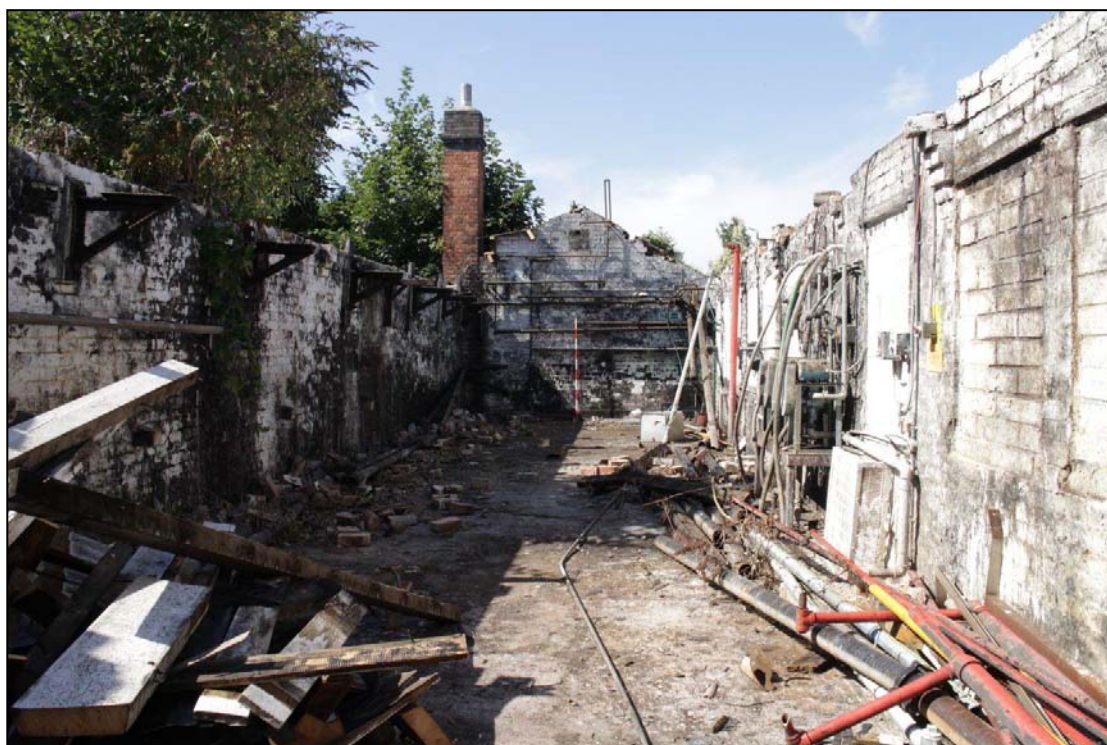
Image 27: Detached workshop 12

Interior, looking towards west end with chimney in adjacent boiler room visible. Note line shaft brackets along rear (left hand) wall
